January 30, 2017
BBA Project No. 16244

RE: Coletto Creek Power – December 2016 Primary and Secondary Ash Ponds Dike Inspection

NAME OF DAM: Coletto Creek Dike System

INSPECTION DATE: December 14, 2016

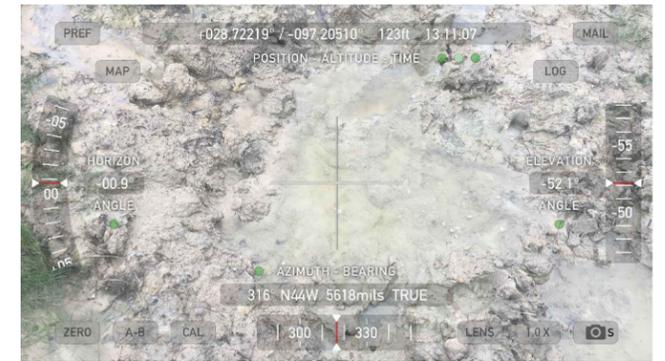
Wet areas were identified near the toe of slope in the approximate area of Sta 84+00 to Sta 90+00, with moist areas, and indications of apparent historic wet areas extending to approximately Sta 95+00. This area has been identified in previous inspections conducted in the 1980s and 1990s, and more recently during the 2015 inspection. The wet areas and associated erosional features are shown in photos 2133, 2144, 2145, 2146, 2147, and 2148. As shown in the photos, some of these areas are wet, ponding and appear associated with recent rain events and possible accumulation of seepage water. The ponded water appeared to have a surface film associated with decomposition of plant (organic) matter, had no appearance of flow, and did not contain suspended sediments. The wet areas have historically been observed with no suspended sediments. There was no discernible subsidence or settlement observed along the interior dike slope, dike crest, or upgradient portions of the external dike slope in these areas. BBA is currently designing a seepage collection system and toe of dike grading plan for implementation to remedy these areas.

2147 - Exterior Toe (Wet Area)

- Complete the engineering design currently being developed to address the wet areas identified along the exterior toe of the Primary Ash Pond, and implement the remedy.

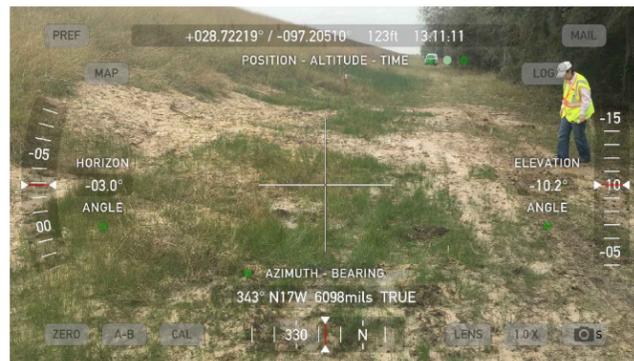
2148 - Exterior (Wet Area)

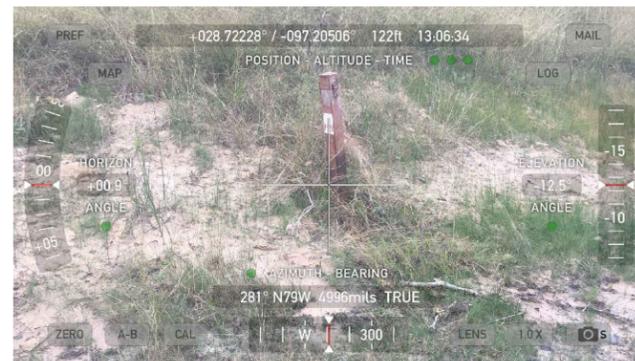
2146 - Exterior - Piezo 9 (Wet Area)

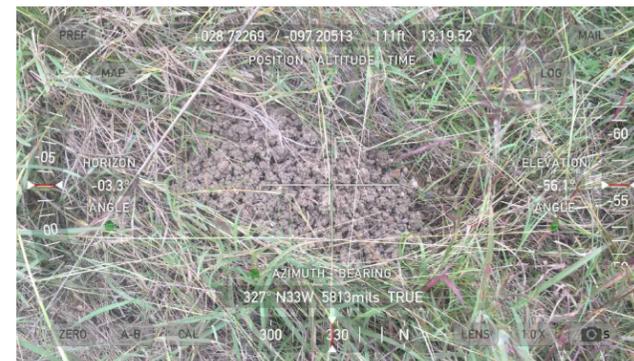
2153 - Exterior Toe (Rodent Grubbing)

- Evidence of animal rooting/grubbing on the dike was minimal during this inspection. However, if evidence of increased activity is observed, implement rodent control as needed. Evidence of fire ants was minimal; however, continue to inspect for fire ants especially in summer months and implement fire ant control as needed (fire ant colonies can be intrusive into the dike interior potentially resulting in piping or initiation of erosion areas).

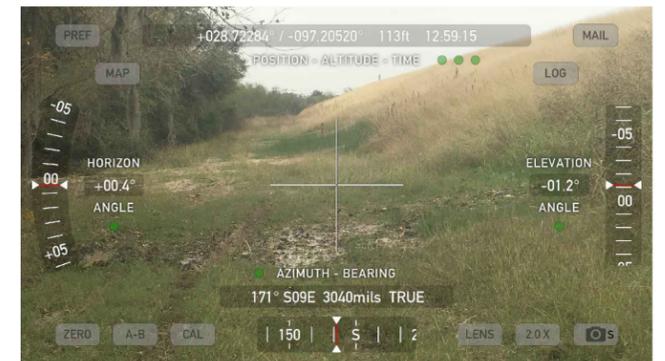
2144 - Exterior Toe (Wet/Erosion Area)

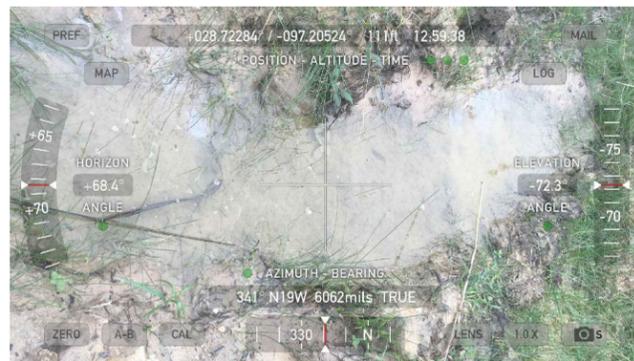
2145 - Exterior (Wet Area)

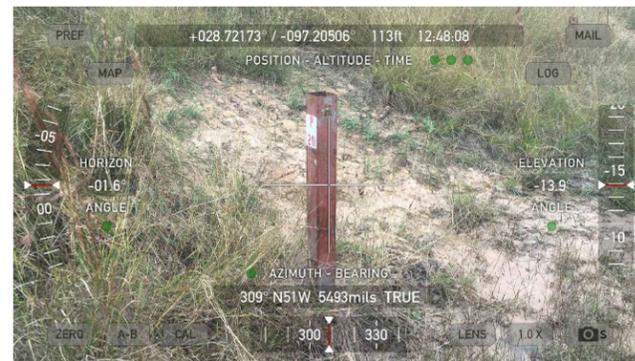
2133 - Exterior - Piezo 20 (Wet Area)

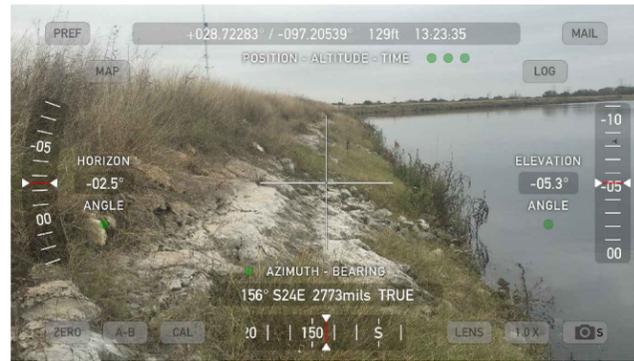
Photos 2159, 2221 and 2304 show inside slope rock armor in areas impounded with water. Photo 2334 shows the inside of the ash pond with a drainage channel cut within the ash to convey sluice material.

2159 - Interior Slope Protection

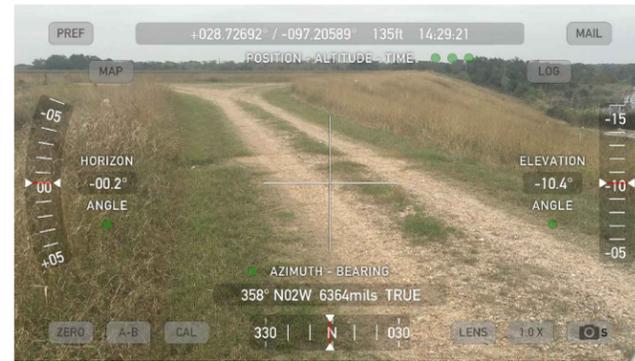
A small diameter steel pipe was observed on the east dike exterior side slope near Sta 70+00, and appears to penetrate the crest of the dike approximately 2 feet below grade. This pipe appears crushed where exposed on the side slope and is not in use. Photo 2208 shows the approximate dike location of the pipe penetration. A steel pipe was also observed on the west dike shared with the Evaporation Pond, near Sta 29+00 as shown in photo 2329. This pipe appeared to be approximately 18 inches in diameter and discharges into the Evaporation Pond. The pipe appeared to penetrate through the upper portion of dike and was not in use during the inspection. The approximate 6-inch diameter pipe observed at the toe of slope near Station 37+00 during the 2015 inspection was not observed during the 2016 inspection likely due to the tall, thick vegetation restricting visibility.

2208 - Top of Levee / Location of Small Diameter Steel Pipe (shallow - buried)

- Pipe penetrations observed in the dikes appeared to occur within the upper approximate 2-3 feet of the dike crest, and no substantial dike erosion or indications of settlement were observed in these areas. However; one six-inch diameter steel pipe (near Sta 70+00) observed along the exterior dike slope appeared crushed and inoperable. Coletto Creek should review all pipes that penetrate the levee and consider proper removal of any pipes that may be identified as no longer planned for use. Additionally, given the pipes appear old, BBA recommends inspection of pipe sections that penetrate the dike and will not be removed, and that are accessible for inspection via use of a remote camera system.

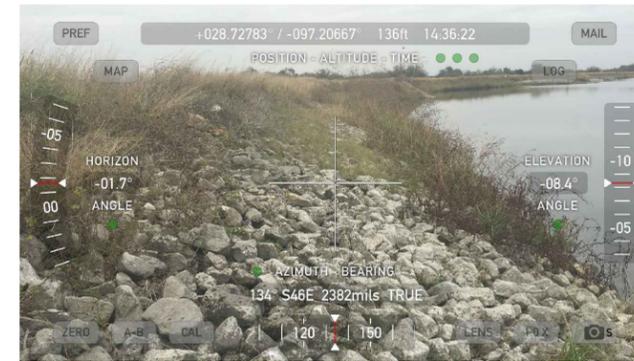
2221 - Interior Slope Protection

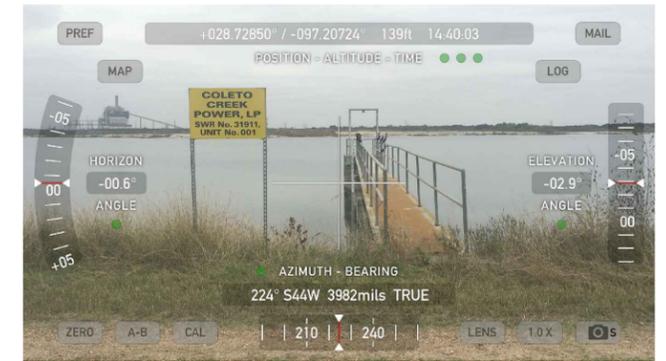
The outlet works from the Primary Ash Pond includes a weir and access walkway as shown in photos 2228, 2237, 2230, 2241 and 2243. Stoplogs were not in place at the time of inspection (photo 2241). The staff plate reading as shown in photo 2237 indicated a water surface elevation of approximately 133.0 ft (approximately 7 feet below top of dike elevation).

2228 - Outlet Works

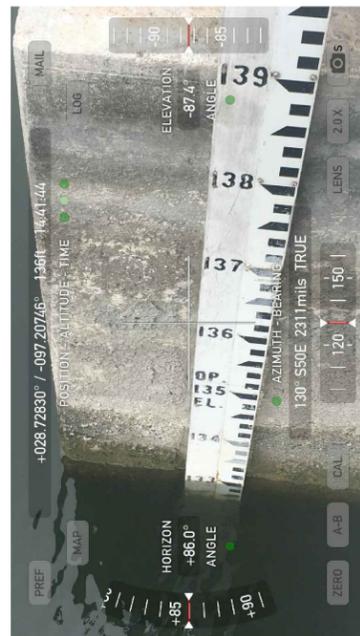
2237 - Staff Plate on Outlet Works

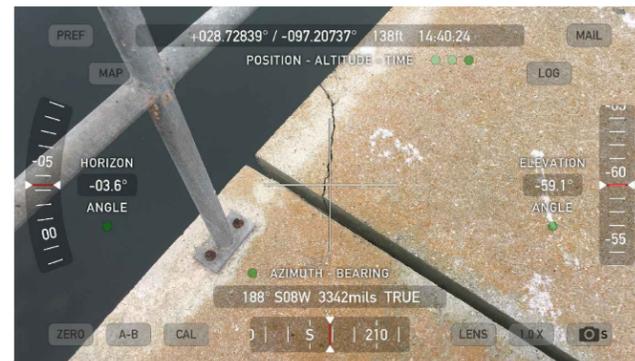
Minor cracks were observed in the outlet concrete walkway structure and some expansion joints appear to have larger than average gaps, indicating possible (appeared likely historic) movement. Additionally, when viewed from the side the concrete walkway decking appears to have a slight sag in areas between bents. The railings for the walkway structure are loose and walkway rail bolts

are rusted. Cracks, a joint in the concrete decking, and rusted handrail bolts are shown in photos 2230 and 2243.

2230 - Concrete Decking Joint (at first bent)

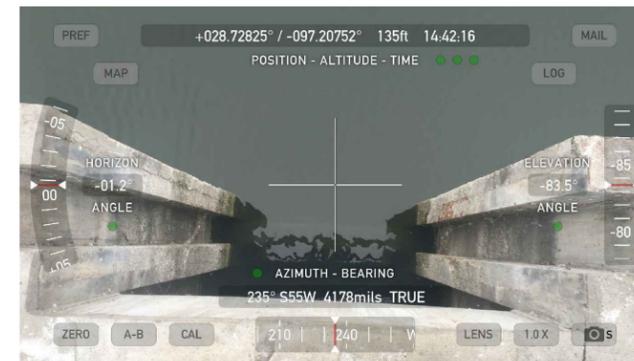
2241 - Stoplog Slots

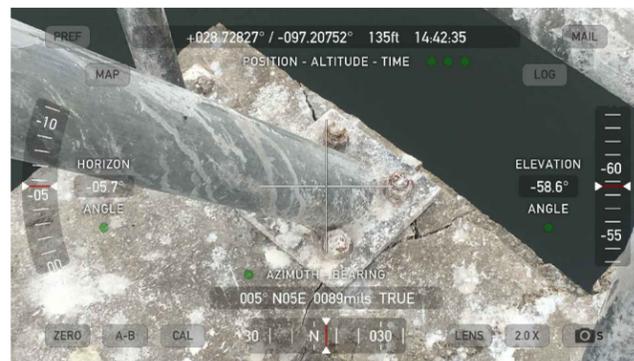
AREA INSPECTED	SPILLWAYS 1 OF 1			CHECK (X) ACTION NEEDED		
	ITEM NO.	CONDITION	OBSERVATIONS	MONITOR	INVEST- IGATE	REPAIR
INLET	30	Weir	Weir structure intake was submerged and therefore could not be inspected. The walkway access handrails were observed to have corroded bolts and were loose. Handrail bolts should be replaced as needed and handrails tightened.	X		
	31	Trashrack (if applicable)	Not observed.	X		
	32

2243 - Rusted Handrail Bolts and Cracked Concrete - Handrail is Loose

- Remove silt accumulation from the existing seepage collection system sump inlet pipe identified in photo 2180.
- For safety purposes, replace severely corroded bolts and tighten the handrails located along the Primary Ash Pond outlet works access walkway.

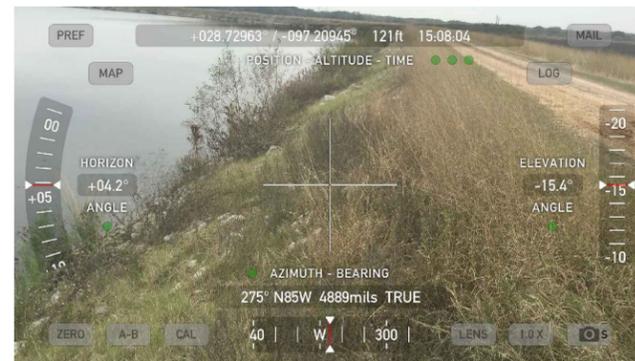
2304 - Interior, Slope Protection (Stone) Covered by Grass

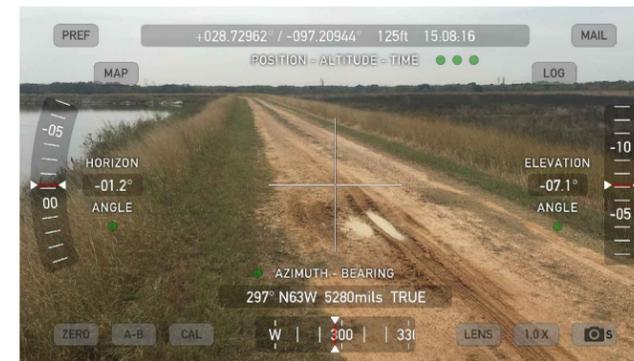
The dike crest appeared in generally good condition with only minor rutting observed in localized areas. The crest included a perimeter access road comprised of a coarse aggregate base material with grassed shoulders and grass intruding through the aggregate in the center of the access road (between tire paths).

2306 - Top of Levee - Minor Ruts

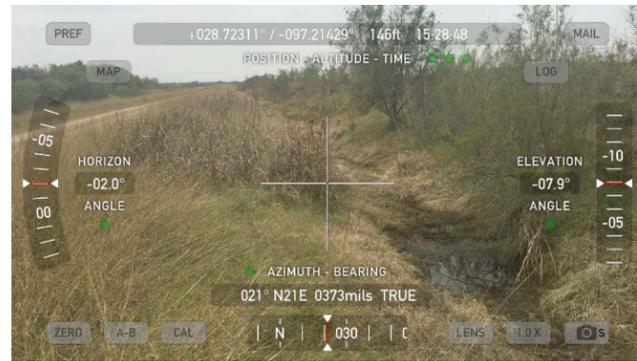
2334 - Interior (Sluice Discharge Channel)

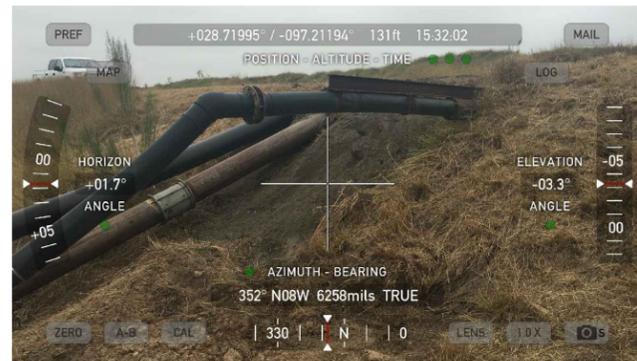
As shown in photo 2349, pipes penetrate through the upper portion of the dike within approximately 2-3 feet of the crest elevation – this is located along the south end of the Primary Ash Pond where the pond is filled with dry ash material to within a few feet of the dike crest elevation.

2349 - Exterior / Pipe Corridor

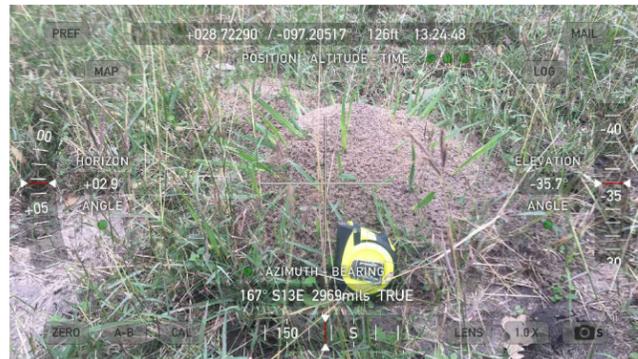
2161 - Exterior (Ant Bed)

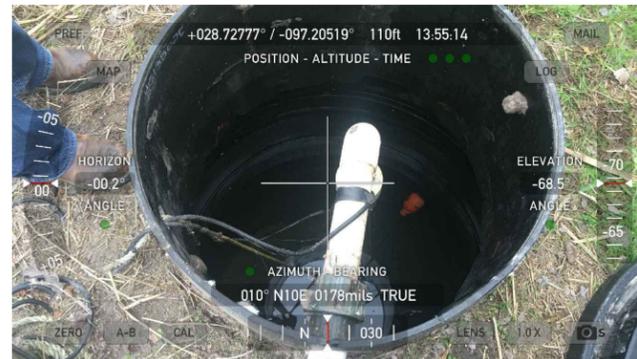
The existing seepage collection system sumps located near the pump house in the vicinity east of Sta 70+00 were visually inspected to verify they were operational. The sump located northwest of the pump station (photos 2179, 2180 and 2186) appears to have substantial silt accumulation in the incoming drain pipe. Silt should be removed to facilitate flow. Both pumps systems cycled on and appeared to work properly during the inspection.

2186 - Seepage Collection System Sump

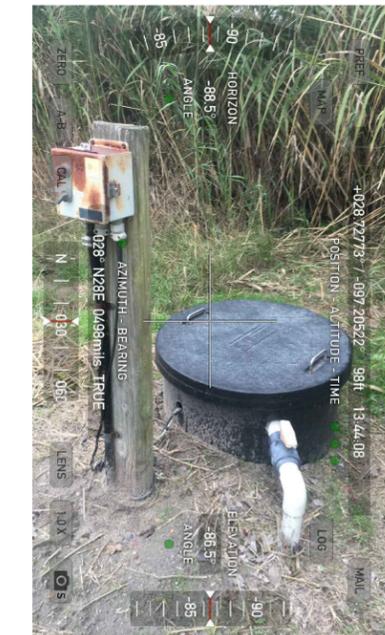
2179 - Seepage Collection System Sump

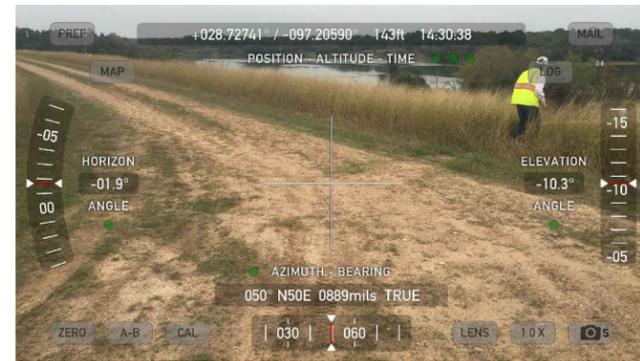
2209 - Top of Levee, Seep Collection Discharge Pipe (shallow burial)

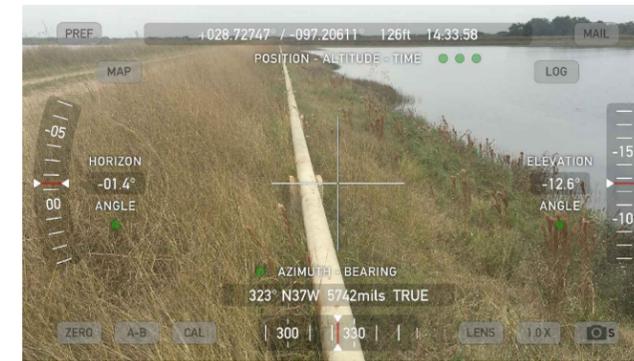
An approximate 6-inch diameter steel pipeline appears to penetrate the exterior side slope of the Secondary Ash Pond within approximately 2-3 feet of the dike crest near Sta 128+00, and then runs along the Secondary Ash Pond interior side slope of the shared dike as shown in photos 2218 and 2223. During this inspection the pipeline was conveying water from the existing seepage collection system into the Secondary Ash Pond and was discharging into the Secondary Ash Pond near the Primary-to-Secondary Ash Pond outlet works. The pipeline also extends west past this discharge location (through a valve), and appears to penetrate the Secondary Ash Pond west dike (shared with the Evaporation Pond) near Sta 111+00. The penetration appears to occur in the upper 3 feet of the dike crest and transitions into a 12-inch diameter steel pipe along the Evaporation Pond interior side slope. The 12-inch diameter pipe discharges into the Evaporation Pond. A concrete splash pad is located below the discharge pipe invert, at the toe of the Evaporation Pond dike interior side slope as shown in photo 2276. The pipe was not in operation during this inspection.

2218 - Interior

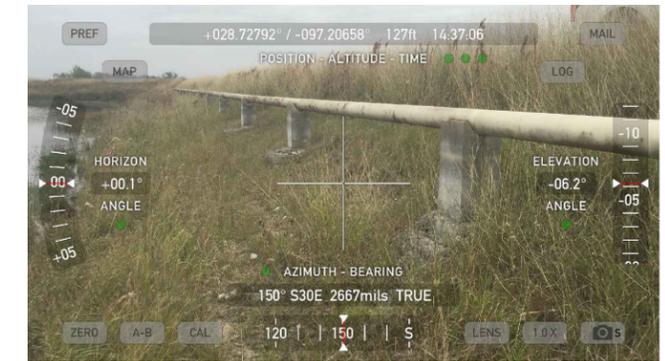
2223 - Interior

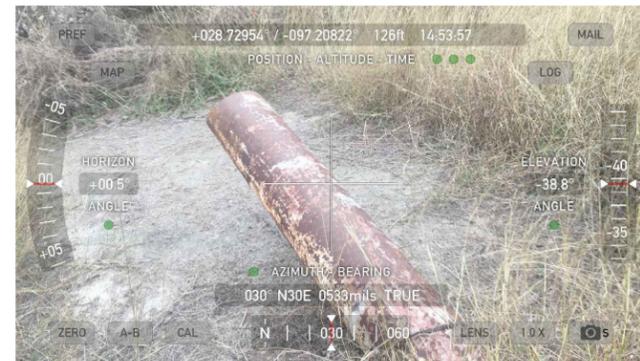
2276 - Exterior Pipe Outlet

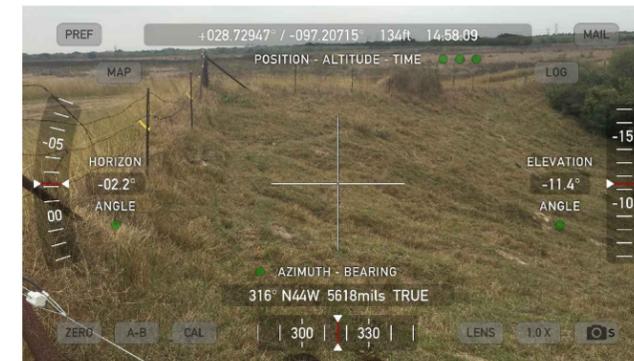
2284 - Exterior, Minor Erosion

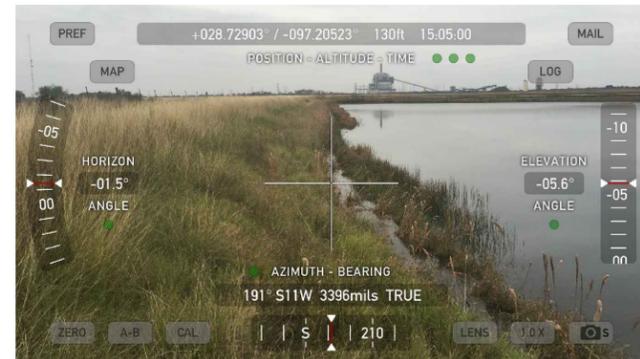
As indicated in the 2015 inspection report, the Secondary Ash Pond interior side slopes appeared to exhibit minor to moderate and generally uniform bank cut likely due to wave action. This erosion feature appears to have occurred a long time ago given the slope is currently heavily vegetated. At the time of inspection, the water level was low enough to enable access to the interior slope as indicated in the photos. The cut does not appear to be problematic from a dike stability standpoint and no immediate action is required. Maintaining the water level as low as observed during the inspection will prevent future progression of erosion. Alternatively, armoring the slope to reduce future bank cut may be considered to reduce potential future erosion. Other than the bank cut observed, the interior slopes appear well vegetated and in generally good condition. Bank cut erosion is shown in photo 2300.

2300 - Interior / Bank Erosion
