ANNUAL INSPECTION OF CCR UNITS

**Oak Grove Steam Electric Station
Robertson County, Texas**

January 2017

Golder Associates Inc. (Golder) was retained by Luminant to perform the 2016 annual inspection of Ash Landfill 1 at the Oak Grove Steam Electric Station located near Franklin, Robertson County, Texas. The inspection of Ash Landfill 1 included the following:

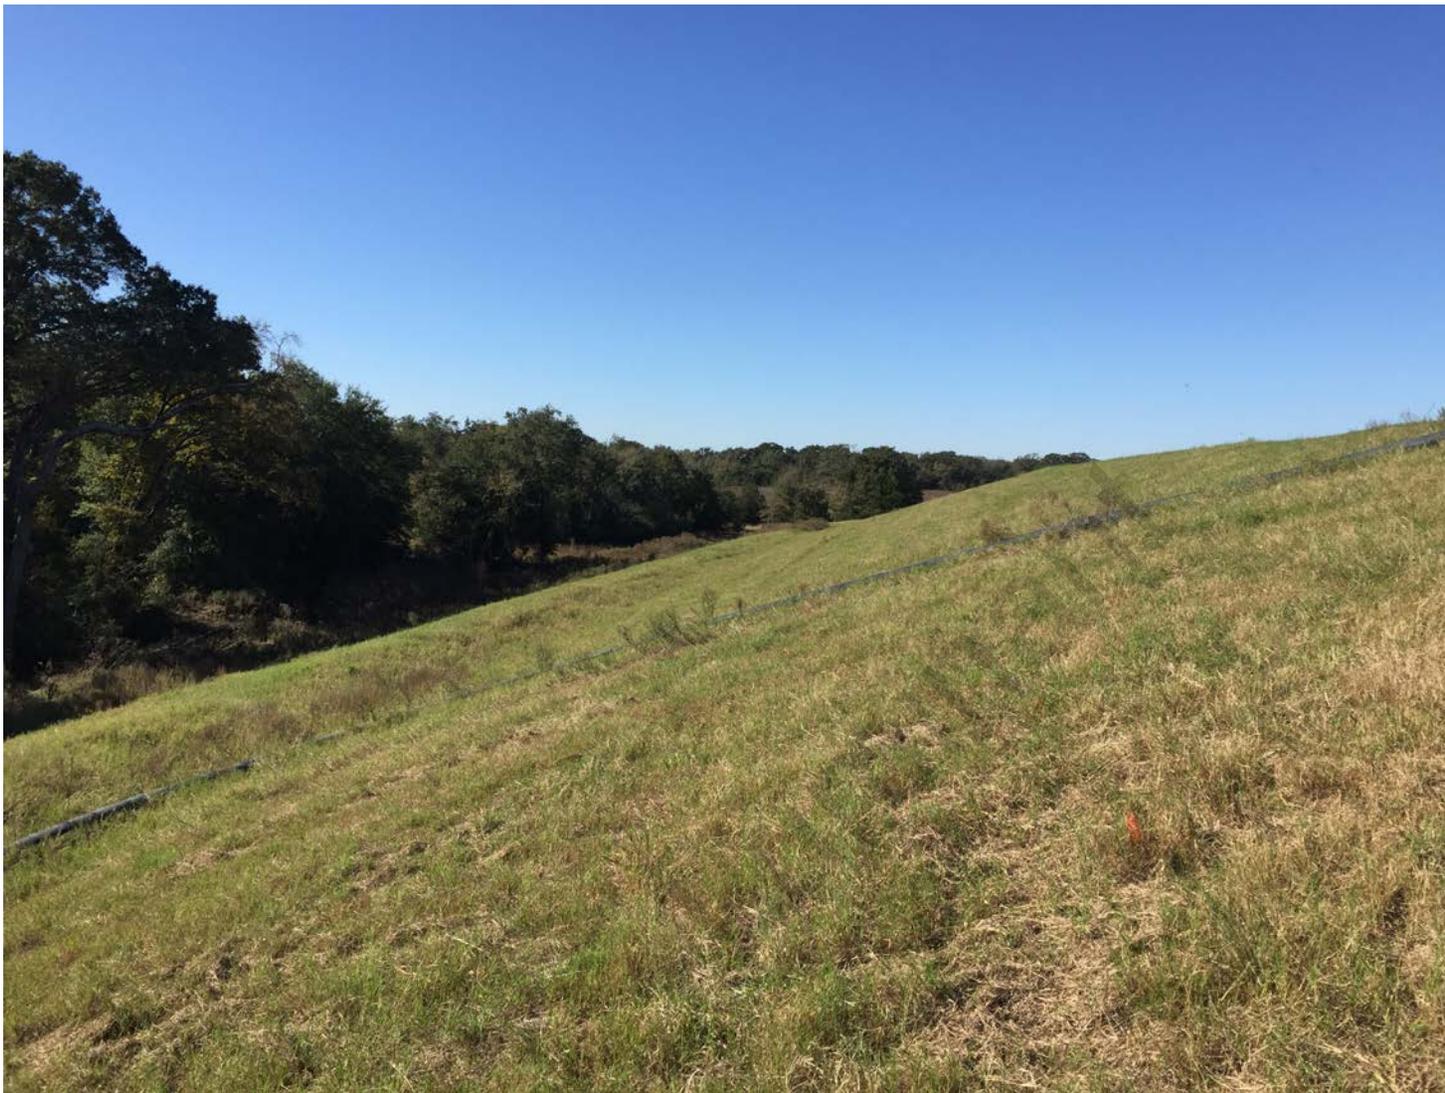
PROJECT NO. 1669251		FILE REF. IMG_2924.JPG	
	DESIGN	VK	11/30/2016	SCALE: NTS
	CHECK	VK	11/30/2016	REV: 0
	REVIEW	JBF	11/30/2016	PHOTO 1

PHOTO DESCRIPTION:
 Southern slope of Cell 3.

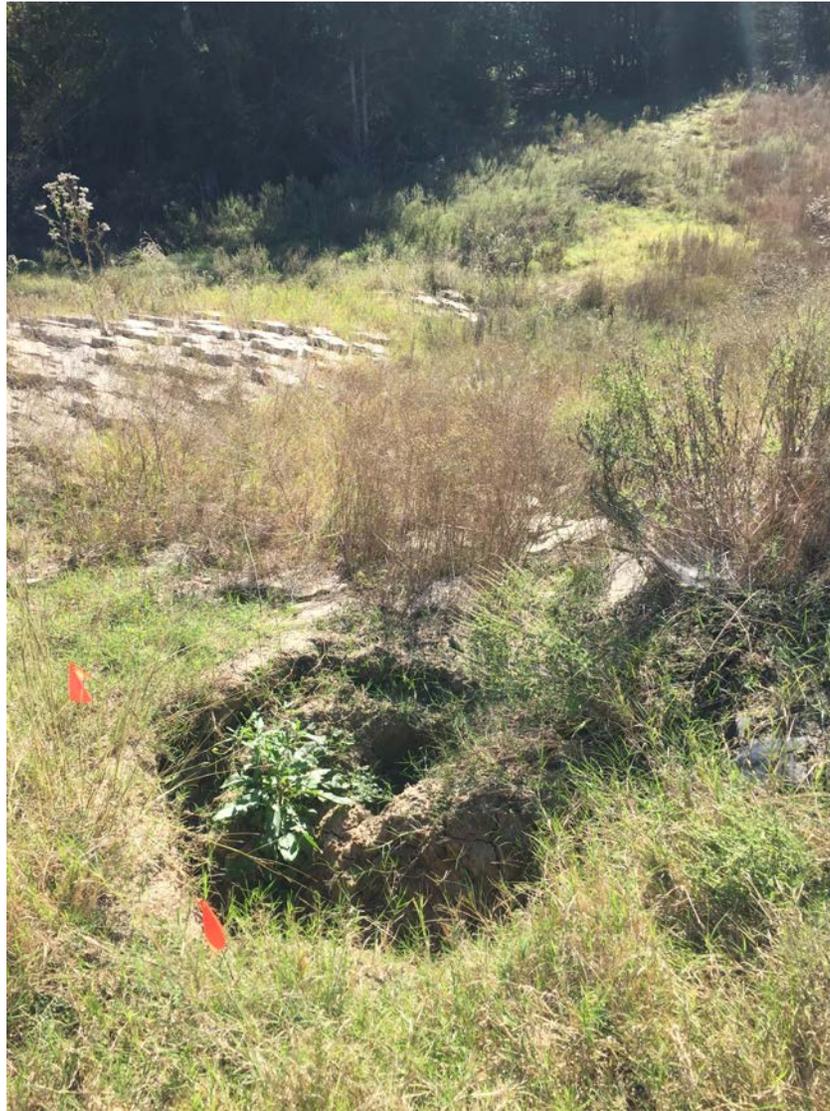
PROJECT NO. 1669251		FILE REF. IMG_2925.JPG	
	DESIGN	VK	11/30/2016	SCALE: NTS
	CHECK	VK	11/30/2016	REV: 0
	REVIEW	JBF	11/30/2016	PHOTO 2

PHOTO DESCRIPTION:
 Seepage below concrete block
 downchute of southern Cell 3
 slope.

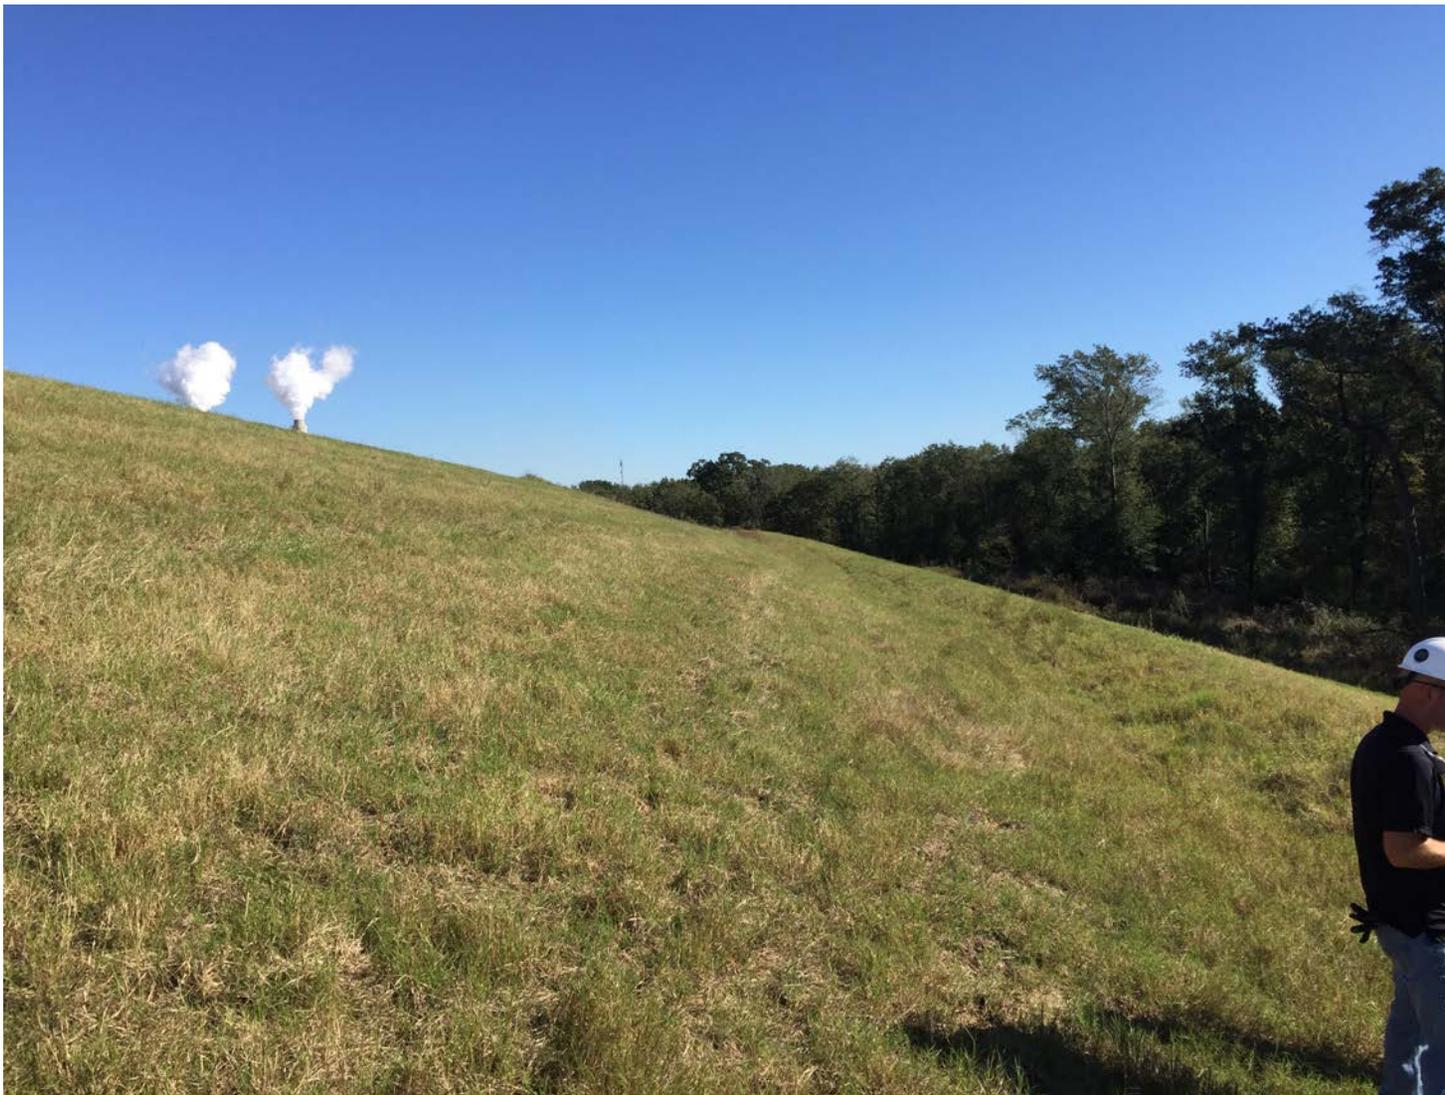
PROJECT NO. 1669251		FILE REF. IMG_2926.JPG	
	DESIGN	VK	11/30/2016	SCALE: NTS
	CHECK	VK	11/30/2016	REV: 0
	REVIEW	JBF	11/30/2016	PHOTO 3

PHOTO DESCRIPTION:
 Southern slope of Cell 3.

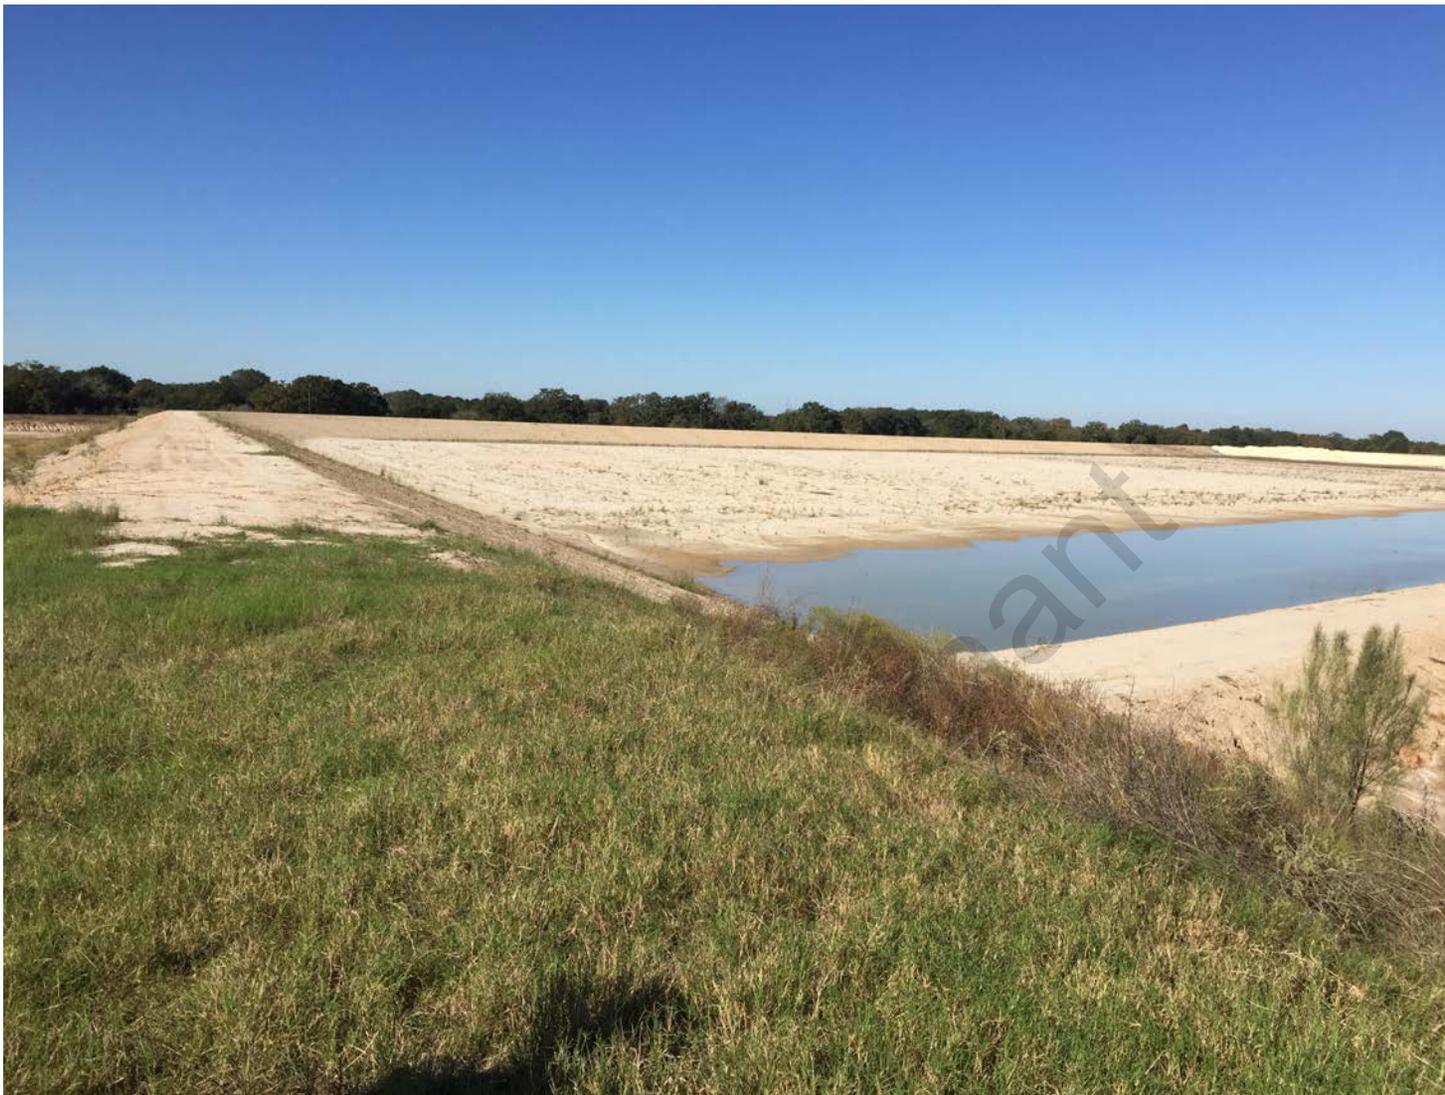
PROJECT NO. 1669251		FILE REF. IMG_2927.JPG	
	DESIGN	VK	11/30/2016	SCALE: NTS
	CHECK	VK	11/30/2016	REV: 0
	REVIEW	JBF	11/30/2016	PHOTO 4

U/S Slope	Good	Vegetation is present on the protective cover in Cell 3.	4	Minor	Check the root depth of the vegetation. If it exceeds the thickness of the protective cover (1 foot) it should be controlled to prevent damage to the clay liner.
	Benches	Fair	Silt fencing around drop inlets is in need of repair and some of the drop inlets are covered or partially covered with vegetation and/or sediment.		Moderate	Drop inlets likely need more frequent maintenance.
			Rutting affecting drainage along upper bench near southeast corner of Cell 1.	11	Minor	Regrade and confirm that area drains to drop inlet. Monitor for ponding water.
			Erosion features due to ponded water present along upper bench on eastern and northern slopes of Cell 1.	18	Moderate	Grade benches to drain to drop inlets. Repair erosion and reseed.
	Final Cover	Fair	Upper flat portion of the final cover vegetation is good. Vegetation on slopes not well established in areas. Repairs have been made, but rilling is occurring due to inadequate vegetation.	8, 9, 16, 17	Moderate

PHOTO DESCRIPTION:
 Cell 3 southern embankment
 and recently completed Cell
 4.

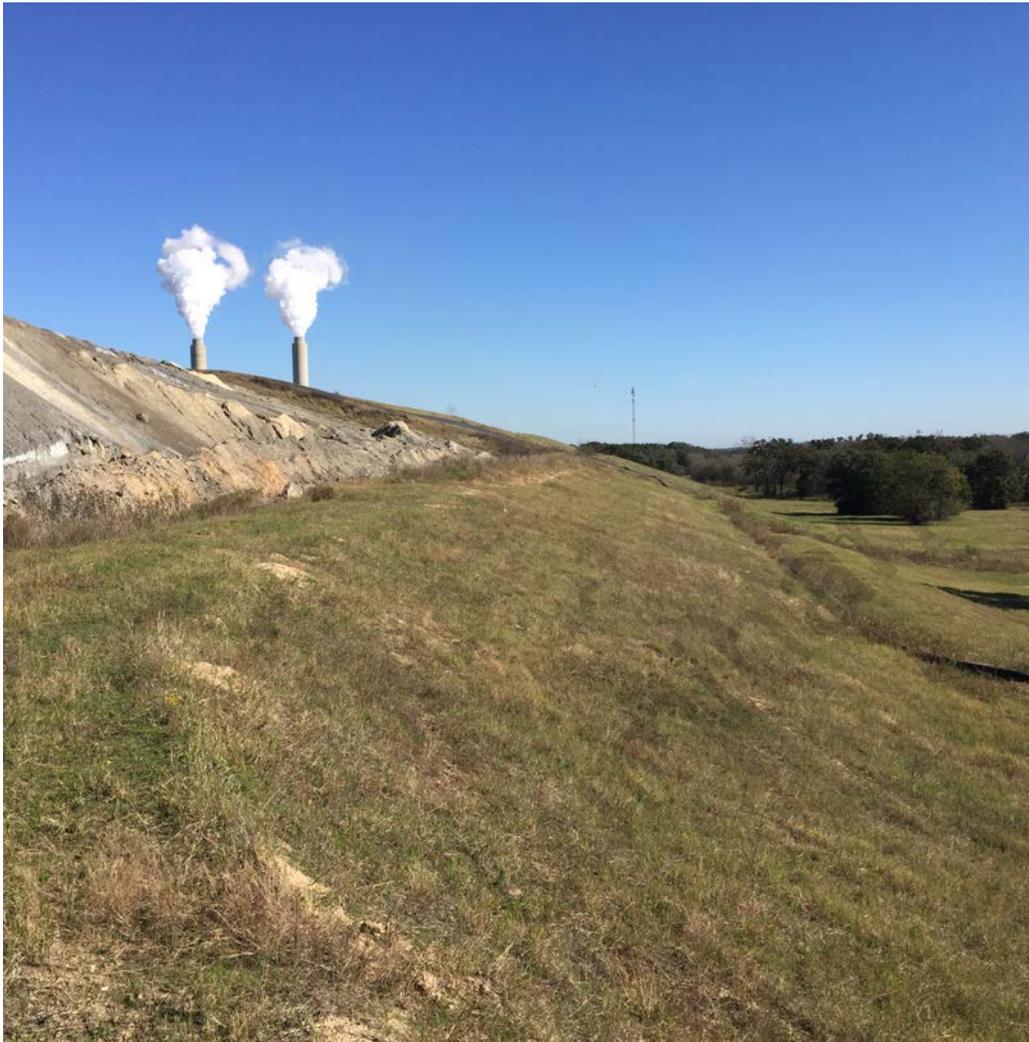
PROJECT NO. 1669251		FILE REF. IMG_2929.JPG	
	DESIGN	VK	11/30/2016	SCALE: NTS
	CHECK	VK	11/30/2016	REV: 0
	REVIEW	JBF	11/30/2016	PHOTO 5

PHOTO DESCRIPTION:
 Southern slope of Cell 2.
 Material place to direct
 contact water away from
 perimeter.

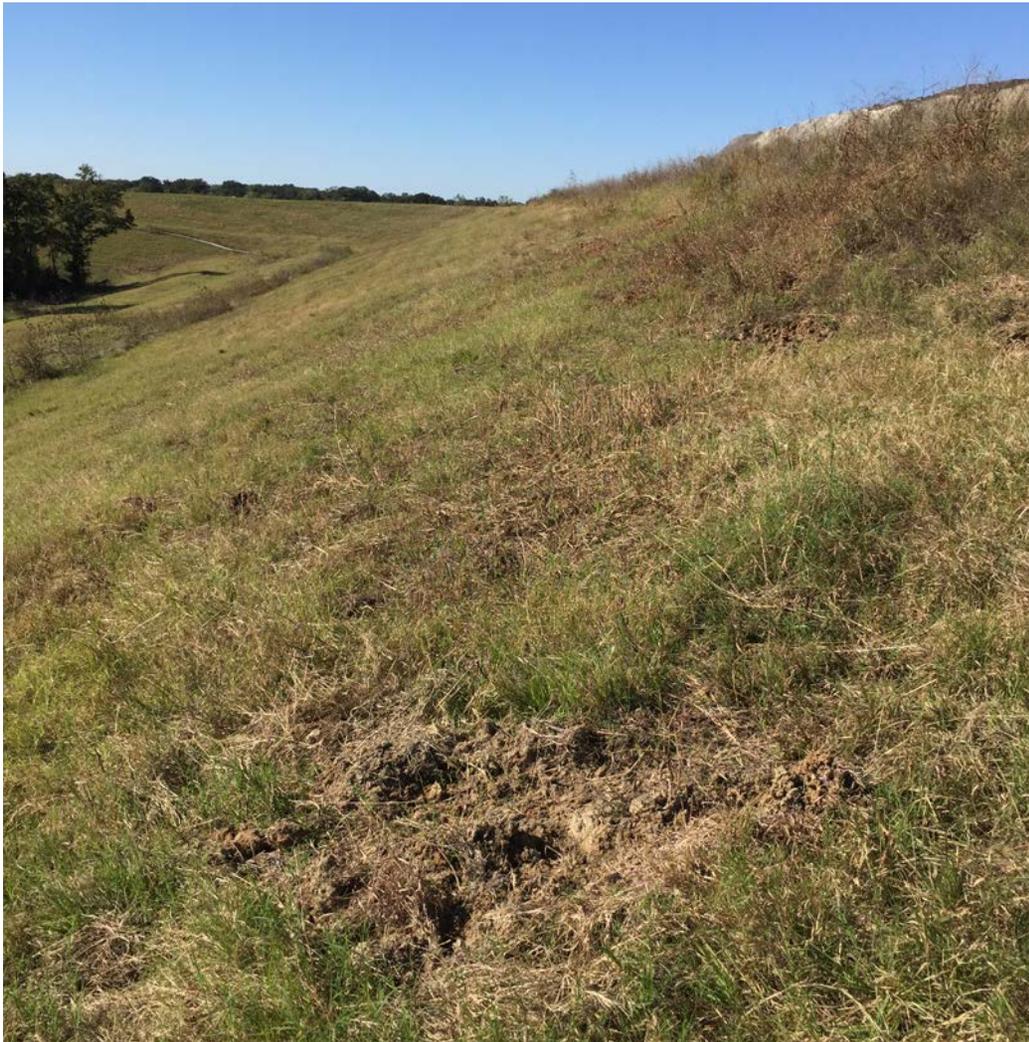
PROJECT NO. 1669251		FILE REF. IMG_2930.JPG	
	DESIGN	VK	11/30/2016	SCALE: NTS
	CHECK	VK	11/30/2016	REV: 0
	REVIEW	JBF	11/30/2016	PHOTO 6

PHOTO DESCRIPTION:
 Animal burrow on southern
 slope of Cell 2.

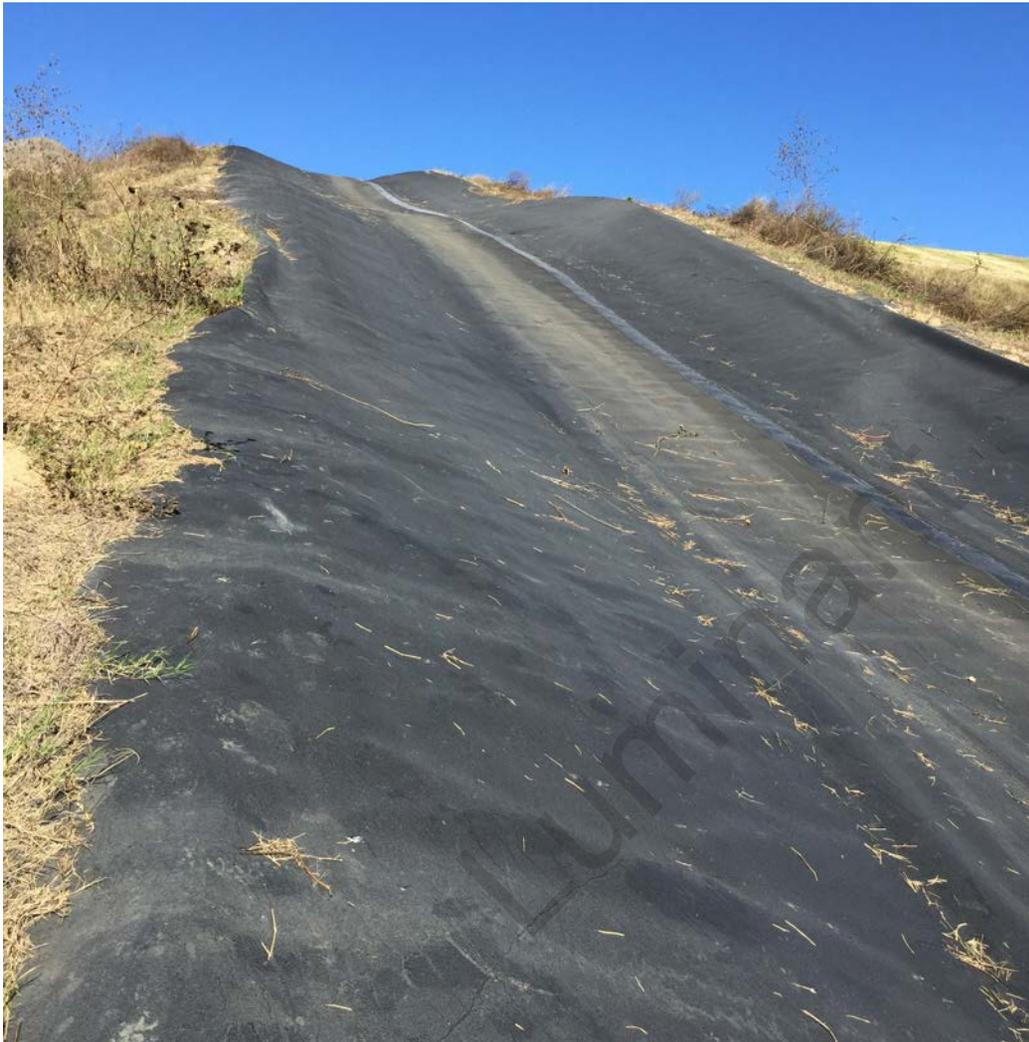
PROJECT NO. 1669251		FILE REF. IMG_2931.JPG	
	DESIGN	VK	11/30/2016	SCALE: NTS
	CHECK	VK	11/30/2016	REV: 0
	REVIEW	JBF	11/30/2016	PHOTO 7

PHOTO DESCRIPTION:
 HDPE geomembrane-lined
 downchute at west end of Cell
 1 southern slope.

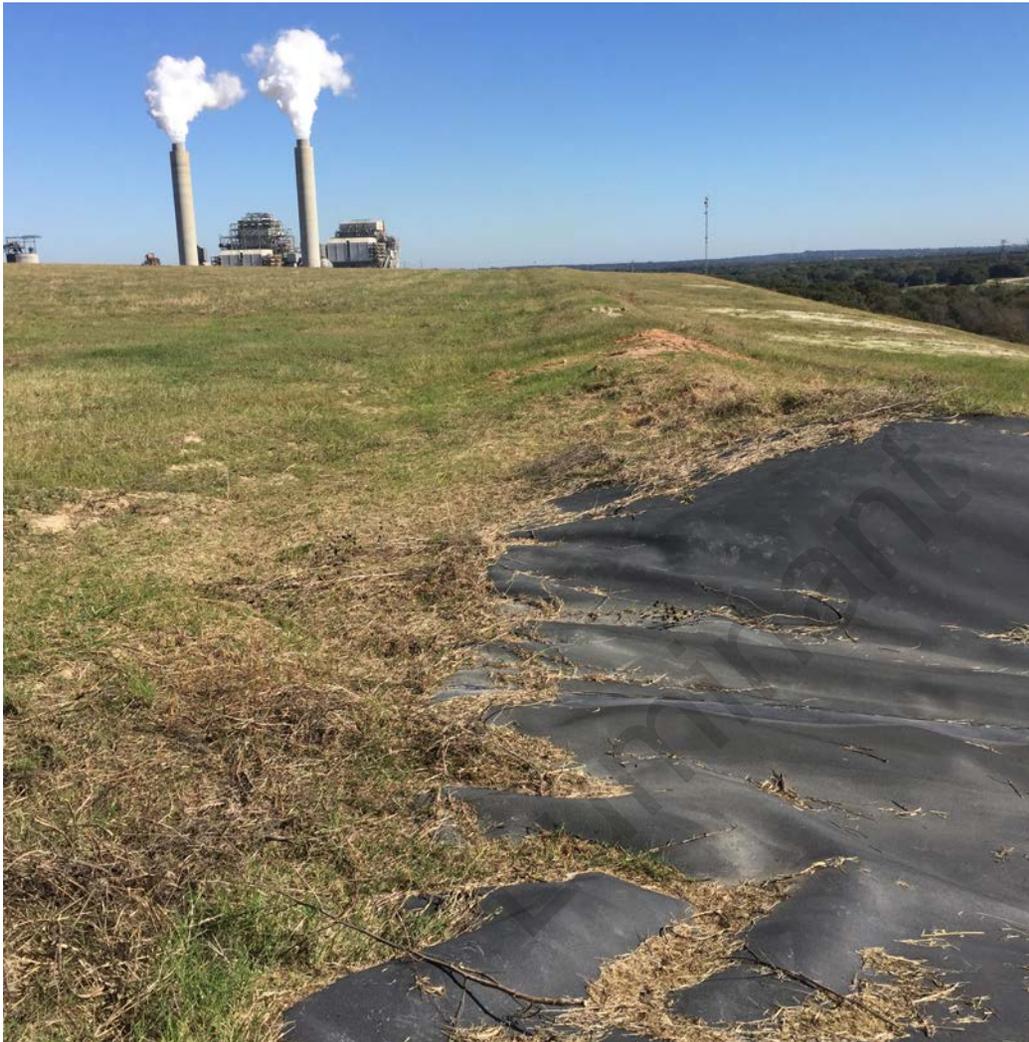
PROJECT NO. 1669251		FILE REF. IMG_2932.JPG	
	DESIGN	VK	11/30/2016	SCALE: NTS
	CHECK	VK	11/30/2016	REV: 0
	REVIEW	JBF	11/30/2016	PHOTO 8

PHOTO DESCRIPTION:
 Final cover along top of Cell 1.

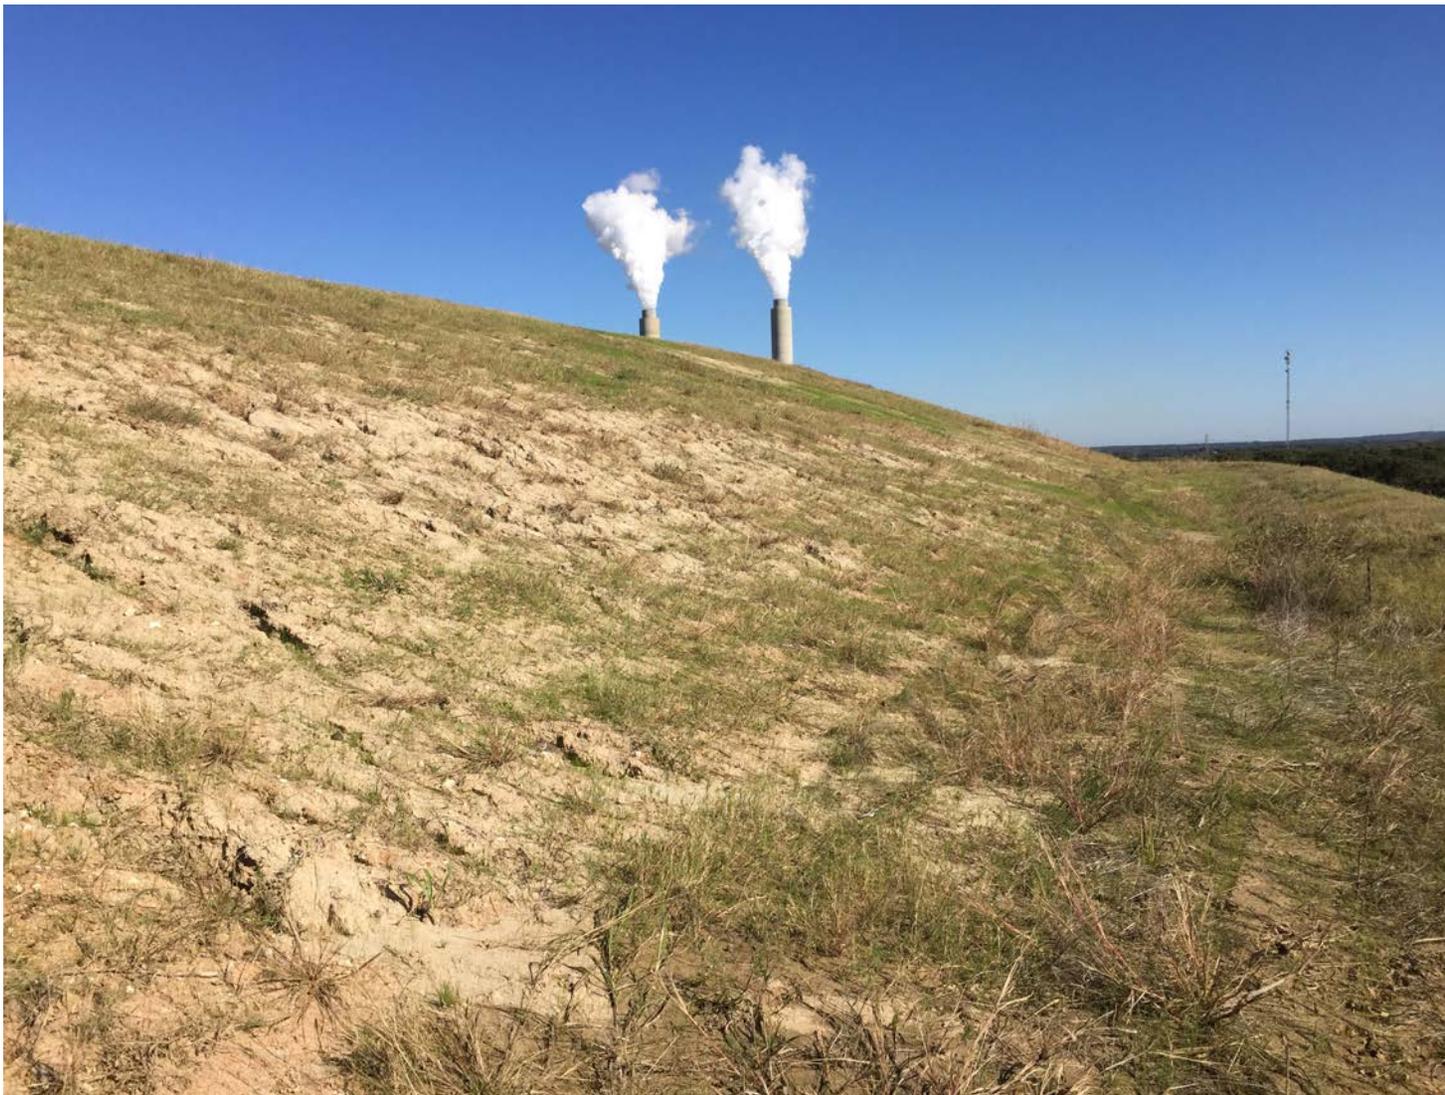
PROJECT NO. 1669251		FILE REF. IMG_2936.JPG	
	DESIGN	VK	11/30/2016	SCALE: NTS
	CHECK	VK	11/30/2016	REV: 0
	REVIEW	JBF	11/30/2016	PHOTO 9

PHOTO DESCRIPTION:
 Erosion of recently repair
 final cover near SW corner of
 Cell1.d

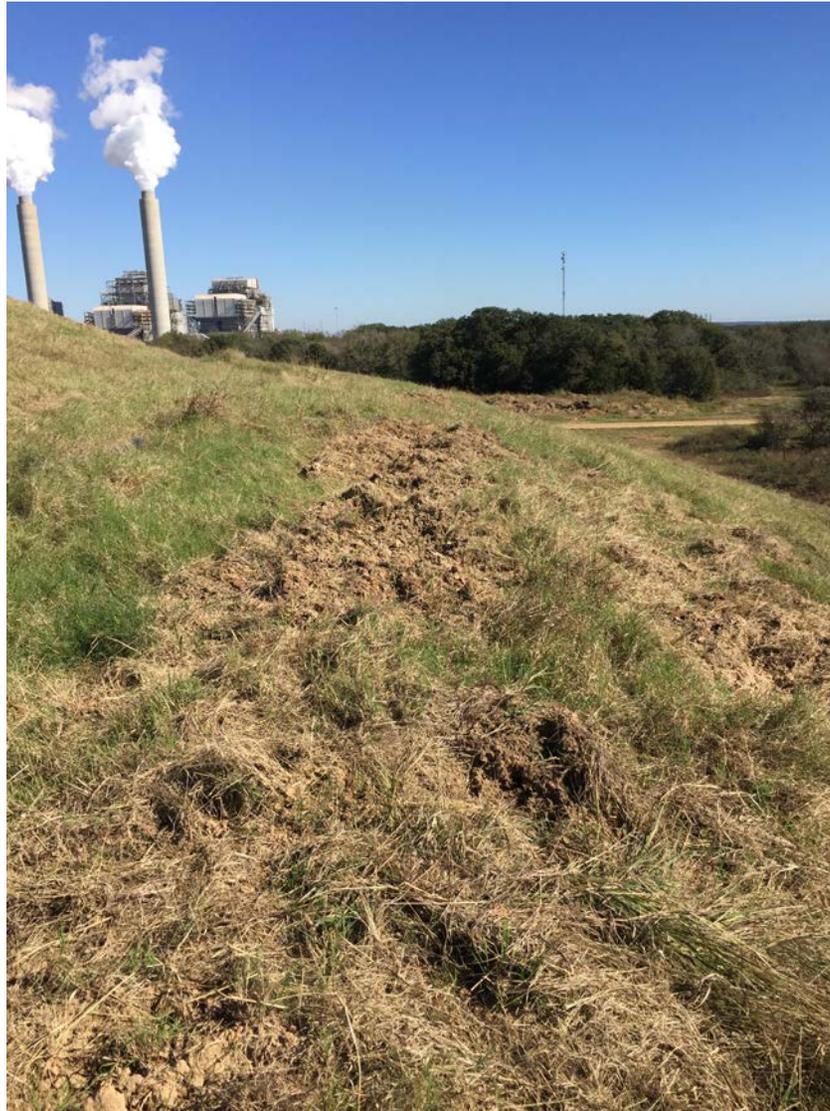
PROJECT NO. 1669251		FILE REF. IMG_2938.JPG	
	DESIGN	VK	11/30/2016	SCALE: NTS
	CHECK	VK	11/30/2016	REV: 0
	REVIEW	JBF	11/30/2016	PHOTO 10

PHOTO DESCRIPTION:
 Animal burrow on southern
 slope of Cell 1.

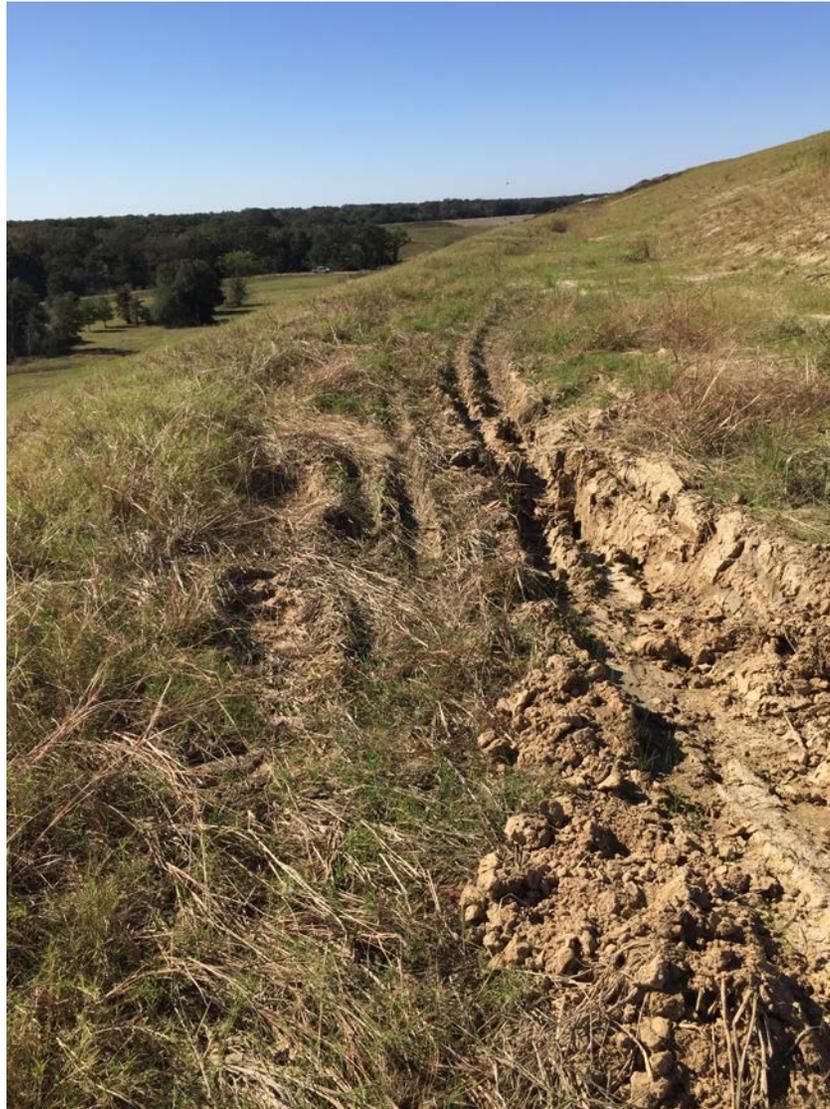
PROJECT NO. 1669251		FILE REF. IMG_2942.JPG	
	DESIGN	VK	11/30/2016	SCALE: NTS
	CHECK	VK	11/30/2016	REV: 0
	REVIEW	JBF	11/30/2016	PHOTO 11

PHOTO DESCRIPTION:
 Rutting on upper bench near
 SE corner of Cell 1.

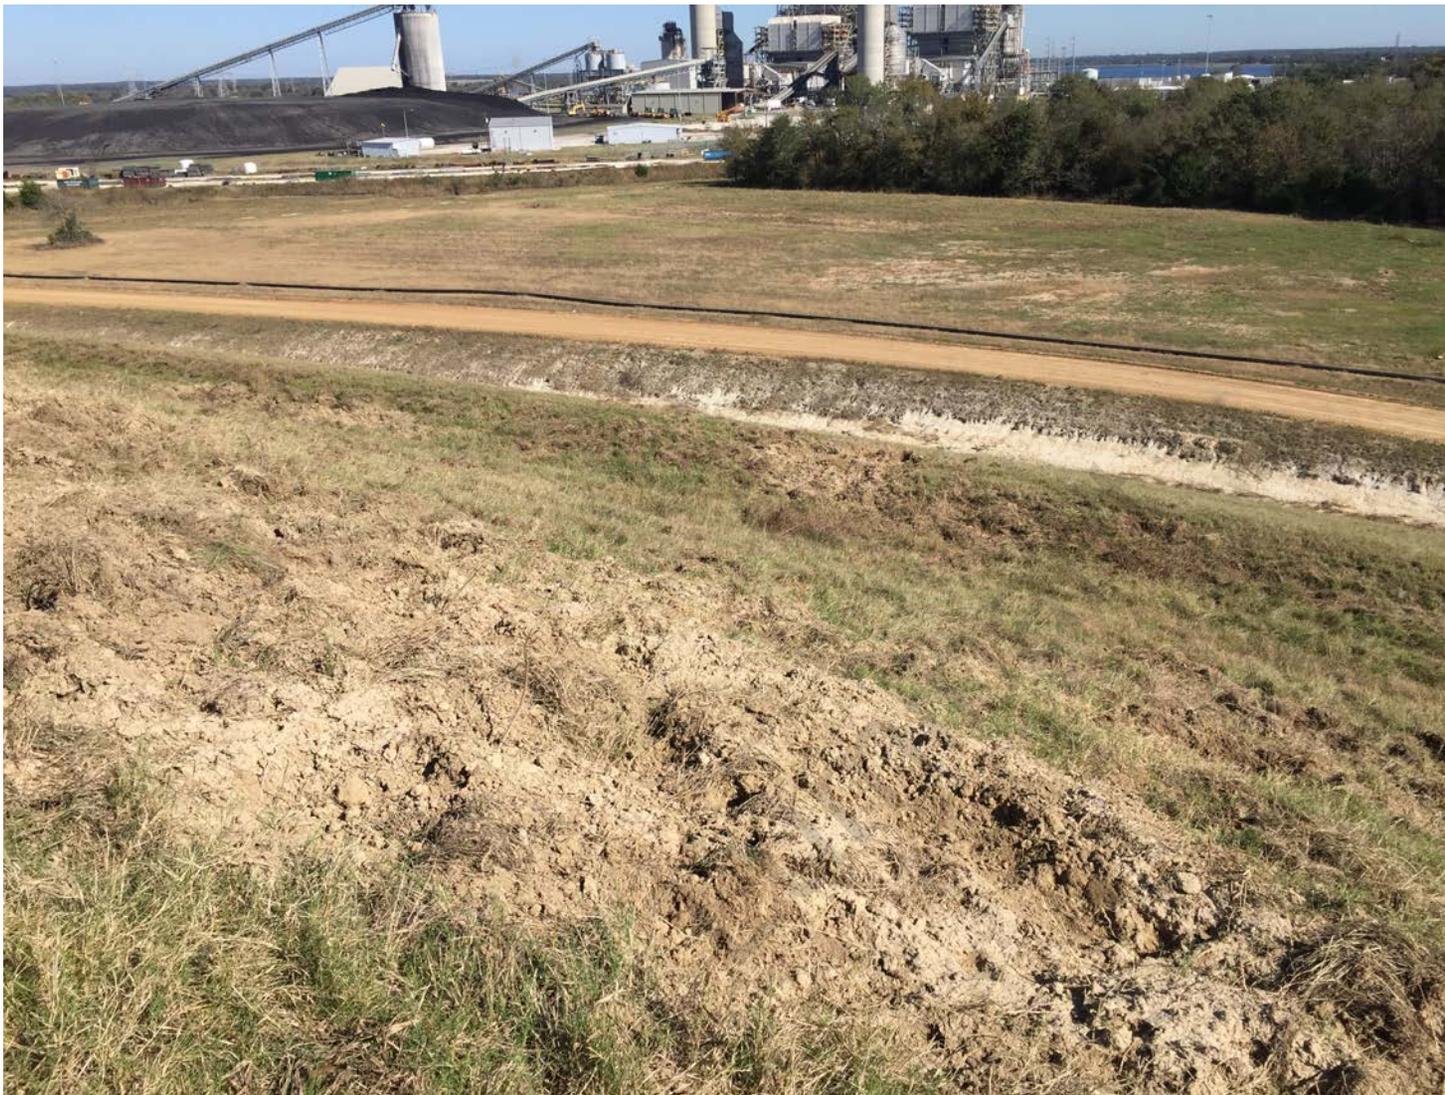
PROJECT NO. 1669251		FILE REF. IMG_2944.JPG	
	DESIGN	VK	11/30/2016	SCALE: NTS
	CHECK	VK	11/30/2016	REV: 0
	REVIEW	JBF	11/30/2016	PHOTO 12

PHOTO DESCRIPTION:
 Animal burrow on eastern
 slope of Cell 1.

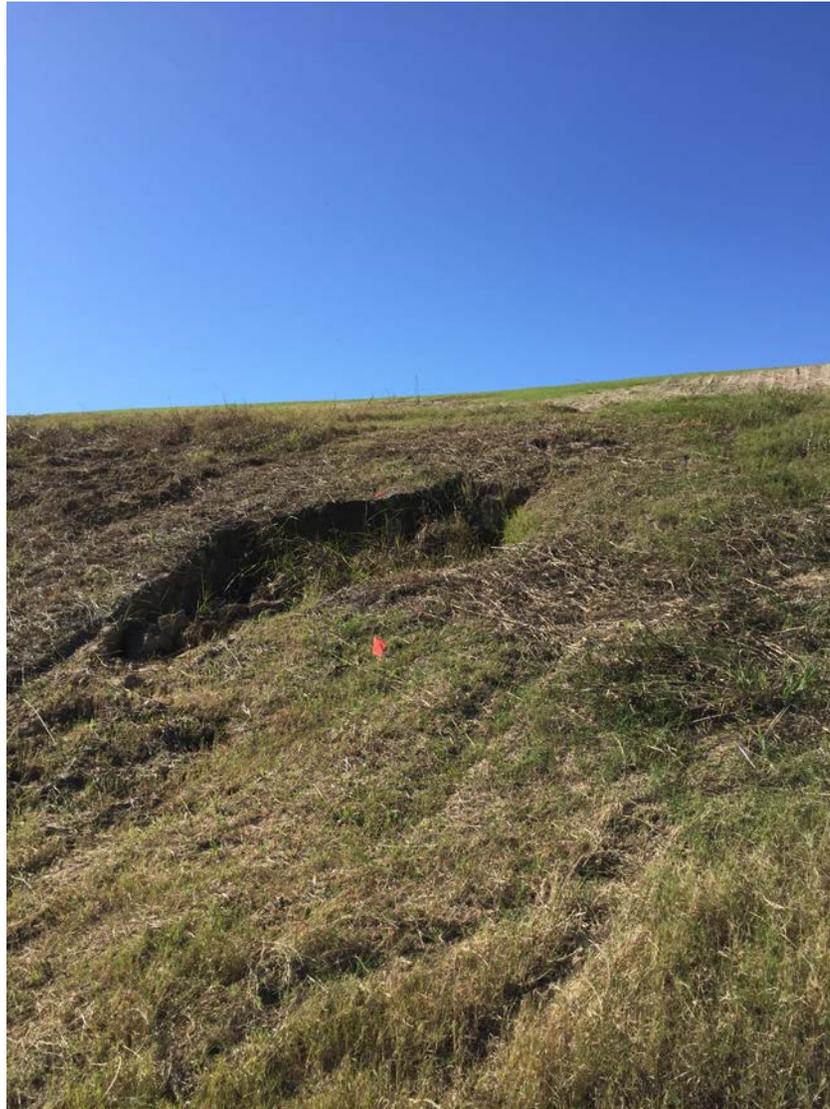
PROJECT NO. 1669251		FILE REF. IMG_2948.JPG	
	DESIGN	VK	11/30/2016	SCALE: NTS
	CHECK	VK	11/30/2016	REV: 0
	REVIEW	JBF	11/30/2016	PHOTO 13

CCR UNIT	Component	Condition * (Good/ Fair/ Poor)	Actions Since Last Inspections and Other Observations and Remarks	Photograph	Severity * (Minor/ Moderate/ Severe)	Further Actions and Recommendations
Ash Landfill 1	D/S Slope	Good to Fair	Cell 1: good vegetation below upper bench (i.e. below final cover).	15, 19	Minor	
			Cell 2 and 3: south slope well vegetated; north side vegetation is fair to good.	1, 3,	Minor	
			Cell 4: vegetation not established.	20, 21	Moderate	Fertilize and seed at start of growing season.
			Significant animal burrows present on south slope of Cell 2 and south and east slope of Cell 1.	5, 6, 10, 12	Moderate	Consider animal control program. Identify what the hogs are burrowing for and use herbicide to remove.
			Erosion features due to ponded water present along upper bench on eastern and northern slopes of Cell 1.	13	Moderate	Grade benches to drain to drop inlets. Repair erosion and reseed.

PHOTO DESCRIPTION:
 Slough due to ponded water
 seepage below upper bench in
 Cell 1.

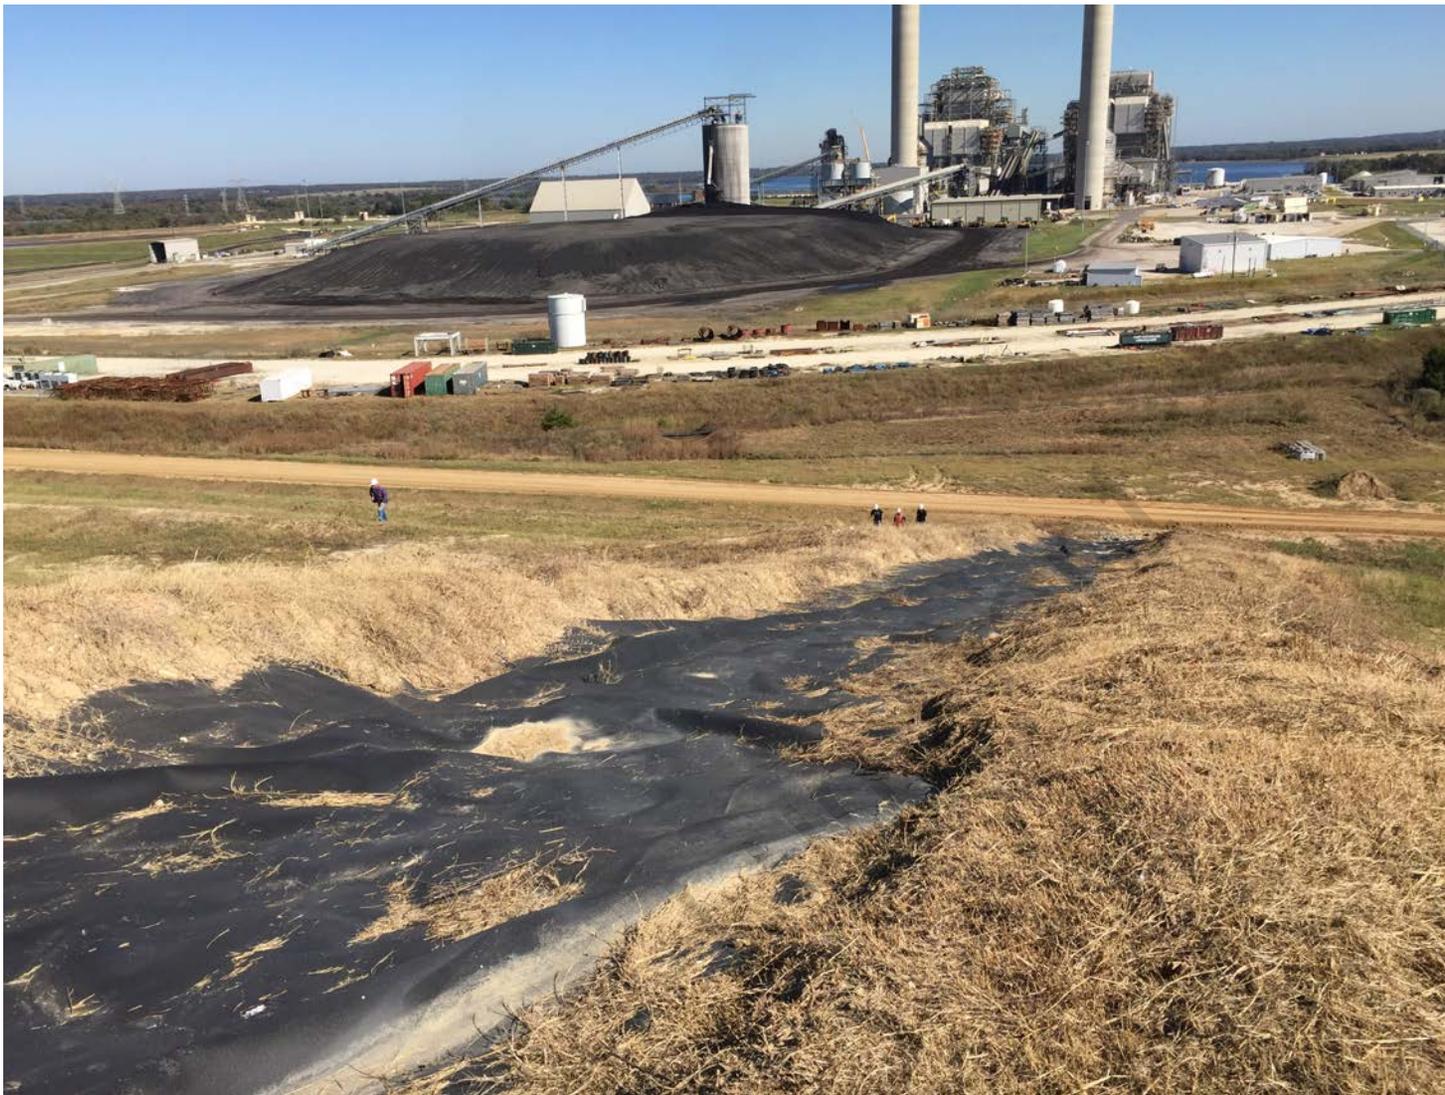
PROJECT NO. 1669251		FILE REF. IMG_2950.JPG	
	DESIGN	VK	11/30/2016	SCALE: NTS
	CHECK	VK	11/30/2016	REV: 0
	REVIEW	JBF	11/30/2016	PHOTO 14

Down-chutes	Good to Fair	The concrete-block downchute on the east slope Cell 1 has been removed and replaced with a temporary HDPE geomembrane-lined downchute. The concrete-block downchute along the northern slope of Cell 1 is performing well.	14		
			The new temporary HDPE geomembrane downchute in Cell 1 and the geomembrane-lined downchute along the southern slope of Cell 2 are performing well.	7, 8		
			Seepage eroding soil below woven geotextile in the concrete block-lined downchute on the southern Cell 3 embankment.	2	Minor	Continue monitoring. If conditions worsen, repair or replace downchute.
Control of Contact Water	Good	Water no longer ponding along south side of Cell 2. Contact water collecting in Cell 3 and Cell 4.

PHOTO DESCRIPTION:
 Concrete block downchute on
 eastern slope of Cell 1
 removed and replaced with
 HDPE-lining.

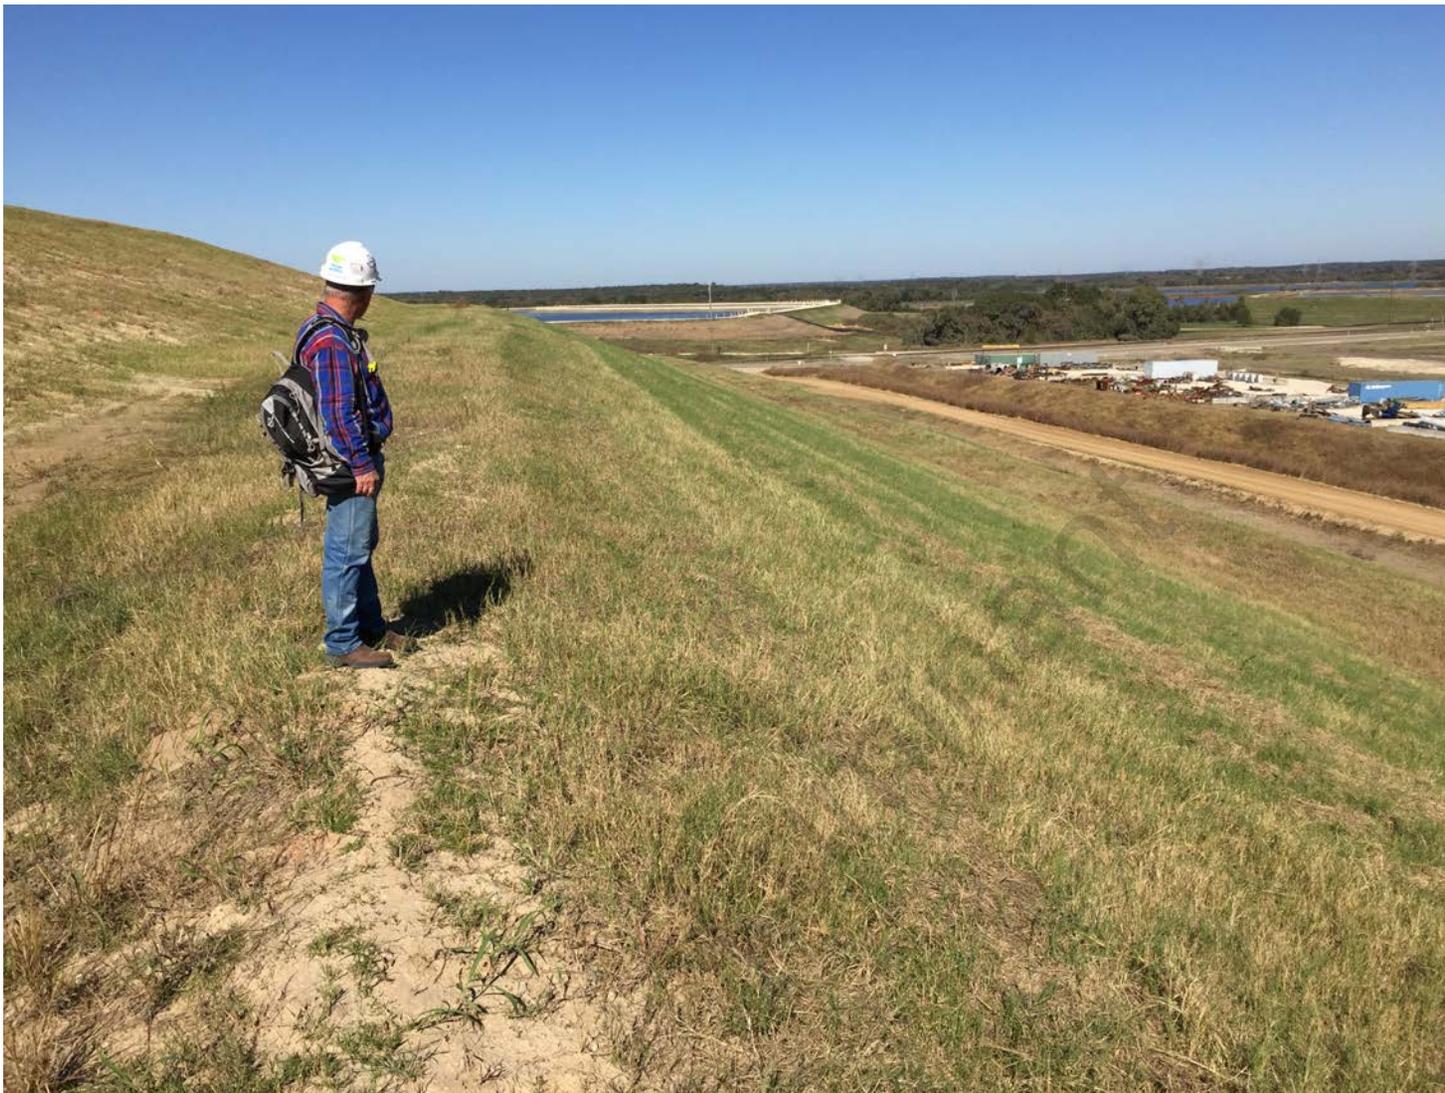
PROJECT NO. 1669251		FILE REF. IMG_2951.JPG	
	DESIGN	VK	11/30/2016	SCALE: NTS
	CHECK	VK	11/30/2016	REV: 0
	REVIEW	JBF	11/30/2016	PHOTO 15

PHOTO DESCRIPTION:
 Upper bench of southern slope
 of Cell 1.

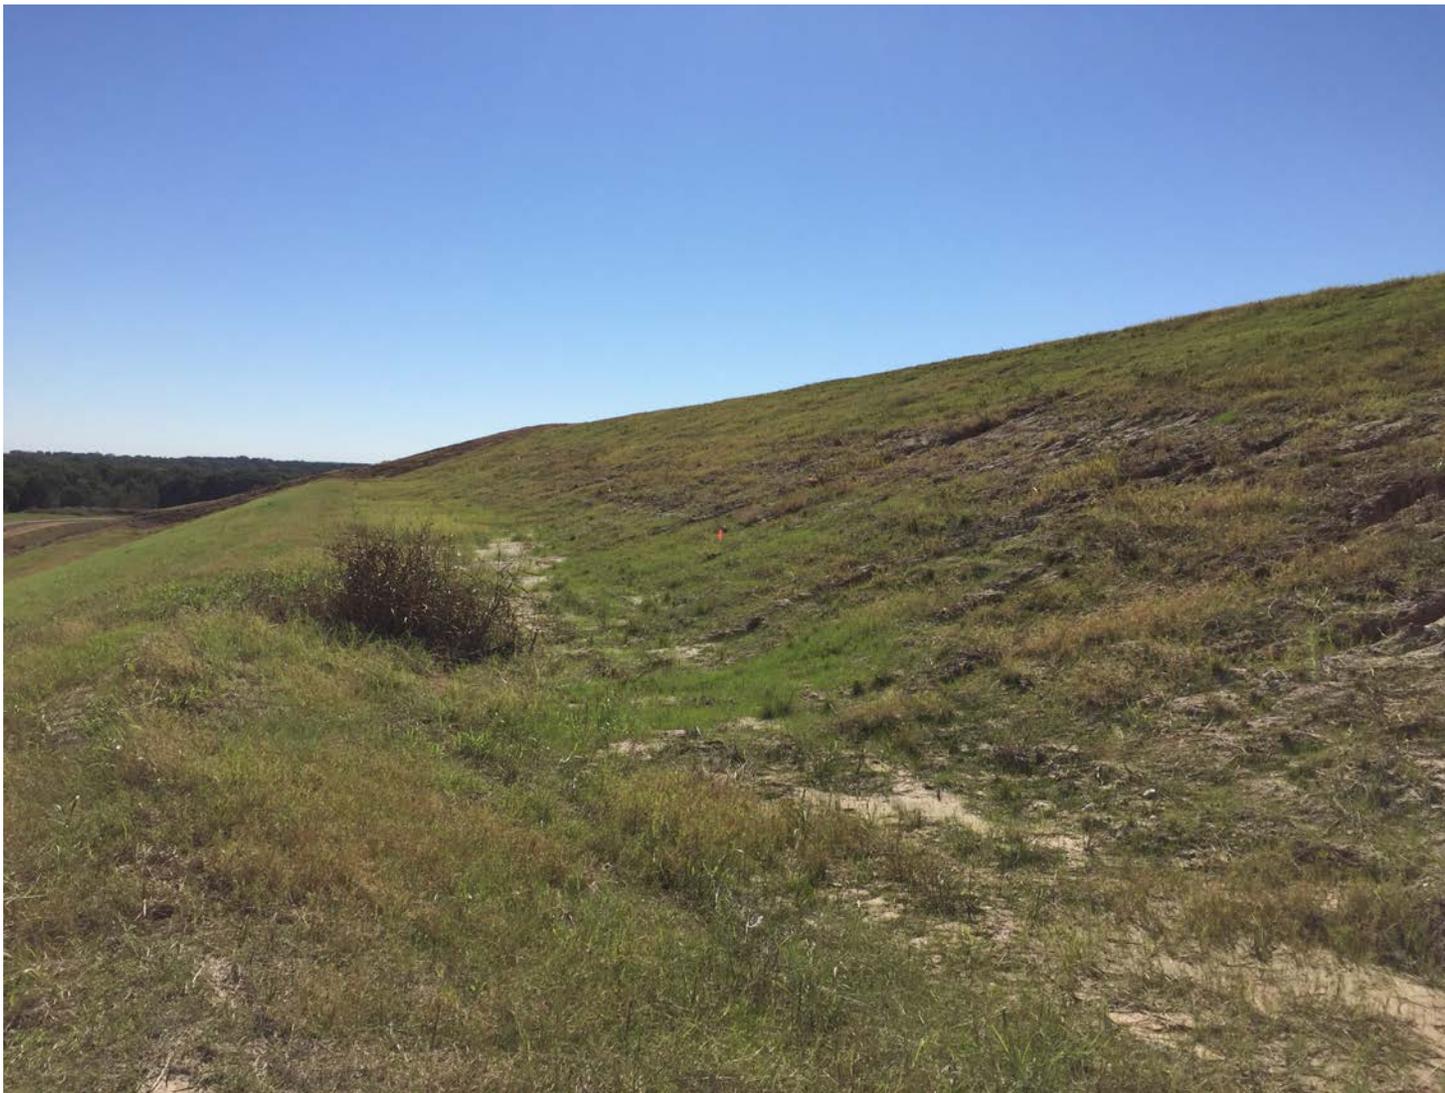
PROJECT NO. 1669251		FILE REF. IMG_2953.JPG	
	DESIGN	VK	11/30/2016	SCALE: NTS
	CHECK	VK	11/30/2016	REV: 0
	REVIEW	JBF	11/30/2016	PHOTO 16

PHOTO DESCRIPTION:
 Upper bench of southern slope
 of Cell 1. Note vegetation
 around drop inlet.
