ANNUAL INSPECTION OF CCR UNITS

**Oak Grove Steam Electric Station
Robertson County, Texas**

January 2017

Golder Associates Inc. (Golder) was retained by Luminant to perform the 2016 annual inspection of Ash Landfill 1 at the Oak Grove Steam Electric Station located near Franklin, Robertson County, Texas. The inspection of Ash Landfill 1 included the following:

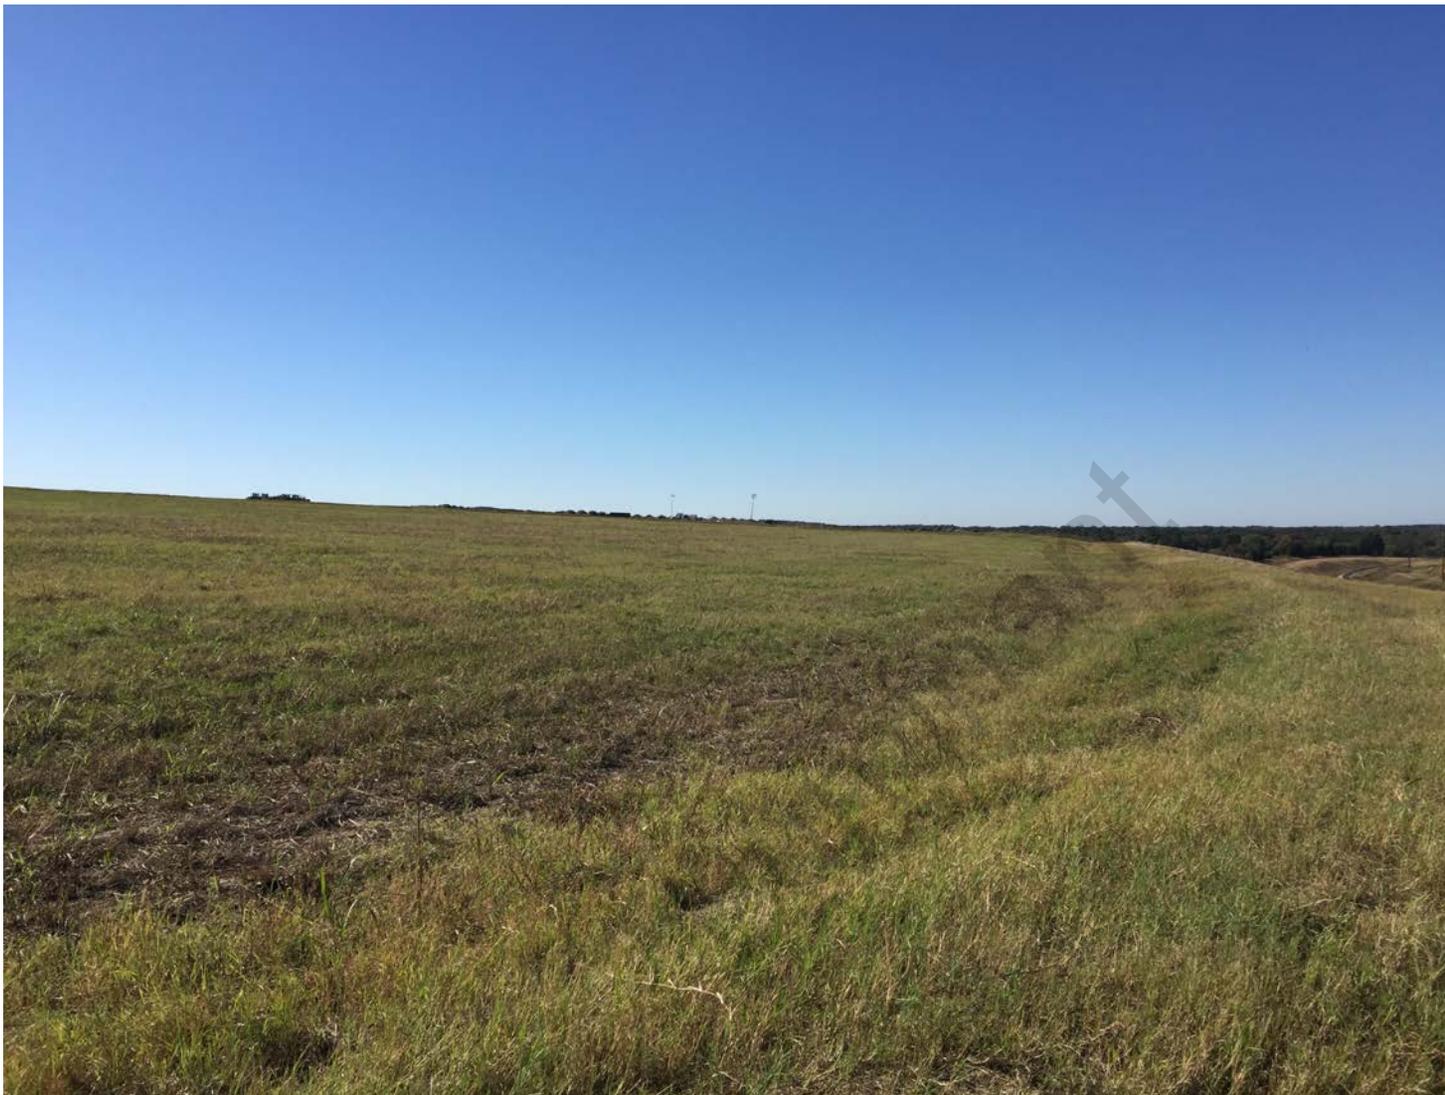
PROJECT NO. 1669251		FILE REF. IMG_2955.JPG	
	DESIGN	VK	11/30/2016	SCALE: NTS
	CHECK	VK	11/30/2016	REV: 0
	REVIEW	JBF	11/30/2016	PHOTO 17

U/S Slope	Good	Vegetation is present on the protective cover in Cell 3.	4	Minor	Check the root depth of the vegetation. If it exceeds the thickness of the protective cover (1 foot) it should be controlled to prevent damage to the clay liner.
	Benches	Fair	Silt fencing around drop inlets is in need of repair and some of the drop inlets are covered or partially covered with vegetation and/or sediment.		Moderate	Drop inlets likely need more frequent maintenance.
			Rutting affecting drainage along upper bench near southeast corner of Cell 1.	11	Minor	Regrade and confirm that area drains to drop inlet. Monitor for ponding water.
			Erosion features due to ponded water present along upper bench on eastern and northern slopes of Cell 1.	18	Moderate	Grade benches to drain to drop inlets. Repair erosion and reseed.
	Final Cover	Fair	Upper flat portion of the final cover vegetation is good. Vegetation on slopes not well established in areas. Repairs have been made, but rilling is occurring due to inadequate vegetation.	8, 9, 16, 17	Moderate

PHOTO DESCRIPTION:
 Final cover along top of Cell 1.

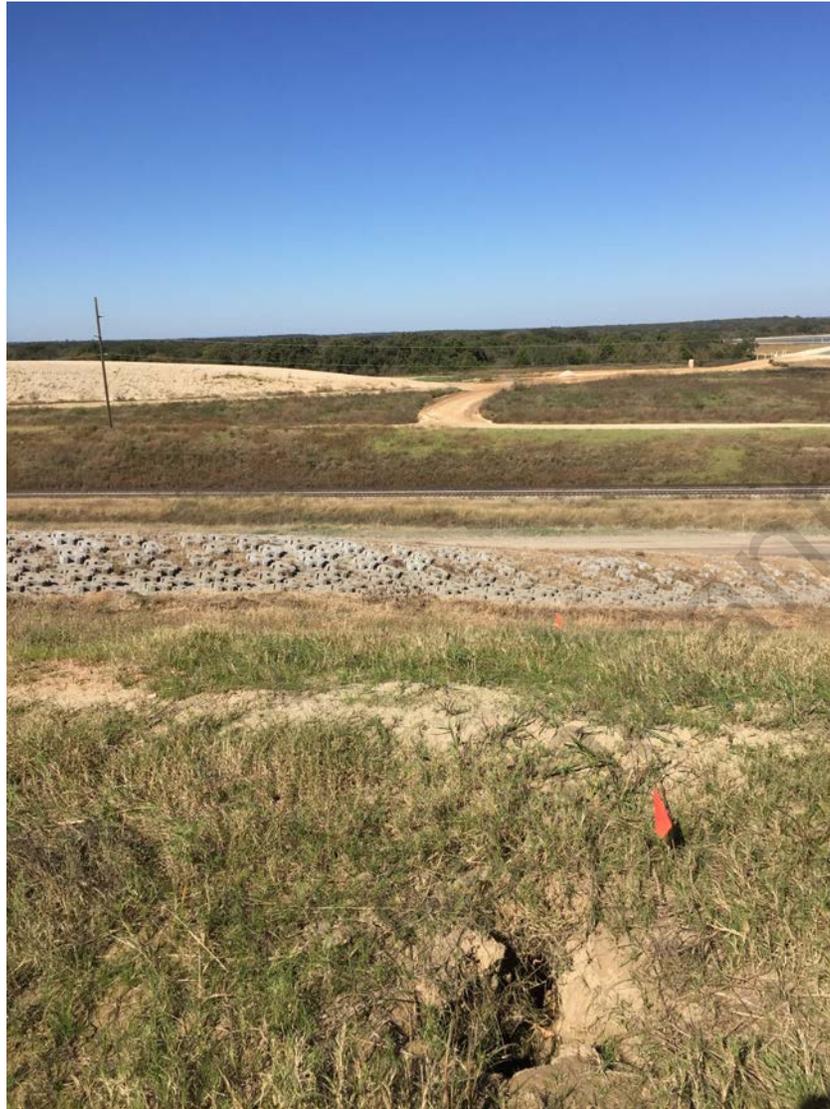
PROJECT NO. 1669251		FILE REF. IMG_2957.JPG	
	DESIGN	VK	11/30/2016	SCALE: NTS
	CHECK	VK	11/30/2016	REV: 0
	REVIEW	JBF	11/30/2016	PHOTO 18

PHOTO DESCRIPTION:
 Erosion below upper bench of
 northern Cell 1 slope.

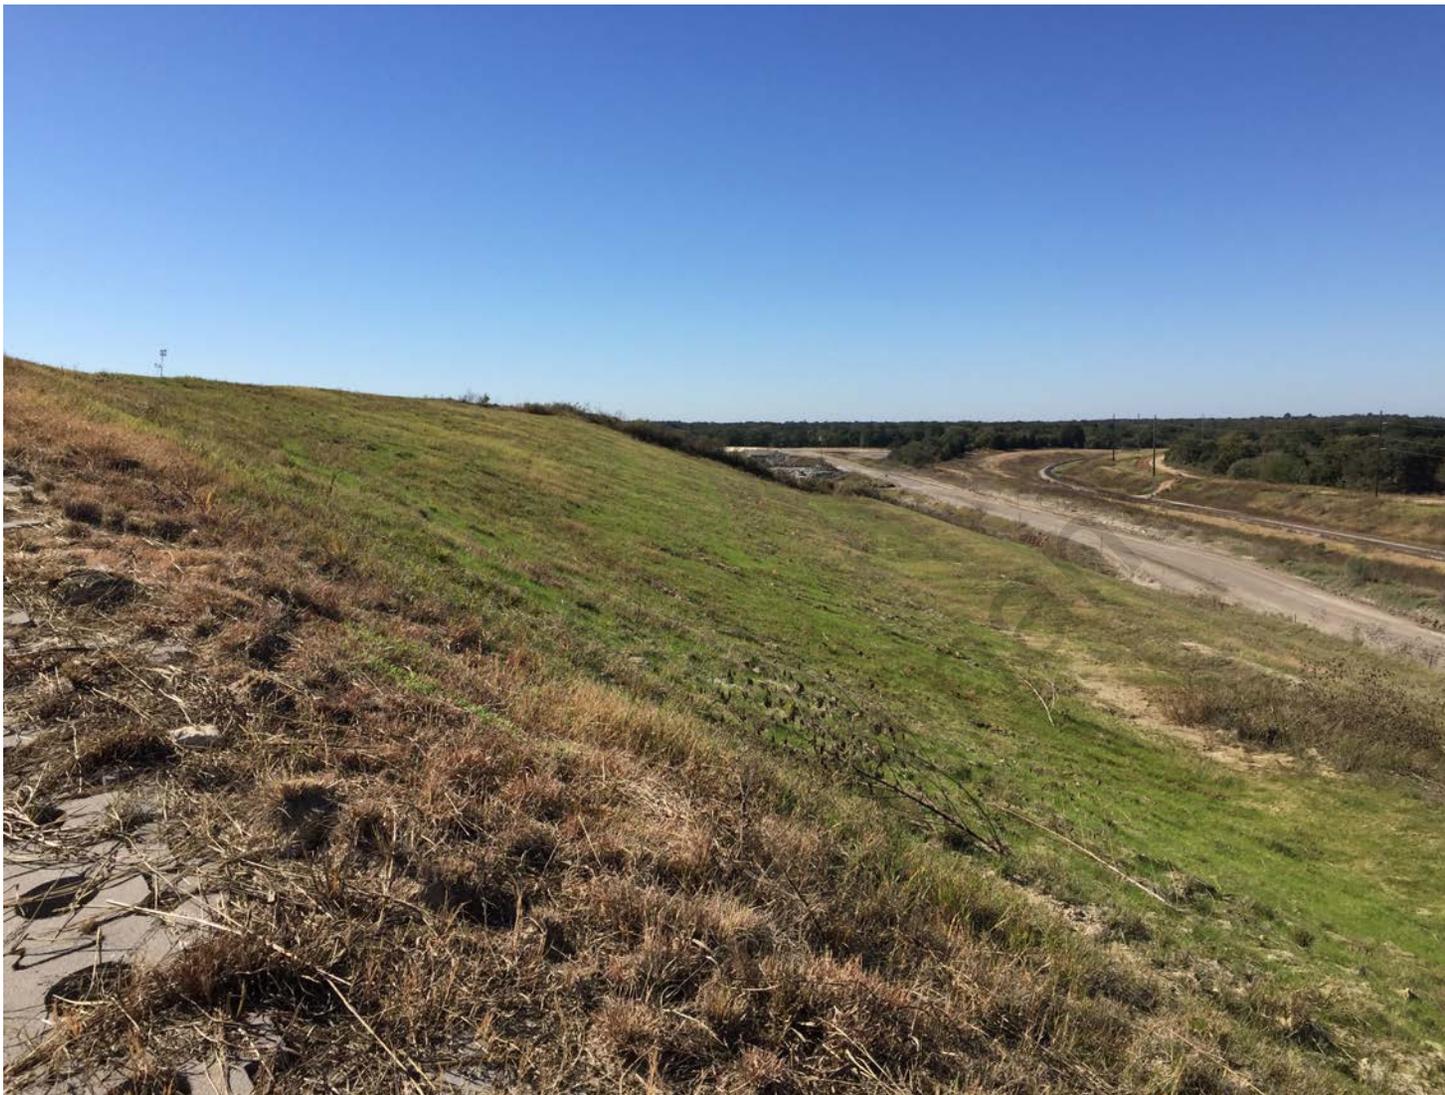
PROJECT NO. 1669251		FILE REF. IMG_2959.JPG	
	DESIGN	VK	11/30/2016	SCALE: NTS
	CHECK	VK	11/30/2016	REV: 0
	REVIEW	JBF	11/30/2016	PHOTO 19

CCR UNIT	Component	Condition * (Good/ Fair/ Poor)	Actions Since Last Inspections and Other Observations and Remarks	Photograph	Severity * (Minor/ Moderate/ Severe)	Further Actions and Recommendations
Ash Landfill 1	D/S Slope	Good to Fair	Cell 1: good vegetation below upper bench (i.e. below final cover).	15, 19	Minor	
			Cell 2 and 3: south slope well vegetated; north side vegetation is fair to good.	1, 3,	Minor	
			Cell 4: vegetation not established.	20, 21	Moderate	Fertilize and seed at start of growing season.
			Significant animal burrows present on south slope of Cell 2 and south and east slope of Cell 1.	5, 6, 10, 12	Moderate	Consider animal control program. Identify what the hogs are burrowing for and use herbicide to remove.
			Erosion features due to ponded water present along upper bench on eastern and northern slopes of Cell 1.	13	Moderate	Grade benches to drain to drop inlets. Repair erosion and reseed.

PHOTO DESCRIPTION:
 Northern slope of Cells 1 and 2.

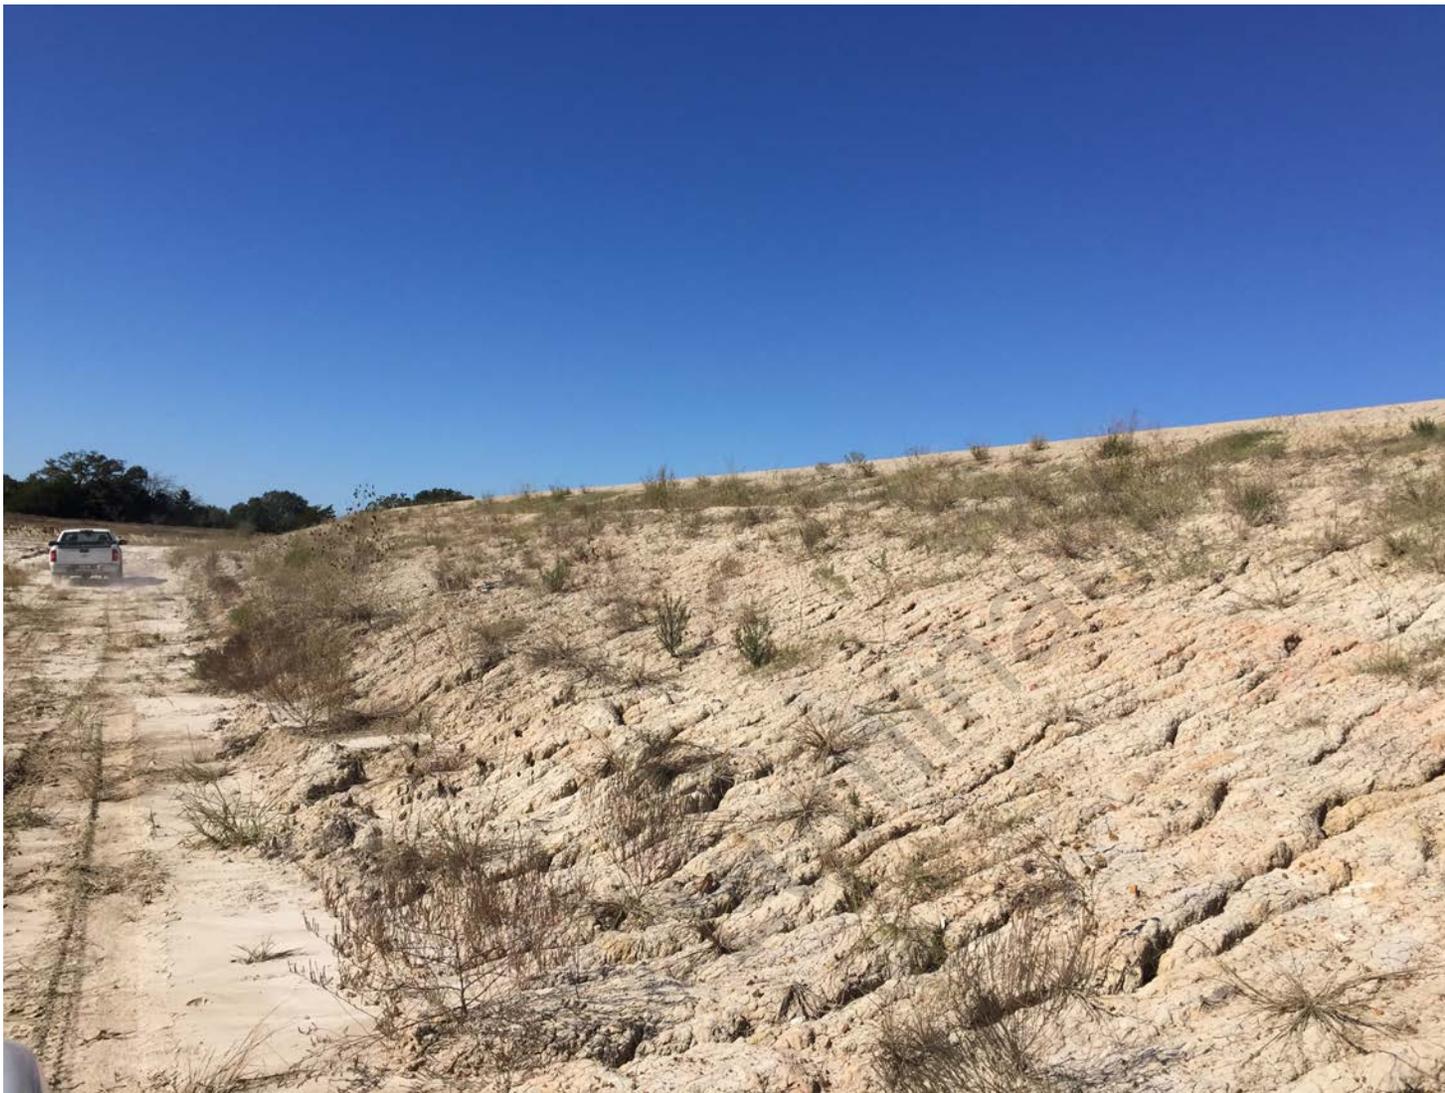
PROJECT NO. 1669251		FILE REF. IMG_2960.JPG	
	DESIGN	VK	11/30/2016	SCALE: NTS
	CHECK	VK	11/30/2016	REV: 0
	REVIEW	JBF	11/30/2016	PHOTO 20

PHOTO DESCRIPTION:
 Erosion on recently completed
 Cell 4 – SW corner of
 embankment.

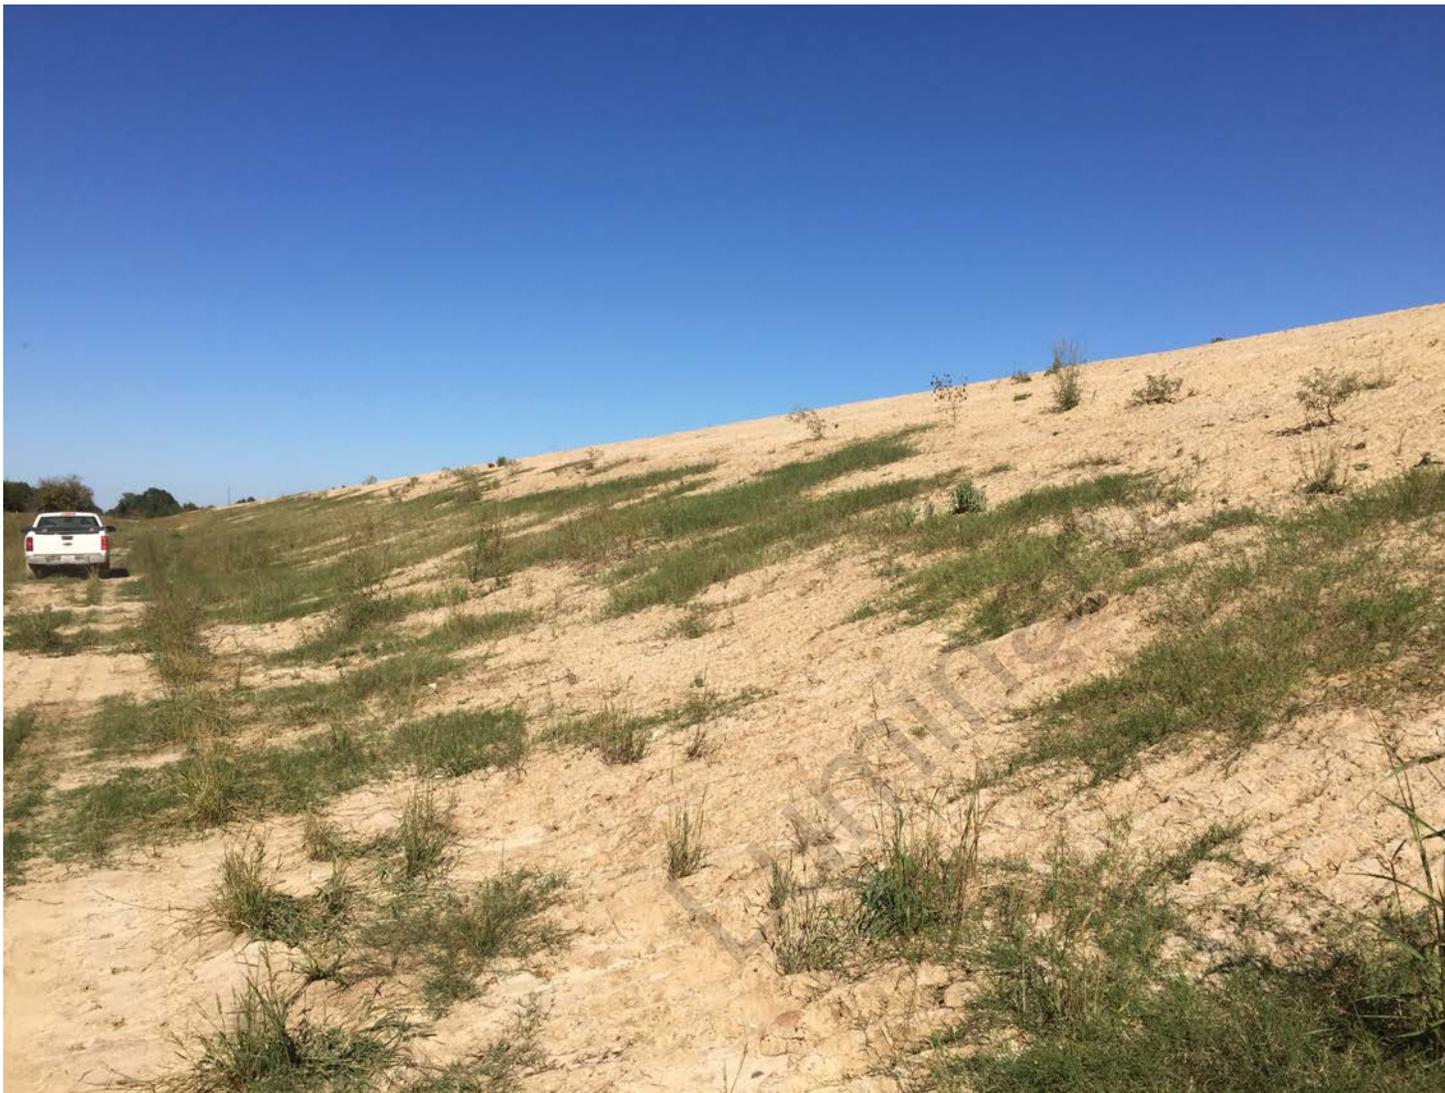
PROJECT NO. 1669251		FILE REF. IMG_2961.JPG	
	DESIGN	VK	11/30/2016	SCALE: NTS
	CHECK	VK	11/30/2016	REV: 0
	REVIEW	JBF	11/30/2016	PHOTO 21

PHOTO DESCRIPTION:
 Erosion on recently completed
 Cell 4 – western embankment.
