**2017 ANNUAL SURFACE IMPOUNDMENT INSPECTION REPORT**

**LUMINANT – MONTICELLO STEAM ELECTRIC STATION  
BOTTOM ASH PONDS  
TITUS COUNTY, TEXAS**

January 2018

**PASTOR, BEHLING & WHEELER, LLC**  
5416 Plaza Drive  
Texarkana, Texas 75503-2704  
Texas Engineering Firm No. 4760

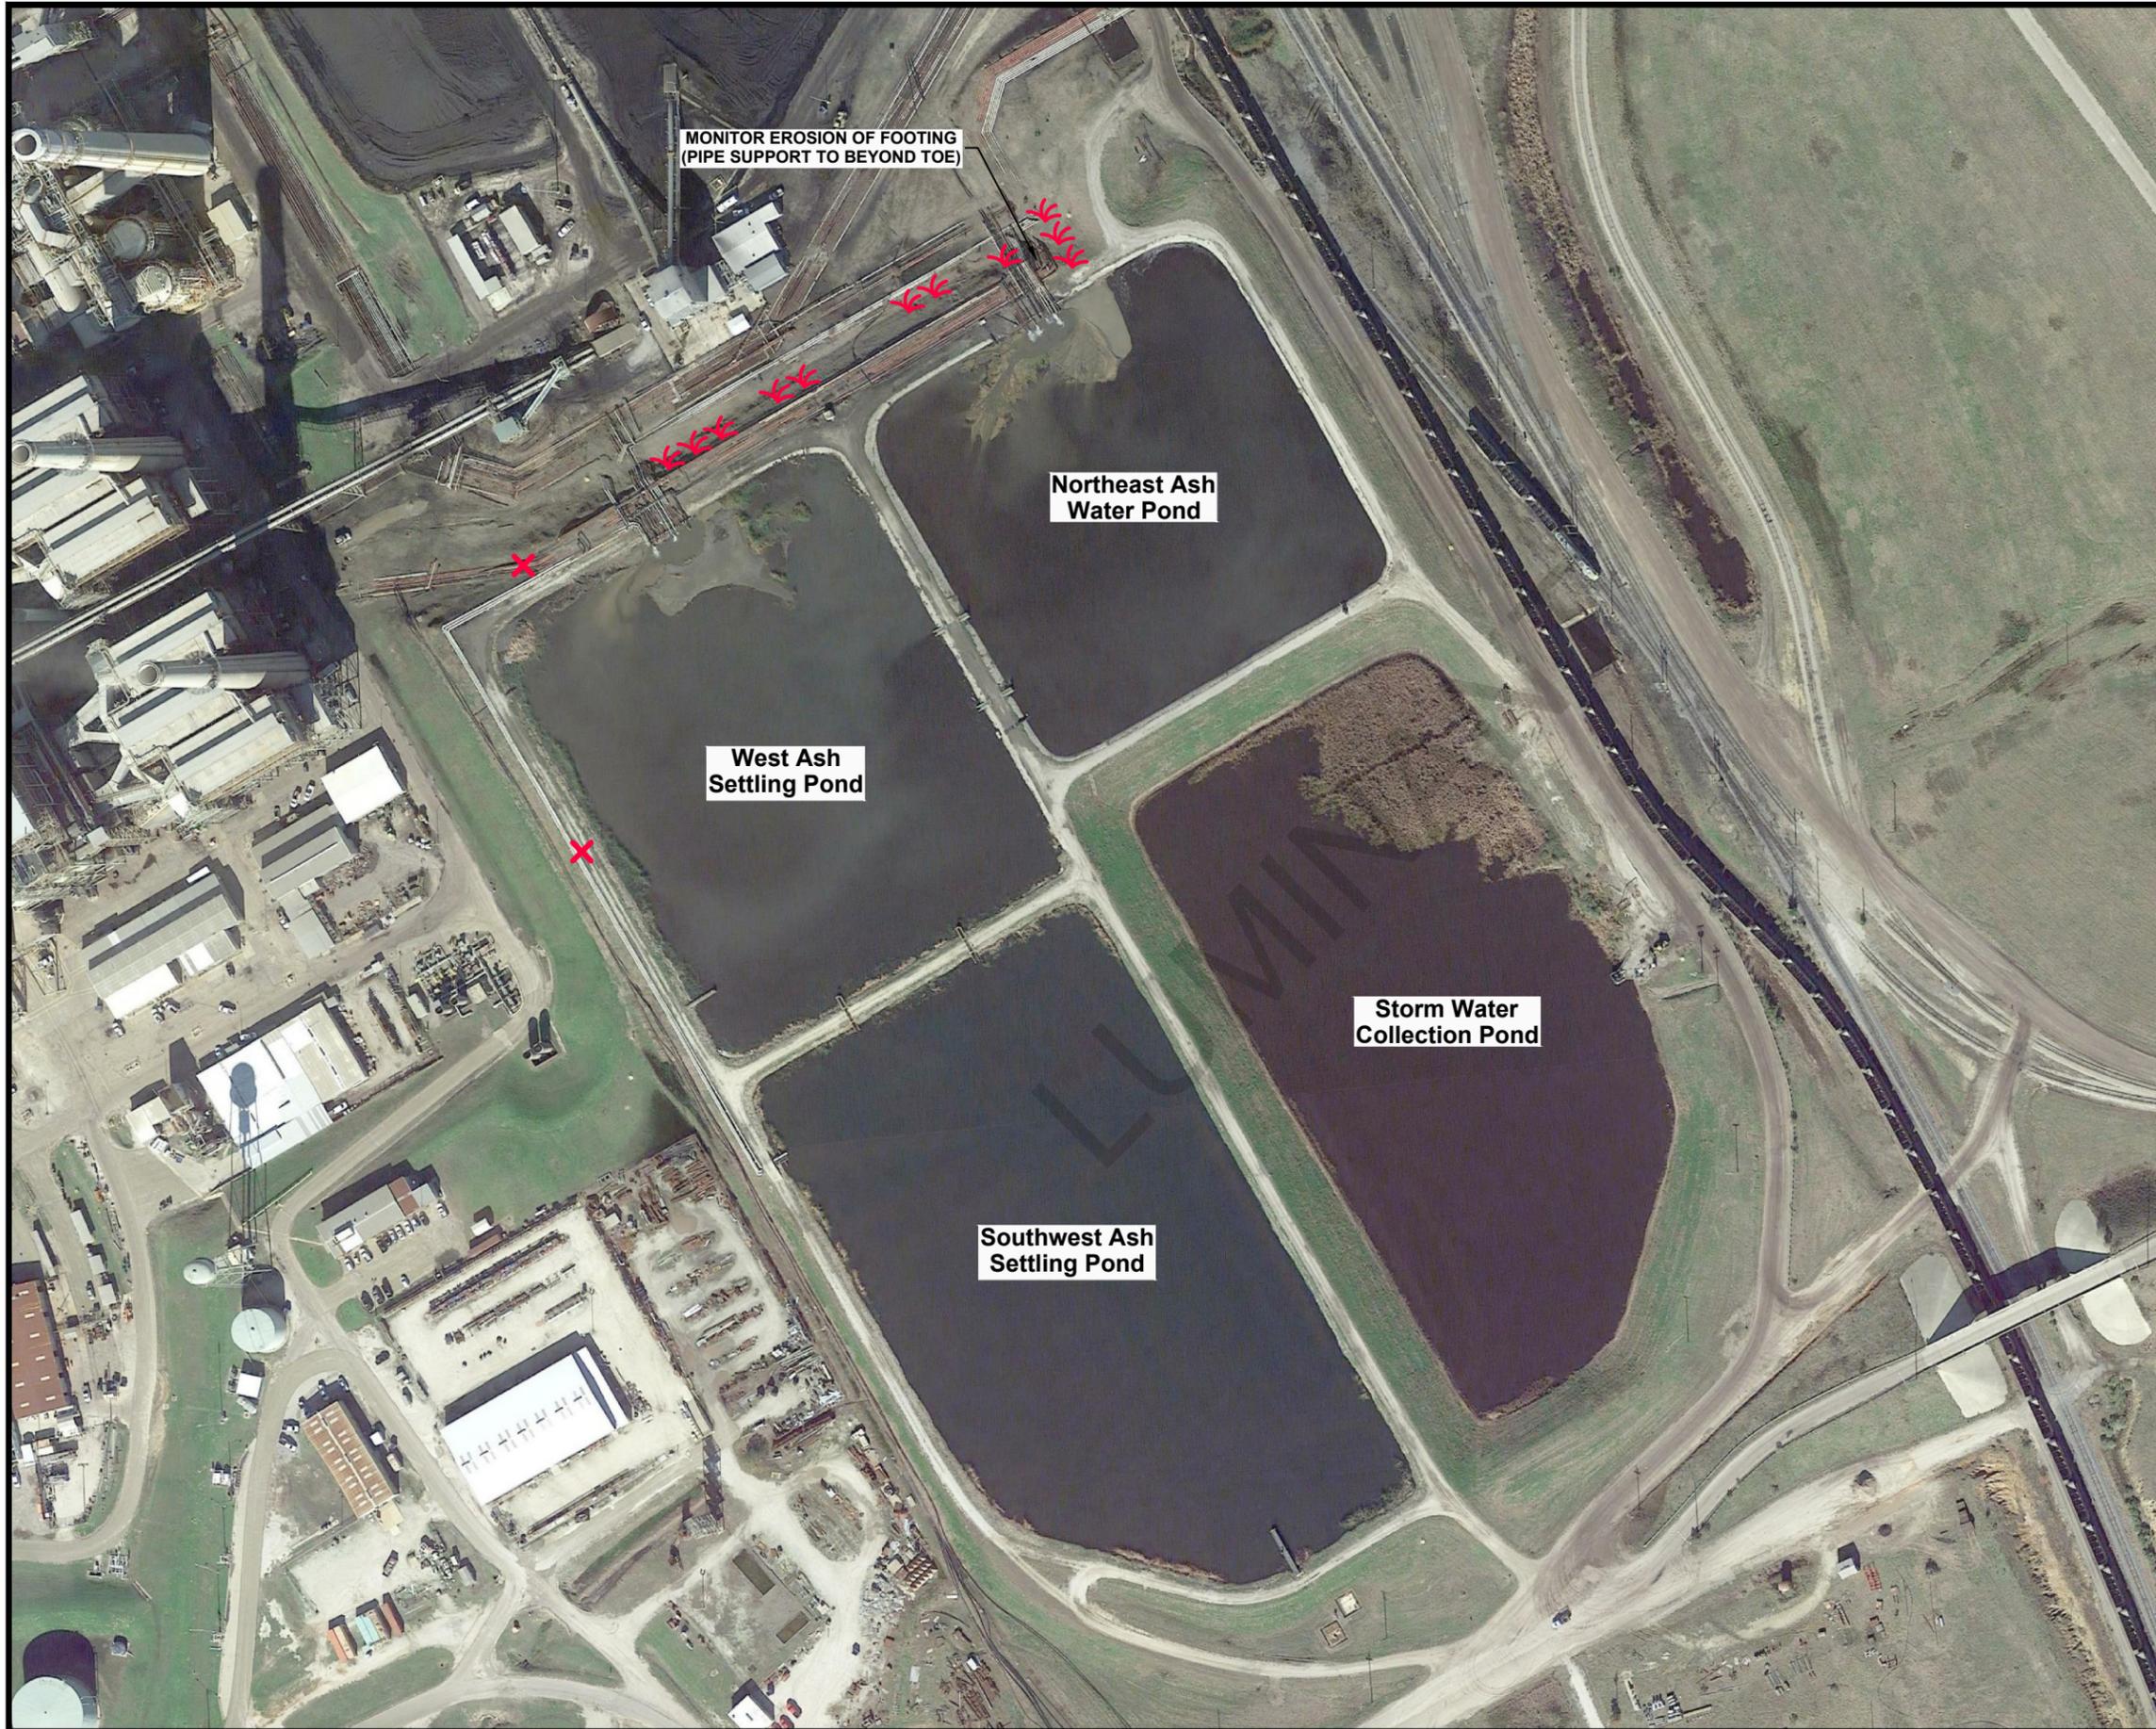
Figure 3  
**ANNUAL INSPECTION  
FINDINGS SUMMARY MAP**

The downstream embankments of the BAPs were generally in good condition and no visual evidence of slope movement or misalignment was noted during the inspection. With exception of areas along the north and west sides of the West Pond, the embankments were well vegetated with grasses that are well maintained. The apparent beneficial use of bottom ash as fill was observed along the piping corridor along the northwest and northern portions of the West Pond. Although the relatively short slope lengths in this area have limited erosion of fill on the embankment, this portion of the embankment should be monitored to ensure adequate vegetative cover is maintained and erosion is not occurring. During the 2015 annual inspection, a former localized slope failure was noted on the surficial bottom ash placed on the slope in this area. No visual indication of slope instability or further slope movement was observed at the time of the inspection. The structural embankment materials (e.g. clayey fill) are not exposed in this area, and the localized feature does not pose a significant threat to the structural integrity of the embankment. Luminant has recently placed topsoil along the northern embankment for the NE and West Ponds to repair areas of surficial erosion/slope irregularities that do not affect structural stability of the embankment. These areas were recently seeded to reestablish vegetative cover. As indicated on Figure 3, the following areas were noted for future monitoring:

- Monitor minor burrowing animal activity on the northern and western embankment of the West Pond.
- Monitor areas where topsoil was recently placed to repair minor slope irregularities/surficial erosion to ensure the establishment of permanent vegetative in the affected areas shown on Figure 3.

- Monitor areas of localized erosion near the influent pipe rack to the West Pond, under the influent pipe rack for the NE Pond, and on the slope near the southwest corner of the NE Pond.

MONITOR EROSION OF FOOTING  
(PIPE SUPPORT TO BEYOND TOE)

- Luminant should continue to monitor the areas of concern documented during the annual inspection and listed in Section of 3.0. However, based on a review of the slope stability assessment and the annual inspection activities presented herein, the recommended monitoring activities for the observed animal borrows and revegetation of recent surficial embankment repairs do not currently pose a significant risk to the structural stability of the embankments. Hence, the recommended actions should only be completed when surface conditions are sufficiently dry to allow for equipment access without causing further damage to the areas of concern.

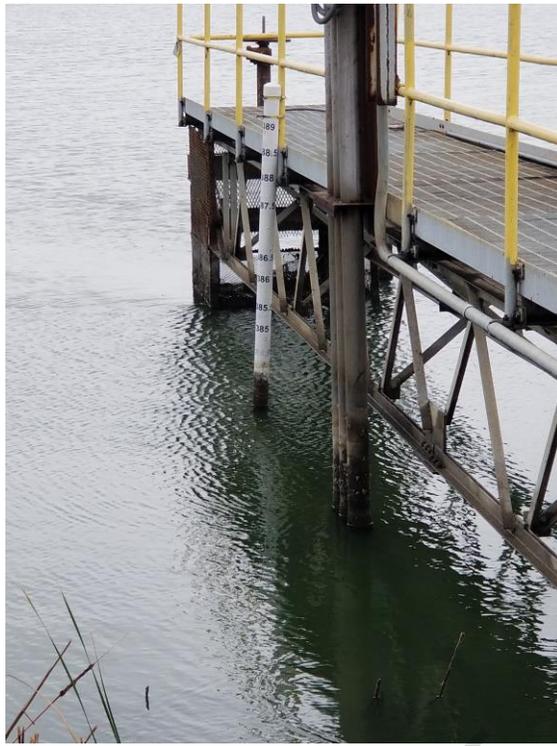
Pastor, Behling & Wheeler	DESCRIPTION	<b>Photograph 1</b> – (View NW) SW Pond pier/manway with sight gauge visible.	
PROJECT NO. 5313-D	SITE NAME	Monticello Steam Electric Station– Annual Surface Impoundment Inspection	DATE 10/3/2017

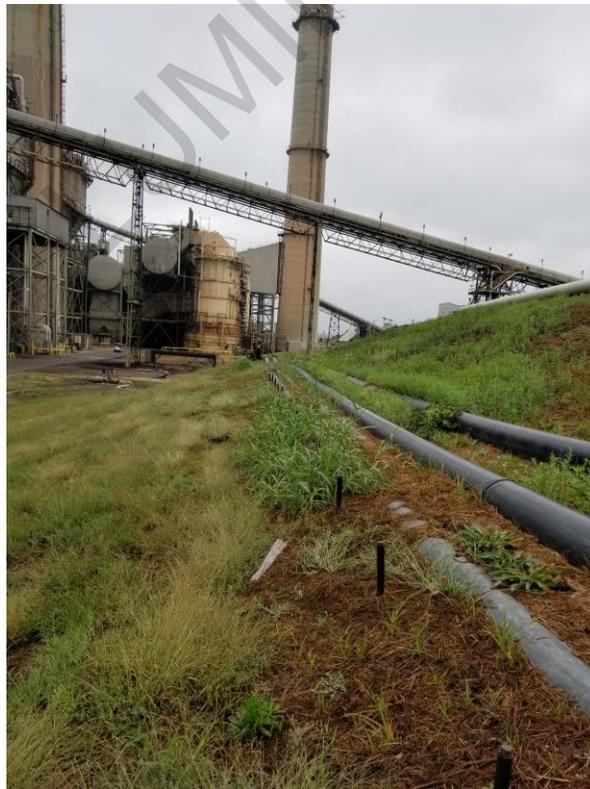
Pastor, Behling & Wheeler	DESCRIPTION	<b>Photograph 2</b> – (View NW) Downstream embankment of SW Pond with piping at toe.	
PROJECT NO. 5313-D	SITE NAME	Monticello Steam Electric Station– Annual Surface Impoundment Inspection	DATE 10/3/2017

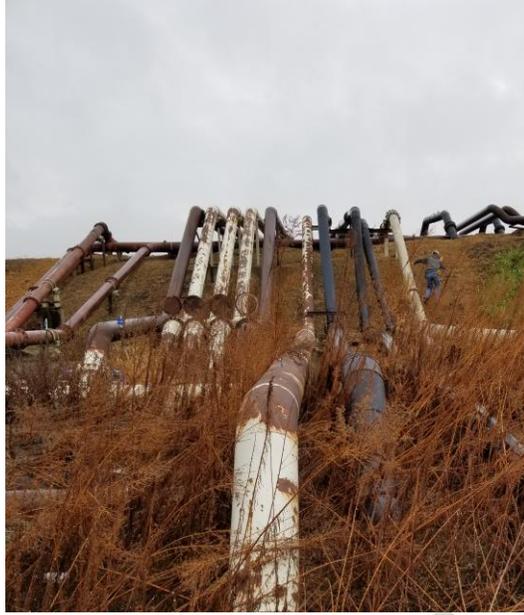
Pastor, Behling & Wheeler	DESCRIPTION	<b>Photograph 3</b> – (View SE) Manifold area for NE Pond. Monitor recent erosion repair during revegetation.	
PROJECT NO. 5313-D	SITE NAE	Monticello Steam Electric Station– Annual Surface Impoundment Inspection	DATE 10/3/2017

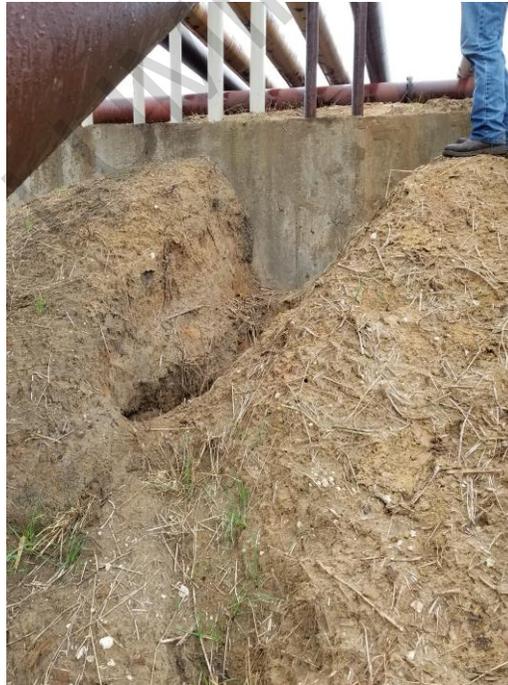
<b>WEST ASH SETTLING POND</b>	
Repair erosion undermining the pipe rack footing on the north side of the West Pond.	Erosion persists but the area remains stable with no visual evidence of subsidence or failure of the pipe rack evident.

Pastor, Behling & Wheeler	DESCRIPTION	<b>Photograph 4</b> – (View SE) Monitor erosion adjacent to a pipe rack footing on the north embankment of the West Ash Pond.	
PROJECT NO. 5313-D	SITE NAE	Monticello Steam Electric Station– Annual Surface Impoundment Inspection	DATE 10/3/2017

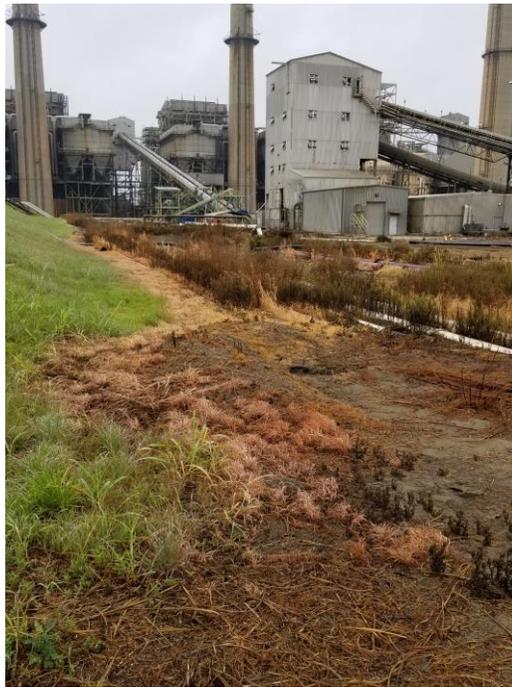
Pastor, Behling & Wheeler	DESCRIPTION	<b>Photograph 5</b> – (View SW) Piping corridor at toe of NE Pond embankment. Piping impedes toe drainage during wet periods.	
PROJECT NO. 5313-D	SITE NAME	Monticello Steam Electric Station– Annual Surface Impoundment Inspection	DATE 10/3/2017

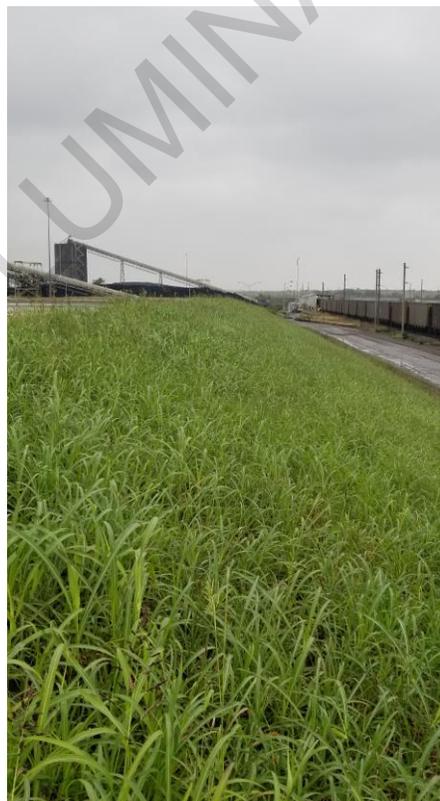
Pastor, Behling & Wheeler	DESCRIPTION	<b>Photograph 6</b> – (View NW) View of Eastern embankment of NE Pond.	
PROJECT NO. 5313-D	SITE NAME	Monticello Steam Electric Station– Annual Surface Impoundment Inspection	DATE 10/3/2017

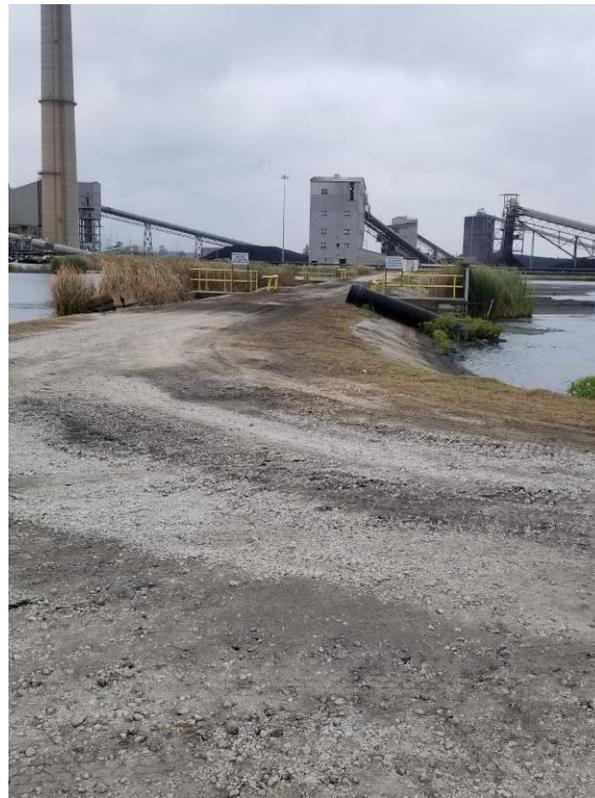
Pastor, Behling & Wheeler	DESCRIPTION	<b>Photograph 7</b> – (View NW) Embankment crest between NE Pond (right) and West Pond (left).	
PROJECT NO. 5313-D	SITE NAME	Monticello Steam Electric Station– Annual Surface Impoundment Inspection	DATE 10/3/2017

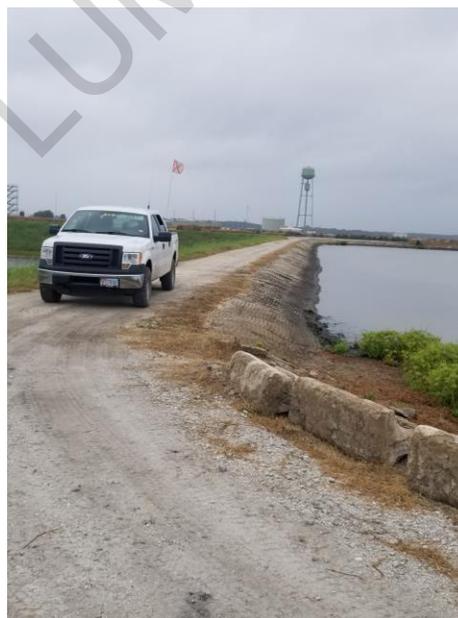
Pastor, Behling & Wheeler	DESCRIPTION	<b>Photograph 8</b> – (View SW) Former CCR transfer area NE Pond (repaired).	
PROJECT NO. 5313-D	SITE NAME	Monticello Steam Electric Station– Annual Surface Impoundment Inspection	DATE 10/3/2017
