ANNUAL CCR UNIT INSPECTION REPORT

**LUMINANT – MARTIN LAKE STEAM ELECTRIC STATION
ASH POND AREA, PERMANENT DISPOSAL POND NO. 5 & A1 AREA LANDFILL
RUSK & PANOLA COUNTY, TEXAS**

January 18, 2016

PBW Project No. 5178B

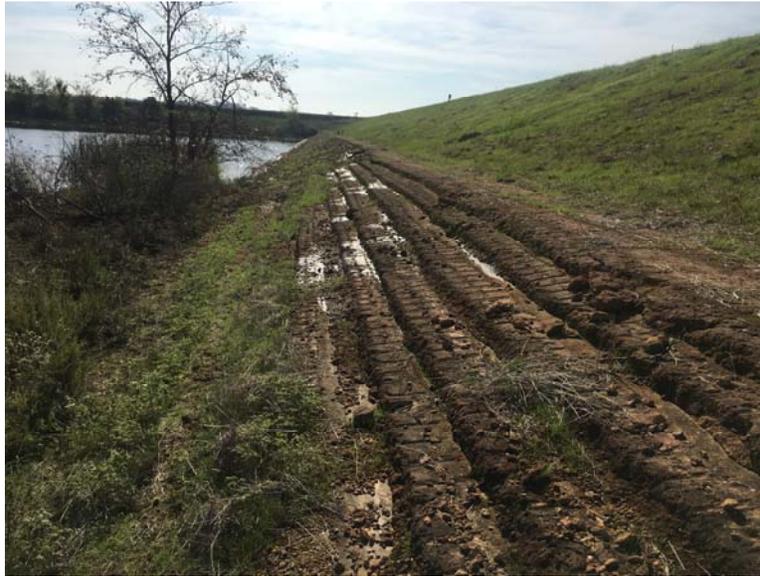
Pastor, Behling & Wheeler	DESCRIPTION	Photograph 1 – (View SE) Monitor wetness on roller compacted cement near toe of EAP embankment	
PROJECT NO. 5178-B	SITE NAME	Martin Lake Steam Electric Station– Annual Surface Impoundment Inspection	DATE 11/10/2015

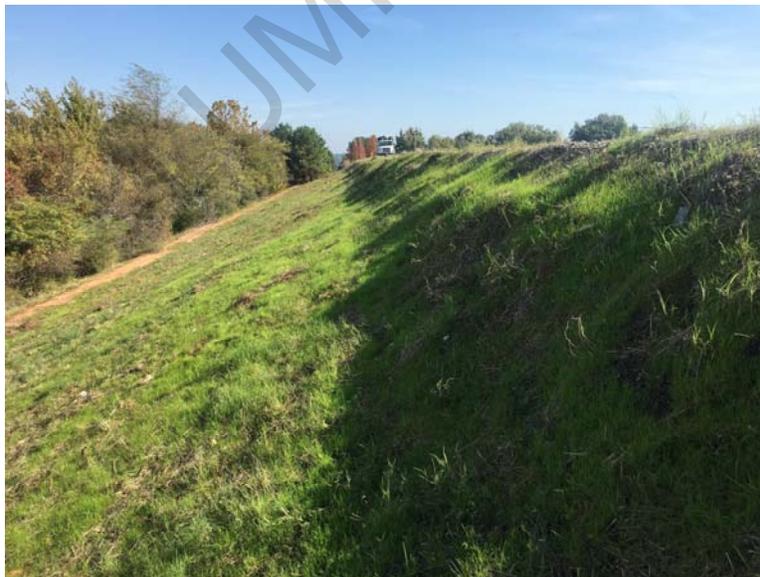
Pastor, Behling & Wheeler	DESCRIPTION	Photograph 2 – (View NE) Typical slope steepening near crest of SP embankment.	
PROJECT NO. 5178-B	SITE NAME	Martin Lake Steam Electric Station– Annual Surface Impoundment Inspection	DATE 11/10/2015

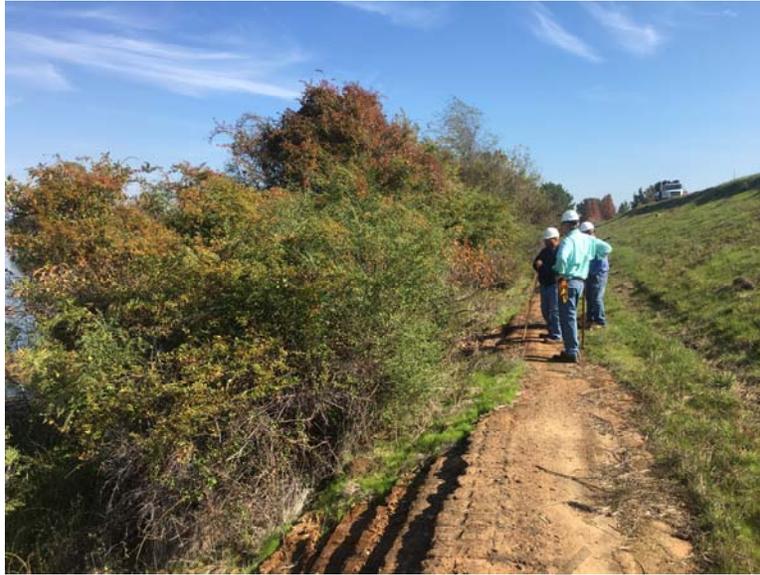
Pastor, Behling & Wheeler	DESCRIPTION	Photograph 3 – (View NE) Trees encroaching at toe of SP embankment. Remove trees to allow inspection of toe.	
PROJECT NO. 5178-B	SITE NAME	Martin Lake Steam Electric Station– Annual Surface Impoundment Inspection	DATE 11/10/2015

- Repair erosion associated with a low pressure ash water transfer line leak on the west side of the WAP.
- Remove trees at the toe of the slope along the northern embankment of the SP and at the southeast corner of the SP to allow for improved inspection and maintenance.

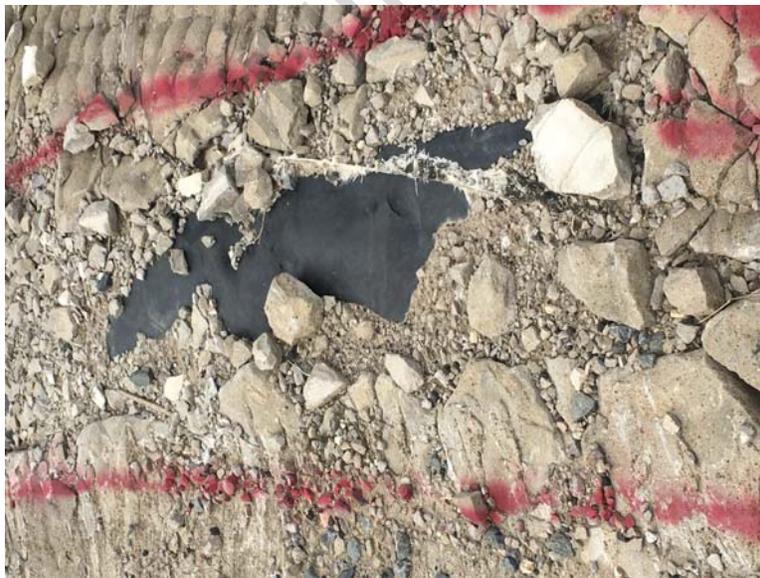
Pastor, Behling & Wheeler	DESCRIPTION	Photograph 4 – Damage to concrete revetment mat with polyethylene liner of SP visible. Repair liner and replace revetment material.	
PROJECT NO. 5178-B	SITE NAME	Martin Lake Steam Electric Station– Annual Surface Impoundment Inspection	DATE 11/10/2015

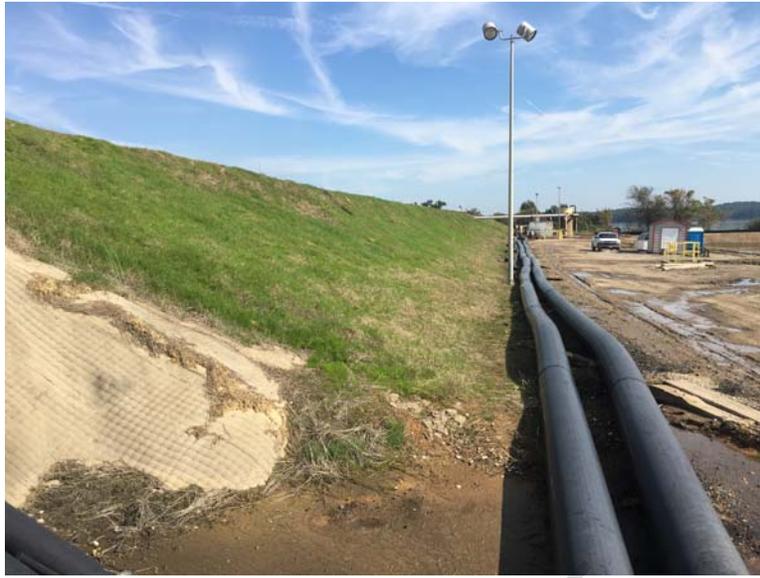
Pastor, Behling & Wheeler	DESCRIPTION	Photograph 5 – (View NE) Downstream embankment of SP with ash water transfer lines at right (piping limits toe drainage). Monitor wetness at toe of slope.	
PROJECT NO. 5178-B	SITE NAME	Martin Lake Steam Electric Station– Annual Surface Impoundment Inspection	DATE 11/10/2015

- South central embankment of the SP.
- Monitor the following areas where area of excessive wetness was observed at the toe of the slope:
 - South slope of the WAP and western portion of south slope of the SP where a piping corridor limits drainage relief at the toe. Reestablishing cribbing beneath the piping may provide for improved drainage;

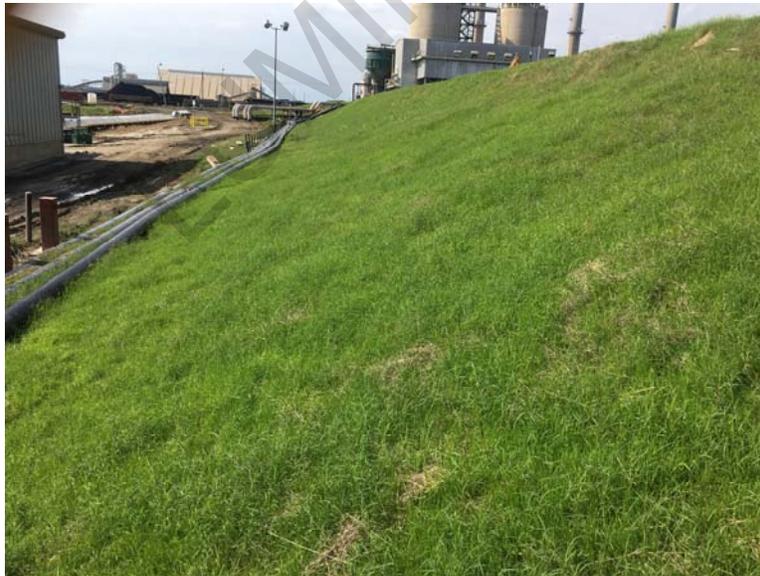
Pastor, Behling & Wheeler	DESCRIPTION	Photograph 6 – (View SW) Downstream embankment of WAP with former slope failure (local shallow slide) flagged at upper right. Monitor wetness at toe near ash water transfer piping.	
PROJECT NO. 5178-B	SITE NAME	Martin Lake Steam Electric Station– Annual Surface Impoundment Inspection	DATE 11/10/2015

- Near influent pipe rack of the EAP
- Repair animal burrows with compacted clay fill.
- Monitor slope irregularities, including a localized bulge (apparent former shallow surface slide) on the south embankment of the WAP and a slight depression near the south central portion of the SP embankment.

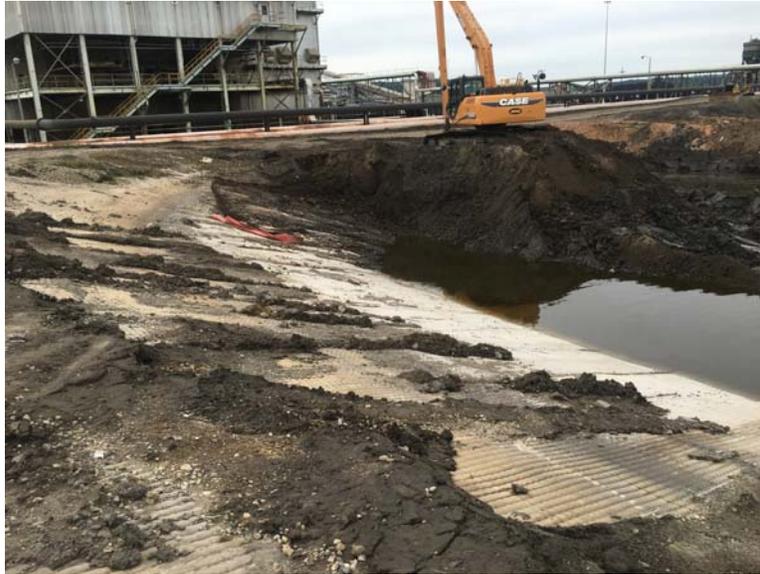
Pastor, Behling & Wheeler	DESCRIPTION	Photograph 7 – (View NW) CCR removal from WAP with concrete revetment mat visible in foreground. CCR visible on lined areas.	
PROJECT NO. 5178-B	SITE NAME	Martin Lake Steam Electric Station– Annual Surface Impoundment Inspection	DATE 11/10/2015

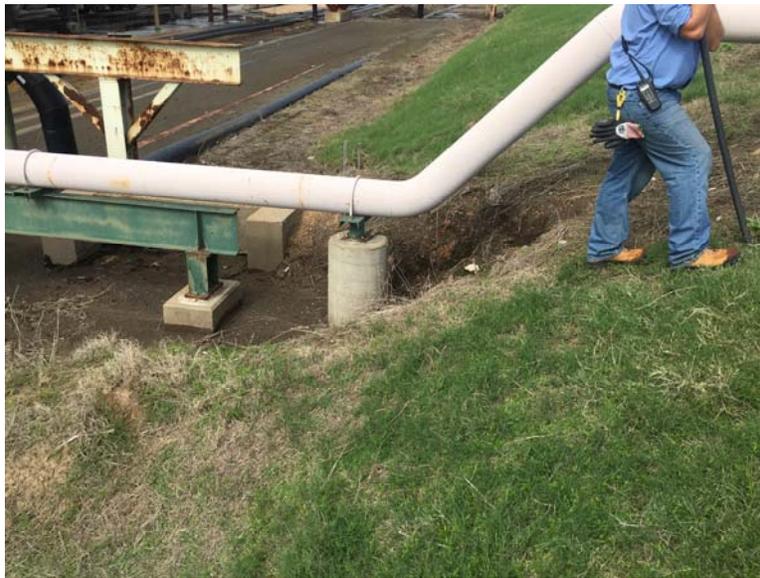
Pastor, Behling & Wheeler	DESCRIPTION	Photograph 9 – (View NW) Monitor erosion surrounding concrete pipe support on west embankment of WAP.	
PROJECT NO. 5178-B	SITE NAME	Martin Lake Steam Electric Station– Annual Surface Impoundment Inspection	DATE 11/10/2015

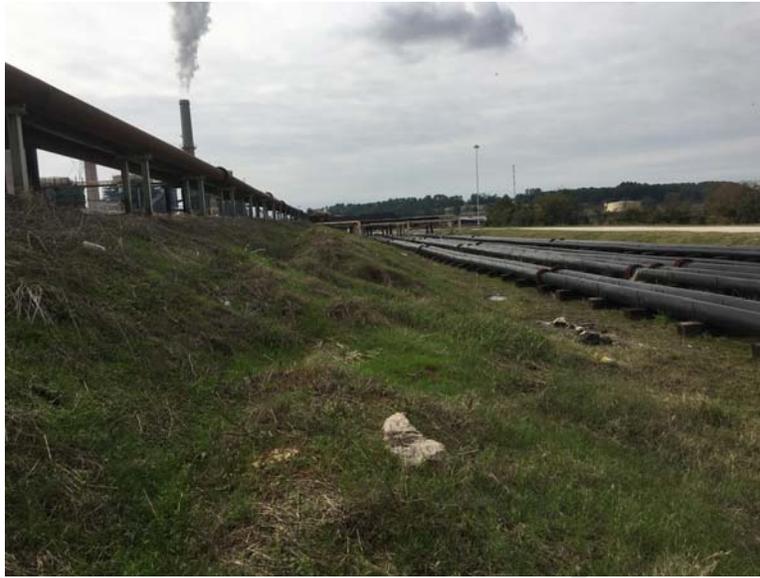
Pastor, Behling & Wheeler	DESCRIPTION	Photograph 11 – (View SW) Monitor irregular slope along north downstream embankment of EAP and WAP. Note cribbing of process wastewater piping at right to promote drainage away from toe of slope.	
PROJECT NO. 5178-B	SITE NAME	Monticello Steam Electric Station– Annual Surface Impoundment Inspection	DATE 11/3/2015

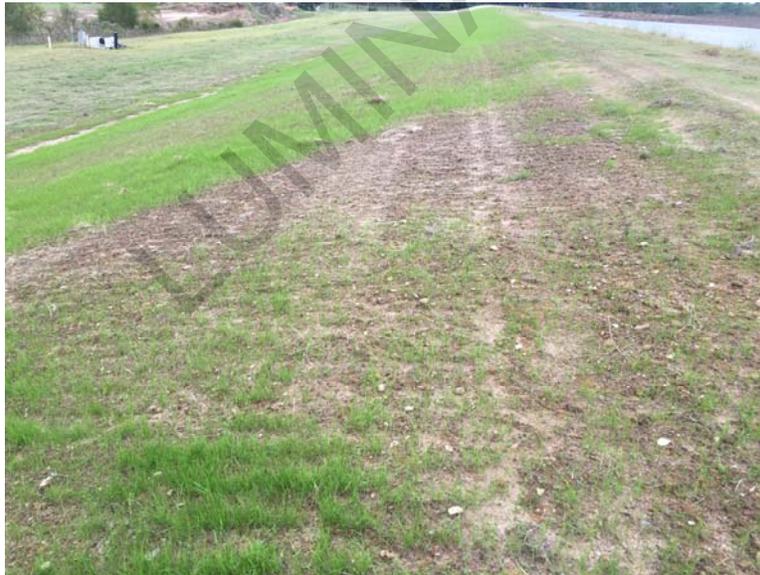
Pastor, Behling & Wheeler	DESCRIPTION	Photograph 2 – (View NE) Downstream embankment of PDP-5 with areas of limited annual rye grass coverage.	
PROJECT NO. 5178-B	SITE NAME	Martin Lake Steam Electric Station– Annual Surface Impoundment Inspection	DATE 11/10/2015

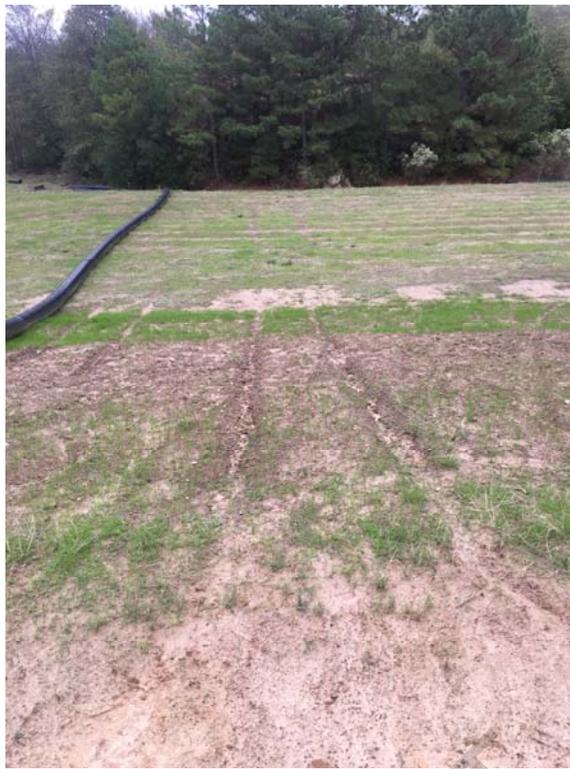
Pastor, Behling & Wheeler PROJECT NO. 5178-B	DESCRIPTION	Photograph 3 – (View E) Moderate rill erosion focused in minor rutting on downstream embankment. Area of limited annual rye grass coverage.	
	SITE NAME	Martin Lake Steam Electric Station– Annual Surface Impoundment Inspection	DATE 11/10/2015

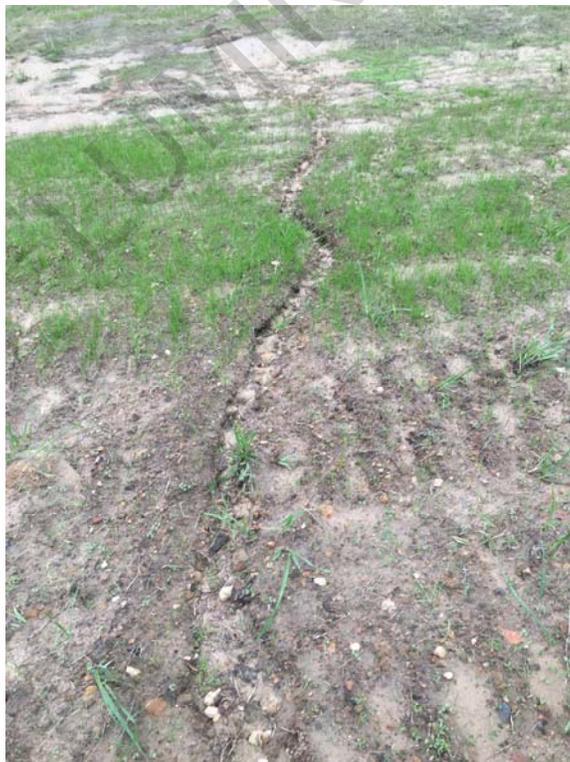
Pastor, Behling & Wheeler PROJECT NO. 5178-B	DESCRIPTION	Photograph 4 – (View NE) Moderate rill erosion on downstream embankment focused in area of limited annual rye grass coverage.	
	SITE NAME	Martin Lake Steam Electric Station– Annual Surface Impoundment Inspection	DATE 11/10/2015

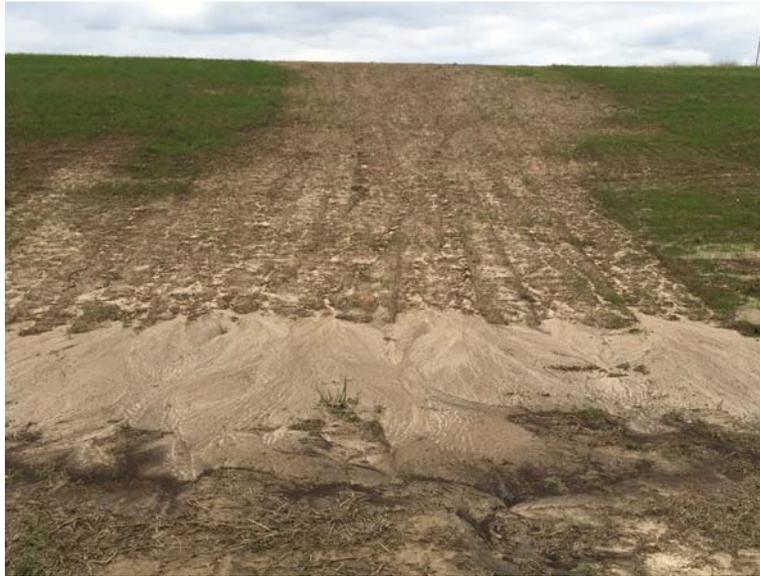
Pastor, Behling & Wheeler	DESCRIPTION	Photograph 5 – (View NW) Recent downstream embankment repair with limited vegetative coverage. Fines at toe from rill erosion.	
PROJECT NO. 5178-B	SITE NAME	Martin Lake Steam Electric Station– Annual Surface Impoundment Inspection	DATE 11/10/2015

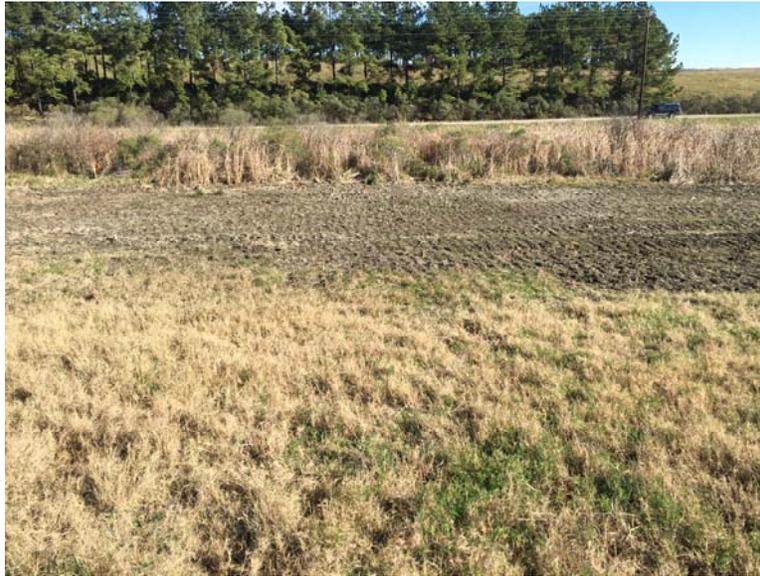
Pastor, Behling & Wheeler	DESCRIPTION	Photograph 1 – (View NE; Sta. 33+00) Monitor recent repair of wet area at toe of embankment	
PROJECT NO. 5178-B	SITE NAME	Martin Lake A1 Landfill – Annual Inspection	DATE 12/9/2015

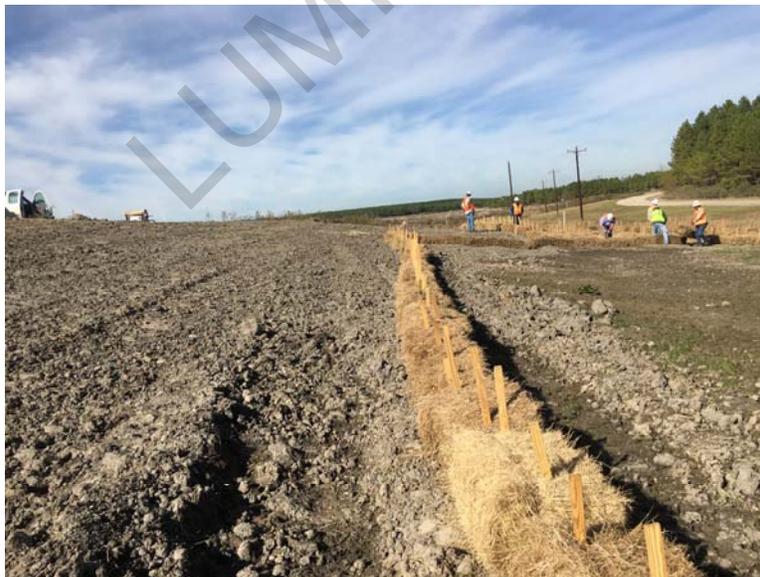
Pastor, Behling & Wheeler	DESCRIPTION	Photograph 2 – (View NW; Sta. 28+00) Monitor recent repair of former seep location near Sta. 27+00.	
PROJECT NO. 5178-B	SITE NAME	Martin Lake A1 Landfill – Annual Inspection	DATE 12/9/2015

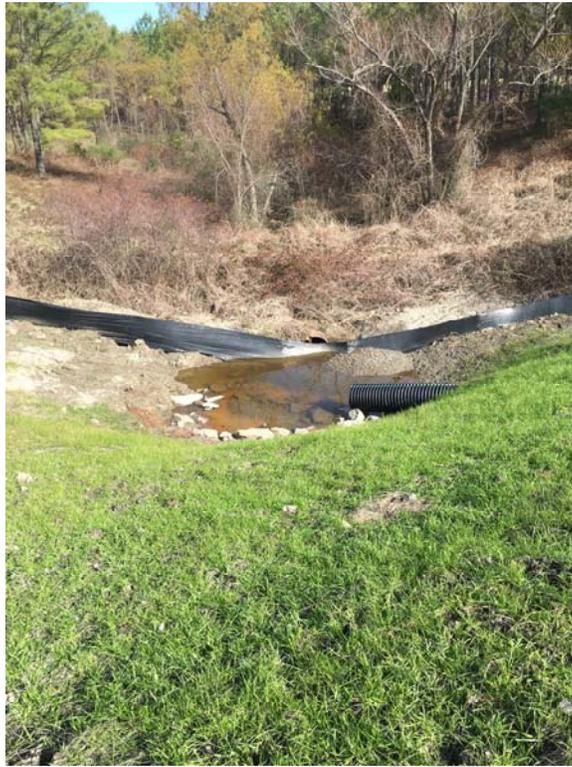
Pastor, Behling & Wheeler	DESCRIPTION	Photograph 3 – (View N; Sta. 13+00) Monitor recent slope repair and discharge point of drainage improvement.	
PROJECT NO. 5178-B	SITE NAME	Martin Lake A1 Landfill – Annual Inspection	DATE 12/9/2015

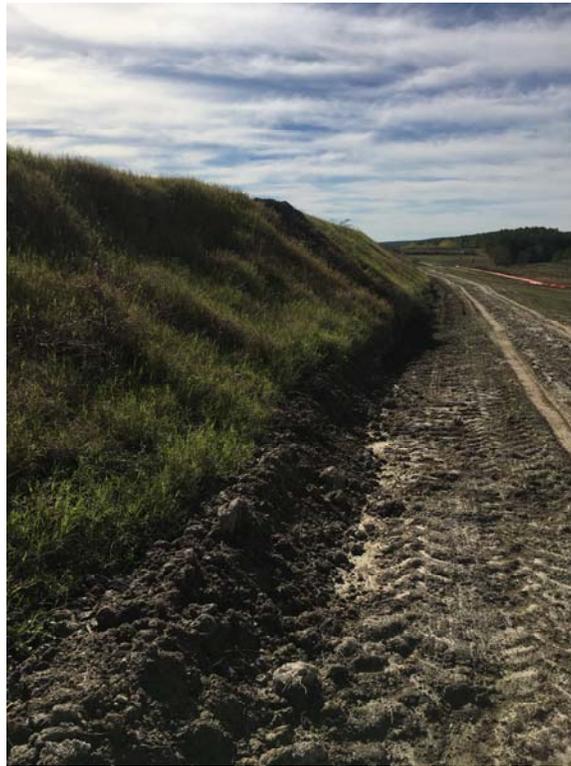
Pastor, Behling & Wheeler	DESCRIPTION	Photograph 5 – (View SW; Sta. 227+00) Monitor recent road repair and cut on slope side.	
PROJECT NO. 5178-B	SITE NAME	Martin Lake A1 Landfill – Annual Inspection	DATE 12/9/2015

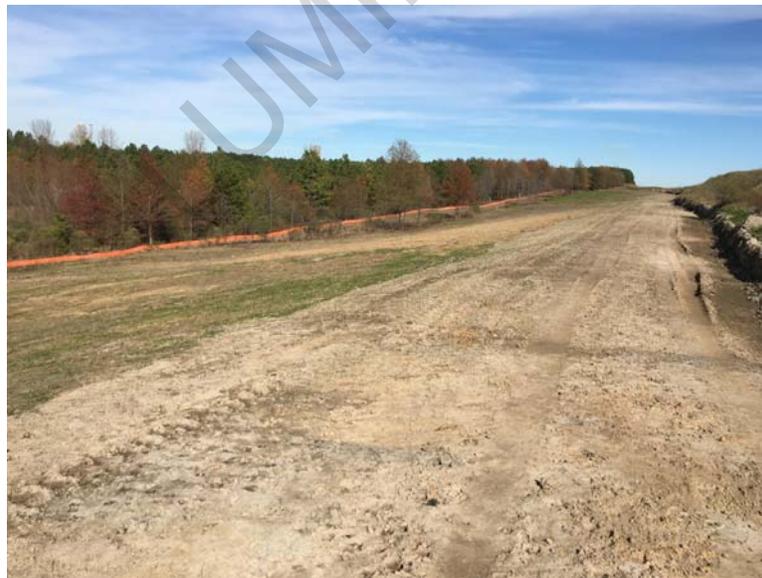
Pastor, Behling & Wheeler	DESCRIPTION	Photograph 6 – (View NE; Sta. 220+00) Embankment of South Holding Pond with large area of recent brush/tree removal. Monitor slope for erosion during reestablishment of vegetative cover.	
PROJECT NO. 5178-B	SITE NAME	Martin Lake A1 Landfill – Annual Inspection	DATE 12/9/2015

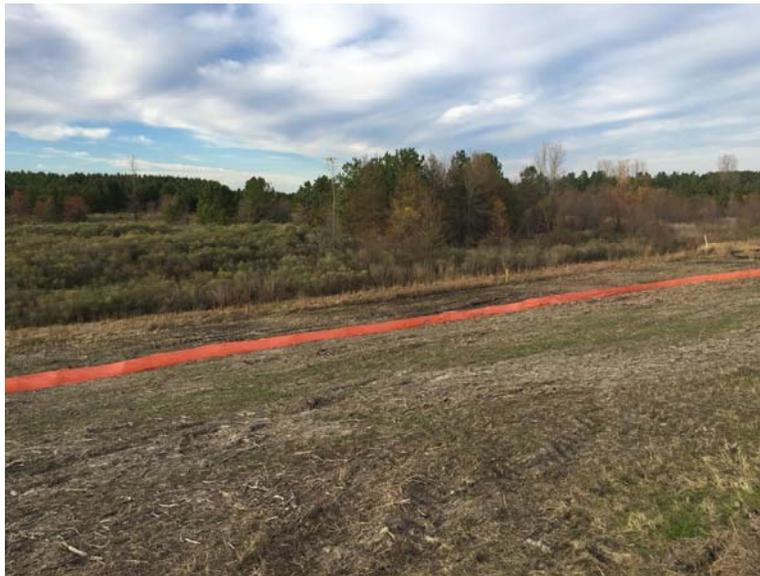
- Monitor two wet areas on the upper portion of the slope (near same elevation) of the northwest embankment near Stations 214+00 and 218+00. Wetness was observed on the embankment immediately downslope of South Holding Pond.

Pastor, Behling & Wheeler	DESCRIPTION	Photograph 7 – (View N; Sta. 217+00) Monitor wet areas beyond toe of slope to the northwest of South Holding Pond.	
PROJECT NO. 5178-B	SITE NAME	Martin Lake A1 Landfill – Annual Inspection	DATE 12/9/2015

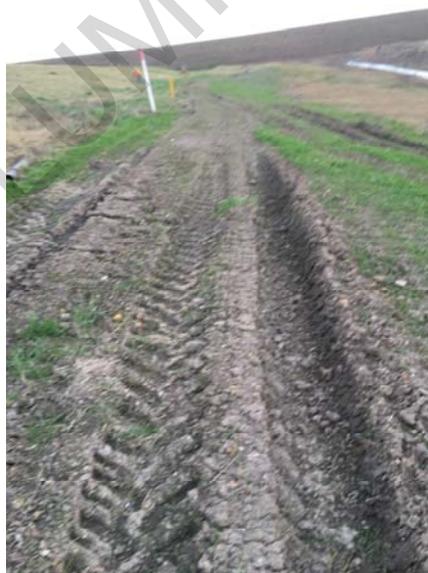
Pastor, Behling & Wheeler	DESCRIPTION	Photograph 8 – (View SE; Sta. 140+00) Monitor recent repair and wetness on embankment.	
PROJECT NO. 5178-B	SITE NAME	Martin Lake A1 Landfill – Annual Inspection	DATE 12/9/2015

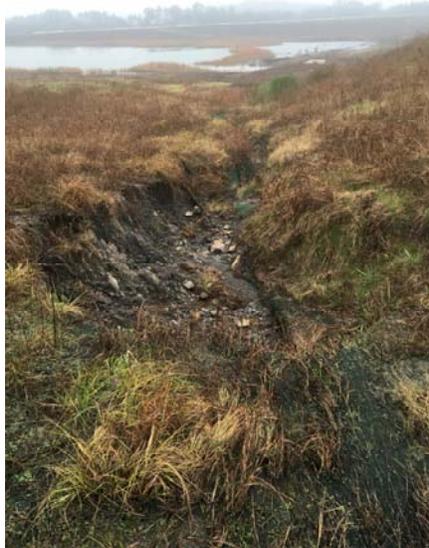
Pastor, Behling & Wheeler PROJECT NO. 5178-B	DESCRIPTION	Photograph 9 – (View S; Sta. 132+00) Repair gully erosion/head cut between cap and railroad embankments.	
	SITE NAME	Martin Lake A1 Landfill – Annual Inspection	DATE 12/10/2015

- Repair erosion near the crest of the embankment on the east side of the railroad embankment near Station 132+00.
- Repair localized area of subsidence on north side of the access road near the toe of the embankment (Station 67+00).
- Monitor the following recent embankment repairs to ensure the repaired area remains stable and uniform vegetative cover is achieved:

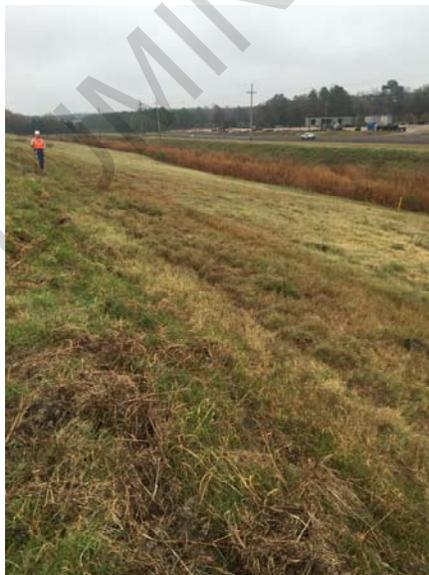
Pastor, Behling & Wheeler PROJECT NO. 5178-B	DESCRIPTION	Photograph 10 – (View NE; 94+00) Monitor wetness at toe of slope in vegetated area. Remove vegetation when conditions allow. (Note: baseflow present from permitted discharge)	
	SITE NAME	Martin Lake A1 Landfill – Annual Inspection	DATE 12/10/2015

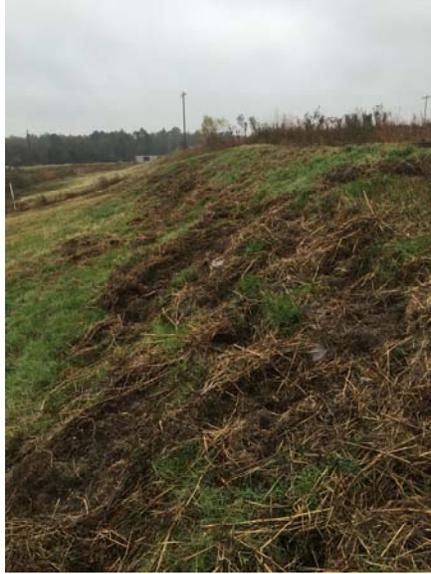
Pastor, Behling & Wheeler PROJECT NO. 5178-B	DESCRIPTION	Photograph 11 – (View SE; Sta 77+00) View of typical feral hog damage near crest of embankment (See Figure 8 for locations of similar damage).	
	SITE NAME	Martin Lake A1 Landfill – Annual Inspection	DATE 12/10/2015
