**2017 ANNUAL CCR UNIT INSPECTION REPORT
LUMINANT SANDOW 5 GENERATING PLANT
AX LANDFILL
MILAM COUNTY, TEXAS**

January 10, 2018

PASTOR, BEHLING & WHEELER, LLC
2201 Double Creek Drive, Suite 4004
Round Rock, Texas 78664
Texas Engineering Firm No. 4760

PBW Project No. 5313B

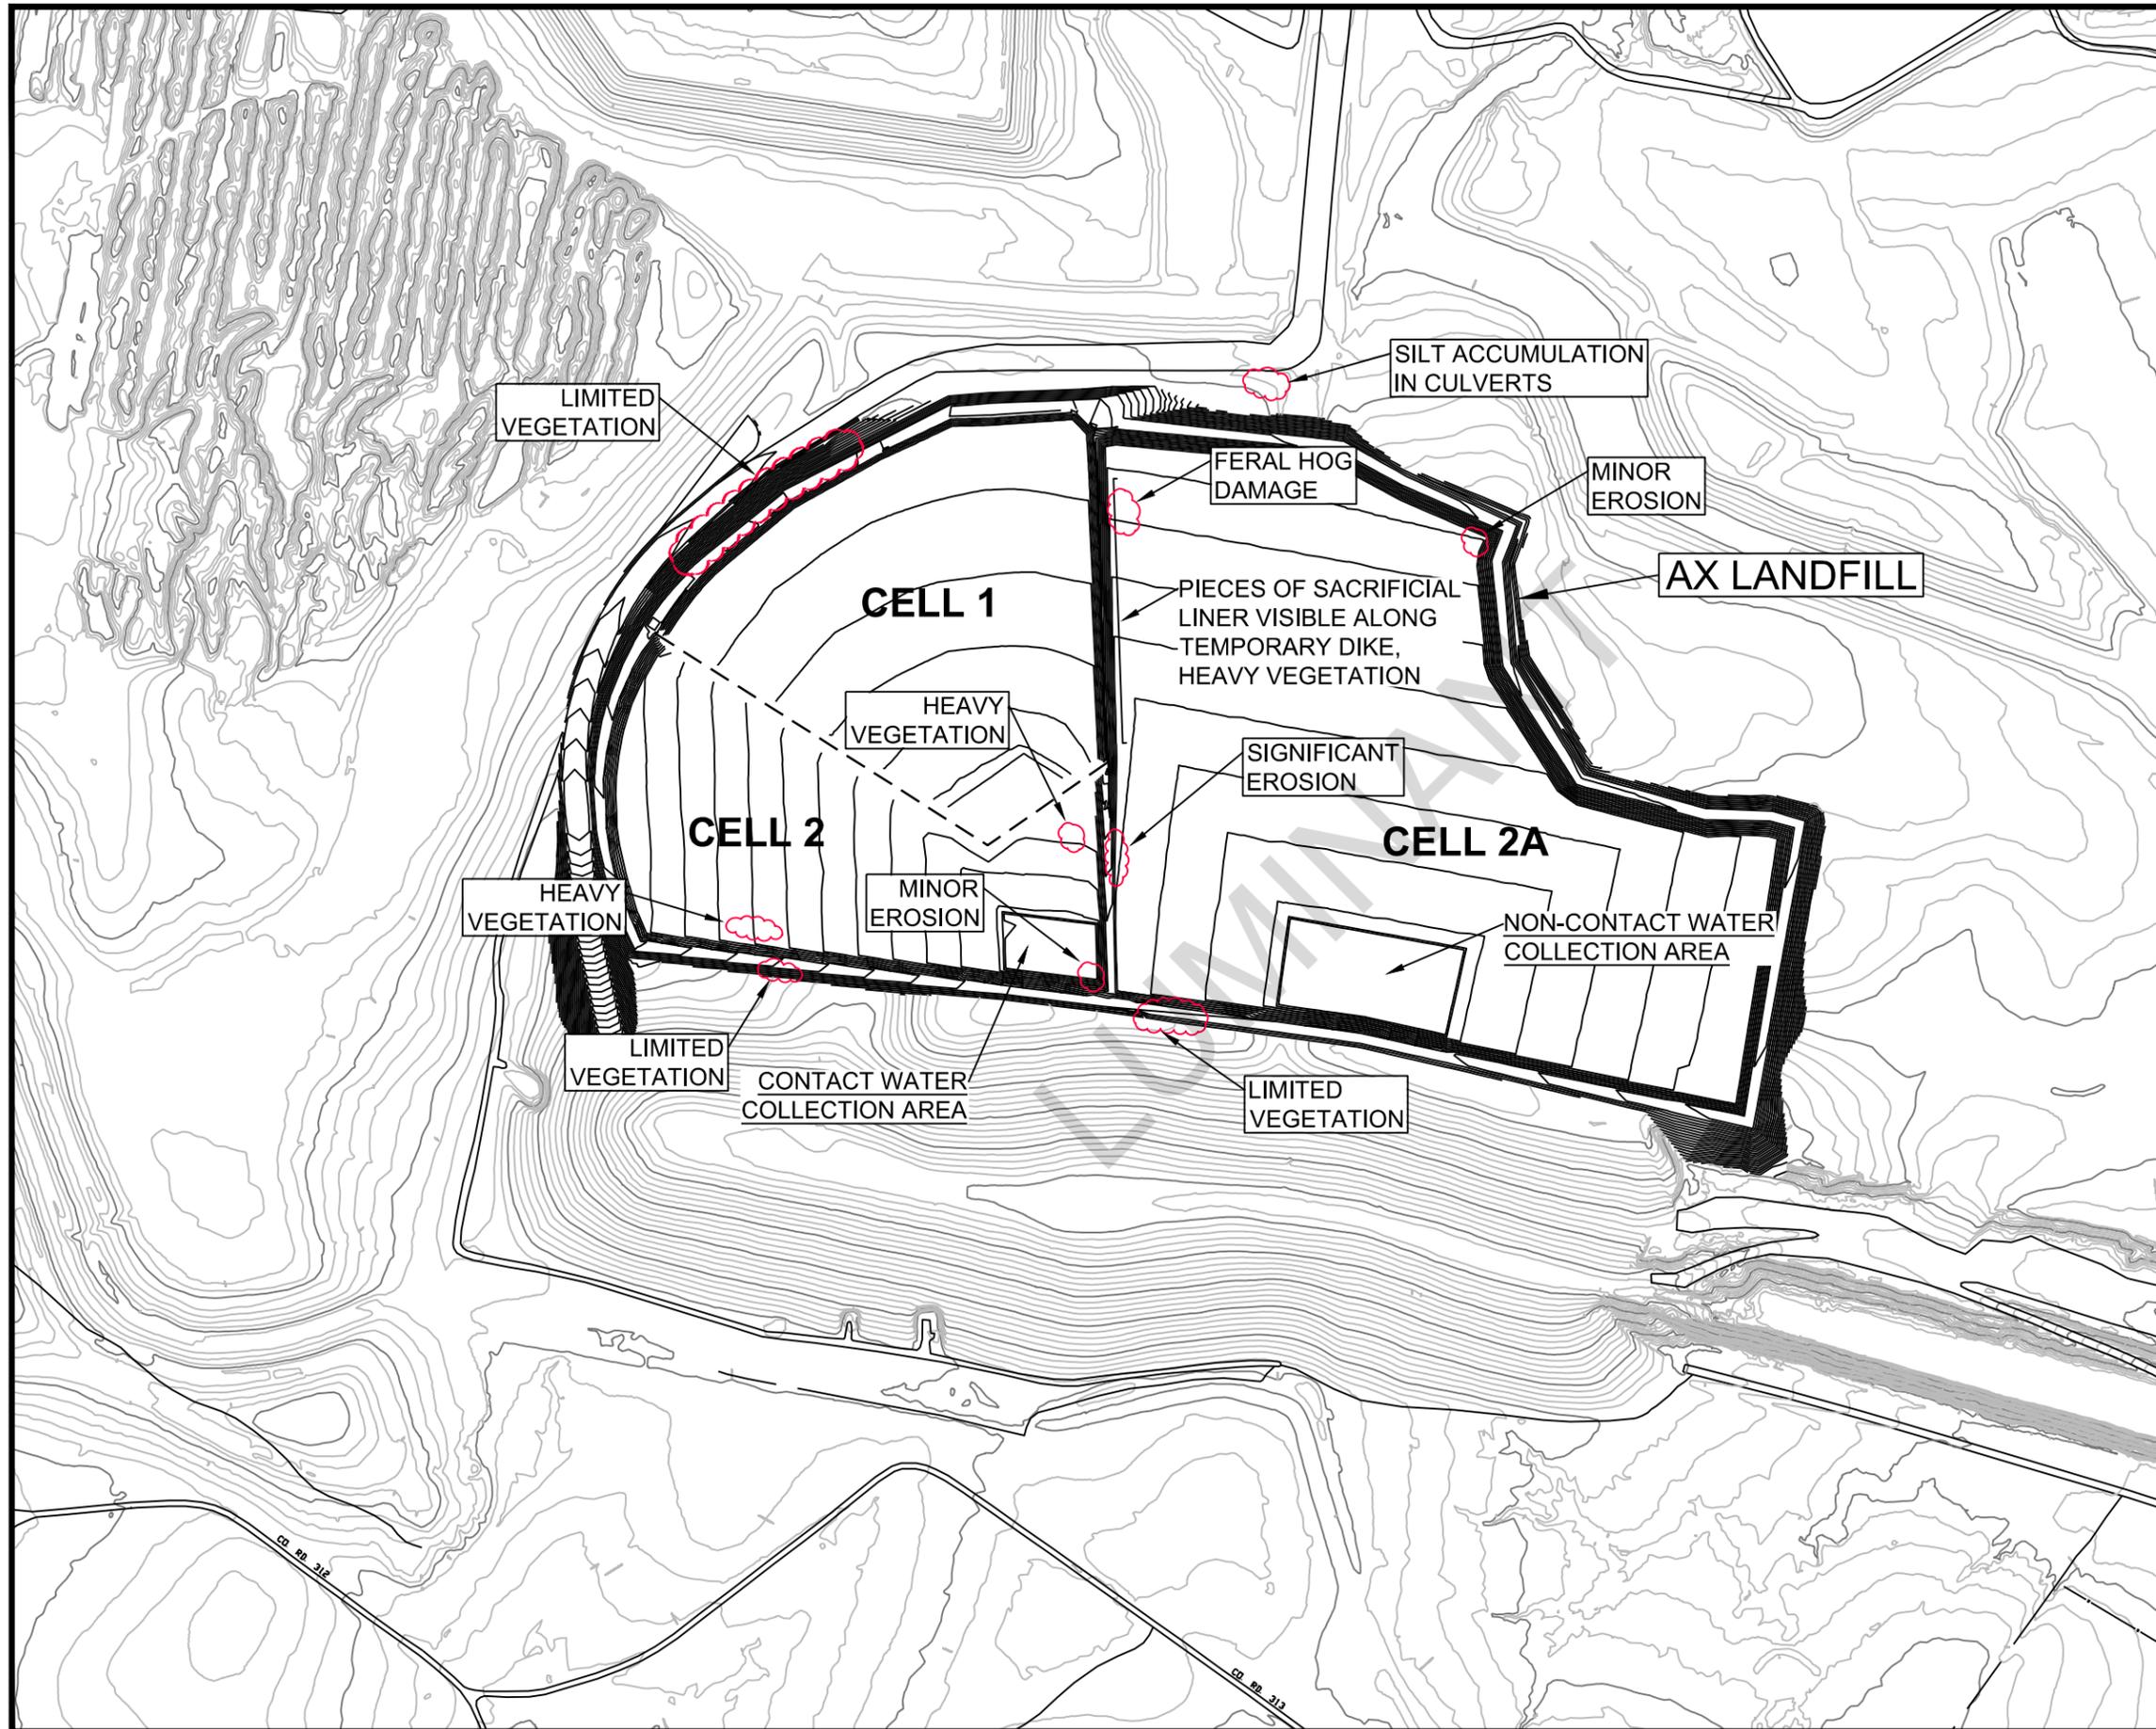
Figure 3
ANNUAL INSPECTION FINDINGS SUMMARY MAP AX LANDFILL

- Heavy vegetation was observed in areas along the interior face of the permanent embankment on the south side of Cell 2 and the interior face of the temporary embankment on the east side of Cells 1 and 2. It is recommended that the vegetation in these areas be cut/maintained to reduce the potential for liner/embankment damage due to shrub/tree roots.
- A small area of significant erosion (liner visible) was observed along the temporary embankment between Cells 2 and 2A. This area should be repaired.

- An accumulation of silt was observed blocking the inlets to two culverts that cross the haul road on the north side of the AX Landfill, northeast of the access ramp. The silt should be removed from the culvert inlets.

- Two areas of limited vegetation were observed on the exterior slopes of the permanent embankment on the west side of Cell 1 and south side of Cells 2 and 2A. These areas should be monitored and repaired as necessary.
- Minor erosion was observed in a small area along the interior slope of the permanent embankment on the south side of Cell 2, near the contact water collection area. This area should be monitored and repaired as necessary.
- Feral hog damage was observed in a small area along the permanent embankment along the north side of Cell 1. This area should be monitored and repaired as necessary.

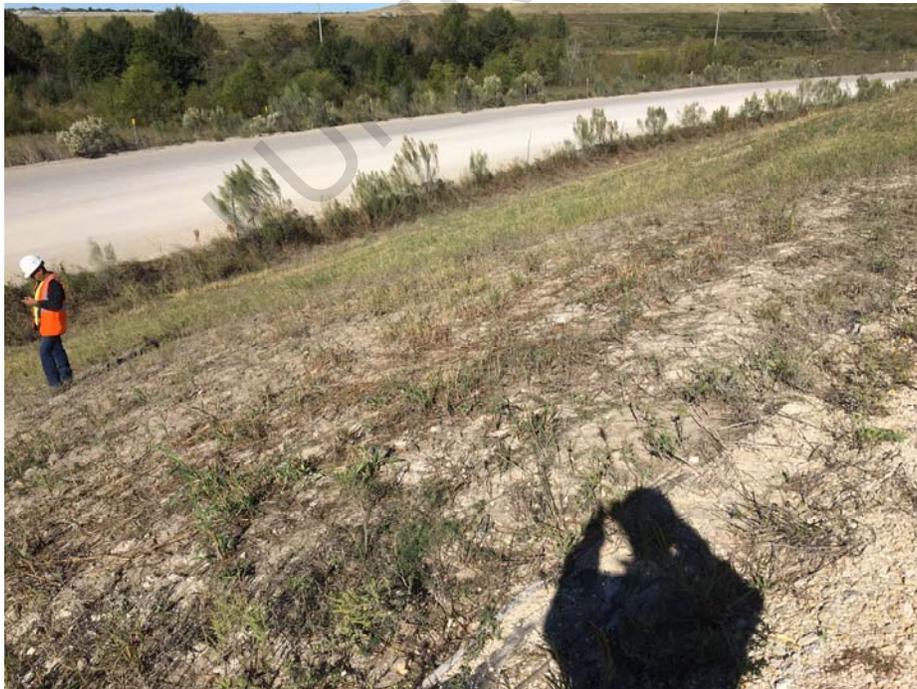
- Two areas of limited vegetation were observed on the exterior slopes of the permanent embankment on the west side of Cell 1 and south side of Cells 2 and 2A. These areas should be monitored and repaired as necessary.

Pastor, Behling & Wheeler	DESCRIPTION	Photograph 8 – Area of limited vegetation along west embankment of Cells 1 and 2.	
PROJECT NO. 5313B	SITE NAME	Sandow Unit No. 5 – AX Landfill Annual Inspection	DATE 10/24/17

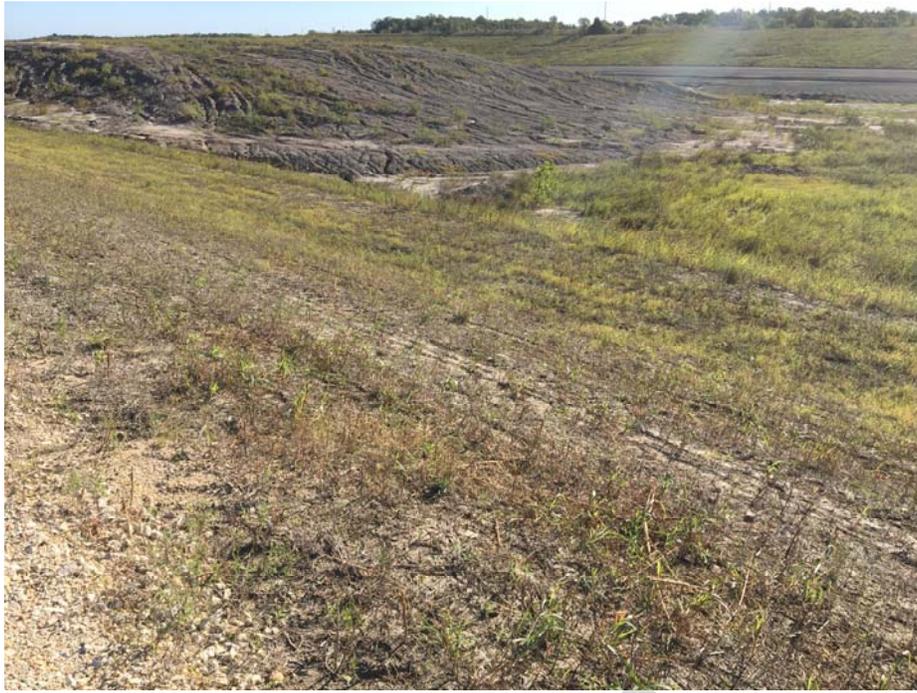
Pastor, Behling & Wheeler PROJECT NO. 5313B	DESCRIPTION	Photograph 11 – Area of limited vegetation along south embankment of Cell 2.	
	SITE NAME	Sandow Unit No. 5 – AX Landfill Annual Inspection	DATE 10/24/17

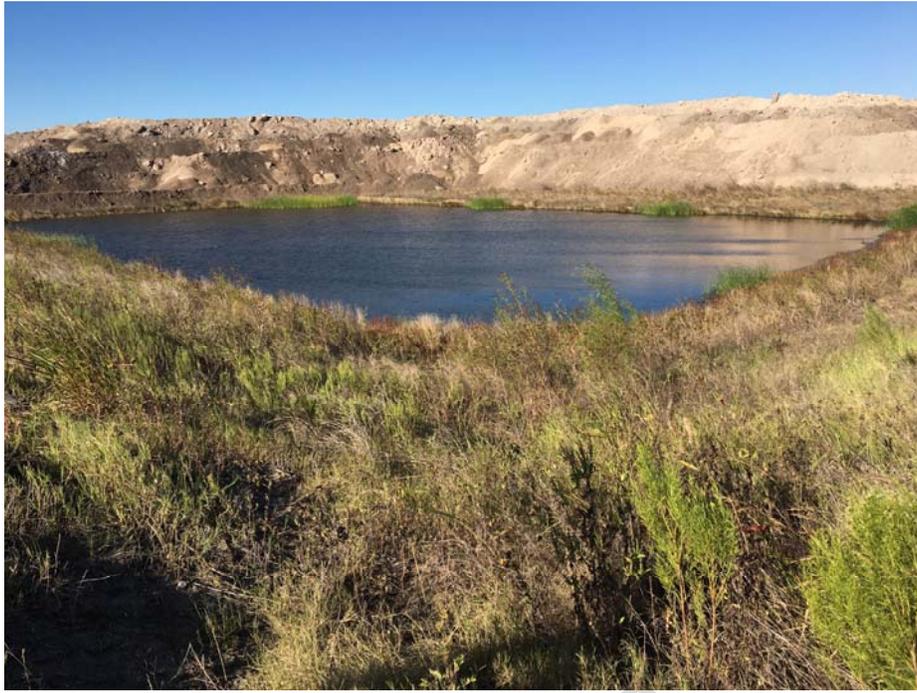
Pastor, Behling & Wheeler PROJECT NO. 5313B	DESCRIPTION	Photograph 13 – Contact water collection area in Cell 2.	
	SITE NAME	Sandow Unit No. 5 – AX Landfill Annual Inspection	DATE 10/24/17

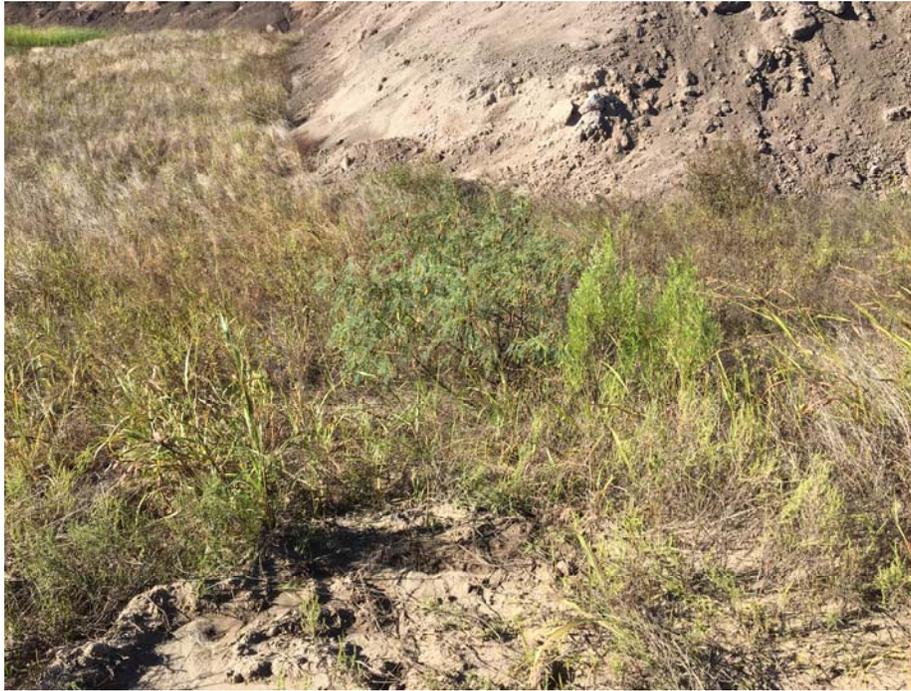
- Heavy vegetation was observed in areas along the interior face of the permanent embankment on the south side of Cell 2 and the interior face of the temporary embankment on the east side of Cells 1 and 2. It is recommended that the vegetation in these areas be cut/maintained to reduce the potential for liner/embankment damage due to shrub/tree roots.

Pastor, Behling & Wheeler	DESCRIPTION	Photograph 15 – Erosion and heavy vegetation on face of temporary embankment in Cell 2.	
PROJECT NO. 5313B	SITE NAME	Sandow Unit No. 5 – AX Landfill Annual Inspection	DATE 10/24/17

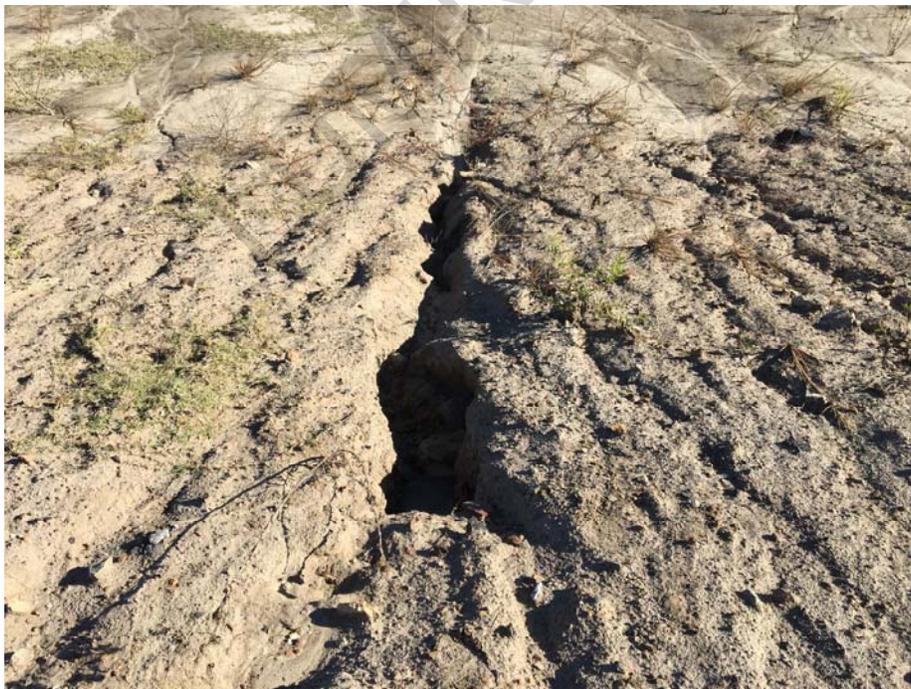
- A small area of significant erosion (liner visible) was observed along the temporary embankment between Cells 2 and 2A. This area should be repaired.

Pastor, Behling & Wheeler	DESCRIPTION	Photograph 16 – Significant erosion on face of temporary embankment in Cell 2A.	
PROJECT NO. 5313B	SITE NAME	Sandow Unit No. 5 – AX Landfill Annual Inspection	DATE 10/24/17

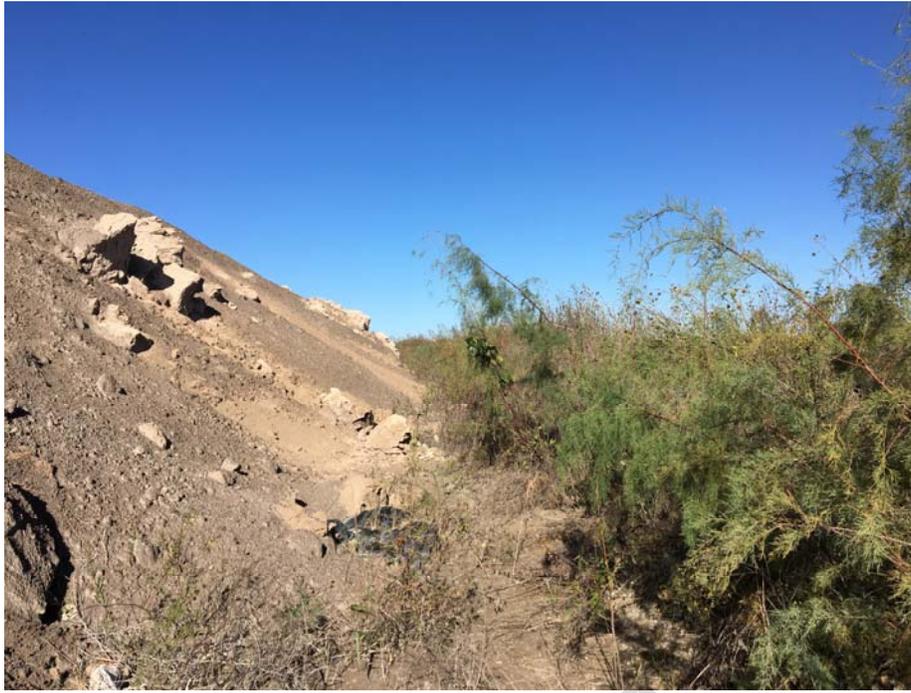
Pastor, Behling & Wheeler PROJECT NO. 5313B	DESCRIPTION	Photograph 17 – (View NW) Heavy vegetation in Cell 1 on face of temporary embankment along east side of Cell 1.	
	SITE NAME	Sandow Unit No. 5 – AX Landfill Annual Inspection	DATE 10/24/17

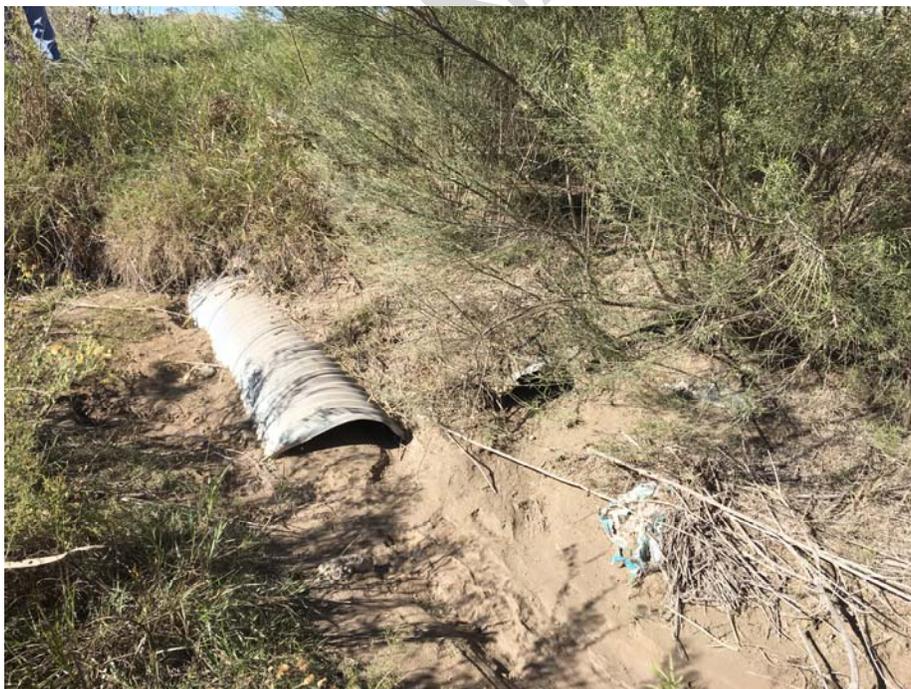
- An accumulation of silt was observed blocking the inlets to two culverts that cross the haul road on the north side of the AX Landfill, northeast of the access ramp. The silt should be removed from the culvert inlets.

Pastor, Behling & Wheeler	DESCRIPTION	Photograph 24 – Significant accumulation of silt in culverts crossing under haul road on north side of landfill.	
PROJECT NO. 5313B	SITE NAME	Sandow Unit No. 5 – AX Landfill Annual Inspection	DATE 10/24/17
