October 2016

**RE: History of Construction
USEPA Final CCR Rule, 40 CFR § 257.73(c)
Joppa Power Station
Joppa, Illinois**

On behalf of Electric Energy, Inc., AECOM has prepared the following history of construction for the East Ash Pond at the Joppa Power Station in accordance with 40 CFR § 257.73(c).

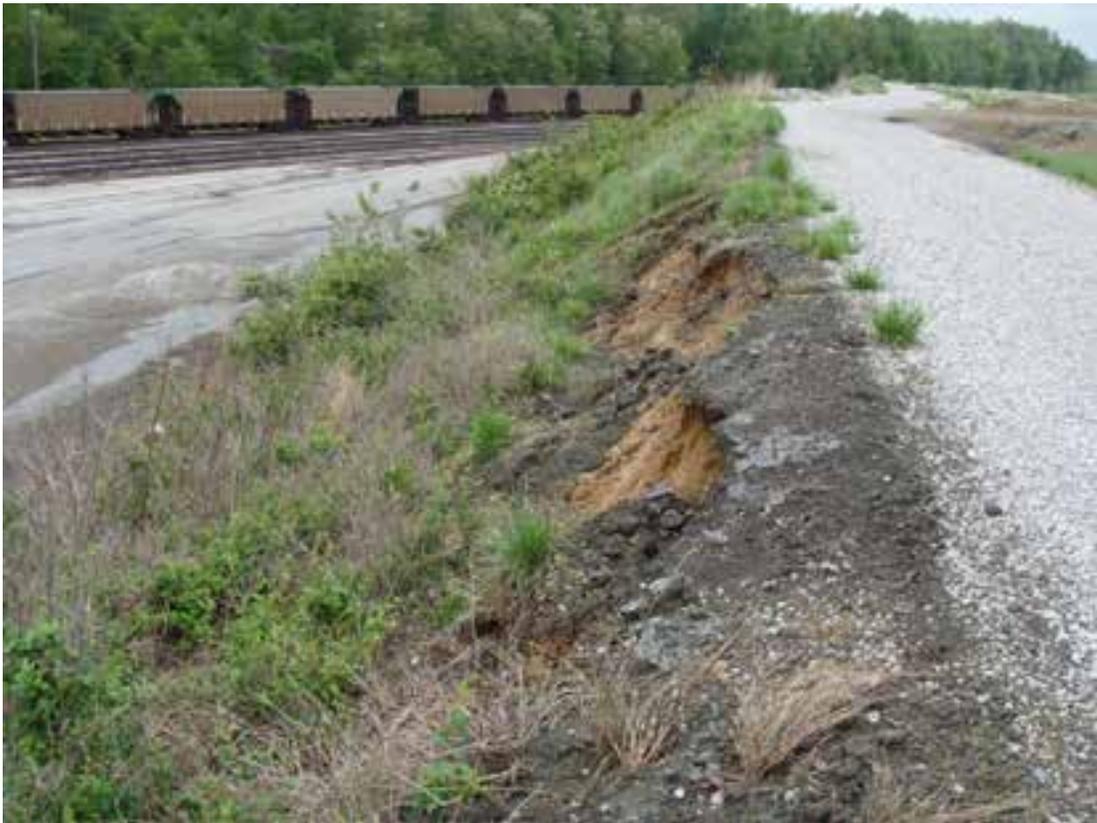
Slide Area #1

During the inspection, sloughs at eight areas of instability were observed. The areas of instability are shown on the attached photographs. The sloughs appeared to be relatively shallow. The length of scarp varied from as little as 25 ft in length to as much as 150 ft in length. The scarps generally began at the top of the slope and extended to between one-half of the embankment height and the full embankment height. The embankment soils exposed by the slide were observed to be firm to hard at a shallow depth (less than 1 ft in most instances) when probed with a thin steel rod (drain tile probe).

The sloughs observed on the northern ash pond (#1 through #6) and one of two slough areas on the southern ash pond (area #7) appeared to be mainly due to sliding at the interface between ash materials apparently added to the downstream embankment slope and the original cohesive soil embankment constructed in 1985. Water infiltration through the ash materials that did not infiltrate the cohesive soils appears to have reduced the friction between these materials and caused sloughing. The sloughed material appeared to be composed of partially hydrated flyash and was generally hard and brittle.

Repair of these areas may be completed using local cohesive soils, or riprap materials similar to those used to repair other areas of sliding. The use of local cohesive soil for repair will probably be the more economic alternative if repairs are made, but will require more favorable weather conditions and soil moisture control as described below.

Repair of the embankment with local cohesive soil should consist of stripping the affected area of all sloughing soil, ash, and vegetative cover; placement of new compacted soil embankment; and establishment of vegetative cover on the repaired embankment. Repair of these areas with soil should not be started until weather conditions allow compaction of thin lifts (8 in. maximum compacted thickness) of soil to be placed and compacted to 95% of the maximum dry density obtained using ASTM Test Method D648 (Standard Compaction Test).

The new embankment materials should be constructed by benching into the existing embankment deep enough to remove all soft or wet soils encountered. The maximum vertical bench height should be limited to 2 ft. The average slope of the benched area within the existing embankment should be no steeper than 1.5H:1.0V during construction of repairs. In order to construct repairs and maintain stability of the existing embankment materials, it will probably be necessary to increase the width of the embankment toe and construct a slope flatter than the 1.5H:1.0 V and 2.0H:1.0V slopes that were originally constructed. It is recommended that slopes no steeper than 2.5H:1.0V be constructed for repairs with local cohesive soils since one area of instability in the 2.0H:1.0V existing slope was observed during the inspection. A typical soil repair section is shown on the attached sheet.

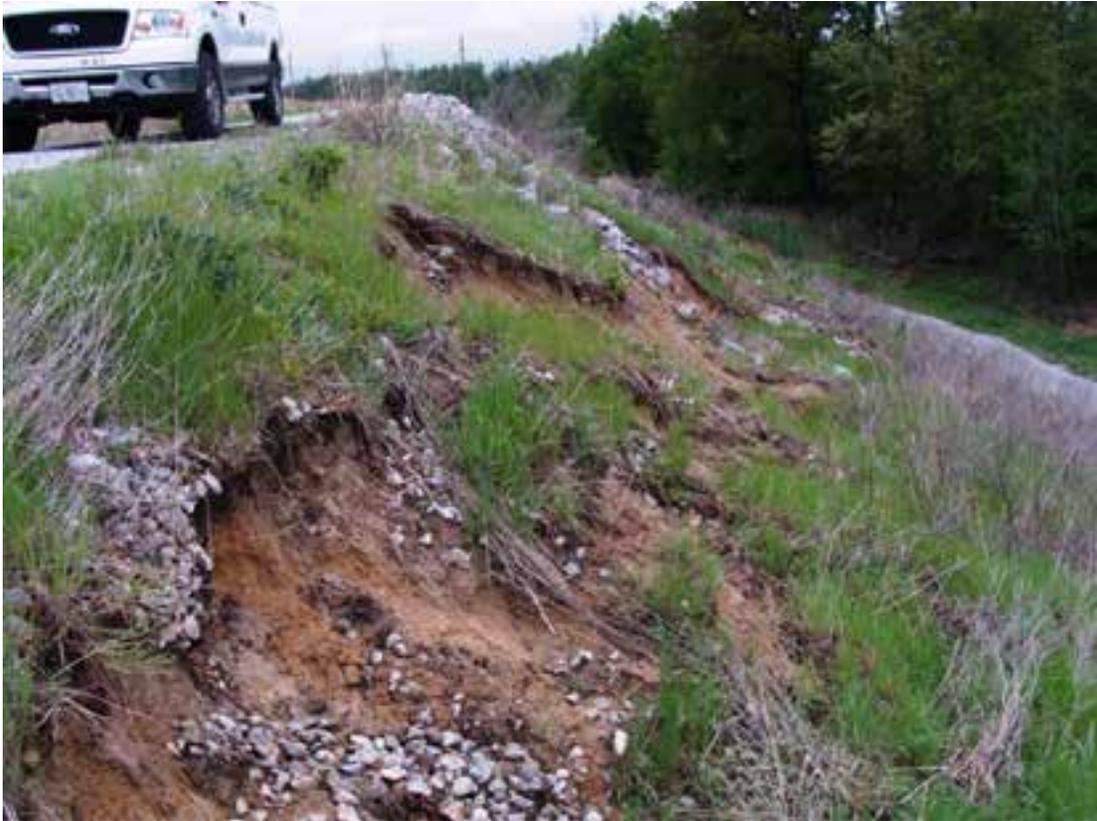
Slide Area #8

Slide area #8 was observed on the southern portion of the eastern embankment. It appeared to be a shallow failure about 50 ft long with a scarp about 8 in. deep. In general, the slide appeared to consist of only topsoil and organic material. Infiltration of water through the topsoil that was trapped between the topsoil and cohesive embankment probably provided the failure mechanism in this area. There were no observations made that would indicate why this area failed and other areas with similar surface condition and slope did not.

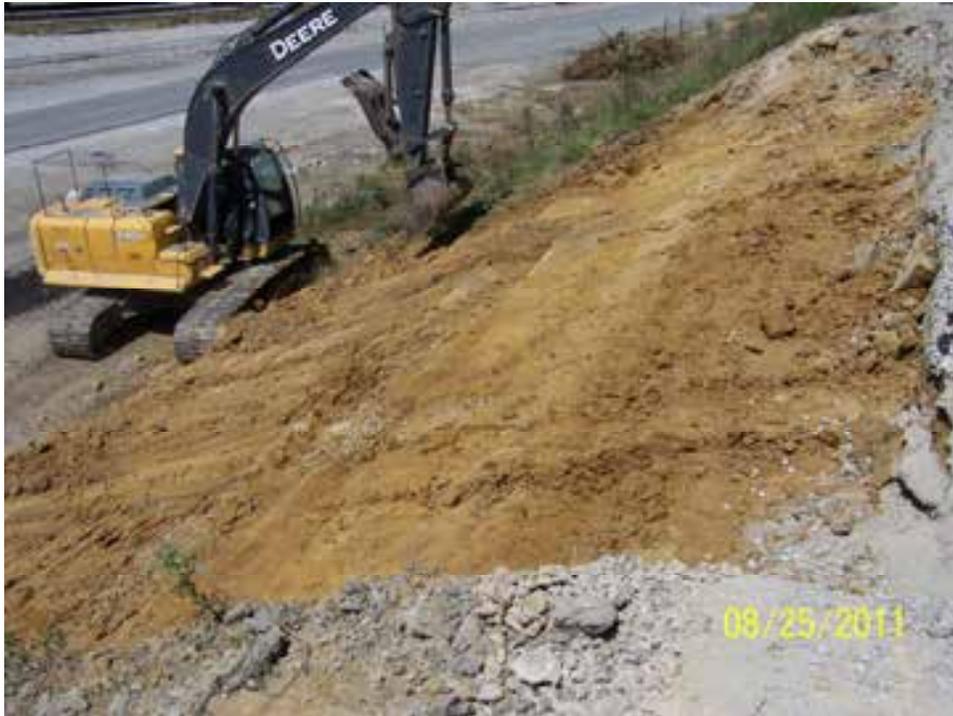
Figure E.1: Photo of stripping the affected area of all sloughing soil, ash, and vegetative cover.

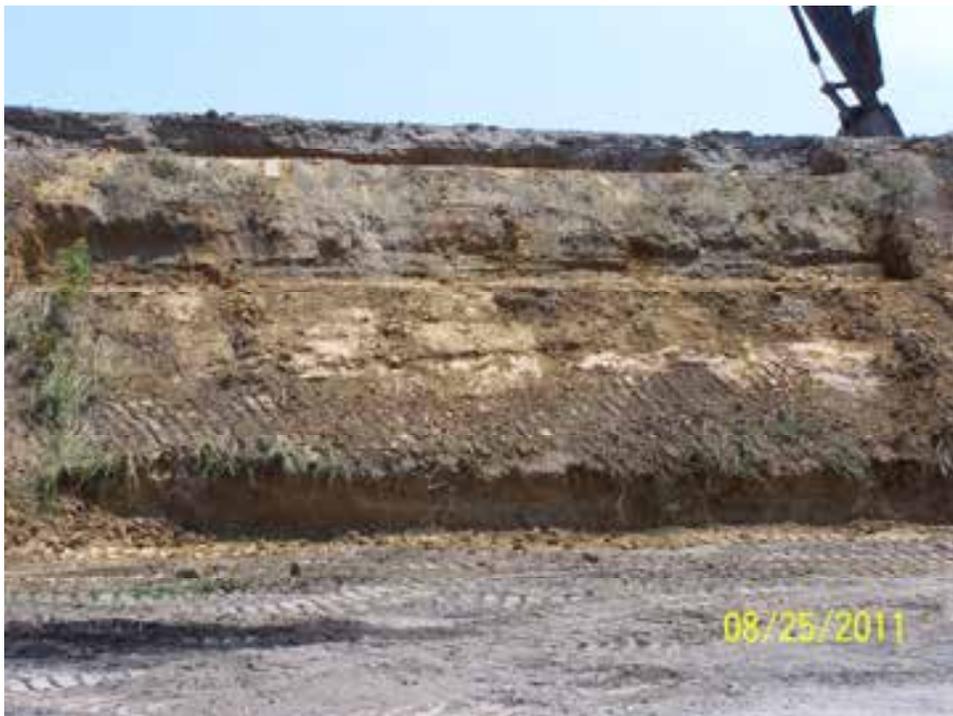
Figure E.2: Photo of benching into the existing embankment.
