RE: History of Construction USEPA Final CCR Rule, 40 CFR § 257.73(c) Newton Power Station Newton, Illinois

On behalf of Illinois Power Generating Company, AECOM has prepared the following history of construction for the Primary Ash Pond at the Newton Power Station in accordance with 40 CFR § 257.73(c).

SUBJECT: Ameren Newton Power Plant Site Visit Report 9-12-08

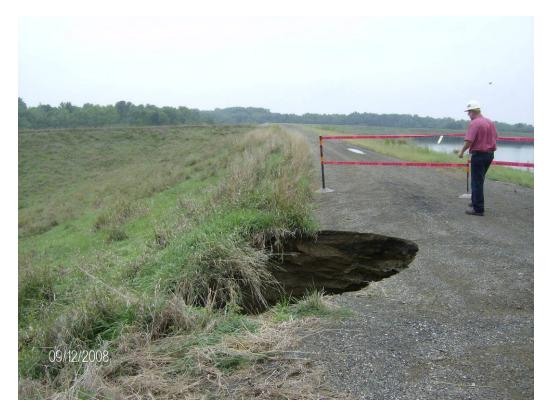
The sinkhole has developed on the downstream crest of the dike between the primary (upper) and secondary (lower) ash ponds (see attached photos). The sinkhole was first observed the morning of September 12, 2008 after a heavy rain. The sinkhole is circular in shape with a diameter of approximately 12 ft. The depth to the bottom of the sinkhole is estimated to be 10 to 12 ft. The sinkhole has developed directly over the location where two discharge pipes between the primary and secondary ponds are joined (see attached Section C-C). The discharge pipes are 30 in. diameter corrugated metal pipes (CMP) installed in the late 1970's. There was no indication of ground movement in the form of settlement or bulging of the dike embankment outside the area of the sinkhole. The water level in the primary ash pond is approximately El. 536 and the water level in the secondary pond is maintained at minimum El. 516.5. There has been no significant fluctuation of the water levels in either pond for over 6 months. The top of the dike is at El. 555 and the top of the discharge pipe below the sinkhole location is approximately El. 514. Therefore, the depth below the ground surface to the top of the pipe at the sinkhole location is approximately 41 ft.

Based on the location of the sinkhole relative to the discharge pipes and considering the age of the metal pipes, it appears that the most likely cause of the sinkhole is due to loss of soil material through a hole or holes in the discharge pipes. In particular, the connection between the two pipes is suspect. The pipe discharges into the secondary pond below the water level and therefore there is no way to visually observe the discharge for soil deposits. If the cause of the sinkhole is due to loss of material through holes in the pipes, this process could have been occurring over several years. There is the possibility that there is a void or voids that extend from the ground surface to the discharge pipes, and it would be expected that the sinkhole would continue to develop over time. It is possible that additional settlement or sloughing of soil material on the downstream crest of the embankment in the immediate vicinity of the sinkhole will occur in the near future. However, considering the relatively low level of water in the

View of Sinkhole Looking Northwest Along Dike

- The existing sinkhole should be filled with soil material to prevent further sloughing and expanding of the sides of the sinkhole. The material should be placed with a backhoe and compacted with the backhoe bucket. No mechanical compaction of the soil should be attempted. The top of the filled area should be crowned to prevent ponding in the area of the sinkhole, and the sinkhole area should be monitored daily for additional settlement or movement.

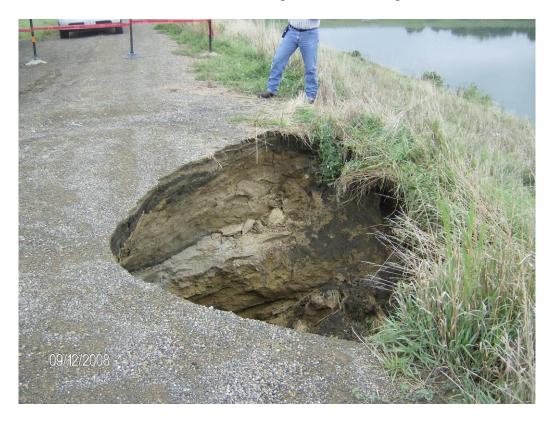
View of Sinkhole Looking Southeast Along Dike

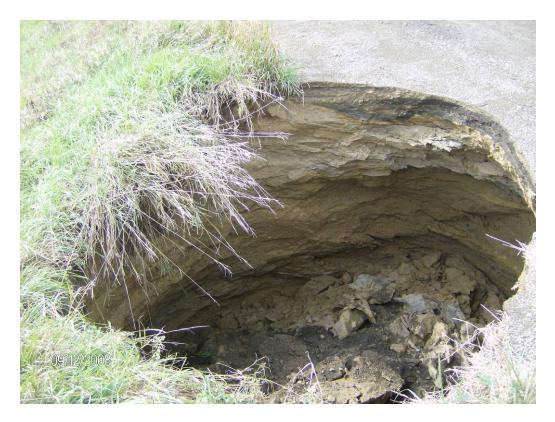
Close-Up of Sinkhole

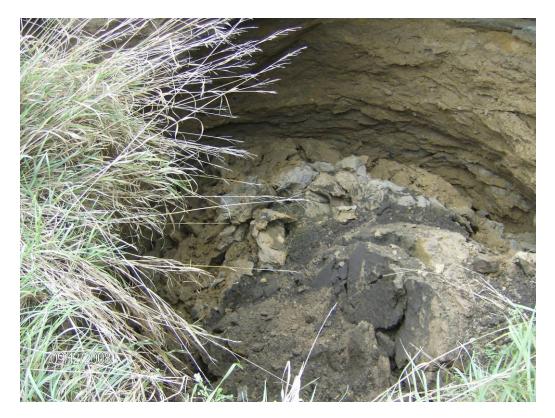
View of Bottom of Sinkhole

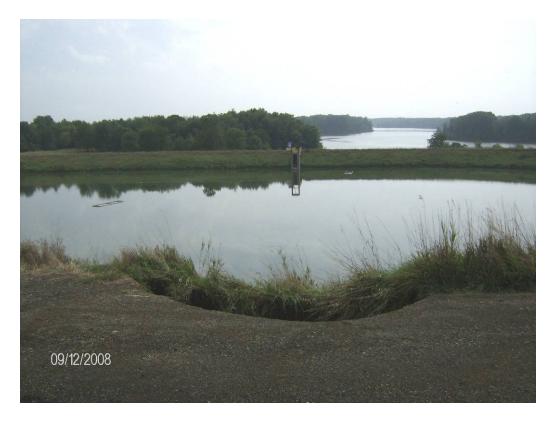
View of Sinkhole Looking Southwest Towards the Secondary Pond and Lake
