January 15, 2016
BBA Project No. 15-214.1

RE: Coletto Creek Power – September 2015 Primary and Secondary Ash Ponds Dike Inspection

Bullock, Bennett, and Associates, LLC (BBA) performed a visual inspection of the Coletto Creek Primary and Secondary Ash Ponds dike systems on September 16, 2015. The Primary Ash Pond is approximately 190 acres and the Secondary Ash Pond is approximately 10 acres (the Primary and Secondary Ash Ponds are hereafter referred to collectively as the Ash Ponds). The Ash Ponds were constructed in the late 1970s and include a perimeter dike system approximately 2.5 miles in total length. The crest width of the Ash Ponds is approximately 15 feet, and side slopes (interior and exterior) of the Primary Ash Pond were reportedly constructed to 2.5(H):1(V) and the Secondary Ash Pond to 3(H):1(V). The Ash Ponds were reportedly constructed in accordance with Texas Department of Water Resources technical guidelines. Ash material is sluiced to the Primary Ash Pond where most settlement takes place, and water is decanted from the Primary Ash Pond through a weir located within the shared dike between the Ash Ponds to the Secondary Ash Pond. Water can be pumped (although

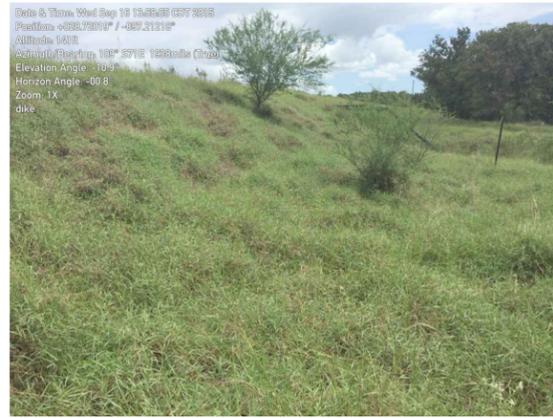
7383 - Exterior

Other than the wet areas discussed above, the exterior slope of the dike appeared in good condition. A few small trees were observed as shown in photos 7383 and 7594, and grass, although in good condition and with good coverage, was tall and restricted visibility of the levee surface.

- Remove small trees and shrubs observed from all side slopes.
- Mow the exterior dikes on a regular basis to improve ability to visually inspect the dike, encourage good vegetation, and maintain removal of trees and shrubs.

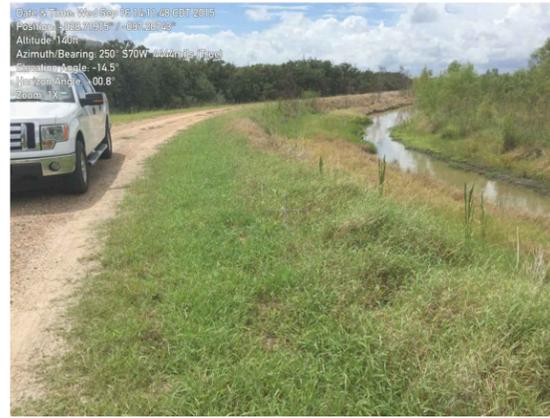
Photos 7429, 7545, and 7564 show inside slope rock armor in areas impounded with water. Photo 7408 shows the inside of the ash pond with a drainage channel cut within the ash to convey sluice material. Photos 7564 and 7571 show small trees on the interior slope.

7408 - Top of Levee

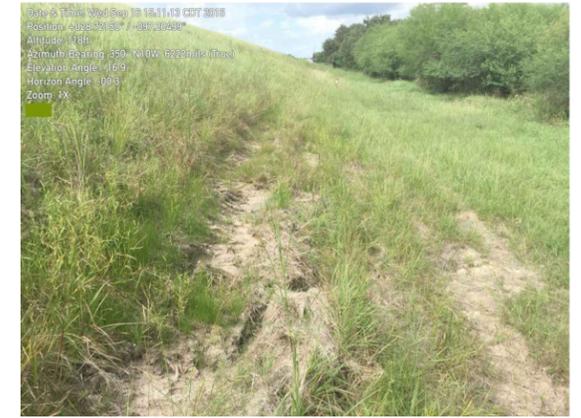
Wet areas were identified near the toe of slope in a few locations between approximately Sta 85+00 and Sta 90+00. These have been identified in previous inspection reports (from the late 1980s and

early 1990s) provided to BBA for review during the site visit. More recent inspection reports were not obtained by BBA for review however, these areas have reportedly continued to persist since observations discussed in the old inspection reports. The wet areas (including some locations of puddled water) and associated erosional features are shown in photos 7455, 7470, 7473, 7478, and 7486 (covering an area approximately 500 feet long). Some of the puddled water observed was cloudy with suspended sediments (photo 7470). The cloudy water is likely a result of accumulation of surface water runoff from rainfall impacting the localized areas of disturbed vegetation given no seepage flow was detected, and some of the wet areas observed within better stands of grass were clear, not cloudy. Similar wet areas along this reach of levee have historically been observed with reportedly no suspended sediments. There was no discernible subsidence observed along the interior dike slope, dike crest, or upgradient portions of the external dike slope in these areas. These areas should be routinely monitored with careful attention paid to the wet areas for observation of possible seepage flow. If seepage flow is observed to include suspended solids (such as clay or silt particles), this could be an indication of internal dike erosion that may lead to unstable dike conditions. These wet areas should be further investigated and addressed based on investigation findings. Given the localized toe erosion and wet soil conditions in the area, this section of dike could worsen to cause unstable dike conditions if not addressed.

7455 - Exterior Toe (Wet Area)

- Continue to monitor the observed Primary Ash Pond wet areas between Sta 85+00 and 90+00. Investigate the observed wet areas and address as appropriate based on investigation findings. During this investigation, also perform a detailed inspection of the existing seepage collection system in the vicinity of the pump house, east of Sta 70+00.

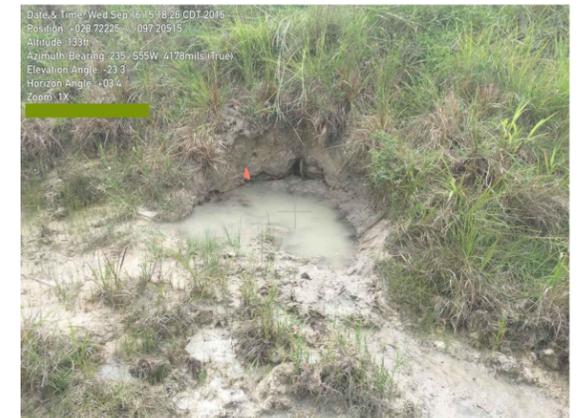
7470 - Exterior Toe (Wet/Erosion Area)

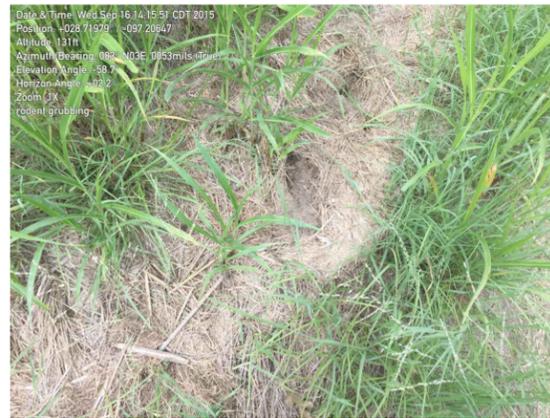
7415 - Exterior Toe (Rodent Grubbing)

- Evidence of animal rooting/grubbing on the dike was minimal during this inspection. However, if evidence of increased activity is observed, implement rodent control as needed. Evidence of fire ants was minimal; however, continue to inspect for fire ants especially in summer months and implement fire ant control as needed (fire ant colonies can be intrusive into the dike interior potentially resulting in piping or initiation of erosion areas).

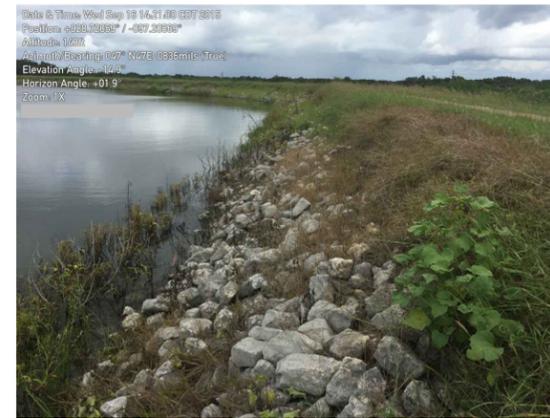
7429 - Interior Slope Protection

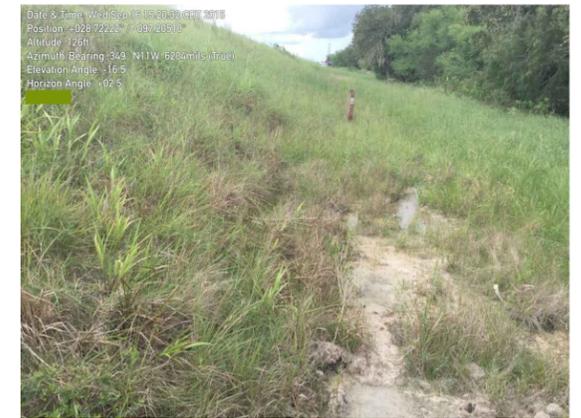
7473 - Exterior Toe (Wet Area)

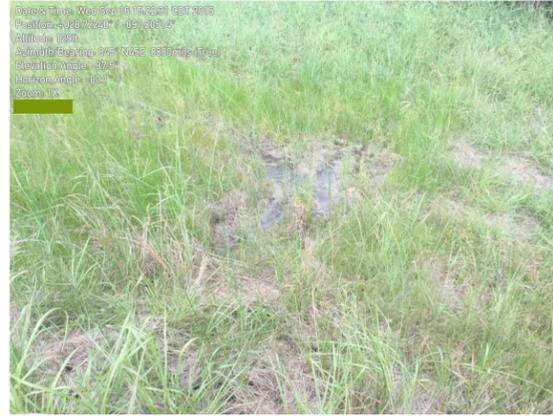
7478 - Exterior Toe (Wet Area)

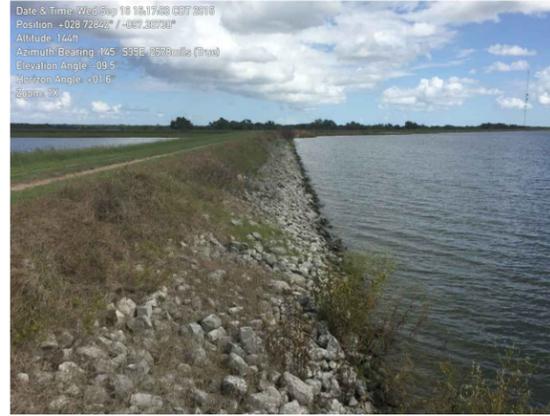
7545 - Interior Slope Protection

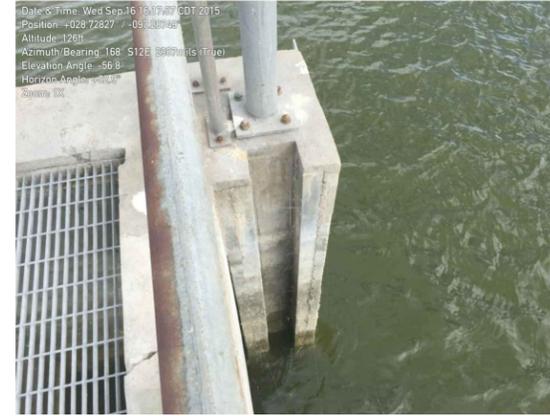
The outlet works from the Primary Ash Pond includes a weir as shown in photos 7547, 7548, and 7549. Stoplogs were not in place at the time of inspection. The staff plate reading as shown in photo 7548 indicated a water surface elevation of approximately 134.0 ft (approximately 6 feet below top of dike elevation).

7549 - Stoplog Slots

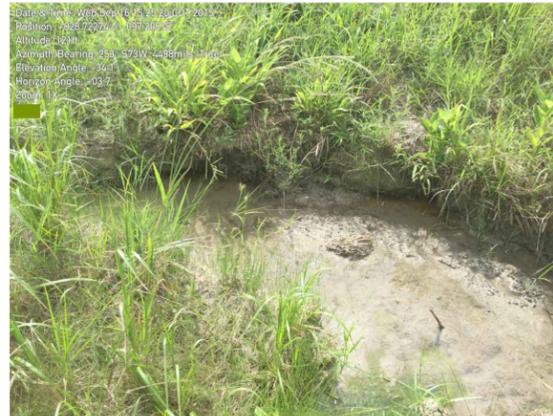
7486 - Exterior Toe (Wet Area)

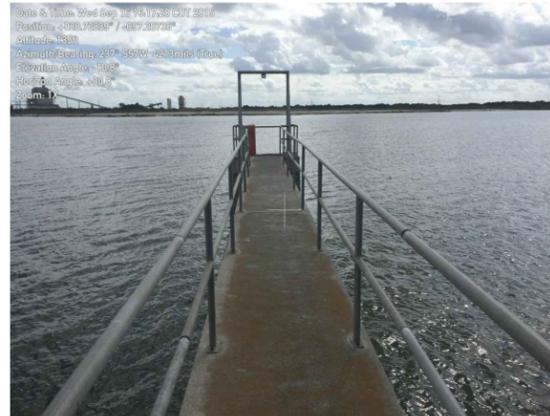
7547 - Outlet Works

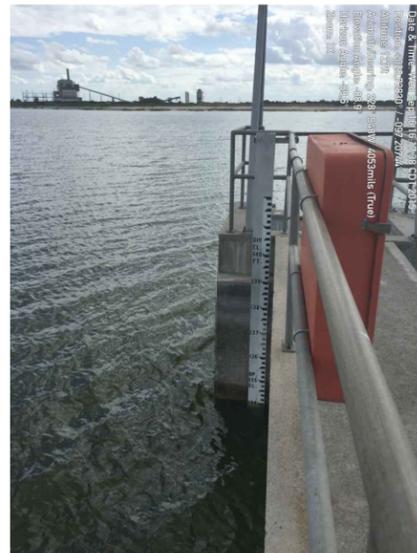
7548 - Staff Plate

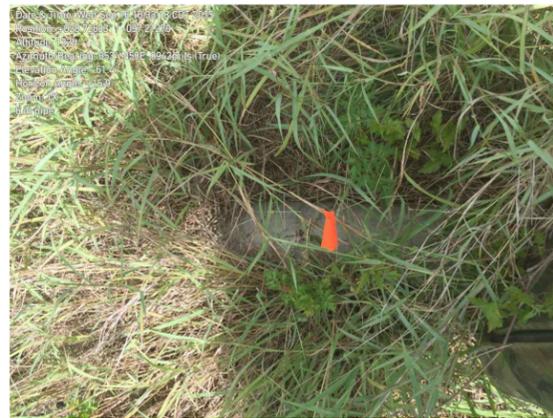
An approximate 6-inch diameter pipe was observed on the west dike near Sta 35+00 as shown in photo 7585.

7585 - 6" Pipe, Exterior

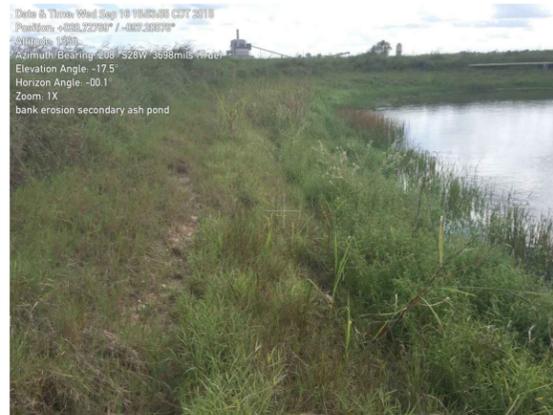
7530 - Interior

As indicated in the attached photos, the Secondary Ash Pond interior side slopes appeared to exhibit minor to moderate and generally uniform bank cut likely due to wave action. This erosion feature appears to have occurred a long time ago given the slope is currently heavily vegetated. At the time of inspection, the water level was low enough to enable access to the interior slope as indicated in the photos. The cut does not appear to be problematic from a dike stability standpoint and no immediate action is required. Maintaining the water level as low as observed during the inspection will prevent future progression of erosion. Alternatively, armoring the slope to reduce future bank cut may be considered as a means to reduce potential future erosion. Other than the bank cut observed, the interior slopes appear well vegetated and in generally good condition. Bank cut erosion is shown in photos 7530 and 7532.

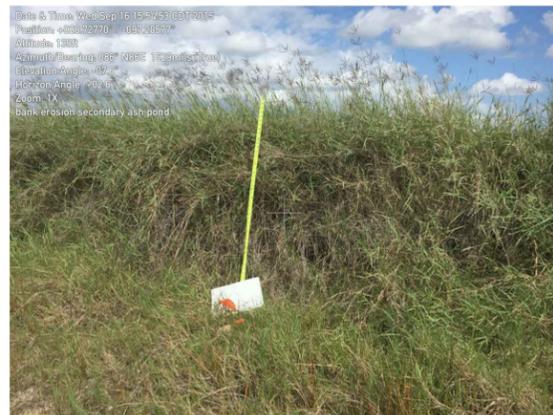
7532 - Bank Erosion, Interior
