May 15, 2018  
BBA Project No. 16244

**RE: Coletto Creek Power – December 2017 Primary Ash Pond (CCR Unit No. 141) Dike Inspection**

# Dam Inspection Report

Name of Dam Primary Ash Pond Dam ID No. 141

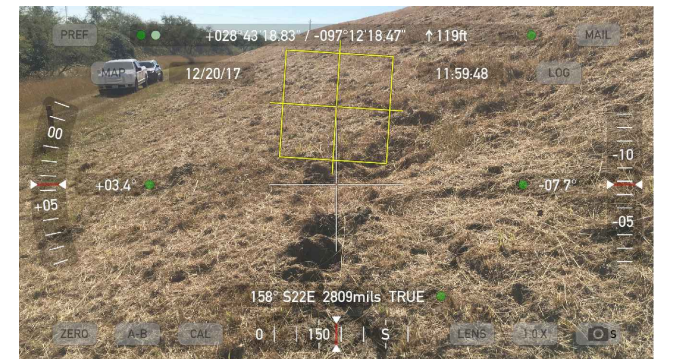
9551 - Exterior, Hog Damage

- Continue hog and rodent control measures. Repair areas of damaged vegetation as shown in photo 9551 and observed in localized surrounding areas.
- Repair minor erosion areas observed in photos 9710, 9718, and 9729.

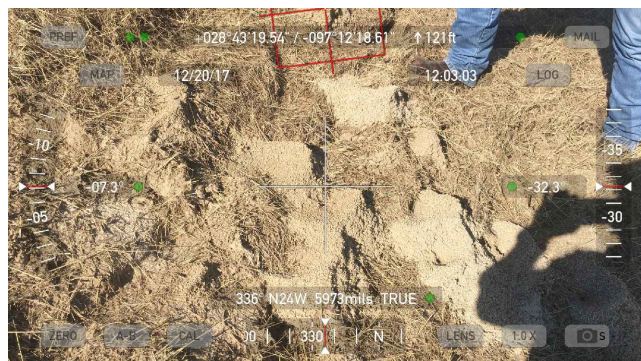
9560 - Exterior, Fire Ant Mounds

- Treat fire ant mounds observed near approximate station 88+00 as shown in photo 9560 and repair area as appropriate. Implement regular fire ant control activities throughout the dike system.

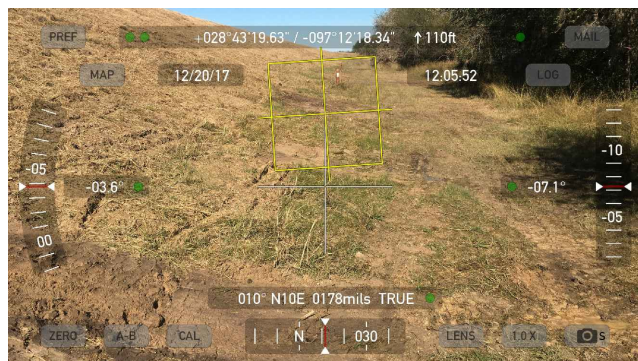
9563 - Exterior, Apparent Seep Area

- Maintain low Primary Ash Pond impoundment water levels to reduce or eliminate seepage at the toe of dike in the area of Station 84+00 to 90+00. Continue to monitor this historic seep area and repair erosional features as needed.

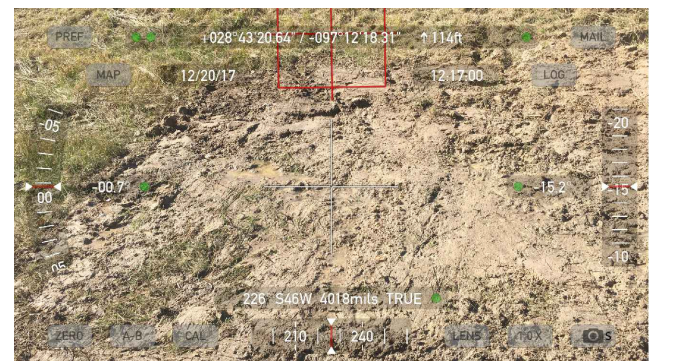
9577 - Exterior, Apparent Seep Area

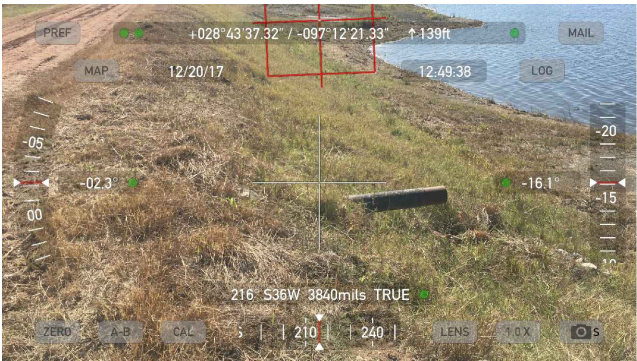
- Pipe penetrations were observed in the dikes within the upper approximate 2 to 3 feet of the dike crest. No substantial dike erosion or indications of settlement were observed in these areas. However; one six-inch diameter steel pipe (near Sta 70+00) observed along the exterior dike slope appeared crushed and inoperable. Coletto Creek Power should review all pipes that penetrate the levee and consider proper removal of any pipes that may be identified as no longer planned for use. Additionally, given the pipes appear old, BBA recommends inspection of pipe sections that penetrate the dike and will not be removed and that are accessible for inspection via use of a remote camera system.

9636 - Pipe Penetration

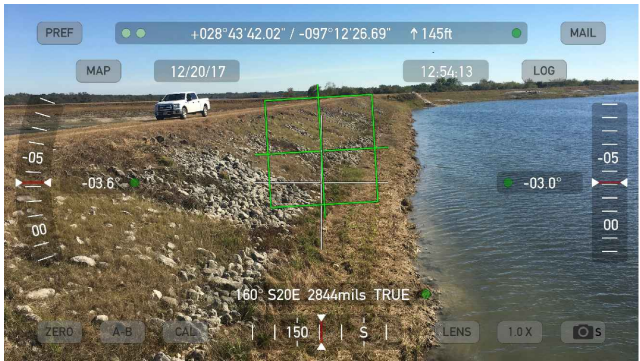
9644 - North Dike Interior, Erosion Below Slope Armor

- Monitor the erosion observed at low elevations along the north dike interior and, if low impoundment water elevations are to be maintained on a long-term basis, consider extending the riprap to an elevation of approximately three feet below operating water surface levels.

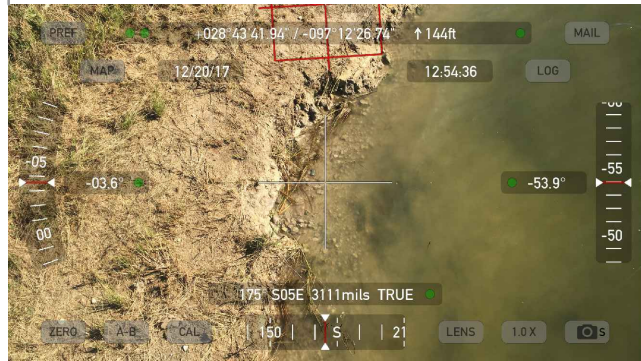
9645 - North Dike Interior, Erosion Below Slope Armor

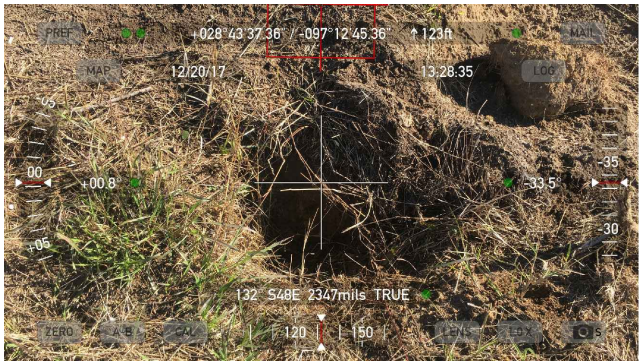
9710 - Exterior Erosion, Burrow

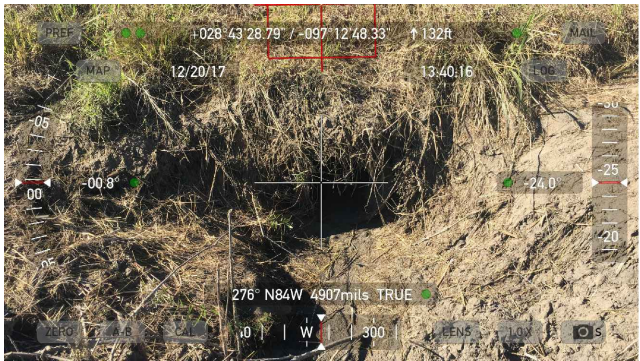
9729 - Interior Erosion

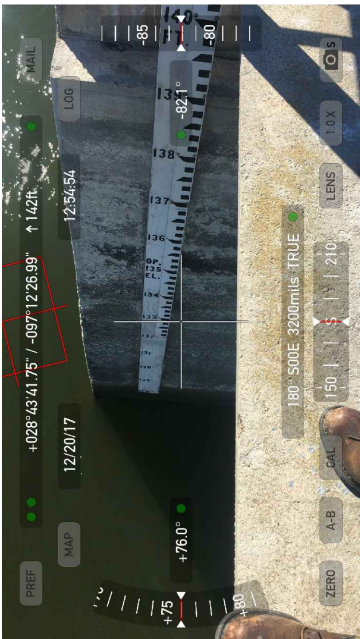
9647 - Staff Plate on Outlet Works

- Replace the existing staff gauge with one that extends lower to capture low impoundment elevations. Reconcile staff gauge with dike spillway elevations.

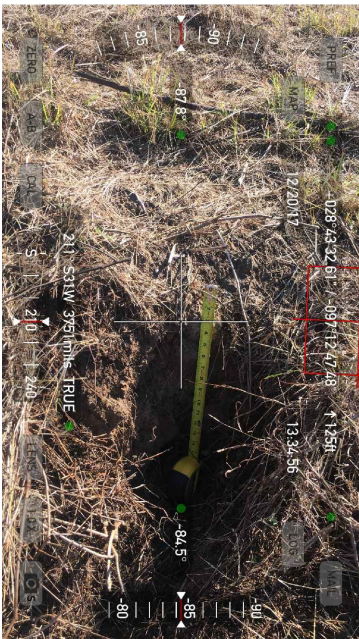
9718 - Exterior Erosion,  
Possible Borrow Near Toe
