ANNUAL INSPECTION OF CCR UNITS

**Oak Grove Steam Electric Station
Robertson County, Texas**

Submitted By: Golder Associates Inc.
500 Century Plaza Drive, Suite 190
Houston, TX 77073 USA

January 2016

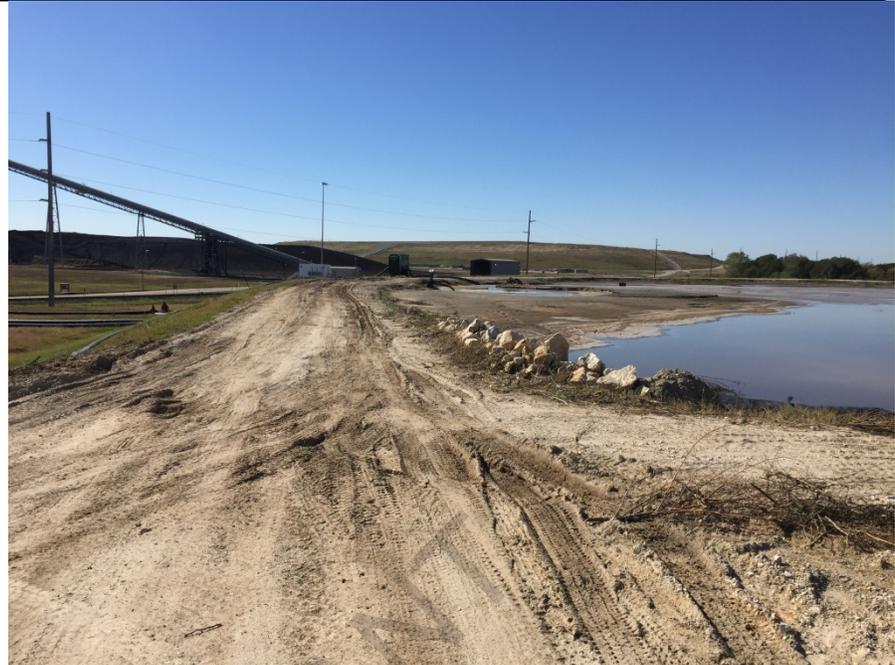
PHOTO 1

- The southeastern corner of the divider berm has been lined with an HDPE geomembrane and riprap for erosion protection. .
- The solids have built up above the waterline around the pond inlet.

Crest near divider berm and inlet pipes. Minor ruts in road. Solids above the water line. Riprap in southeastern corner of divider berm.

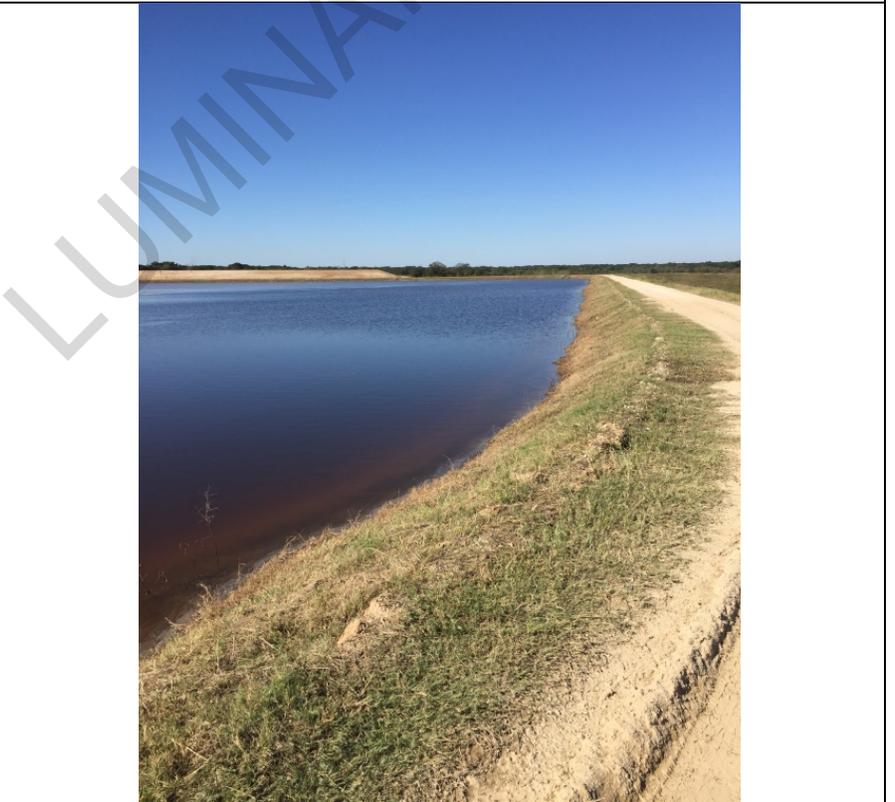
PHOTO 2

Western upstream slope.

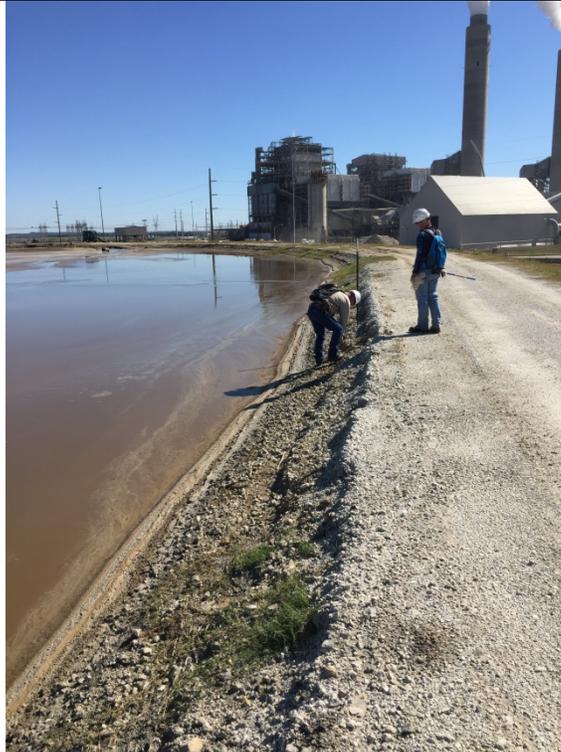
PHOTO 3

FGD-A Pond
Southern upstream slope
lined with gravel.

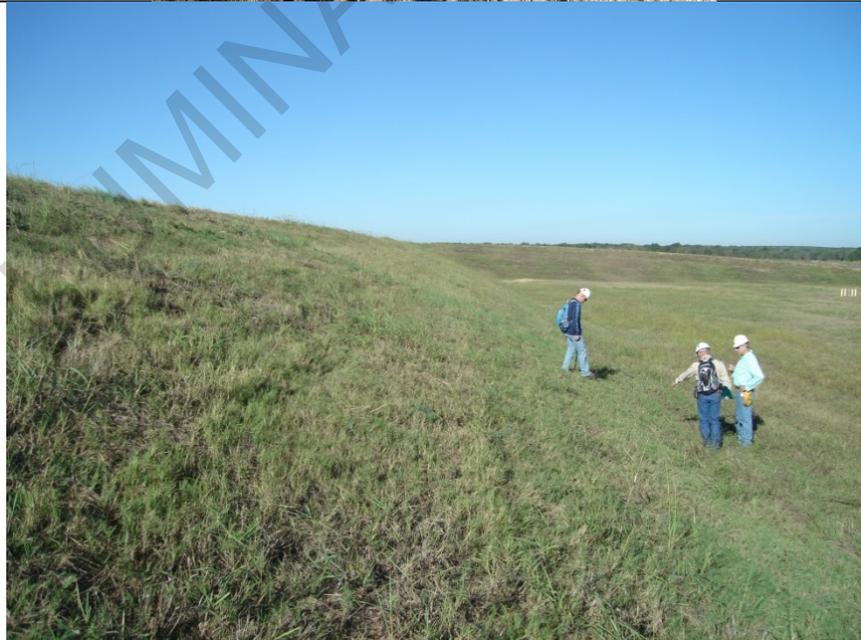
PHOTO 4

FGD-A Pond
Northern downstream
slope.

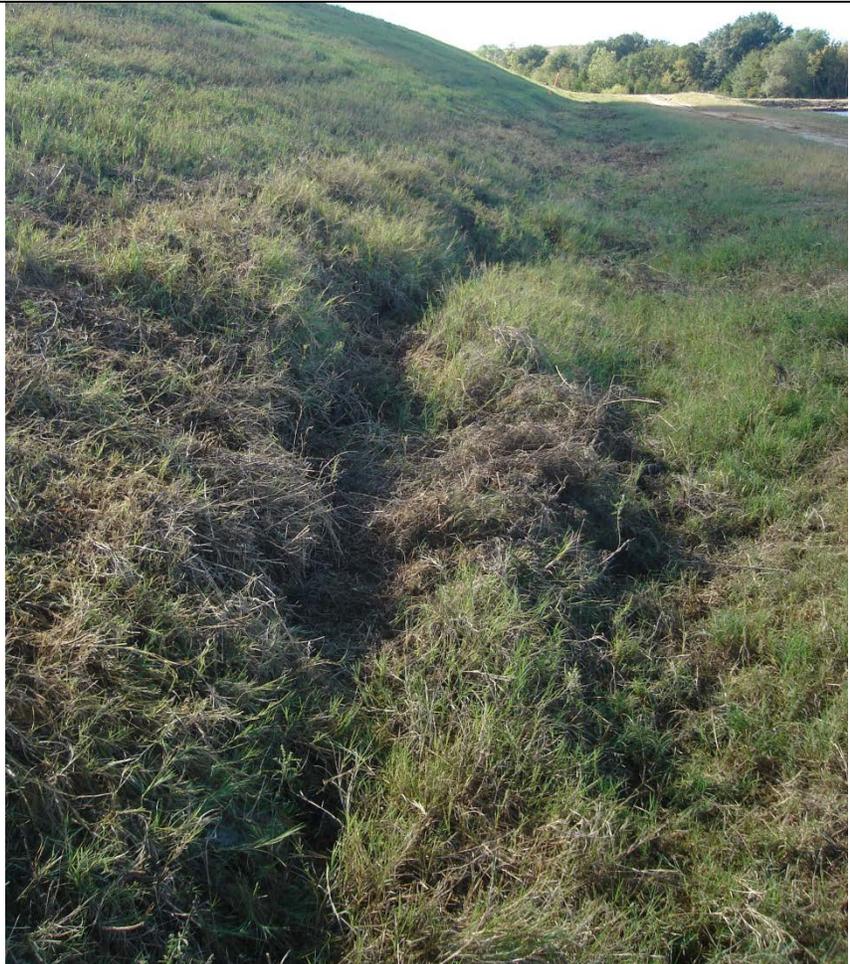
PHOTO 5

- It appears that mowing equipment is causing depression in portions of the downstream slope, particularly near the toe of the western embankment.
- Animal burrows were observed and marked for repair along the downstream slope. Several had been recently repaired.

Large ruts caused by mowing equipment present along northern slope.	5	Minor	Limit mowing to drier periods.
			Animal burrows visible. Several recently repaired burrows visible.		Minor	Consider animal control program.
			Ant mounds visible.		Minor	Broadcast fire ant bait annually.
			Standing water, which appears to be stormwater, was visible near the southwestern toe.	6	Minor	Regrade area to provide positive drainage.
Inlet Pipes	Fair	Solids have built up above the waterline around the spillway inlet.	1	Minor	No action required. Continue to monitor.	
Outlet Pipes	Good	Upstream end submerged. Minor depression above HDPE pipe.	10		Depression previously flagged for repair.	
FGD-B Pond	U/S Slope	Fair	The 2014 upstream embankment repairs, consisting of clay cover and erosion matting, have been eroded by wave action. Gravel has been placed in heavily eroded areas.	11	Moderate	Soil placed above a geomembrane tends to slough when wetted. Consider alternate erosion protection: e.g. gravel-filled geowebbing, more robust erosion control matting (HydroTurf), or placing a weighted geomembrane flap over the protective soil cover.

FGD-A Pond
Large ruts from mower
near toe of western
embankment

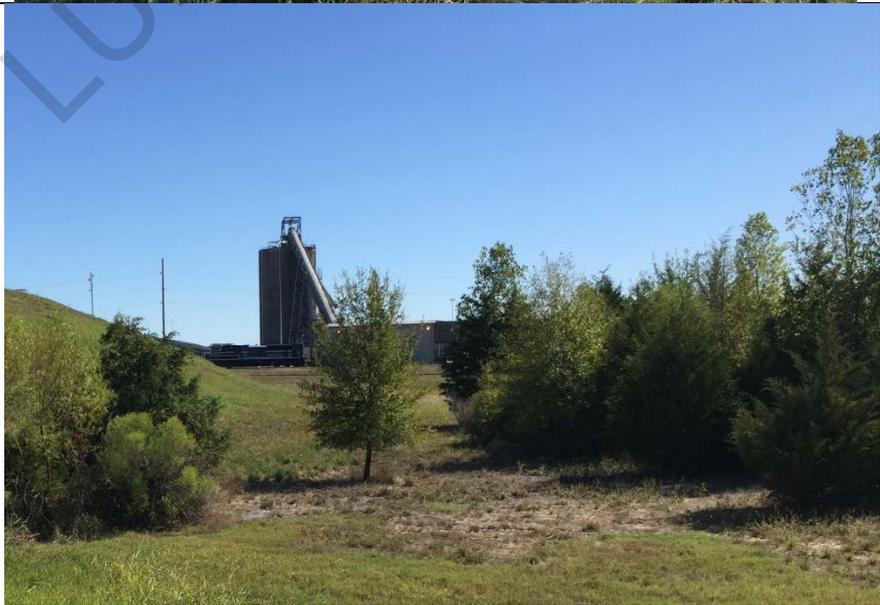
PHOTO 6

- Numerous ant mounds were present.
- Evidence of standing water was visible near the southwest toe of the embankment; however the water appears to be the result of run-off collecting in a depression.

FGD-A Pond
Standing water near
southwest toe

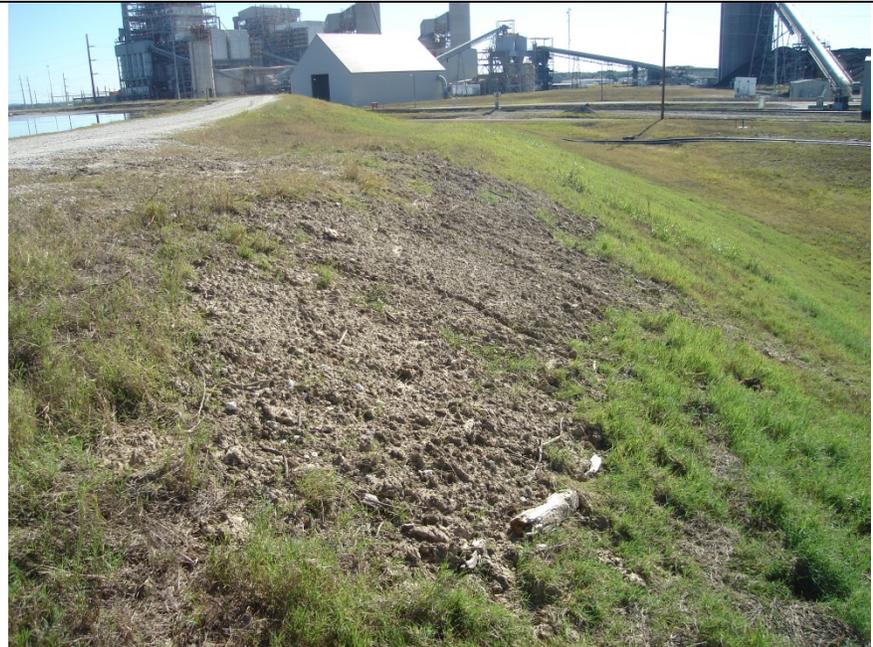
PHOTO 7

Recently repaired area near crest of southern downstream embankment slope

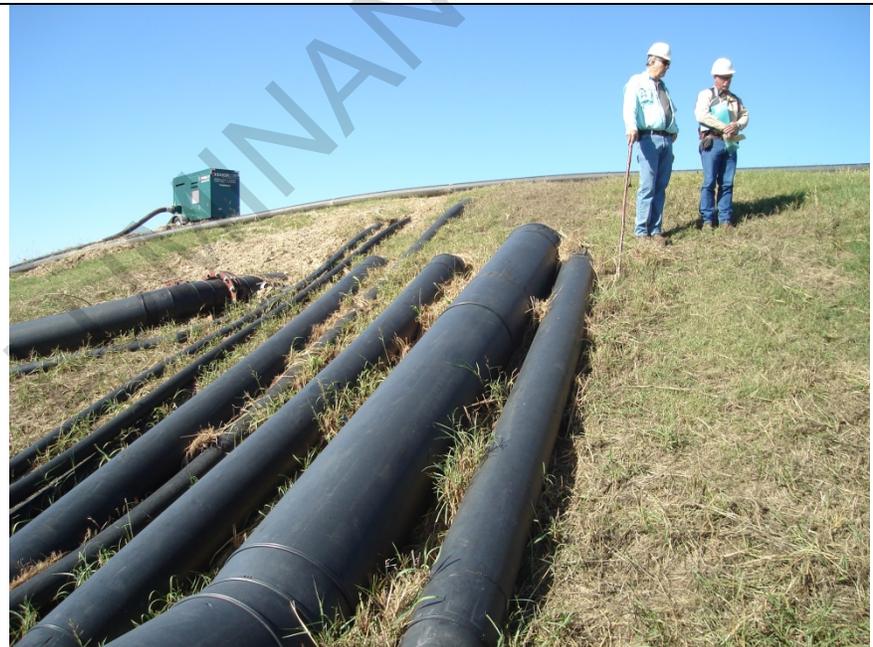
PHOTO 8

Inlet pipes and portable pump.

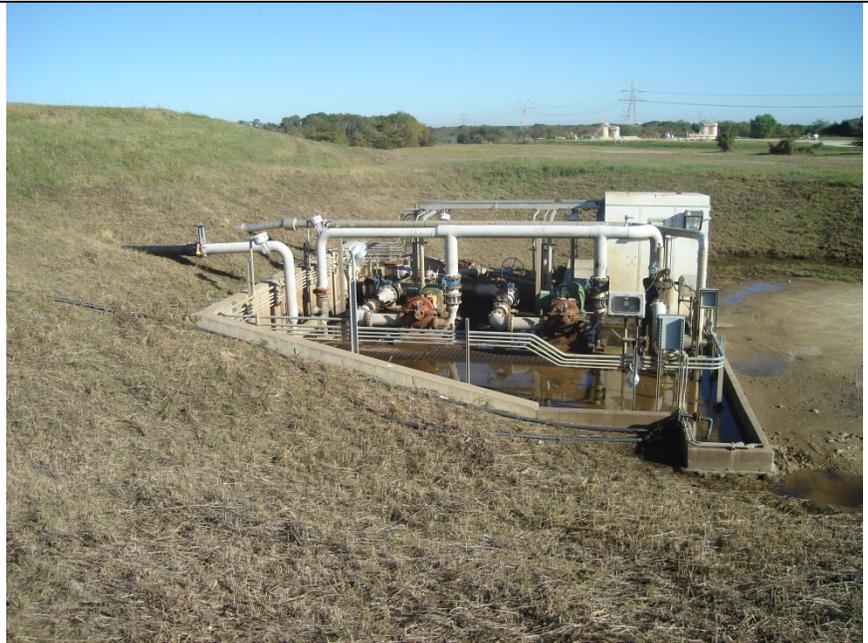
PHOTO 9

- Standing water was present on the concrete pad that supports the outlet pipes and pumps for returning water to the SES. The water appears to be the result of the recent heavy rainfall event.

FGD-A Pond
Reclaim/recycling pump station

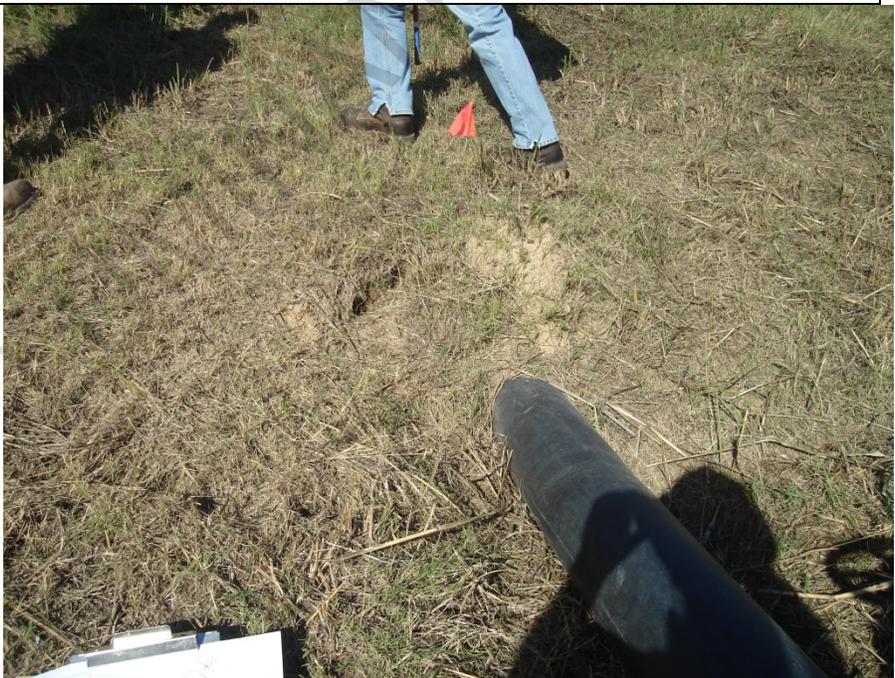
PHOTO 10

FGD-A Pond
Depression above HDPE outlet pipe.

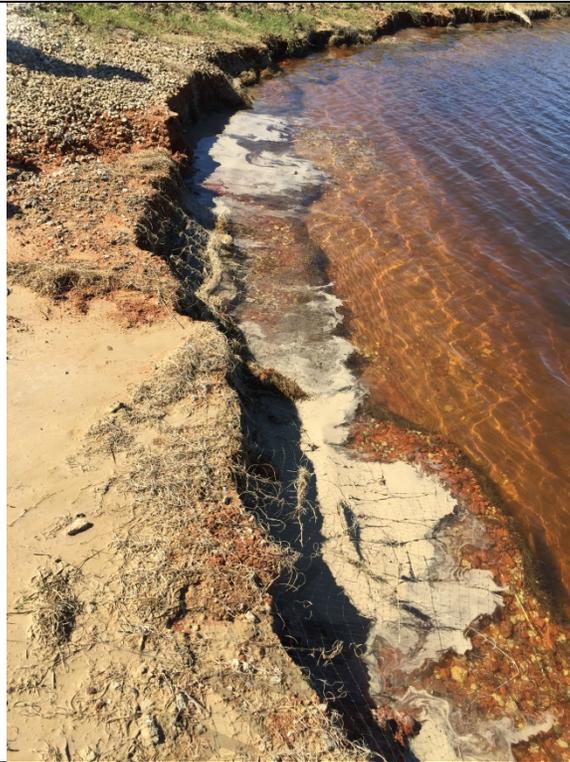
PHOTO 11

FGD-B Pond
Southeast corner of
upstream slope. Protective
cover and erosion control
matting placed in 2014.

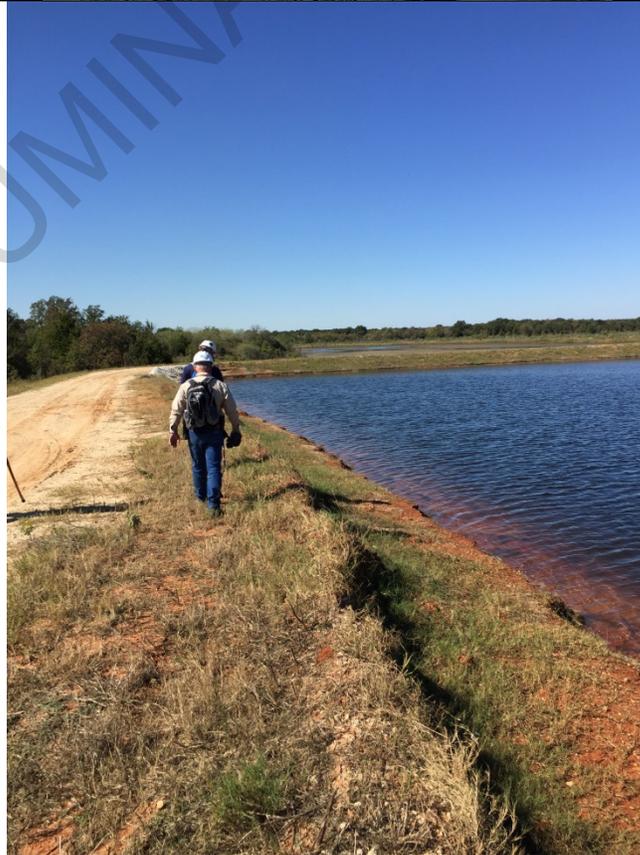
PHOTO 12

FGD-B Pond
Southern crest and
upstream slope. Upstream
edge of crest raised.

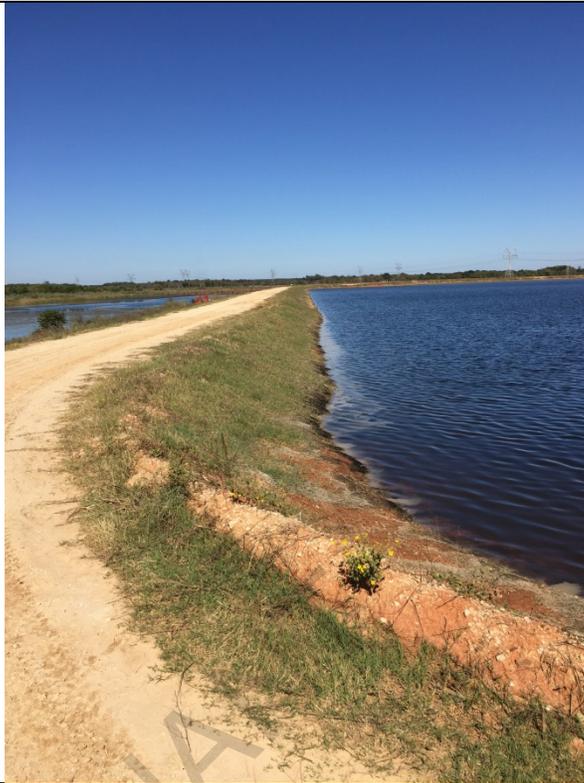
PHOTO 13

FGD-B Pond
Western crest and
upstream slope.

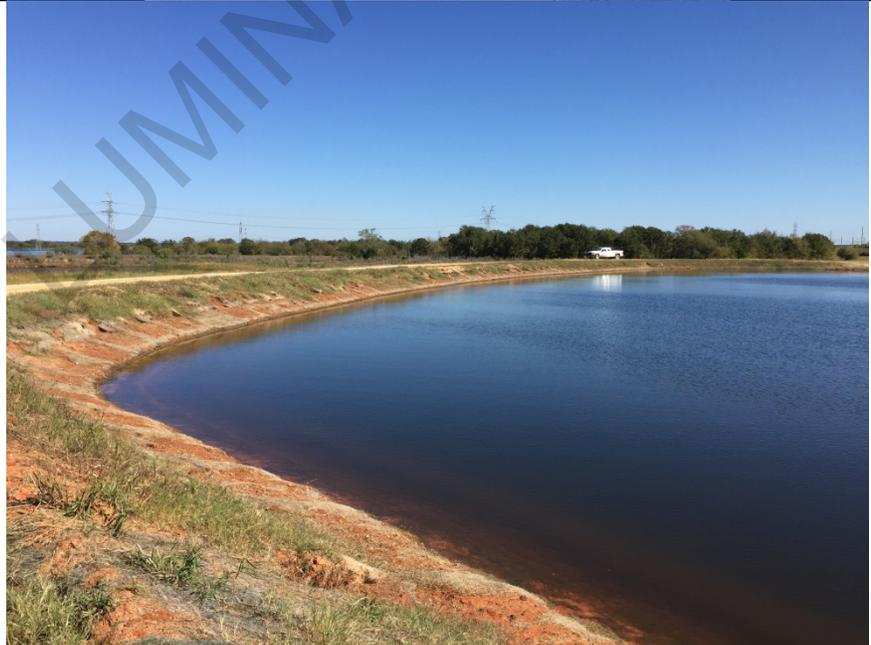
PHOTO 14

FGD-B Pond
Northern upstream slope.

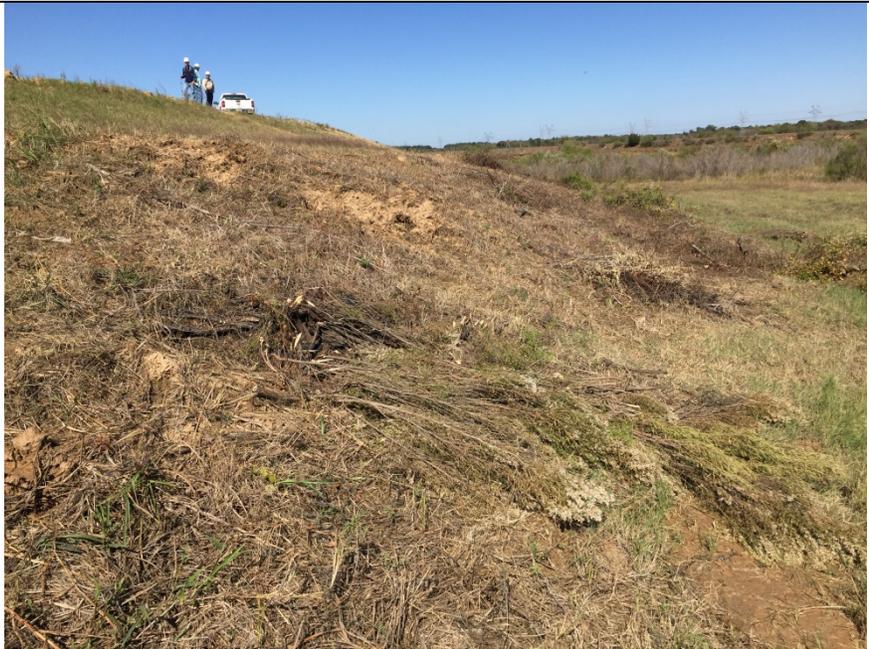
PHOTO 15

Recently cut brush on northeastern downstream slope.

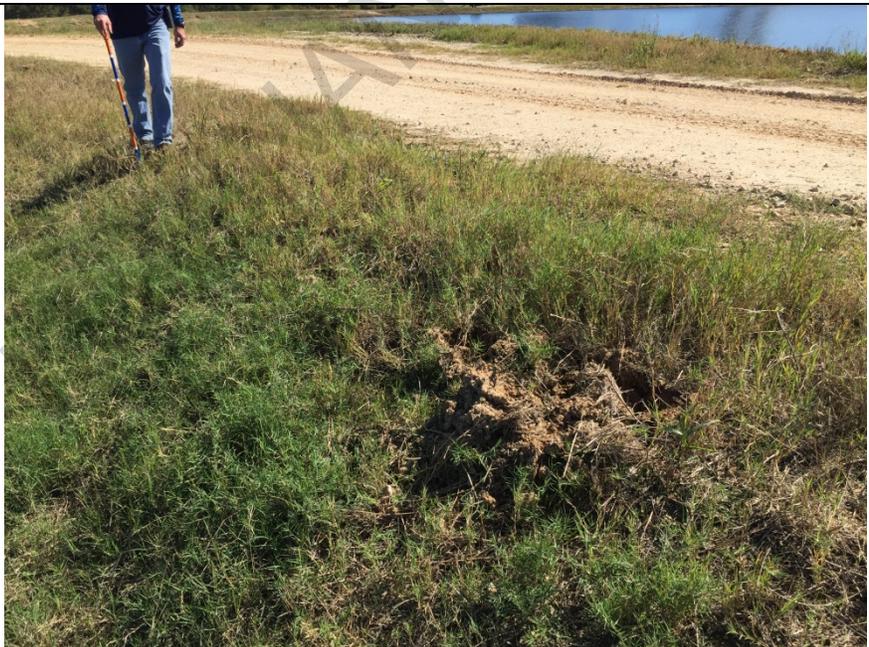
PHOTO 16

Animal burrow along western downstream embankment

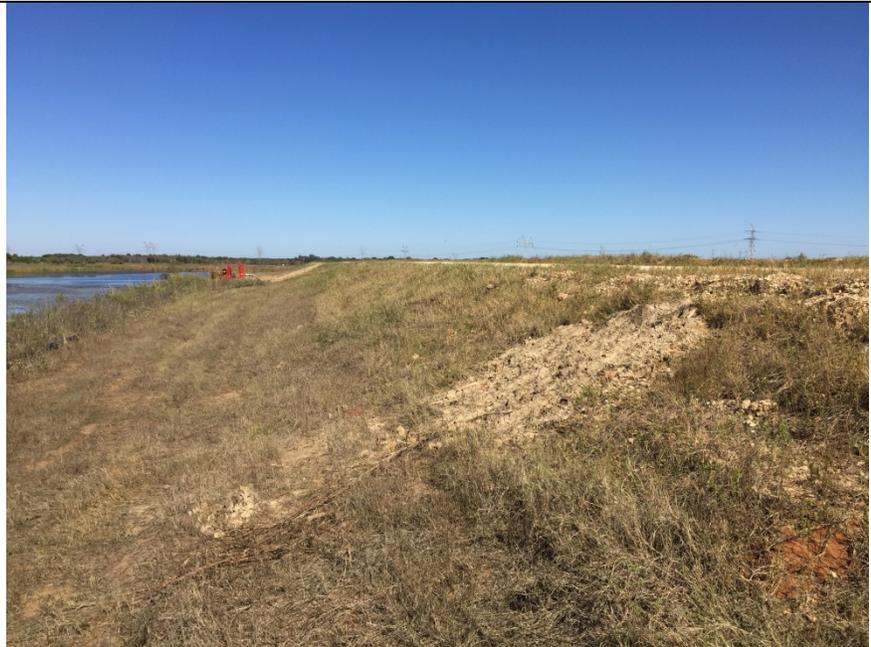
PHOTO 17

Recently repaired area along southern end western downstream slope. Pump in background.

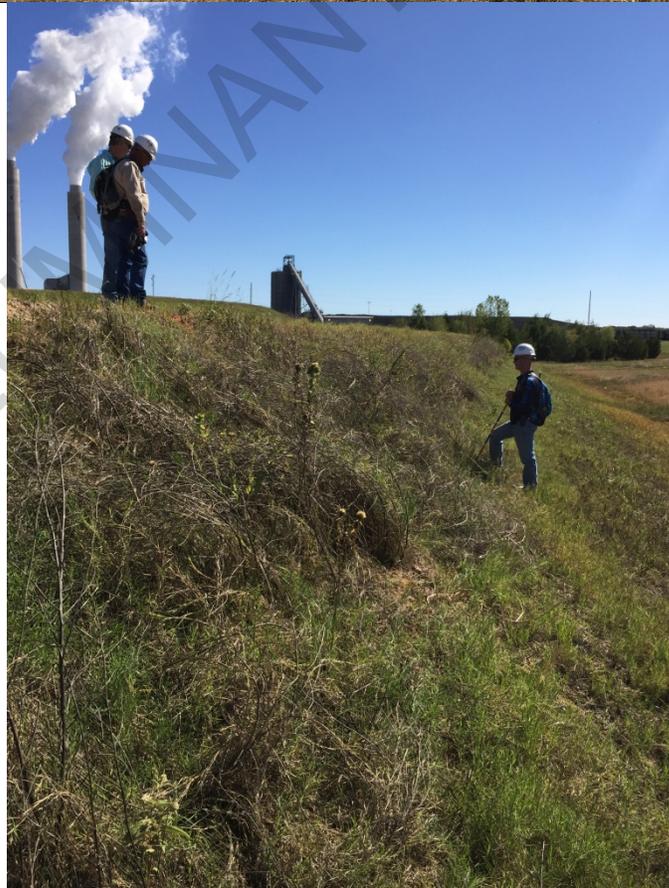
PHOTO 18

- Due to the steepness of the slope, vegetation along the upper portion of the southern downstream slope cannot be mowed using the equipment used on the rest of the embankment. At the time of this inspection, there were zones where this vegetation exceeded 6 inches, but the vegetation height did not prevent a thorough inspection of the integrity of the embankment. Luminant indicated that these steeper slopes are maintained using weed-wackers, but due to the recent wet conditions, this area could not be safely accessed prior to the inspection.

Southern downstream slope. Steep slope makes mowing difficult and recent wet weather has prevented safe access with weed-wacker.

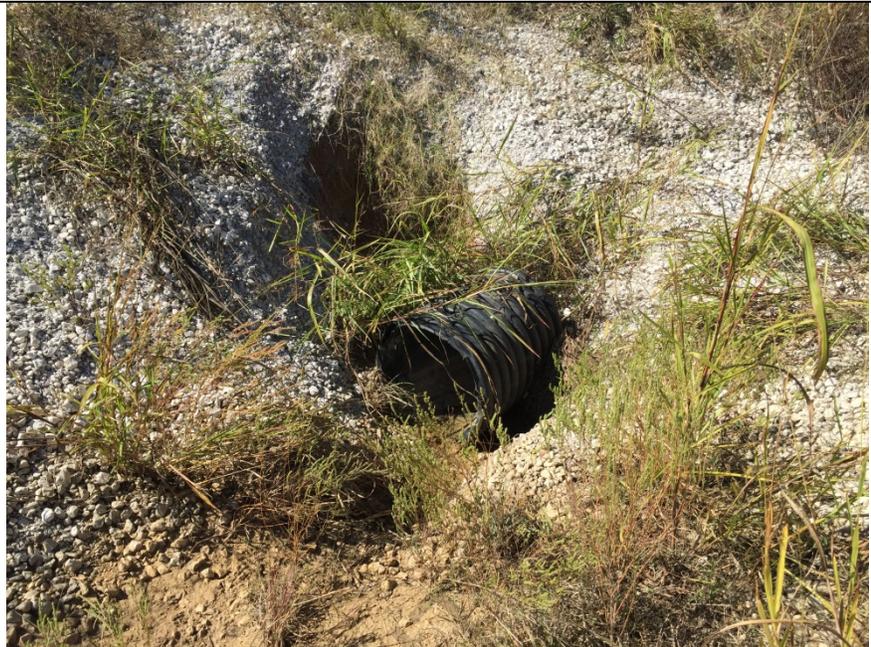
PHOTO 19

- It appears that water recently backed up behind a corrugated HDPE culvert below the southern access ramp.

FGD-B Pond
Corrugated HDPE pipe
below southern access
ramp.

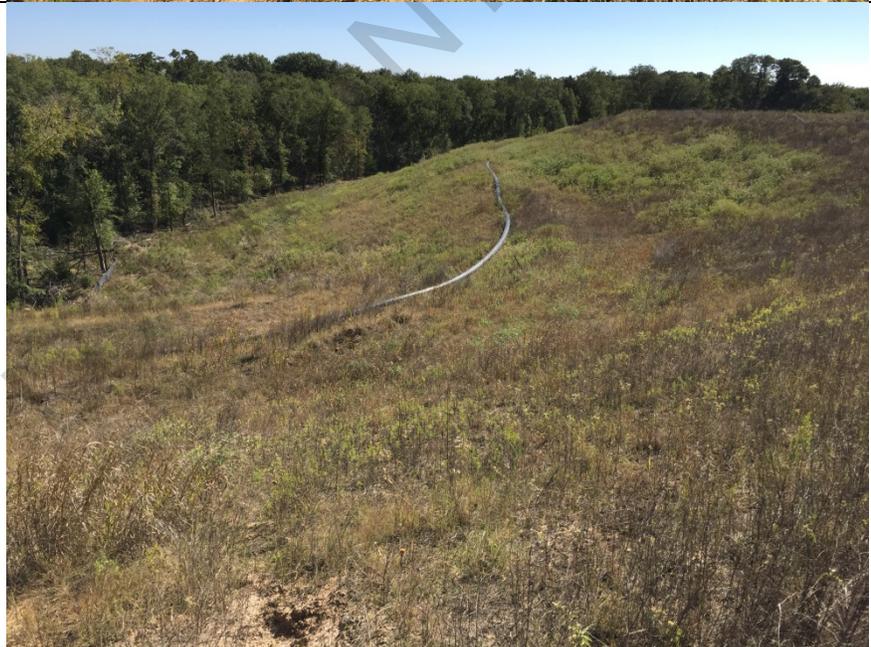
PHOTO 20

Ash Landfill 1
Southern slope of Cell 3.
Pipe delivers water from
FGD ponds to clay lined
Cell 3 floor.

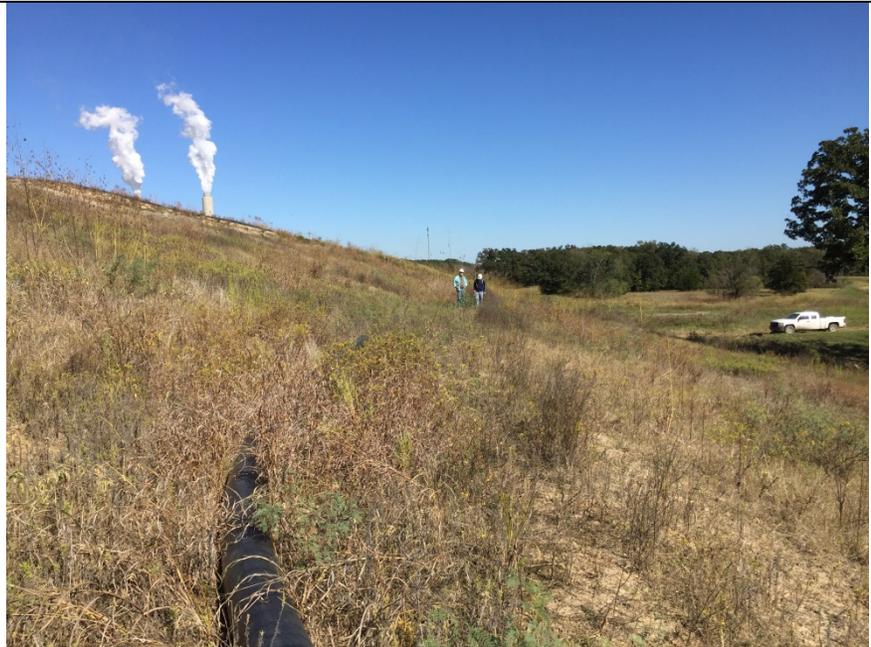
PHOTO 21

Ash Landfill 1
Southern slope of Cell 2.

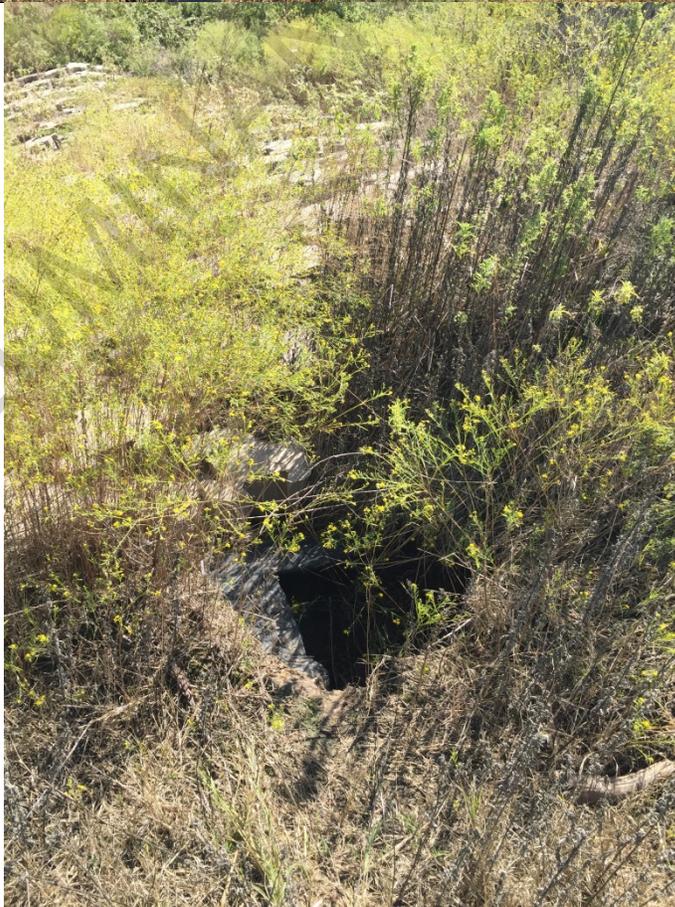
PHOTO 22

Ash Landfill 1
Seepage below concrete block downchute at lower bench of southern Cell 3 slope.

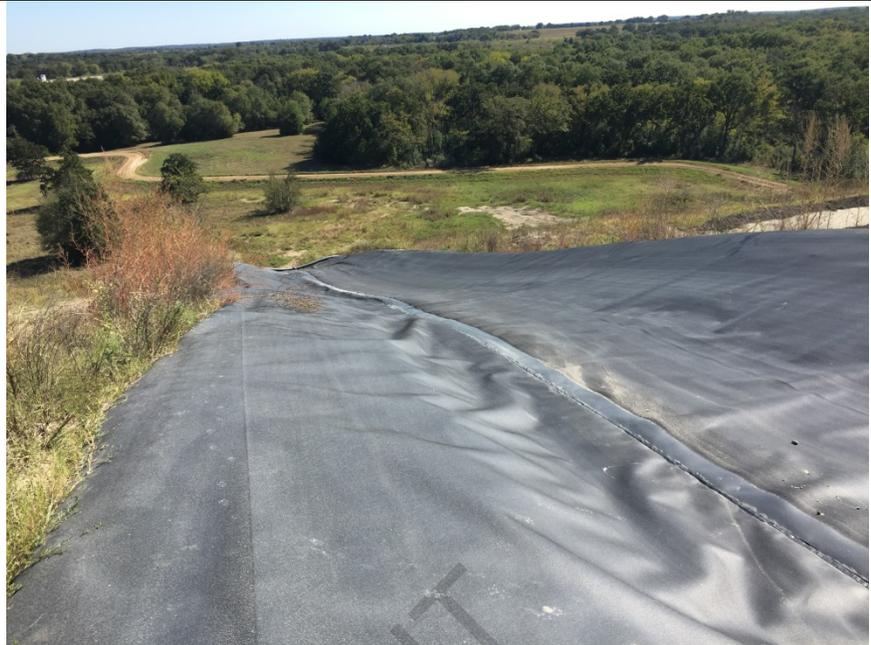
PHOTO 23

- The temporary HDPE geomembrane-lined downchute located on the southern embankment at the western edge of Cell 1 is performing well; however, it appears that some runoff from the final cover is not being directed to the downchute and is flowing down the slope, causing erosion.

Ash Landfill 1
Temporary HDPE
geomembrane-lined
downchute at west end of
Cell 1 southern slope.

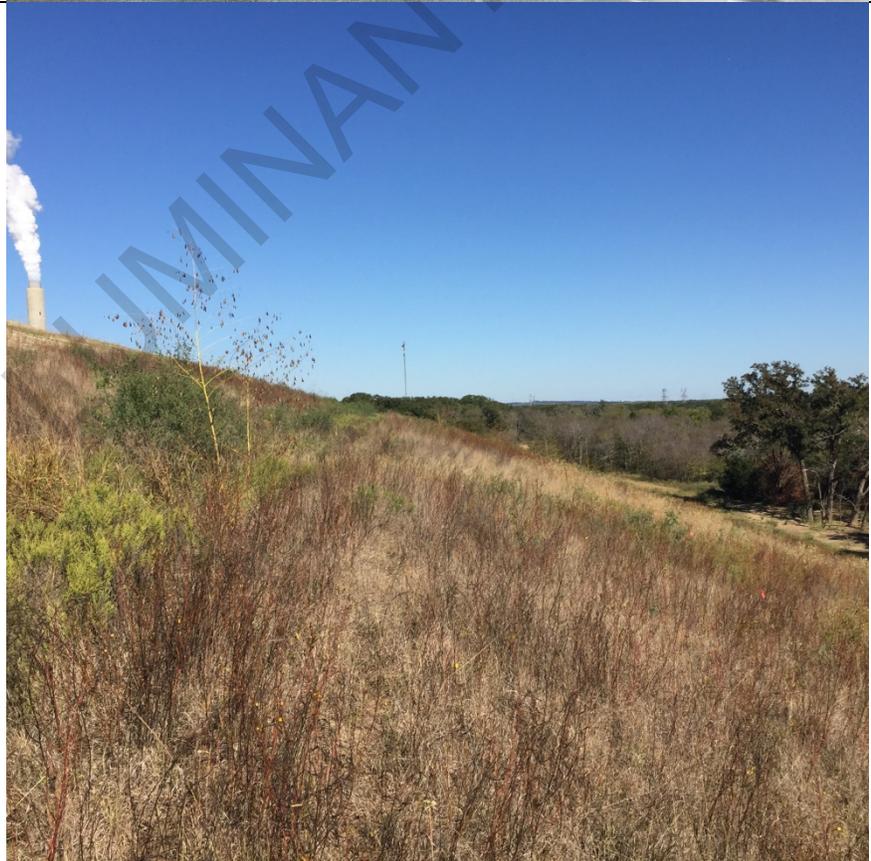
PHOTO 24

Ash Landfill 1
Southern slope at lower
bench in Cell 1

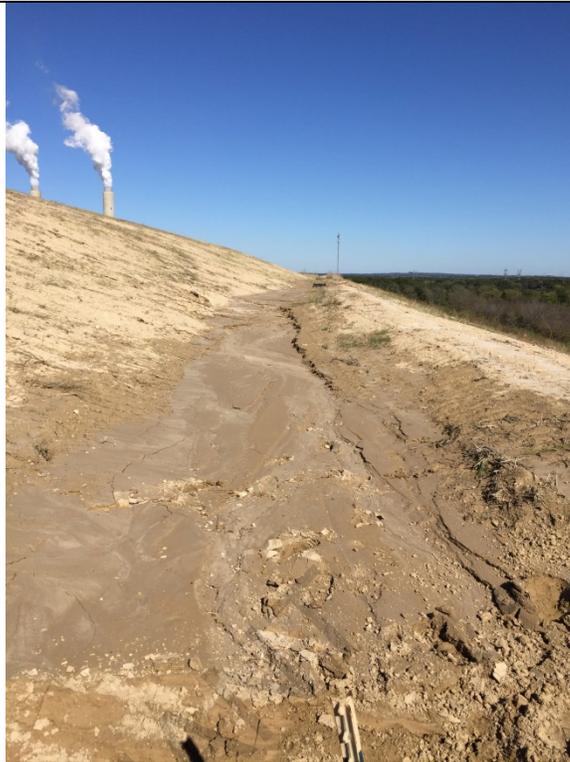
PHOTO 25

Upper bench on Cell 1 southern slope. Vegetation not established on final cover.

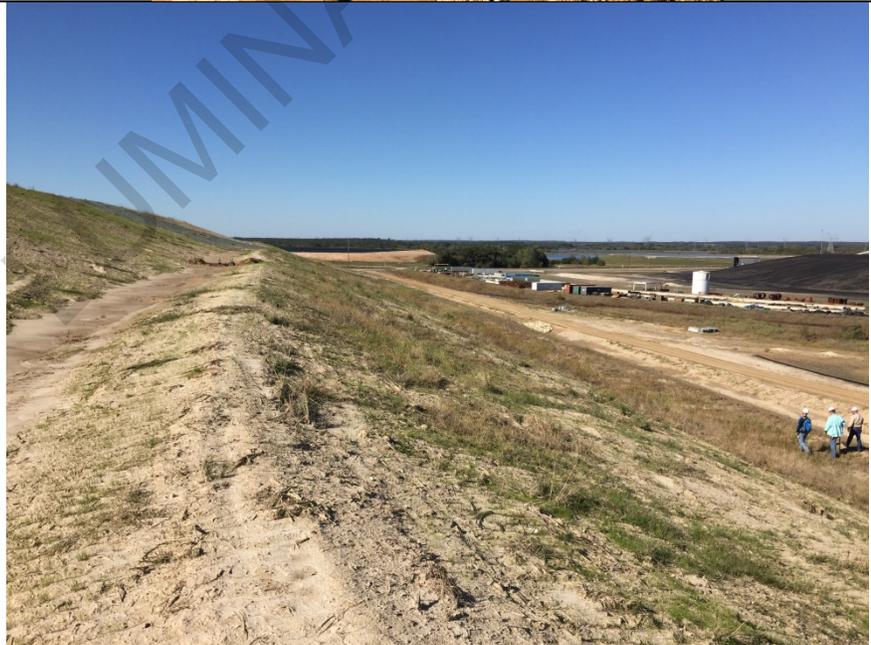
PHOTO 26

Upper bench on Cell 1 eastern slope. Sediment removed from drop inlet in background.

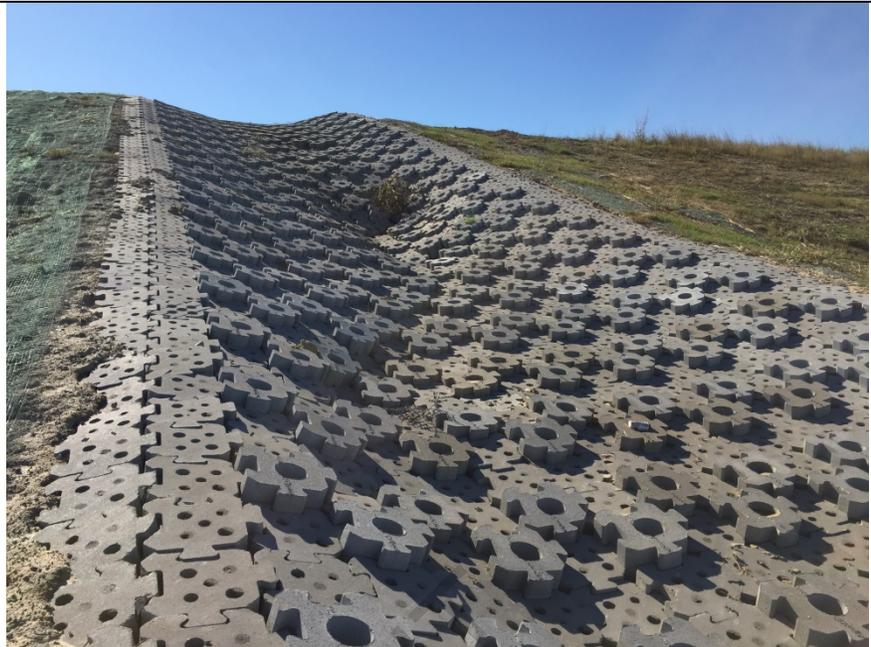
PHOTO 27

- The final cover below the concrete block downchute on the eastern slope has eroded resulting in a void below the woven geotextile layer.
 - The concrete block downchute along the northern portion of the embankment is performing well.

Concrete block lined downchute on Cell 1 final cover on eastern slope. Void below blocks due to erosion.

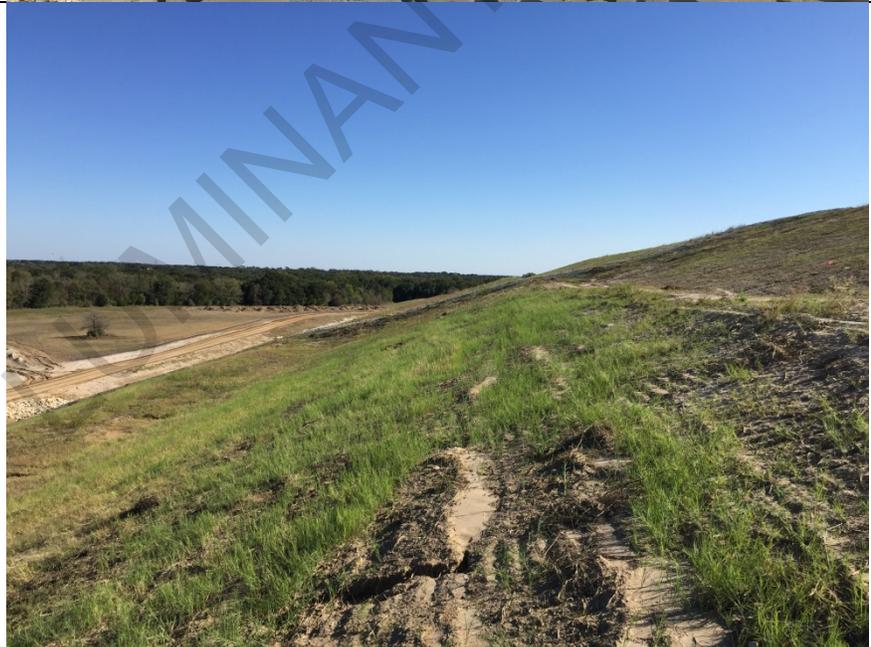
PHOTO 28

Recently repaired area below upper bench of Cell 1 eastern slope.

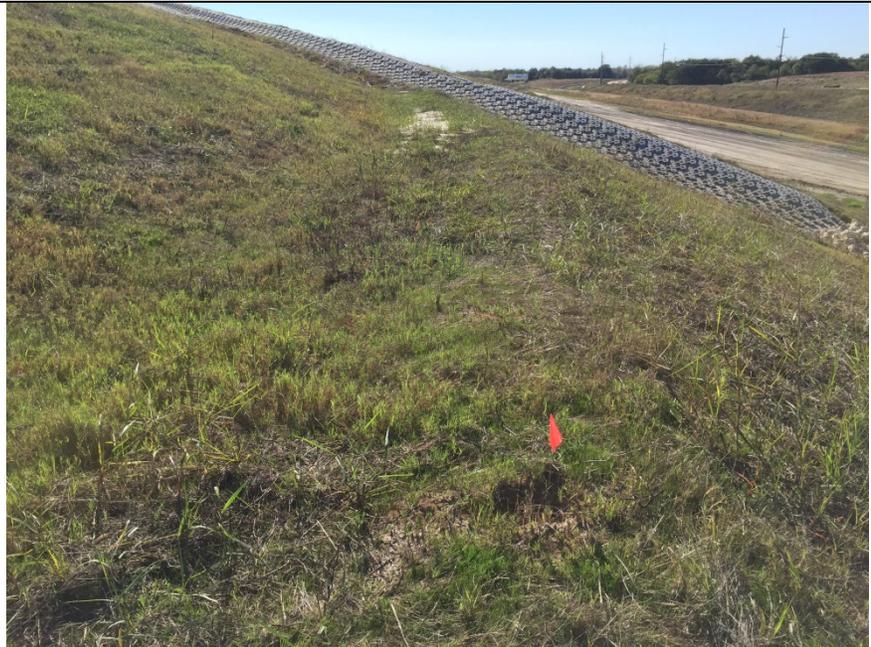
PHOTO 29

Concrete block downchute on Cell 1 northern slope. Previously marked animal burrow in foreground.

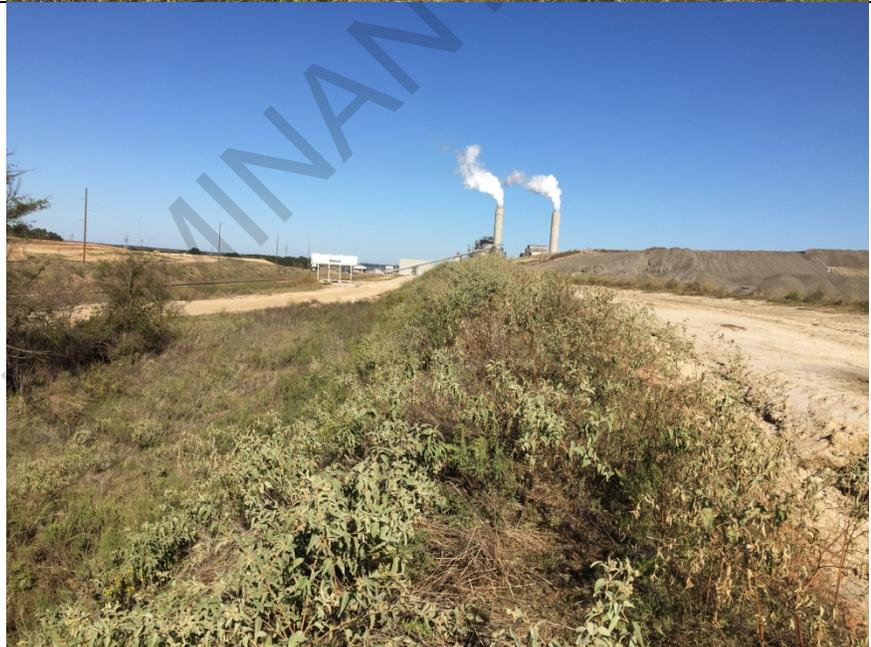
PHOTO 30

Northern slope of Cell 2 and 3.
