**2017 ANNUAL CCR UNIT INSPECTION REPORT**

**LUMINANT – MARTIN LAKE STEAM ELECTRIC STATION  
ASH POND AREA, PERMANENT DISPOSAL POND NO. 5 & A-1 AREA LANDFILL  
RUSK & PANOLA COUNTY, TEXAS**

January 2018

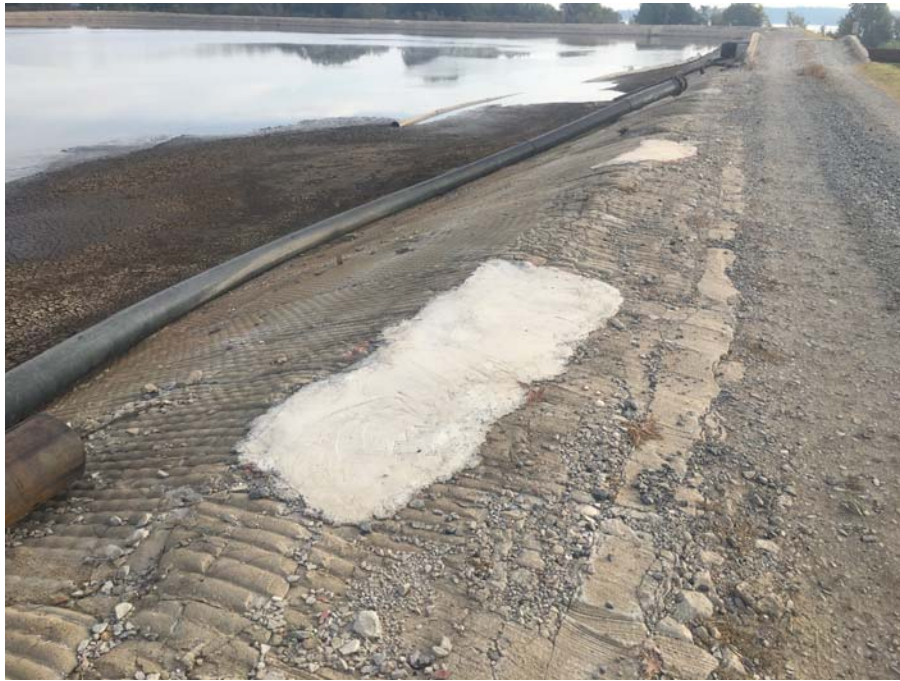
| Pastor, Behling & Wheeler | DESCRIPTION | <b>Photograph 1</b> – (View NE) Crest and armored upstream embankment of Scrubber Pond. Repair areas visible (former areas of exposed liner). | |

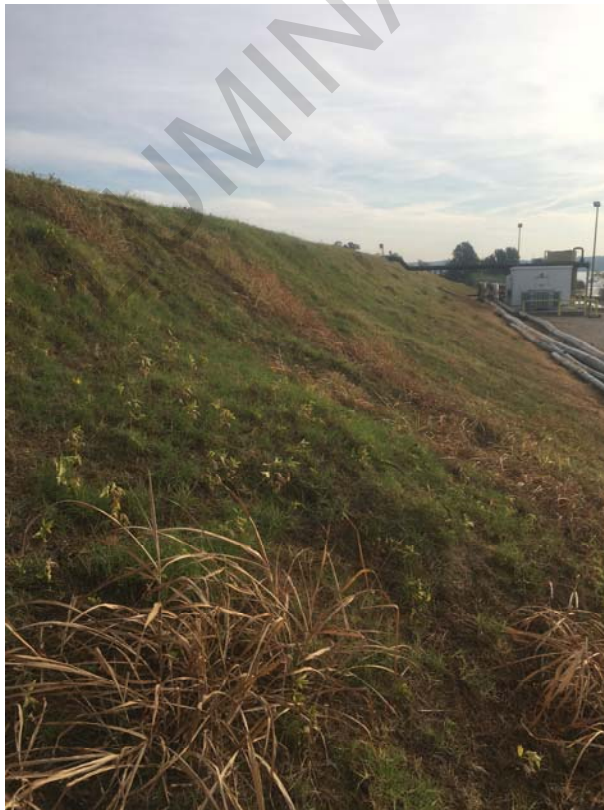
| Pastor, Behling & Wheeler | DESCRIPTION | <b>Photograph 2</b> – (View NE) Downstream embankment of West Ash Pond and Scrubber Pond. Steepened slope at crest and piping at toe. | |

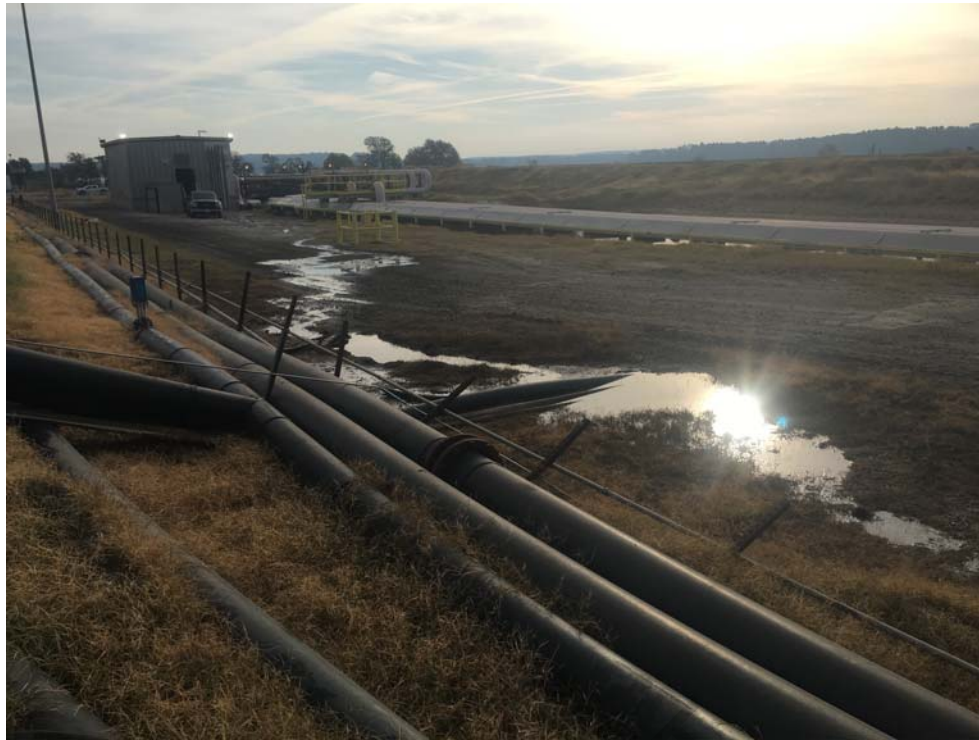
| Pastor, Behling<br>& Wheeler<br><br>PROJECT NO.<br>5313-C | DESCRIPTION | <b>Photograph 3</b> – (View SE) Downstream embankment of West Ash Pond with wetness at toe (Pipe leak, drainage controlled by catch basin). | |

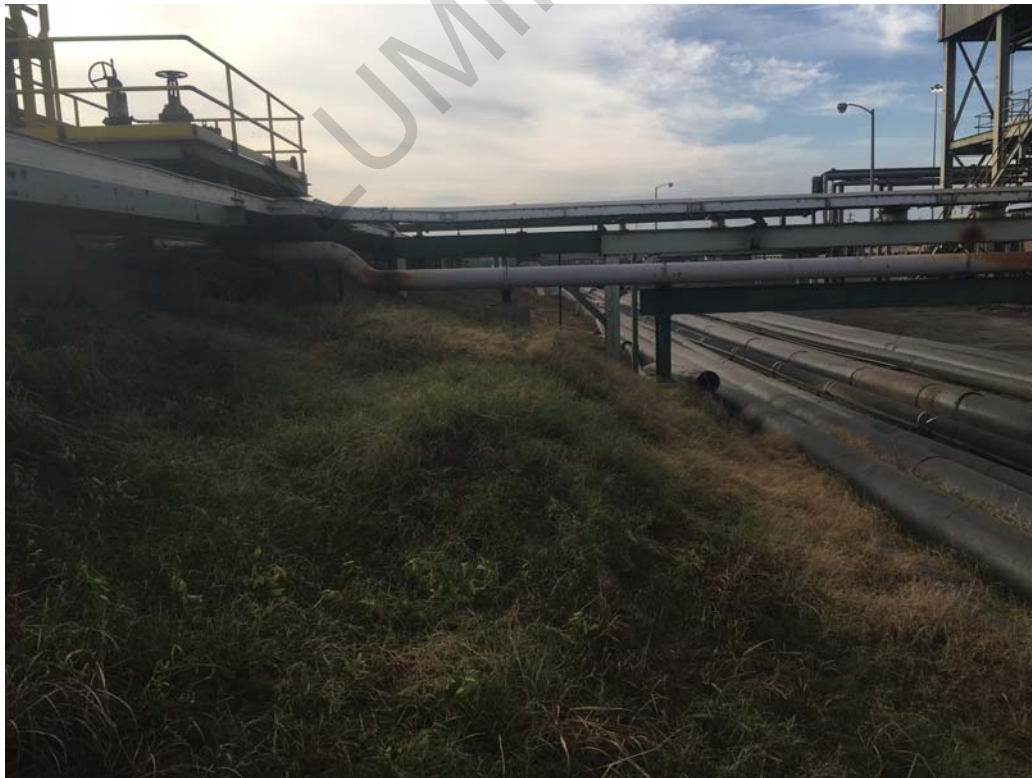
| Pastor, Behling<br>& Wheeler<br><br>PROJECT NO.<br>5313-C | DESCRIPTION | <b>Photograph 4</b> – (View SE) Downstream Embankment of West Ash Pond with irregular slope visible. | |

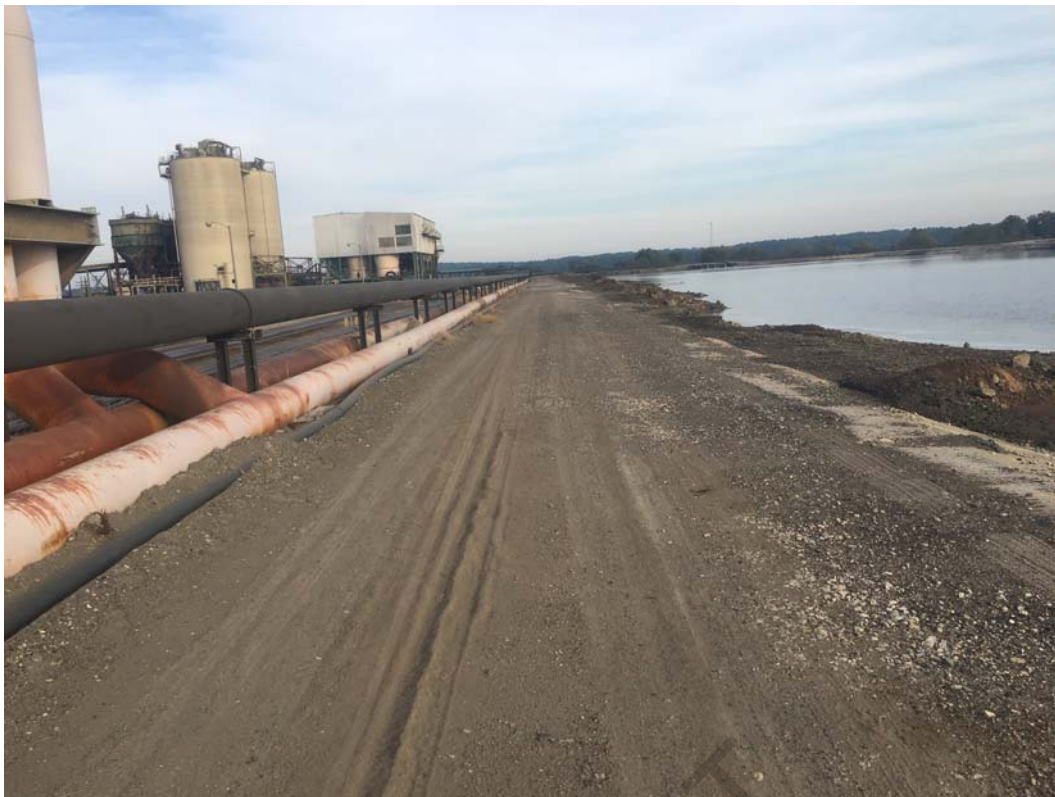
| Pastor, Behling<br>& Wheeler<br><br>PROJECT NO.<br>5313-C | DESCRIPTION | <b>Photograph 5</b> – (View NW) West Ash Pond crest with solids on downstream embankment. Regrade to ensure drainage to pond. | |

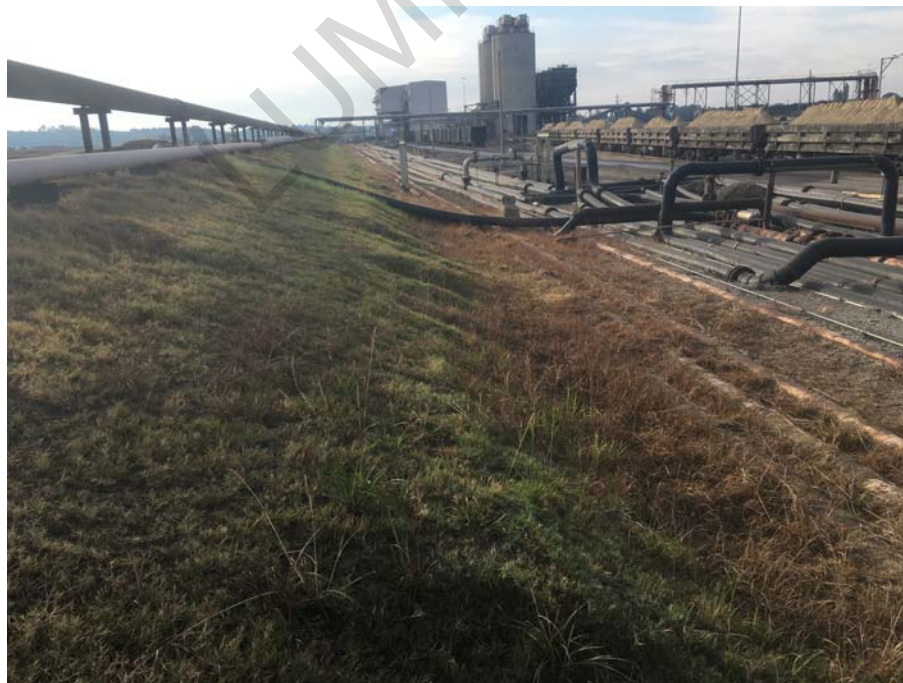
| Pastor, Behling<br>& Wheeler<br><br>PROJECT NO.<br>5313-C | DESCRIPTION | <b>Photograph 6</b> – (View SE) View of west embankment of West Ash Pond. Monitor areas of erosion at toe (currently stable/vegetated). | |

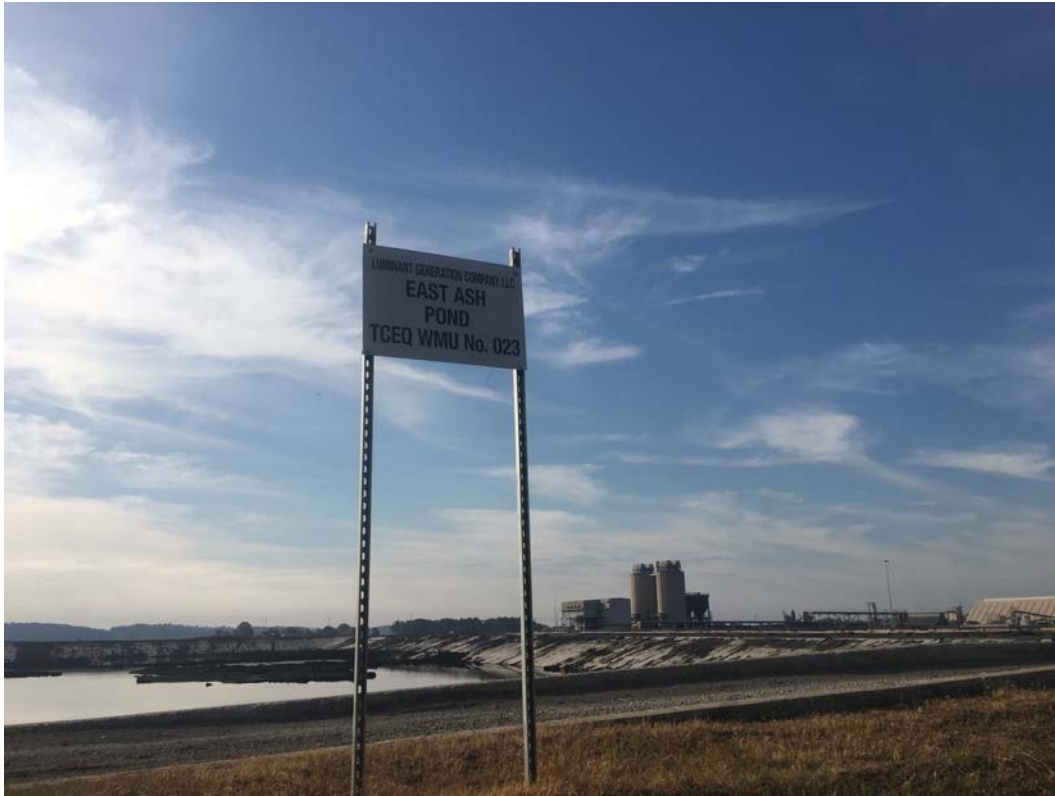
| Pastor, Behling<br>& Wheeler | DESCRIPTION | <b>Photograph 7–</b> (View S) Northeast corner of East Ash Pond. | |

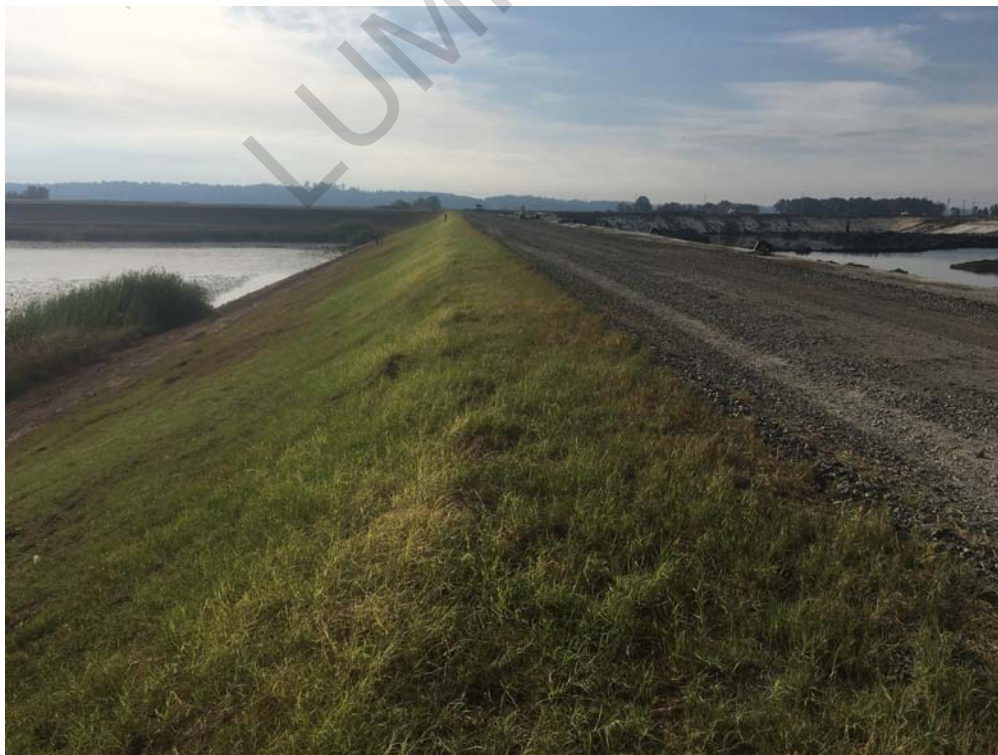
| Pastor, Behling<br>& Wheeler | DESCRIPTION | <b>Photograph 8 –</b> (View SE) Crest and downstream Embankment of East Ash Pond. | |

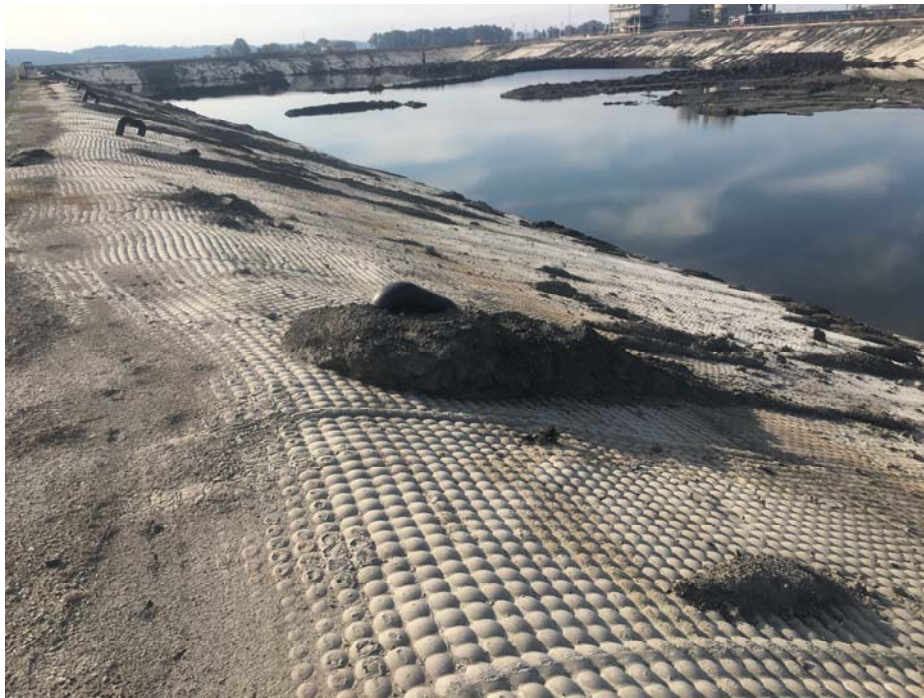
| Pastor, Behling<br>& Wheeler | DESCRIPTION | <b>Photograph 9</b> – (View SE) Armored upstream embankment of East Ash Pond. Remove solids accumulation around liner vents. | |

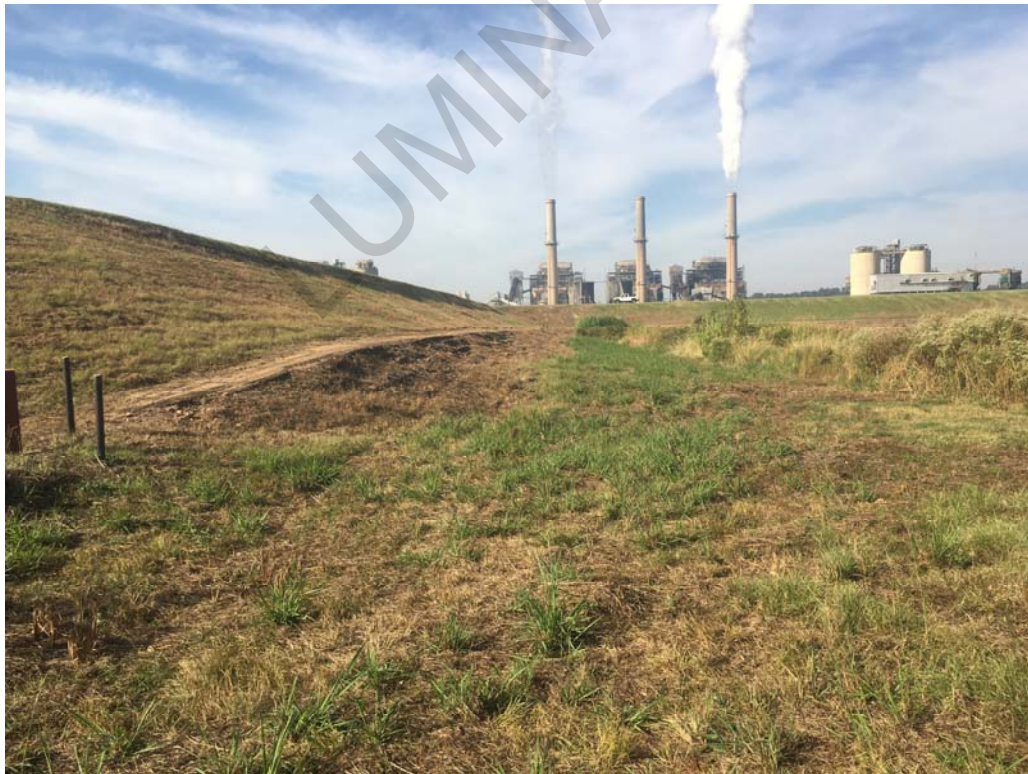
| Pastor, Behling<br>& Wheeler | DESCRIPTION | <b>Photograph 10</b> – (View SW) Toe of Scrubber Pond embankment. Area cleared to allow for inspection of embankment toe. | |

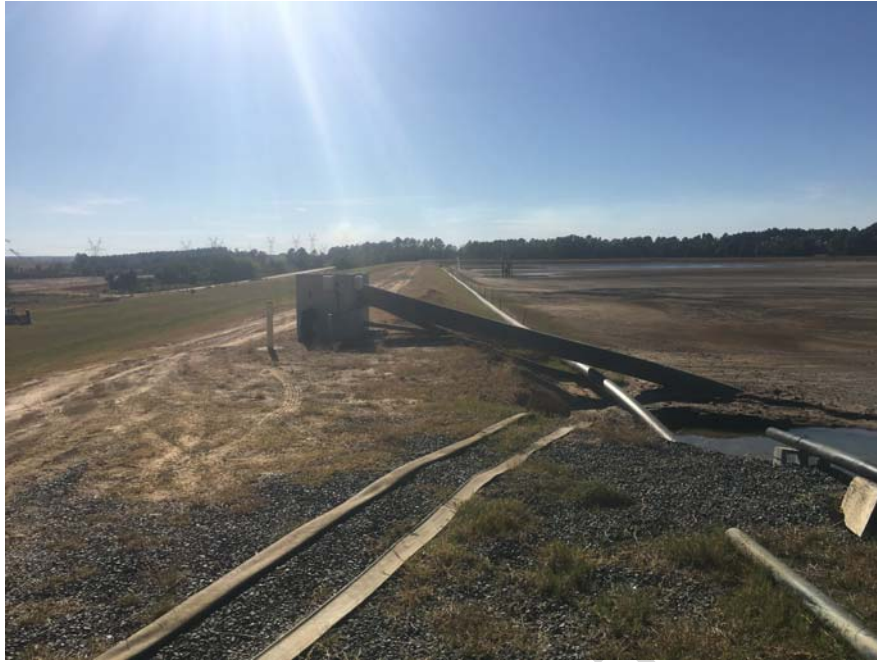
| Pastor, Behling<br>& Wheeler | DESCRIPTION | <b>Photograph 1</b> – (View SW) Southeast corner of PDP-5; Erosion repair/armor needed for influent discharge point | |

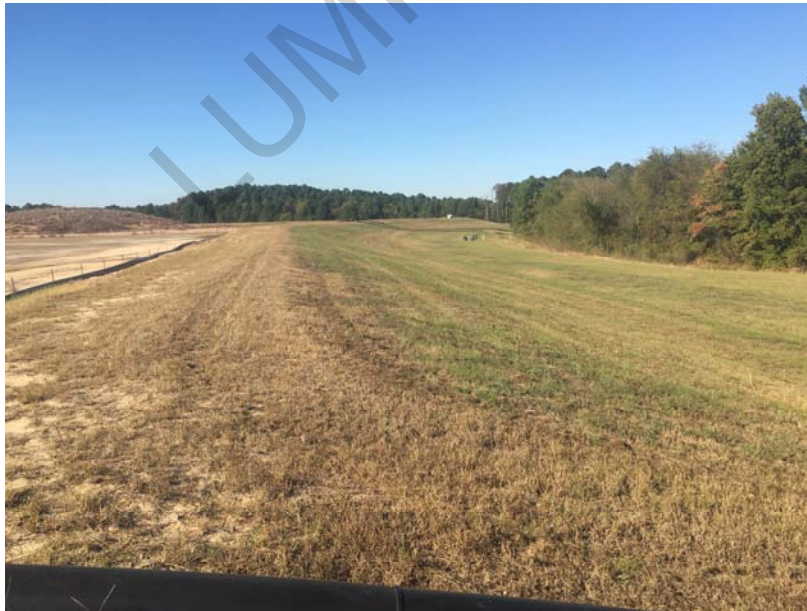
| Pastor, Behling<br>& Wheeler | DESCRIPTION | <b>Photograph 2</b> – (View NW) Eastern downstream embankment of PDP-5. Former area of poor vegetative cover and rill erosion (repaired). | |

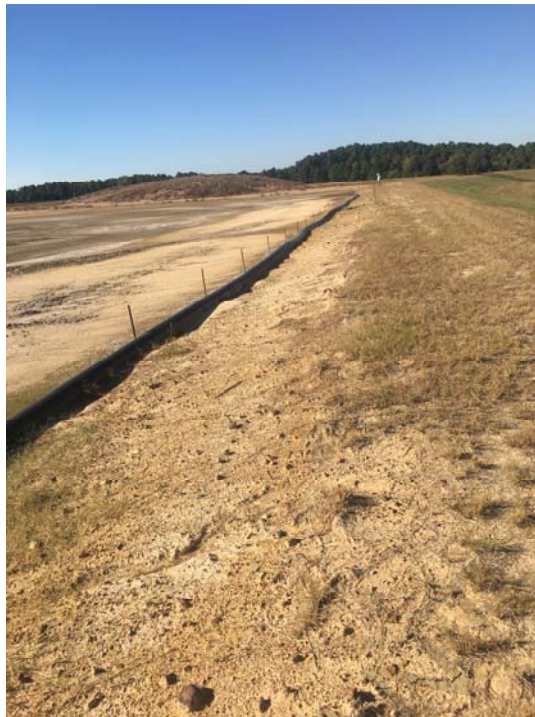
| Pastor, Behling<br>& Wheeler<br><br>PROJECT NO.<br>5313-C | DESCRIPTION | <b>Photograph 3</b> – (View NW) Crest and upstream embankment of PDP-5 on eastern side. Monitor rill erosion and poor vegetative cover. | |

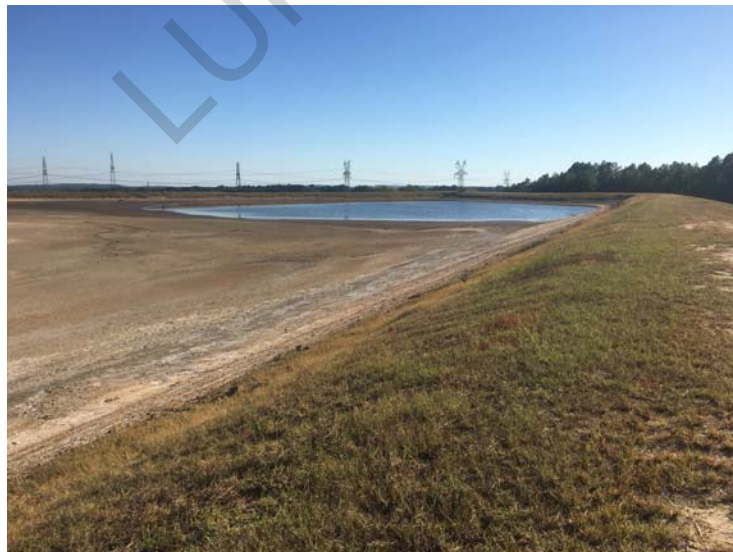
| Pastor, Behling<br>& Wheeler<br><br>PROJECT NO.<br>5313-C | DESCRIPTION | <b>Photograph 4</b> – (View SW) Crest and upstream embankment on west side of PDP-5. Monitor erosion from wave action. | |

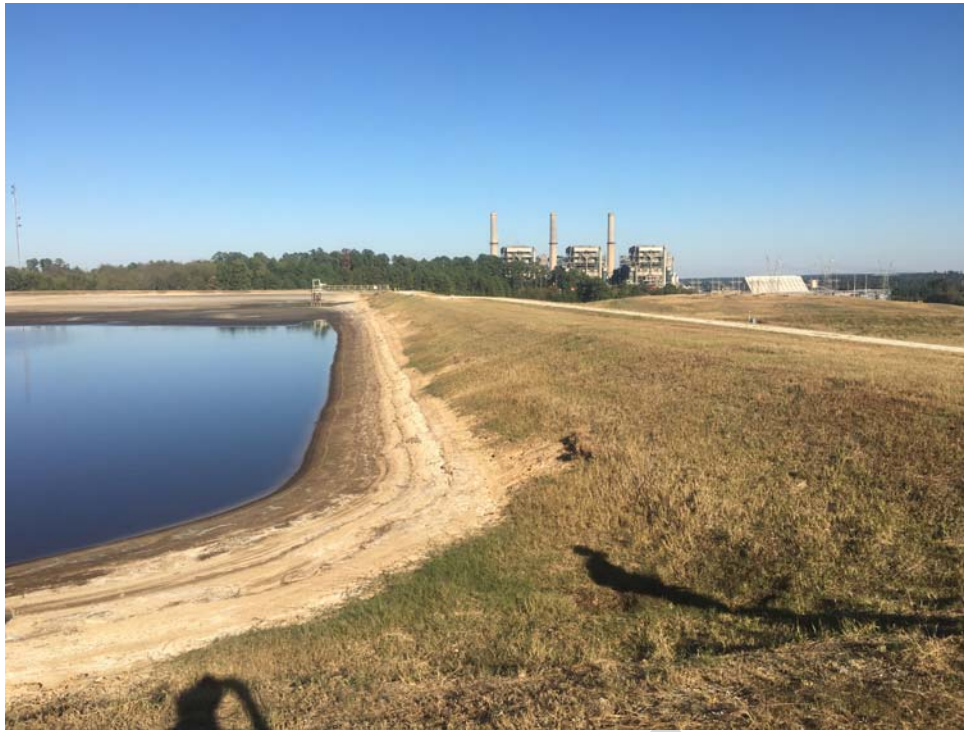
| Pastor, Behling<br>& Wheeler<br><br>PROJECT NO.<br>5313-C | DESCRIPTION | <b>Photograph 5</b> – (View NE) Southern embankment of PDP-5. Monitor erosion from wave action. | |

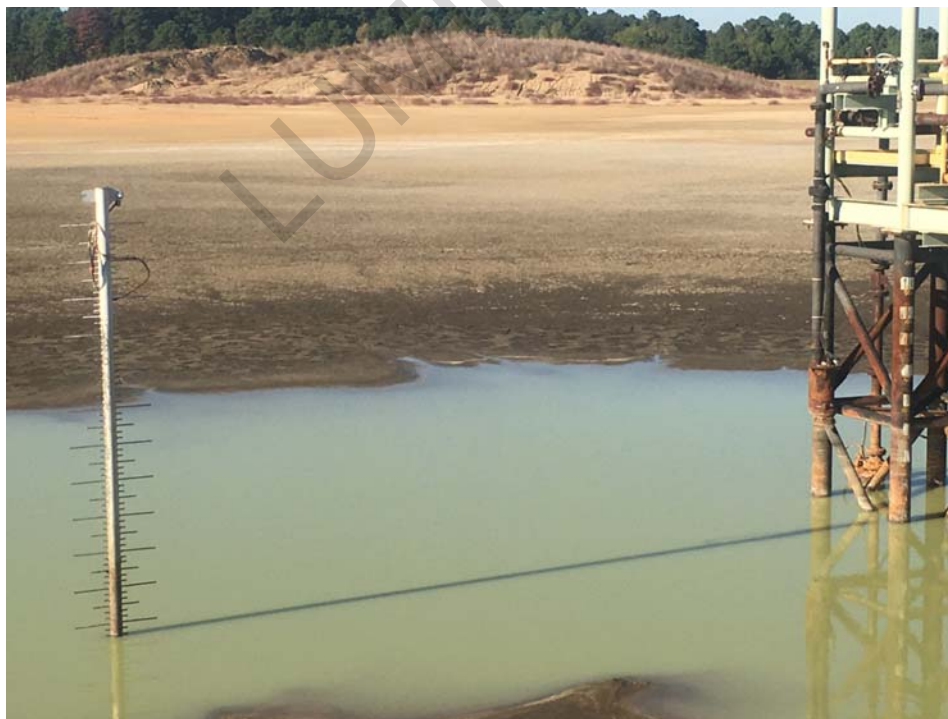
| Pastor, Behling<br>& Wheeler<br><br>PROJECT NO.<br>5313-C | DESCRIPTION | <b>Photograph 6</b> – (View N) Staff gauge and pump station at south end of PDP-5. Majority of accumulated water has been removed from PDP5. | |

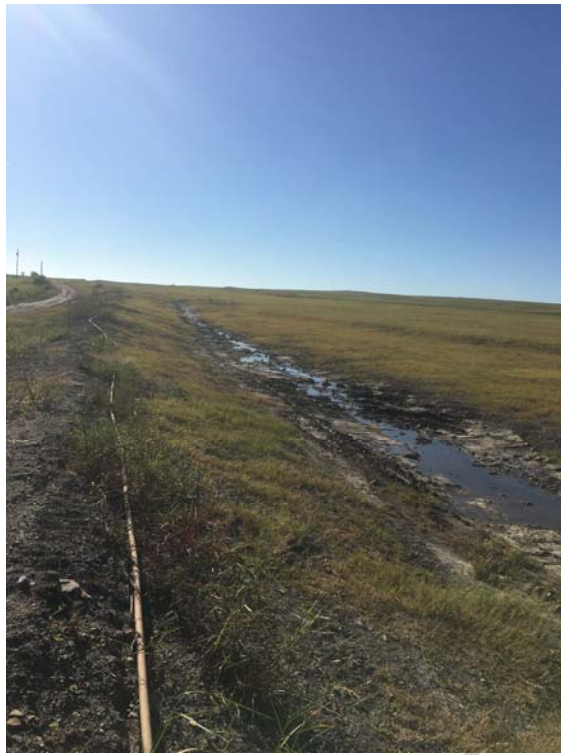
| Pastor, Behling<br>& Wheeler<br><br>PROJECT NO.<br>5313-C | DESCRIPTION | <b>Photograph 1</b> – (View SE; Near Sta. 18+00) Embankment crest (left), vegetated cap (right), and run off diversion berm (to NRCA) with soil cement armored channel visible. Category 2 (active seep) is located at crest within run off control zone approximately 1,400 feet to SE. | |

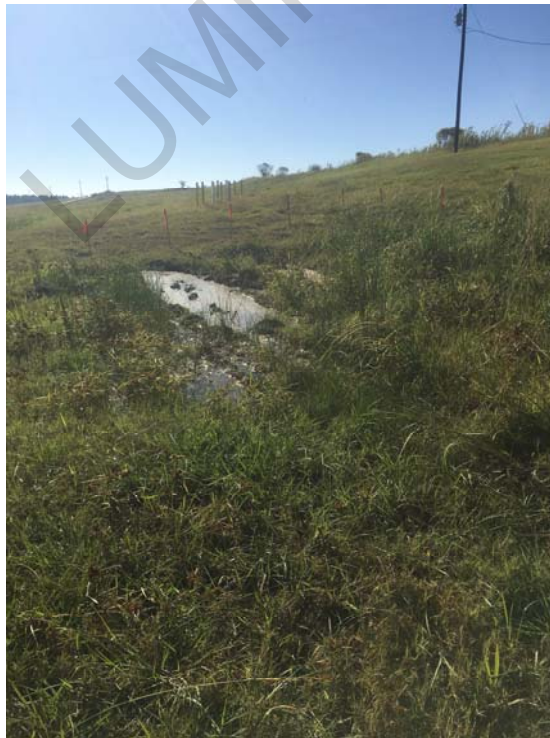
| Pastor, Behling<br>& Wheeler<br><br>PROJECT NO.<br>5313-C | DESCRIPTION | <b>Photograph 2</b> – (View SE; Sta 26+00) Former slope repair area following revegetation with saturated soil present at toe of embankment. | |

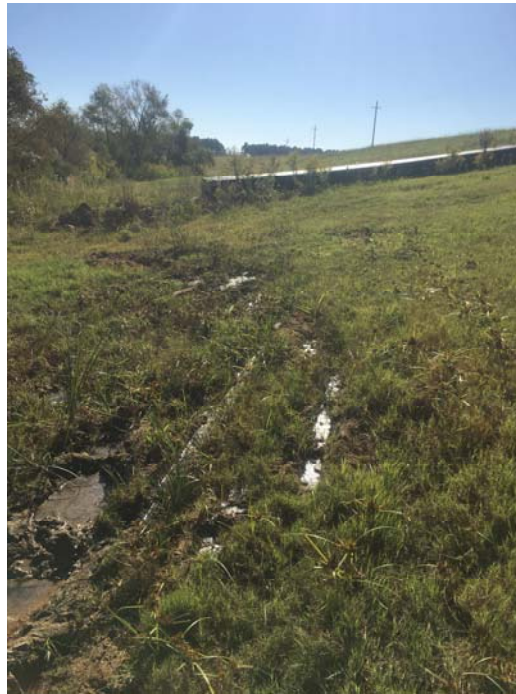
| Pastor, Behling<br>& Wheeler<br><br>PROJECT NO.<br>5313-C | DESCRIPTION | <b>Photograph 3</b> – (View SE; Sta 38+00) Saturated soil at toe of embankment. Category 1 seep (no discharge from the saturated area). | |

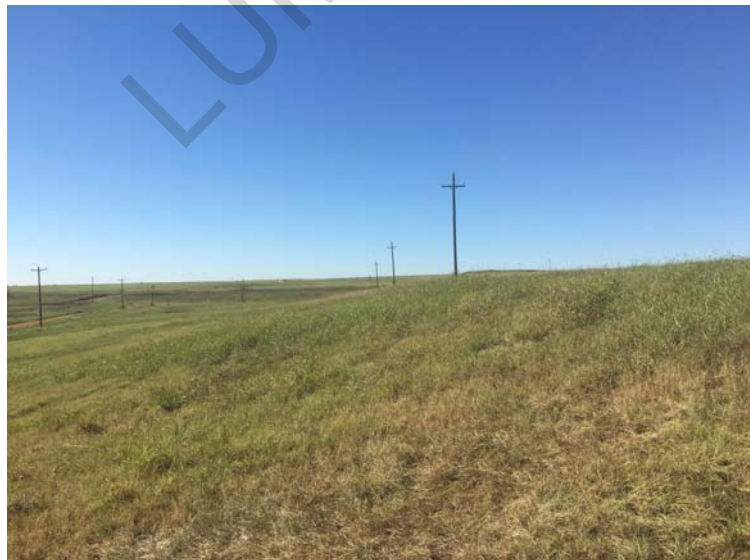
| Pastor, Behling<br>& Wheeler<br><br>PROJECT NO.<br>5313-C | DESCRIPTION | <b>Photograph 4</b> – (View SW; Sta. 53+00) Downstream embankment. | |

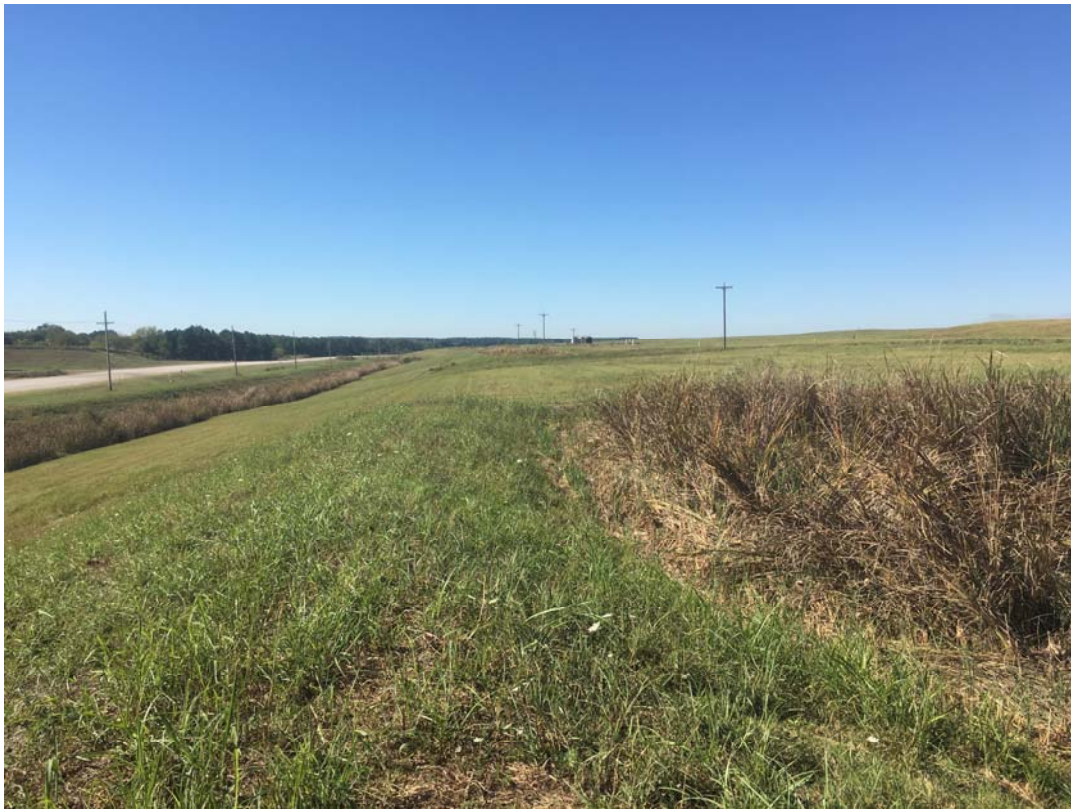
| Pastor, Behling<br>& Wheeler<br><br>PROJECT NO.<br>5313-C | DESCRIPTION | <b>Photograph 5</b> – (View SW; Sta. 84+00) Crest of southeast embankment. | |

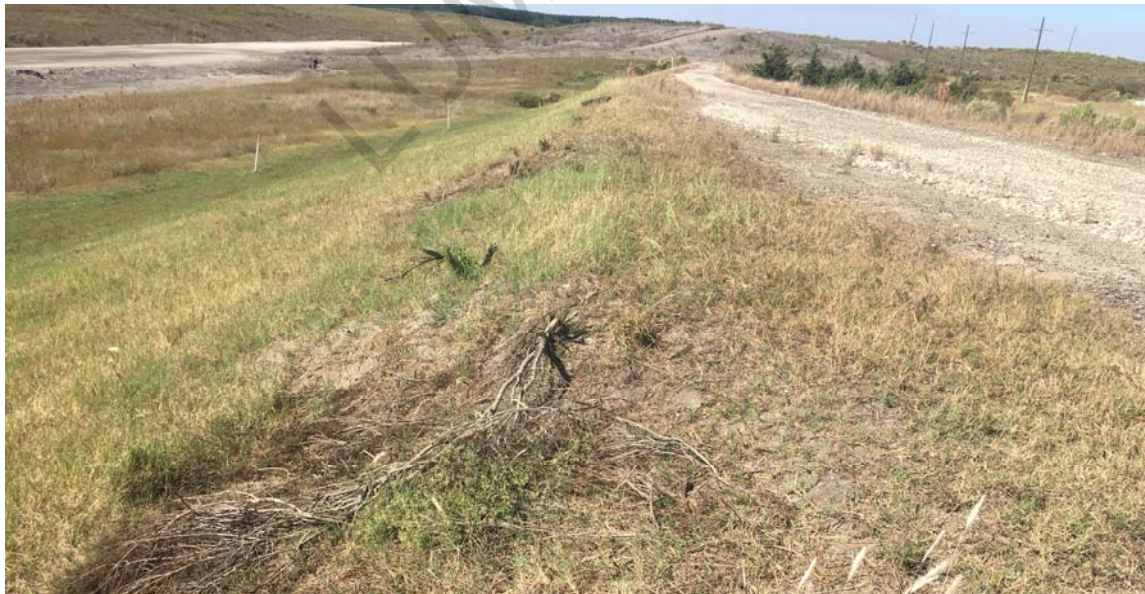
| Pastor, Behling<br>& Wheeler<br><br>PROJECT NO.<br>5313-C | DESCRIPTION | <b>Photograph 6</b> – (View SW; Near Sta. 145+00) Monitor embankment crest following recent vegetation/shrub removal. | |

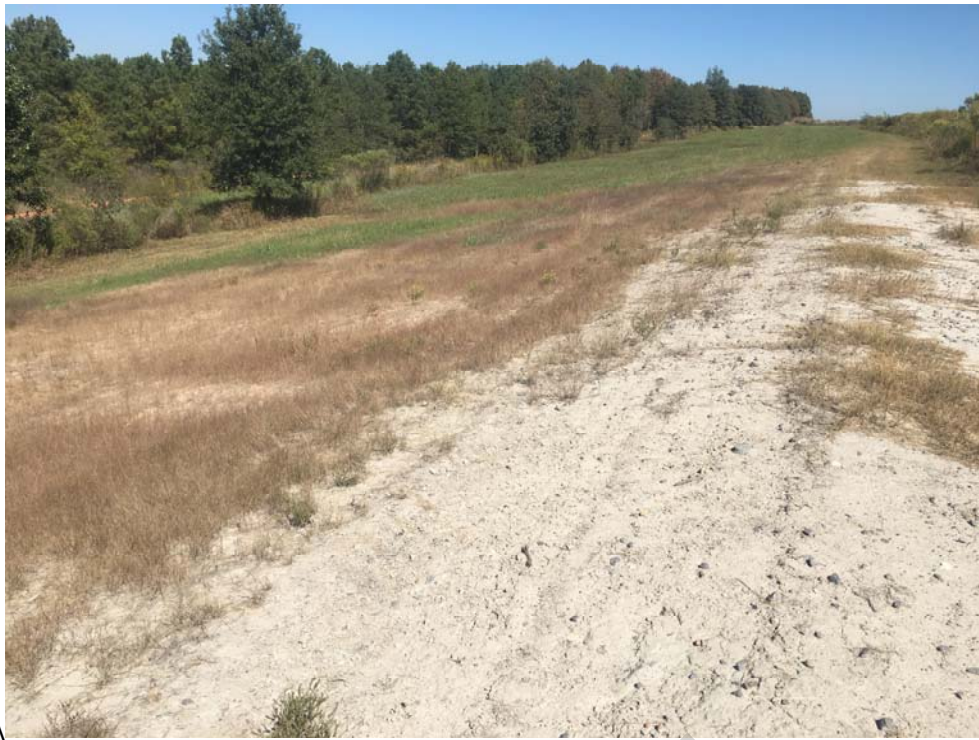
| Pastor, Behling<br>& Wheeler<br><br>PROJECT NO.<br>5313-C | DESCRIPTION | <b>Photograph 7</b> – (View NE; Sta. 222+00) Monitor poor vegetative cover and rill erosion near embankment crest (along lower access road). | |

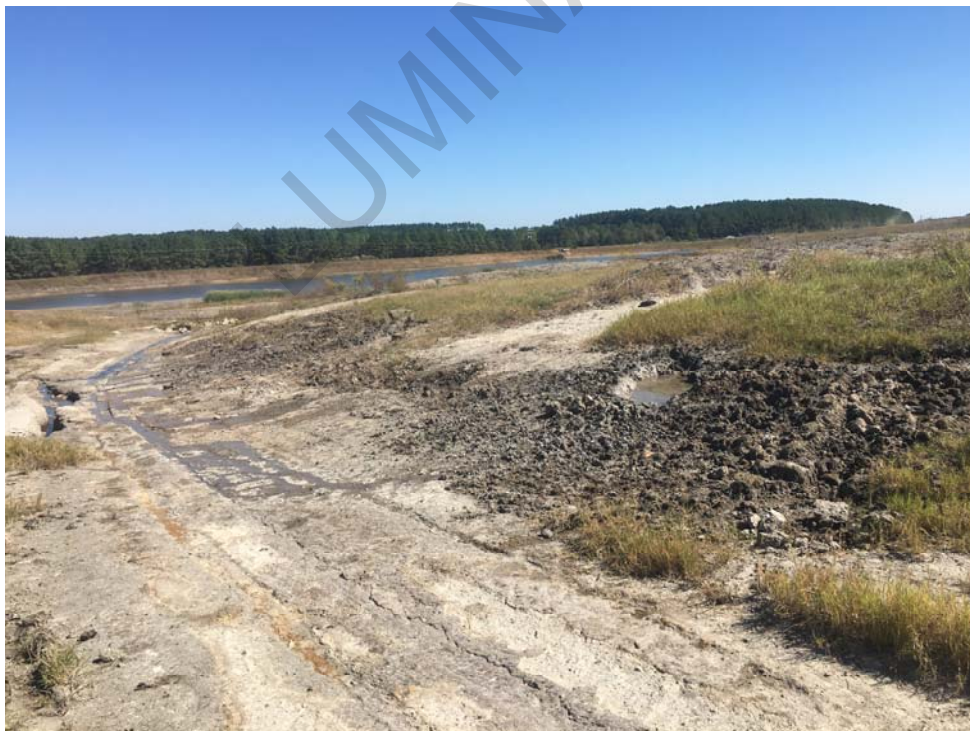
| Pastor, Behling<br>& Wheeler<br><br>PROJECT NO.<br>5313-C | DESCRIPTION | <b>Photograph 8</b> – (View NE; Sta. 257+00) Feral hog disturbance of vegetated cap (right). Soil cement armored run off collection ditch (to NRCA) with Category 2 seep (active seepage) visible. Seepage is located within run off control zone. | |
