**2016 ANNUAL CCR UNIT INSPECTION REPORT  
LUMINANT SANDOW 5 GENERATING PLANT  
AX LANDFILL  
MILAM COUNTY, TEXAS**

January 13, 2017

PBW Project No. 5256

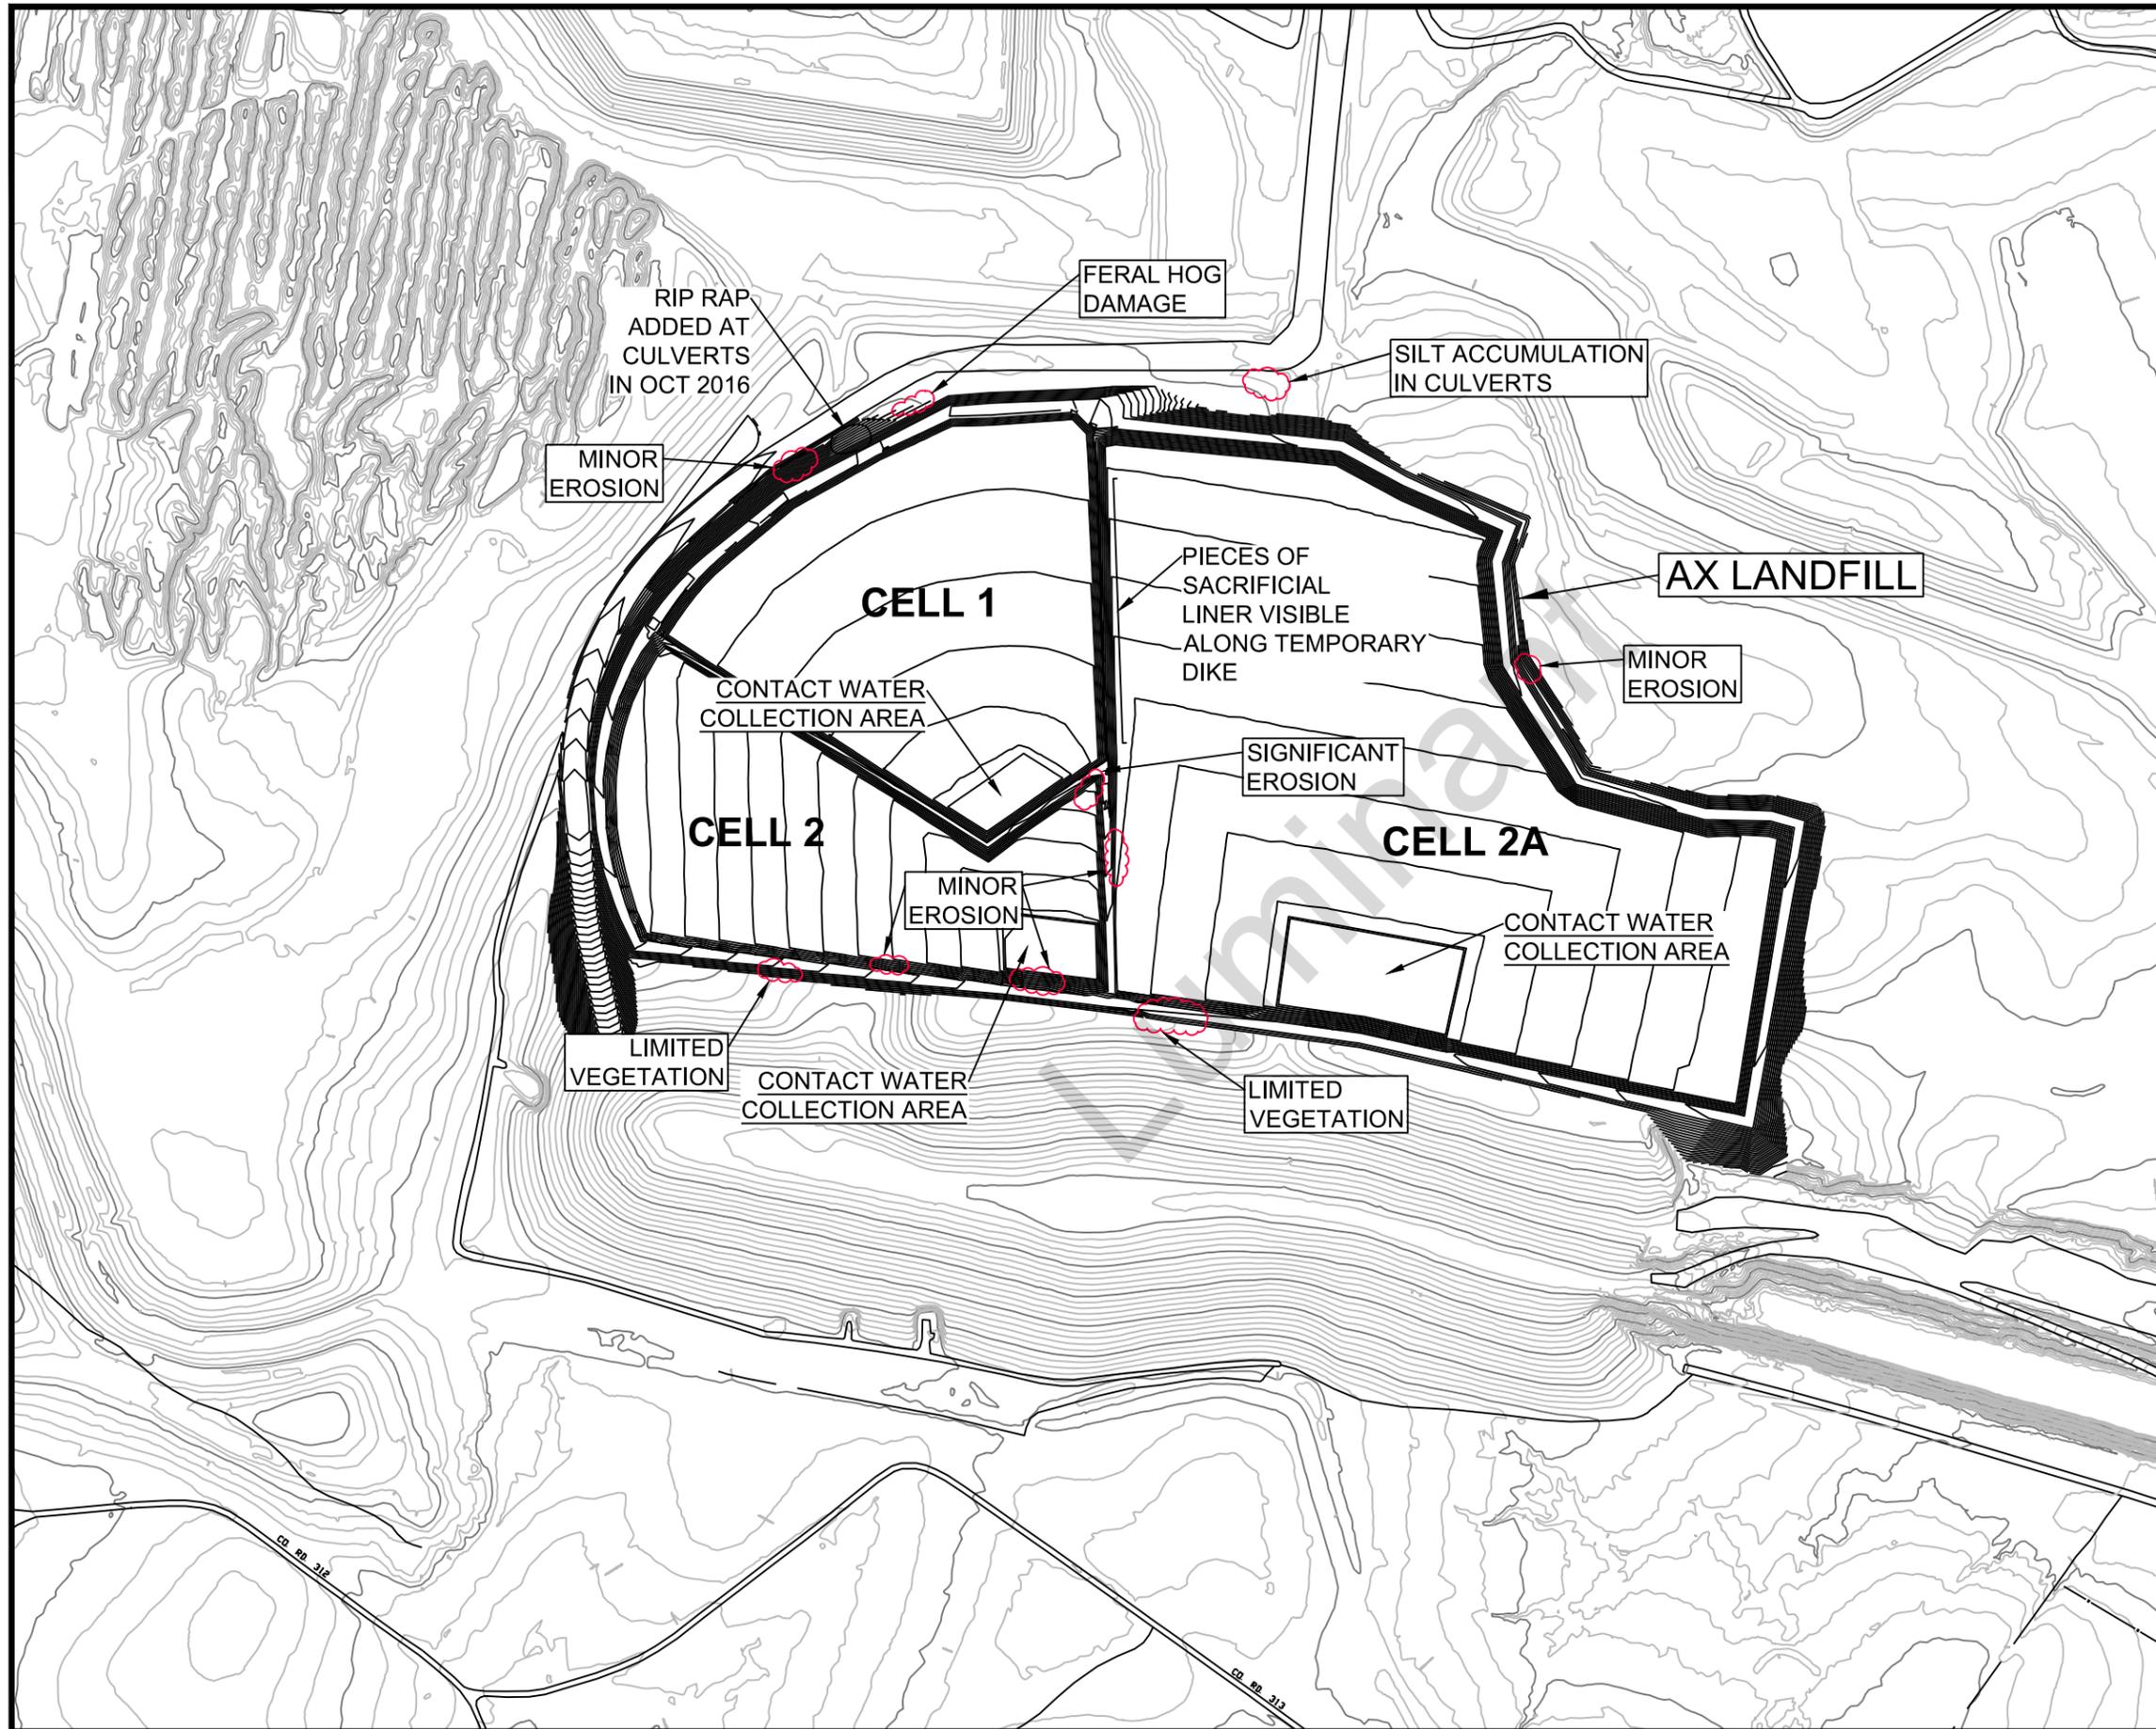
Figure 3  
**ANNUAL INSPECTION FINDINGS SUMMARY MAP**  
**AX LANDFILL**

The inspection consisted of a walking visual survey of the embankments, CCR placement areas, and storm water/contract water control in AX Landfill Cells 1, 2 and 2A. Figure 3 summarizes the field observations from the inspection. Photographs of the landfill taken during the annual inspection are included as Appendix A and Figure 4 illustrates the location where the photographs were taken. The following sections present the results of the annual inspection, including specific observations related to the structural elements of the landfill.

As indicated on Figure 3, the following areas were noted for future monitoring for the landfill:

- Minor erosion was observed in a small area along the exterior slope of the permanent embankment on the west side of Cell 1. This area should be monitored and repaired as necessary.
- Feral hog damage was observed in a small area on the exterior slope of the permanent embankment on west side of Cell 1. This area should be monitored and repaired as necessary.
- Two areas of limited vegetation were observed on the exterior slopes of the permanent embankment on the south sides of Cells 2 and 2A. These areas should be monitored and repaired as necessary.

- Areas of minor erosion were observed on the interior slopes of the permanent embankment on the south side of Cell 2 and the temporary embankment between Cells 2 and 2A. These areas should be monitored and repaired as necessary.
- A small area of significant erosion (liner visible) was observed along the temporary embankment between Cells 1 and 2. This area should be repaired.
- Minor erosion was observed in a small area along the exterior slope of the permanent embankment on the north side of Cell 2A. This area should be monitored and repaired as necessary.
- An accumulation of silt was observed partially blocking the inlets to two culverts that cross the haul road on the north side of the AX Landfill, northeast of the access ramp. The silt should be removed from the culvert inlets.

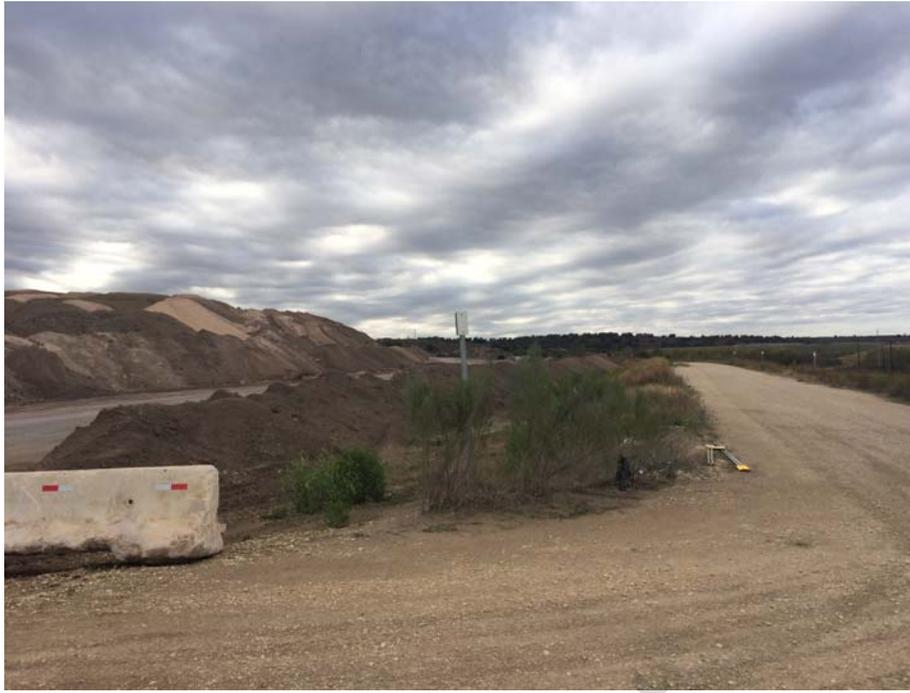
Pastor, Behling & Wheeler	DESCRIPTION	<b>Photograph 1</b> – (View SW) View along top of permanent earthen embankment along north side of Cell 1. Cell 1 to left	
PROJECT NO. 5256	SITE NAME	Sandow Unit No. 5 – AX Landfill Annual Inspection	DATE 11/29/2016

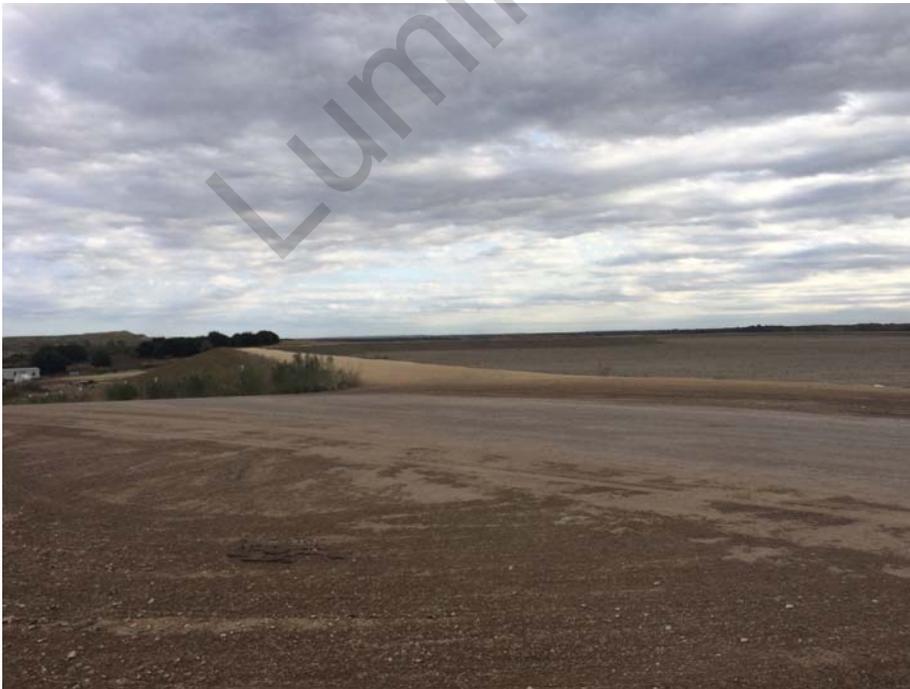
Pastor, Behling & Wheeler	DESCRIPTION	<b>Photograph 2</b> – (View NE) View along top of permanent earthen embankment along north side of Cell 2A. Cell 2A to right	
PROJECT NO. 5256	SITE NAME	Sandow Unit No. 5 – AX Landfill Annual Inspection	DATE 11/29/2016

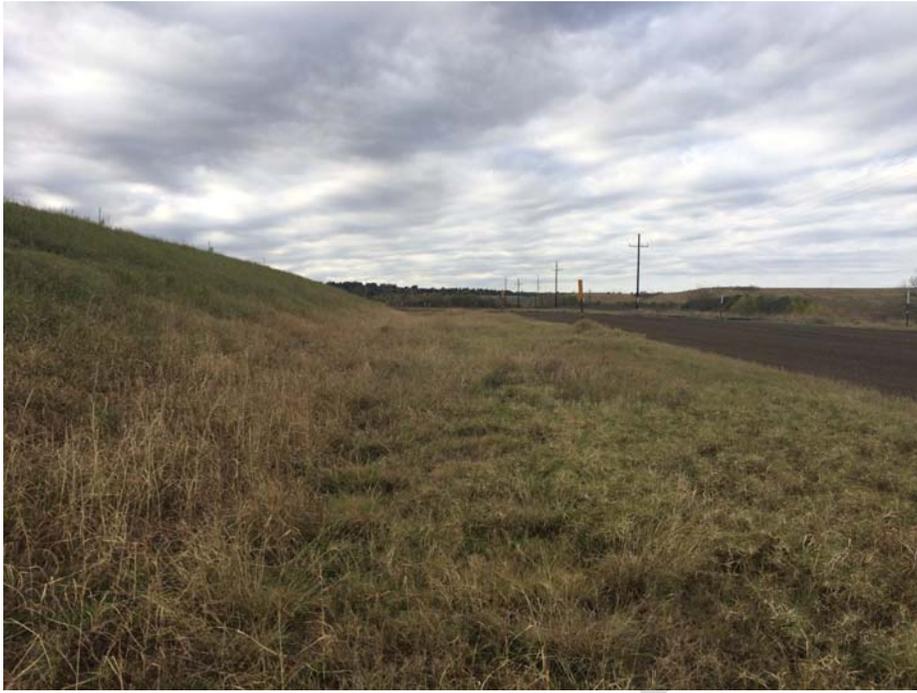
Pastor, Behling & Wheeler  PROJECT NO. 5256	DESCRIPTION	<b>Photograph 3</b> – (View SW) View along toe of permanent embankment along north side of Cell 1. Cell 1 to left	
	SITE NAME	Sandow Unit No. 5 – AX Landfill Annual Inspection	DATE 11/29/2016

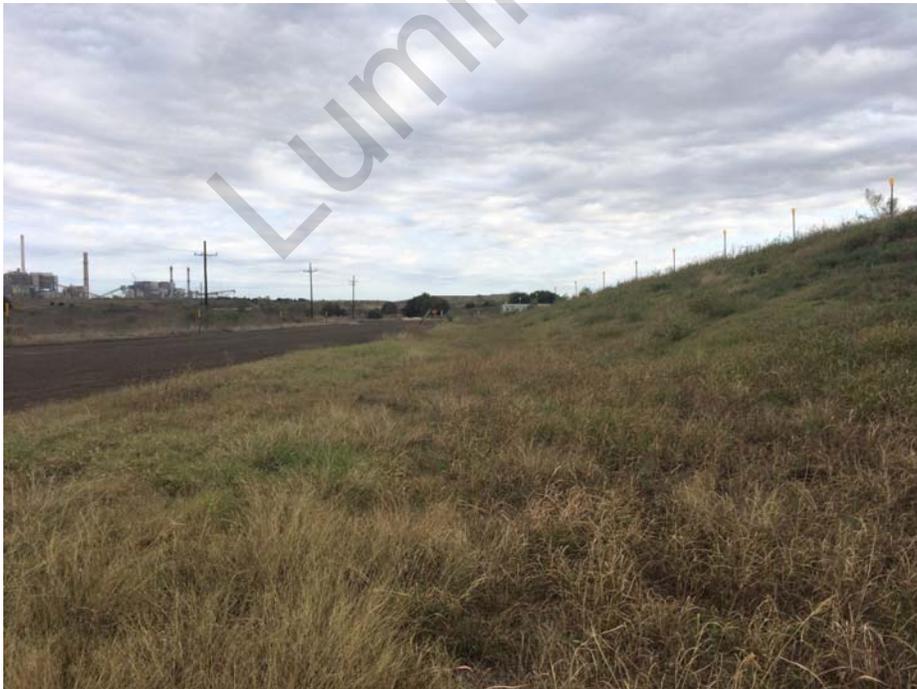
Pastor, Behling & Wheeler  PROJECT NO. 5256	DESCRIPTION	<b>Photograph 4</b> – (View NE) View along toe of permanent embankment along north side of Cell 1	
	SITE NAME	Sandow Unit No. 5 – AX Landfill Annual Inspection	DATE 11/29/2016

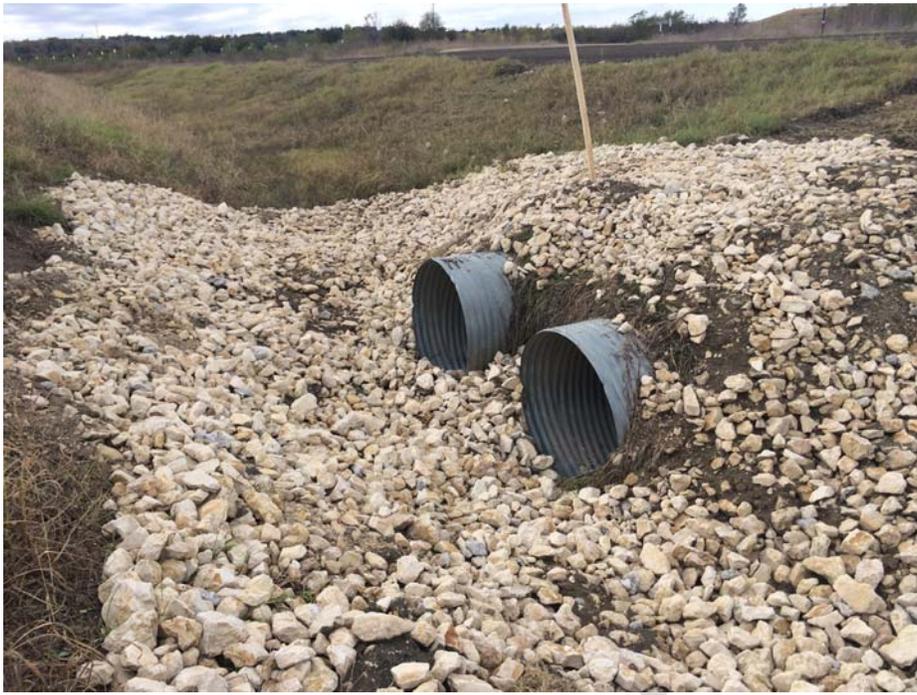
- Monitor small areas of feral hog damage to vegetation on west/northwest side of Cell 1;
- Monitor minor erosion on the south side of Cell 2 exterior embankment slope; and
- Minor erosion was observed beneath the inverts of two culverts near the toe of the exterior embankment on the west side of Cell 1. Rip rap stone was placed in this area in October 2016 to address the erosion.

Pastor, Behling & Wheeler  PROJECT NO. 5256	DESCRIPTION	<b>Photograph 5</b> – (View W) Rip rap placed to control erosion at culverts on north side of Cell 1	
	SITE NAME	Sandow Unit No. 5 – AX Landfill Annual Inspection	DATE 11/29/2016

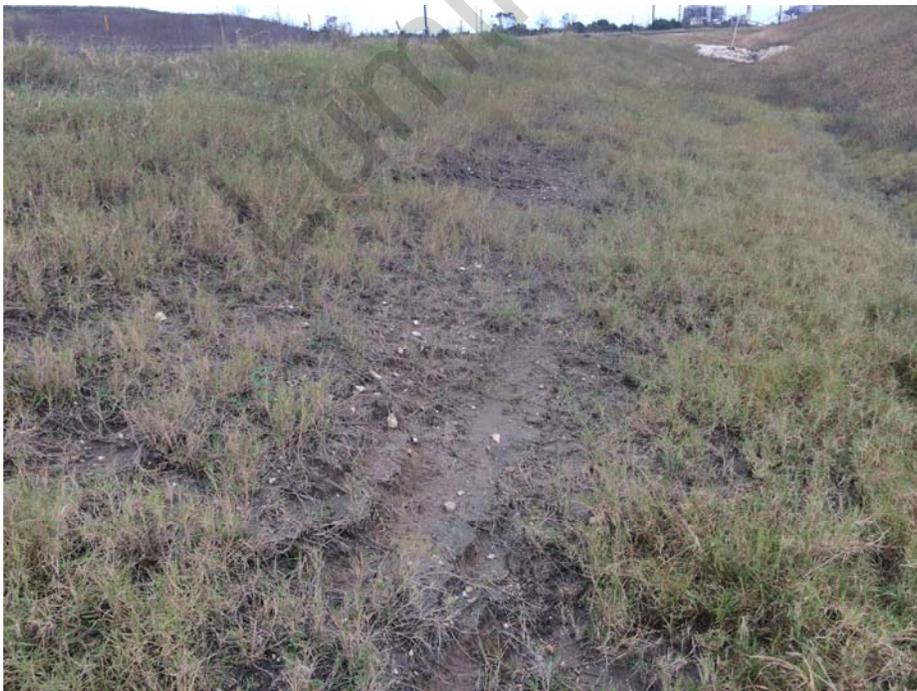
Pastor, Behling & Wheeler  PROJECT NO. 5256	DESCRIPTION	<b>Photograph 6</b> – Minor erosion on face of drainage ditch along north side of Cell 1	
	SITE NAME	Sandow Unit No. 5 – AX Landfill Annual Inspection	DATE 11/29/2016

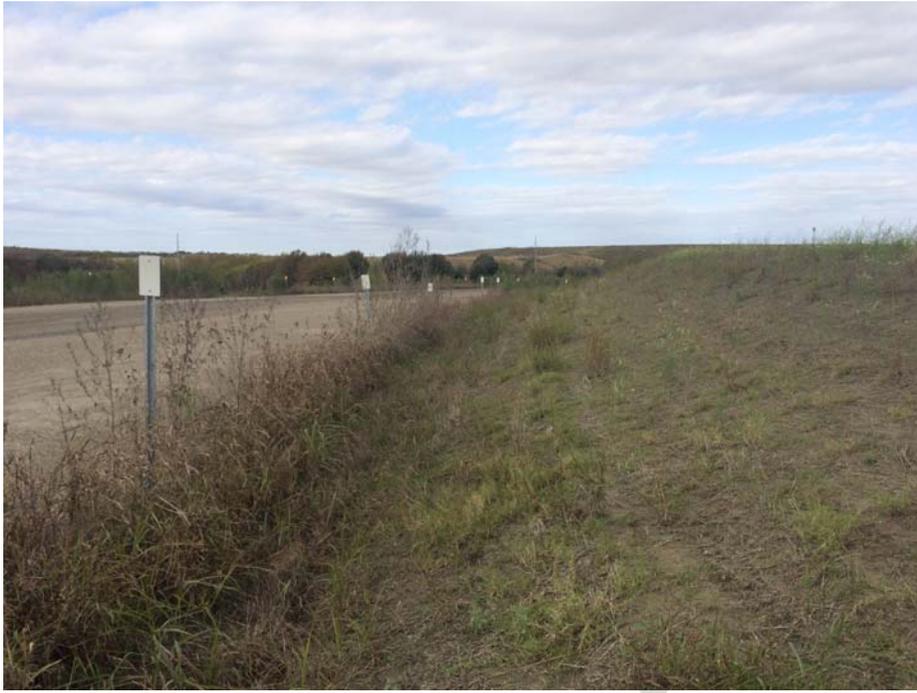
Pastor, Behling & Wheeler	DESCRIPTION	<b>Photograph 7</b> – (View N) View along toe of permanent embankment on west side of Cell 2	
PROJECT NO. 5256	SITE NAME	Sandow Unit No. 5 – AX Landfill Annual Inspection	DATE 11/29/2016

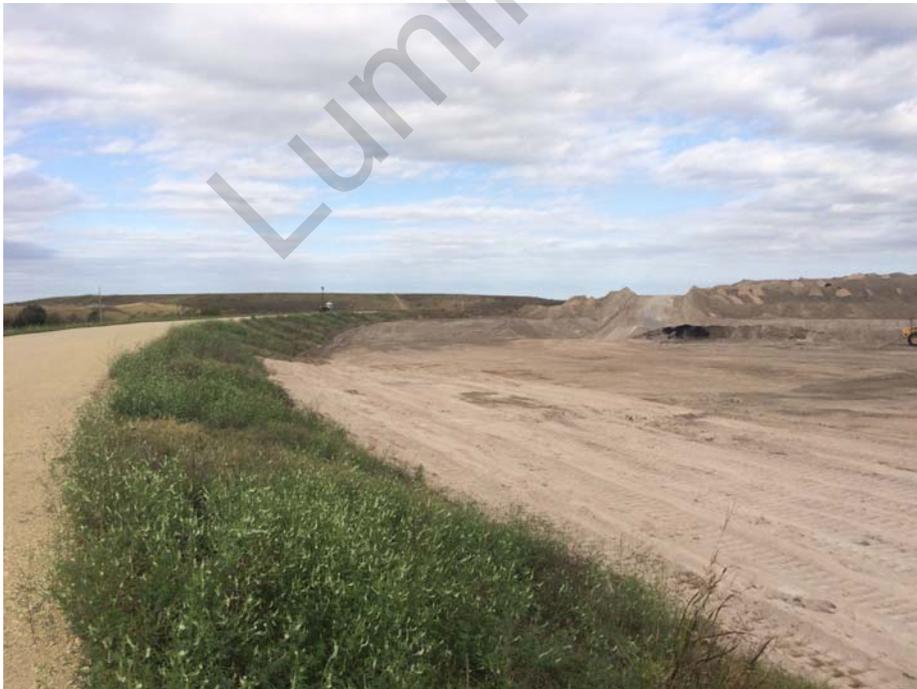
Pastor, Behling & Wheeler	DESCRIPTION	<b>Photograph 8</b> – (View N) View along top of embankment on west side of Cell 2. Cell 2 to right, Cell 1 in background	
PROJECT NO. 5256	SITE NAME	Sandow Unit No. 5 – AX Landfill Annual Inspection	DATE 11/29/2016

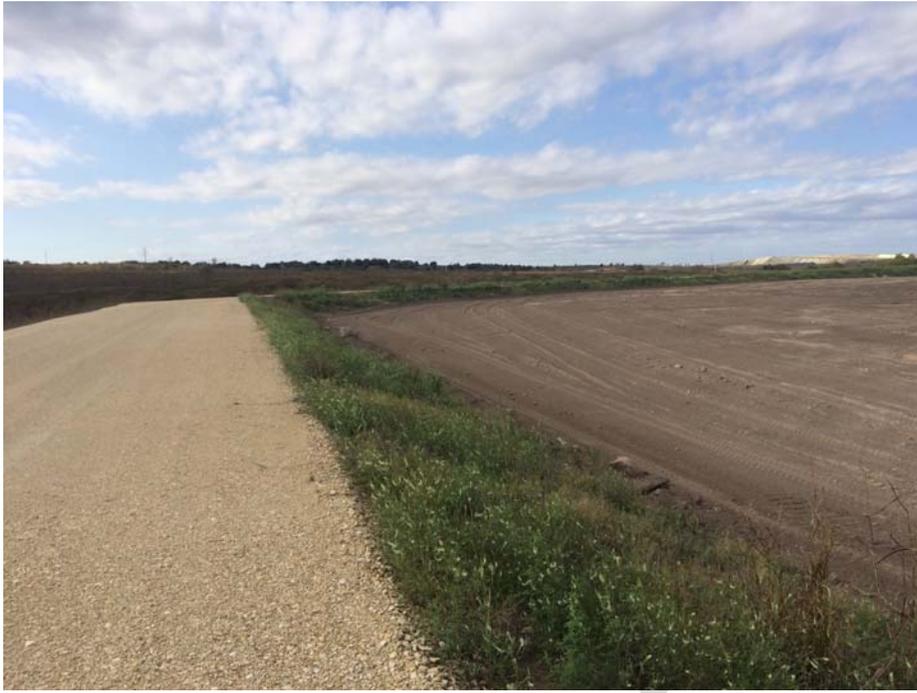
Pastor, Behling & Wheeler	DESCRIPTION	<b>Photograph 9</b> – (View SW) View along top of permanent embankment on south side of Cell 2. Cell 2 to right	
PROJECT NO. 5256	SITE NAME	Sandow Unit No. 5 – AX Landfill Annual Inspection	DATE 11/29/2016

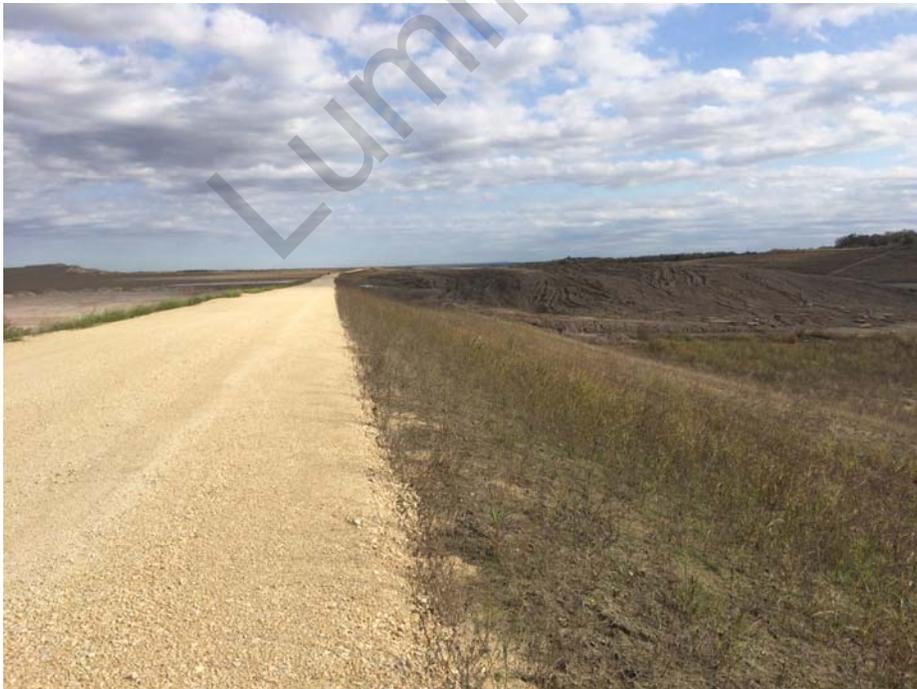
Pastor, Behling & Wheeler	DESCRIPTION	<b>Photograph 10</b> – (View NE) View along top crest of permanent embankment along south side of Cell 2. Cell 2 to left	
PROJECT NO. 5256	SITE NAME	Sandow Unit No. 5 – AX Landfill Annual Inspection	DATE 11/29/2016

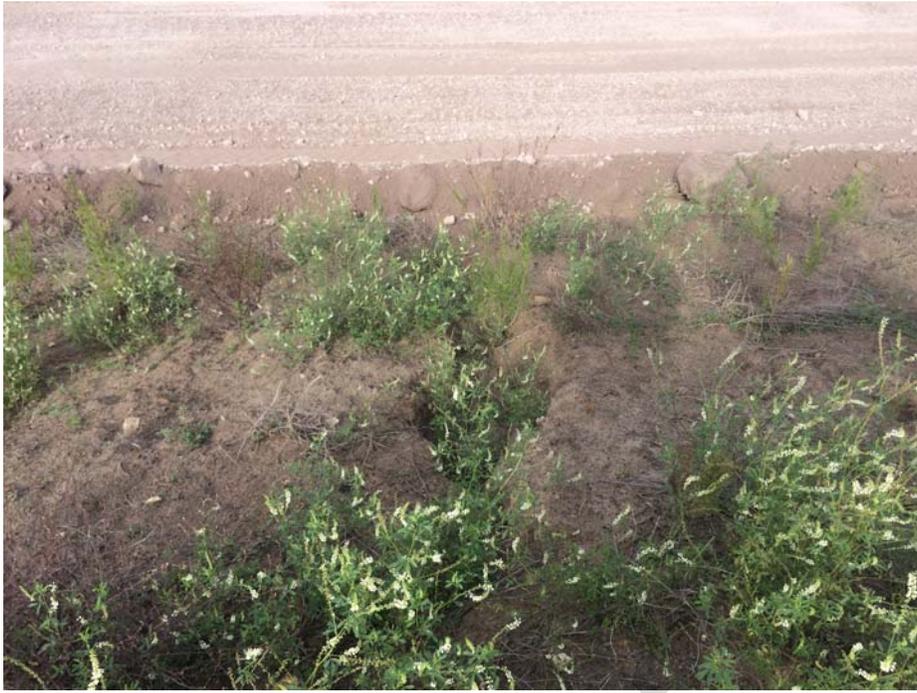
- Areas of minor erosion were observed on the interior slopes of the permanent embankment on the south side of Cell 2 and the temporary embankments between Cells 2 and 2A. These areas should be monitored and repaired as necessary.

Pastor, Behling & Wheeler  PROJECT NO. 5256	DESCRIPTION	<b>Photograph 11</b> – Erosion on interior of south embankment of Cell 2	
	SITE NAME	Sandow Unit No. 5 – AX Landfill Annual Inspection	DATE 11/29/2016

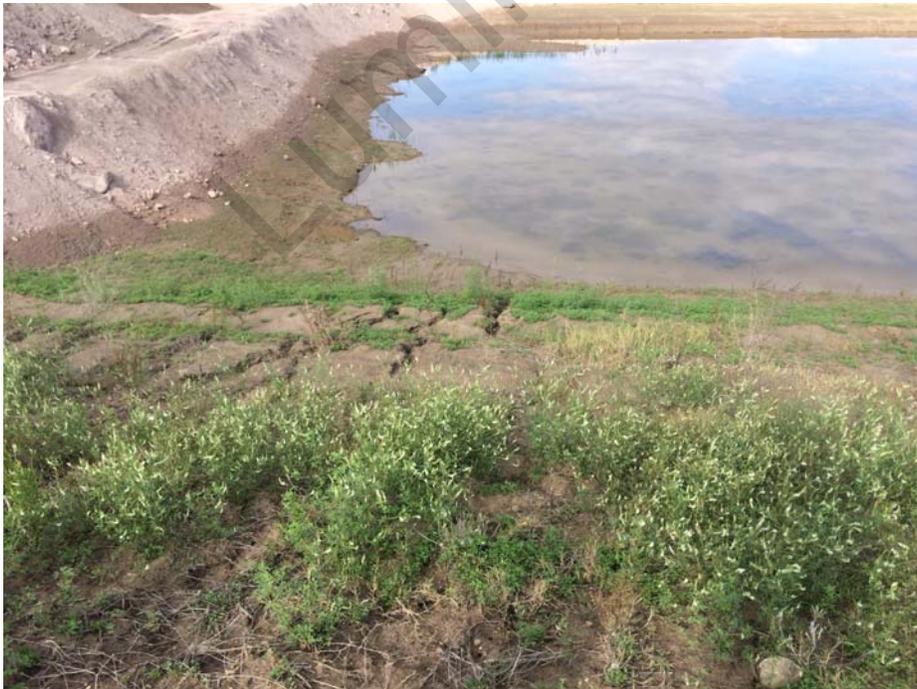
Pastor, Behling & Wheeler  PROJECT NO. 5256	DESCRIPTION	<b>Photograph 12</b> – Erosion on interior of south embankment of Cell 2, near contact water area	
	SITE NAME	Sandow Unit No. 5 – AX Landfill Annual Inspection	DATE 11/29/2016

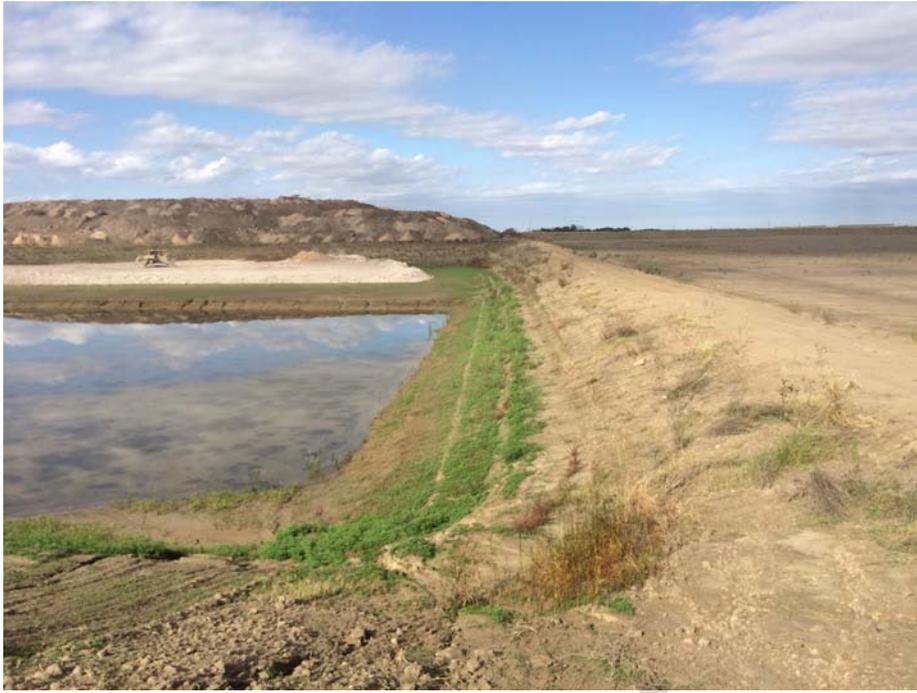
Pastor, Behling & Wheeler  PROJECT NO. 5256	DESCRIPTION	<b>Photograph 13</b> – (View W) View along top of temporary embankment between Cells 2 and 2A. Cell 2 to left, Cell 2A to right	
	SITE NAME	Sandow Unit No. 5 – AX Landfill Annual Inspection	DATE 11/29/2016

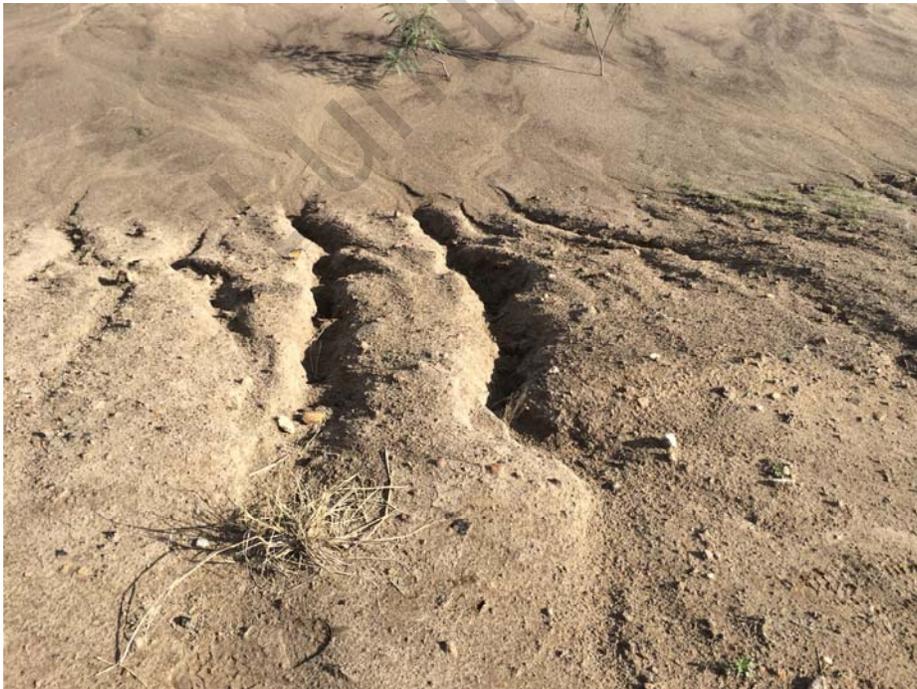
Pastor, Behling & Wheeler  PROJECT NO. 5256	DESCRIPTION	<b>Photograph 14</b> – Erosion on interior of temporary embankment on west side of Cell 2A	
	SITE NAME	Sandow Unit No. 5 – AX Landfill Annual Inspection	DATE 11/29/2016

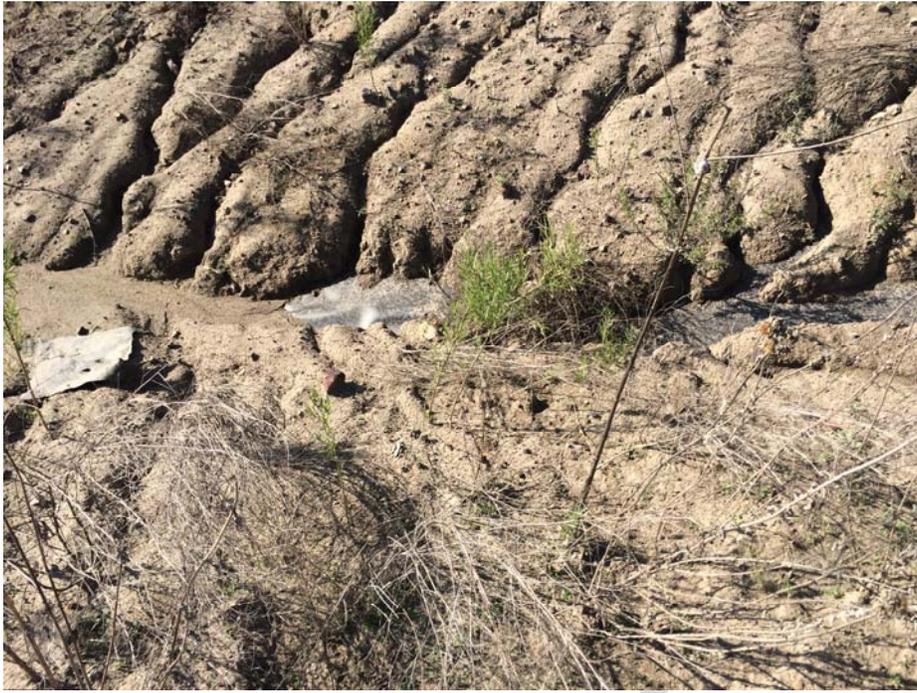
Pastor, Behling & Wheeler  PROJECT NO. 5256	DESCRIPTION	<b>Photograph 15</b> – Significant erosion on interior wall in north corner of temporary embankment between Cells 1 and 2	
	SITE NAME	Sandow Unit No. 5 – AX Landfill Annual Inspection	DATE 11/29/2016

- A small area of significant erosion (liner visible) was observed along the temporary embankment between Cells 1 and 2. This area should be repaired.
- Minor erosion was observed in a small area along the exterior slope of the permanent embankment on the north side of Cell 2A. This area should be monitored and repaired as necessary.

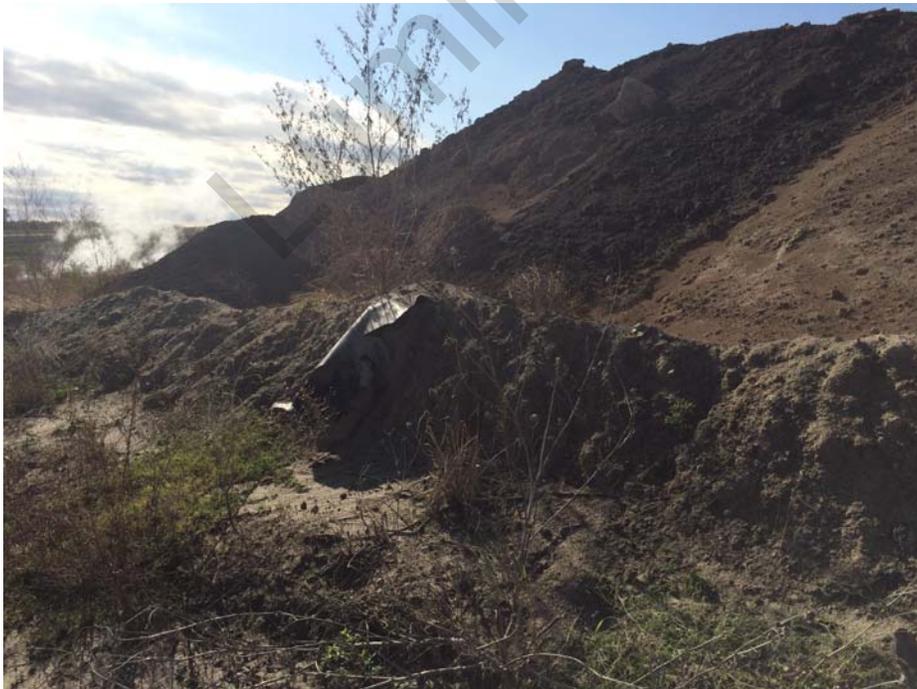
Pastor, Behling & Wheeler  PROJECT NO. 5256	DESCRIPTION	<b>Photograph 16</b> – Sacrificial liner removed from temporary embankment along north side of Cell 1 when Cell 2A was constructed	
	SITE NAME	Sandow Unit No. 5 – AX Landfill Annual Inspection	DATE 11/29/2016

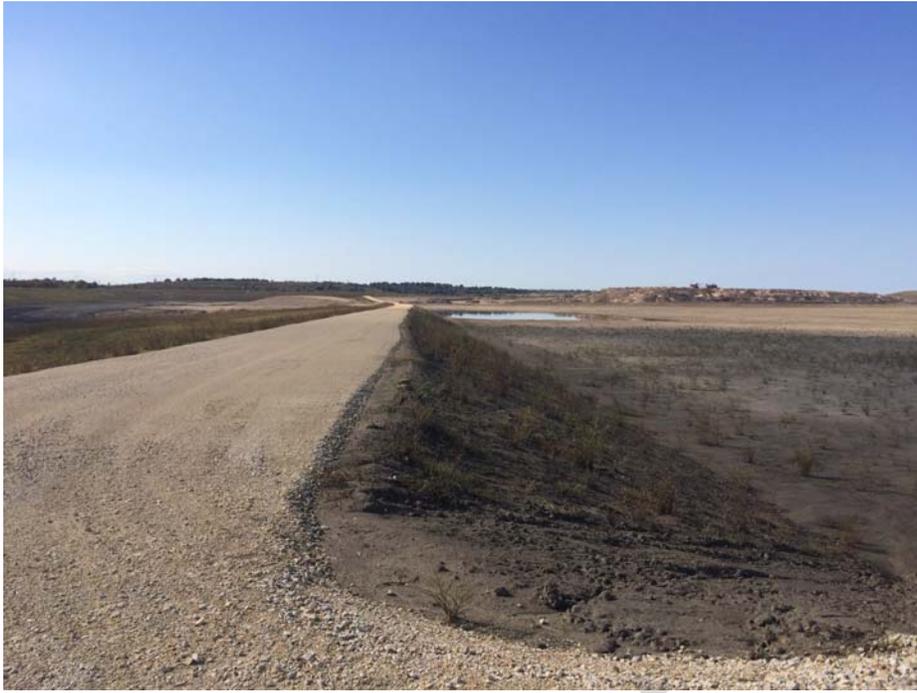
Pastor, Behling & Wheeler	DESCRIPTION	<b>Photograph 17</b> – (View SW) View along top of permanent embankment on south side of Cell 2A. Cell 2A to right	
PROJECT NO. 5256	SITE NAME	Sandow Unit No. 5 – AX Landfill Annual Inspection	DATE 11/29/2016

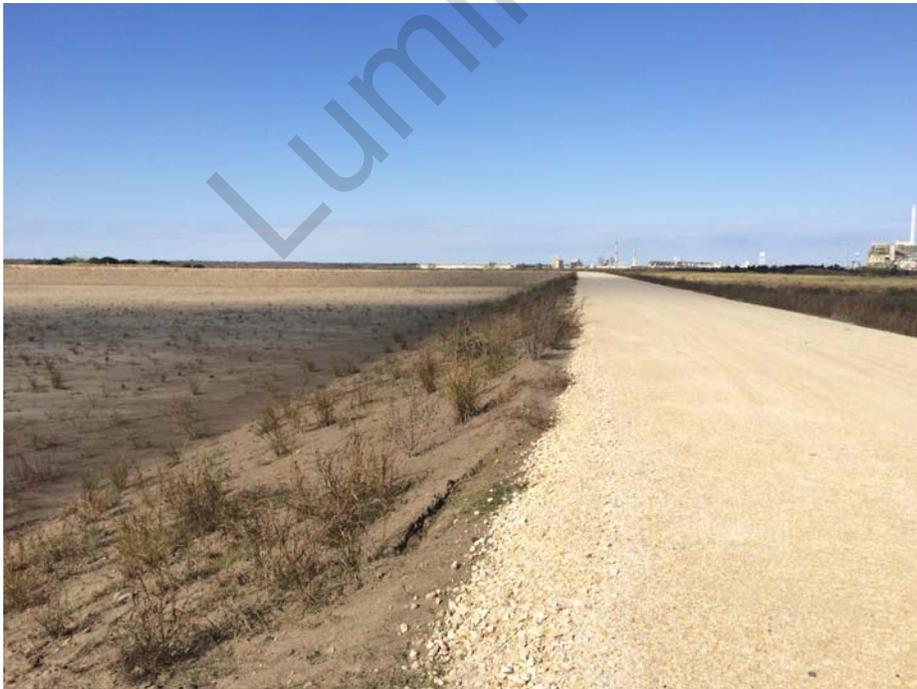
Pastor, Behling & Wheeler	DESCRIPTION	<b>Photograph 18</b> – (View NW) View along top of permanent embankment on east side of Cell 2A. Cell 2A to left	
PROJECT NO. 5256	SITE NAME	Sandow Unit No. 5 – AX Landfill Annual Inspection	DATE 11/29/2016

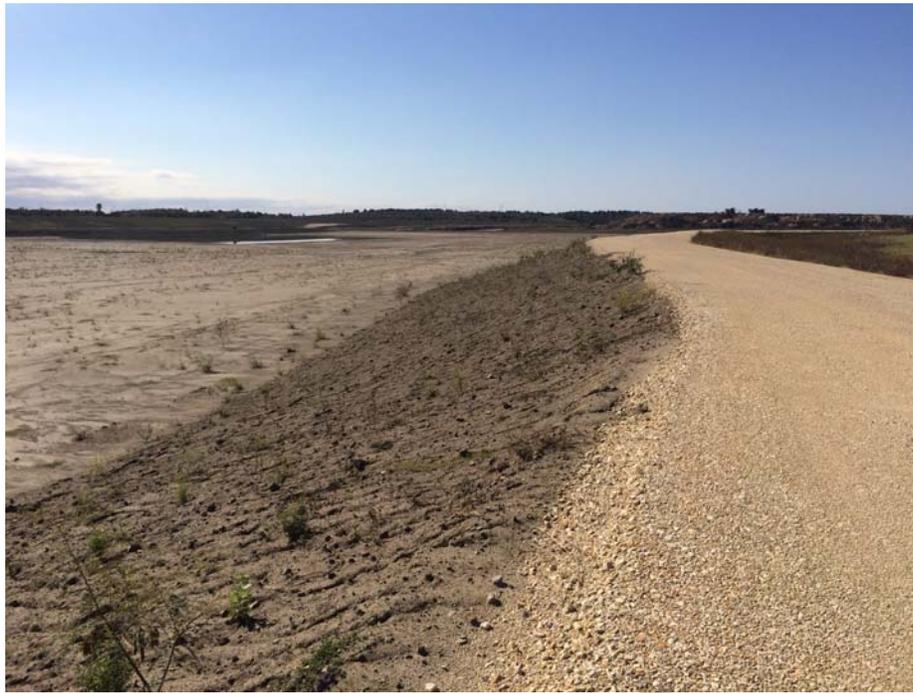
Pastor, Behling & Wheeler	DESCRIPTION	<b>Photograph 19</b> – (View SW) View along top of permanent embankment on north side of Cell 2A. Cell 2A to left	
PROJECT NO. 5256	SITE NAME	Sandow Unit No. 5 – AX Landfill Annual Inspection	DATE 11/29/2016

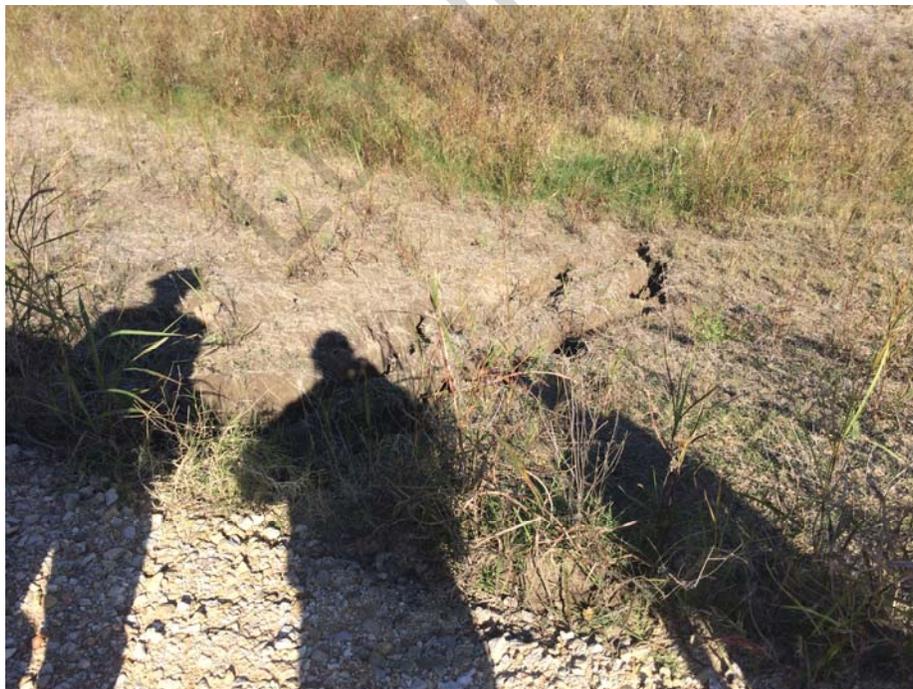
Pastor, Behling & Wheeler	DESCRIPTION	<b>Photograph 20</b> – (View N) Erosion on exterior face of permanent embankment on north side of Cell 2A	
PROJECT NO. 5256	SITE NAME	Sandow Unit No. 5 – AX Landfill Annual Inspection	DATE 11/29/2016

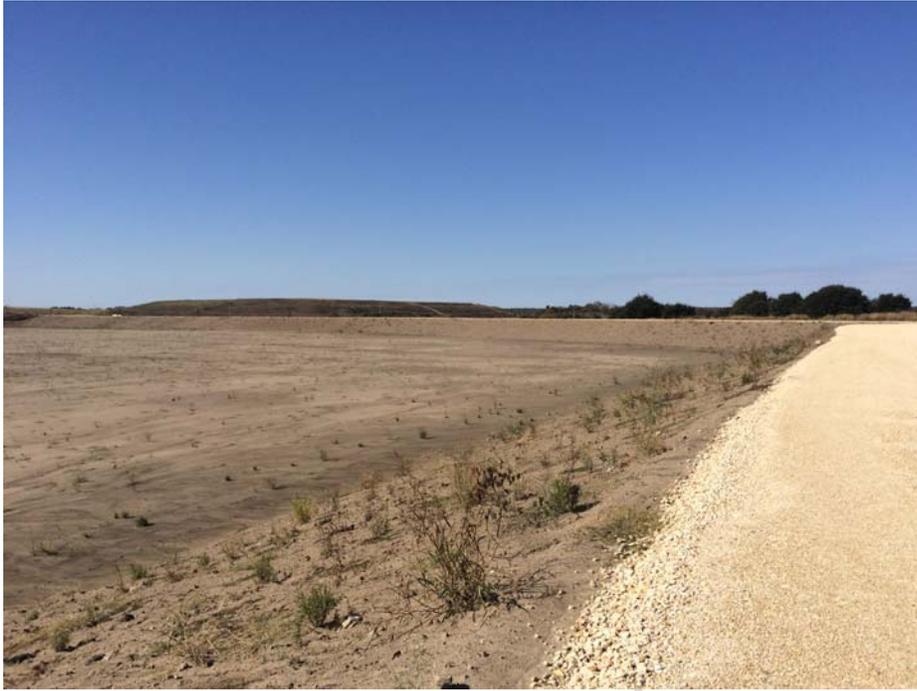
Pastor, Behling & Wheeler	DESCRIPTION	<b>Photograph 21</b> – (View W) View along top of permanent embankment on north side of Cell 2A. Cell 2A to left	
PROJECT NO. 5256	SITE NAME	Sandow Unit No. 5 – AX Landfill Annual Inspection	DATE 11/29/2016

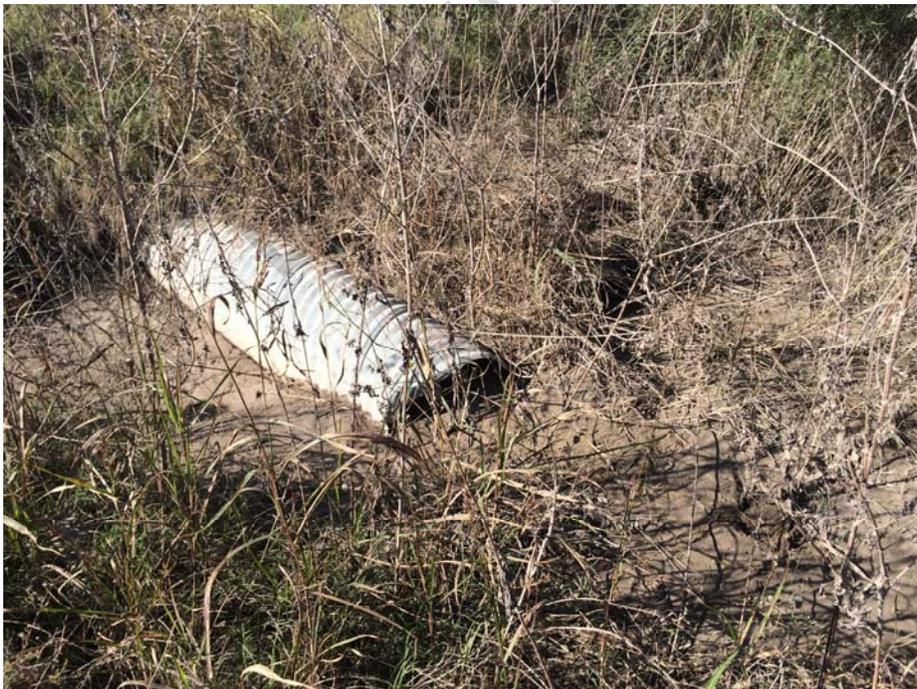
Pastor, Behling & Wheeler	DESCRIPTION	<b>Photograph 22</b> – Significant silt accumulation in culverts on north side of AX Landfill	
PROJECT NO. 5256	SITE NAME	Sandow Unit No. 5 – AX Landfill Annual Inspection	DATE 11/29/2016

- An accumulation of silt was observed partially blocking the inlets to two culverts that cross the haul road on the north side of the AX Landfill, northeast of the access ramp. The silt should be removed from the culvert inlets.
