**RE: History of Construction  
USEPA Final CCR Rule, 40 CFR § 257.73(c)  
Kincaid Power Station  
Kincaid, Illinois**

On behalf of Kincaid Generation, L.L.C., AECOM has prepared the following history of construction for the Ash Pond at the Kincaid Power Station in accordance with 40 CFR § 257.73(c).

RE: Ash Pond Embankment Settlement

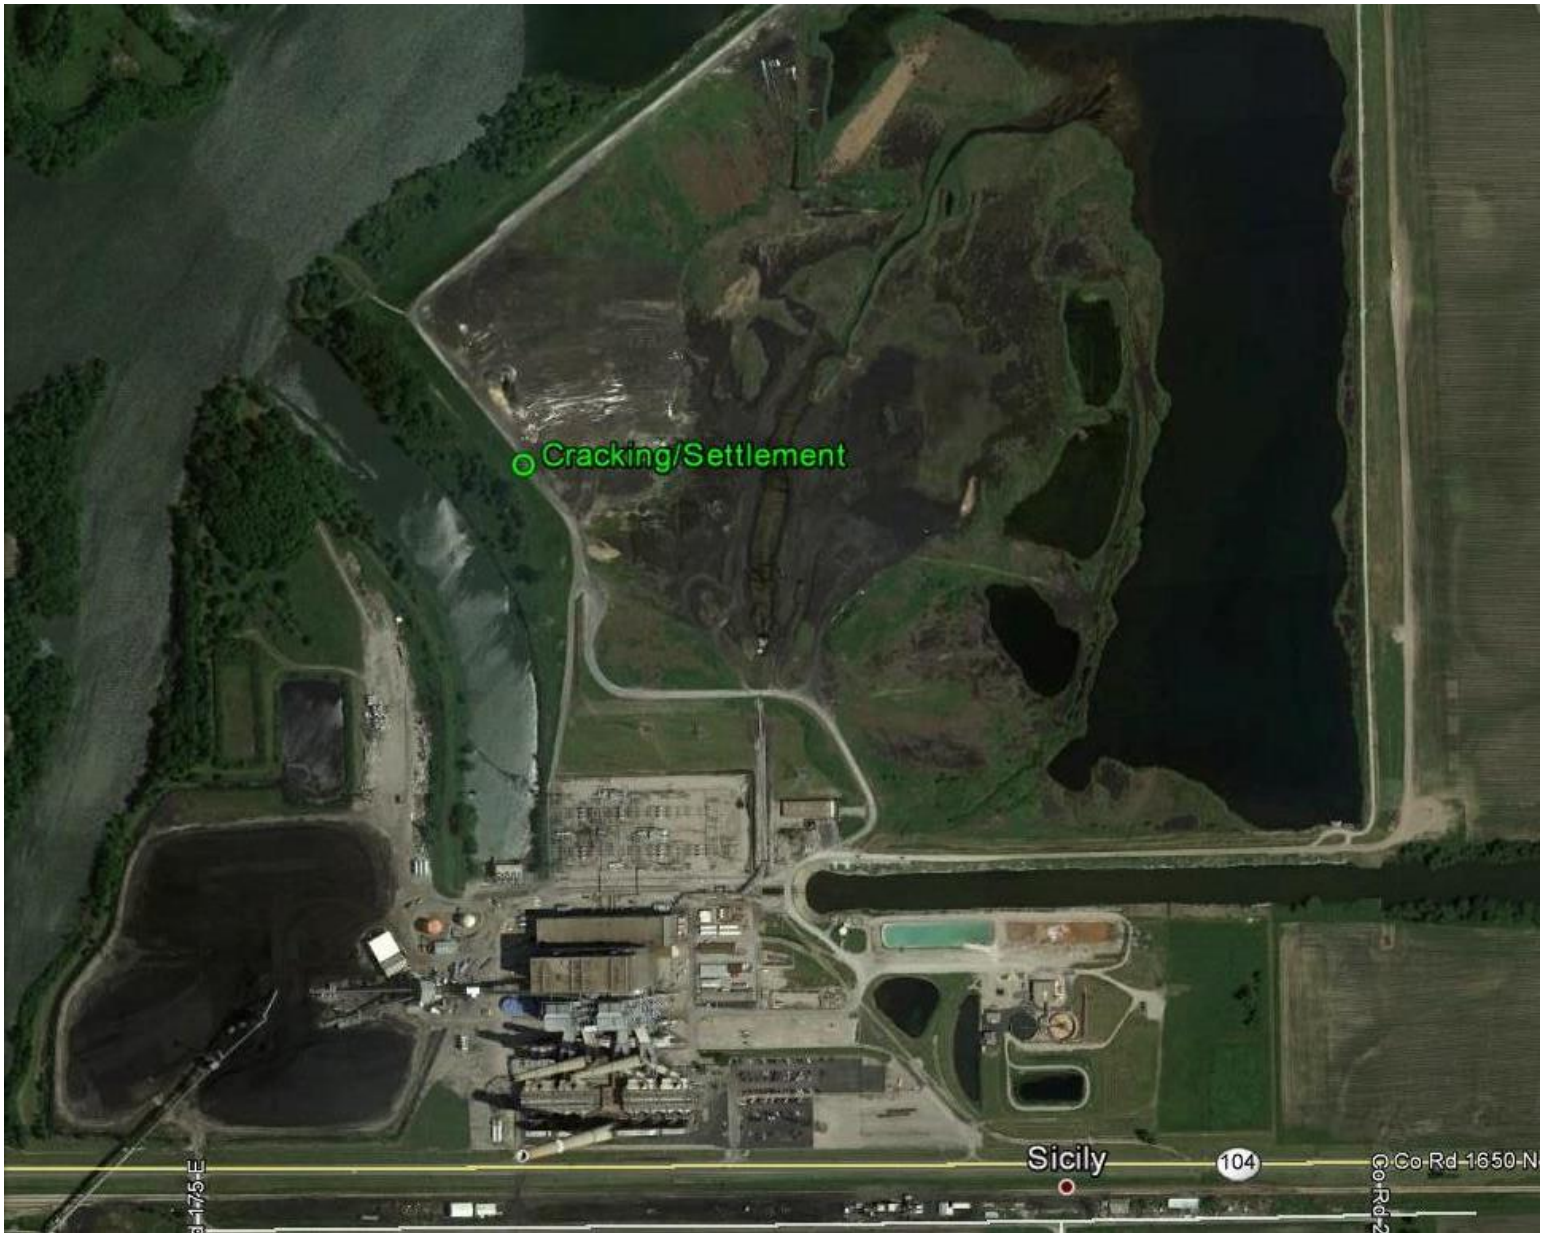
Aerial photo of affected area

- The affected area was approximately 250 ft by 250 ft. The area is situated on the southwest side of the ash pond adjacent to the water intake channel for the power station. The location of the affected area is shown on the attached aerial photo and coal mine map.

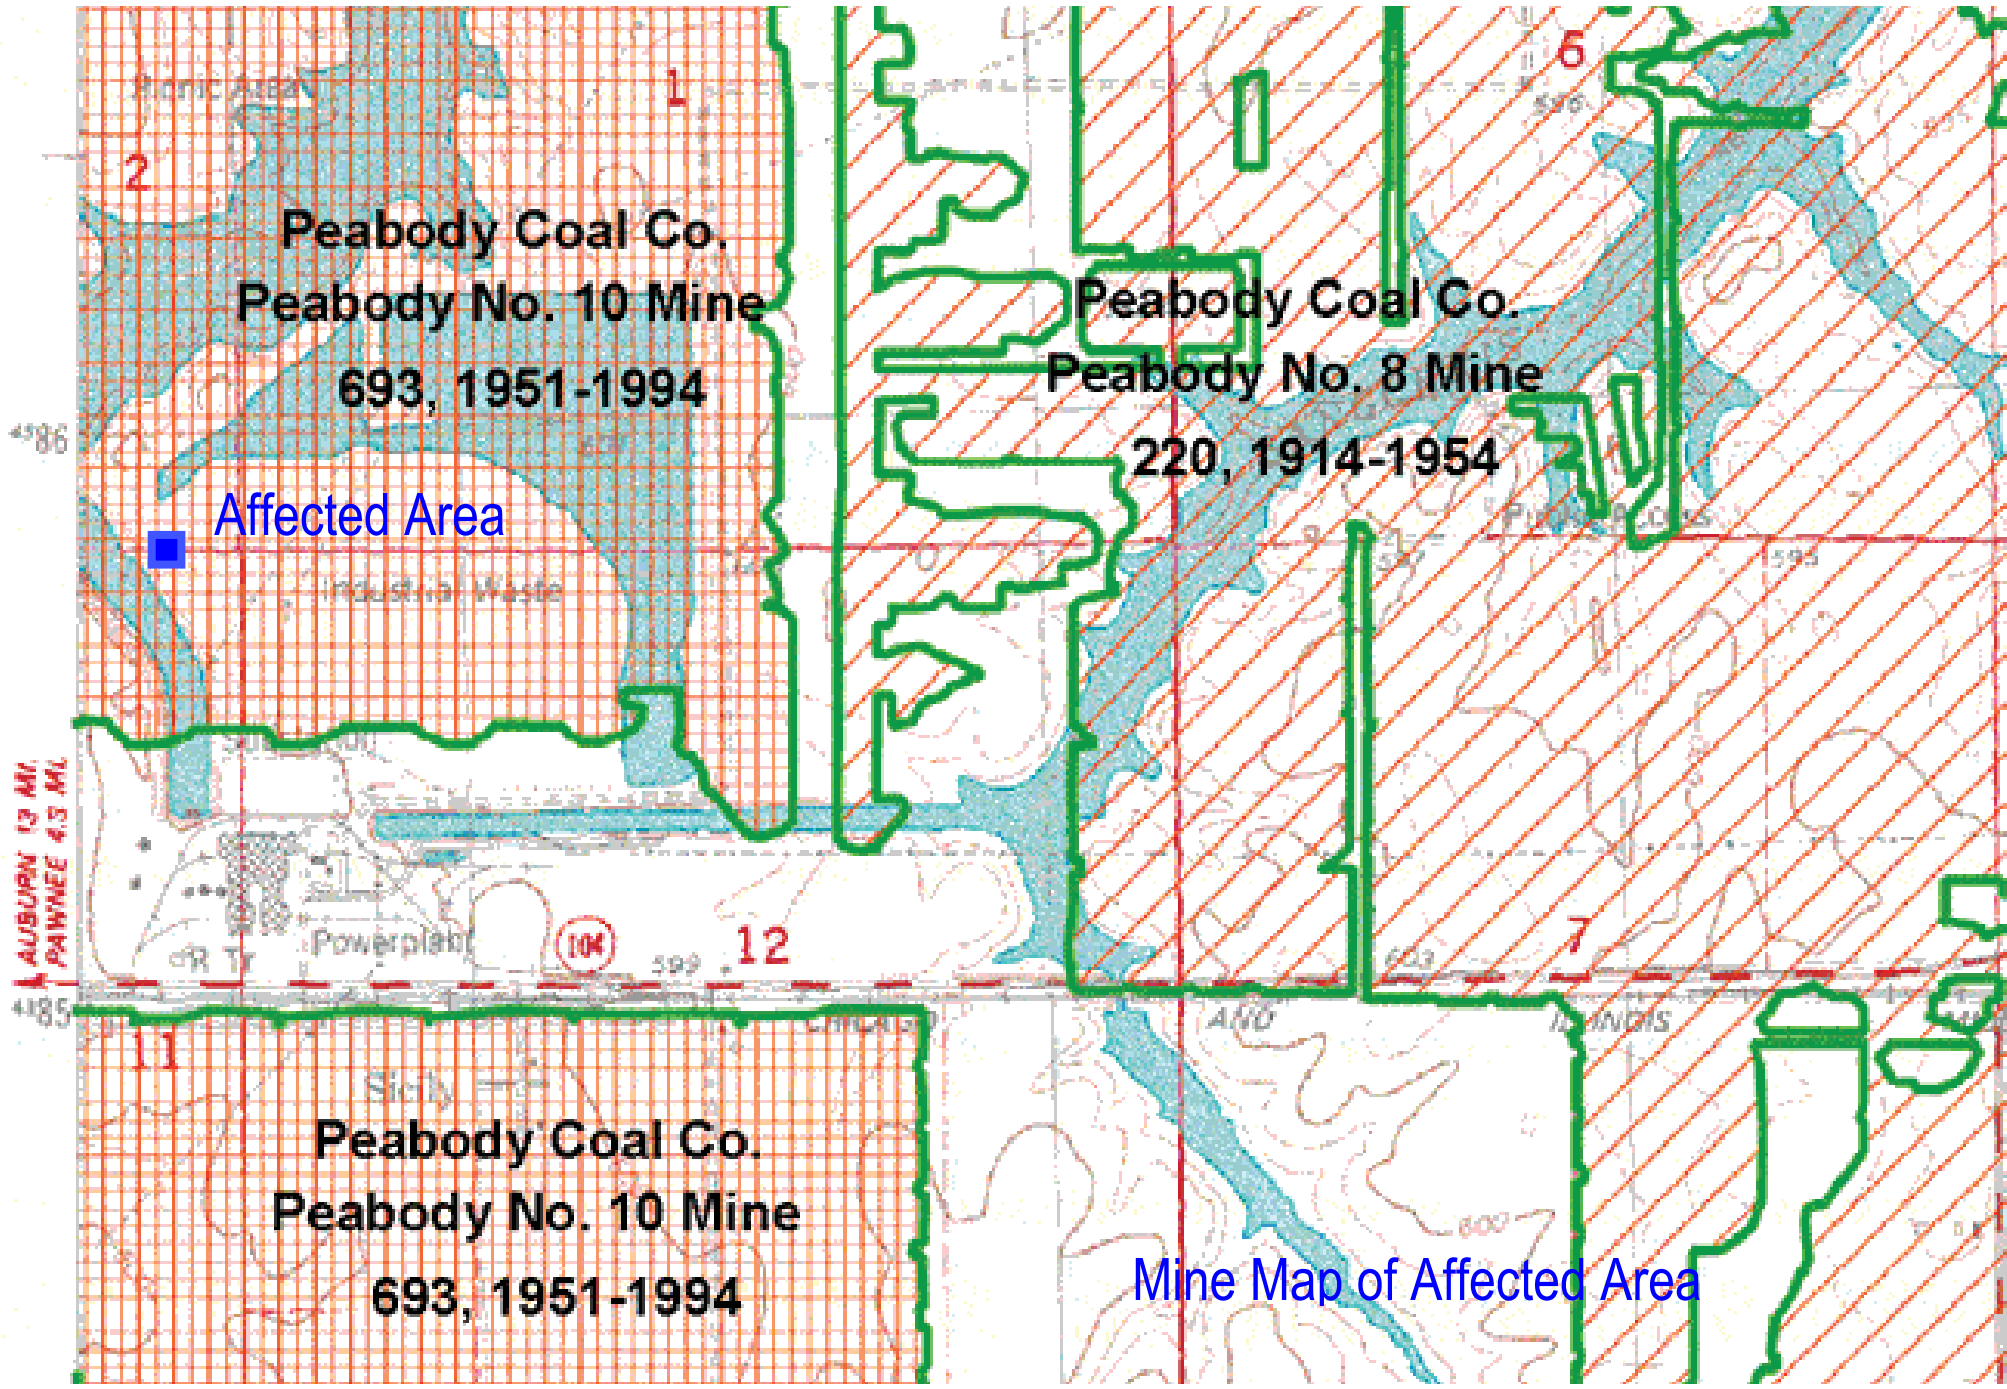
**Mine Map of Affected Area**

The surficial features at the southwest embankment of the ash pond appear to be related to mine subsidence of the Peabody No. 10 coal mine that was active between 1951 and 1994. The following points indicate data or observations to support this conclusion:

- The affected area is undermined according to the available map.
- There are no utilities or other underground structures within the affected area that could be a source of leakage and underground erosion.
- The tension cracking and surface heaving that was observed transverse to the embankment crest are consistent with a sag subsidence above room and pillar mining.

The Peabody No. 10 mine is listed as blind room and pillar mine. Between 40% and 70% of the coal is removed in this type of mining. The Herrin coal seam was mined at depths between 300 ft and 380 ft. The average thickness of the coal seam was between 6.5 ft and 7.5 ft in this mine and the maximum thickness was 13.0 ft. The coal was mined beneath the Anna Shale or a limestone roof. Generally 6 ft to 7 ft of the coal was removed.

Since injection of coal combustion byproduct (CCB) materials into the abandoned mine around the power station is currently part of the plant operation, it is recommended that CCB injection into areas beneath critical components of the power plant be given priority. Filling these areas would most likely result in greatly reduced, or eliminate future surface subsidence. Filling undermined areas that have already experienced subsidence may reduce or prevent additional subsidence.

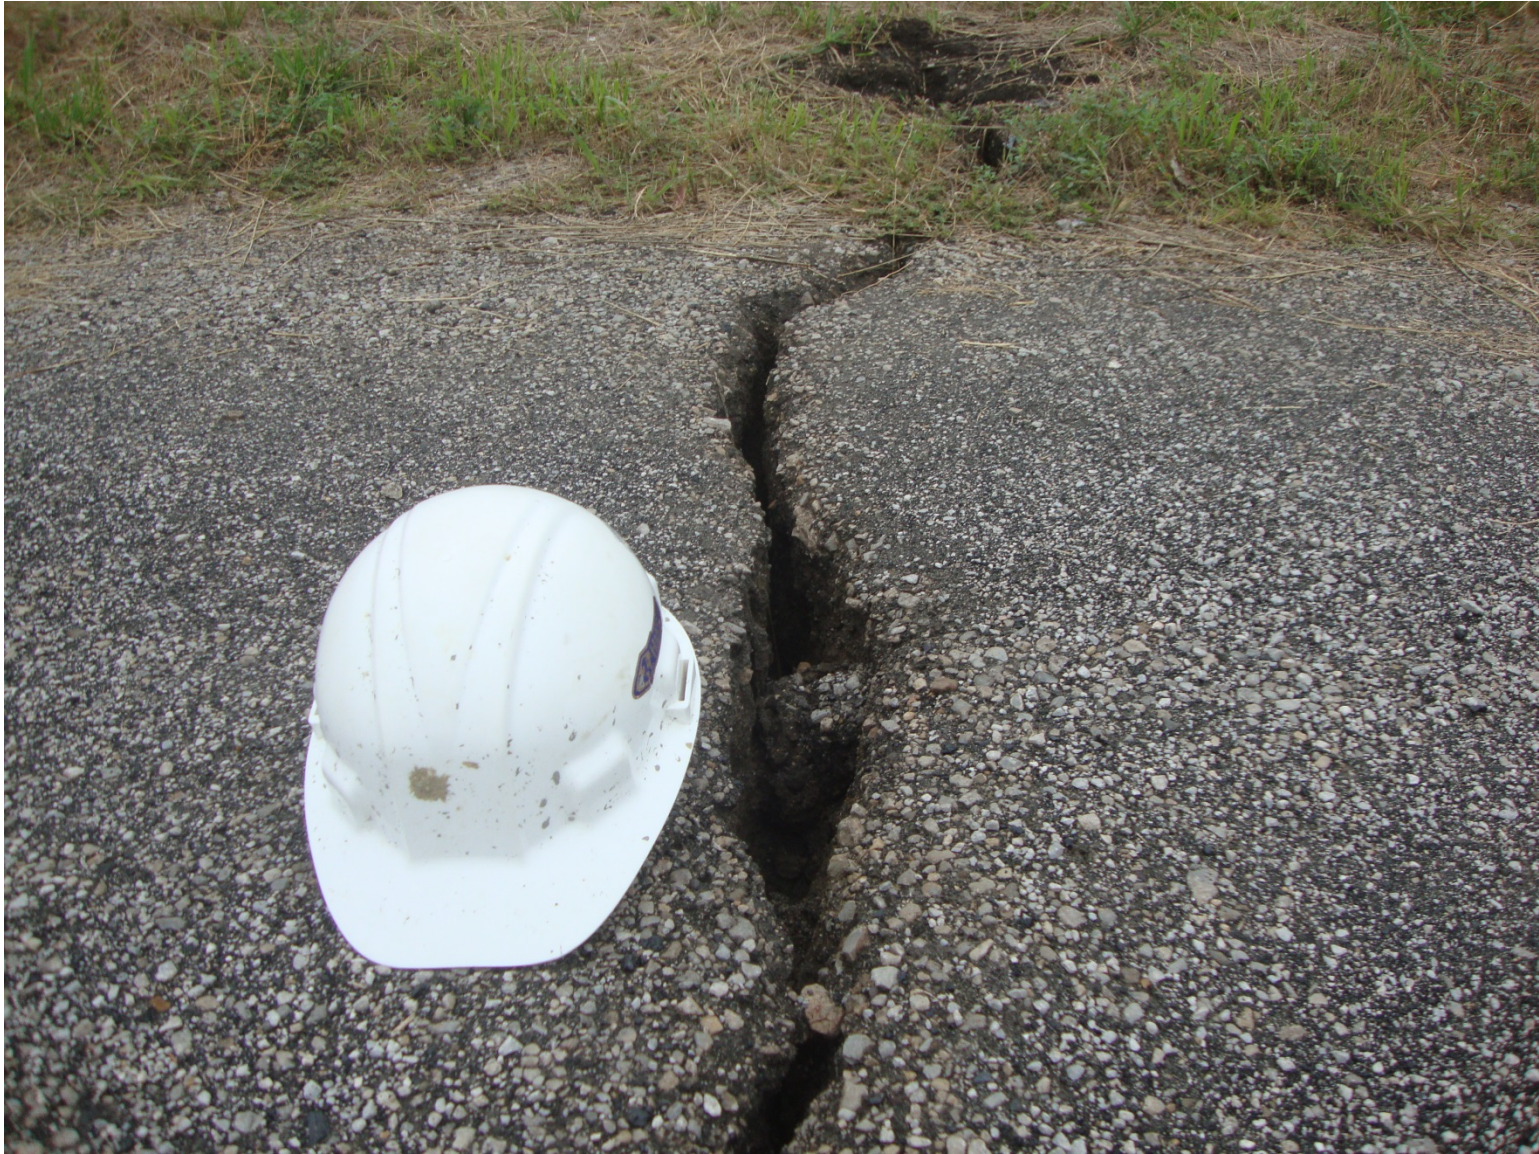
- Tension cracks cross the embankment perpendicular to the embankment crest. On the upstream side of the embankment where ash has been filled to the elevation of the crest, the tension cracks change direction slightly.

Tension cracking in embankment crest

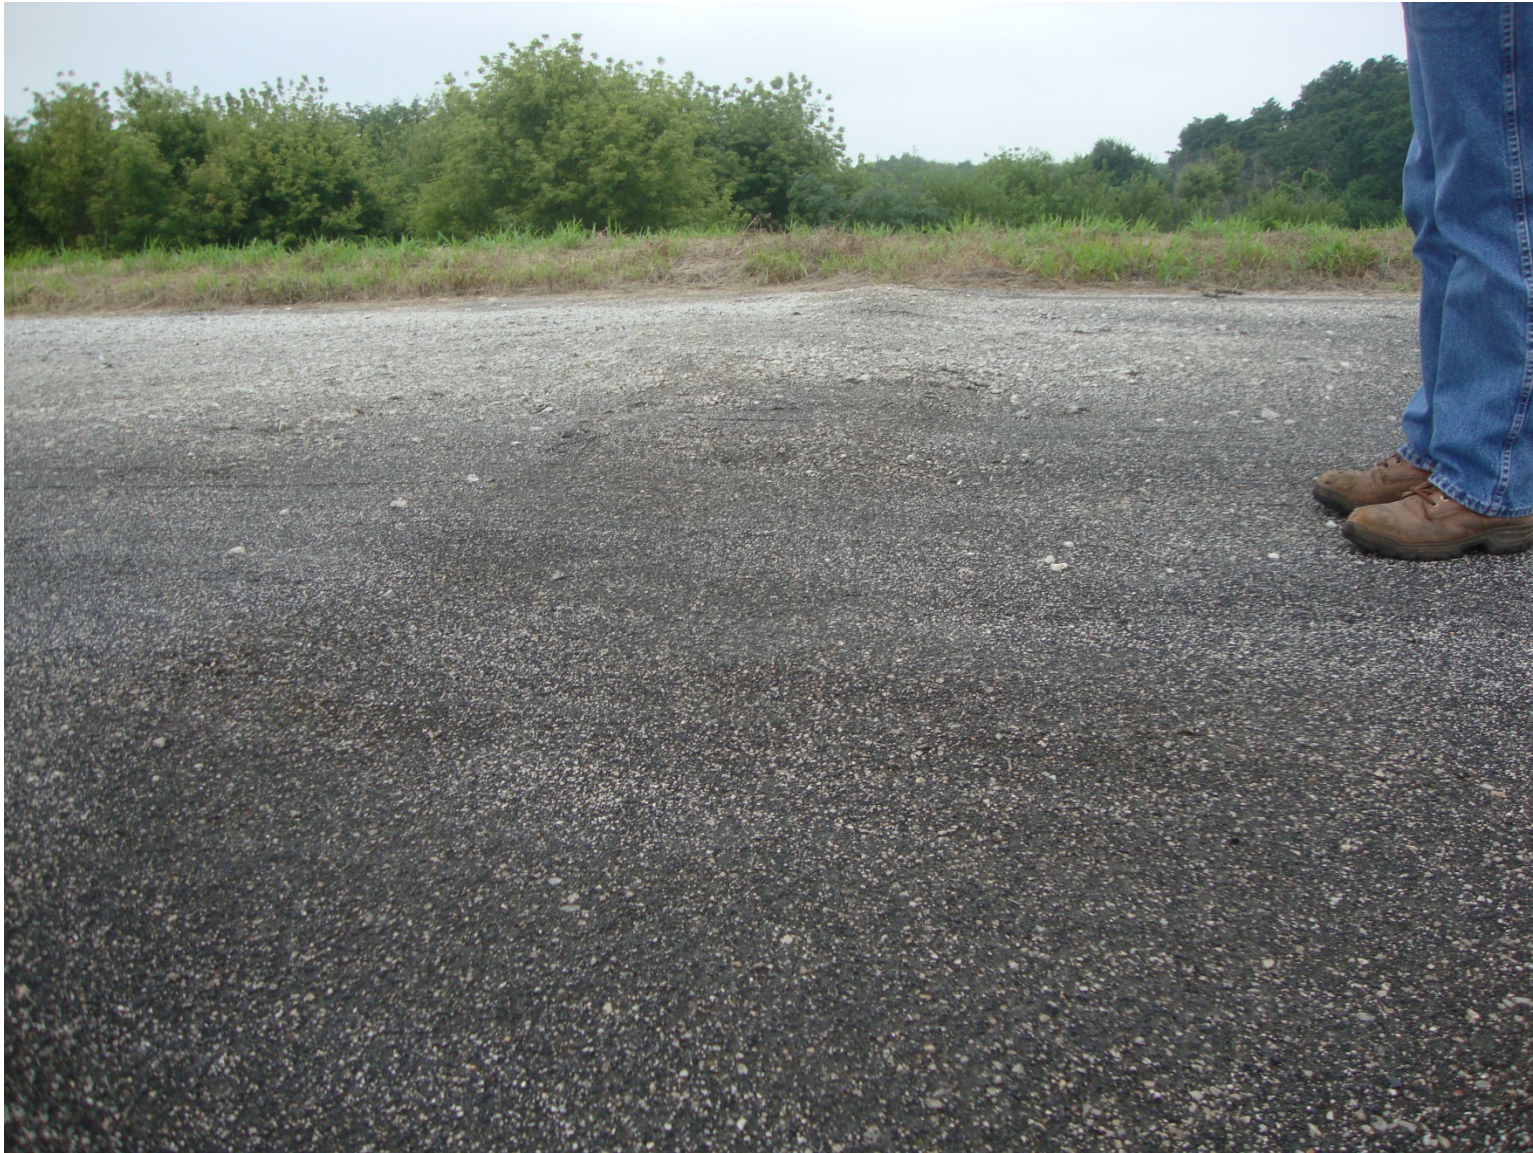
- Compression heaving of the ground surface was observed along two lines near the center of the affected area and the lines of heaving were separated by about 12 ft. Compression heaving only occurred in the low area of the depression.

Compression heaving in crest of embankment

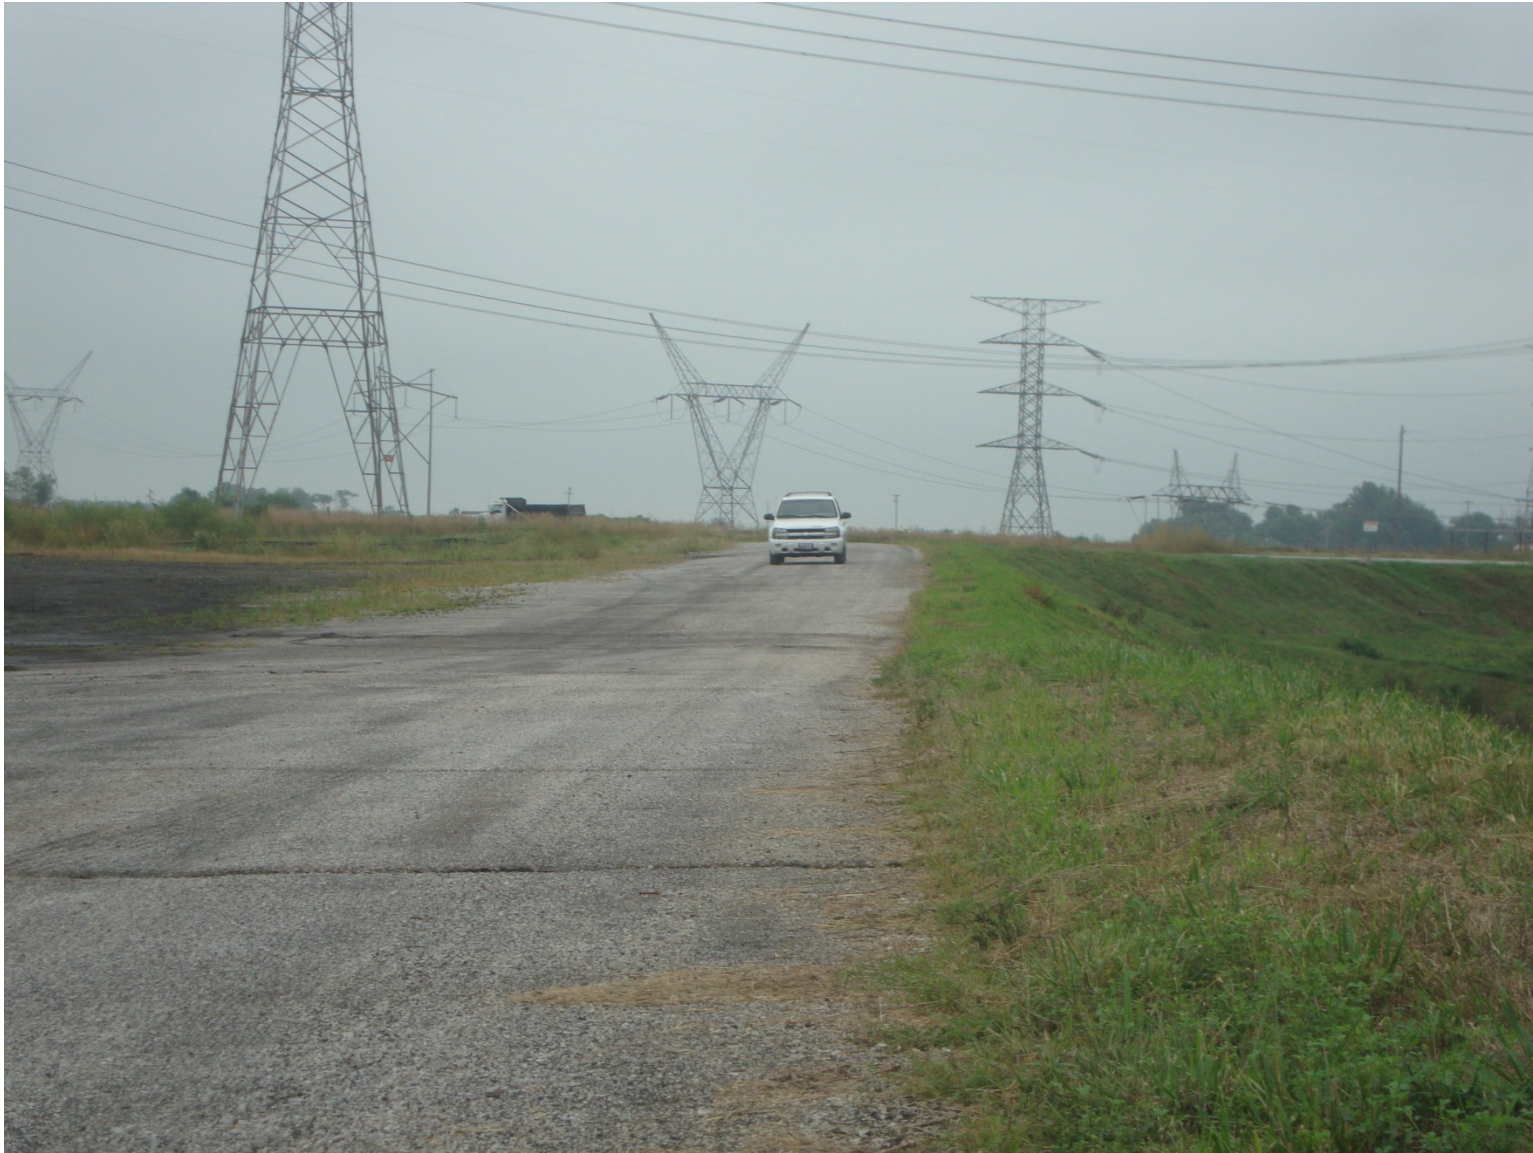
- Surface features within the affected area include tension cracks, compression heaving, and apparent settlement. There is no survey data showing that settlement has occurred, however the crest of the dam is approximately 2 ft lower in the affected area than the adjacent crest.

- The tension cracks were not visible more than 5 ft down the downstream slope of the embankment due to dense vegetative cover. A noticeable depression in the downstream slope was observed in the affected area.

Depression in embankment crest and downstream slope, tension cracks visible

Repair of the embankment does not appear to be necessary at this time because: there is no observed seepage or evidence of seepage in the embankment in this area, the depression in the embankment crest does detrimentally affect the freeboard of the impoundment, and the water detention within the impoundment is hundreds of feet from the affected embankment

This area should be observed daily for a week following the date of subsidence event and weekly thereafter for a period of 2 months. Noticeable additional cracking or settlement, seepage through the embankment, or wet areas near the toe of then embankment should be reported to Hanson immediately.
