# Office Memorandum

**Subject:** Ash Pond Structural Stability Assessment  
Kincaid Generation, LLC  
Kincaid Power Station

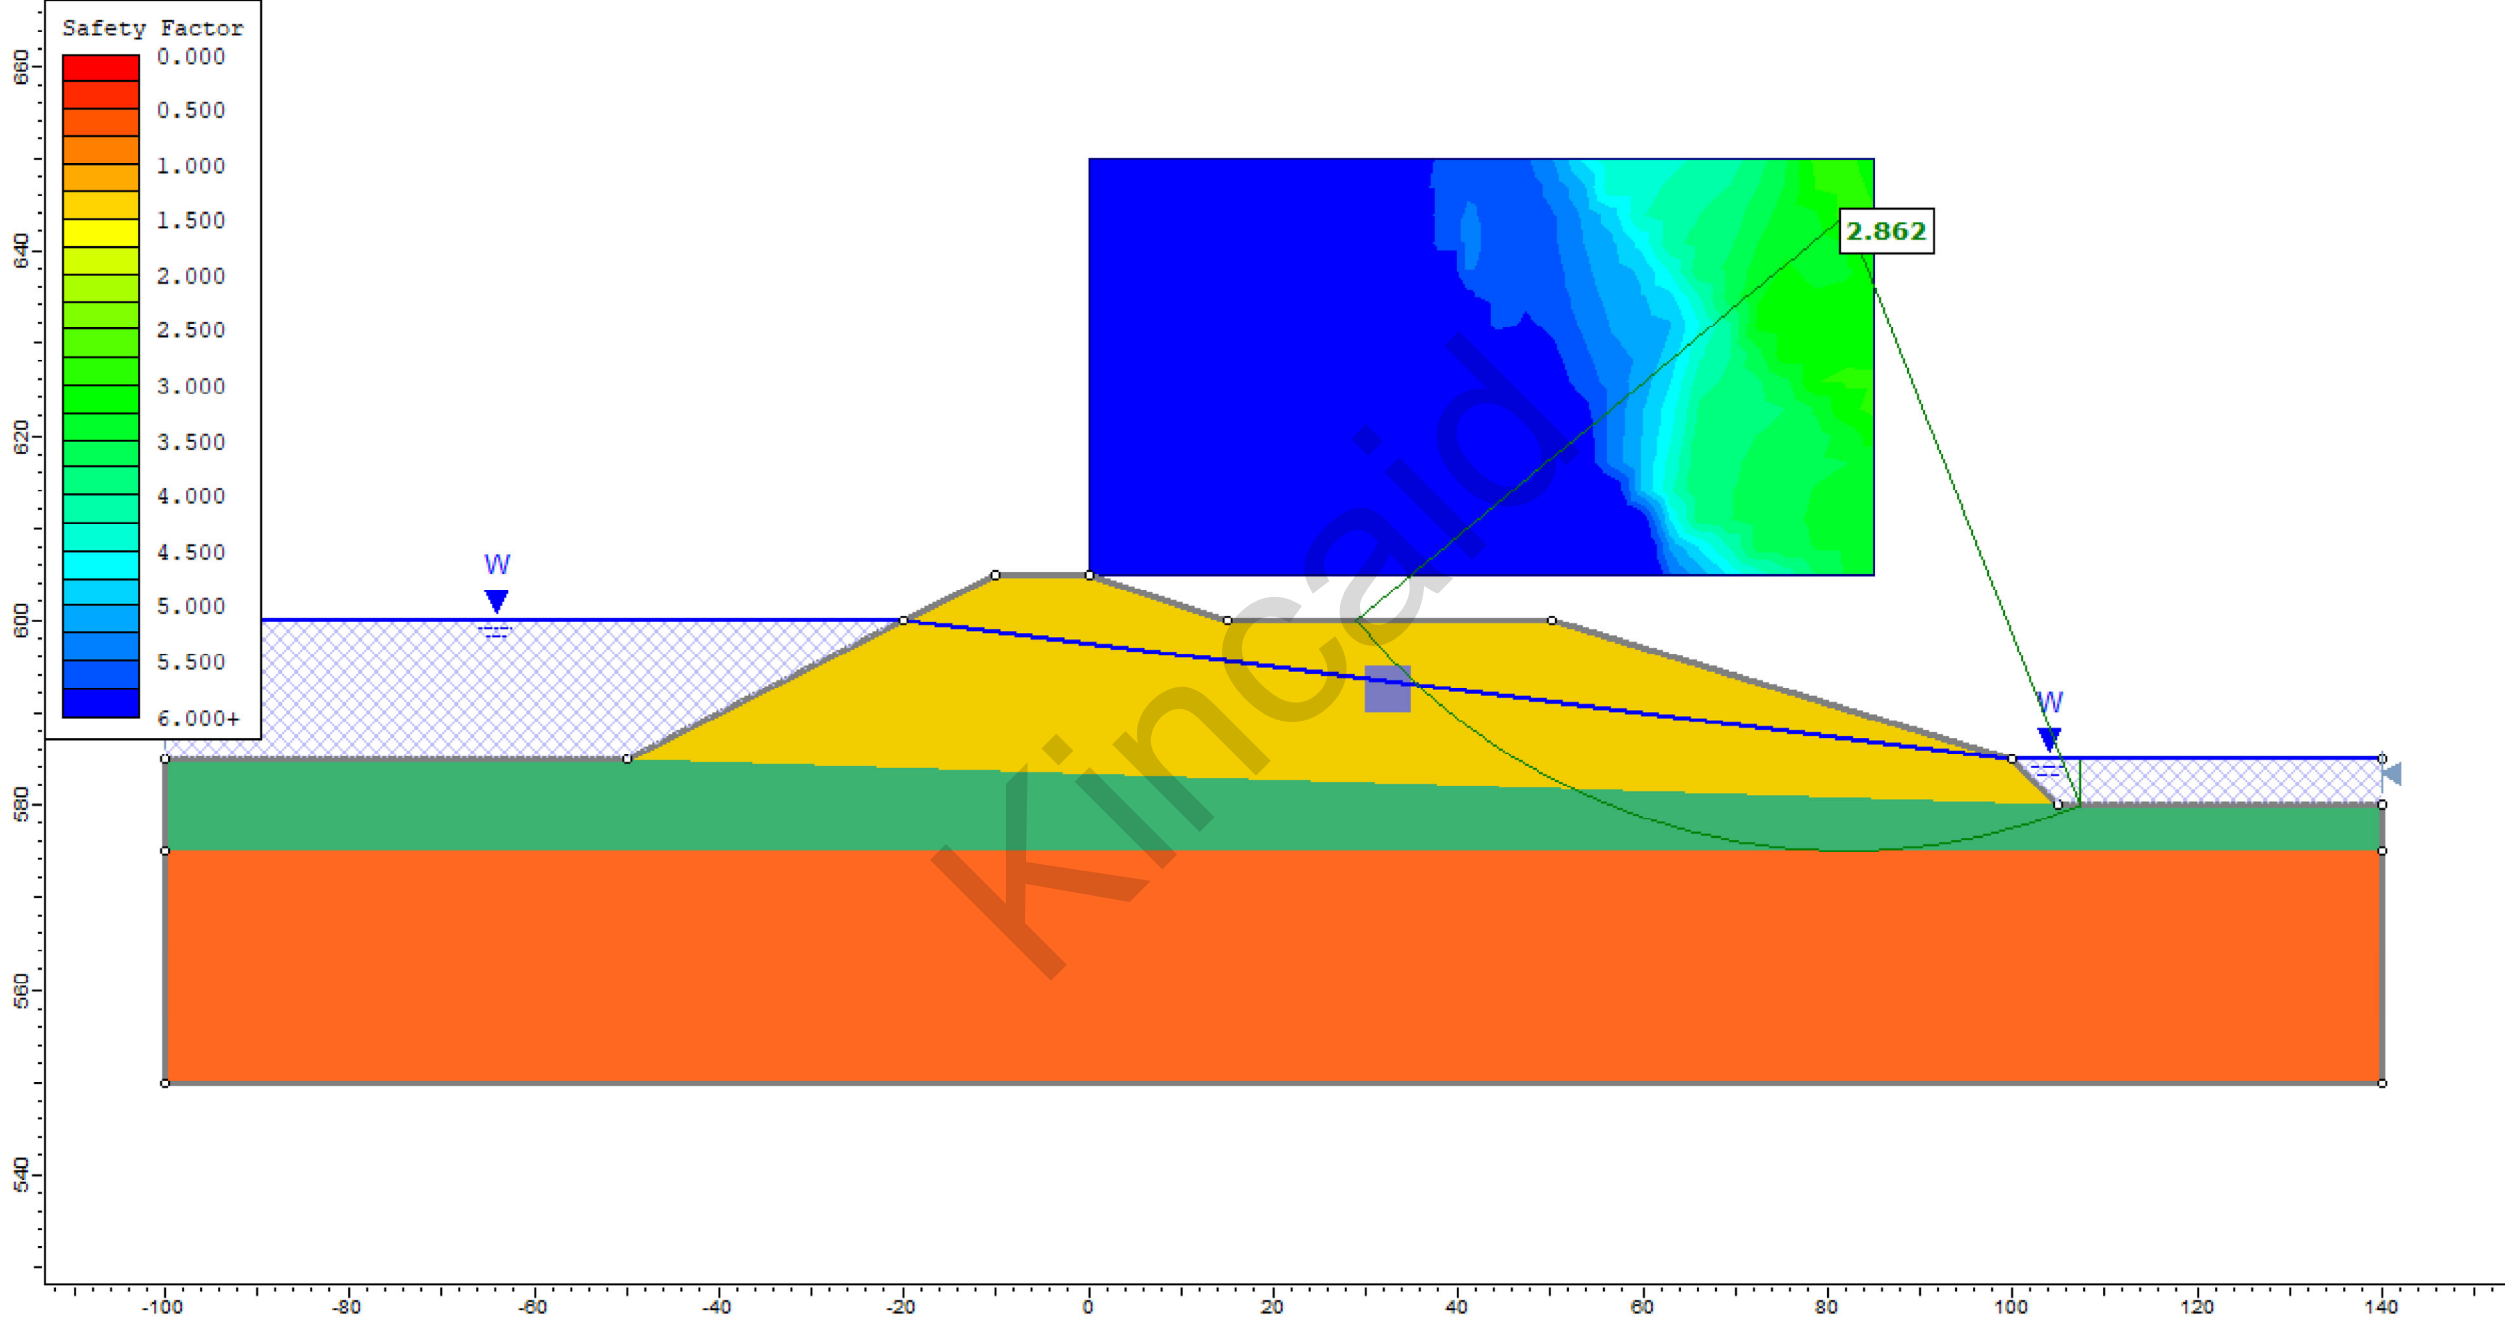
FIGURE 2

- § 257.73(e)(1)(ii), Maximum surcharge pool safety factor must be at least 1.40. Figure 2 provides the graphic results of the analysis. The calculated safety factor is 2.04.

§257.73(e)(1)(II) Maximum Surcharge Pool Safety Factor must be at least 1.4

- Square in embankment represents the 60-inch diameter pipe - in failure - no strength
- Short term undrained strengths were used in this analysis

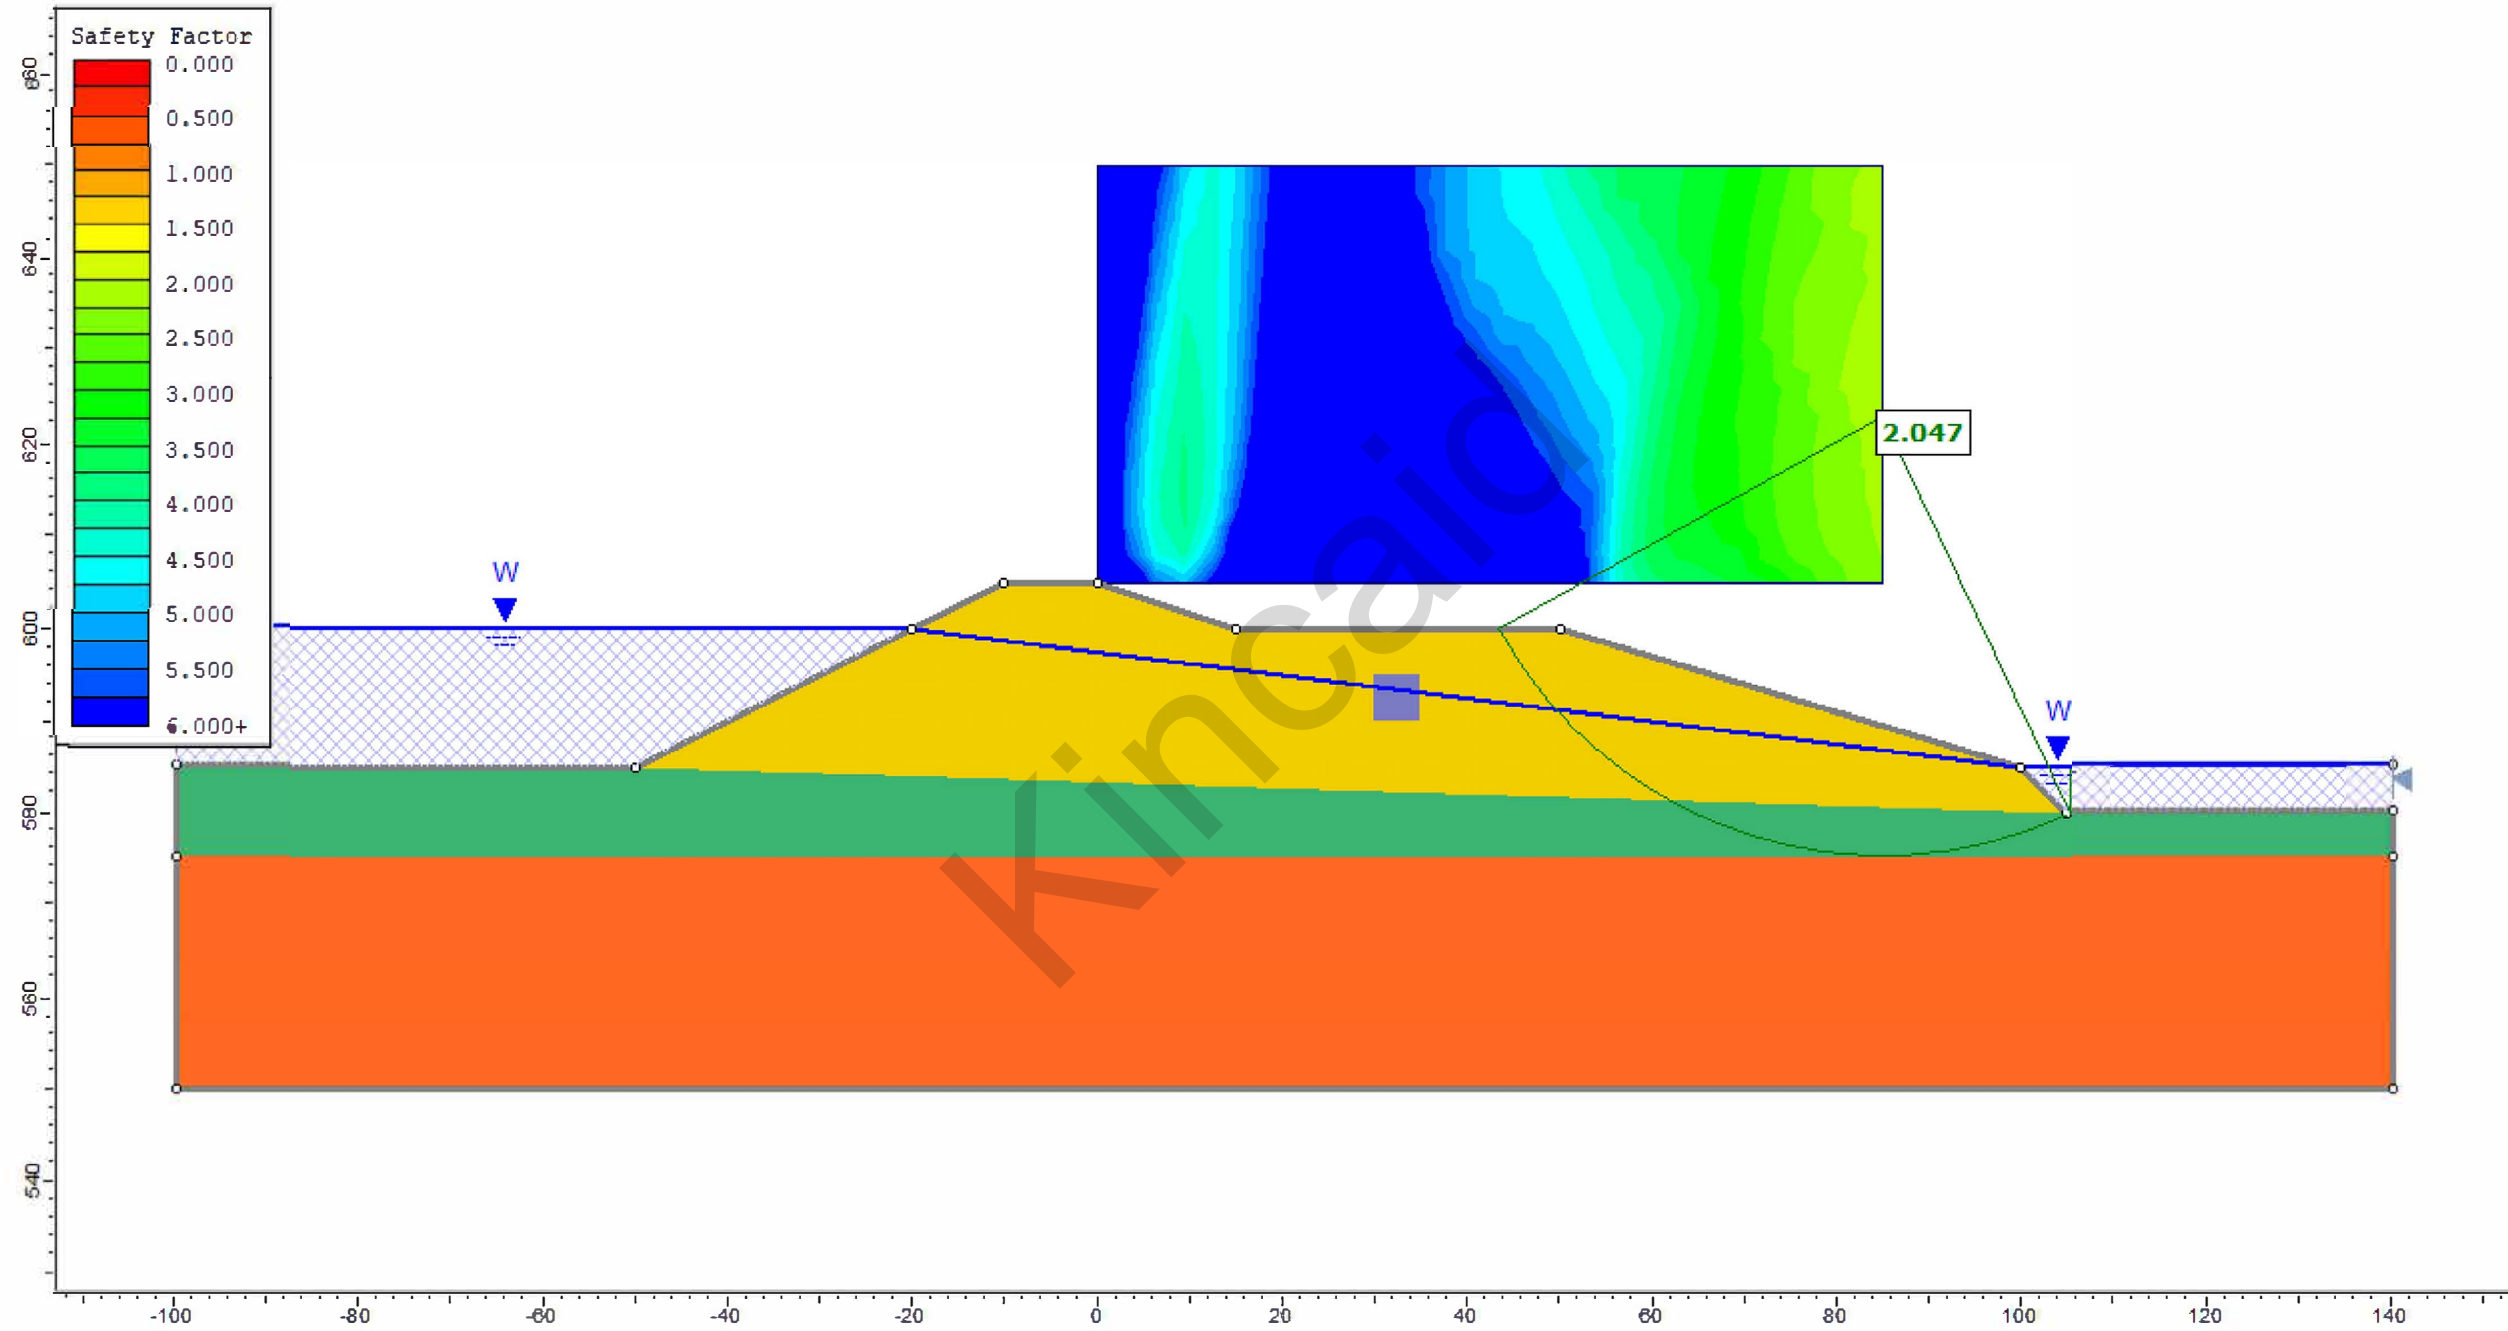
**FIGURE 3**

- § 257.73(e)(1)(iii), Seismic safety factor must be at least 1.00, Figures 3 and 3A provide the graphic results of the analysis. The calculated safety factor is greater than 1.00 as shown in Figure 3 and the soils do not sustain perceptible movement according to the results shown in Figure 3A.

**257.73(e)(1)(III) Seismic Safety Factor must be at least 1.0**

- Square in embankment represents the 60-inch diameter pipe - in failure - no strength
- The horizontal acceleration from certification report is 0.07
- This analysis finds the lowest horizontal acceleration for a safety factor 1.0
- Lowest horizontal acceleration = 0.204 < 0.07, therefore embankment meets rule

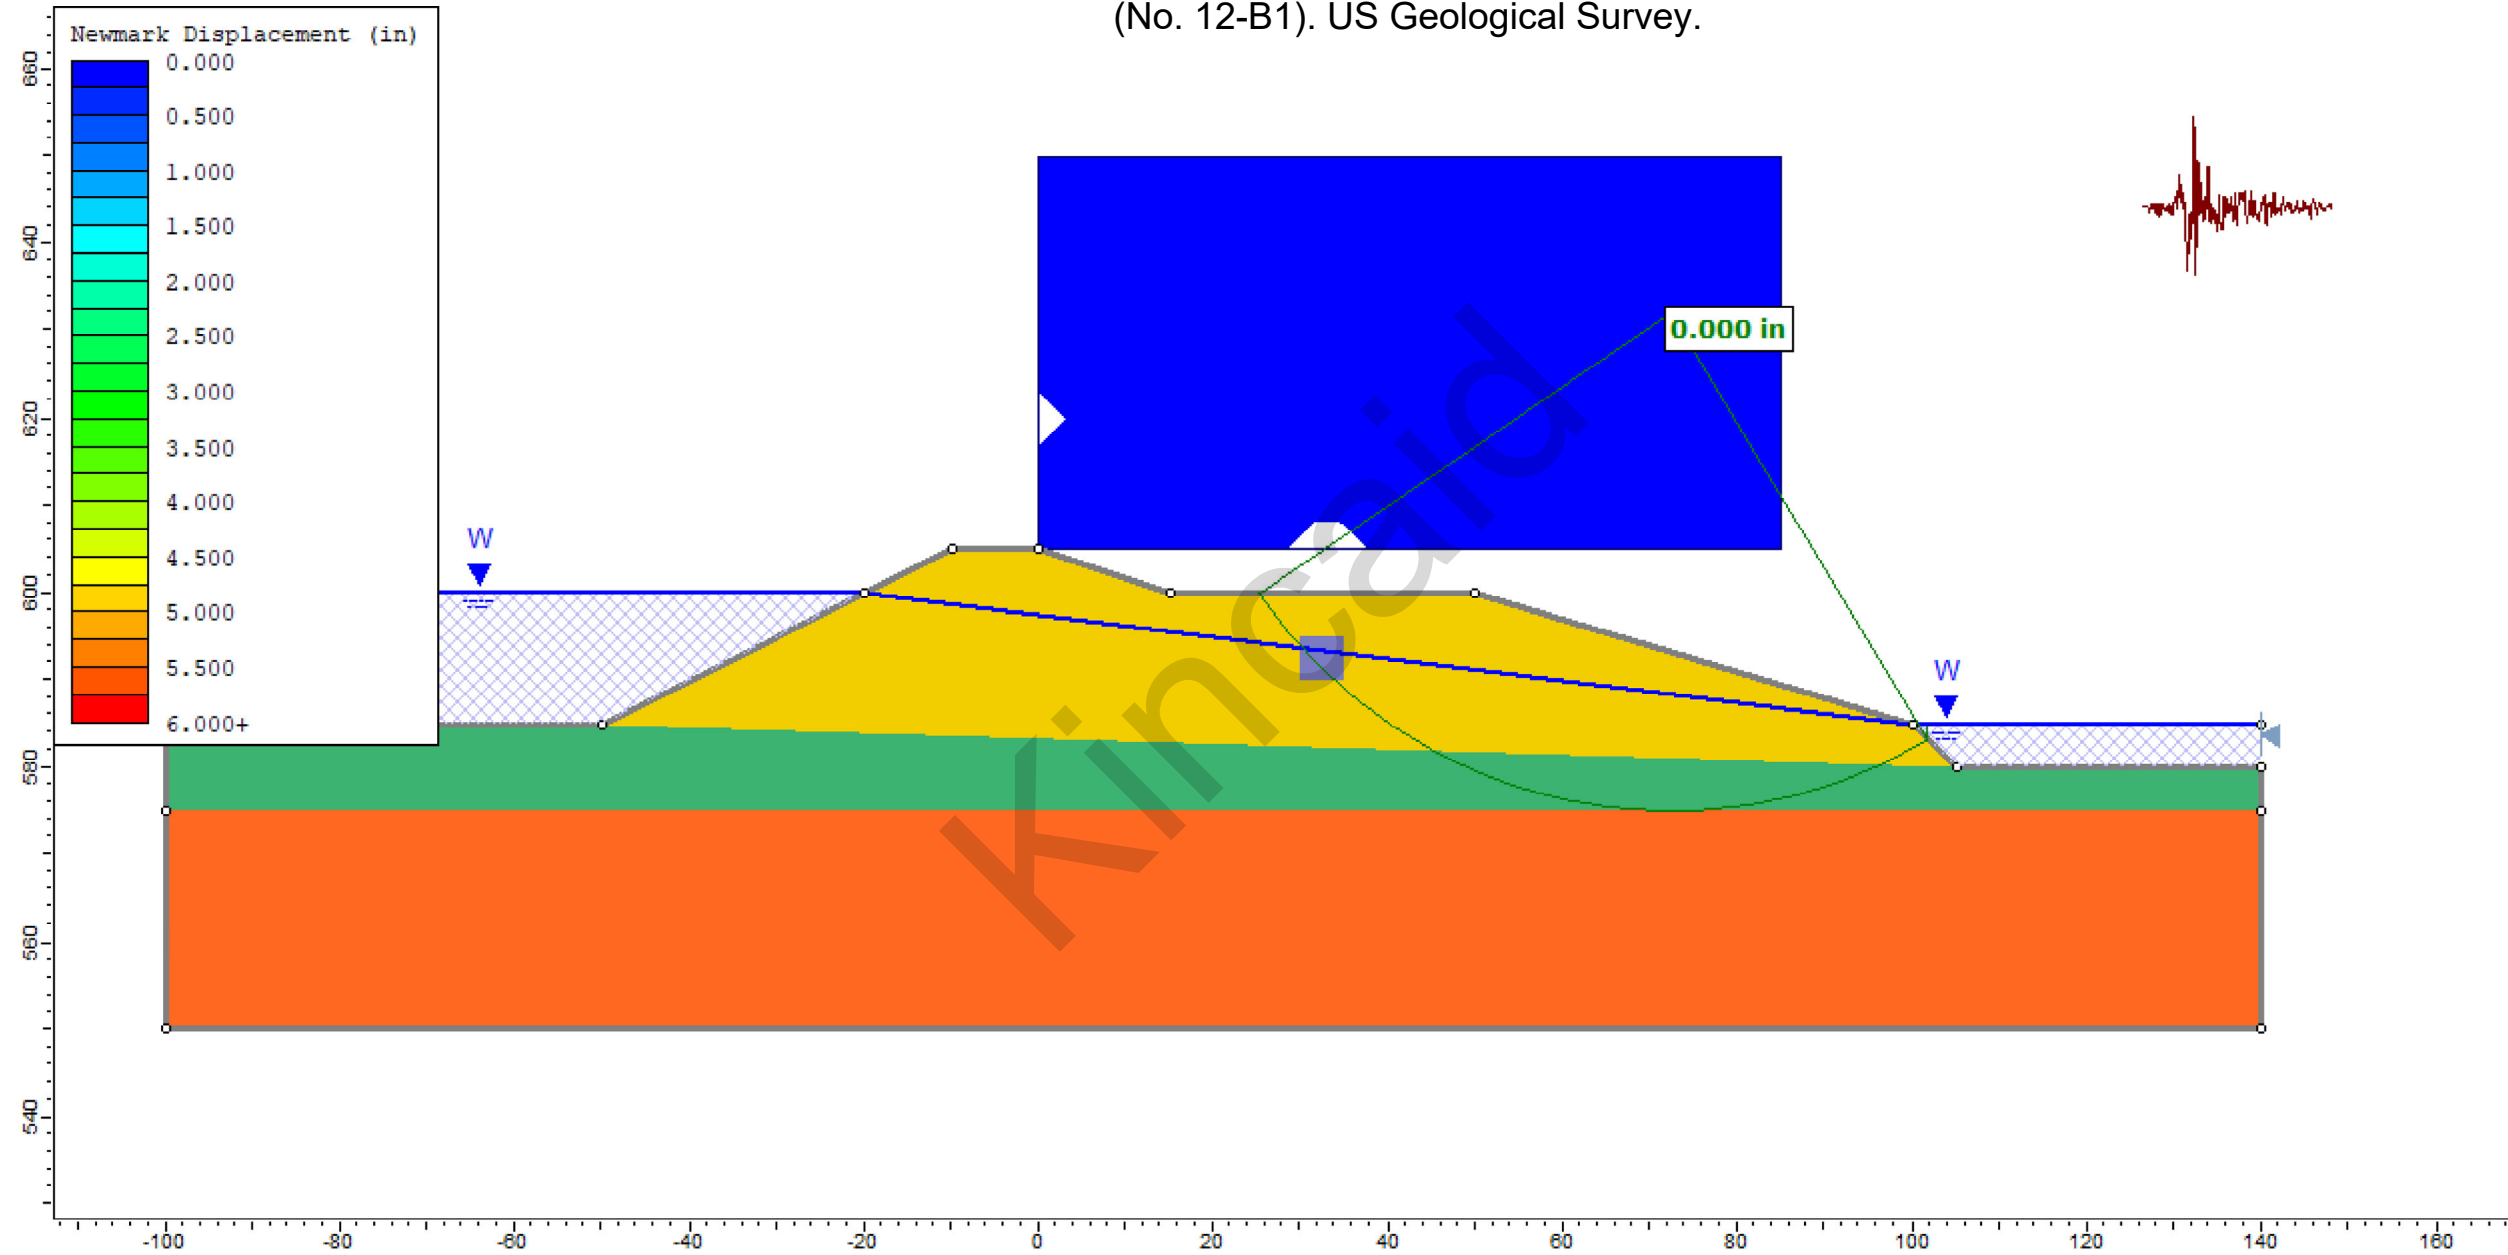
**FIGURE 3A**

- The analysis of the movement shown in Figure 3A is to determine the integrity of the pipe should earthquake movement occur at the outlet.
  - The design earthquake parameters were taken from the results of the Probabilistic Seismic Hazard Analysis (PSHA) from the 2016 AECOM report.

- The analysis of Figure 3A is based on the state of the practice method by Jibson, et.al. (Jibson, R.W., Rathje, E.M., Jibson, M.W. and Lee, Y.W., 2013. *SLAMMER: Seismic landslide movement modeled using earthquake records* (No. 12-B1). US Geological Survey).

**§257.73(e)(1)(III) Seismic Safety Factor must be at least 1.0**

- Square in embankment represents the 60-inch diameter pipe - in failure - no strength
- This analysis shows the displacement from the modeled earthquake in the PSHA from the certification report
- Reference: Jibson, R.W., Rathje, E.M., Jibson, M.W. and Lee, Y.W., 2013. SLAMMER: Seismic landslide movement modeled using earthquake records (No. 12-B1). US Geological Survey.

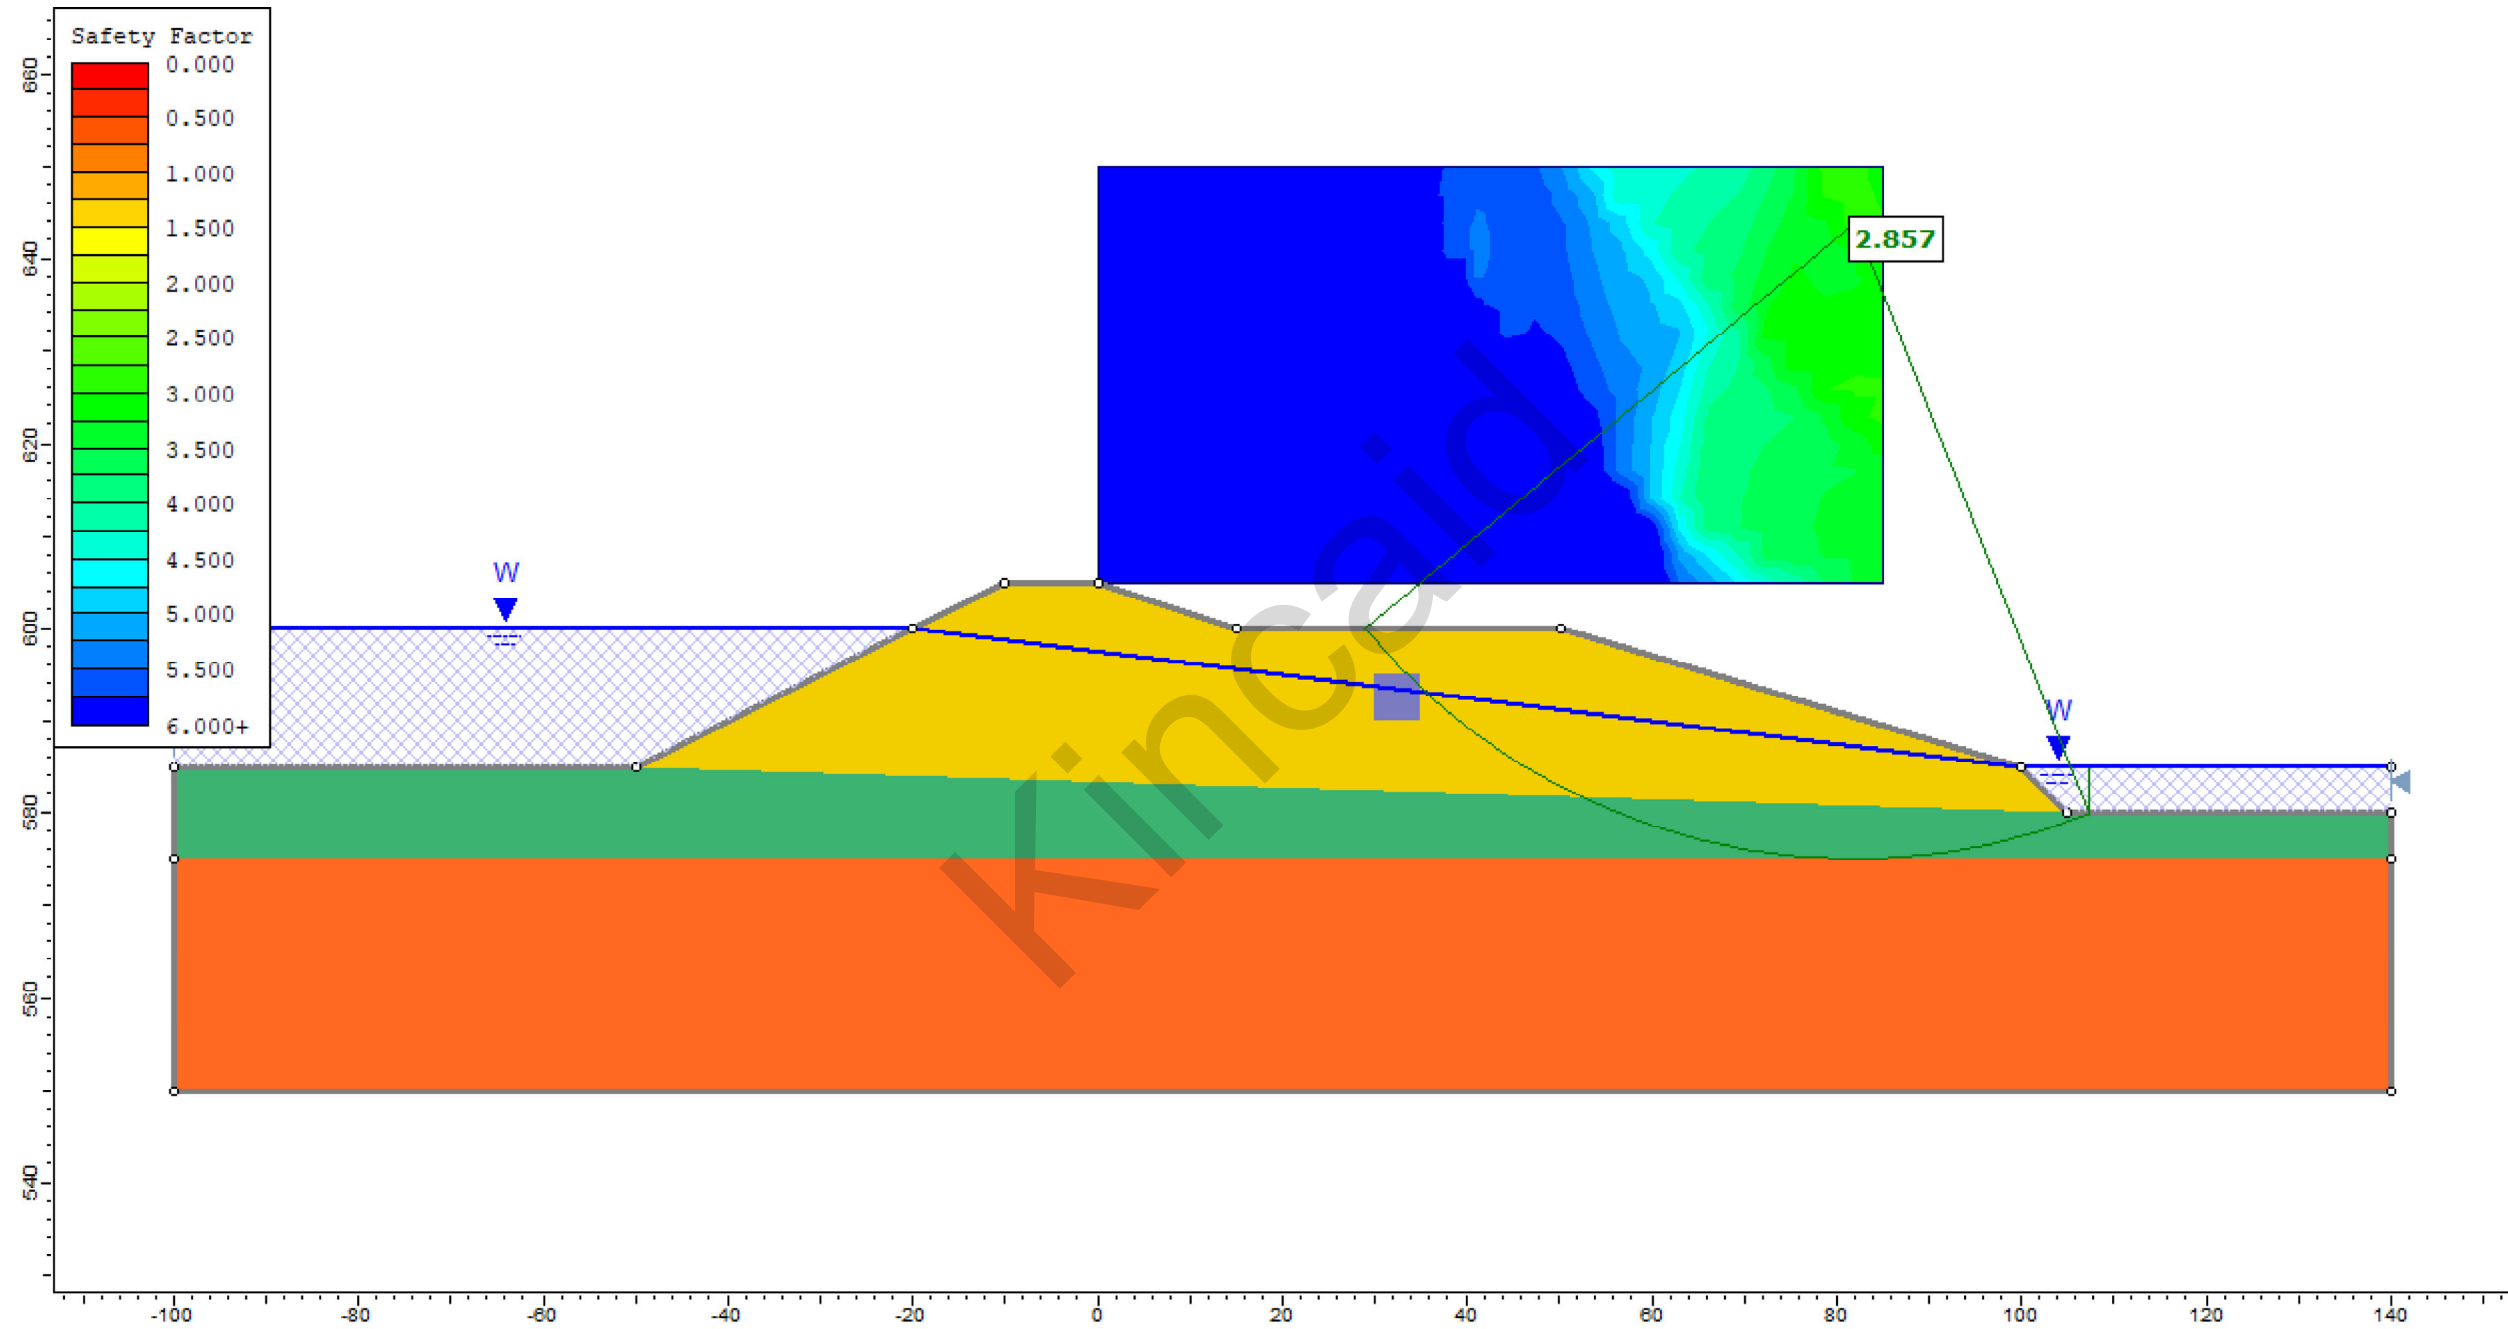
**FIGURE 4**

- § 257.73(e)(1)(iv) For dikes constructed of soils that have susceptibility to liquefaction safety factor must be at least 1.20. The soils are not susceptible to liquefaction, and the results of the analysis have a calculated safety factor of 2.83.

**§257.73(e)(1)(IV) For dikes constructed of soils that have susceptibility to liquefaction safety factor must be at least 1.2**

- Square in embankment represents the 60-inch diameter pipe - in failure - no strength
- The soils immediately below embankment were shown in certification report to be susceptible to earthquake or strain softening
- This analyses slope with strain softened strengths
