**2021 USEPA CCR RULE OPERATING
RECORD PERIODIC CERTIFICATION
REPORT
§257.73(a)(2)-(3), (c), (d¹), (e) and §257.82
MIAMI FORT POND SYSTEM
Miami Fort Power Plant
North Bend, Ohio**

Miami Fort Power Company, LLC

October 11, 2021

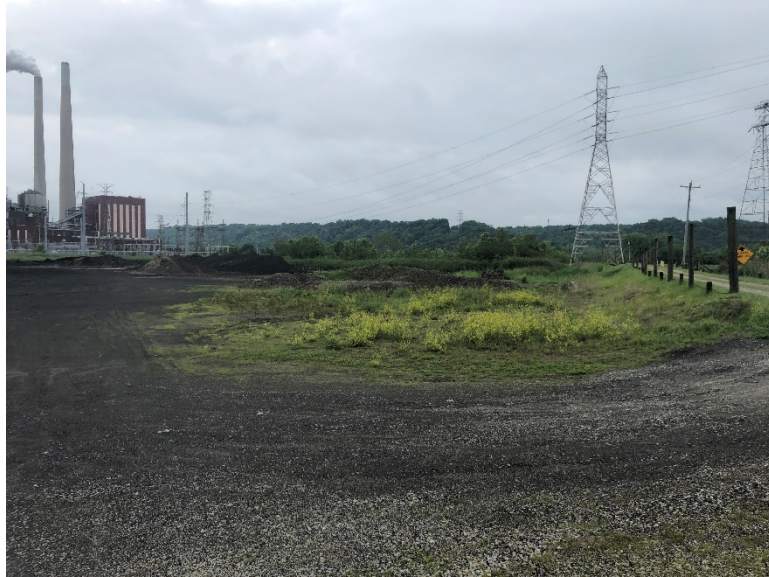
Photo: 02

Comments:
Photo of the filled
in portion of the
former Basin A.
Some vegetative
growth, no trees.
No erosion noted.

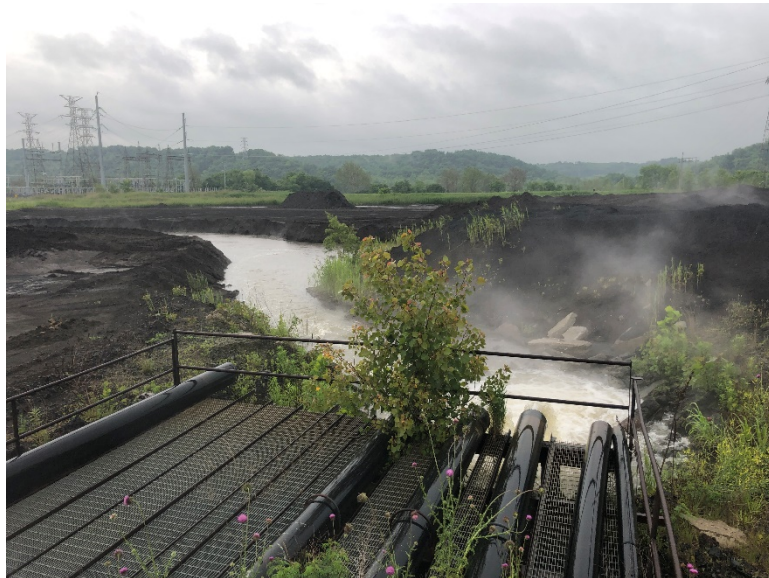
Comments:
Sluiced discharge
along the northern
side of former
Basin A. Discharge
channel and sluiced
ash flow to the
east.

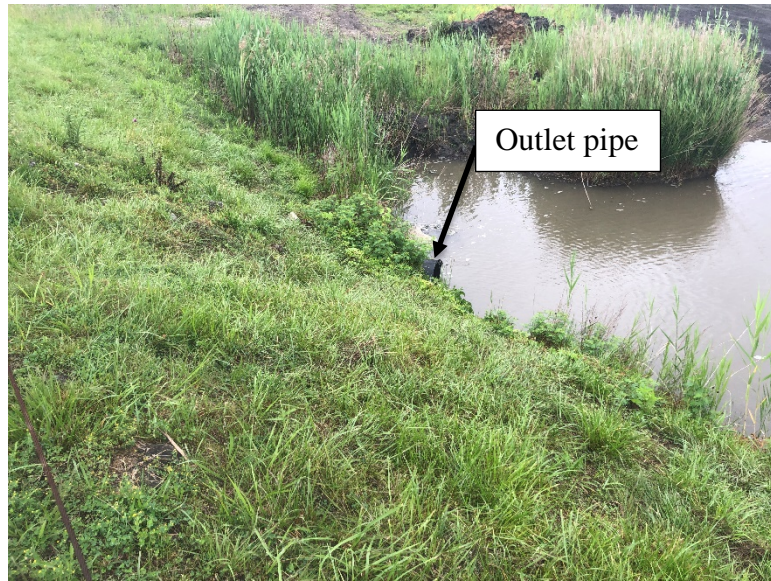
Comments:
Outlet pipe from former Basin A to former Basin B. Outlet pipe is unobstructed.

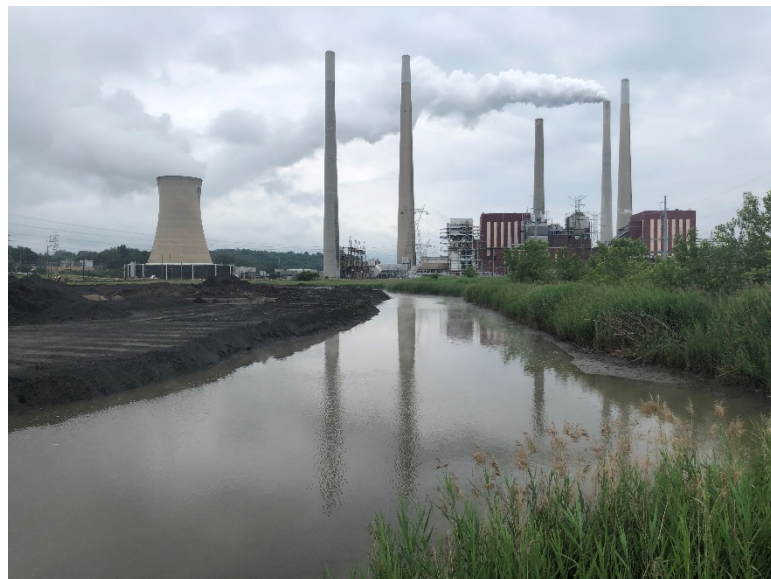
Photo: 04

Comments:
Discharge channel in Former Basin A. Phragmite and small tree growth observed along the internal separation dike within Former Basin A.

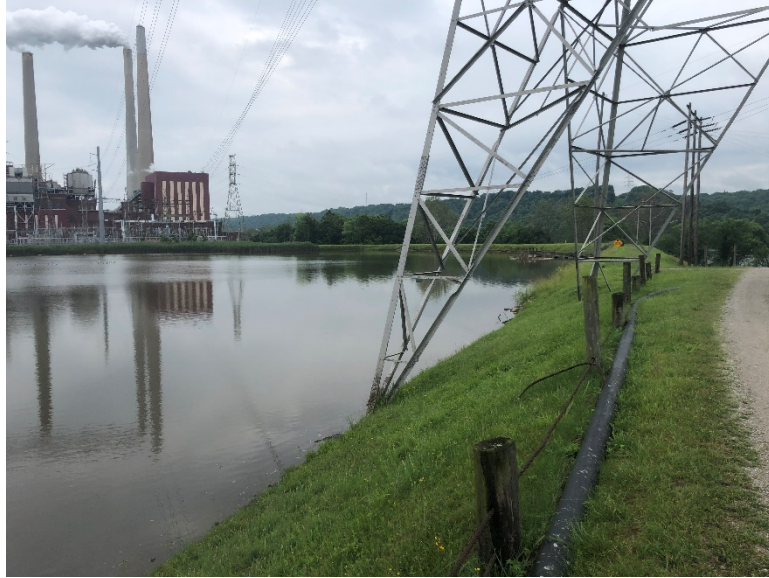
Comments:
Good vegetative cover and no signs of erosion along upstream side of the western dike for Former Basin A. No observed structural integrity issues along dike crest.

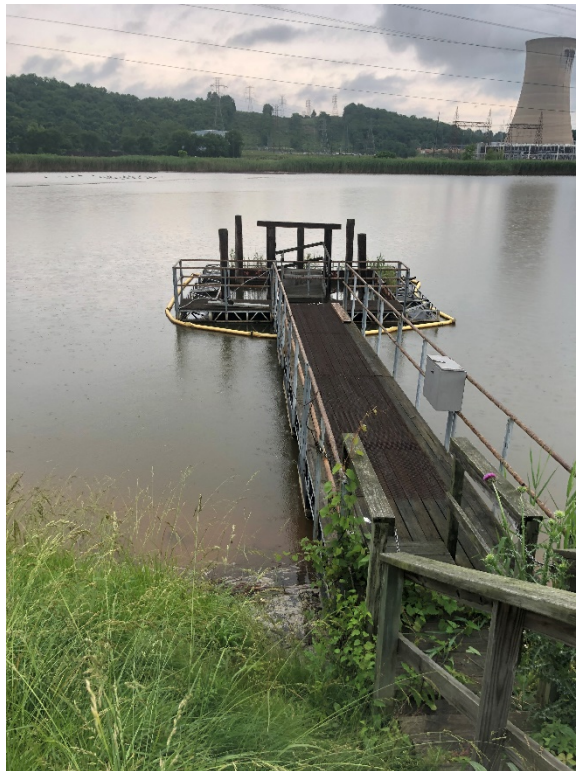
Photo: 06

Comments:
Outlet structure from Former Basin A, in good condition, generally not operable.

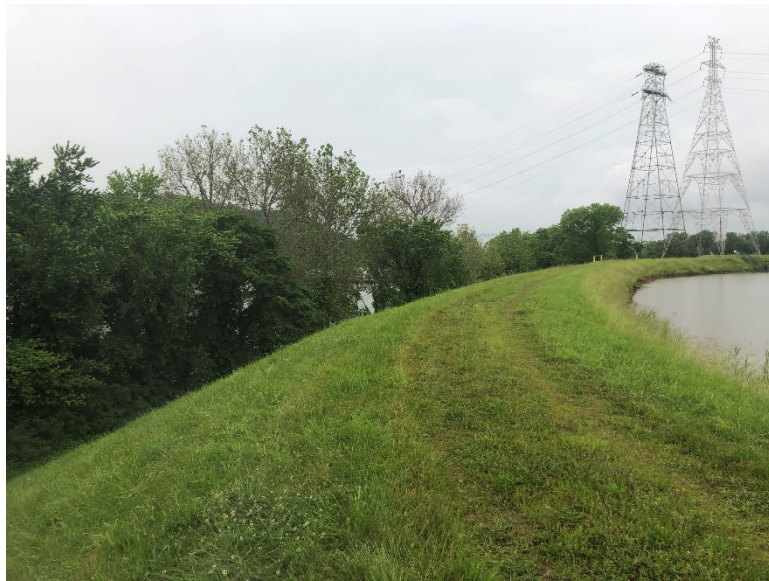
Comments:
Downstream slope of the southern dike for Former Basin A. Good vegetative cover, no signs of erosion, no signs of instability along dike crest.

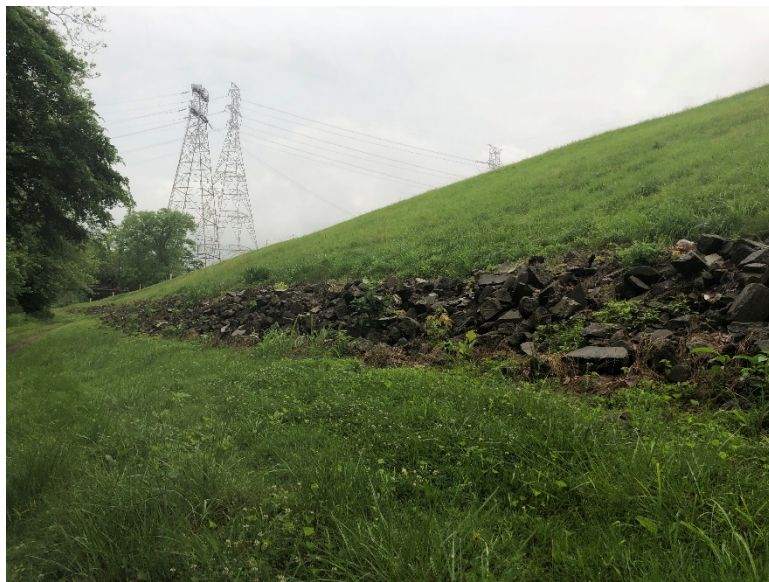
Photo: 08

Comments:
Recycled concrete toe armoring along the downstream toe of the southern Former Basin A dike. No signs of rapid draw related damage. Good vegetative cover observed along the dike slope.

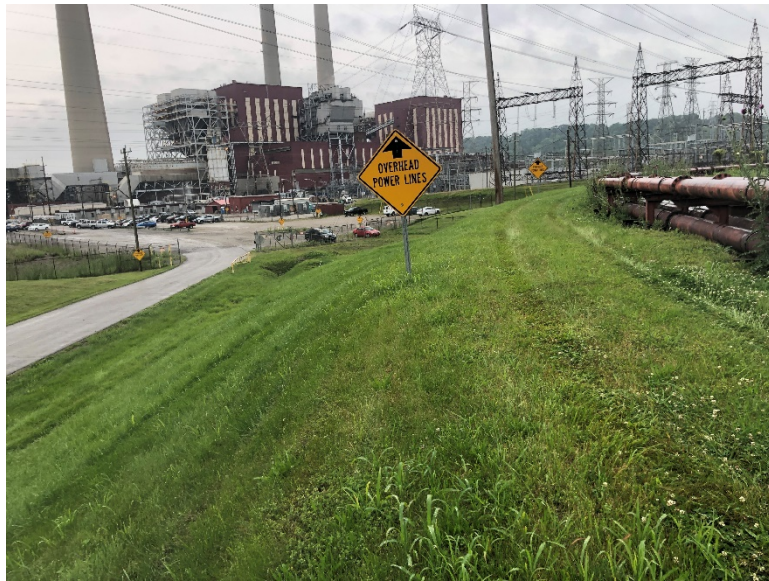
Comments:
Downstream slope of the northeastern corner of the Former Basin A dike. Good vegetative cover, no signs of erosion, no signs of instability along dike crest.

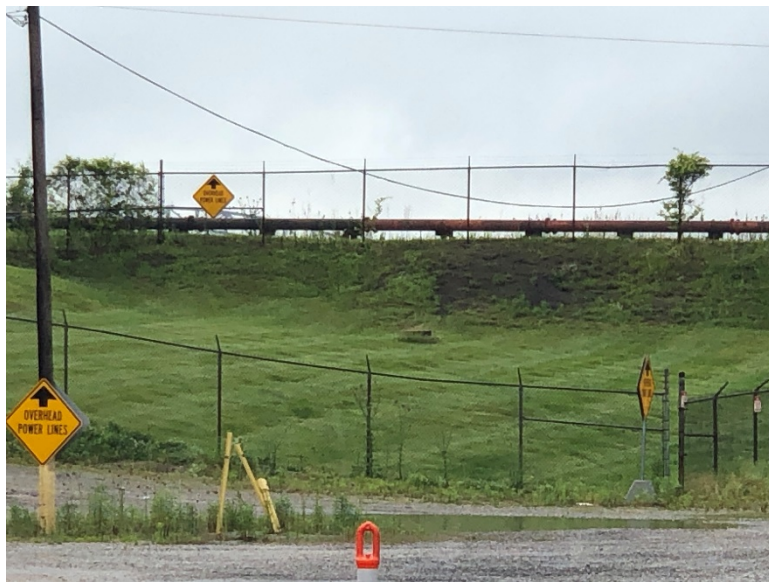
Photo: 10

Comments:
Downstream slope of the eastern dike of the Former A Basin. Some poor vegetative cover observed. Geosyntec recommended area be vegetated as part of regular maintenance.

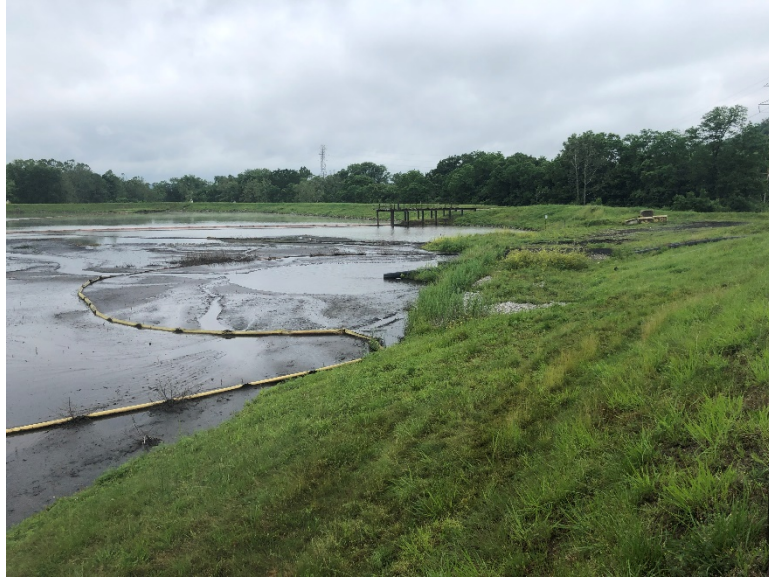
Comments:
Upstream slopes of the western and northern dikes for Former Basin B. Good vegetative cover and no signs of erosion of the dike slopes.

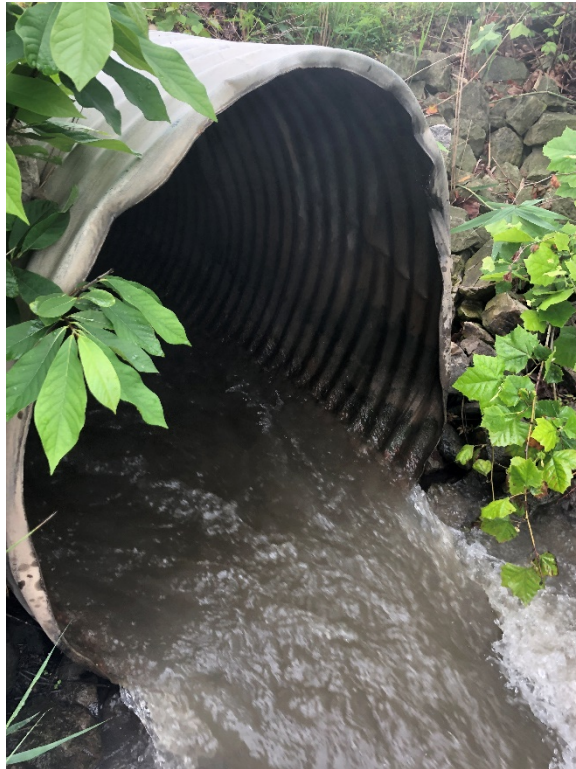
Photo: 12

Comments:
Discharge pipe from Former Basin A to Former Basin B. The pipe is unobstructed and appears to be in good condition at the point of discharge.

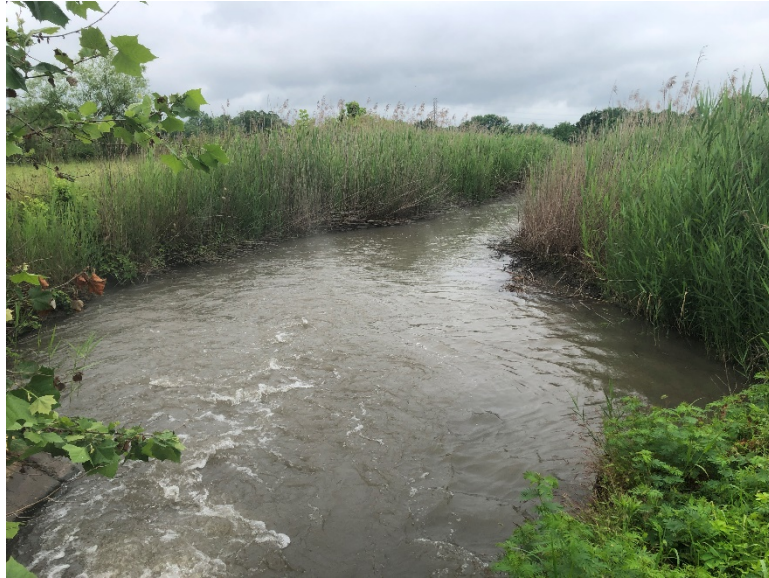
Comments:
Discharge channel
in Former Basin B.
Some phragmite
growth along the
channel.

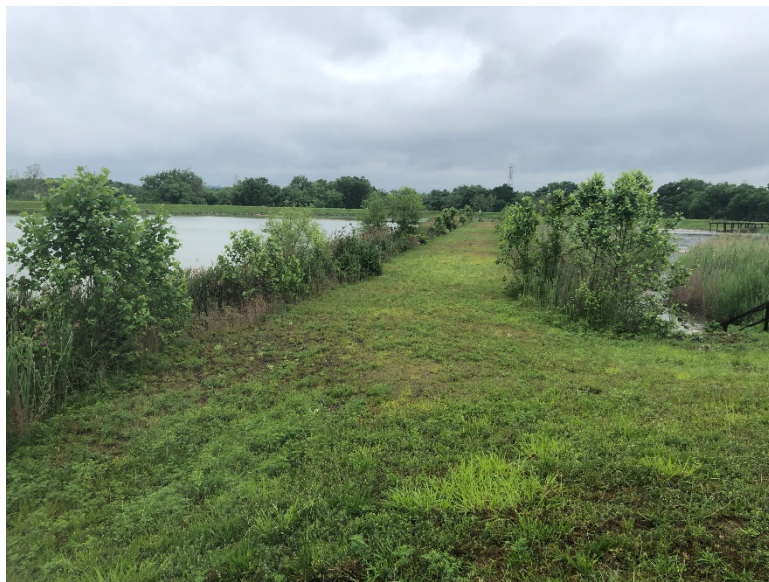
Photo: 14

Comments:
Internal diversion
dike within Former
Basin B. Some
vegetative
overgrowth and
phragmite growth
on the side slopes.
No erosion or signs
of instability along
the crest.

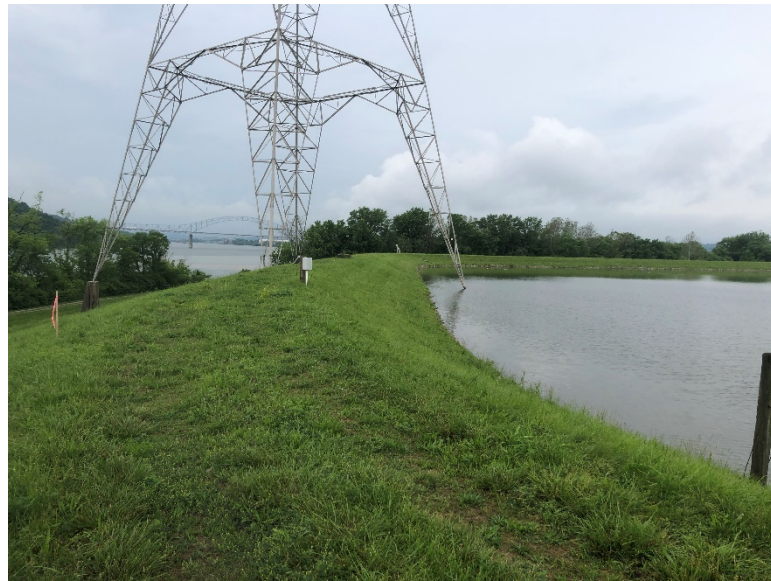
Comments:
Upstream slopes of the western and southern dikes for Former Basin B. Good vegetative cover, no side slope erosion was observed, and the crest appears to be stable with no signs of slope instability.

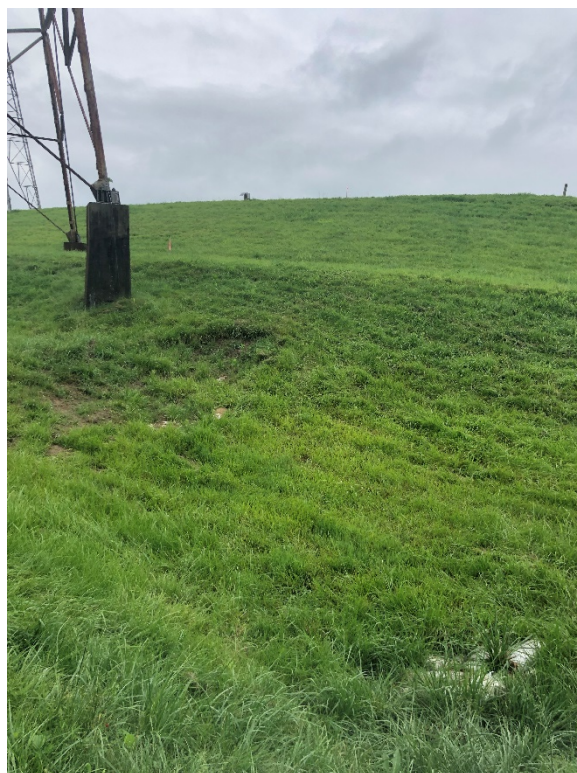
Photo: 16

- No.
- Were there any instances of embankment and/or structural instability for the MFPS since 2015?
 - In 2018 a seep was observed in the southern embankment of Basin B, on the downstream side. The seep was investigated and a damaged drainage pipe for the toe drainage system was uncovered and repaired.

Comments:
Location of observed seepage in the downstream side of the southern dike for Former Basin B. Test pit was excavated and crushed piping for the internal toe drainage system was identified.

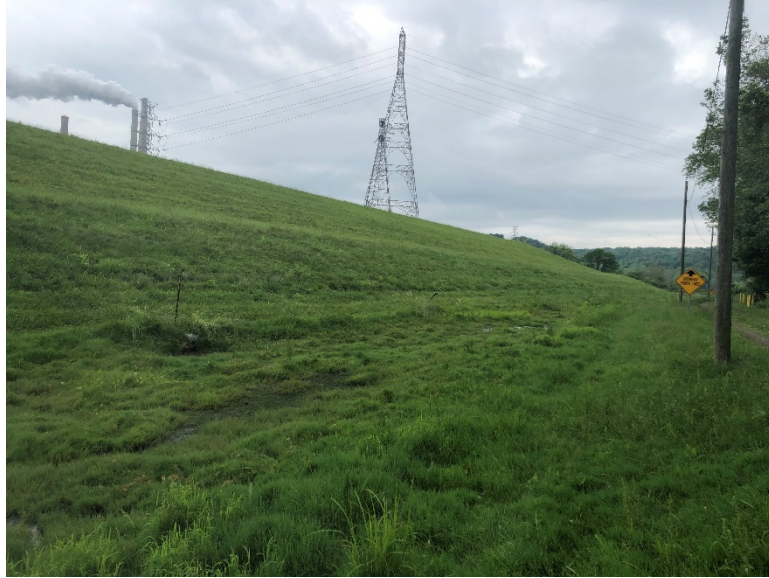
Comments:
Downstream side of southern dike for Former Basin B. Good vegetative cover, and no signs of damage from rapid drawdown.

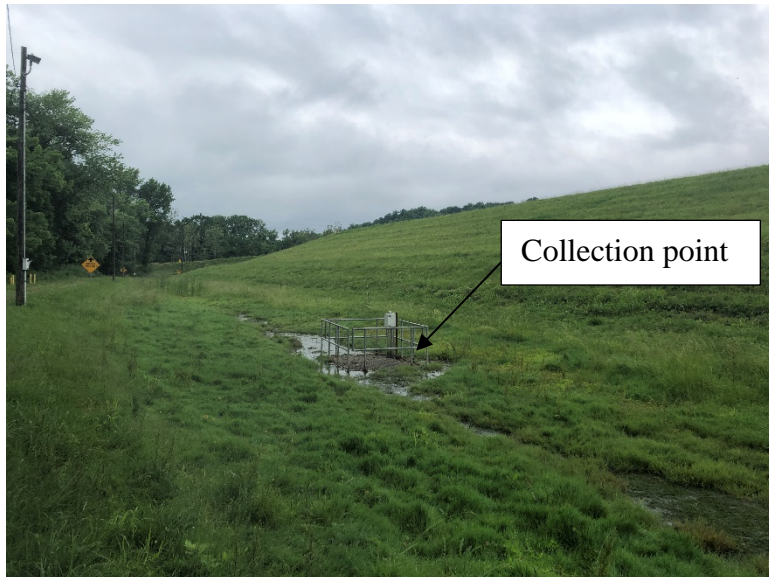
Photo: 18

Comments:
Downstream side of western dike for Former Basin B. Good vegetative cover, no signs of damage from rapid drawdown. Typical pump collection point for dike seepage shown.

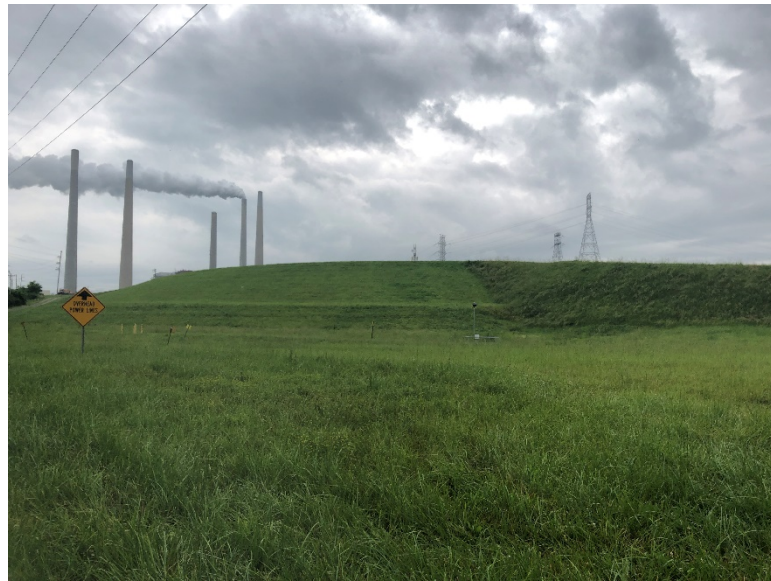
Comments:
Downstream side of southern dike for Former Basin B. Good vegetative cover, no signs of damage from rapid drawdown.

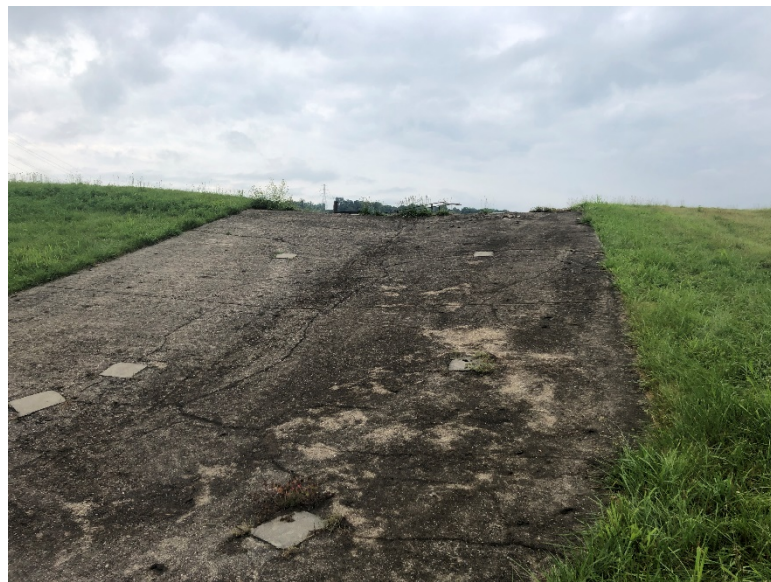
Photo: 20

Comments:
Emergency spillway along northern dike for Former Basin B. The spillway has never been active.

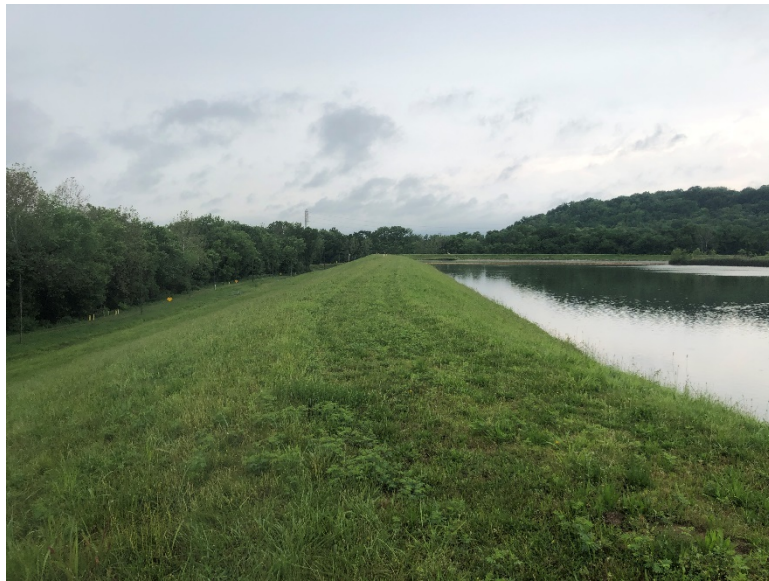
Western dike for Former Basin B. Crest and side slopes in good condition with good vegetative cover, no sign instability or erosion.

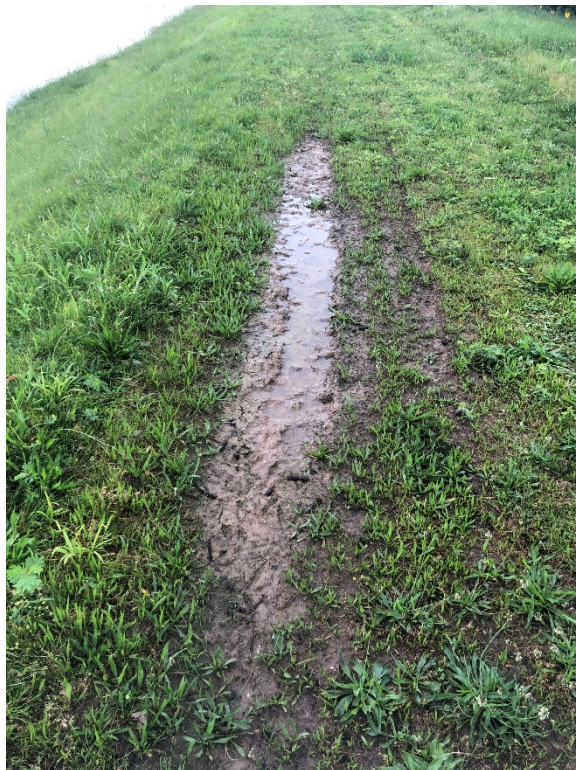
Photo: 22

Some rutting in poor vegetated areas observed along dike crest. Geosyntec recommended to be vegetated during regular maintenance.
