**2017 ANNUAL CCR UNIT INSPECTION REPORT  
LUMINANT BIG BROWN STEAM ELECTRIC STATION  
NORTH AND SOUTH ASH PONDS & ASH DISPOSAL AREA II  
FREESTONE COUNTY, TEXAS**

January 10, 2018

**PASTOR, BEHLING & WHEELER, LLC**  
2201 Double Creek Drive, Suite 4004  
Round Rock, Texas 78664  
Texas Engineering Firm No. 4760

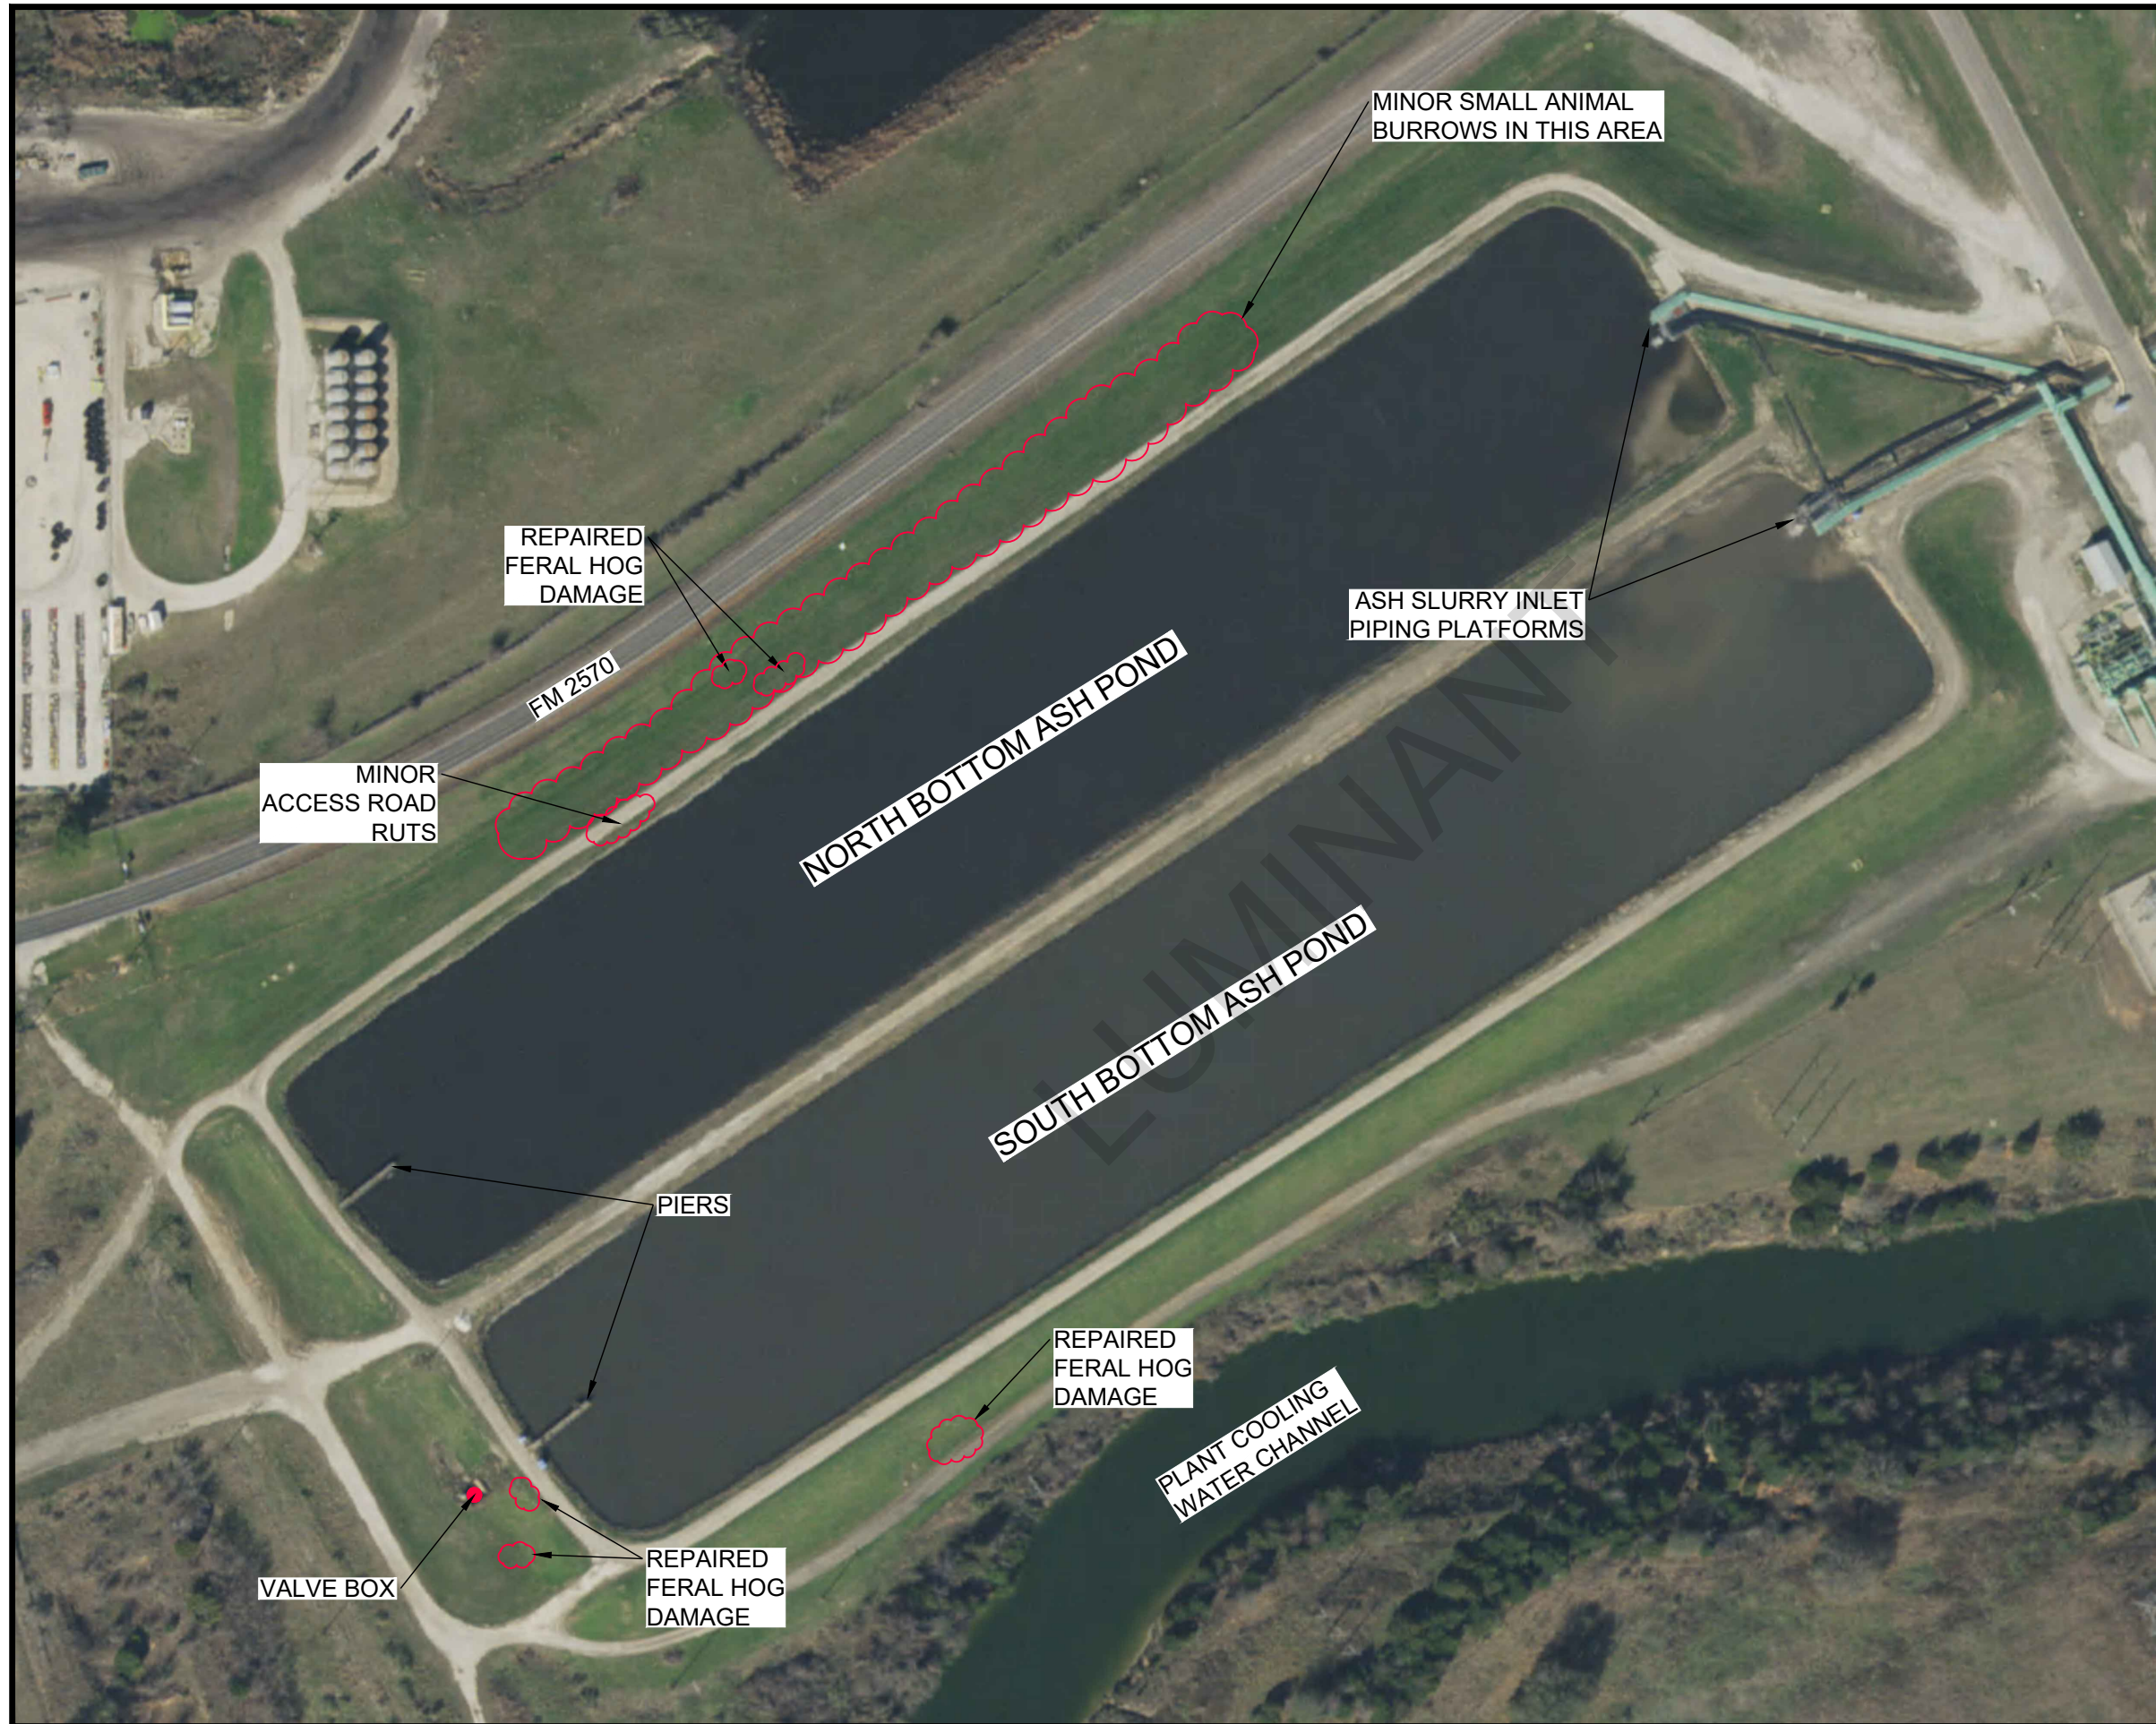
Surface conditions near the BAPs were generally dry and in good condition. As indicated on Figure 3, the following areas were noted for future monitoring or repair:

The majority of the embankment crest is improved with a crushed aggregate access road. The access roads are generally in good condition. As indicated on Figure 3, the following areas were noted for future monitoring or repair:

MINOR SMALL ANIMAL  
BURROWS IN THIS AREA

REPAIRED  
FERAL HOG  
DAMAGE

- Monitor the area of small animal burrows observed on the north embankment of the NBAP and repair with compacted clay fill or similar material if necessary.

- Monitor the limited area of minor rutting observed on the crest of the north embankment of the NBAP and repair as necessary.

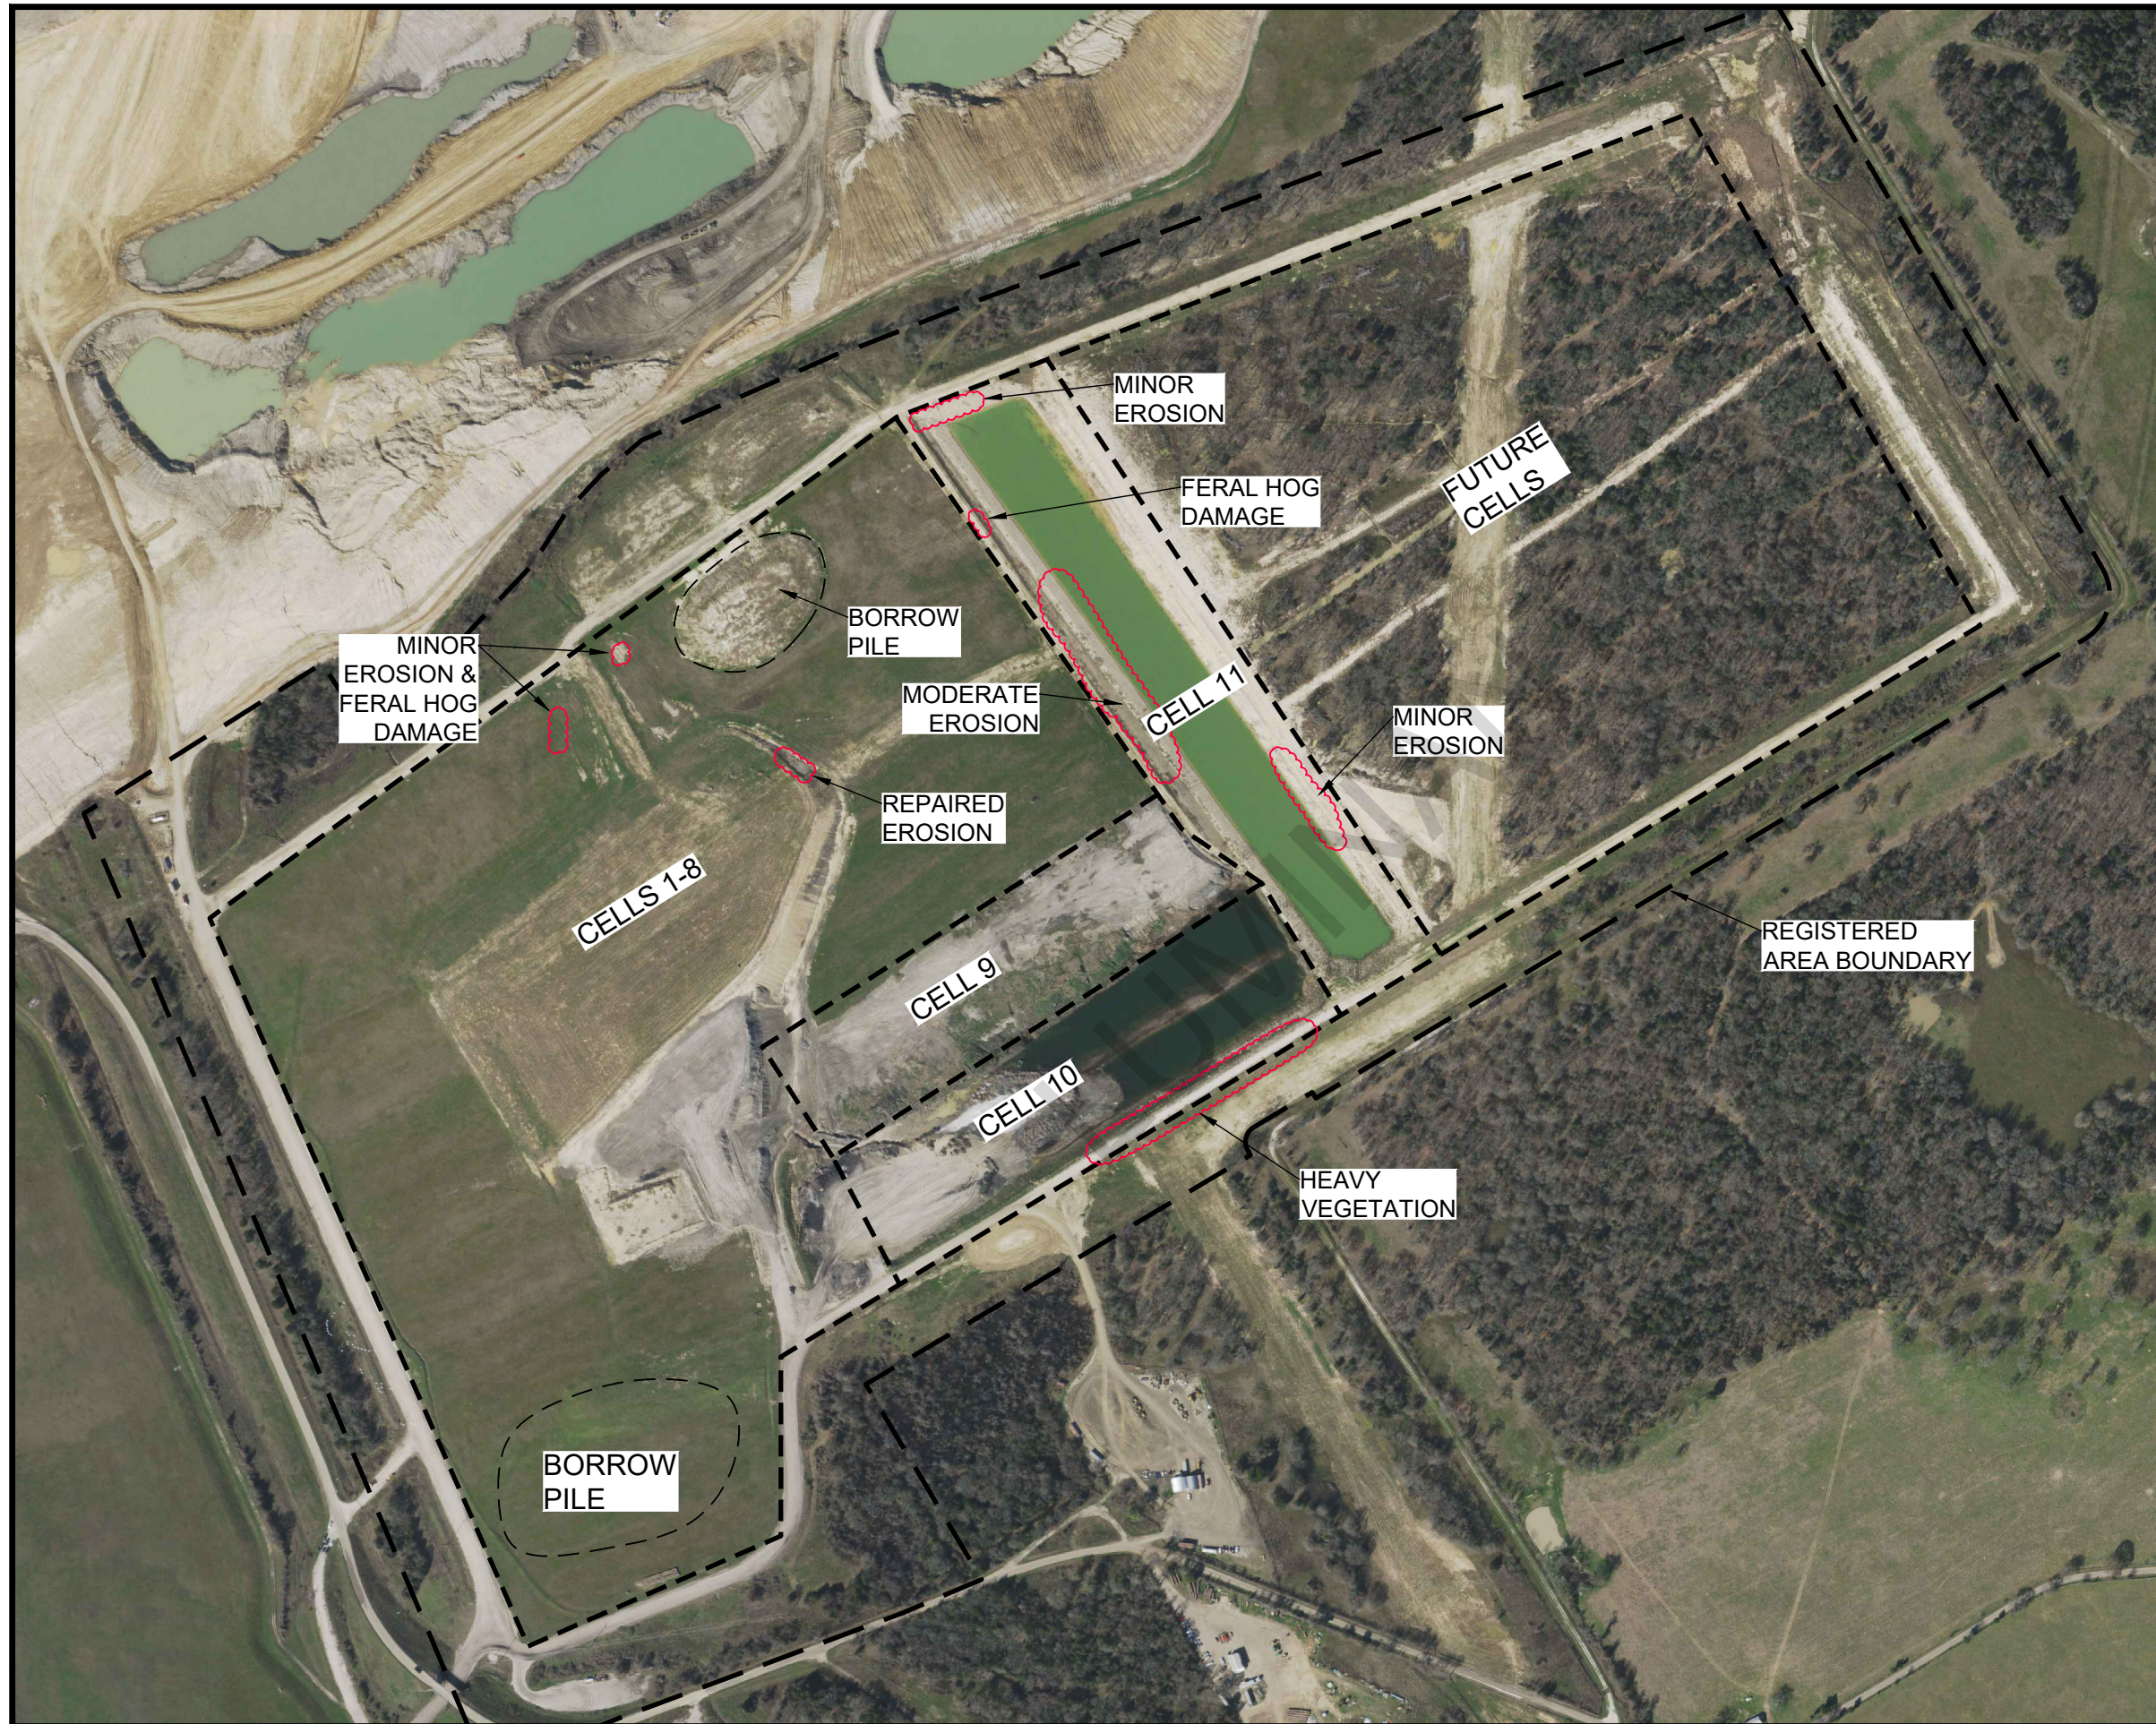
As indicated on Figure 5, the following areas were noted for future monitoring or repair on the embankments around Cells 10 and 11:

The capped portions of Cells 1-8 appear to be adequately vegetated with limited areas of erosion. Small areas of feral hog damage and minor surficial erosion were observed along the north side of capped Cells 1-8. These areas should be monitored and repaired as necessary.

- Heavy vegetation was observed in areas along the interior face of the permanent embankment on the south side of Cell 10. It is recommended that the vegetation in this area be cut/maintained to reduce the potential for liner/embankment damage due to shrub/tree roots.
- Moderate erosion was observed along the interior slope face of the west embankment of Cell 11. This area should be repaired.
- Minor erosion was observed along the interior slope face of the north and east embankments of Cell 11. These areas should continue to be monitored and repaired as necessary.
- A small area of feral hog damage was observed along the top of the interior slope face of the west embankment of Cell 11. This area should be monitored and repaired as necessary.

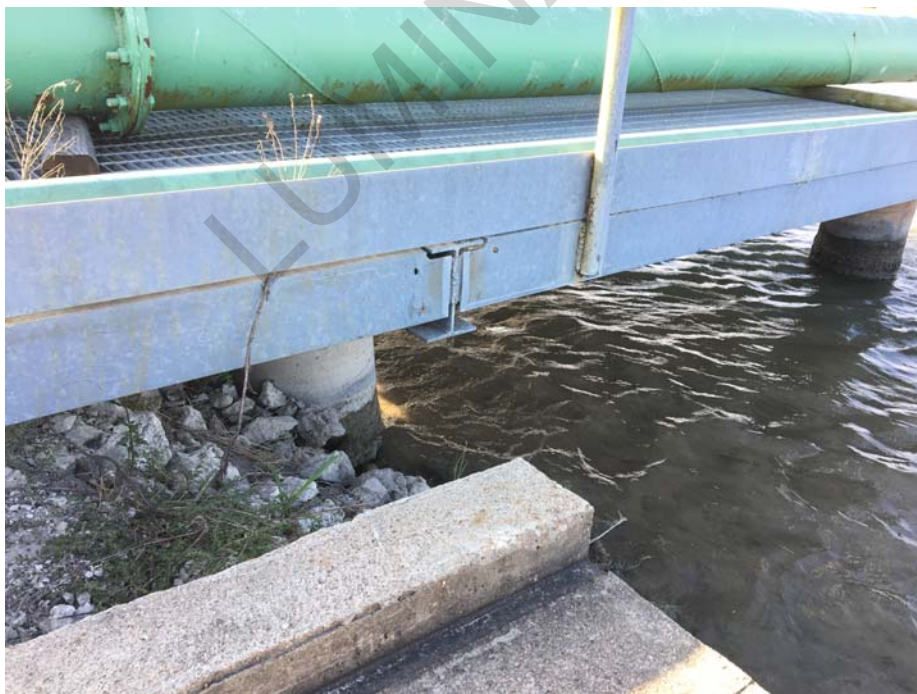
Pastor, Behling & Wheeler	DESCRIPTION	<b>Photograph 2</b> – Detail of repaired erosion at NBAP Ash Slurry Inlet Piping Structure.	
PROJECT NO. 5313A	SITE NAME	Big Brown Steam Electric Station – Bottom Ash Ponds Annual Inspection	DATE 10/10/2017

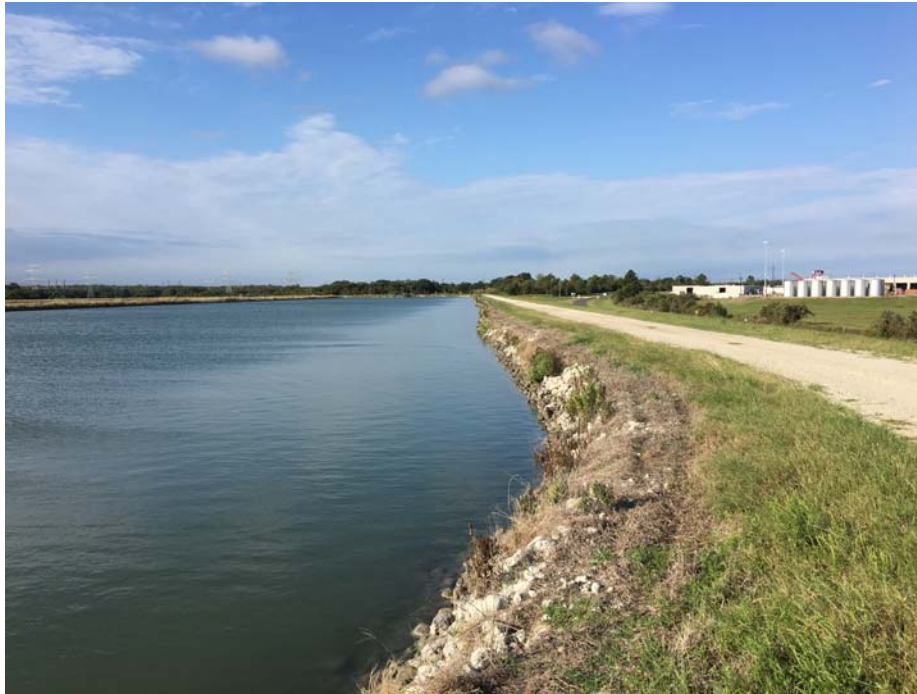
Pastor, Behling & Wheeler	DESCRIPTION	<b>Photograph 3</b> – (View SW) Interior of north embankment of NBAP from NE corner of pond. Note erosion control rock along waterline.	
PROJECT NO. 5313A	SITE NAME	Big Brown Steam Electric Station – Bottom Ash Ponds Annual Inspection	DATE 10/10/2017

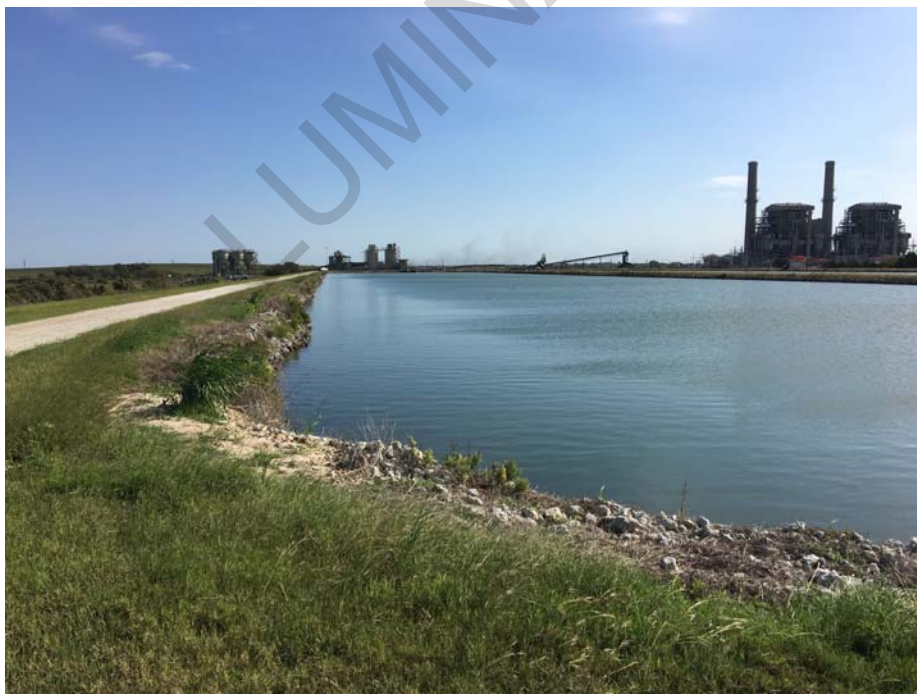
Pastor, Behling & Wheeler	DESCRIPTION	<b>Photograph 8</b> – (View NE) Interior of north embankment of NBAP from NW corner of pond. Note erosion control rock along waterline.	
PROJECT NO. 5313A	SITE NAME	Big Brown Steam Electric Station – Bottom Ash Ponds Annual Inspection	DATE 10/10/2017

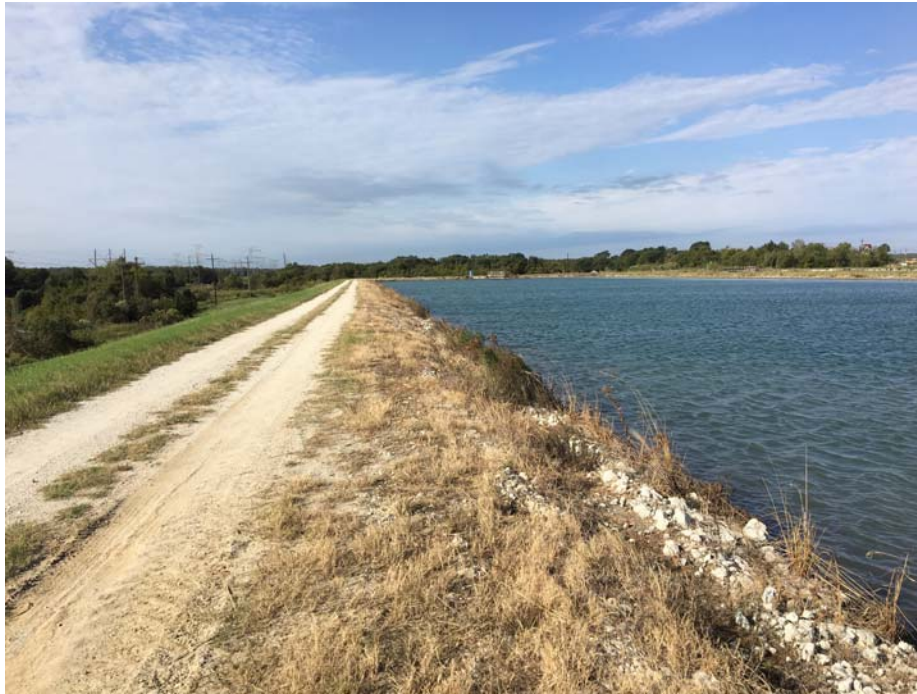
Pastor, Behling & Wheeler	DESCRIPTION	<b>Photograph 13</b> – (View SW) Interior south embankment of SBAP. Note erosion control rock along waterline.	
PROJECT NO. 5313A	SITE NAME	Big Brown Steam Electric Station – Bottom Ash Ponds Annual Inspection	DATE 10/10/2017

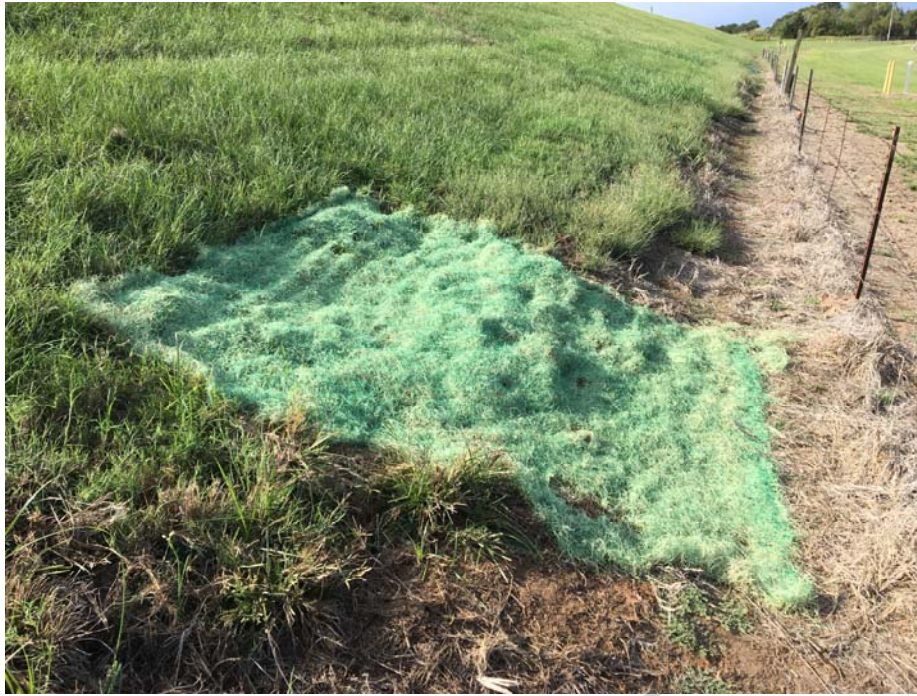
Pastor, Behling & Wheeler	DESCRIPTION	<b>Photograph 19</b> – Typical repair of feral hog damage.	
PROJECT NO. 5313A	SITE NAME	Big Brown Steam Electric Station – Bottom Ash Ponds Annual Inspection	DATE 10/10/2017

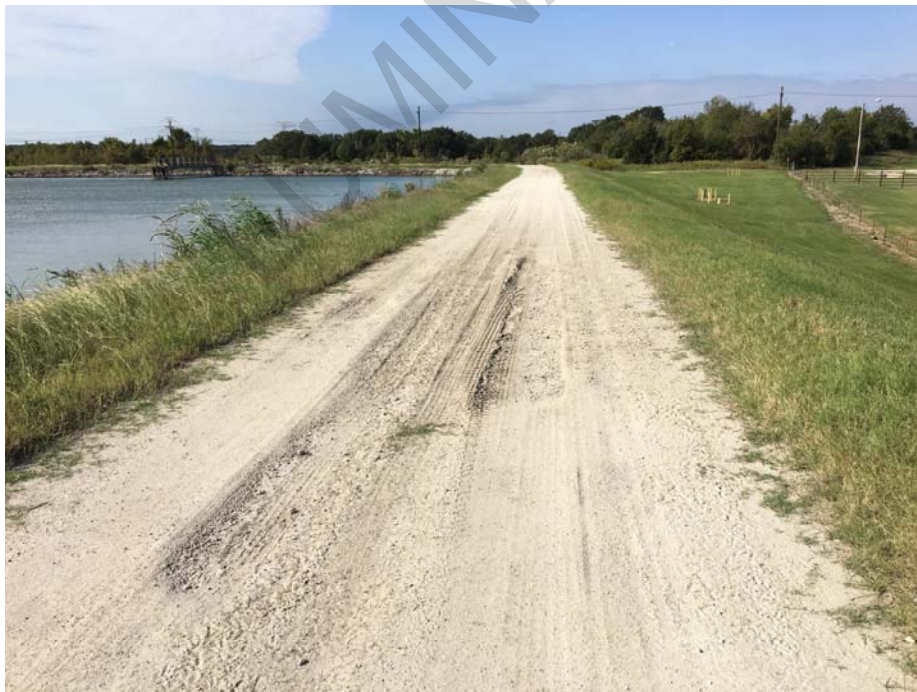
Pastor, Behling & Wheeler	DESCRIPTION	<b>Photograph 20</b> – Minor access road ruts on north embankment of NBAP.	
PROJECT NO. 5313A	SITE NAME	Big Brown Steam Electric Station – Bottom Ash Ponds Annual Inspection	DATE 10/10/2017

- BAPs - Monitor the limited area of minor rutting observed on the crest of the north embankment of the NBAP and repair as necessary.
- Ash Disposal Area II - Heavy vegetation was observed in areas along the interior face of the permanent embankment on the south side of Cell 10. It is recommended that the vegetation in this area be cut/maintained to reduce the potential for liner/embankment damage due to shrub/tree roots.

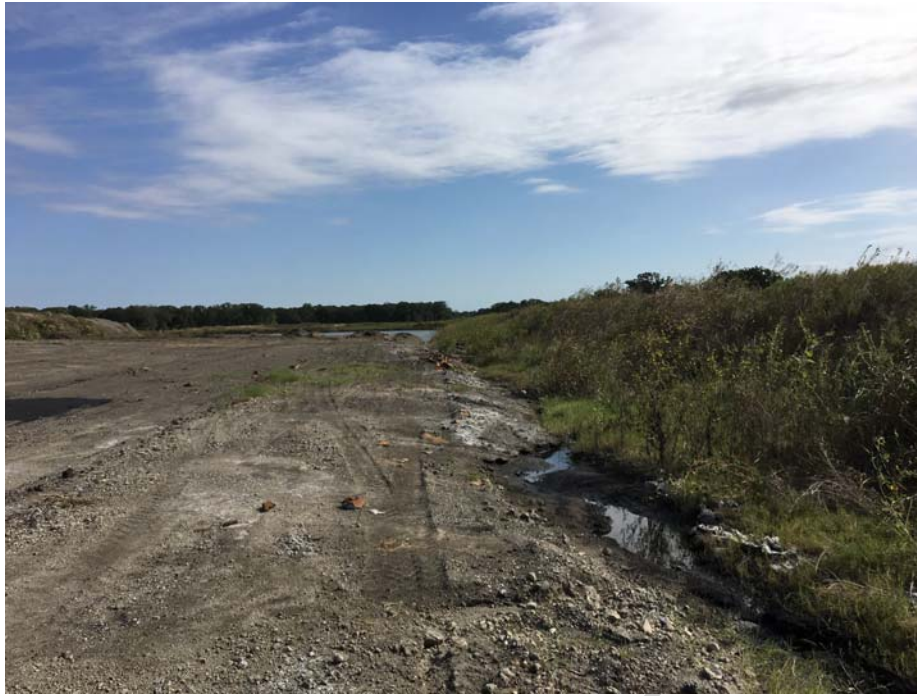
Pastor, Behling & Wheeler	DESCRIPTION	<b>Photograph 1</b> – (View NE) Interior toe of south embankment of Cell 10. Cell 10 on left. Active ash placement area. Heavy vegetation on right.	
PROJECT NO. 5313A	SITE NAME	Big Brown Steam Electric Station – Ash Disposal Area II Annual Inspection	DATE 10/10/2017

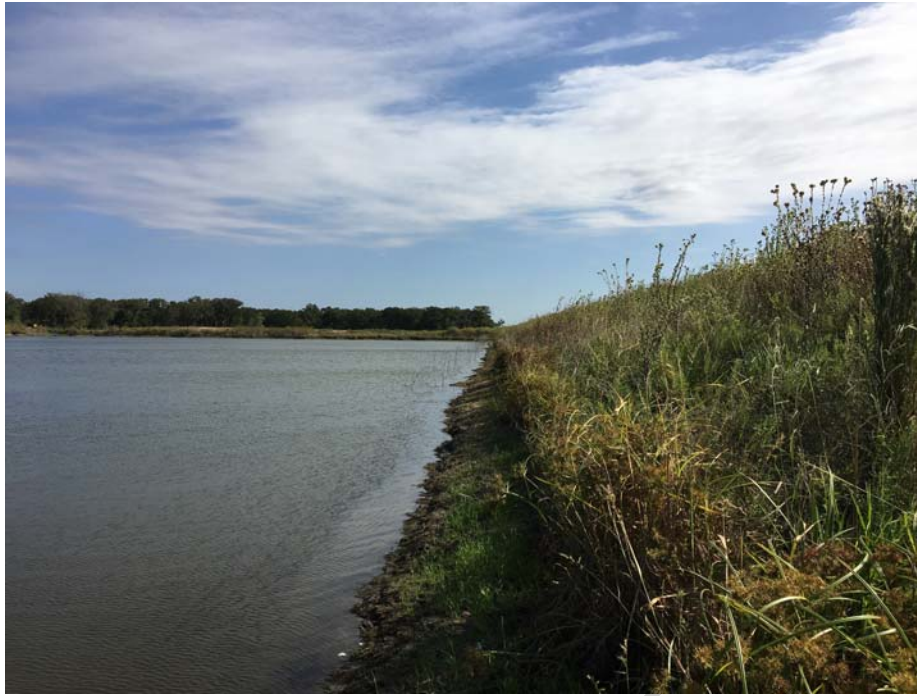
Pastor, Behling & Wheeler	DESCRIPTION	<b>Photograph 3</b> – (View NE) Interior toe of south embankment of Cell 10. Cell 10 contact water collection area on left. Heavy vegetation on right.	
PROJECT NO. 5313A	SITE NAME	Big Brown Steam Electric Station – Ash Disposal Area II Annual Inspection	DATE 10/10/2017

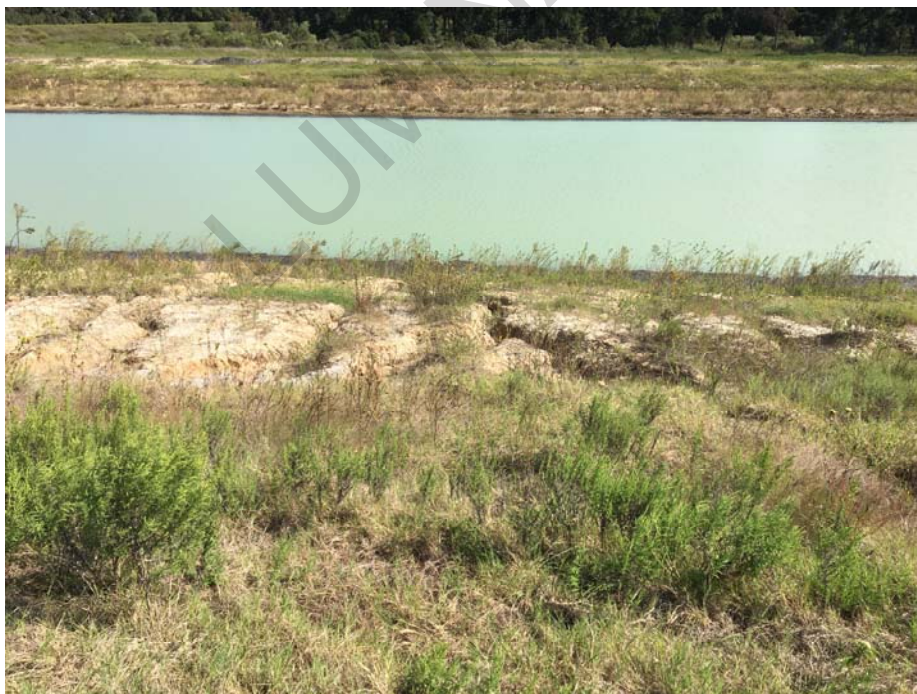
Pastor, Behling & Wheeler	DESCRIPTION	<b>Photograph 6</b> – Moderate erosion along west embankment of Cell 11.	
PROJECT NO. 5313A	SITE NAME	Big Brown Steam Electric Station – Ash Disposal Area II Annual Inspection	DATE 10/10/2017

- Ash Disposal Area II - Moderate erosion was observed along the interior slope face of the west embankment of Cell 11. This area should be repaired.
- Ash Disposal Area II - Minor erosion was observed along the interior slope face of the north and east embankments of Cell 11. These areas should continue to be monitored and repaired as necessary.

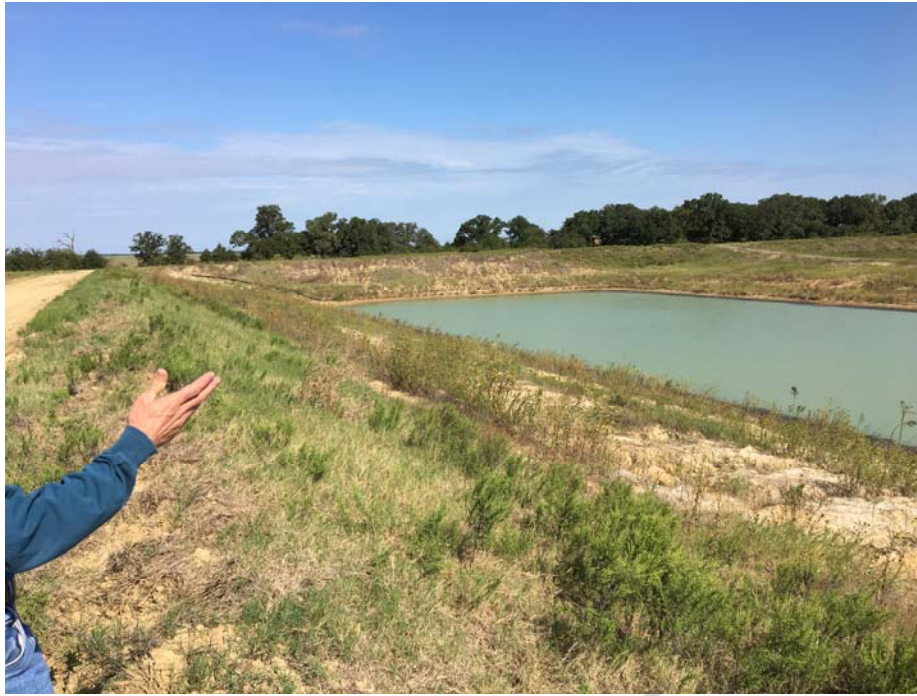
Pastor, Behling & Wheeler	DESCRIPTION	<b>Photograph 7</b> – (View NW) West embankment of Cell 11. Feral hog damage at left foreground.	
PROJECT NO. 5313A	SITE NAME	Big Brown Steam Electric Station – Ash Disposal Area II Annual Inspection	DATE 10/10/2017

- Ash Disposal Area II - A small area of feral hog damage was observed along the top of the interior slope face of the west embankment of Cell 11. This area should be monitored and repaired as necessary.

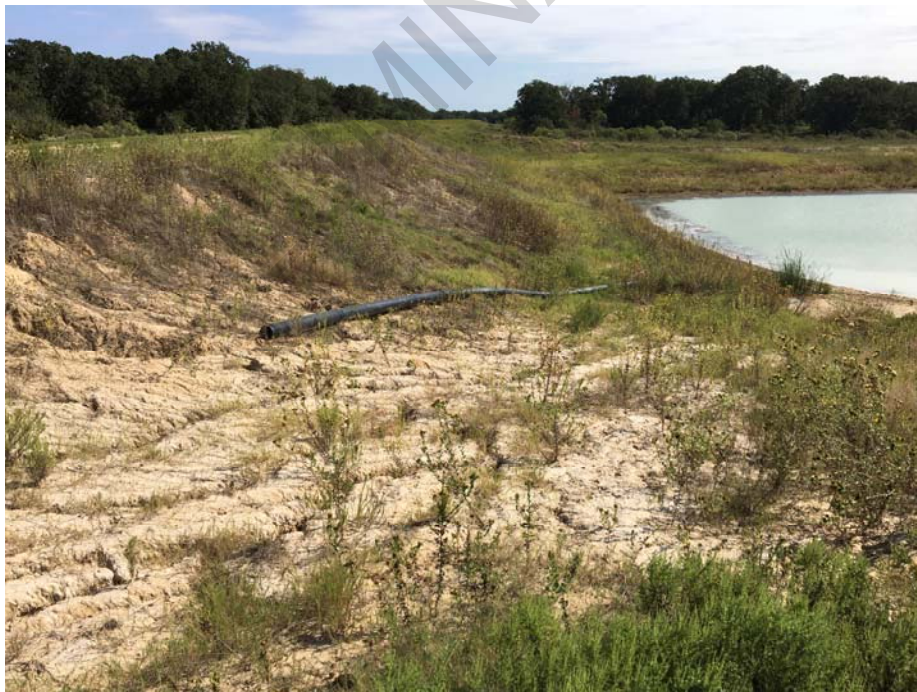
Pastor, Behling & Wheeler	DESCRIPTION	<b>Photograph 8</b> – Minor erosion at NW corner of Cell 11.	
PROJECT NO. 5313A	SITE NAME	Big Brown Steam Electric Station – Ash Disposal Area II Annual Inspection	DATE 10/10/2017

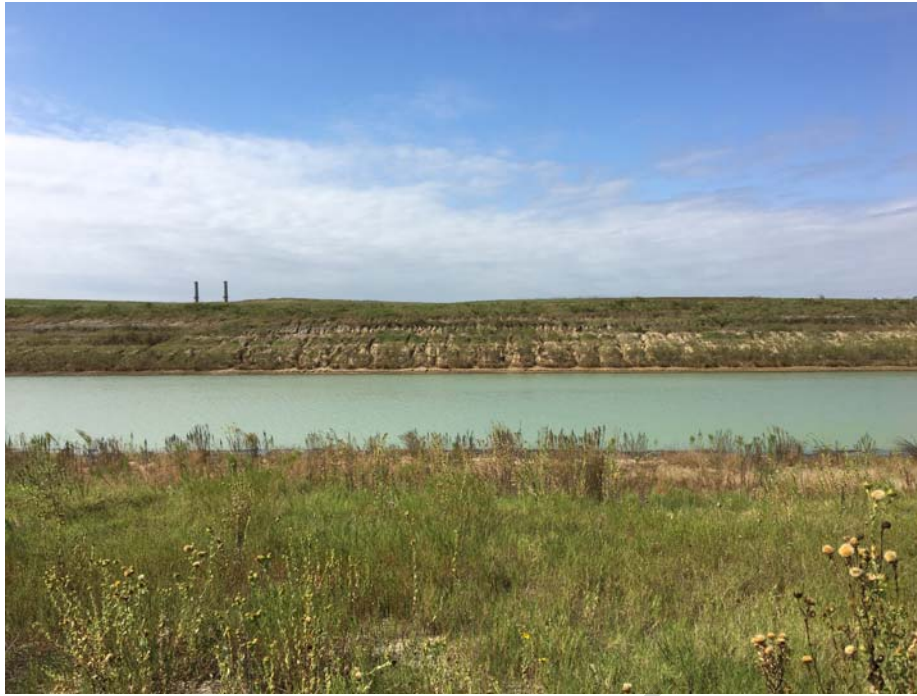
Pastor, Behling & Wheeler	DESCRIPTION	<b>Photograph 11</b> – (View SW) Moderate erosion of west embankment of Cell 11 (across cell).	
PROJECT NO. 5313A	SITE NAME	Big Brown Steam Electric Station – Ash Disposal Area II Annual Inspection	DATE 10/10/2017

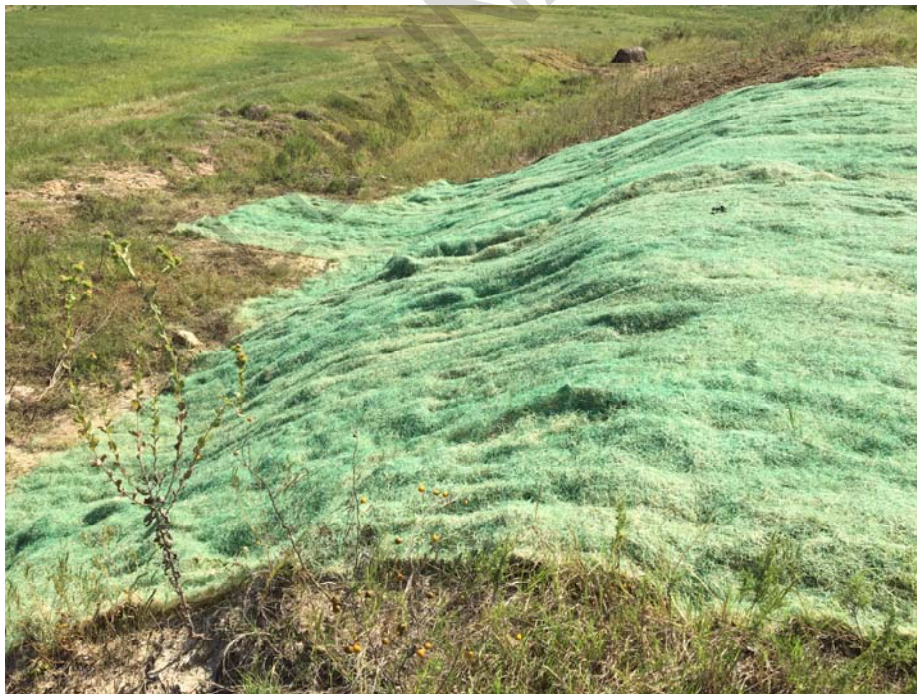
Pastor, Behling & Wheeler	DESCRIPTION	<b>Photograph 14</b> – Typical cap erosion repair area.	
PROJECT NO. 5313A	SITE NAME	Big Brown Steam Electric Station – Ash Disposal Area II Annual Inspection	DATE 10/10/2017
