Rev. January 24, 2018  
(Original Date January 15, 2016)  
BBA Project No. 15-214.1

**RE: Coletto Creek Power – September 2015 Primary Ash Pond and Secondary Pond Dike Inspection**

Bullock, Bennett, and Associates, LLC (BBA) performed a visual inspection of the Coletto Creek Primary Ash Pond and Secondary Pond dike systems on September 16, 2015<sup>1</sup>. The Primary Ash Pond is approximately 190 acres and the Secondary Pond is approximately 10 acres (the Primary Ash and Secondary Ponds are hereafter referred to collectively as the Ponds). The Ponds were constructed in the late 1970s and include a perimeter dike system approximately 2.5 miles in total length. The crest width of the Ponds is approximately 15 feet, and side slopes (interior and exterior) of the Primary Ash Pond were reportedly constructed to 2.5(H):1(V) and the Secondary Pond to 3(H):1(V). The Ponds were reportedly constructed in accordance with Texas Department of Water Resources technical guidelines. Ash material is sluiced to the Primary Ash Pond where most settlement takes place, and water is decanted from the Primary Ash Pond through a weir located within the shared dike between the Ponds to the Secondary Po

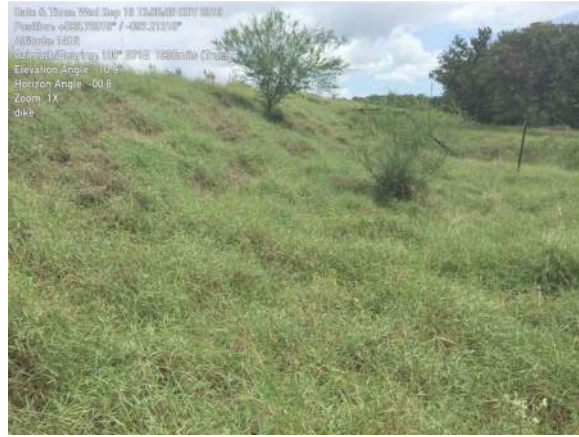
7383 - Exterior

Other than the seep areas discussed above, the exterior slope of the dike appeared in good condition. A few small trees were observed as shown in photos 7383 and 7594, and grass, although in good condition and with good coverage was tall, restricting visibility of the levee surface.

- Remove small trees and shrubs observed from all side slopes.
- Mow the exterior dikes on a regular basis to improve ability to visually inspect the dike, encourage good vegetation, and maintain removal of trees and shrubs.

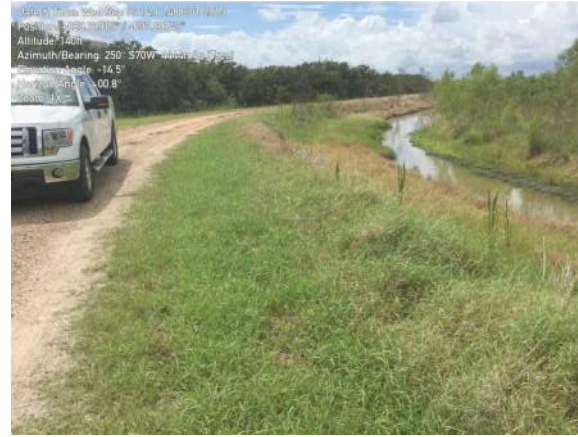
7408 - Top of Levee

Photos 7429, 7545, and 7564 show inside slope rock armor in areas impounded with water. Photo 7408 shows the inside of the ash pond with a drainage channel cut within the ash to convey sluice material. Photos 7564 and 7571 show small trees on the interior slope.

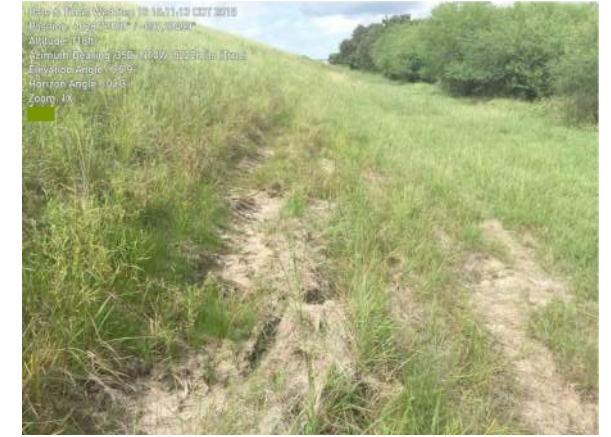
7455 - Exterior Toe (Wet Area)

An active seepage area was identified near the toe of slope in the approximate area of Sta 85+00 to Sta 90+00. This area has been identified in previous inspection reports (from the late 1980s and early 1990s) provided to BBA for review during the site visit. More recent inspection reports were not obtained by BBA for review however, these seeps have reportedly continued to persist since observations discussed in the old inspection reports. The seepage areas and associated erosional features are shown in photos 7455, 7470, 7473, 7478, and 7486 (covering an area approximately 500 feet long). As shown in the photos, some of these areas are wet and ponding. This is partially due to rainfall during the day of inspection, but likely due to accumulation of seepage as well. Some of the ponded water observed was cloudy with suspended sediments (photo 7470). The cloudy water is likely a result of accumulation of surface water runoff from rainfall impacting the localized areas of disturbed vegetation given no seepage flow was detected. The same seepage areas have historically been observed with no suspended sediments, and other ponded areas from nearby seeps surrounded with better stands of grass exhibited no suspended solids. There was no discernible subsidence observed along the interior dike slope, dike crest, or upgradient portions of the external dike slope in these areas. These areas should be routinely monitored with careful attention paid to seepage flow. If seepage flow is observed to include suspended solids (such as clay or silt particles), this could be an indication of internal dike erosion that may lead to unstable dike conditions. This seep area should be further investigated and seepage addressed based on investigation findings. Given the localized toe erosion and wet soil conditions in the area associated with the long-term seepage, this section of dike could worsen to cause unstable dike conditions if not addressed.

Exterior slope generally appears in good condition; however, a seepage area in the proximity of Stat 85+00 to 90+00 was observed. Seepage flow was not detected, however ponding water was observed – likely associated with a combination of seepage accumulation and collection of recent rainfall. This area should be investigated and addressed appropriately based on investigation findings. This seep area has been observed in historic inspections performed by others. Future observations of fines in seep water (such as clay or silt particles) may indicate internal erosion of the dike which could lead to unstable conditions.

- Continue to monitor the observed Primary Ash Pond seep locations between Sta 85+00 and 90+00. Investigate the observed seepage area and address as appropriate based on investigation findings. During this investigation, also perform a detailed inspection of the existing seepage collection system in the vicinity of the pump house, east of Sta 70+00.

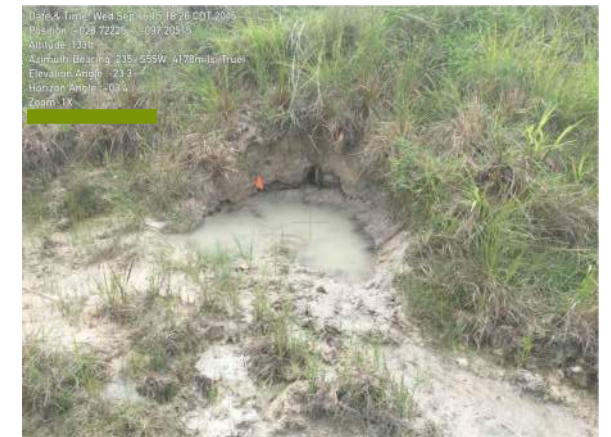
7470 - Exterior Toe (Wet/Erosion Area)

20	EROSION	Erosion associated with seepage observed in proximity of Sta 85+00 to 90+00 as shown in photos. No other substantial erosion areas observed.	X		
	21	UNUSUAL MOVEMENT	No indication of unusual movement observed.	X		
	22	PRESENCE/COND. OF VEGETATION	Grass generally in good condition, but tall at time of inspection - should be mowed to enhance ability to visually inspect. Sporadic stands of small trees observed – should be removed (see tree removal discussion on page 1 of 2).	X		
	23					
INSTRUMENTATION	24	PIEZOMETERS/OBSERV. WELLS	Not inspected. Piezos and wells observed and inspected during routine groundwater monitoring.	X		
	25	STAFF GAUGE AND RECORDER	Staff plate appeared in good condition. Water surface elevation observed at approximately 134.0 ft (approximately 6.0 feet below top of dike)	X		
	26	SURVEY MONUMENTS	Not observed.	X		
	27	DRAINS	No internal chimney drains within levee system. Seepage collection system located east of levee (near the bank of Coletto Creek Cooling Pond) in vicinity of Sta 70+00 was not inspected, however, no embankment seepage was observed in the area.	X

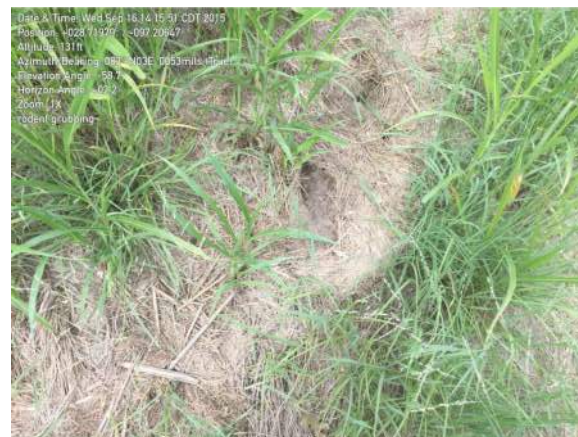
7415 - Exterior Toe (Rodent Grubbing)

AREA INSPECTED	ITEM NO.	EMBANKMENT 2 OF 2		CHECK (X) ACTION NEEDED		
		CONDITION	OBSERVATIONS	MONITOR	INVEST- IGATE	REPAIR
EXTERIOR SLOPE	15	WET AREA(S)	Wet areas observed at toe of slope in approximate area of Sta 85+00 to 90+00. Appears to be a combination of accumulated seep water and ponding from recent rainfall events.	X		
	16	SEEPAGE	Seepage accumulation observed in area of Sta 85+00 to 90+00. No flow observed, eroded areas from historic seepage were observed to have ponded water, partially from recent rainfall events (it rained the night prior and morning of the inspection). Follow up seepage investigation of this area is recommended.	X	X	
	17	SLIDE, SLOUGH, SCARP	None observed.	X		
	18	EMB.-ABUT. CONTACT	Embankment intersections of Primary Ash/Secondary Ponds appear in good condition.	X		
	19	CAVE IN, ANIMAL BURROW	No cave-ins observed. Evidence of minor animal rooting/grubbing observed in sporadic locations.	X

Tall grass should be mowed and small trees removed from side slopes (see discussion of tree removal included on page 1 of 2). Some evidence of minor animal rooting/grubbing observed – control of rodents should be implemented as needed.

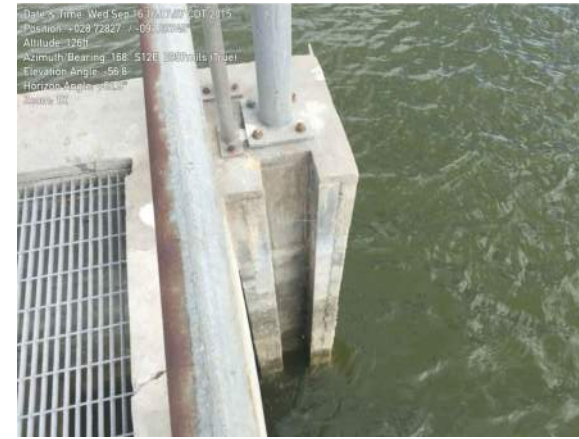
7549 - Stoplog Slots

The outlet works from the Primary Ash Pond includes a weir as shown in photos 7547, 7548, and 7549. Stoplogs were not in place at the time of inspection. The staff plate reading as shown in photo 7548 indicated a water surface elevation of approximately 134.0 ft (approximately 6 feet below top of dike elevation).

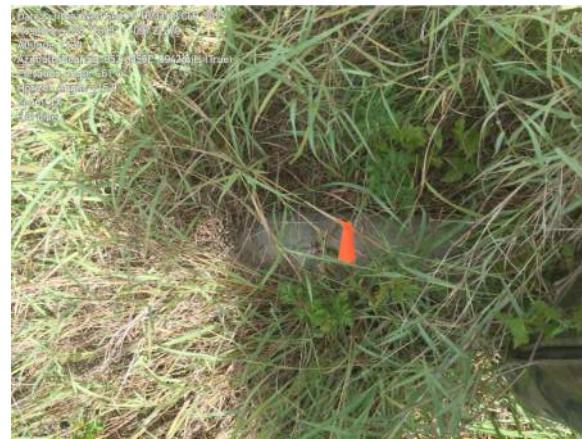
7585 - 6" Pipe, Exterior

An approximate 6-inch diameter pipe was observed on the west dike near Sta 35+00 as shown in photo 7585.

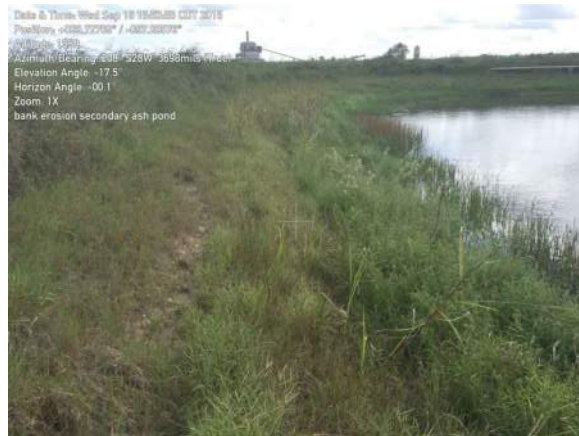
7530 - Interior

As indicated in the attached photos, the Secondary Pond interior side slopes appeared to exhibit minor to moderate and generally uniform bank cut likely due to wave action. This erosion feature appears to have occurred a long time ago given the slope is currently heavily vegetated. At the

time of inspection the water level was low enough to enable access to the interior slope as indicated in the photos. The cut does not appear to be problematic from a dike stability standpoint and no immediate action is required. Maintaining the water level as low as observed during the inspection will prevent future progression of erosion. Alternatively, armoring the slope to reduce future bank cut may be considered as a means to reduce potential future erosion. Other than the bank cut observed, the interior slopes appear well vegetated and in generally good condition. Bank cut erosion is shown in photos 7530 and 7532.
