Rev. January 22, 2018
(Original Date January 30, 2017)
BBA Project No. 16244

RE: Coletto Creek Power – December 2016 Primary Ash Pond and Secondary Pond Dike Inspection

**DIKE INSPECTION
(December 2016)**

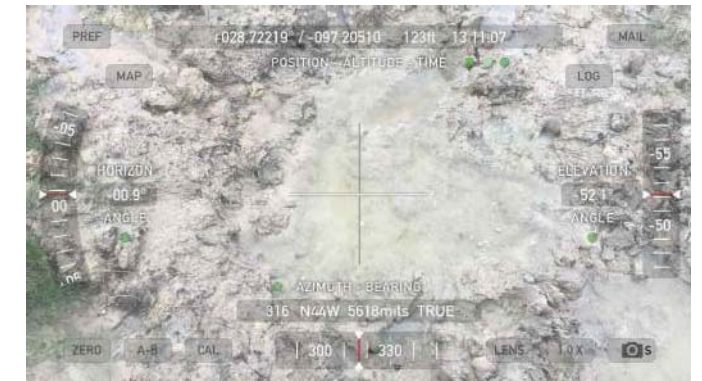
Wet areas were identified near the toe of slope in the approximate area of Sta 84+00 to Sta 90+00, with moist areas, and indications of apparent historic wet areas extending to approximately Sta 95+00. This area has been identified in previous inspections conducted in the 1980s and 1990s, and more recently during the 2015 inspection. The wet areas and associated erosional features are shown in photos 2133, 2144, 2145, 2146, 2147, and 2148. As shown in the photos, some of these areas are wet, ponding and appear associated with recent rain events and possible accumulation of seepage water. The ponded water appeared to have a surface film associated with decomposition of plant (organic) matter, had no appearance of flow, and did not contain suspended sediments. The wet areas have historically been observed with no suspended sediments. There was no discernible subsidence or settlement observed along the interior dike slope, dike crest, or upgradient portions of the external dike slope in these areas. BBA is currently designing a seepage collection system and toe of dike grading plan for implementation to remedy these areas.

2147 - Exterior Toe (Wet Area)

- Complete the engineering design currently being developed to address the wet areas identified along the exterior toe of the Primary Ash Pond, and implement the remedy.

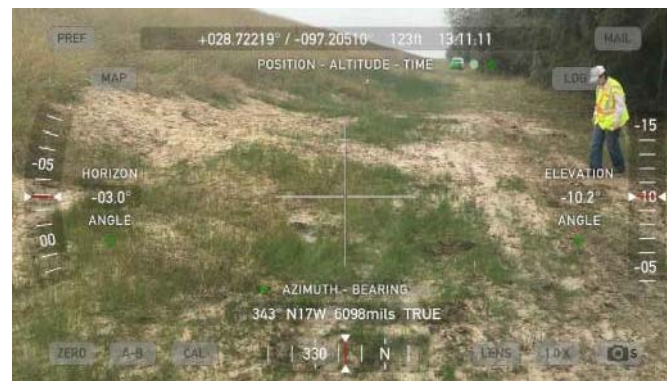
2148 - Exterior (Wet Area)

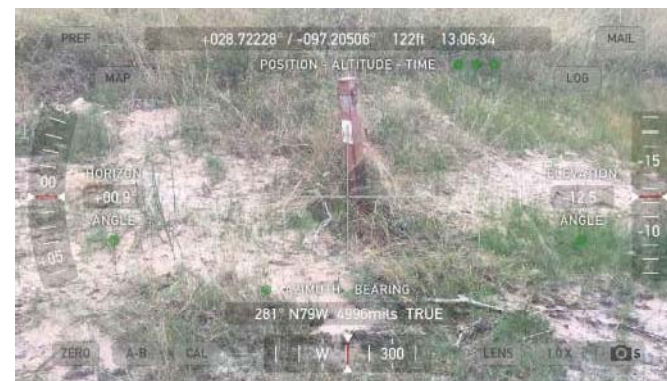
2146 - Exterior - Piezo 9 (Wet Area)

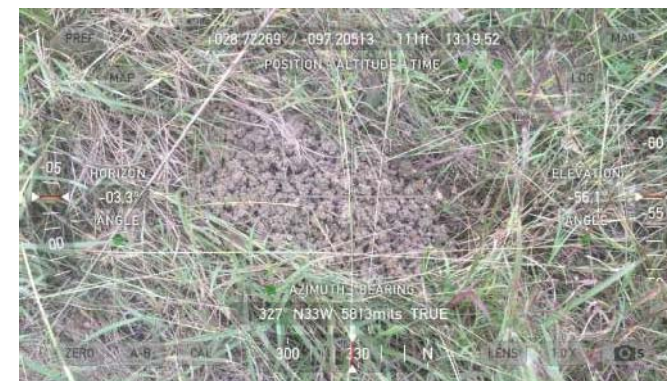
2153 - Exterior Toe (Rodent Grubbing)

- Evidence of animal rooting/grubbing on the dike was minimal during this inspection. However, if evidence of increased activity is observed, implement rodent control as needed. Evidence of fire ants was minimal; however, continue to inspect for fire ants especially in summer months and implement fire ant control as needed (fire ant colonies can be intrusive into the dike interior potentially resulting in piping or initiation of erosion areas).

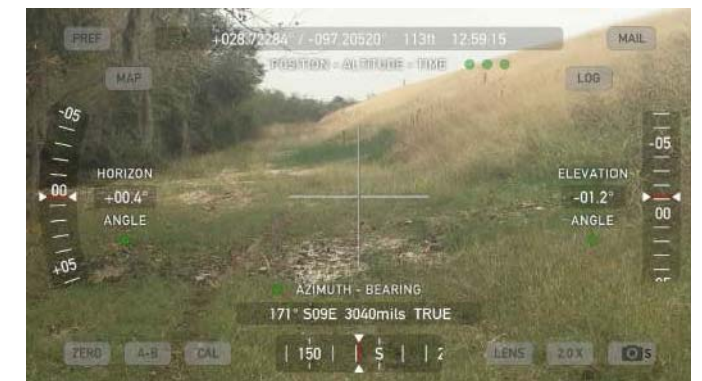
2144 - Exterior Toe (Wet/Erosion Area)

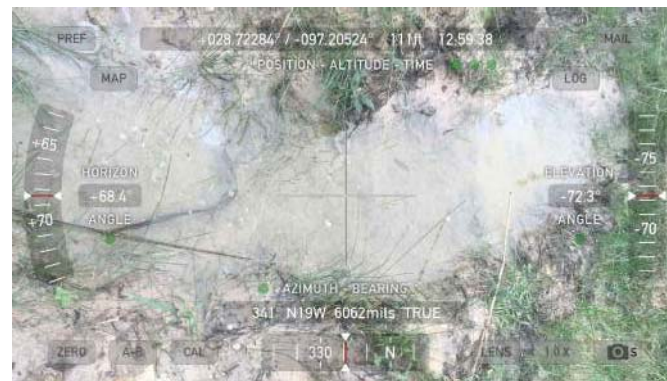
2145 - Exterior (Wet Area)

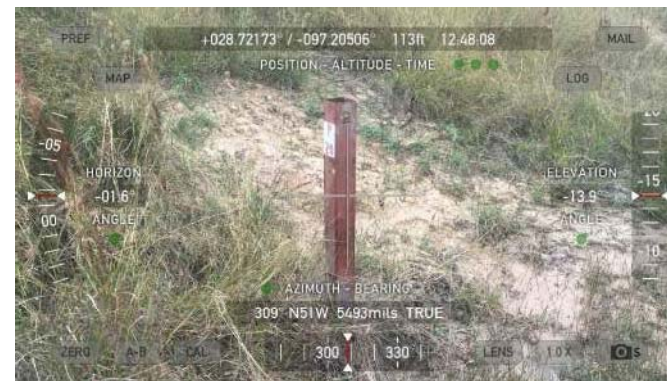
2133 - Exterior - Piezo 20 (Wet Area)

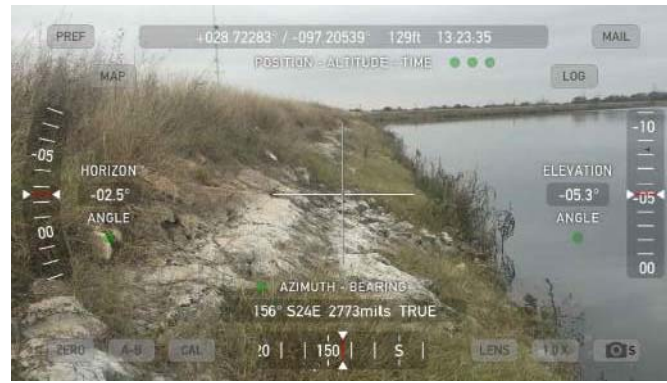
Photos 2159, 2221 and 2304 show inside slope rock armor in areas impounded with water. Photo 2334 shows the inside of the ash pond with a drainage channel cut within the ash to convey sluice material.

2159 - Interior Slope Protection

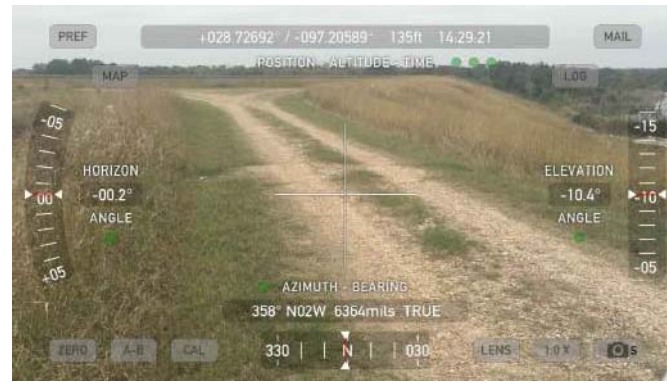
A small diameter steel pipe was observed on the east dike exterior side slope near Sta 70+00, and appears to penetrate the crest of the dike approximately 2 feet below grade. This pipe appears crushed where exposed on the side slope and is not in use. Photo 2208 shows the approximate dike location of the pipe penetration. A steel pipe was also observed on the west dike shared with the Evaporation Pond, near Sta 29+00 as shown in photo 2329. This pipe appeared to be approximately 18 inches in diameter and discharges into the Evaporation Pond. The pipe appeared to penetrate through the upper portion of dike and was not in use during the inspection. The approximate 6-inch diameter pipe observed at the toe of slope near Station 37+00 during the 2015 inspection was not observed during the 2016 inspection likely due to the tall, thick vegetation restricting visibility.

2208 - Top of Levee / Location of Small Diameter Steel Pipe (shallow - buried)

- Pipe penetrations observed in the dikes appeared to occur within the upper approximate 2-3 feet of the dike crest, and no substantial dike erosion or indications of settlement were observed in these areas. However; one six-inch diameter steel pipe (near Sta 70+00) observed along the exterior dike slope appeared crushed and inoperable. Coletto Creek should review all pipes that penetrate the levee and consider proper removal of any pipes that may be identified as no longer planned for use. Additionally, given the pipes appear old, BBA recommends inspection of pipe sections that penetrate the dike and will not be removed, and that are accessible for inspection via use of a remote camera system.

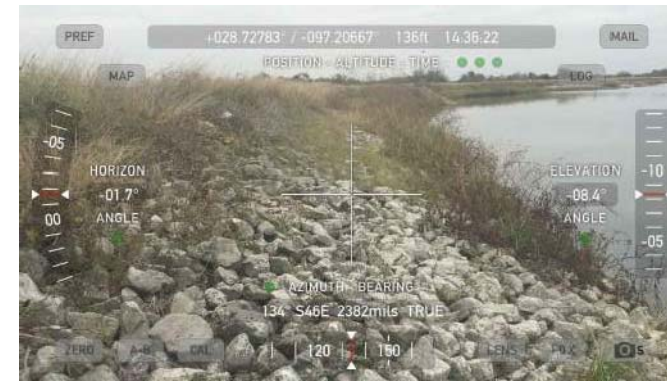
2221 - Interior Slope Protection

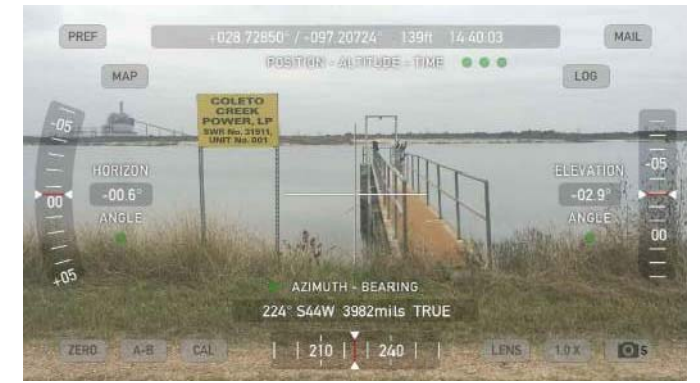
The outlet works from the Primary Ash Pond includes a weir and access walkway as shown in photos 2228, 2237, 2230, 2241 and 2243. Stoplogs were not in place at the time of inspection (photo 2241). The staff plate reading as shown in photo 2237 indicated a water surface elevation of approximately 133.0 ft (approximately 7 feet below top of dike elevation).

2228 - Outlet Works

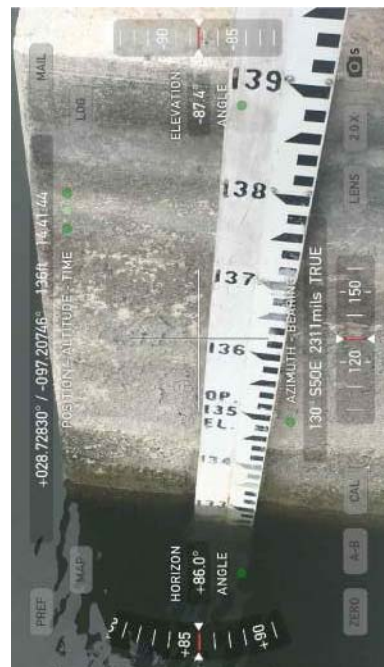
2237 - Staff Plate on Outlet Works

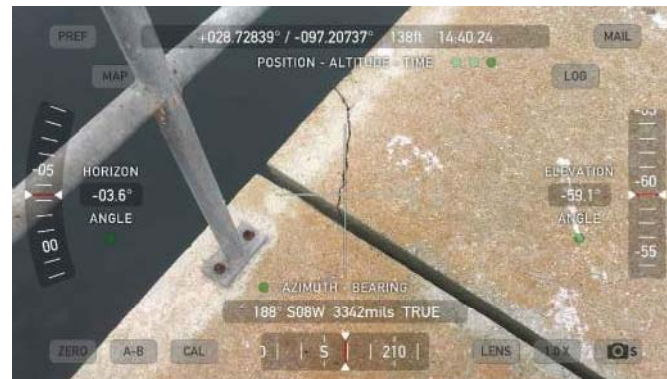
Minor cracks were observed in the outlet concrete walkway structure and some expansion joints appear to have larger than average gaps, indicating possible (appeared likely historic) movement. Additionally, when viewed from the side the concrete walkway decking appears to have a slight sag in areas between bents. The railings for the walkway structure are loose and walkway rail bolts are rusted. Cracks, a joint in the concrete decking, and rusted handrail bolts are shown in photos 2230 and 2243.

2230 - Concrete Decking Joint (at first bent)

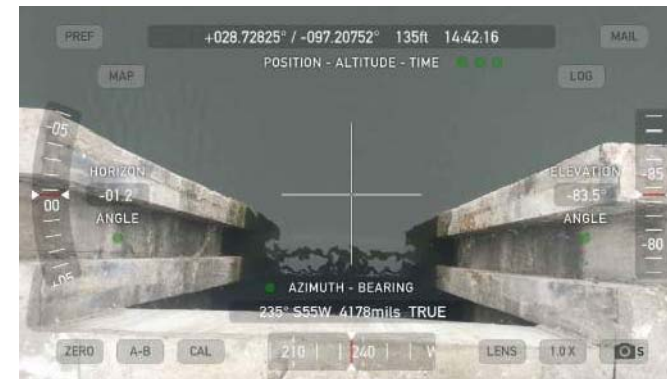
2241 - Stoplog Slots

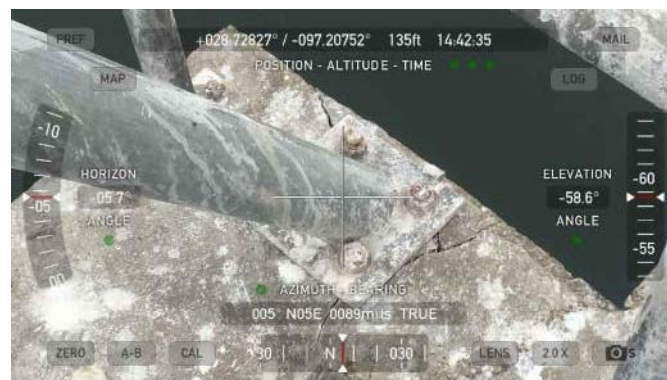
AREA INSPECTED	SPILLWAYS 1 OF 1			CHECK (X) ACTION NEEDED		
	ITEM NO.	CONDITION	OBSERVATIONS	MONITOR	INVEST-IGATE	REPAIR
INLET	30	Weir	Weir structure intake was submerged and therefore could not be inspected. The walkway access handrails were observed to have corroded bolts and were loose. Handrail bolts should be replaced as needed and handrails tightened.	X		
	31	Trashrack (if applicable)	Not observed.	X		
	32

2243 - Rusted Handrail Bolts and Cracked Concrete - Handrail is Loose

- Remove silt accumulation from the existing seepage collection system sump inlet pipe identified in photo 2180.
- For safety purposes, replace severely corroded bolts and tighten the handrails located along the Primary Ash Pond outlet works access walkway.

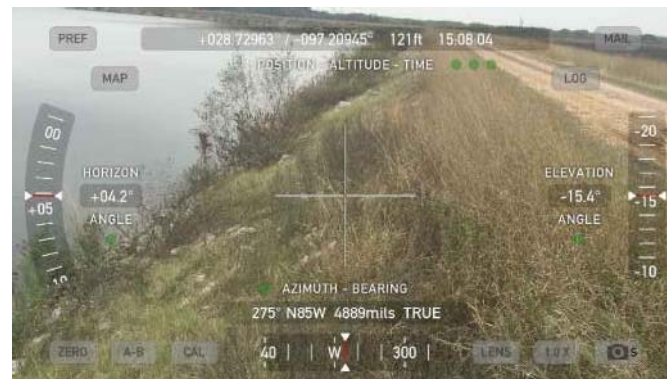
2304 - Interior, Slope Protection (Stone) Covered by Grass

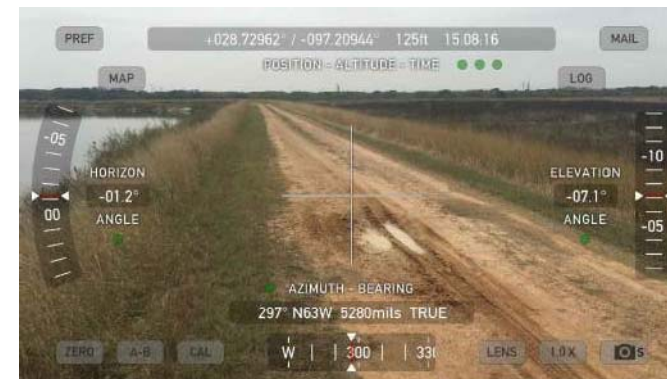
The dike crest appeared in generally good condition with only minor rutting observed in localized areas. The crest included a perimeter access road comprised of a coarse aggregate base material

2306 - Top of Levee - Minor Ruts

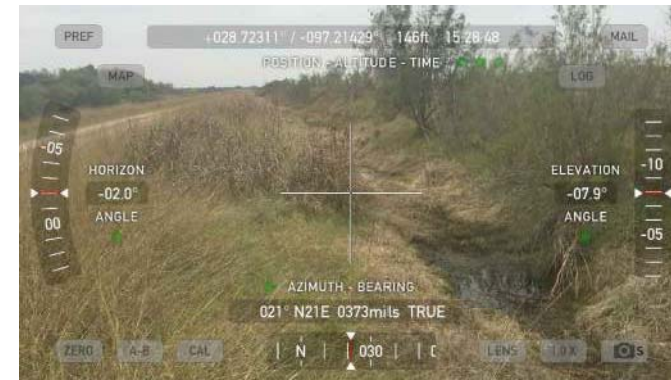
2334 - Interior (Sluice Discharge Channel)

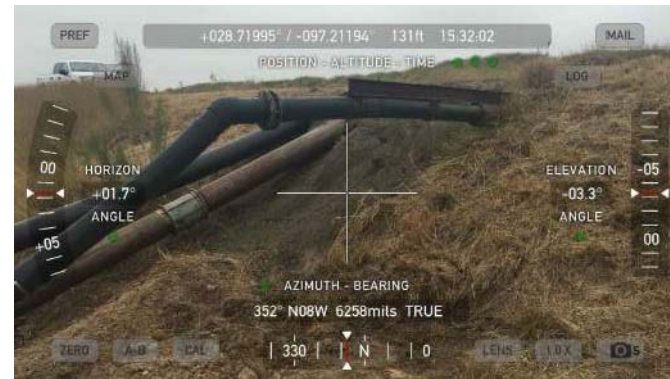
As shown in photo 2349, pipes penetrate through the upper portion of the dike within approximately 2-3 feet of the crest elevation – this is located along the south end of the Primary Ash Pond where the pond is filled with dry ash material to within a few feet of the dike crest elevation.

2349 - Exterior / Pipe Corridor

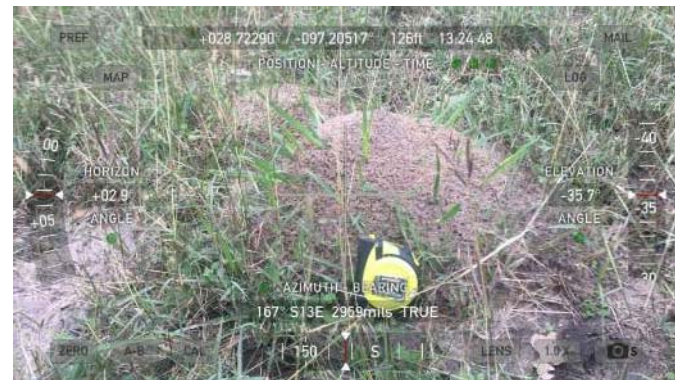
2161 - Exterior (Ant Bed)

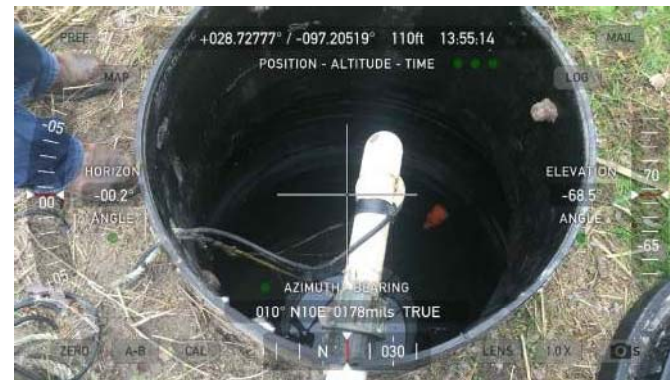
The existing seepage collection system sumps located near the pump house in the vicinity east of Sta 70+00 were visually inspected to verify they were operational. The sump located northwest of the pump station (photos 2179, 2180 and 2186) appears to have substantial silt accumulation in the incoming drain pipe. Silt should be removed to facilitate flow. Both pumps systems cycled on and appeared to work properly during the inspection.

2186 - Seepage Collection System Sump

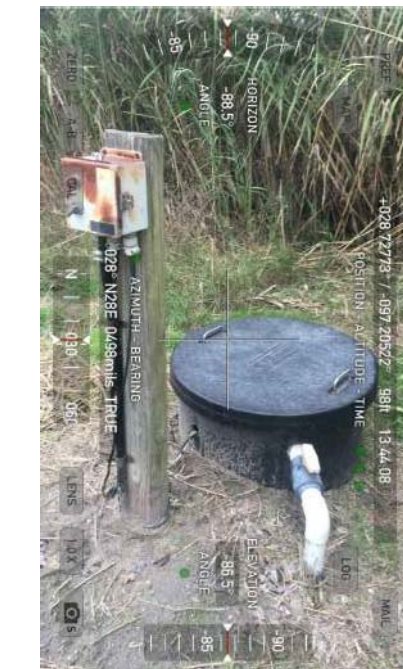
2179 - Seepage Collection System Sump

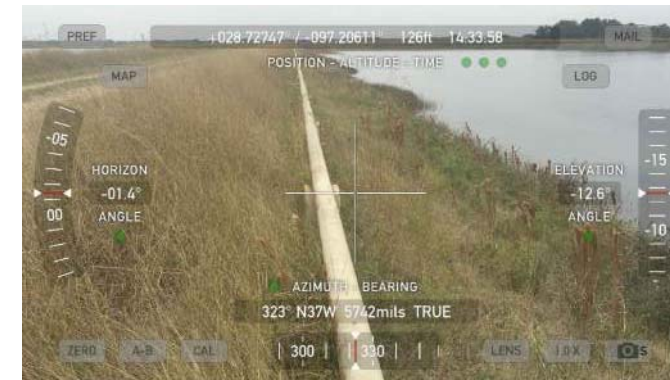
An approximate 6-inch diameter steel pipeline appears to penetrate the exterior side slope of the Secondary Pond within approximately 2-3 feet of the dike crest near Sta 128+00, and then runs along the Secondary Pond interior side slope of the shared dike as shown in photos 2218 and 2223. During this inspection the pipeline was conveying water from the existing seepage collection system into the Secondary Pond and was discharging into the Secondary Pond near the Primary Ash Pond-to-Secondary Pond outlet works. The pipeline also extends west past this discharge location (through a valve), and appears to penetrate the Secondary Pond west dike (shared with the Evaporation Pond) near Sta 111+00. The penetration appears to occur in the upper 3 feet of the dike crest and transitions into a 12-inch diameter steel pipe along the Evaporation Pond interior side slope. The 12-inch diameter pipe discharges into the Evaporation Pond. A concrete splash pad is located below the discharge pipe invert, at the toe of the Evaporation Pond dike interior side slope as shown in photo 2276. The pipe was not in operation during this inspection.

2218 - Interior

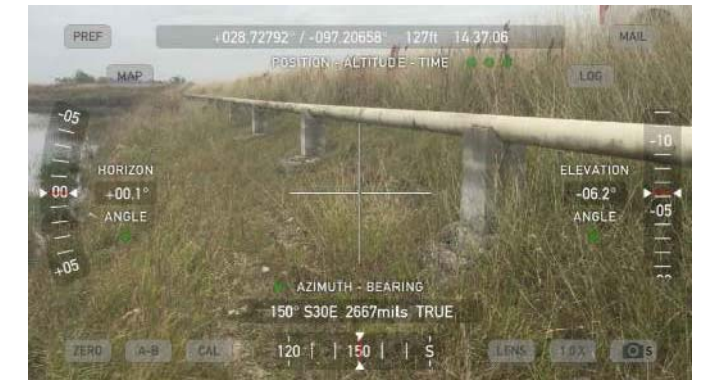
2223 - Interior

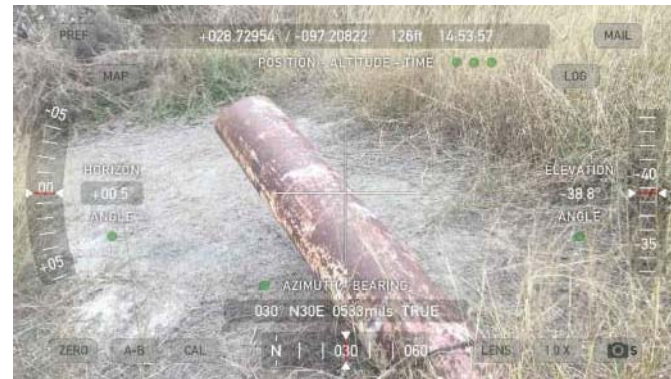
2276 - Exterior Pipe Outlet

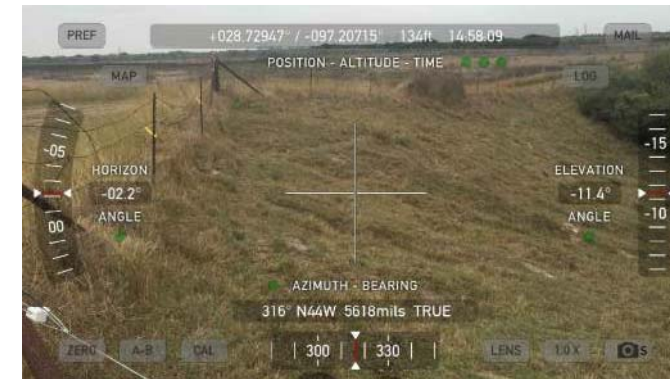
19	EROSION	Erosion associated with wet areas (see Items 14/15, above) as shown in photos. Minor erosion observed at intersection of Evaporation Pond and Secondary Pond along access ramp (near Sta 115+00).	X		
	20	UNUSUAL MOVEMENT	No indication of unusual movement observed.	X		
	21	PRESENCE/COND. OF VEGETATION	Grass generally in good condition, but tall in some areas at time of inspection - should be mowed to enhance ability to visually inspect the dikes.	X		
INSTRUMENTATION	22	PIEZOMETERS/OBSERV. WELLS	Not inspected. Piezos and wells observed and inspected during routine groundwater monitoring.	X		
	23	STAFF GAUGE AND RECORDER	Staff plate appeared in good condition. Water surface elevation observed at approximately 133.0 ft (approximately 7.0 feet below top of dike)	X		
	24	SURVEY MONUMENTS	Not observed.	X		
	25	DRAINS	There are no internal chimney drains within dike system. An existing seepage collection system, including 2 sumps and pumps, is located east of Sta 70+00. The sumps were visually inspected to verify they were operational. System appeared to operate properly; however, an inlet line to the west sump was observed with excessive silt accumulation (see photos). Silt should be removed.	X	X	X

2284 - Exterior, Minor Erosion

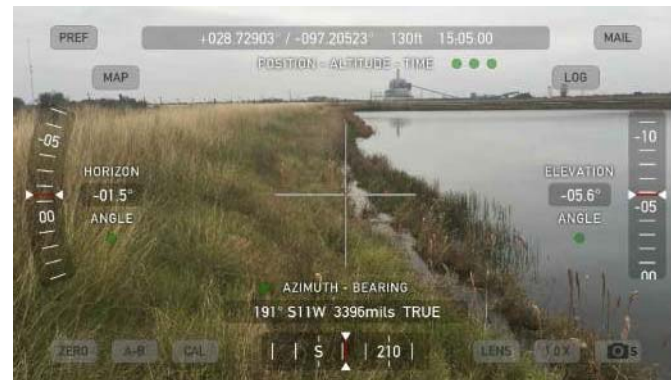
As indicated in the 2015 inspection report, the Secondary Pond interior side slopes appeared to exhibit minor to moderate and generally uniform bank cut likely due to wave action. This erosion feature appears to have occurred a long time ago given the slope is currently heavily vegetated. At the time of inspection, the water level was low enough to enable access to the interior slope as indicated in the photos. The cut does not appear to be problematic from a dike stability standpoint and no immediate action is required. Maintaining the water level as low as observed during the inspection will prevent future progression of erosion. Alternatively, armoring the slope to reduce future bank cut may be considered to reduce potential future erosion. Other than the bank cut observed, the interior slopes appear well vegetated and in generally good condition. Bank cut erosion is shown in photo 2300.

2300 - Interior / Bank Erosion
