**2016 ANNUAL CCR UNIT INSPECTION REPORT
LUMINANT – MARTIN LAKE STEAM ELECTRIC STATION
A-1 AREA LANDFILL
PANOLA COUNTY, TEXAS**

January 13, 2017

PASTOR, BEHLING & WHEELER, LLC
5416 Plaza Drive
Texarkana, Texas 75503-2704
Texas Engineering Firm No. 4760

PBW Project No. 2226B

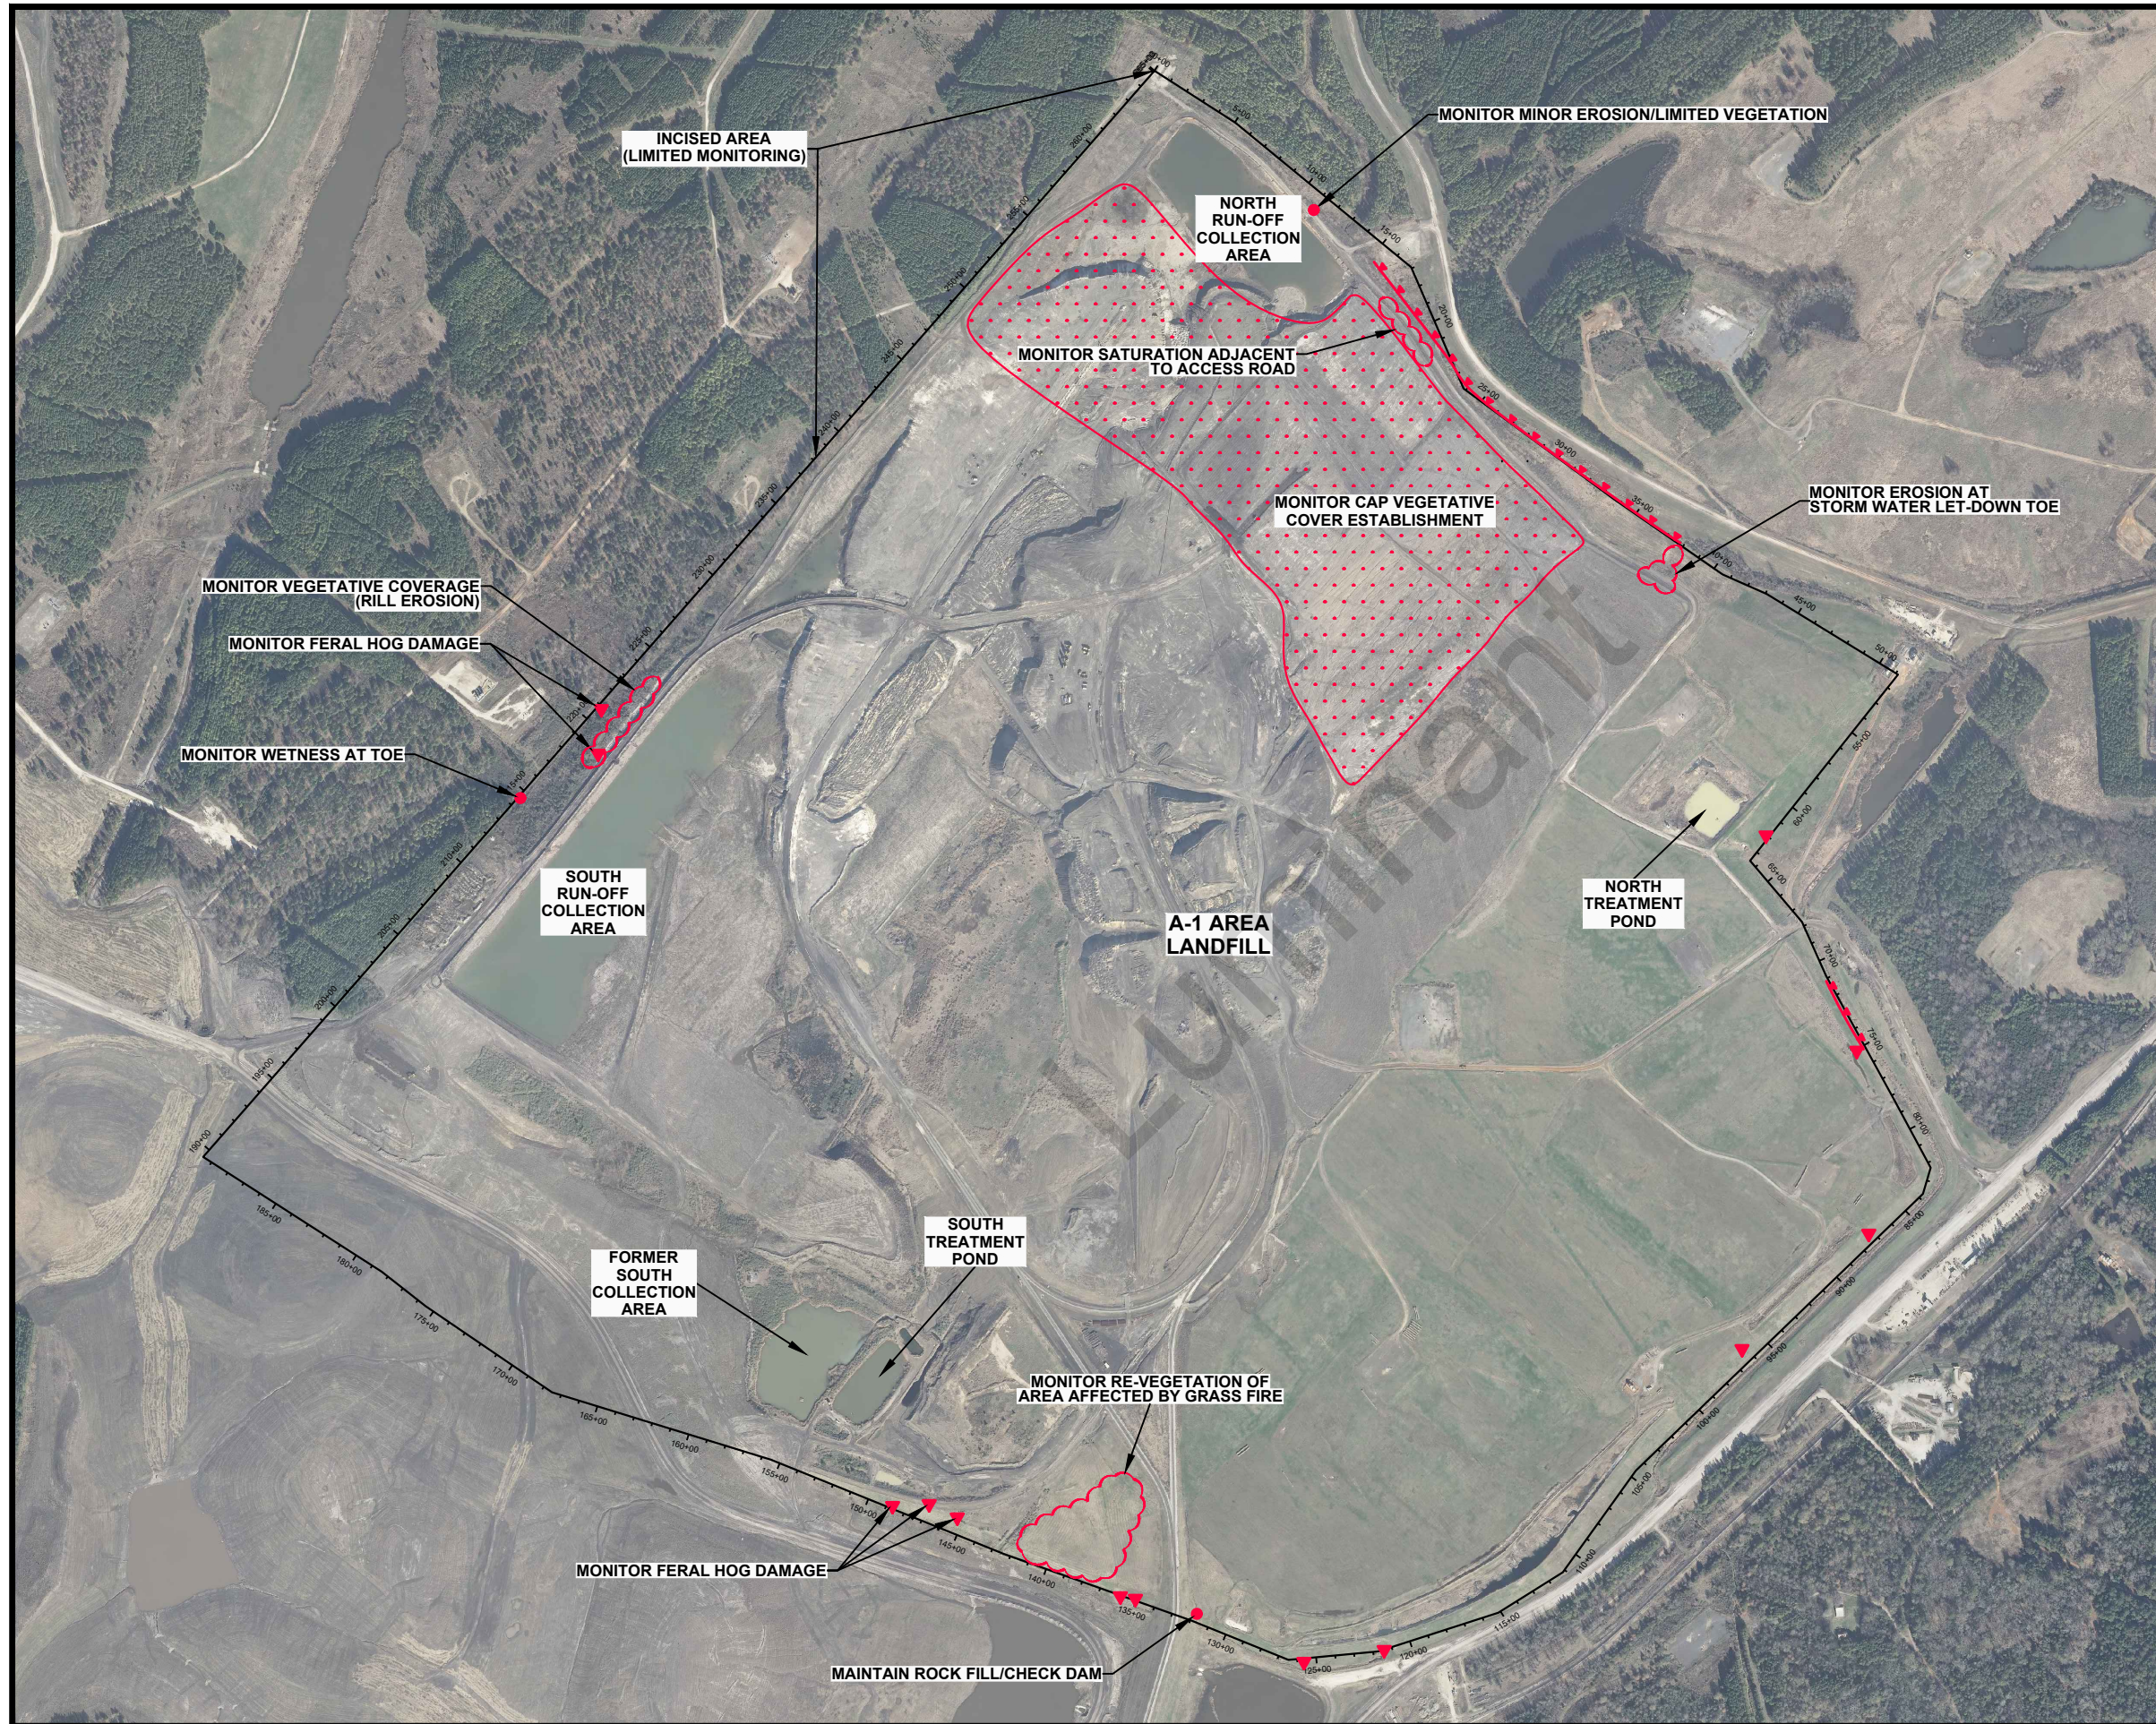
As previously noted, that surface conditions at the Site were dry due to an extended period without rainfall prior to the 2016 annual inspection. Performing the recommended monitoring of wet areas as part of the 2016 weekly inspection activities allowed for the identification of persistently wet areas. As indicated on Figure 3, the following areas were noted for future monitoring:

- Monitor limited vegetative cover and minor erosion beneath infrastructure on the NROCA downstream embankment near Station 11+00.
- Monitor the following areas where saturated soil was observed at the toe of the slope:
 - Station 15+00 to 38+00, including drainage ditch (Station 13+00 to 25+00);
 - Station 71+00 to 75+00; and
 - Toe of the SROCA embankment (Station 214+00 and 223+00);
- Monitor the wet areas at the crest of the embankment along the lower portion of the north embankment access road, which are directly adjacent to the surface water diversion berm for the NROCA (Appendix A; Photograph 3).

Monitor Wet Area at Toe
(No Active Seepage Observed
November 17, 2016)
-

Hog Damage Area
-

- Monitor the several areas where saturated soil was observed at the toe of the perimeter embankment of the landfill near Stations 15+00 to 38+00, Station 71+00 to 75+00, and the Toe of the SROCA embankment (Station 214+00 and 223+00). Wet areas at the crest of the embankment along the lower portion of the north embankment access road, which are directly adjacent to the surface water diversion berm for the NROCA should also be monitored.

- Monitor the re-vegetation of an area affected by a recent grass fire on the southernmost closed portion of the landfill.
- Monitor isolated areas of minor erosion occurring in areas with limited vegetative cover noted on Figure 3. Continue to monitor/repair feral hog damage present on the embankment to ensure erosion is not occurring due to the irregular slope and loss of vegetation (Figure 3). These areas should be repaired when conditions allow and the existing deterrent program should be reviewed and improved to prevent further damage to the extent practicable.

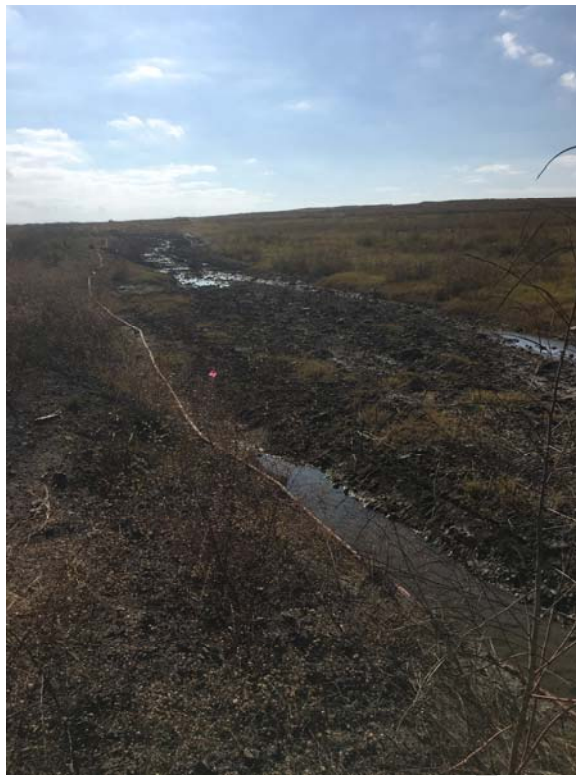
Pastor, Behling & Wheeler PROJECT NO. 2226-B	DESCRIPTION	Photograph 1 – (View Southeast) Drainage to NROCA along the toe of the storm water diversion berm (at left). Landfill cap visible at right.	
	SITE NAME	Martin Lake A-1 Area Landfill – Annual Inspection	DATE 11/17/2016

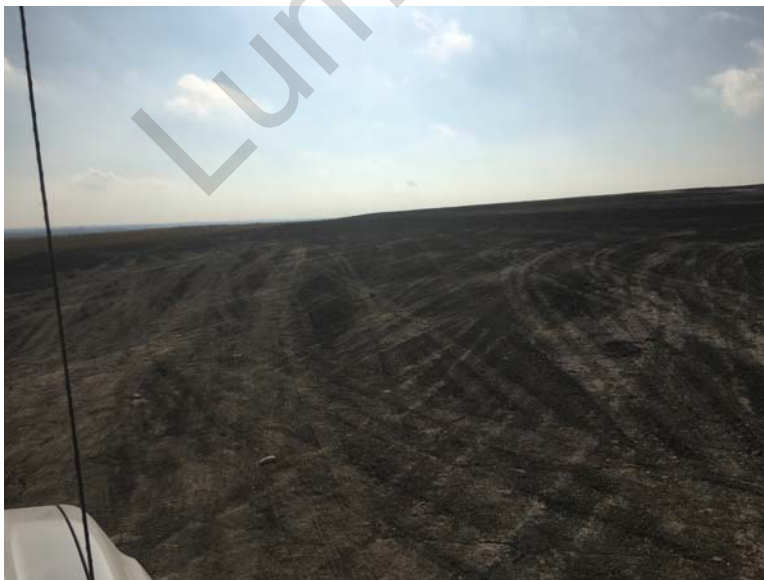
Pastor, Behling & Wheeler PROJECT NO. 2226-B	DESCRIPTION	Photograph 2 – (View South) Recently placed Clay cap	
	SITE NAME	Martin Lake A-1 Area Landfill – Annual Inspection	DATE 11/17/2016

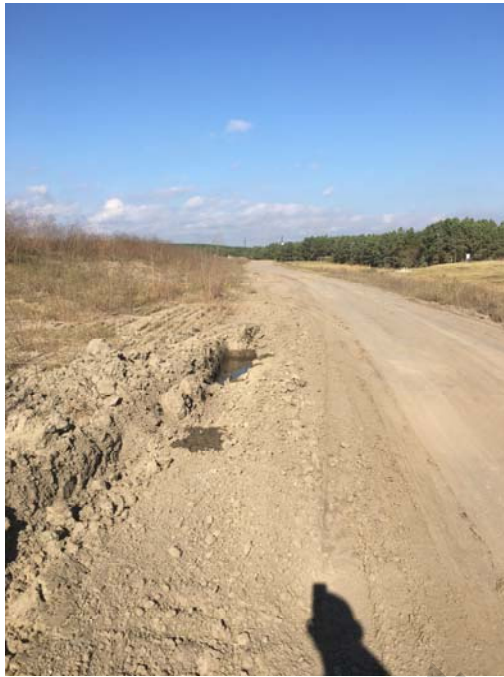
Pastor, Behling & Wheeler	DESCRIPTION	Photograph 3 – (View Northwest) Saturated soil along north access road. Diversion berm for NROCA visible at left.	
PROJECT NO. 2226-B	SITE NAME	Martin Lake A-1 Area Landfill – Annual Inspection	DATE 11/17/2016

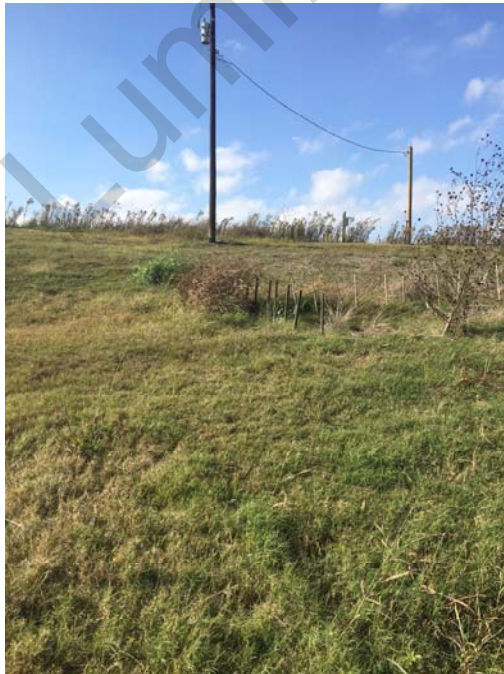
To reduce the hydraulic head within the sand strata identified as the source of the seep near Station 27+00, interim measures were initiated on September 1, 2016 by installing and operating a constant drawdown dewatering pump in an existing 4-inch piezometer (GT-5). To date, over 800,000 gallons of water has been pumped from GT-5, which is completed at the crest of the embankment within the saturated sand strata underlying the embankment. Static water levels within the sand strata in the vicinity of the former seep have been lowered between 3.5 to 6.5 feet as a result of the interim measures.

Pastor, Behling & Wheeler	DESCRIPTION	Photograph 4 – (View Southwest) Former embankment repair near Station 27+00. GT-5 visible between power poles (top of embankment).	
PROJECT NO. 2226-B	SITE NAME	Martin Lake A-1 Area Landfill – Annual Inspection	DATE 11/17/2016

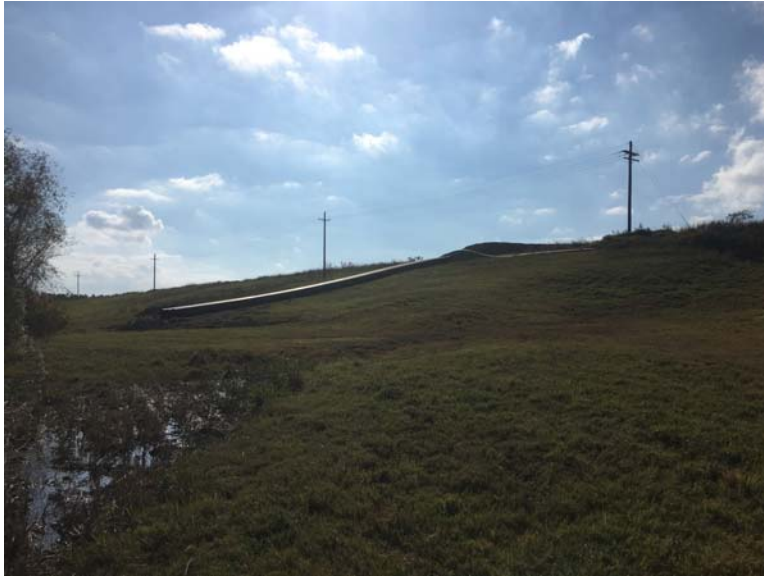
Pastor, Behling & Wheeler	DESCRIPTION	Photograph 5 – (View Southeast) Storm water let-down structure	
PROJECT NO. 2226-B	SITE NAME	Martin Lake A-1 Area Landfill – Annual Inspection	DATE 11/17/2016

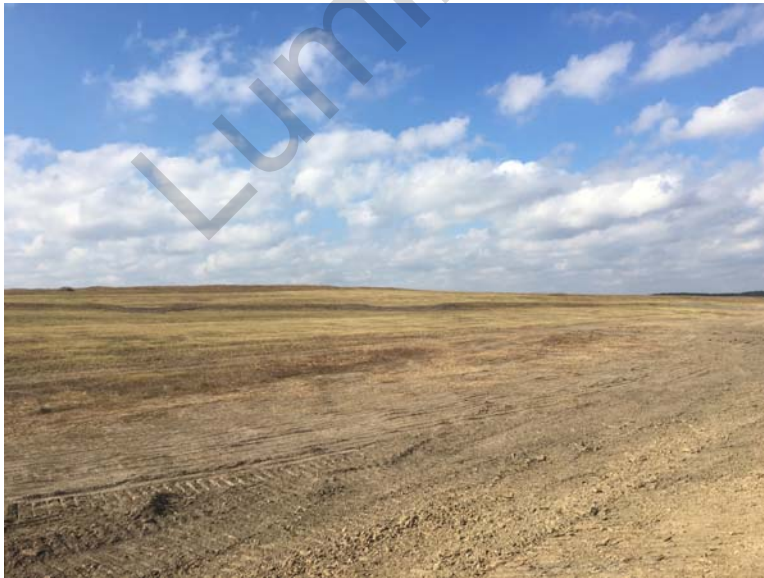
Pastor, Behling & Wheeler	DESCRIPTION	Photograph 6 – (View West) Landfill cap near inlet to storm water let-down structure.	
PROJECT NO. 2226-B	SITE NAME	Martin Lake A-1 Area Landfill – Annual Inspection	DATE 11/17/2016

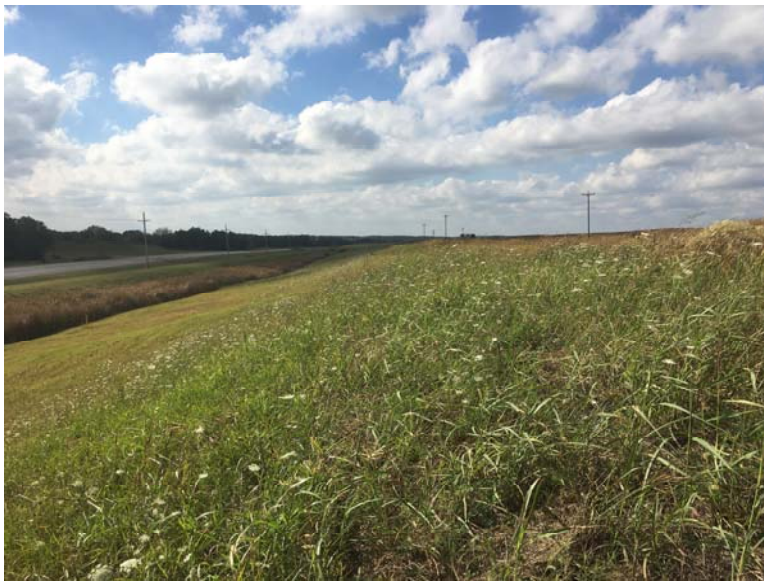
Pastor, Behling & Wheeler PROJECT NO. 2226-B	DESCRIPTION	Photograph 7 – (View Southwest) South embankment with drainage ditch conveying treated effluent from North Treatment Pond at left.	
	SITE NAME	Martin Lake A-1 Area Landfill – Annual Inspection	DATE 11/17/2016

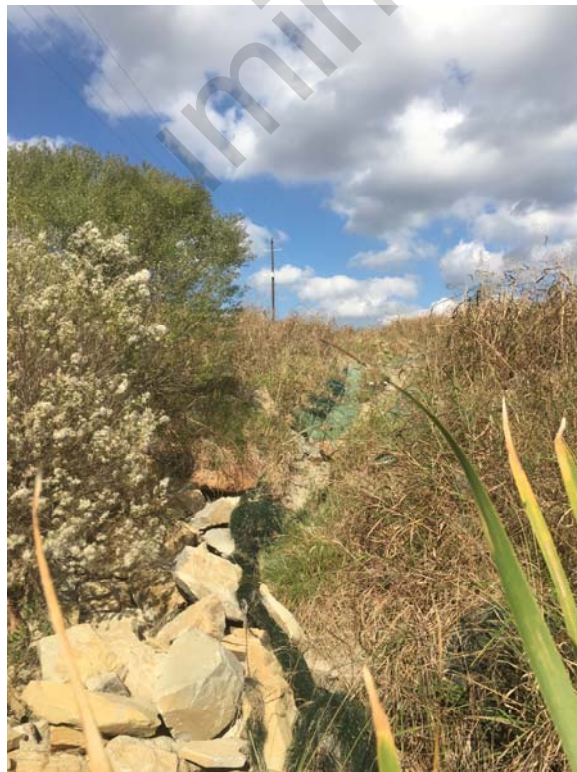
Pastor, Behling & Wheeler PROJECT NO. 2226-B	DESCRIPTION	Photograph 8 – (View North) Former area of groin erosion repaired with rockfill and erosion control mat.	
	SITE NAME	Martin Lake A-1 Area Landfill – Annual Inspection	DATE 11/17/2016

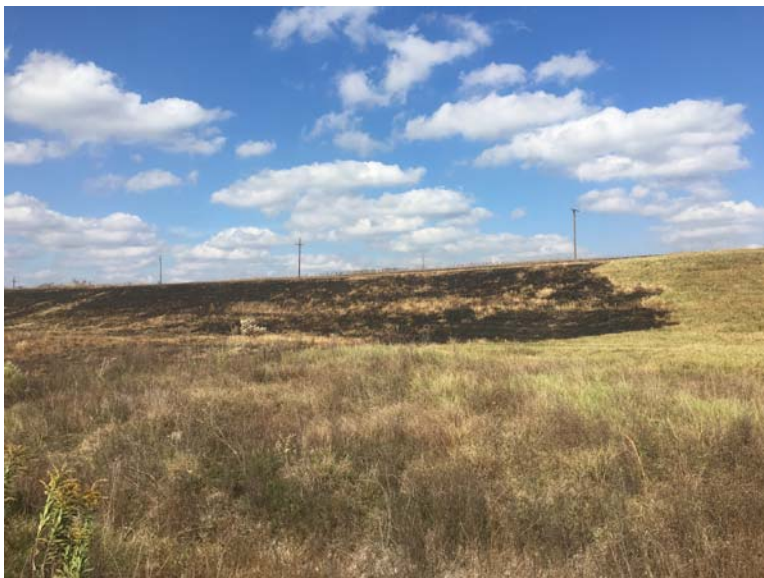
Pastor, Behling & Wheeler PROJECT NO. 2226-B	DESCRIPTION	Photograph 9 – (View North) South embankment and cap areas affected by a recent grass fire.	
	SITE NAME	Martin Lake A-1 Area Landfill – Annual Inspection	DATE 11/17/2016

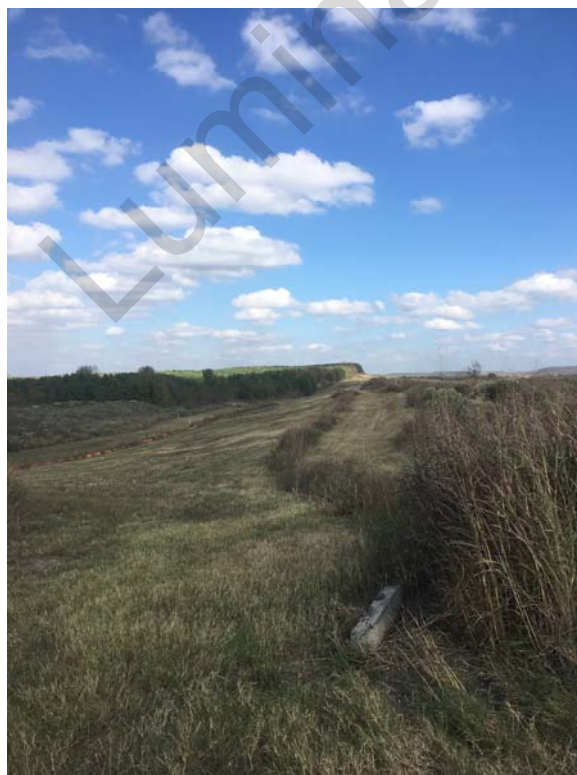
Pastor, Behling & Wheeler PROJECT NO. 2226-B	DESCRIPTION	Photograph 10 – (View Northeast) Downstream embankment of South Run-off Collection Area	
	SITE NAME	Martin Lake A-1 Area Landfill – Annual Inspection	DATE 11/17/2016
