**ANNUAL CCR UNIT INSPECTION REPORT
LUMINANT – SANDOW 5 GENERATING PLANT
AX LANDFILL
MILAM COUNTY, TEXAS**

January 14, 2016

PBW Project No. 5170B

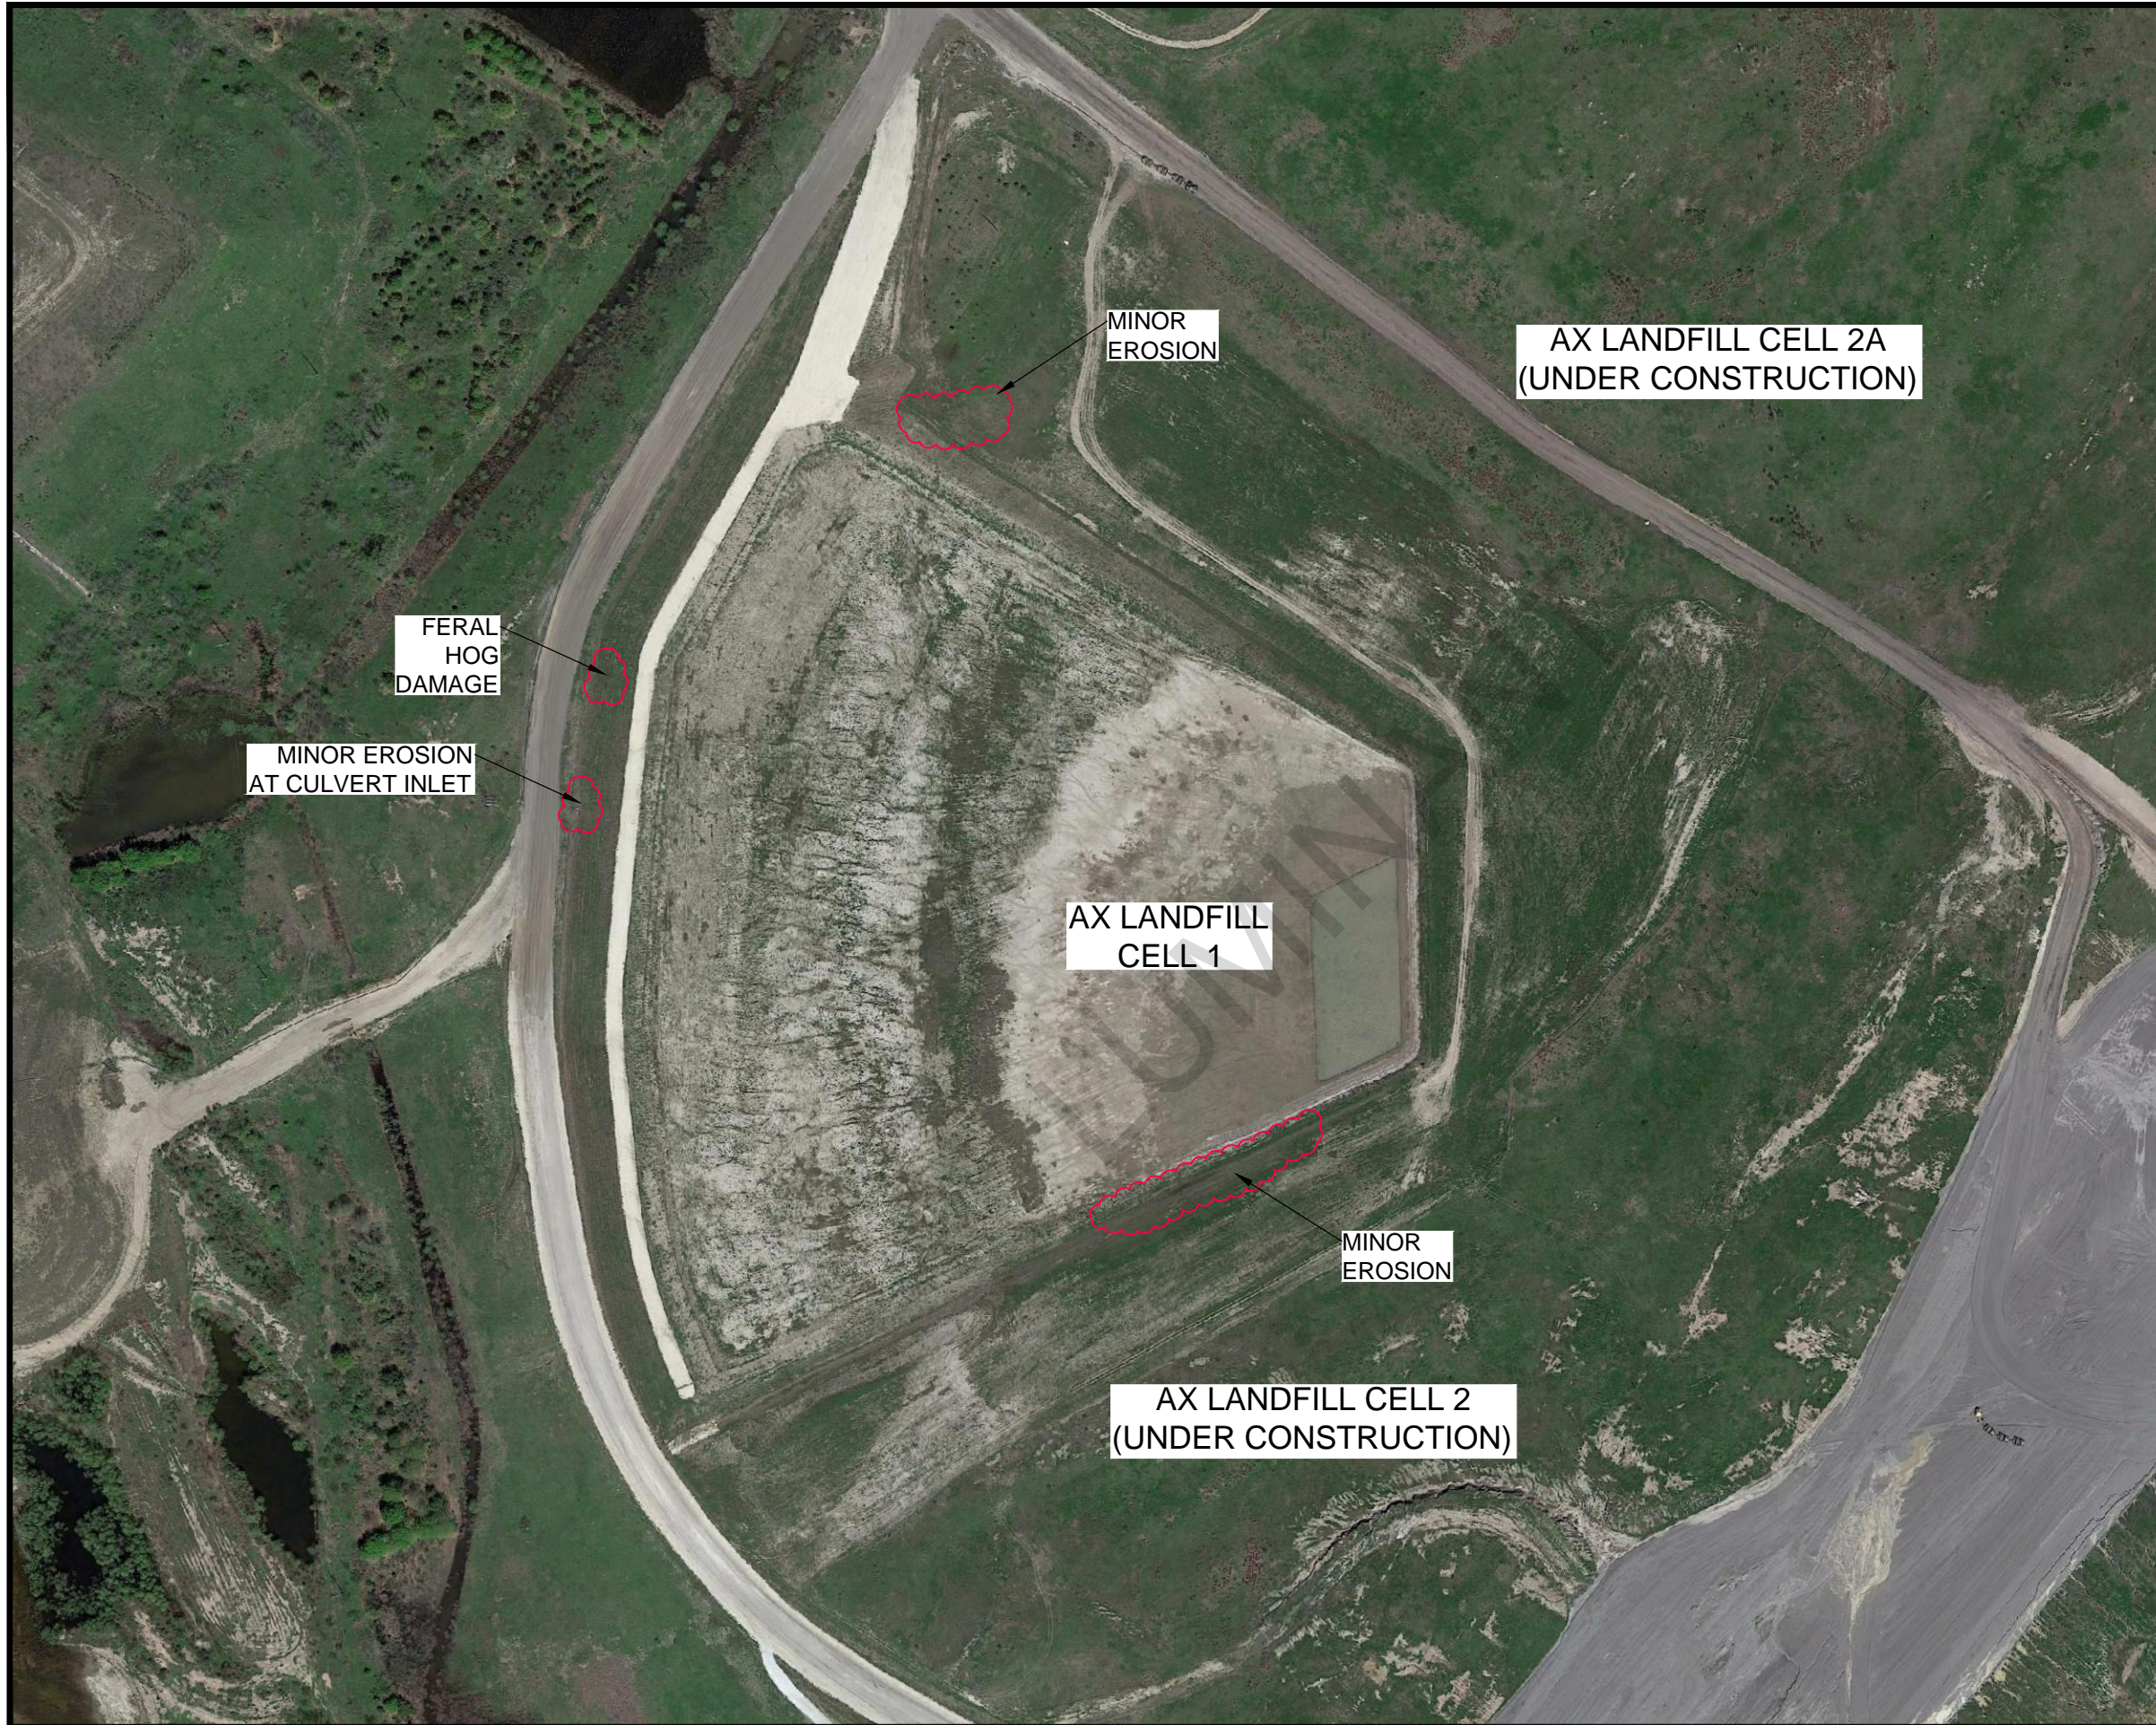
Figure 3
**ANNUAL INSPECTION
FINDINGS SUMMARY MAP
AX LANDFILL**

As indicated on Figure 3, the following areas were noted for future monitoring for AX Landfill

- Minor erosion was observed below the inverts of two culverts near the toe of the exterior embankment on the west side of the landfill. This area should continue to be monitored and repaired if the erosion becomes severe.
- Minor erosion was observed in small areas along the exterior slopes of the temporary embankments on the north and south sides of Cell. These areas should continue to be monitored and repaired as necessary.
- Feral hog damage was observed in a small area on the exterior of the permanent embankment on west side of Cell 1. This area should be monitored and repaired as necessary.

MINOR
EROSION

FERAL
HOG
DAMAGE

MINOR EROSION
AT CULVERT INLET

- Luminant should continue to monitor the areas of concern listed in Section 3.0 of this report.
- This annual inspection report should be completed by filing the report in the operating record of the respective CCR units no later than January 19, 2016.
- The 2016 annual inspection of the AX Landfill should be performed in November/December 2016 unless otherwise required by the CCR rule.

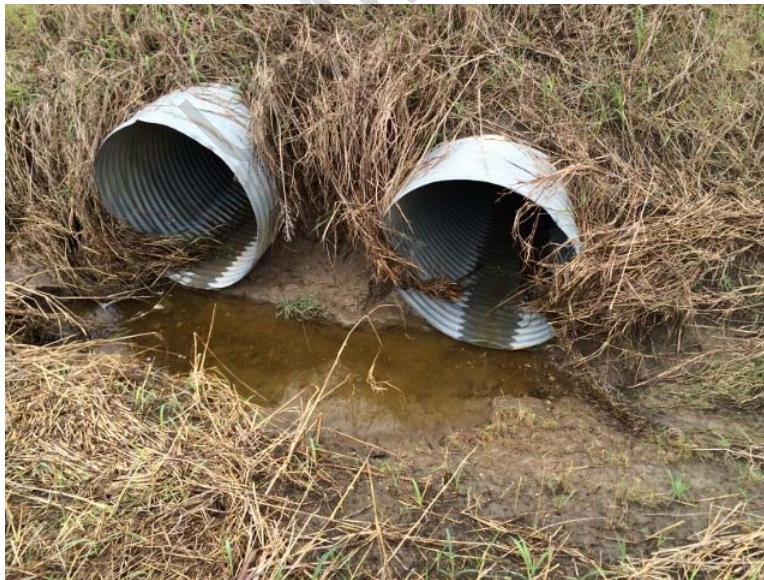
- Monitor minor erosion on the south side of Cell 1 exterior embankment slope near the access ramp; and
- Monitor minor erosion beneath the inverts of two culverts near the toe of the exterior embankment on the west side of the landfill.

Pastor, Behling & Wheeler	DESCRIPTION	Photograph 2 – Minor erosion beneath two culverts at embankment toe on west side of Cell 1	
PROJECT NO. 5170B	SITE NAME	Sandow 5 Generating Plant – AX Landfill Annual Inspection	DATE 11/17/2015

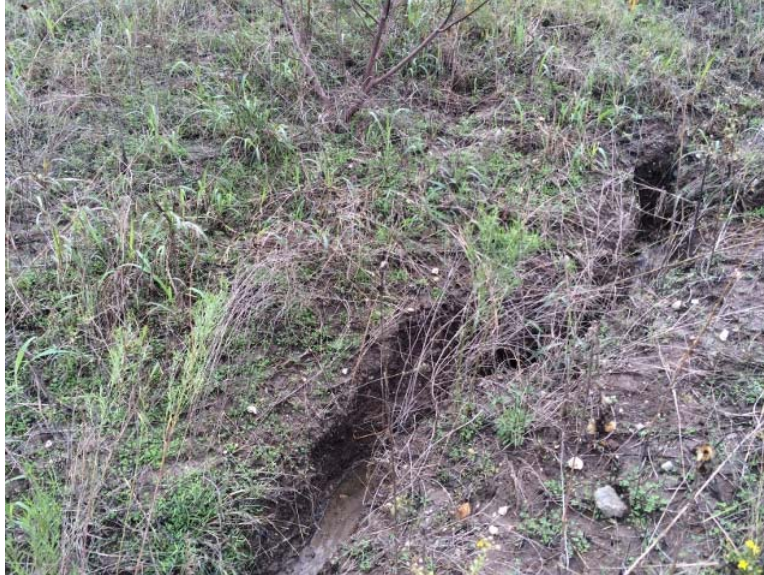
Pastor, Behling & Wheeler	DESCRIPTION	Photograph 6 – Minor erosion on face of temporary embankment between Cell 1 and Cell 2A	
PROJECT NO. 5170B	SITE NAME	Sandow 5 Generating Plant – AX Landfill Annual Inspection	DATE 11/17/2015
