**Subject: USEPA CCR Rule and IEPA Part 845 Rule Applicability Cross-Reference
2021 USEPA CCR Rule Periodic Certification Report
GMF Pond, Duck Creek Power Plant, Canton, Illinois**

**2021 USEPA CCR RULE PERIODIC
CERTIFICATION REPORT
§257.73(a)(2), (c), (d), (e) and §257.82
GMF POND
Duck Creek Power Plant
Fulton County, Illinois**

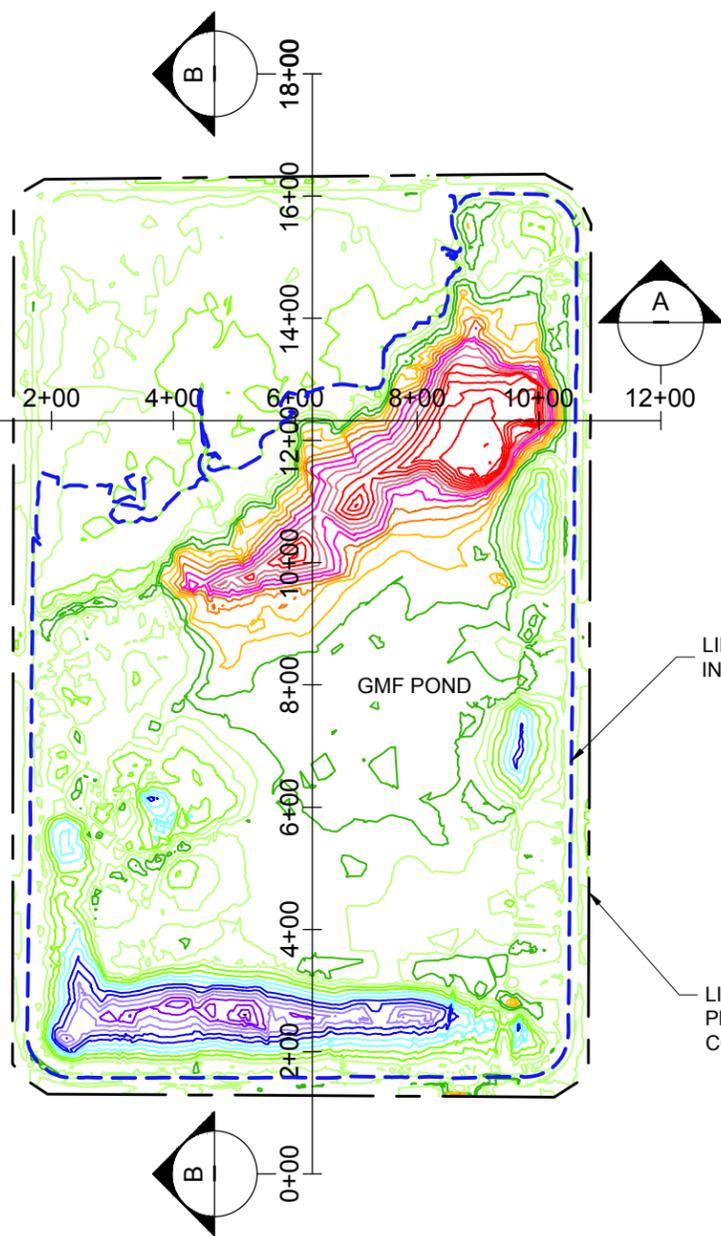
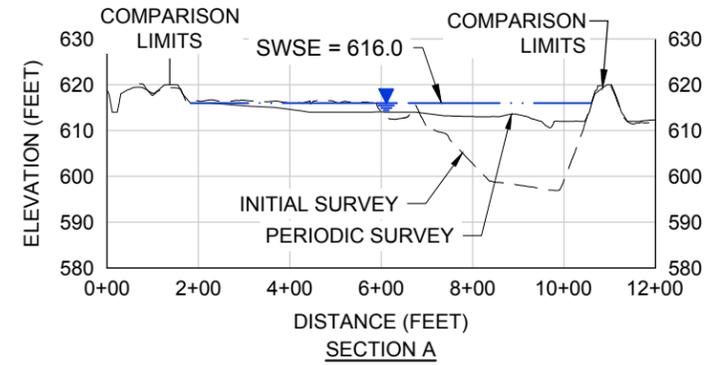
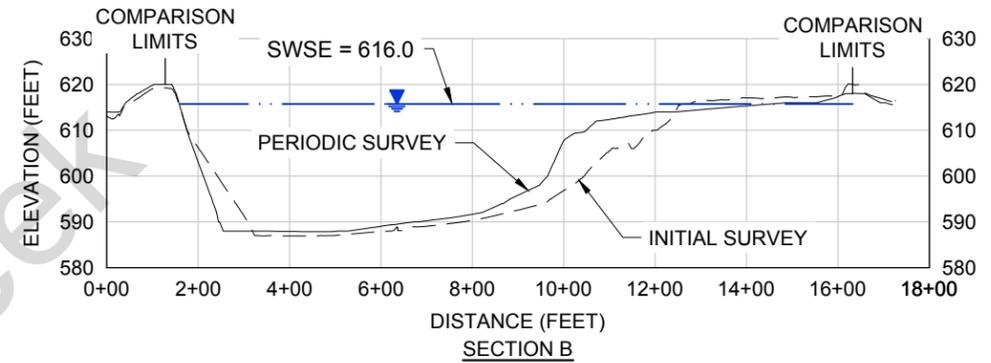
GMF POND DUCK CREEK POWER PLANT CANTON, ILLINOIS	
GLP8027.03	AUGUST 2021
DRAWING	
2

The comparison indicated that approximately 8,000 CY of CCR was placed in the GMF Pond between the initial and periodic surveys. The CCR was placed entirely below the SWSE and a net cut occurred above the SWSE. CCR grades above the SWSE were generally similar to the initial survey (e.g., within +/- 2 ft). These changes are considered unlikely to result in increase in the peak water surface elevation (PWSE) during a flood event, as additional flood storage is present relative to conditions observed in 2015. No significant changes to embankment geometry appeared to have occurred between the initial and periodic surveys.

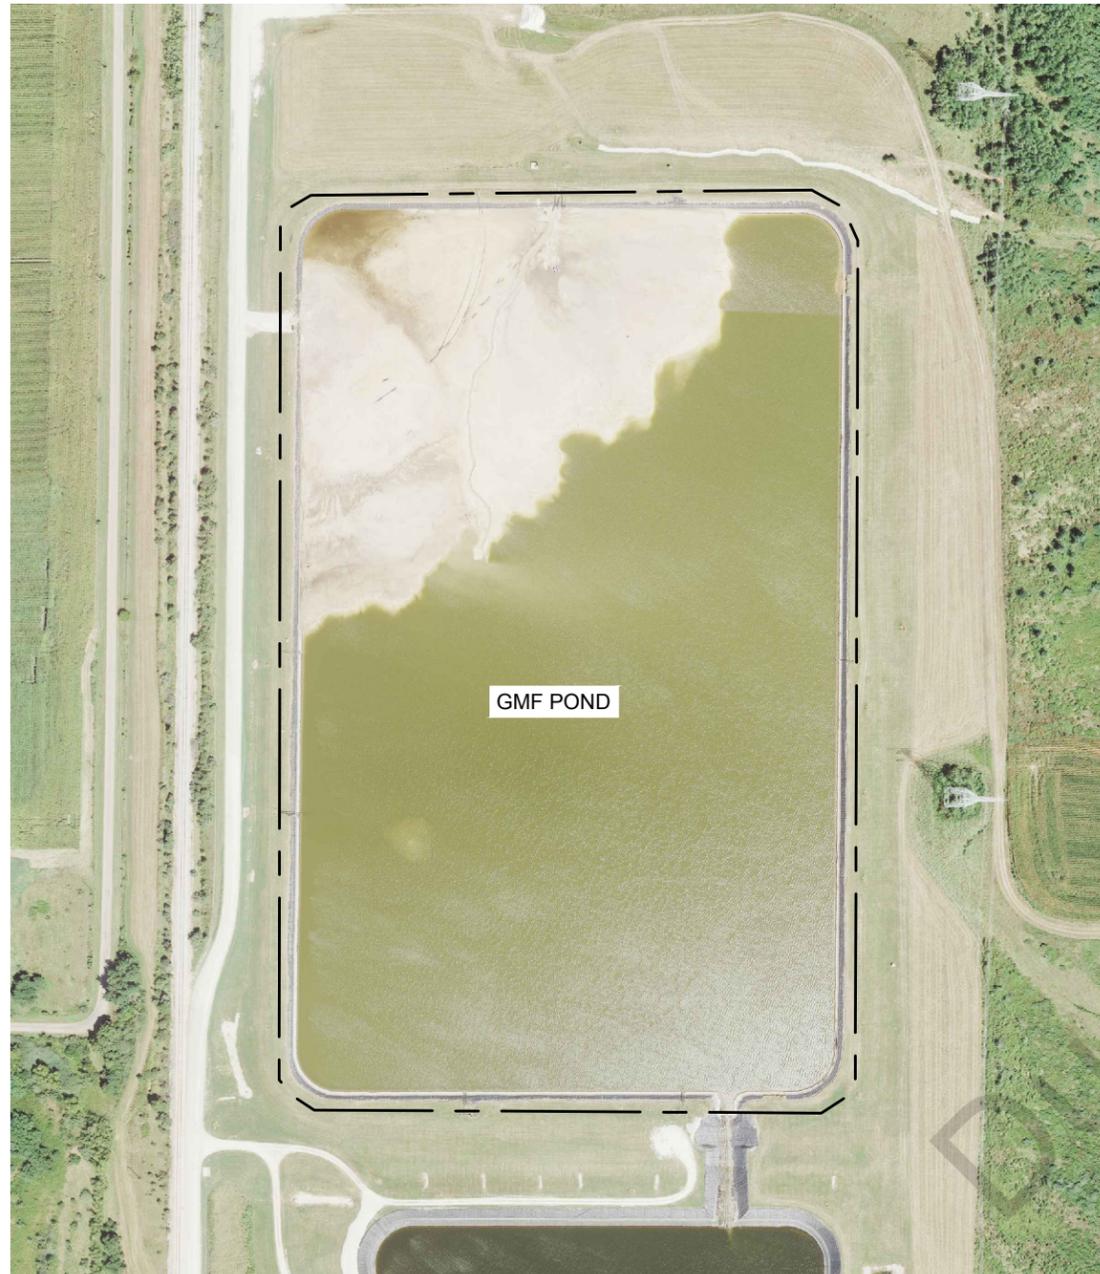
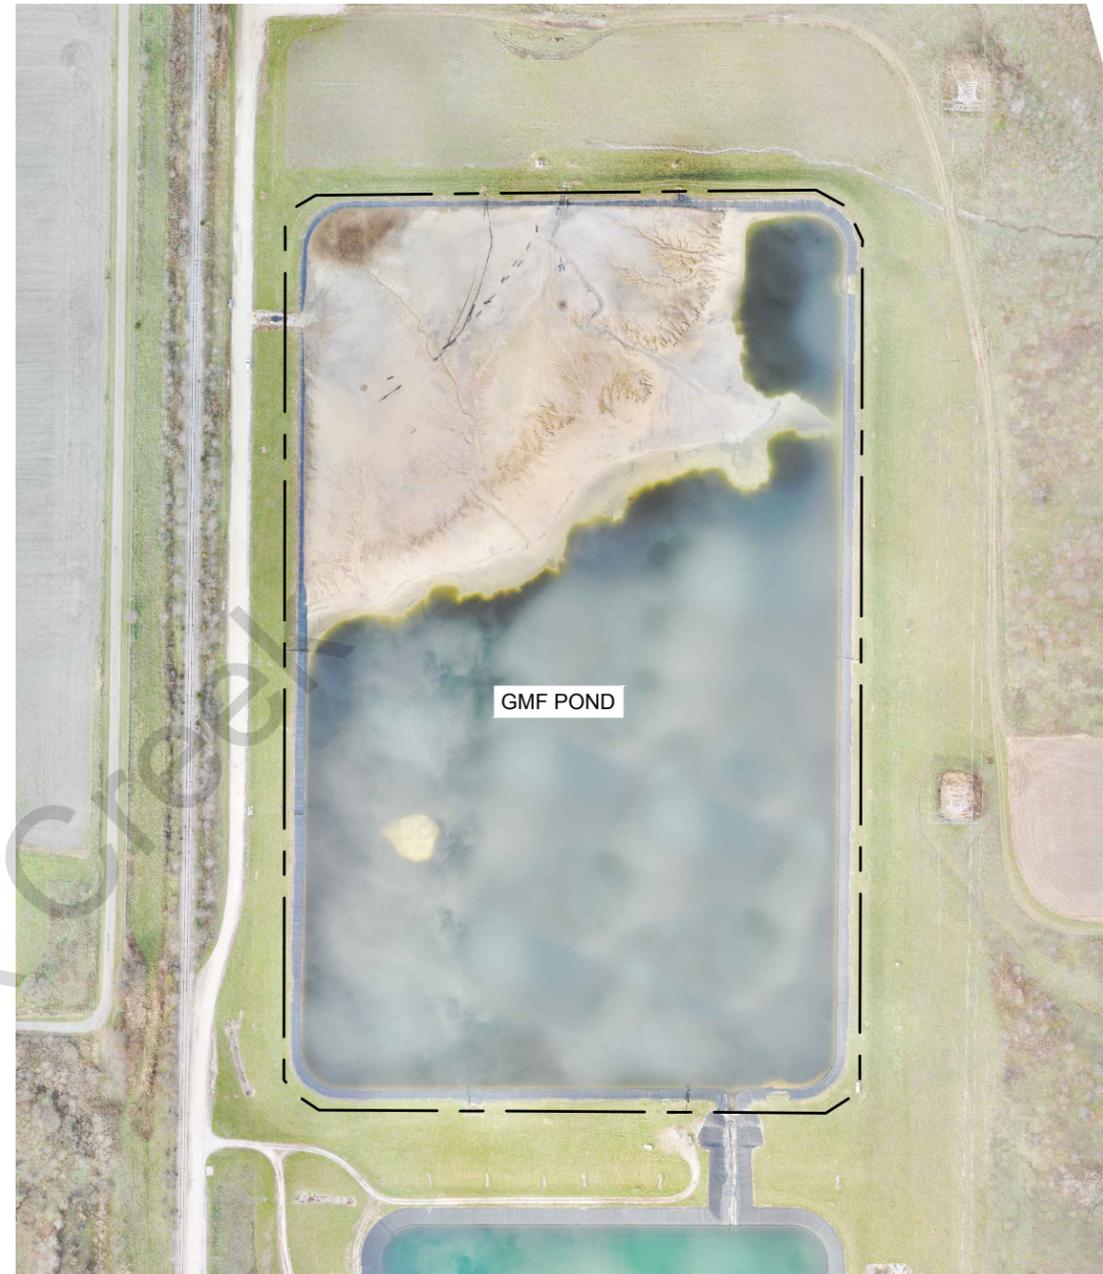
may have occurred. A comparison of these aerial photographs is provided in **Drawing 3**. No significant changes were noted during this comparison.

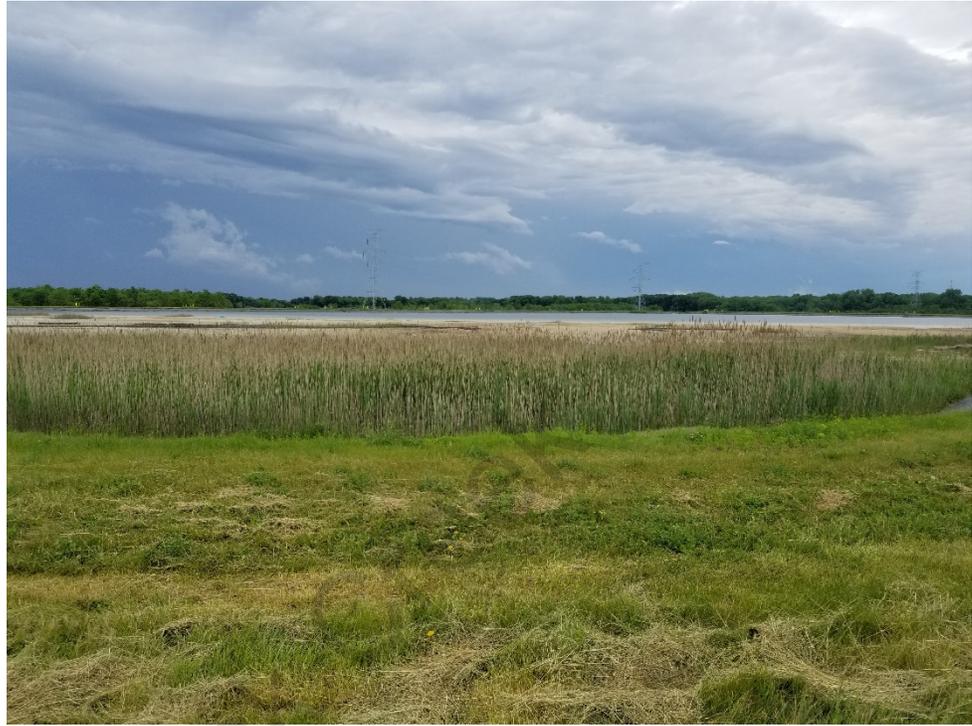
Comments:
GMFP north
overview

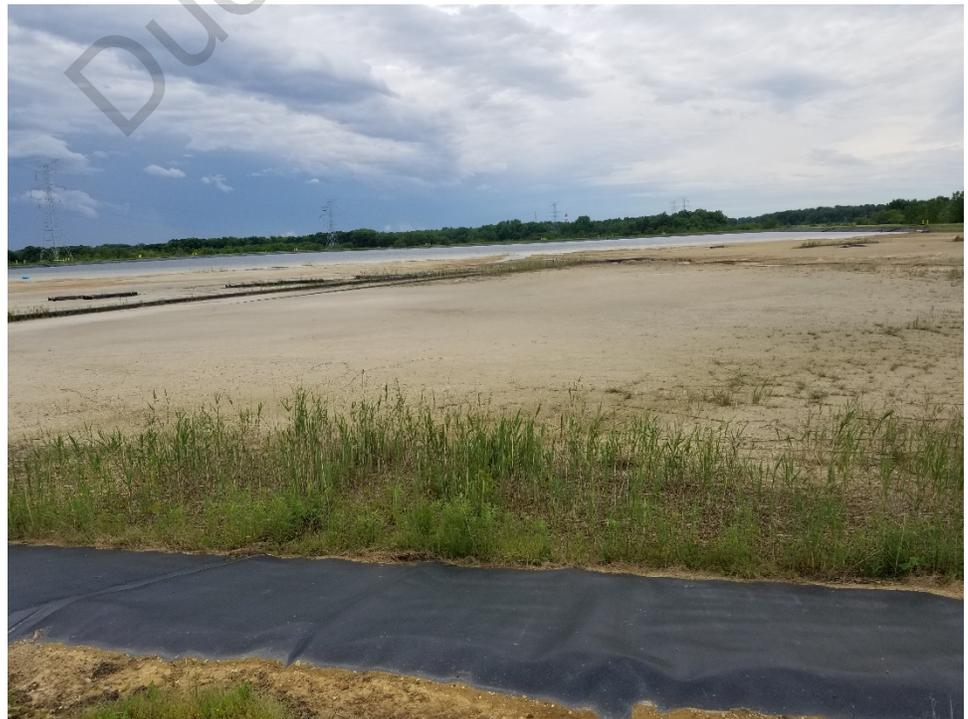
Photo: 02

Comments:
GMFP north
overview

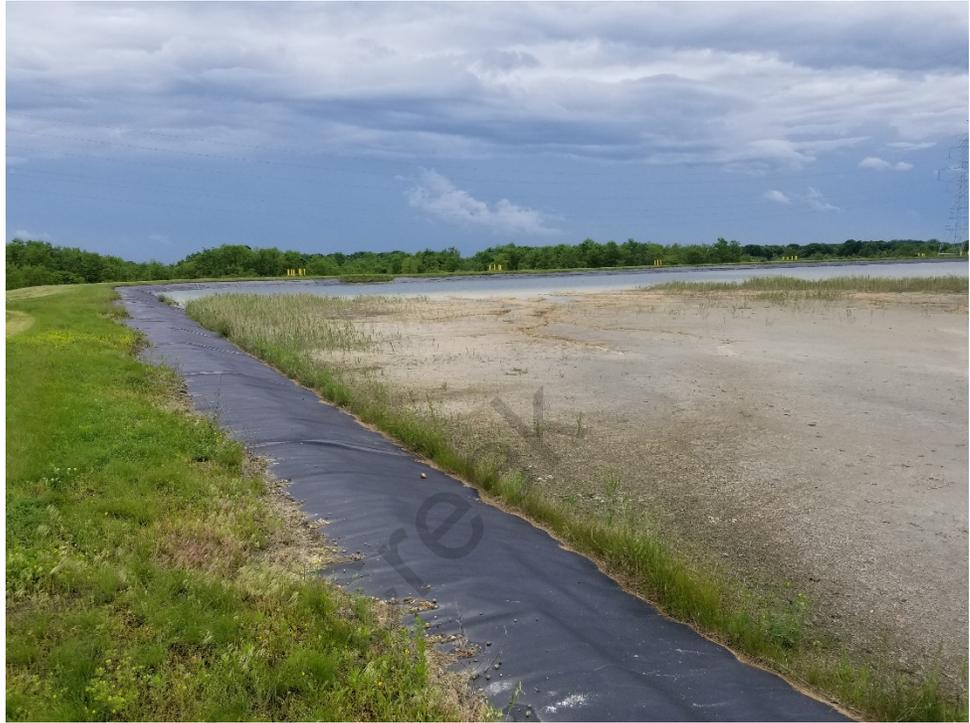
Comments:
GMFP north
interior slope and
crest.

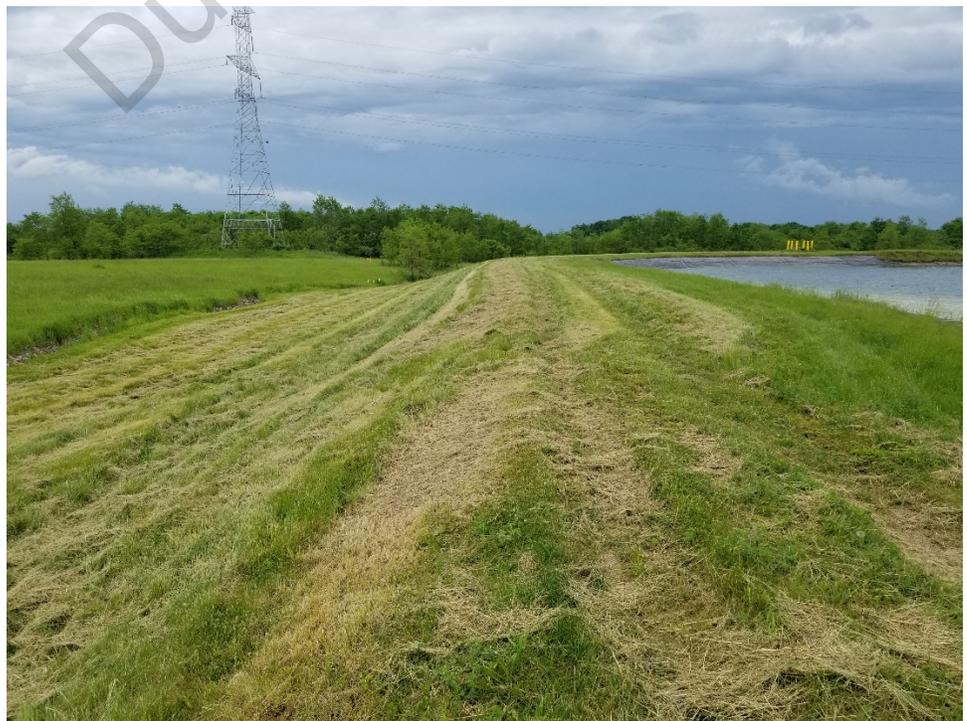
Photo: 04

Comments:
GMFP north
exterior slope and
crest.

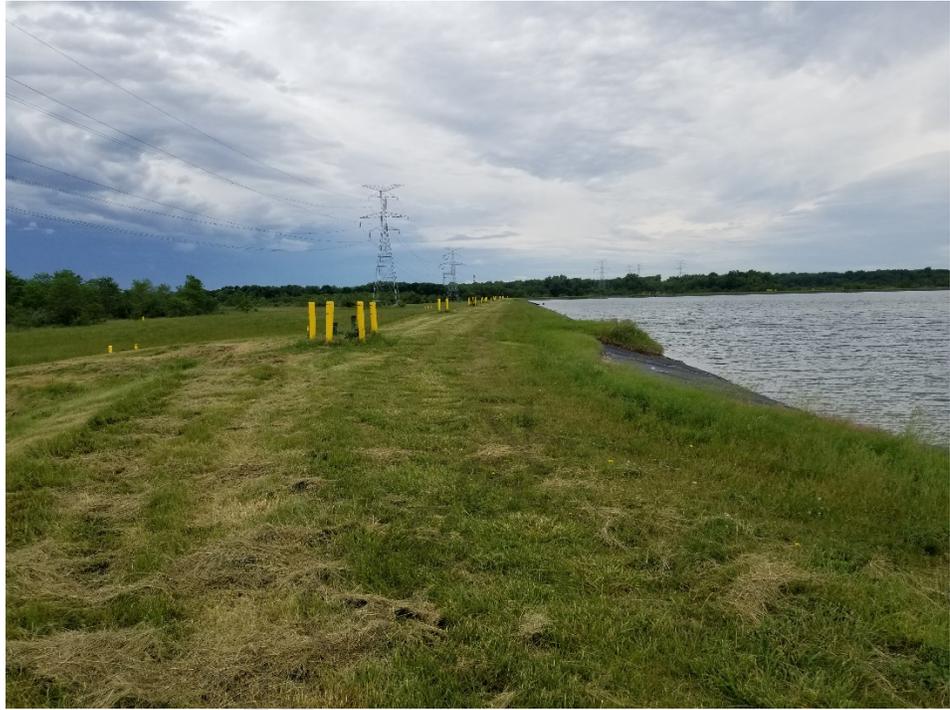
Photo: 05
Date: 05/27/2021
Direction Facing:
S
Comments:
GMFP east exterior
slope and crest.

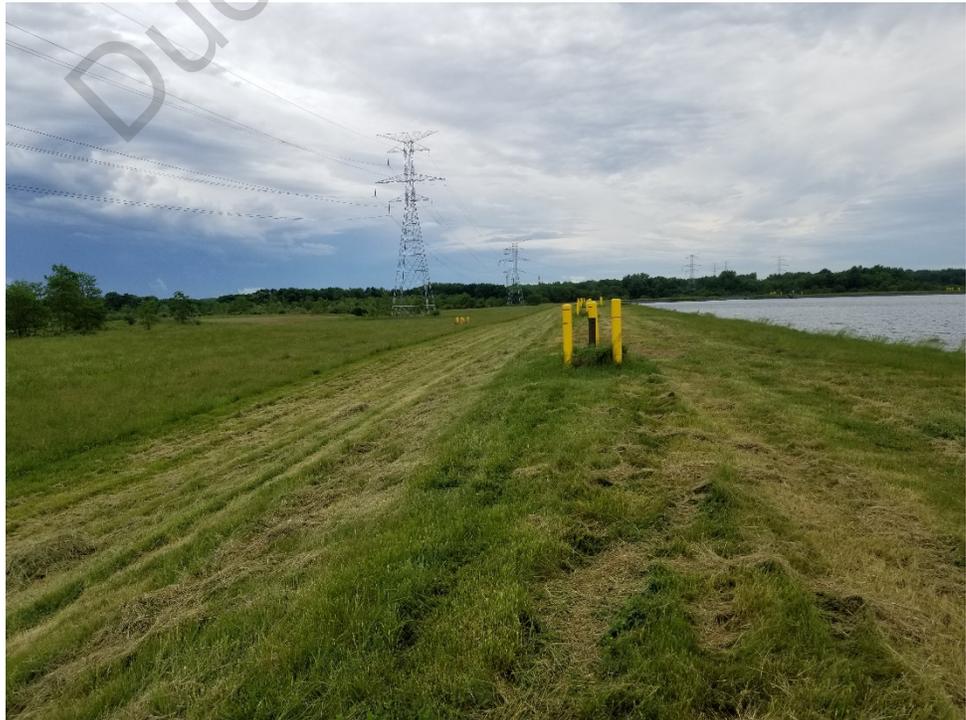
Photo: 06
Date: 05/27/2021
Direction Facing:
N
Comments:
GMFP east exterior
slope and crest.

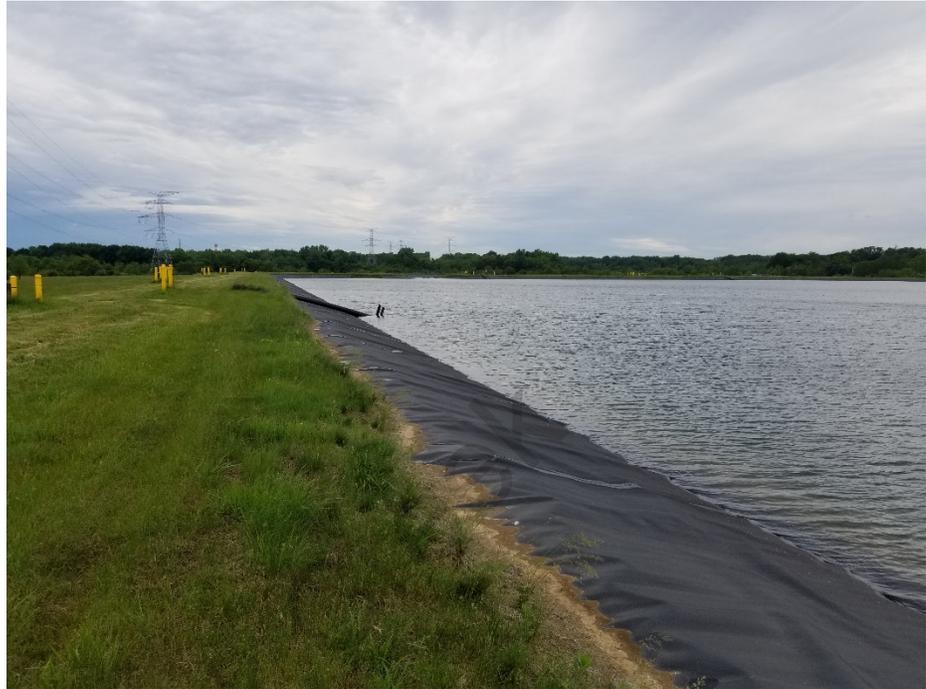
Photo: 07
Date: 05/27/2021
Direction Facing:
S
Comments:
GMFP east interior
slope and crest.

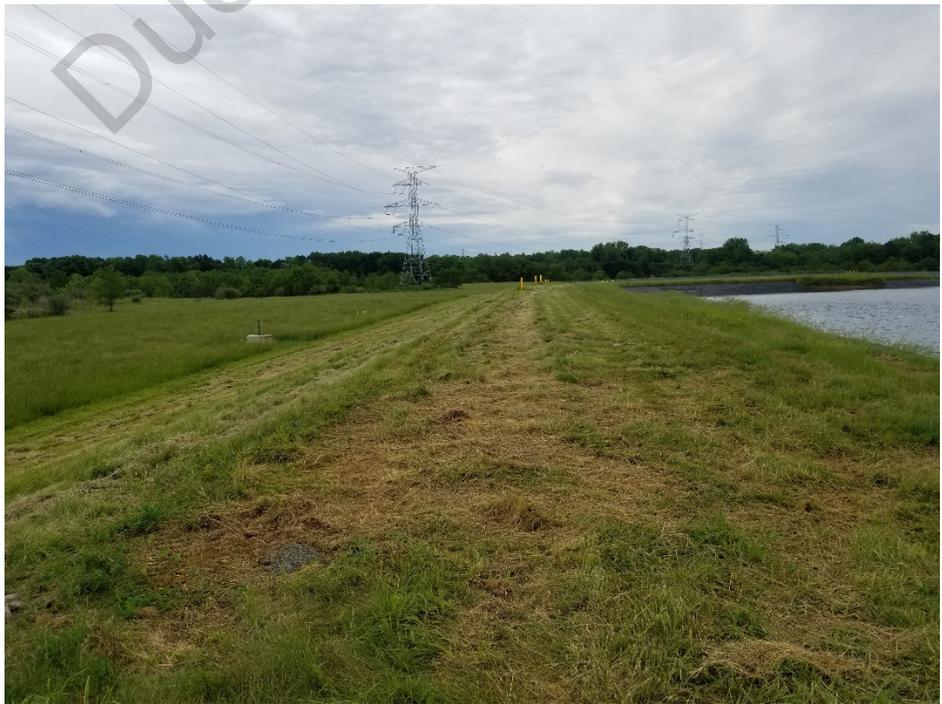
Photo: 08
Date: 05/27/2021
Direction Facing:
S
Comments:
GMFP east slope
crest.

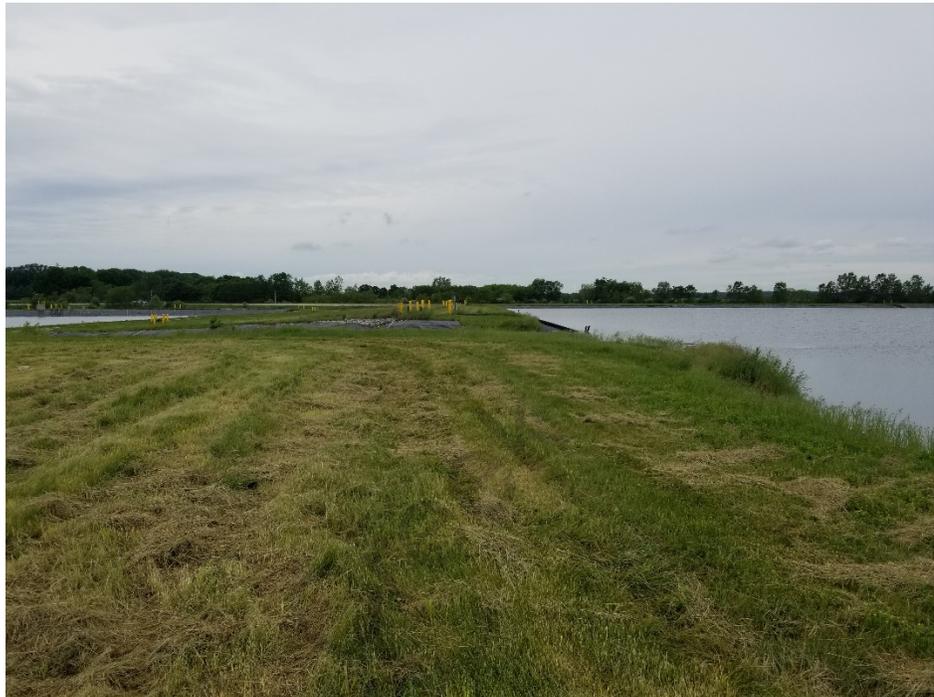
Comments:
GMFP south crest
and transfer
channel.

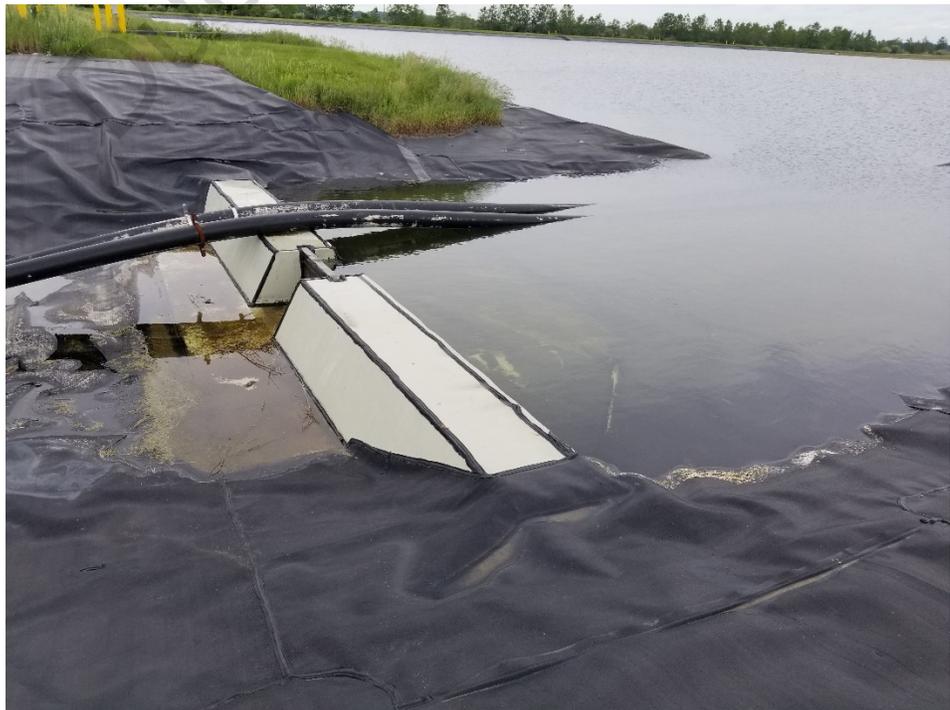
Photo: 10

Comments:
GMFP transfer
channel and weir.
All stoplogs were
installed.

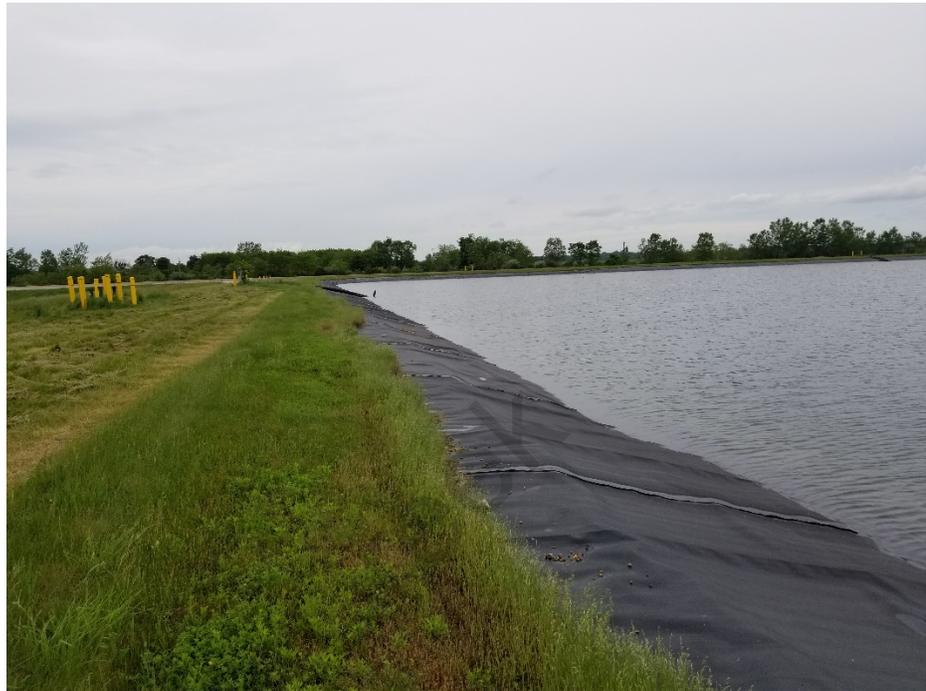
Comments:
GMFP south dike
interior slope.

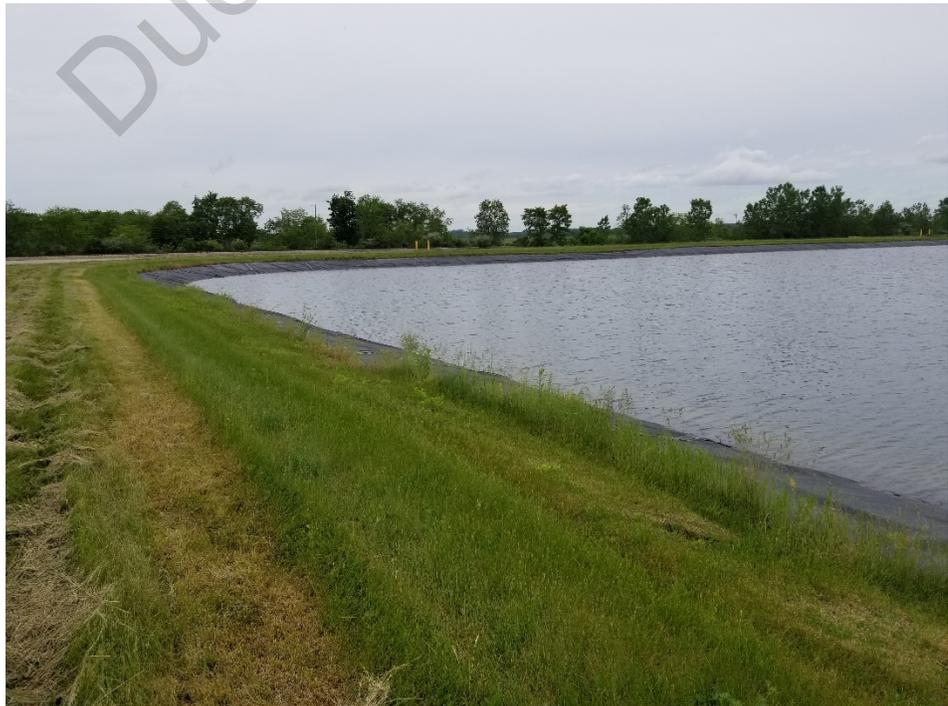
Photo: 12

Comments:
GMFP southwest
corner overview.

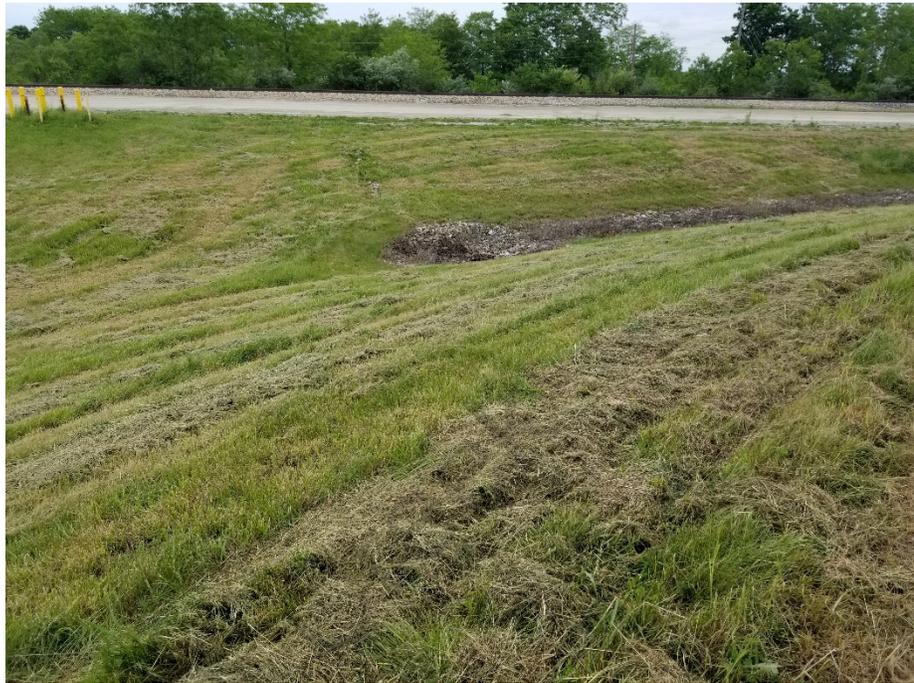
Comments:
GMFP southwest corner exterior dike overview.

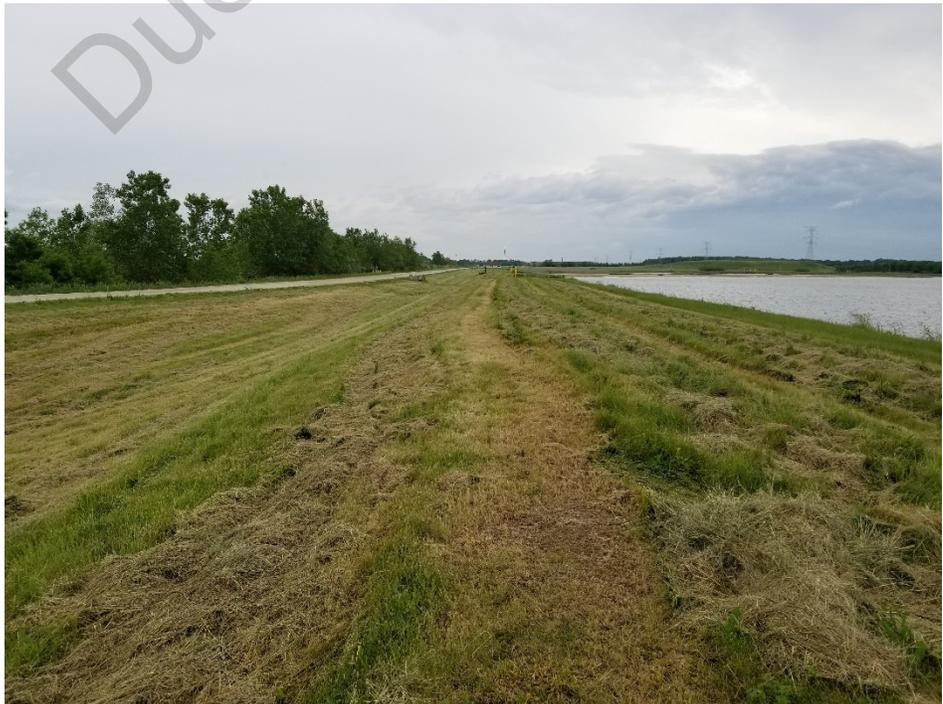
Photo: 14

Comments:
GMFP west dike overview.

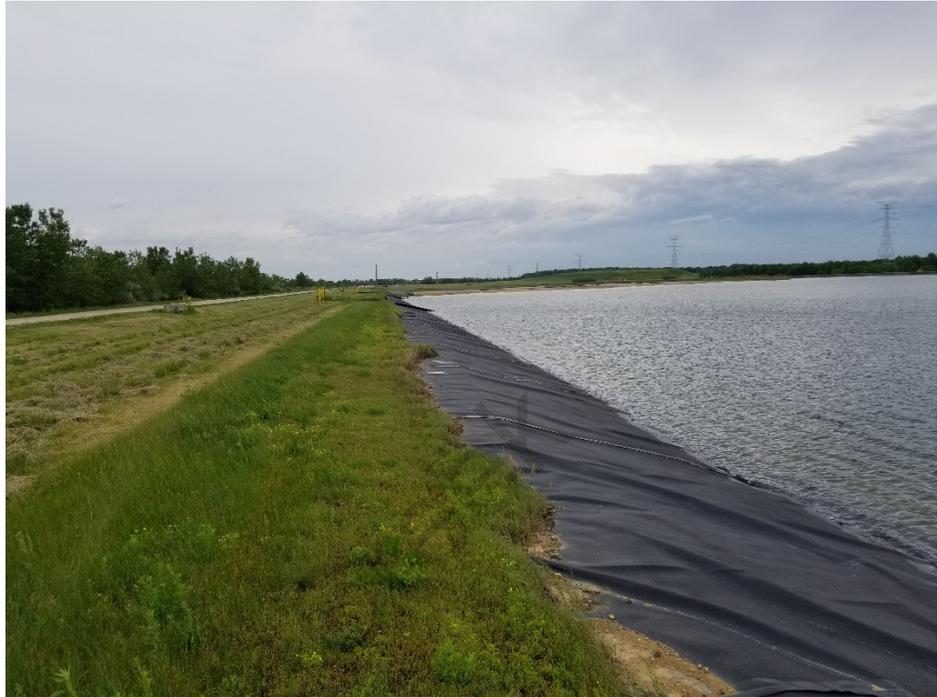
GMFP west interior dike overview.

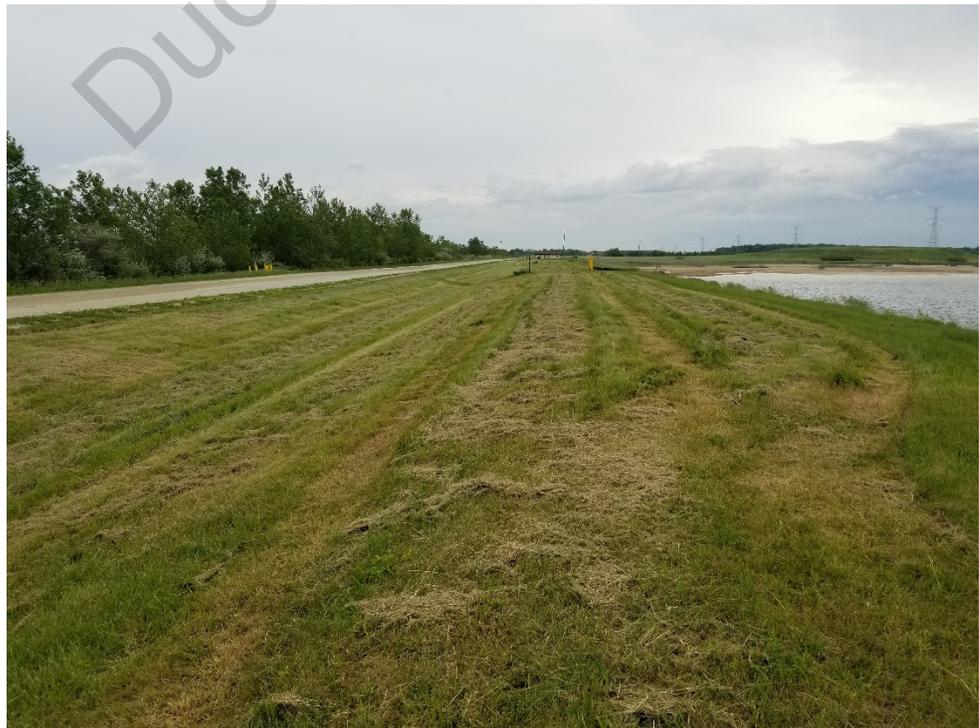
Photo: 16

GMFP west exterior dike overview.

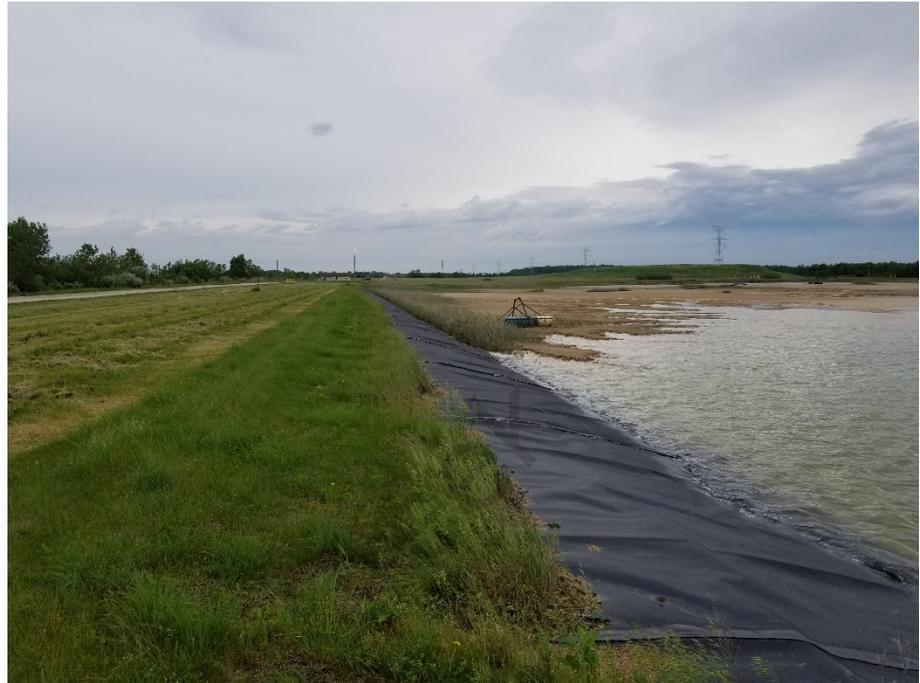
GMFP west interior dike overview.

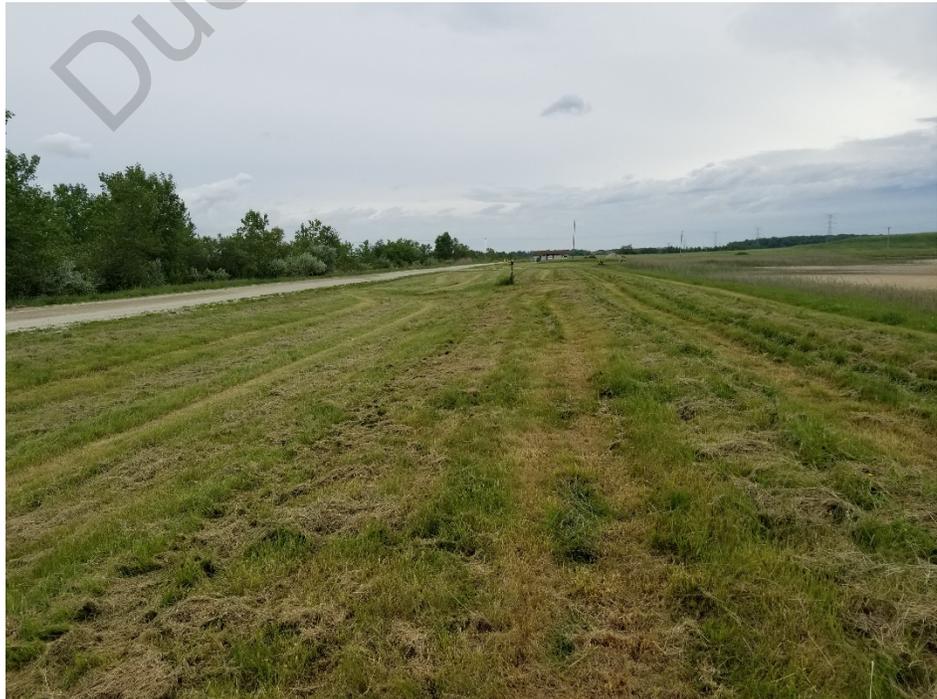
Photo: 18

GMFP west exterior dike overview.

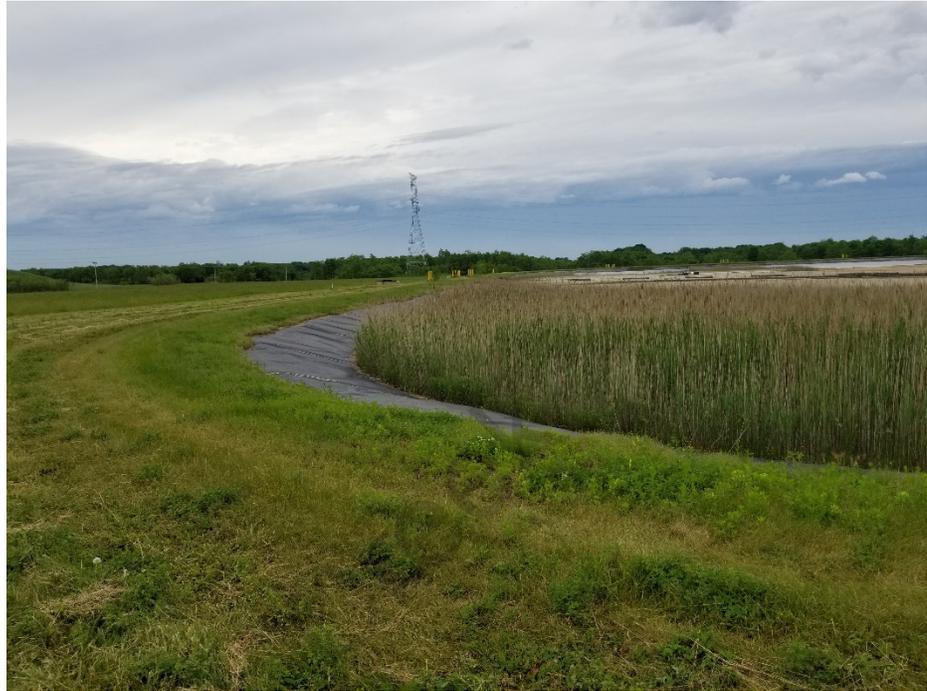
Comments:
GMFP northwest corner overview.

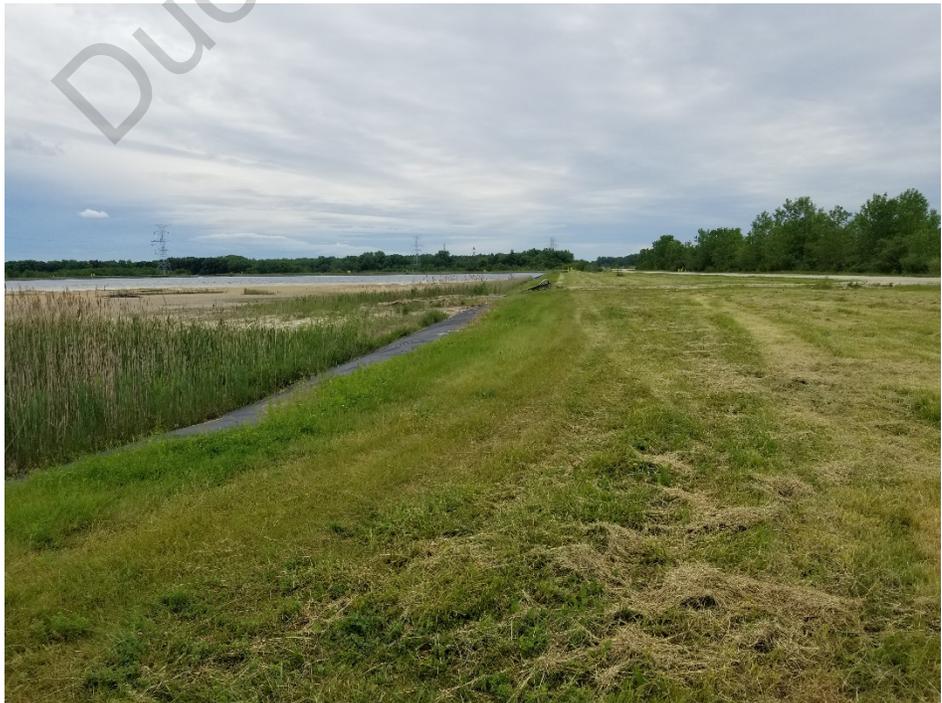
Photo: 20

Comments:
GMFP west dike overview.
