**Subject: USEPA CCR Rule and IEPA Part 845 Rule Applicability Cross-Reference
2021 USEPA CCR Rule Periodic Certification Report
East Ash Pond, Hennepin Power Plant, Hennepin, Illinois**

**2021 USEPA CCR RULE PERIODIC
CERTIFICATION REPORT
§257.73(a)(2), (c), (d¹), (e) and §257.82
EAST ASH POND
Hennepin Power Plant
Hennepin, Illinois**

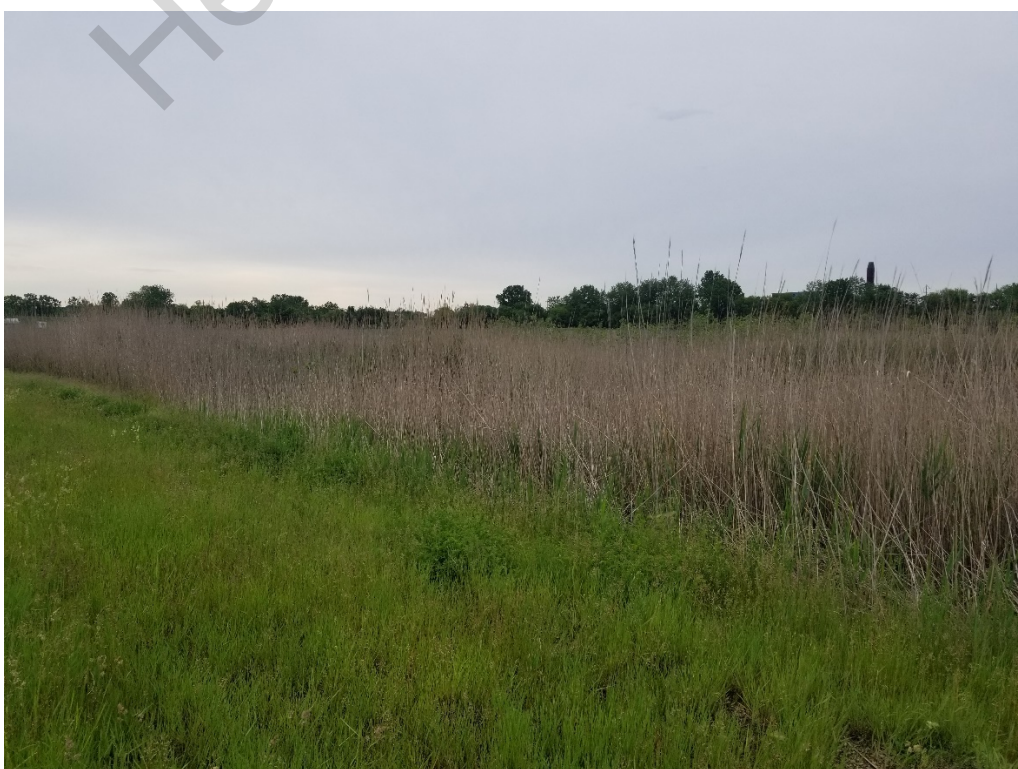
Photo: 02

Comments:
Interior slope
vegetation of EAP.

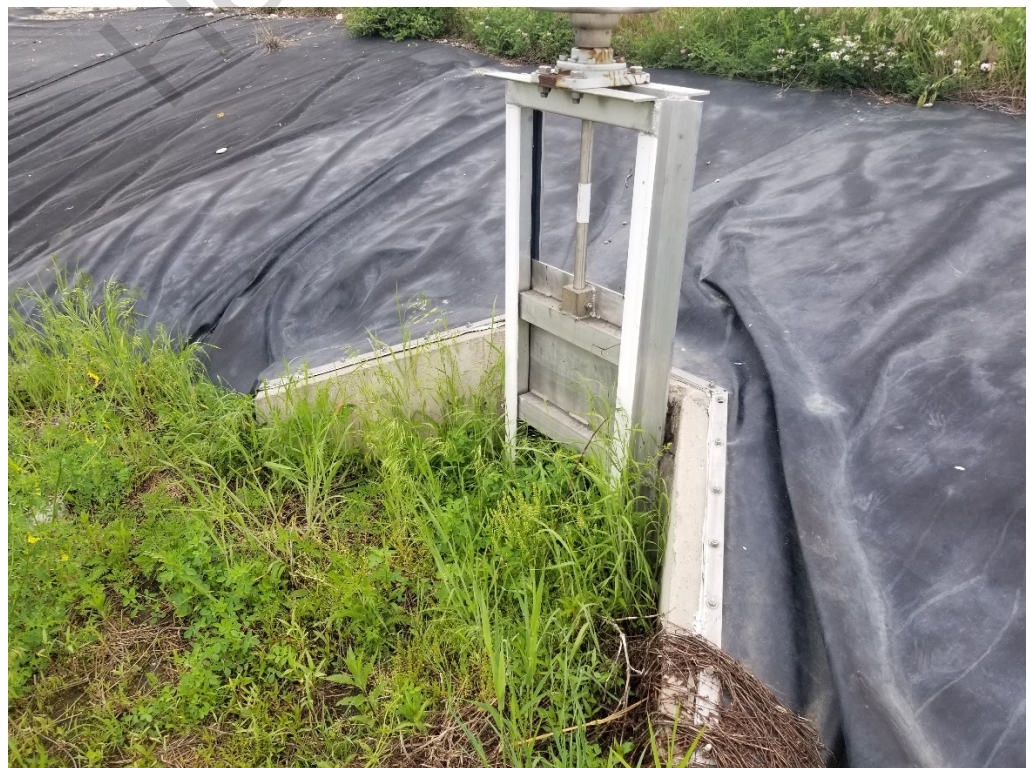
Photo: 04

Comments:
Gate valve at inlet of culvert between EAP and Leachate Pond. Note partial obstruction with vegetation. Geosyntec recommended clearing as part of routine site maintenance.

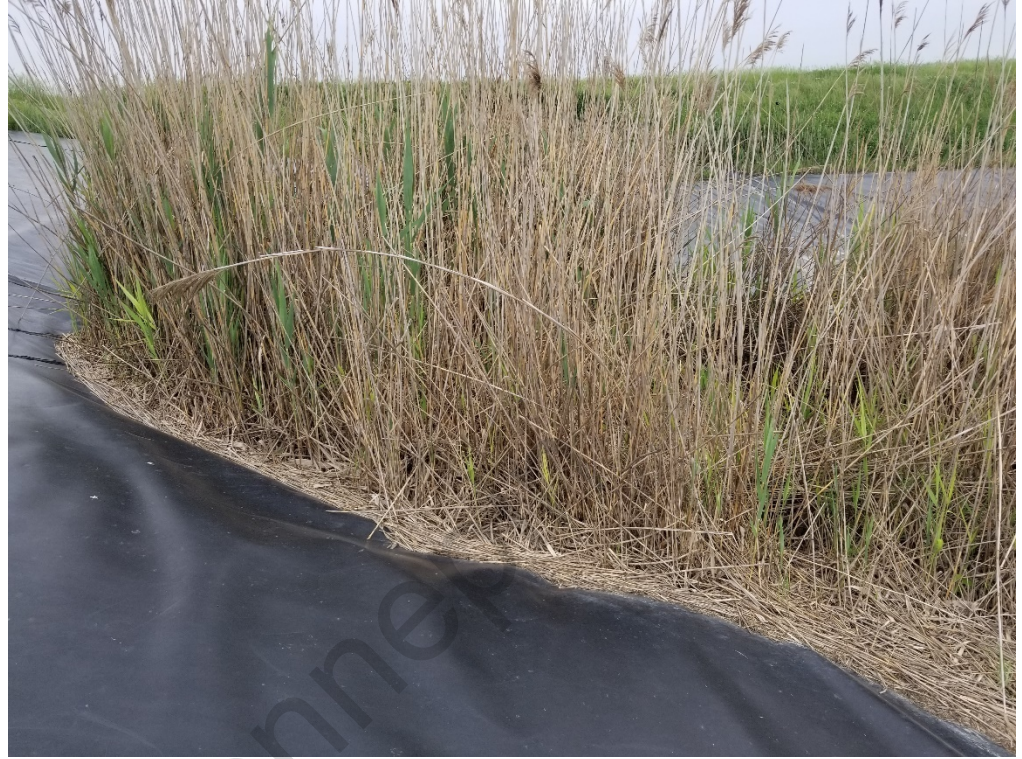
Comments:
Outlet of culvert between EAP and Leachate Pond, on the Leachate Pond sideslopes. Note heavy vegetation growth obstructing the culvert. Geosyntec recommended clearing as part of routine site maintenance.

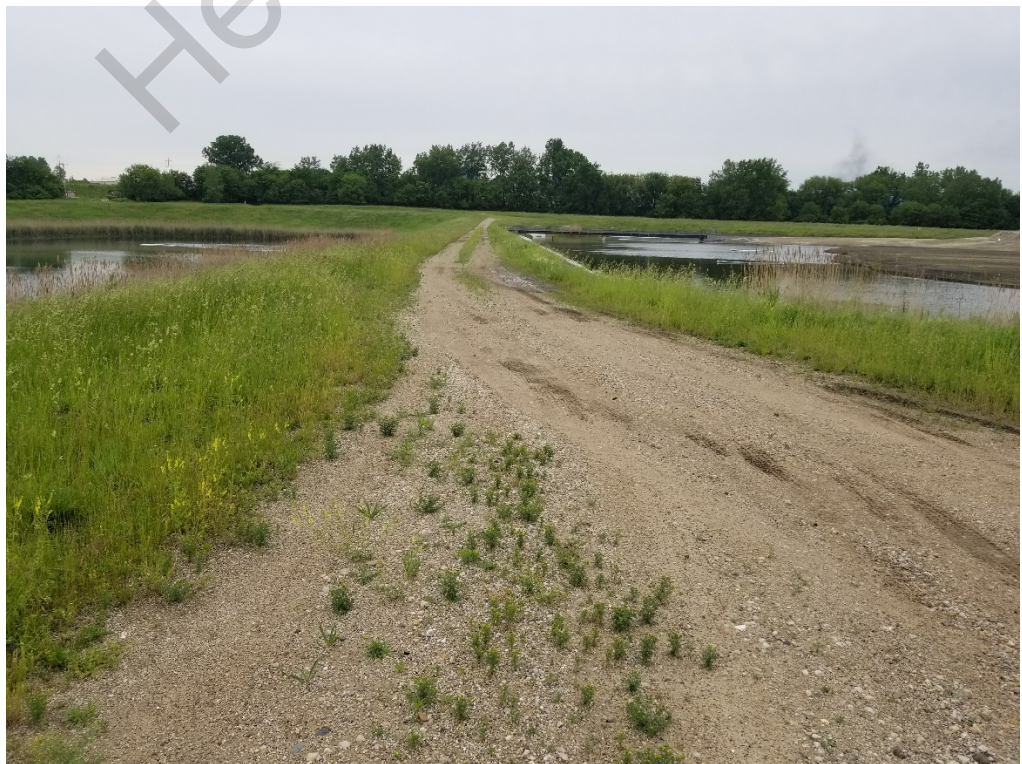
Photo: 06

Comments:
Overview of the EAP dike crest.

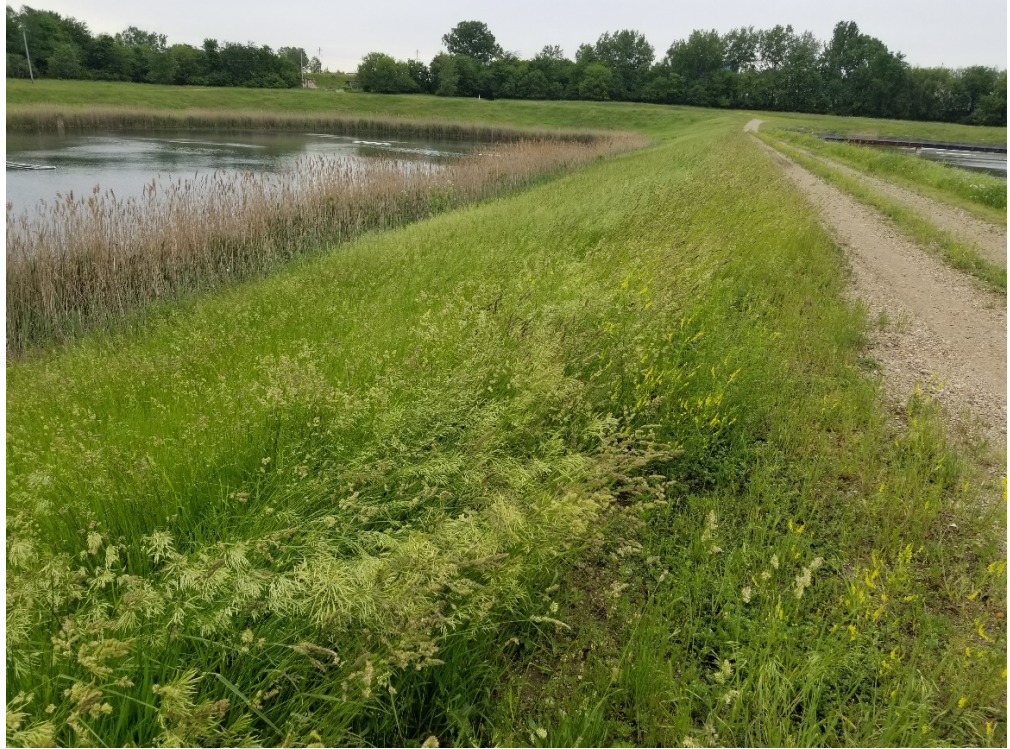
Comments:
Overview of
vegetation on the
downstream slope
of the EAP dike.

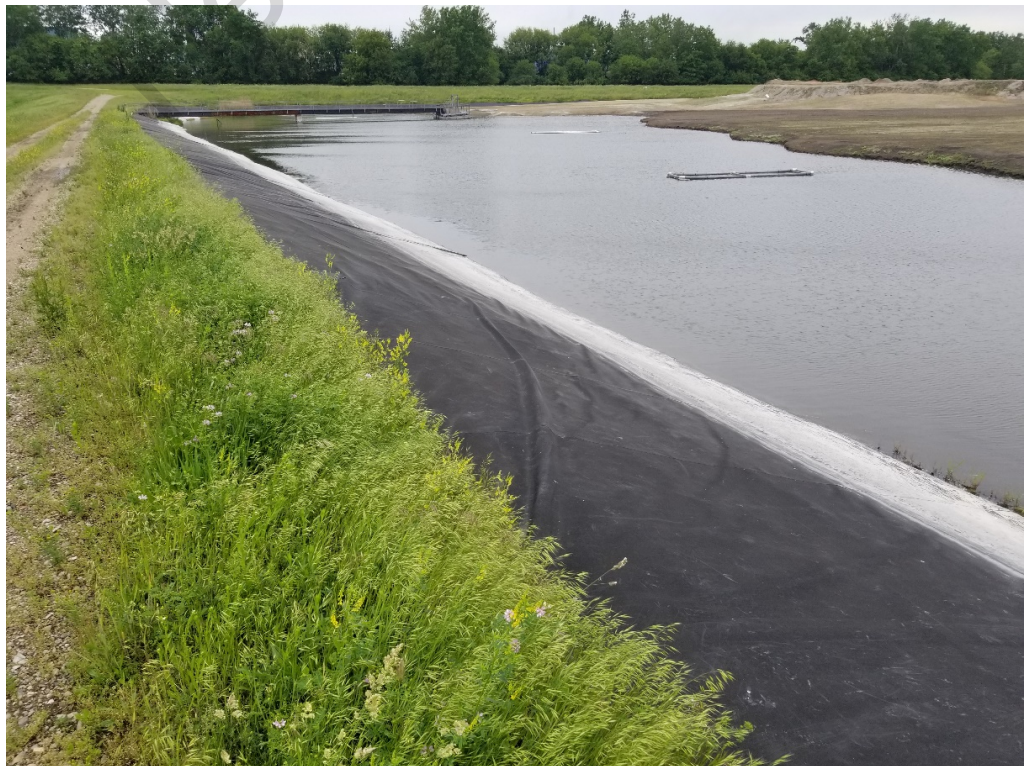
Photo: 08

Comments:
EAP upstream dike
geomembrane
slope covering
overview

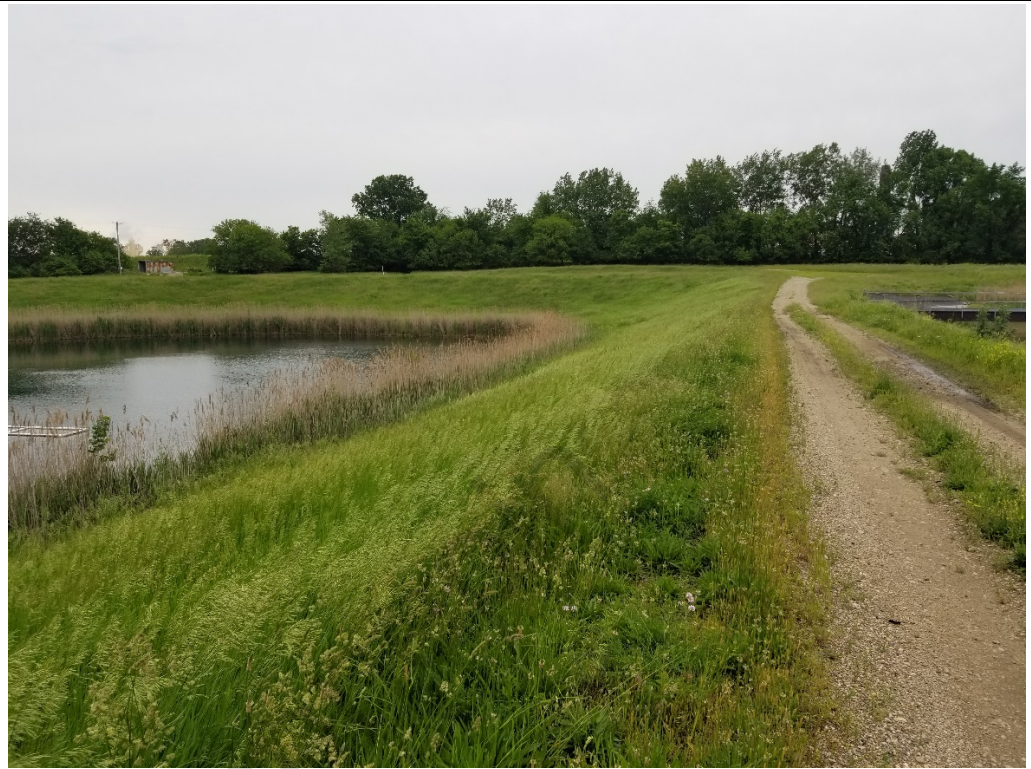
Comments:
EAP downstream
dike vegetation
overview.

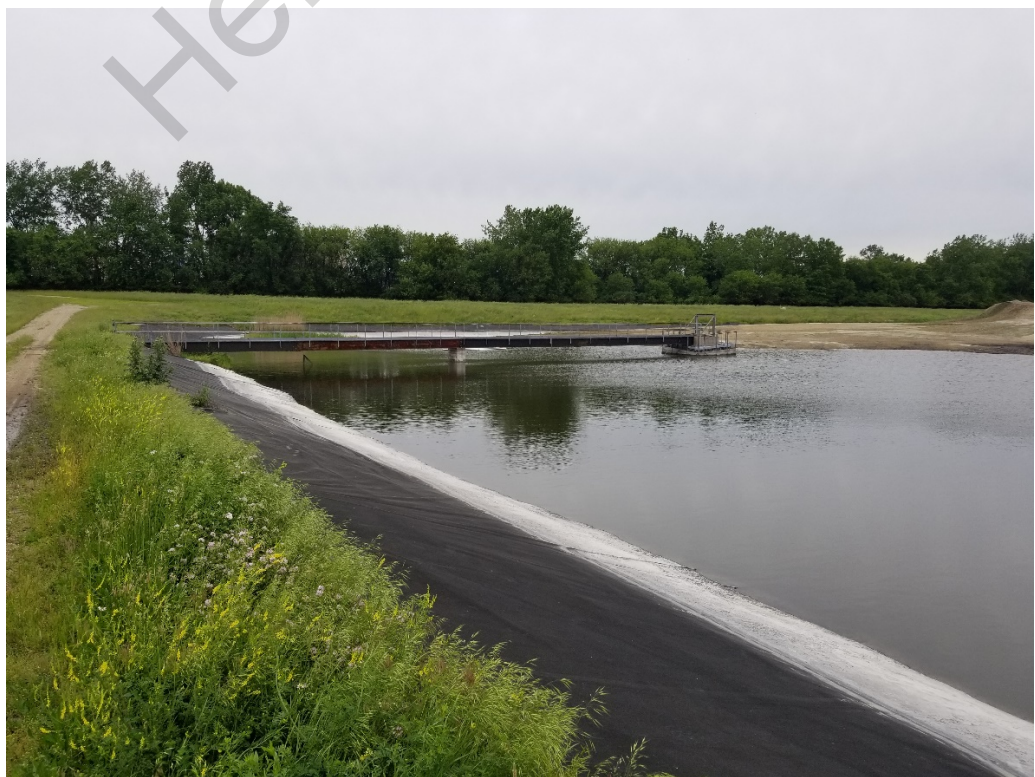
Photo: 10

Comments:
EAP upstream dike
geomembrane
overview and
outlet structure.

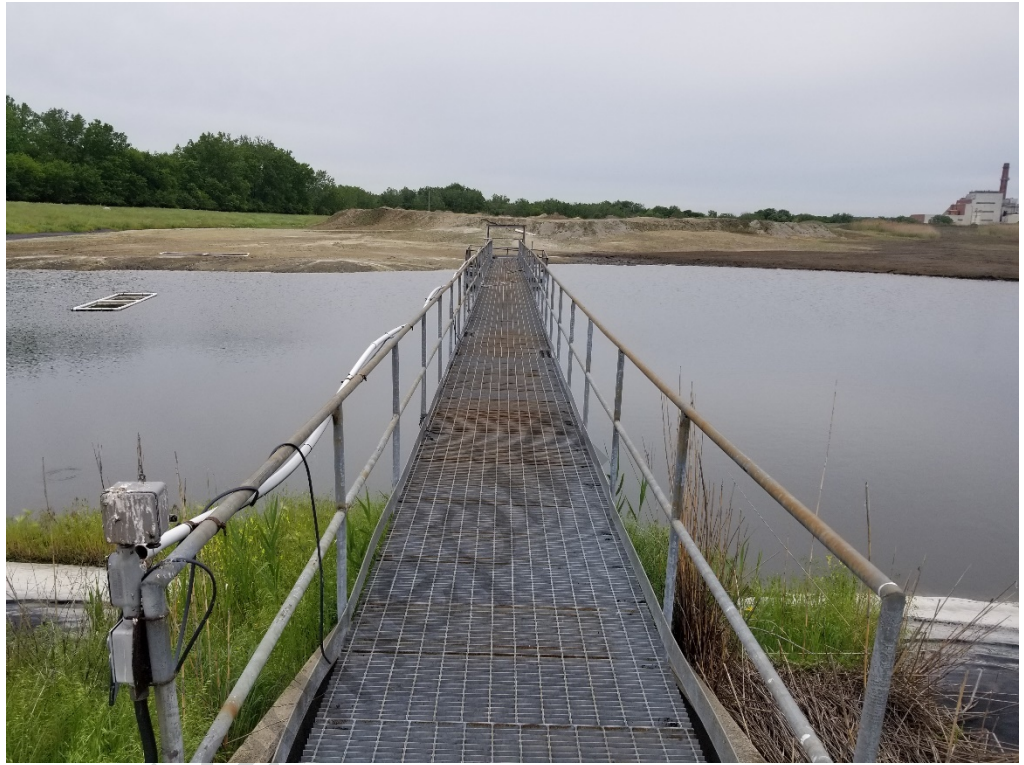
Comments:
EAP outfall
structure catwalk

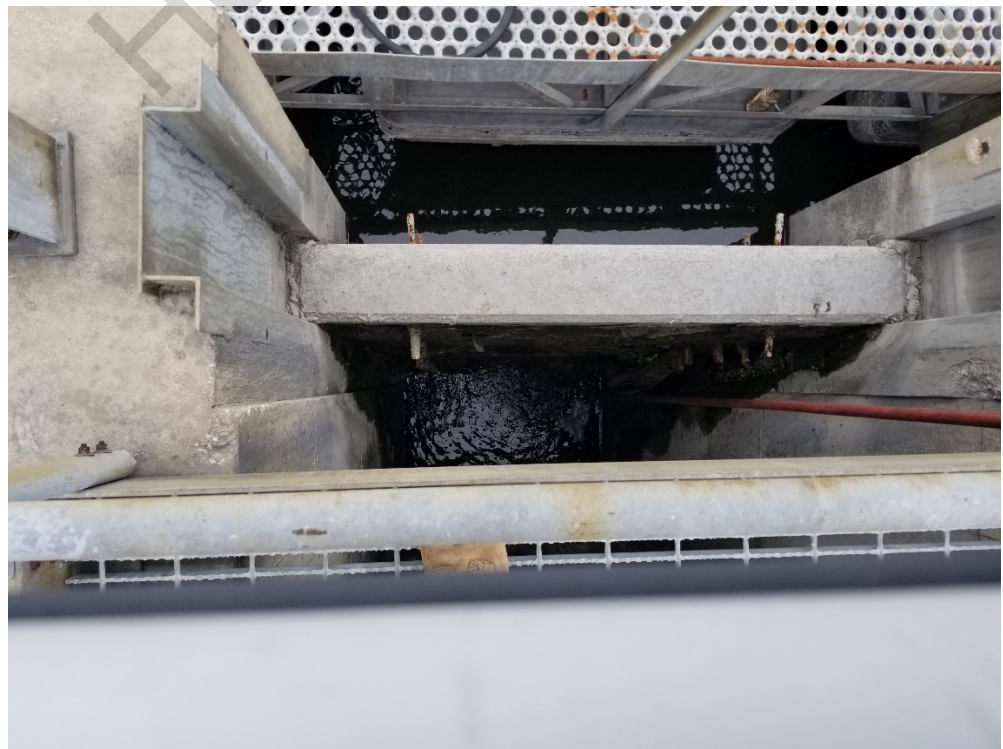
Photo: 12

Comments:
EAP outfall
structure stoplogs
from above
