**Subject: USEPA CCR Rule and IEPA Part 845 Rule Applicability Cross-Reference  
2021 USEPA CCR Rule Periodic Certification Report  
East Ash Pond, Joppa Power Plant, Joppa, Illinois**

**2021 USEPA CCR RULE PERIODIC  
CERTIFICATION REPORT  
§257.73(a)(2), (c), (d<sup>1</sup>), (e) and §257.82  
EAST ASH POND  
Joppa Power Plant  
Joppa, Illinois**

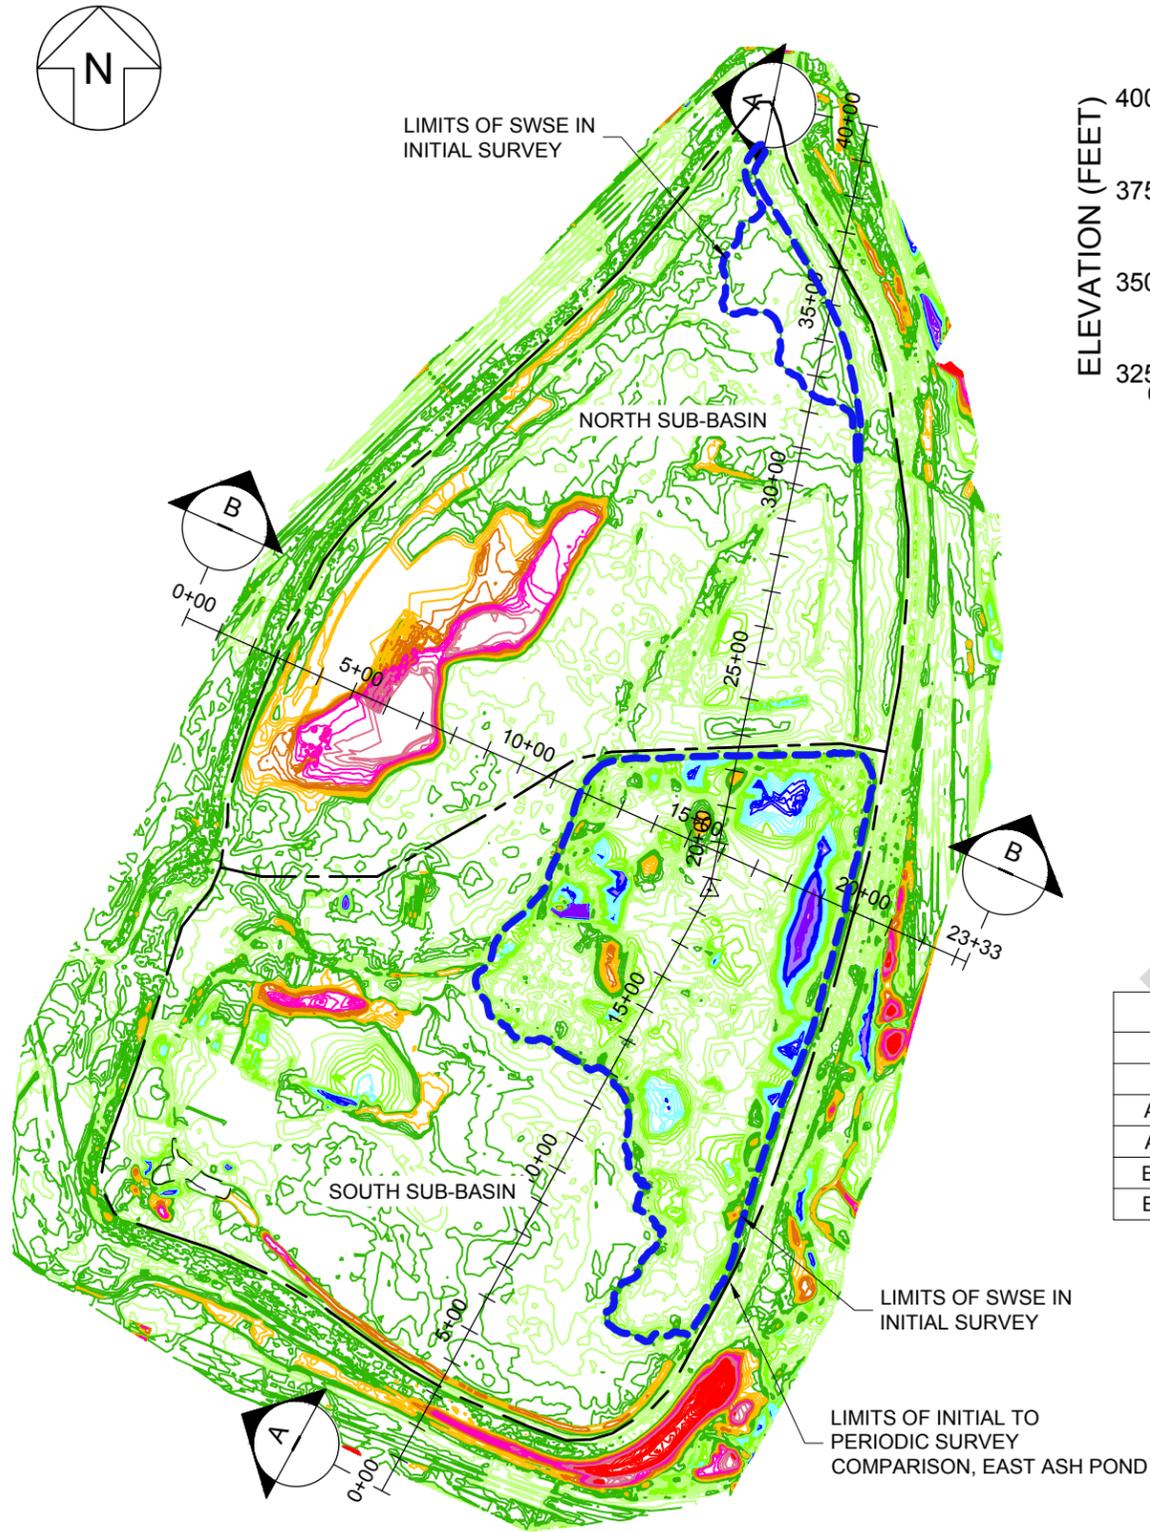
SURVEY COMPARISON ISOPACH EAST ASH POND JOPPA POWER PLANT JOPPA, ILLINOIS	
GLP8027.06	MAY 2021
FIGURE 2

INITIAL TO PERIODIC SURVEY COMPARISON SUMMARY			
	CUT	FILL	NET (CU. YD.)
EAST ASH POND	102,389	141,063	38,674 (FILL)
ABOVE SWSE - NORTH SUB-BASIN	21,085	98,639	77,554 (FILL)
ABOVE SWSE - SOUTH SUB-BASIN	17,252	35,435	18,182 (FILL)
BELOW SWSE - NORTH SUB-BASIN	192	1,853	1,661 (FILL)
BELOW SWSE - SOUTH SUB-BASIN	63,829	5,151	58,677 (CUT)

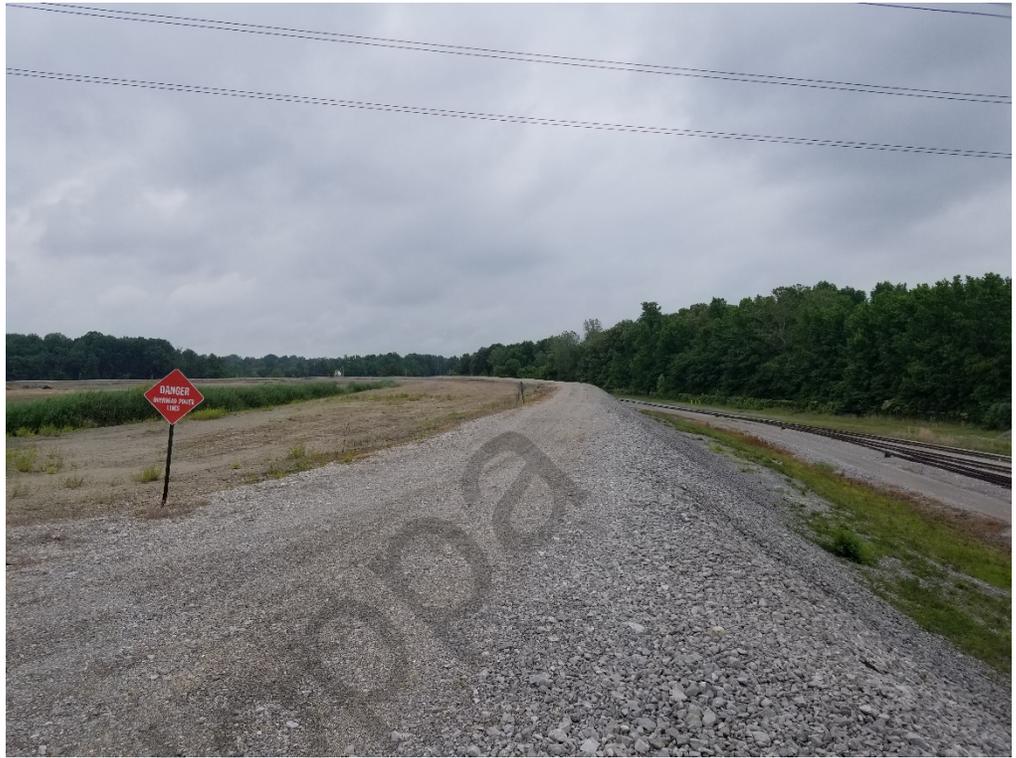
**Comments:**  
Overview of EAP  
perimeter dike.

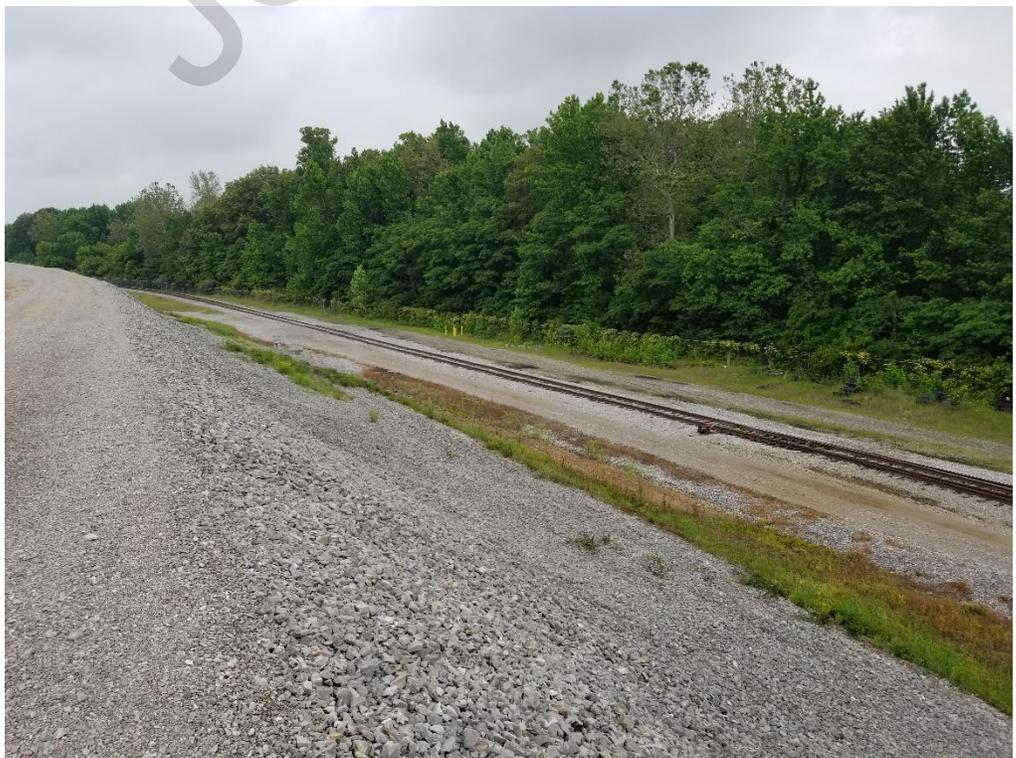
**Photo:** 02

**Comments:**  
Overview of  
perimeter slope  
protection

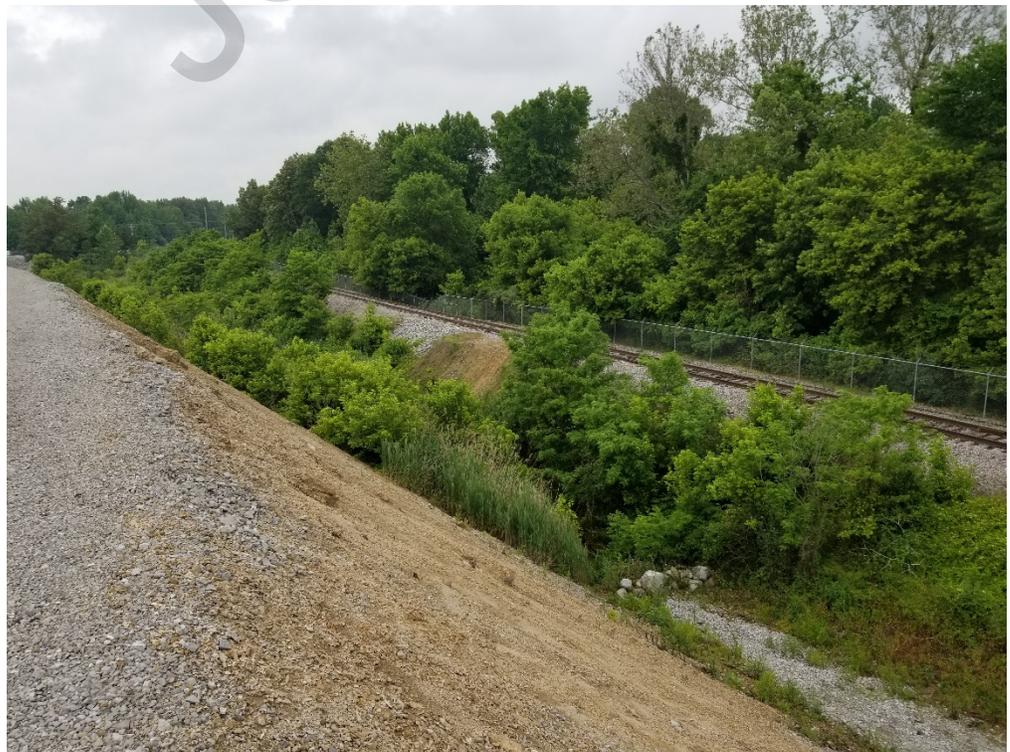
**Photo:** 04

**Comments:**  
Overview of slope  
protection near 72''  
CMP inlet

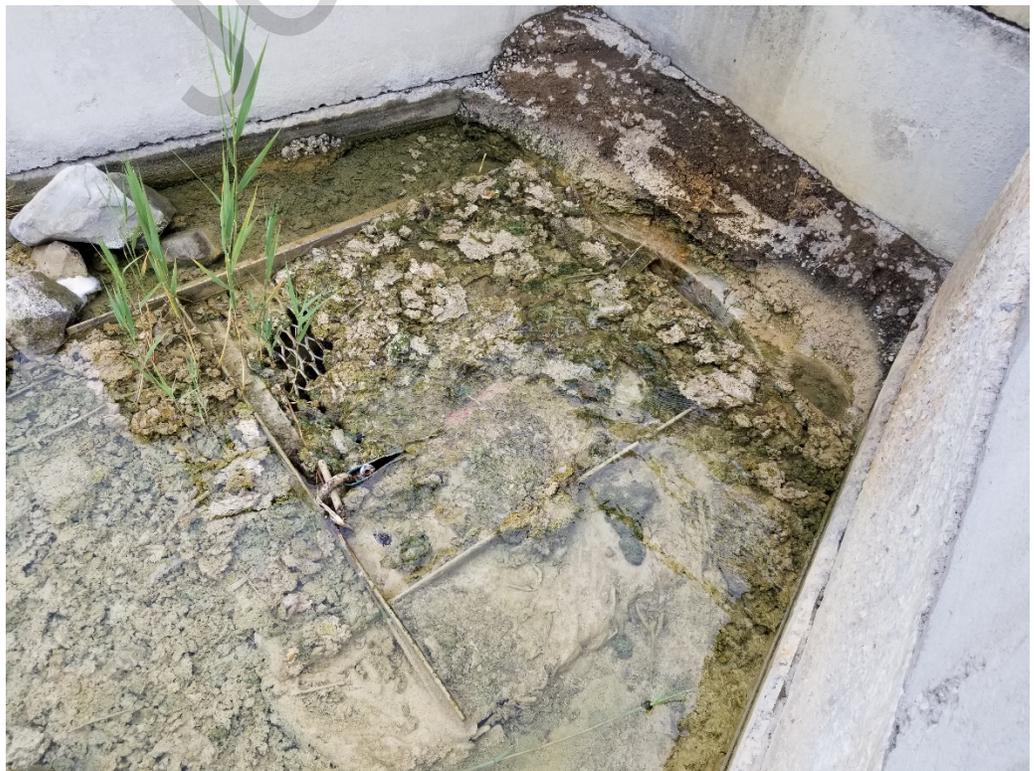
**Photo:** 08

**Comments:**  
Inlet for culvert  
leading to outfall  
structure. Note  
plugging with  
algae and debris.  
Geosyntec  
recommended  
cleaning of inlet as  
part of routine site  
maintenance.

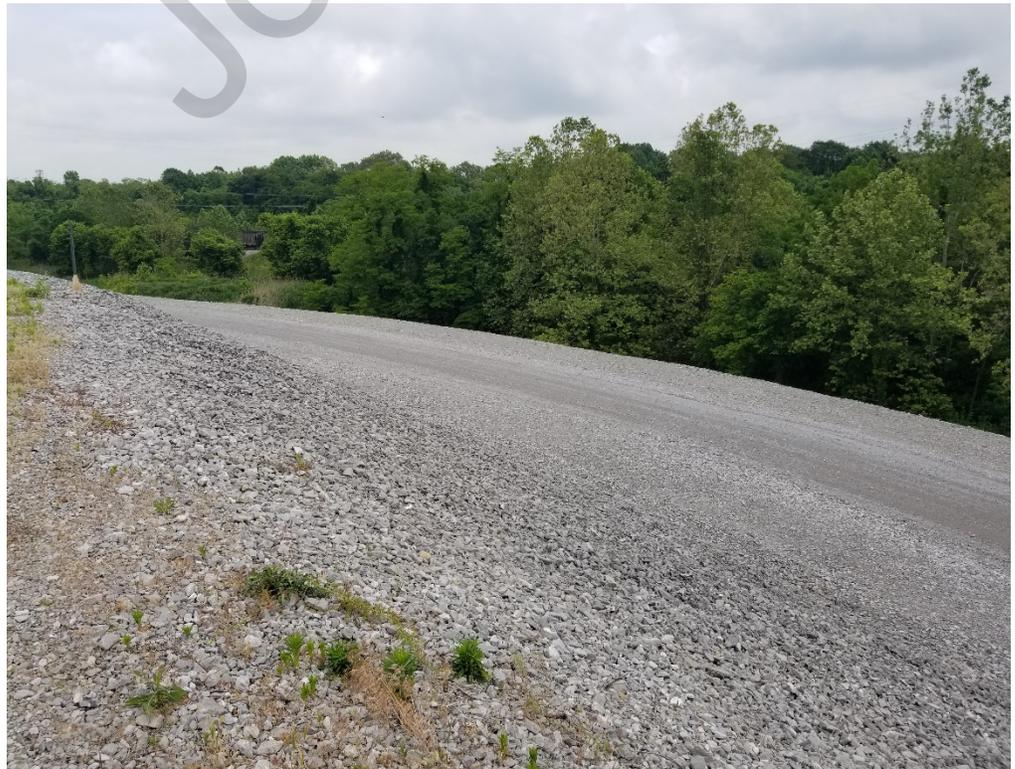
Photo: 24

Overview of DMM area and slope protection.

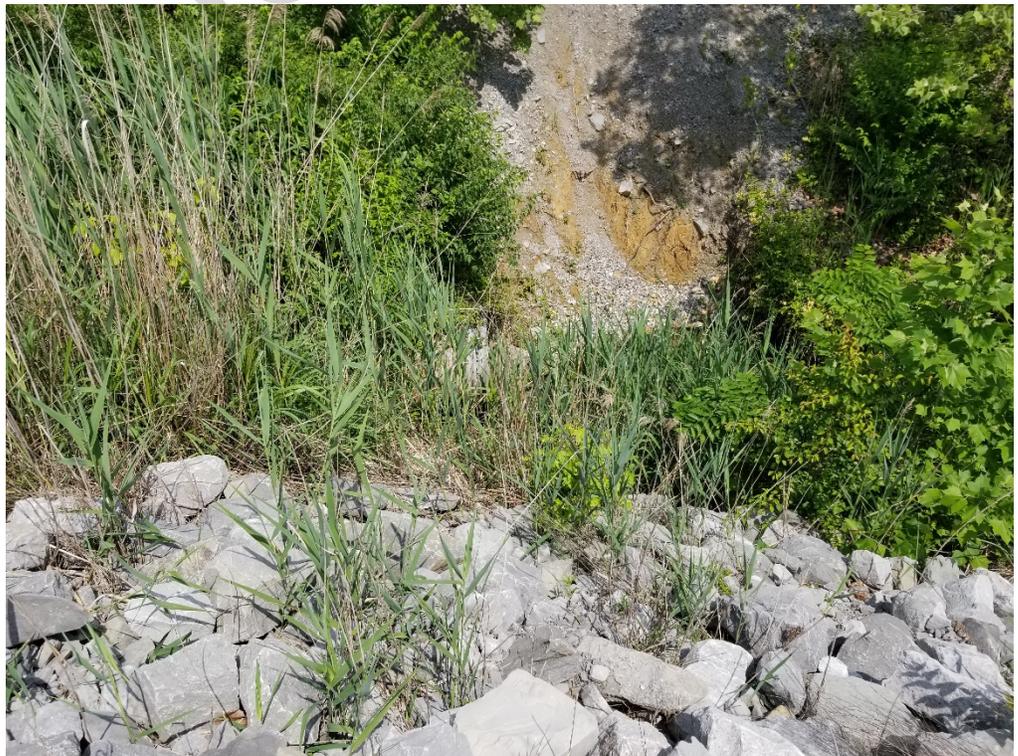
**Photo:** 34

**Comments:**  
Outlet to 72” CMP.  
Some section loss  
observed at outlet.  
However, this pipe  
does not penetrate  
the dike of the EAP  
and is located  
downstream of the  
discharge of the  
EAP.
