Kincaid Power Plant Weekly CCR Impoundment Inspection

| Date | 05/12/21 |

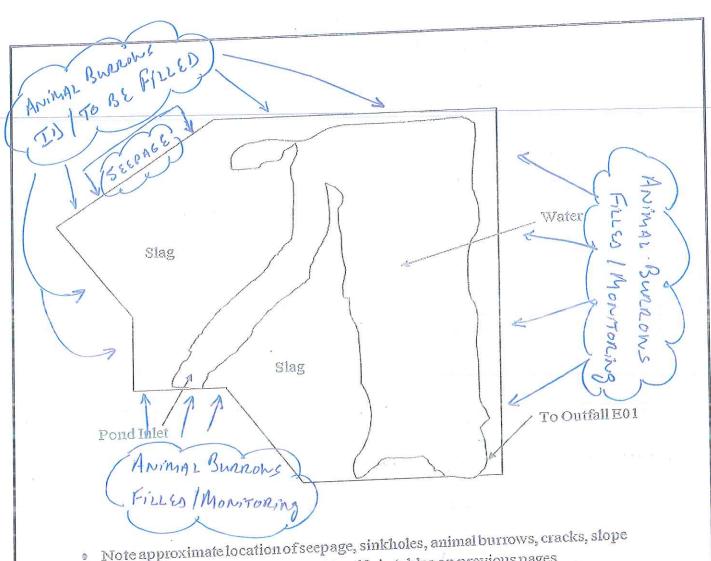
| | Ţ. | Slag Field | |
|---|--|---|---|
| | Seepage | 03 | NORTHWEST BURM BASE (SEE MAP) |
| | Animal Damage | MM | ANIMAL BURROWS (SEE MAD) |

· 16 Bunnows Frues beTWEEN 5/5/21 Ans 5/12/21 by K&M.
