REPORT

Safety Factor Assessment 5-Year Update

Oak Grove Steam Electric Station FGD Ponds Robertson County, Texas

Golder Associates Inc.

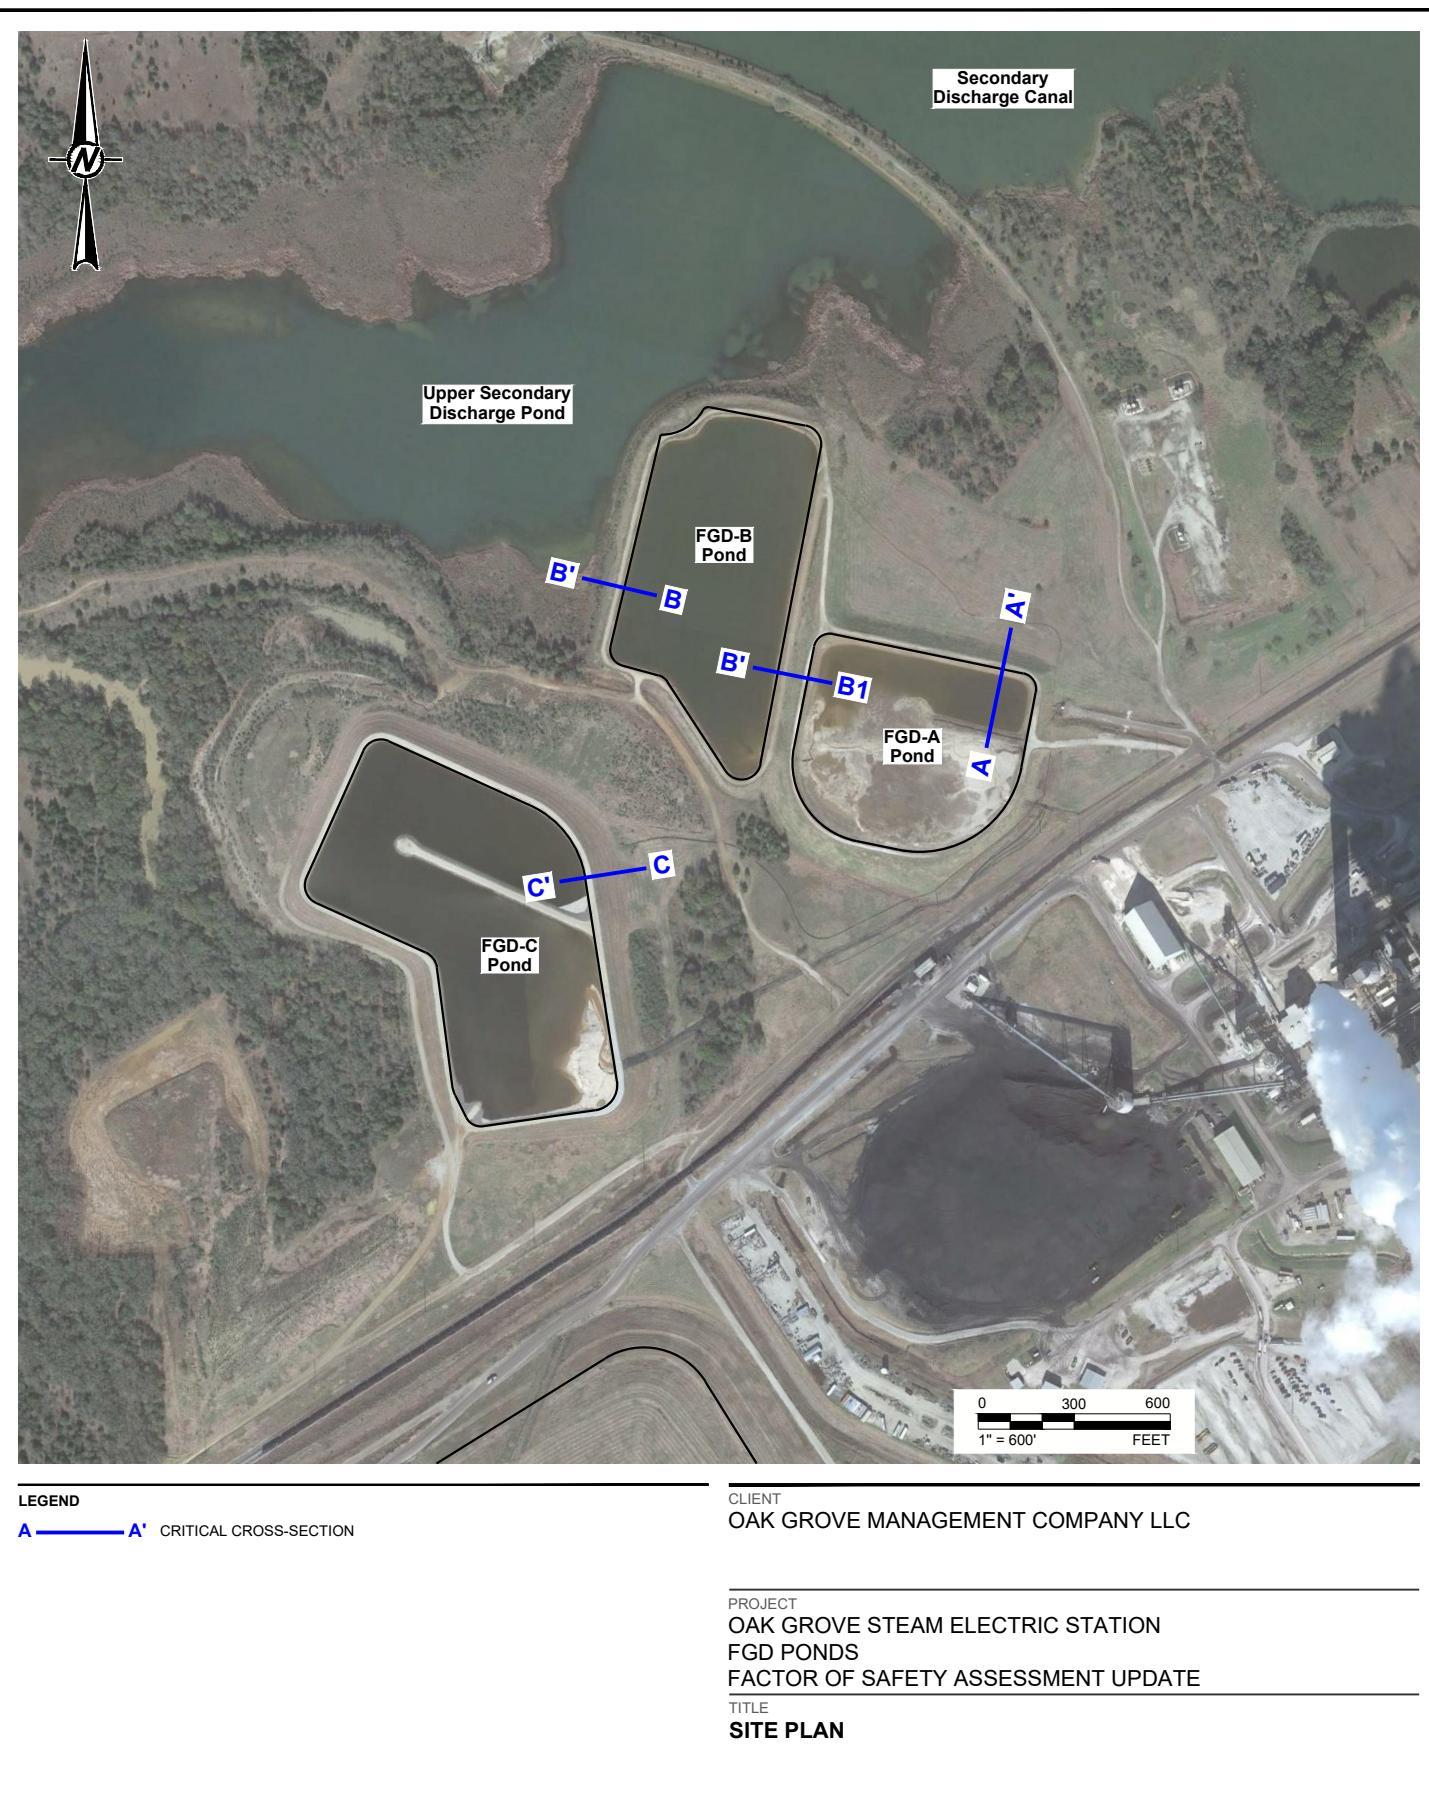
FIGURE

After considering multiple cross-sections a critical cross-section was identified for each pond and used for the stability analysis. The critical cross-section was determined considering the geometry of the slopes, soil profile, phreatic surface and loading conditions. More than one cross-section was used when required. For example, the critical section for the interior slopes of FGD-B is located to the east bordering pond FGD-A. However, since FGD-A adjoins FGD-B here, the critical section for exterior slopes of FGD-B is not located on this section. Hence, another section is analyzed on the west side of FGD-B to evaluate the exterior slopes. The critical cross-sections analyzed – A-A', B-B', B1-B1', C-C' – for each pond are shown in Figure 1.
