SAFETY FACTOR ASSESSMENT REPORT

Big Brown Steam Electric Station

Submitted To: Luminant
1601 Bryan Street
Dallas, TX 75201

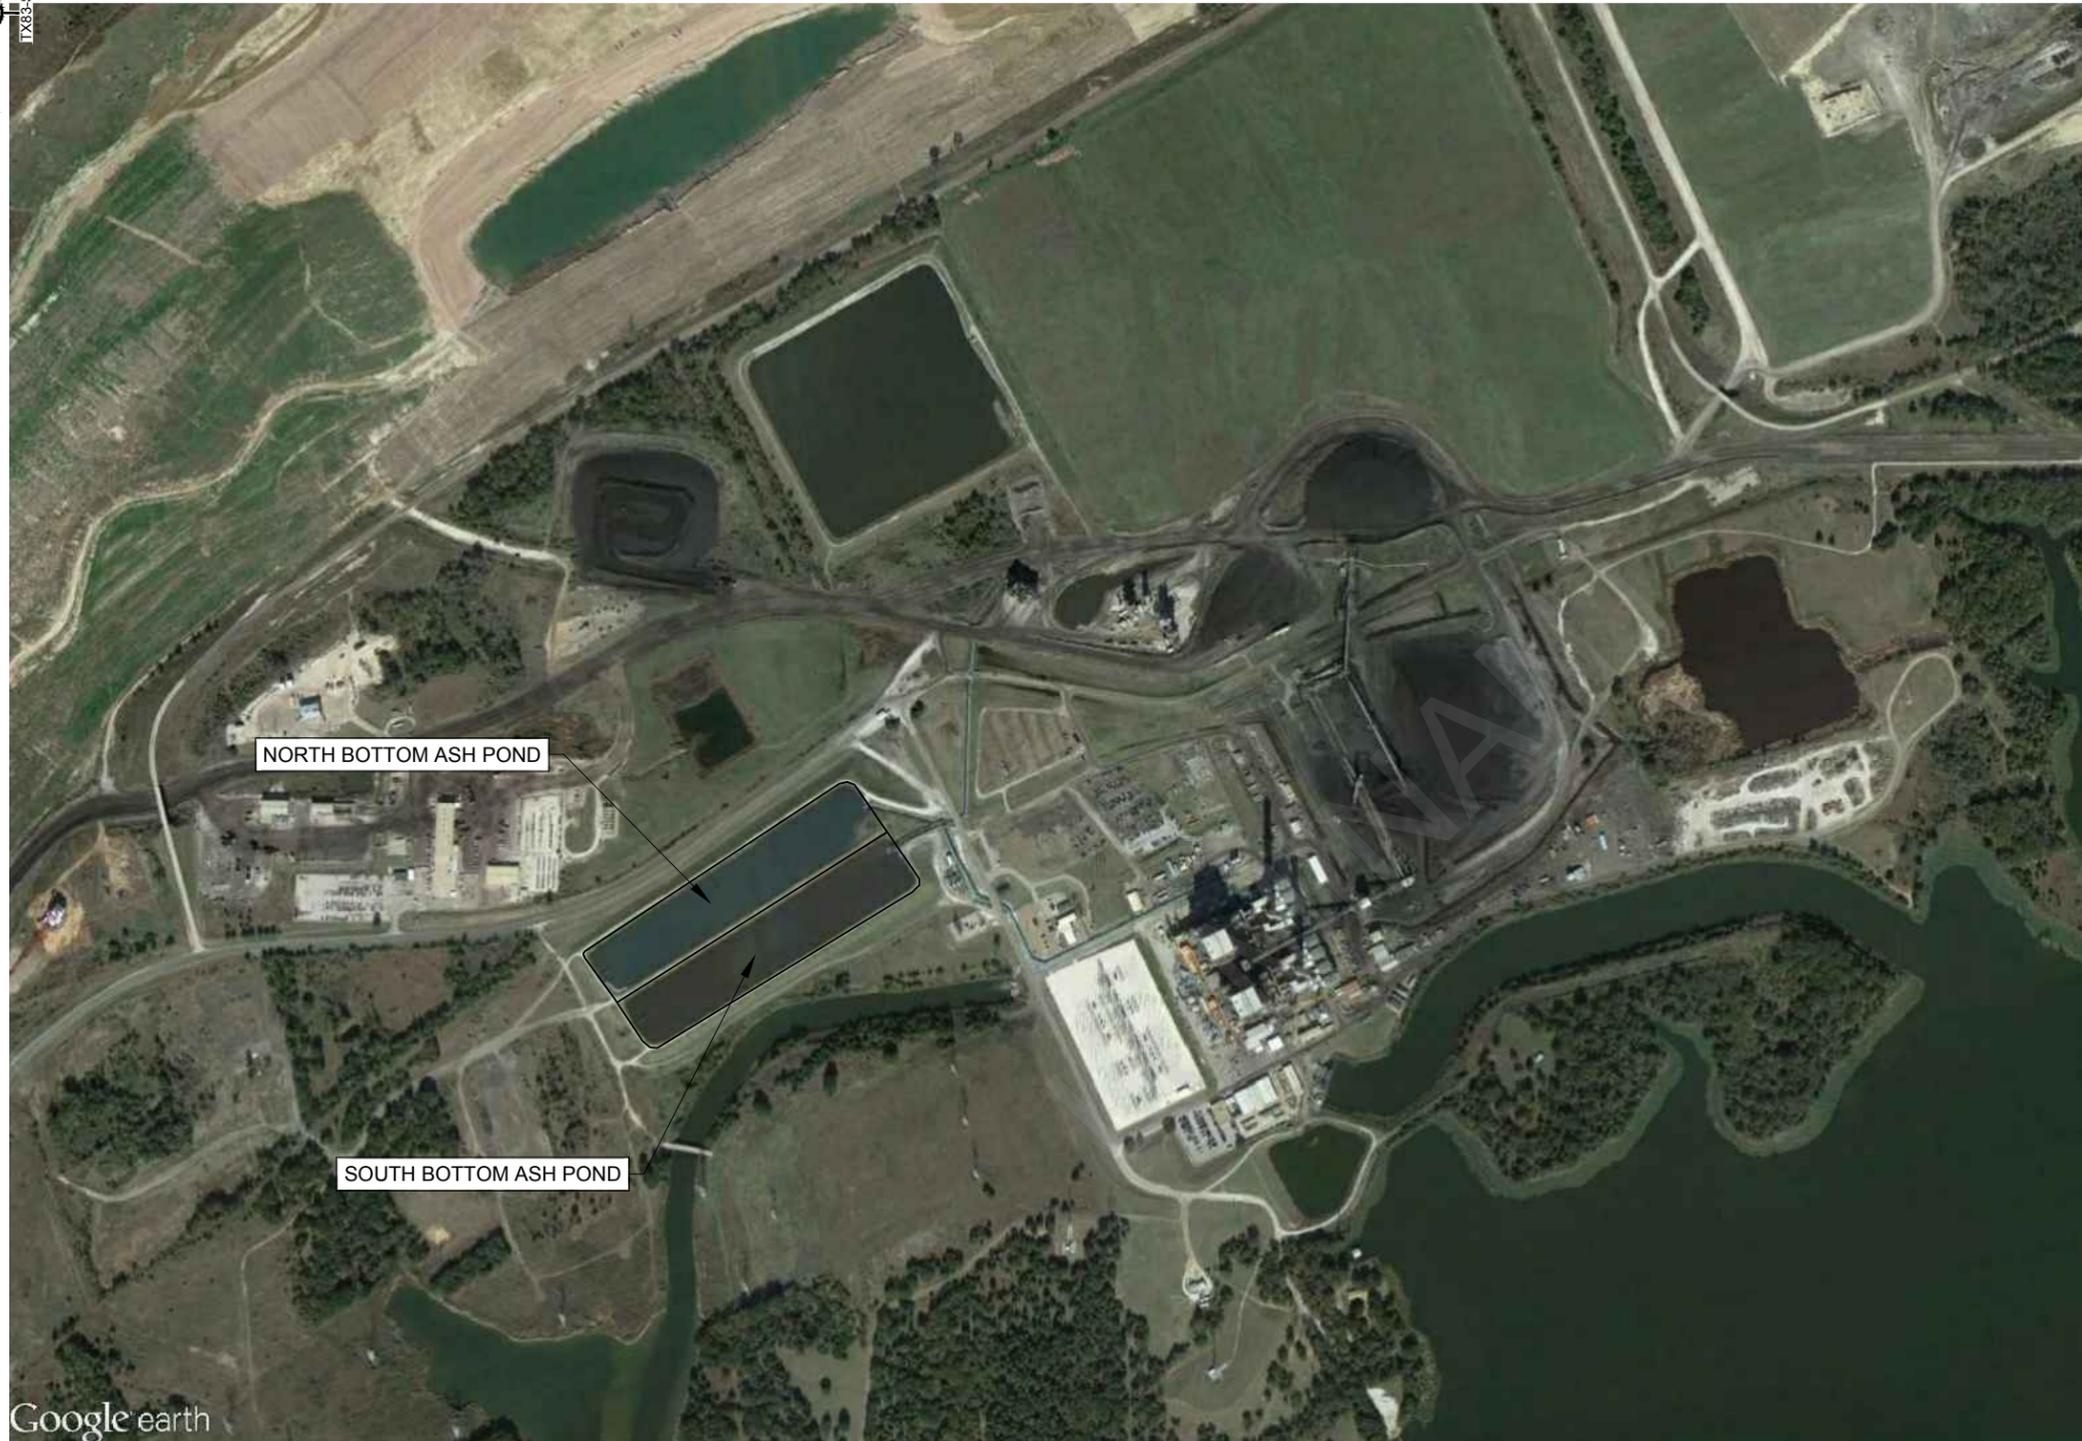
FIGURE
1

- Figure 1 General Site Map
- Figure 2 Bottom Ash Ponds Cross-Sections for Slope Stability Analysis

The BBSES generates fly ash, bottom ash and boiler slag during electricity generation. The NBAP and SBAP are active, clay lined, excavated impoundments surrounded and separated by an engineered earthen berm. Each pond receives a slurry of bottom ash/boiler slag and water and is used to separate the solids from the water using gravity sedimentation. Water decanted from the ponds is returned to the power plant. Separated solids accumulate in the ponds and are periodically removed and placed in an adjacent surface lignite mine operated by an affiliated Luminant company (Luminant Mining Company). Refer to Figure 1. This is the only CCR surface impoundment at the BBSES.

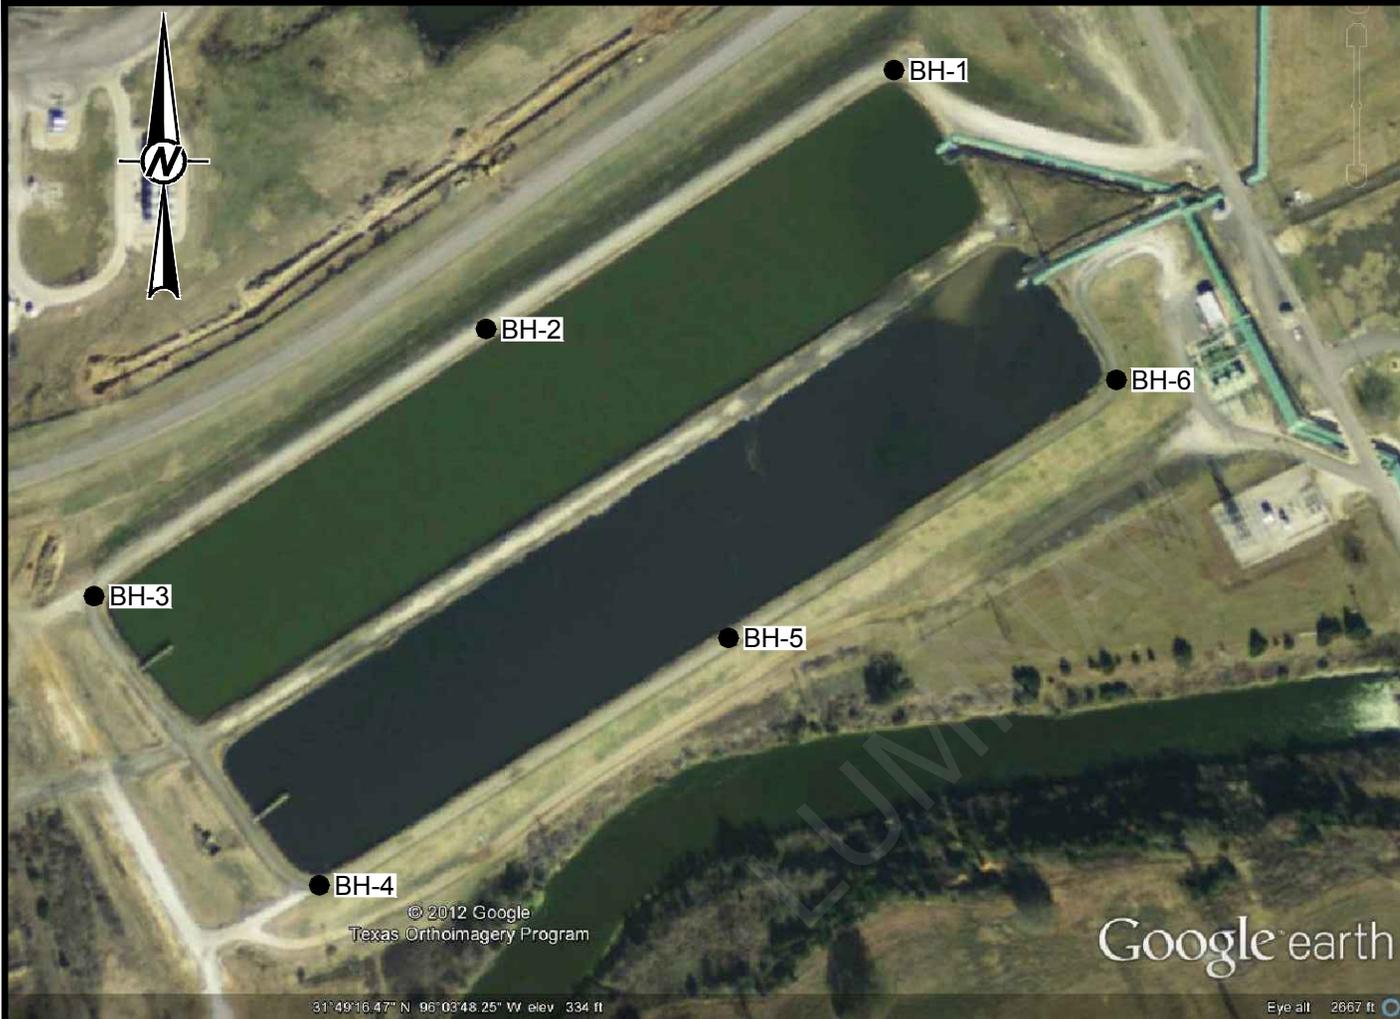
APPENDIX A
BORING LOCATION MAP & BORING LOGS

Information from a previous subsurface investigation was used to characterize the subsurface site conditions. Golder conducted a subsurface investigation for the BAP in October 2012, as part of a slope stability evaluation. Golder completed six borings through the crest of the pond embankment at an elevation of approximately 350 feet – mean sea level (ft-msl). The boring depths ranged from 30 to 50 feet below ground surface (bgs) (Golder, 2012). Appendix A includes the boring location map and the boring logs.

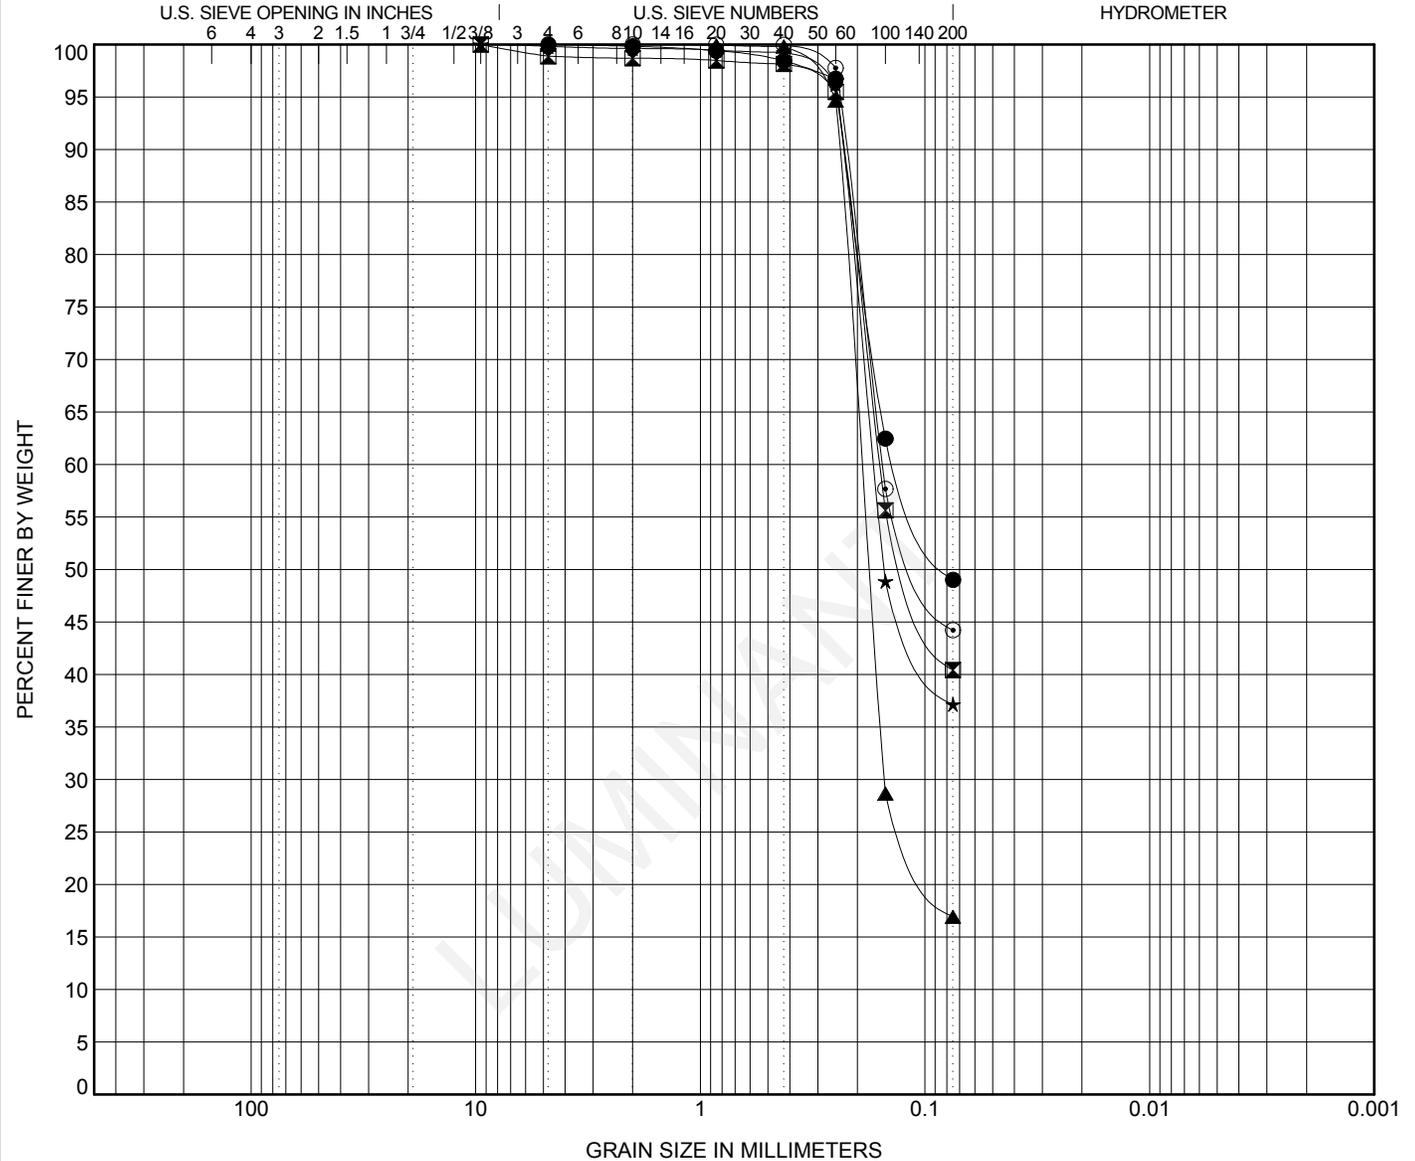
BOREHOLE	DEPTH	Classification					LL	PL	PI	Cc	Cu
● BH-1	6										
☒ BH-2	39										
▲ BH-3	29										
★ BH-4	18										
◎ BH-5	33										
BOREHOLE	DEPTH	D100	D60	D30	D10	%Gravel	%Sand	%Silt	%Clay		
● BH-1	6	4.75	0.132			0.0	51.0		49.0		
☒ BH-2	39	9.5	0.159			1.1	58.5		40.4		
▲ BH-3	29	4.75	0.191	0.152		0.0	83.1		16.9		
★ BH-4	18	9.5	0.169			0.2	62.7		37.2		
◎ BH-5	33	2	0.155			0.0	55.8		44.2

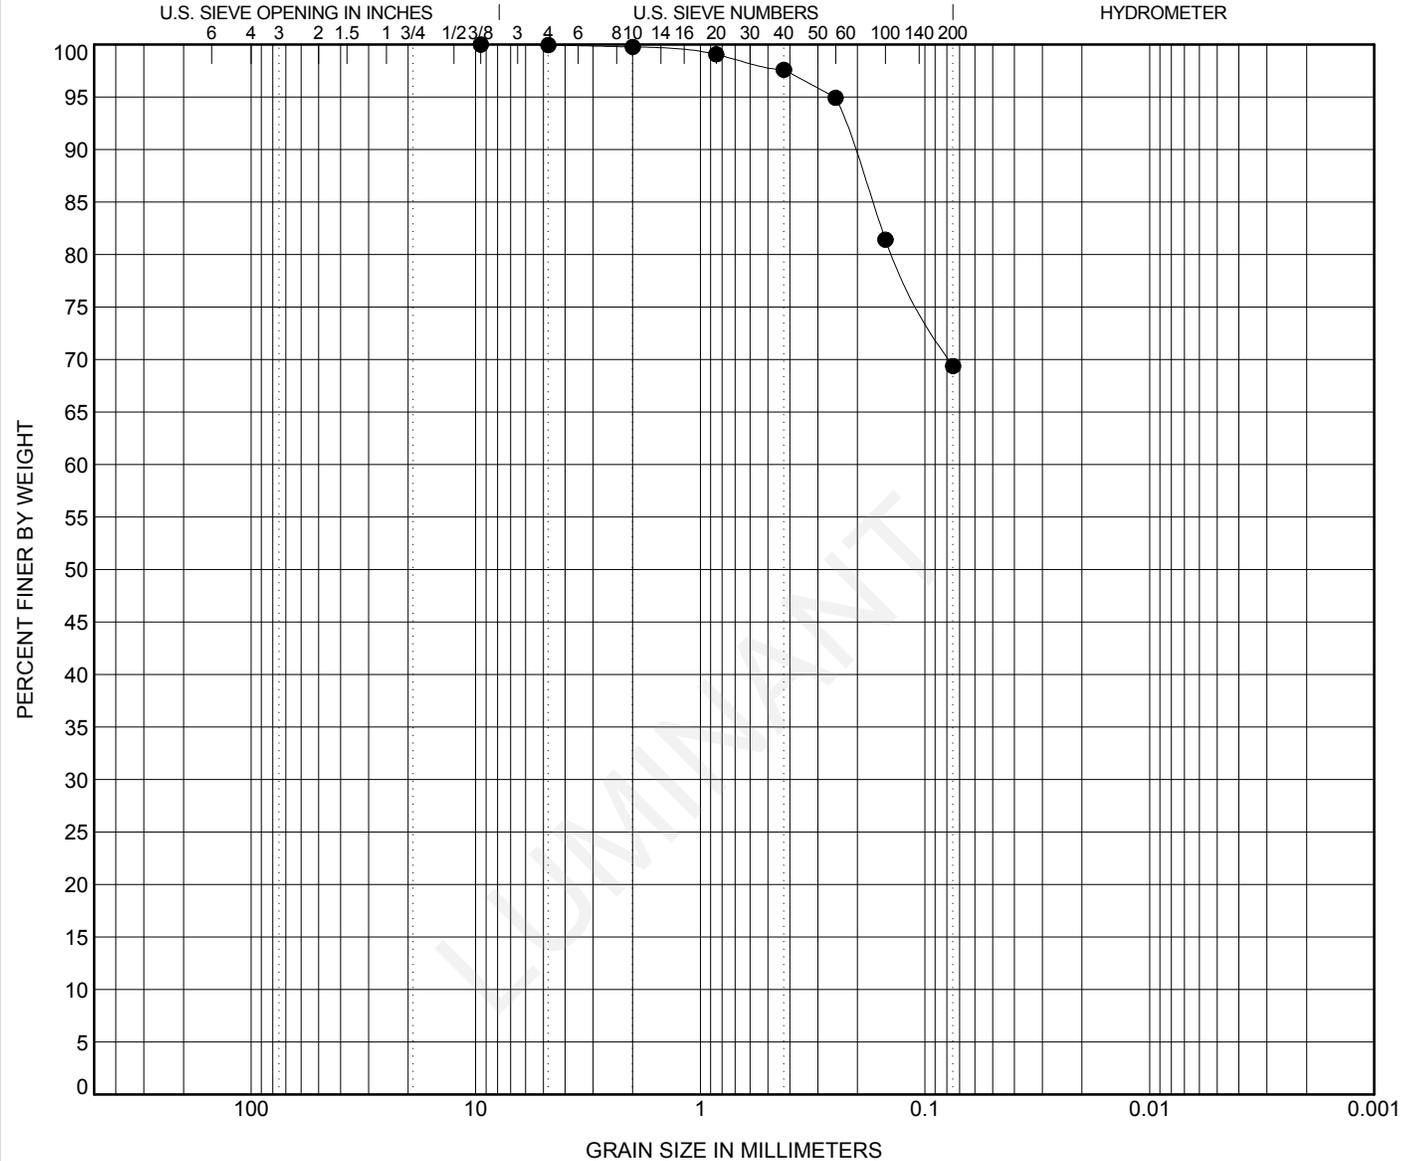
BOREHOLE	DEPTH	Classification					LL	PL	PI	Cc	Cu
● BH-6	38										
BOREHOLE	DEPTH	D100	D60	D30	D10	%Gravel	%Sand	%Silt	%Clay		
● BH-6	38	9.5				0.1	30.6	69.4

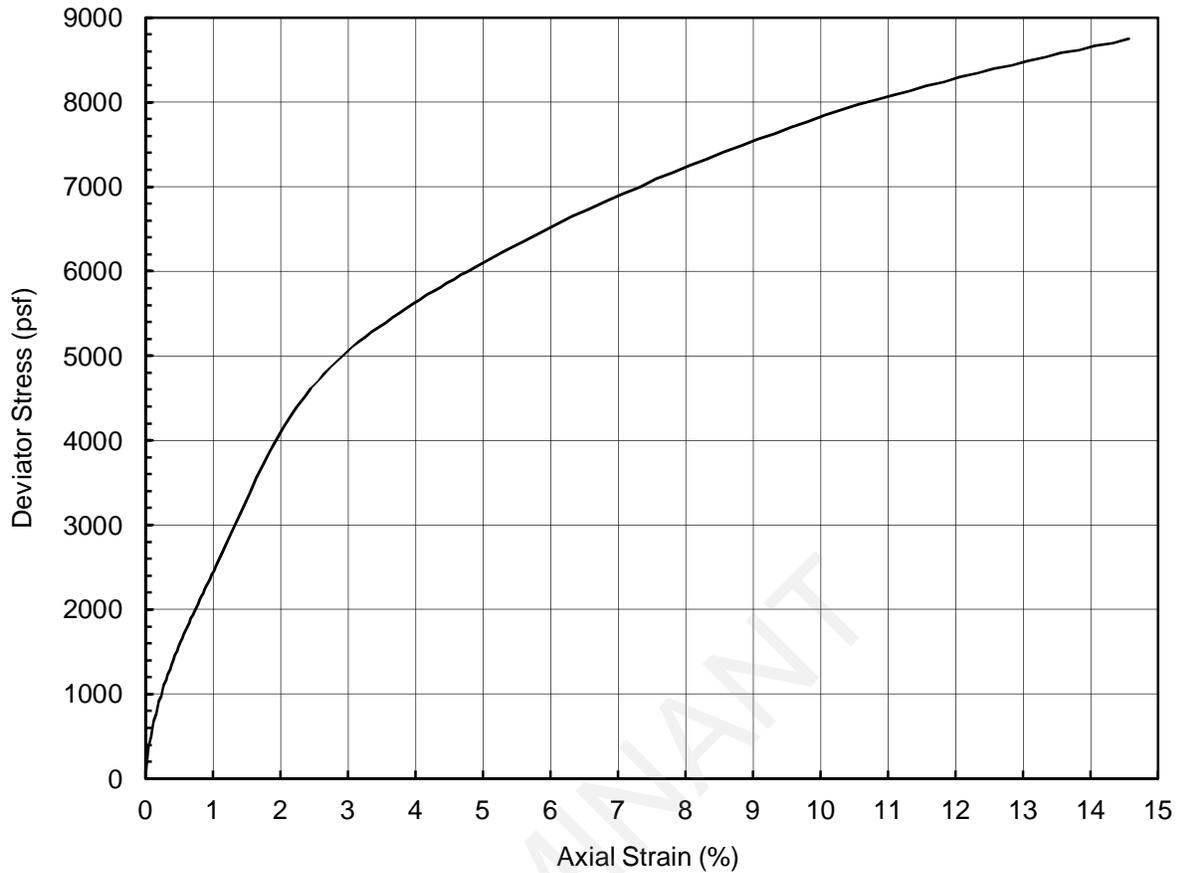
**UNCONSOLIDATED / UNDRAINED COMPRESSIVE STRENGTH
ASTM D 2850**

Specimen Description		Light Tan and Gray Clayey Sand					
LL	33	PI	20	LI	0.2	USCS	CL

Depth (ft)	28.0	Confining Pressure (psf)	2879
Specimen Height (inch)	5.9	Strain Rate (%/min)	1.0
Specimen Diameter (inch)	2.8	Peak Deviator Stress (psf)	8784
Initial Specimen Weight (g)	1253.7	Axial Strain at Peak Stress (%)	15.0
Moist Unit Weight (pcf)	132.8		
Initial Water Content (%)	17		
Initial Dry Unit Weight (pcf)	113.3

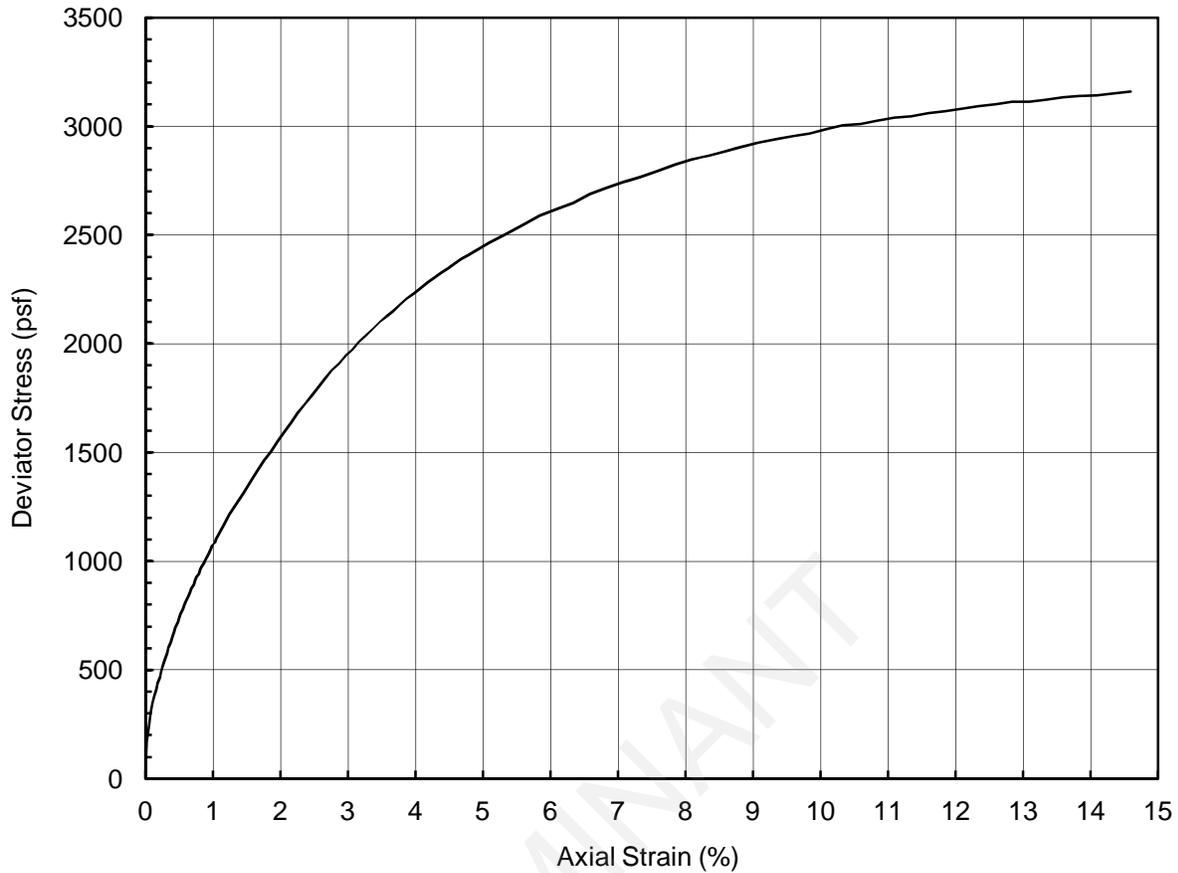
**UNCONSOLIDATED / UNDRAINED COMPRESSIVE STRENGTH
ASTM D 2850**

Specimen Description		Light Tan and Gray Clayey Sand					
LL	39	PI	23	LI	0.2	USCS	CL

Depth (ft)	13.0	Confining Pressure (psf)	1754
Specimen Height (inch)	4.9	Strain Rate (%/min)	1.0
Specimen Diameter (inch)	2.8	Peak Deviator Stress (psf)	3164
Initial Specimen Weight (g)	950.5	Axial Strain at Peak Stress (%)	14.8
Moist Unit Weight (pcf)	121.4		
Initial Water Content (%)	20		
Initial Dry Unit Weight (pcf)	101.3

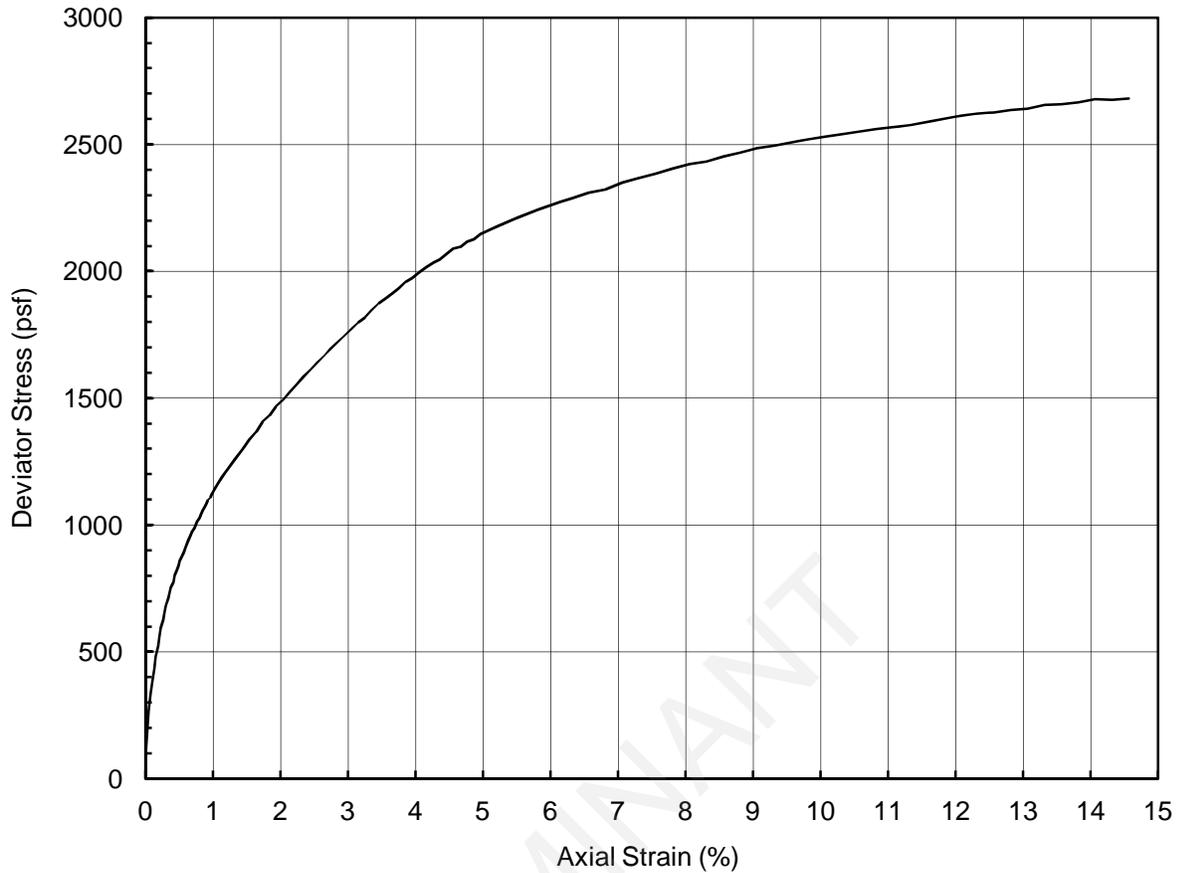
**UNCONSOLIDATED / UNDRAINED COMPRESSIVE STRENGTH
ASTM D 2850**

Specimen Description		Reddish Gray Clayey Sand					
LL	43	PI	28	LI	0.2	USCS	CL

Depth (ft)	6.0	Confining Pressure (psf)	891
Specimen Height (inch)	4.6	Strain Rate (%/min)	1.0
Specimen Diameter (inch)	2.8	Peak Deviator Stress (psf)	2688
Initial Specimen Weight (g)	926.5	Axial Strain at Peak Stress (%)	14.8
Moist Unit Weight (pcf)	122.1		
Initial Water Content (%)	20		
Initial Dry Unit Weight (pcf)	101.5

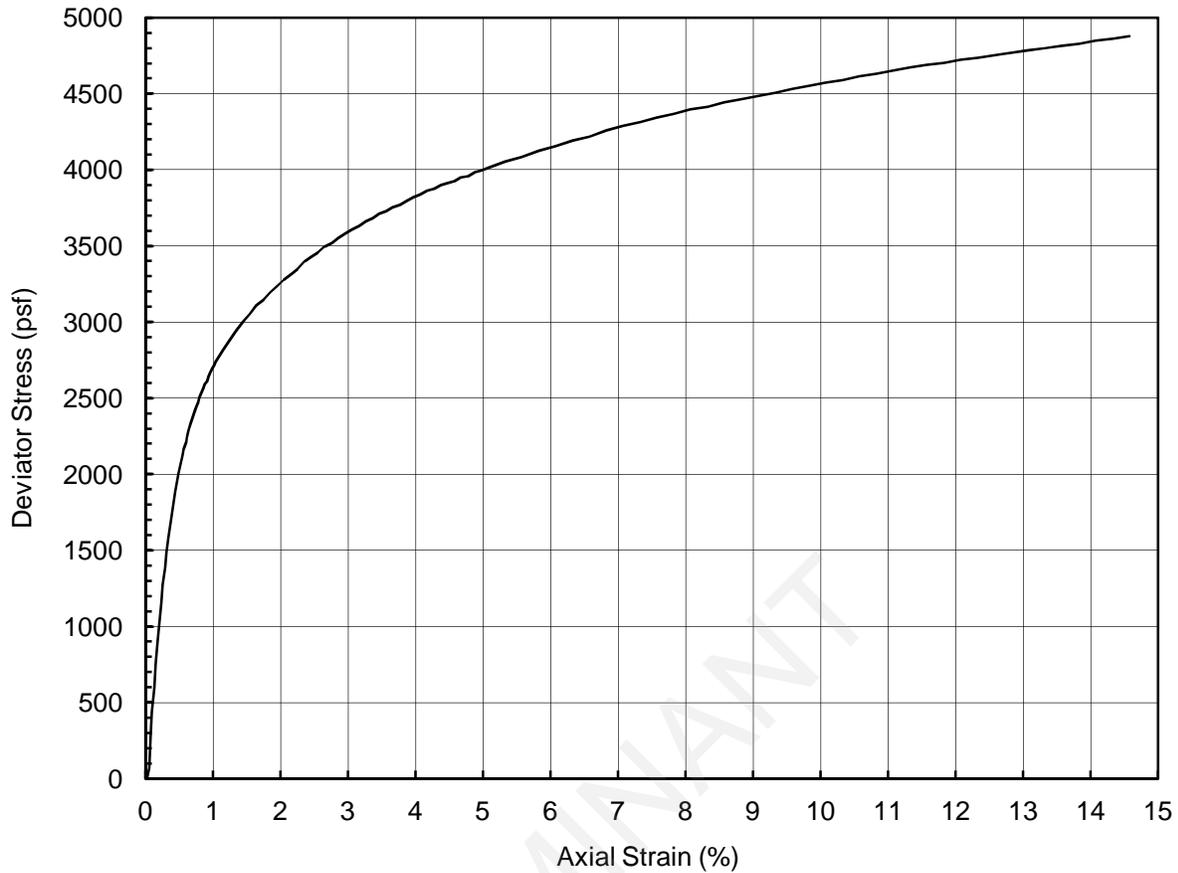
**UNCONSOLIDATED / UNDRAINED COMPRESSIVE STRENGTH
ASTM D 2850**

Specimen Description		Reddish Gray Clay					
LL	60	PI	46	LI	0.1	USCS	CH

Depth (ft)	23.0	Confining Pressure (psf)	2879
Specimen Height (inch)	6.0	Strain Rate (%/min)	1.0
Specimen Diameter (inch)	2.8	Peak Deviator Stress (psf)	4887
Initial Specimen Weight (g)	1218.0	Axial Strain at Peak Stress (%)	15.0
Moist Unit Weight (pcf)	131.2		
Initial Water Content (%)	20		
Initial Dry Unit Weight (pcf)	109.1

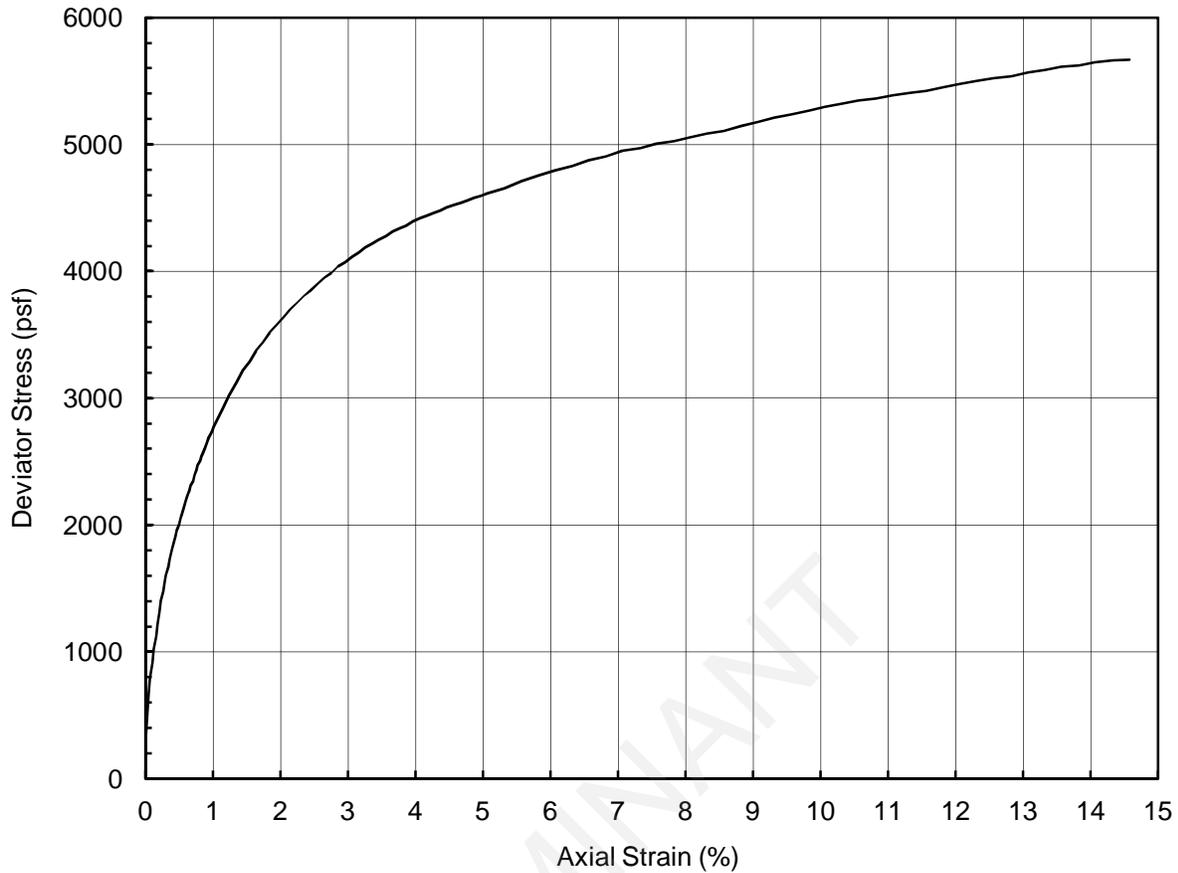
**UNCONSOLIDATED / UNDRAINED COMPRESSIVE STRENGTH
ASTM D 2850**

Specimen Description		Light Red Sandy Clay					
LL	49	PI	33	LI	0.0	USCS	CL

Depth (ft)	13.0	Confining Pressure (psf)	1752
Specimen Height (inch)	5.7	Strain Rate (%/min)	1.0
Specimen Diameter (inch)	2.8	Peak Deviator Stress (psf)	5685
Initial Specimen Weight (g)	1150.2	Axial Strain at Peak Stress (%)	14.8
Moist Unit Weight (pcf)	125.3		
Initial Water Content (%)	17		
Initial Dry Unit Weight (pcf)	107.5

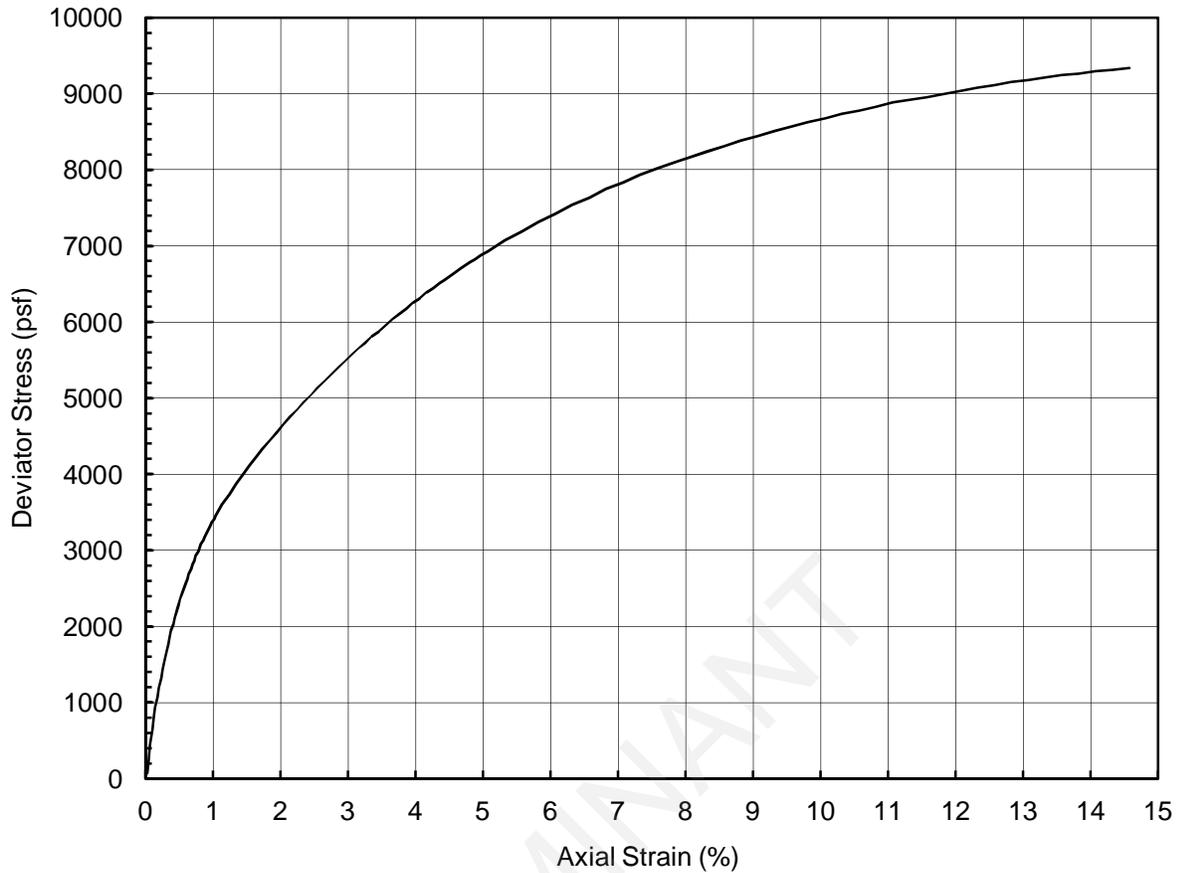
**UNCONSOLIDATED / UNDRAINED COMPRESSIVE STRENGTH
ASTM D 2850**

Specimen Description		Light Gray Sandy Clay					
LL	44	PI	30	LI	0.1	USCS	CL

Depth (ft)	33.0	Confining Pressure (psf)	3304
Specimen Height (inch)	6.0	Strain Rate (%/min)	1.0
Specimen Diameter (inch)	2.9	Peak Deviator Stress (psf)	9360
Initial Specimen Weight (g)	1270.9	Axial Strain at Peak Stress (%)	15.0
Moist Unit Weight (pcf)	127.4		
Initial Water Content (%)	18		
Initial Dry Unit Weight (pcf)	107.9

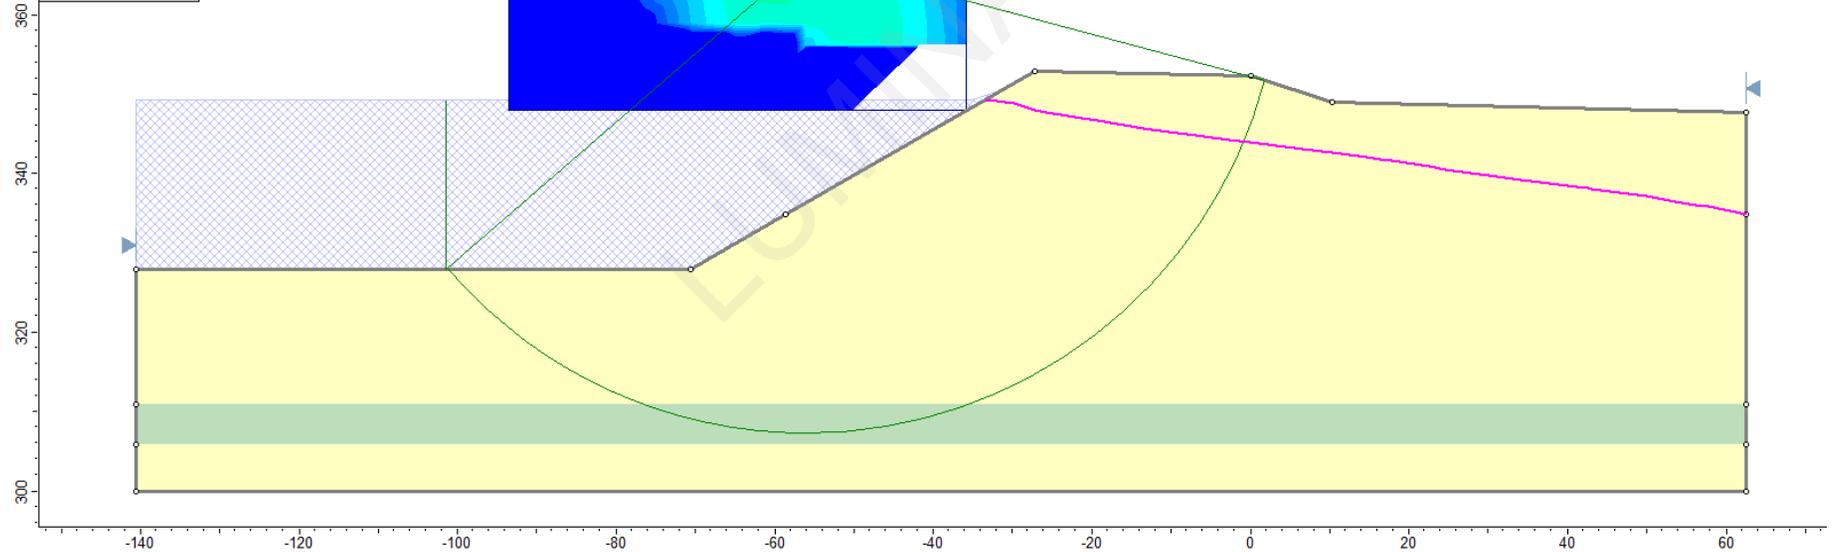
FIGURE D.5
Results of Stability Analysis – BAP: B-B' – Case 3a
 Stability and Safety Factor Assessment, Big Brown SES

Material Name	Color	Unit Weight (lbs/ft3)	Strength Type	Cohesion (psf)	Phi (deg)
Clayey Sand/ Sandy Clay	Yellow	127	Mohr-Coulomb	1000	14
Clean Sand	Green	127	Mohr-Coulomb	0	29

As mentioned earlier, slope stability analyses were performed for long-term conditions for each of the critical cross-sections considered under static and seismic loading conditions. Both interior and exterior slopes were analyzed for “Maximum Storage Pool” (3 feet of freeboard) and “Maximum Surcharge Pool” (no freeboard) conditions. The interior slopes were analyzed for the condition where the pond is empty. The results of the slope stability analysis cases are presented in Table 2, and the corresponding analysis outputs can be found in Appendix D. The results indicate that the BAP slopes are sufficiently stable under all considered loading scenarios.

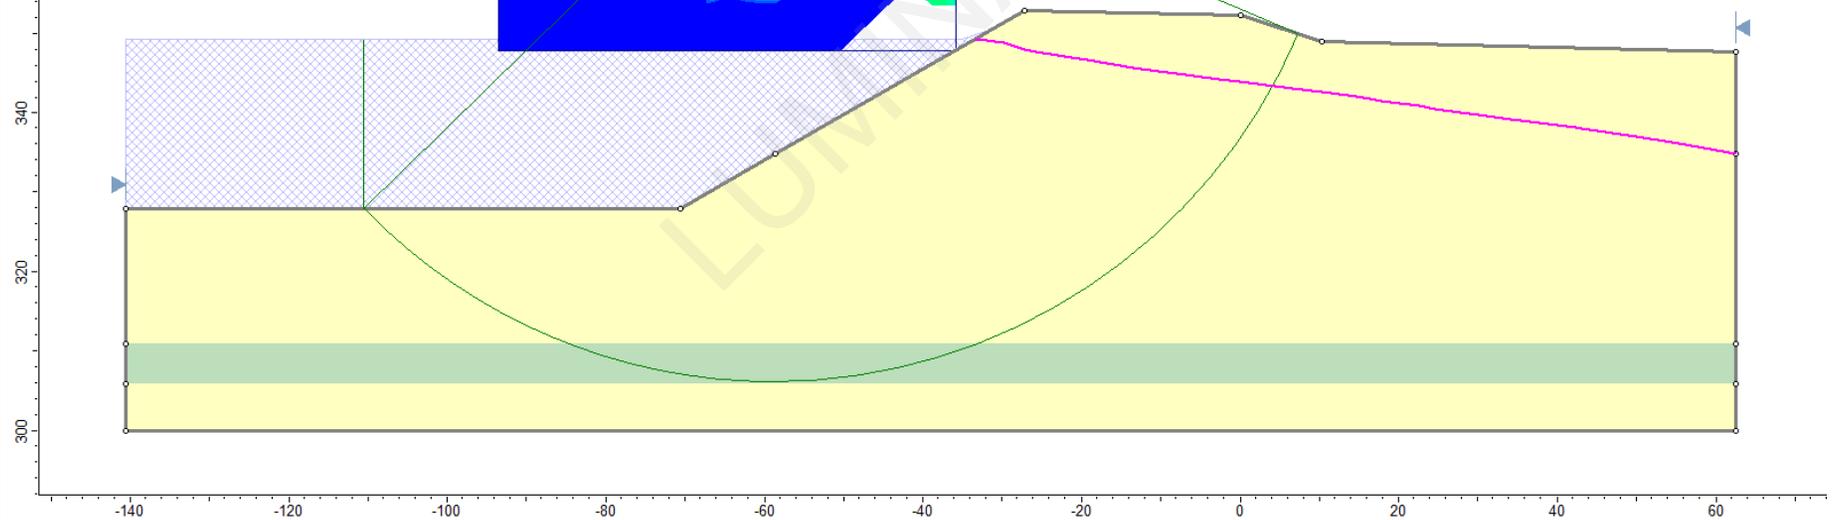
FIGURE D.6
Results of Stability Analysis – BAP: B–B' – Case 3b
 Stability and Safety Factor Assessment, Big Brown SES

Material Name	Color	Unit Weight (lbs/ft ³)	Strength Type	Cohesion (psf)	Phi (deg)
Clayey Sand/ Sandy Clay		127	Mohr-Coulomb	1000	14
Clean Sand		127	Mohr-Coulomb	0	29

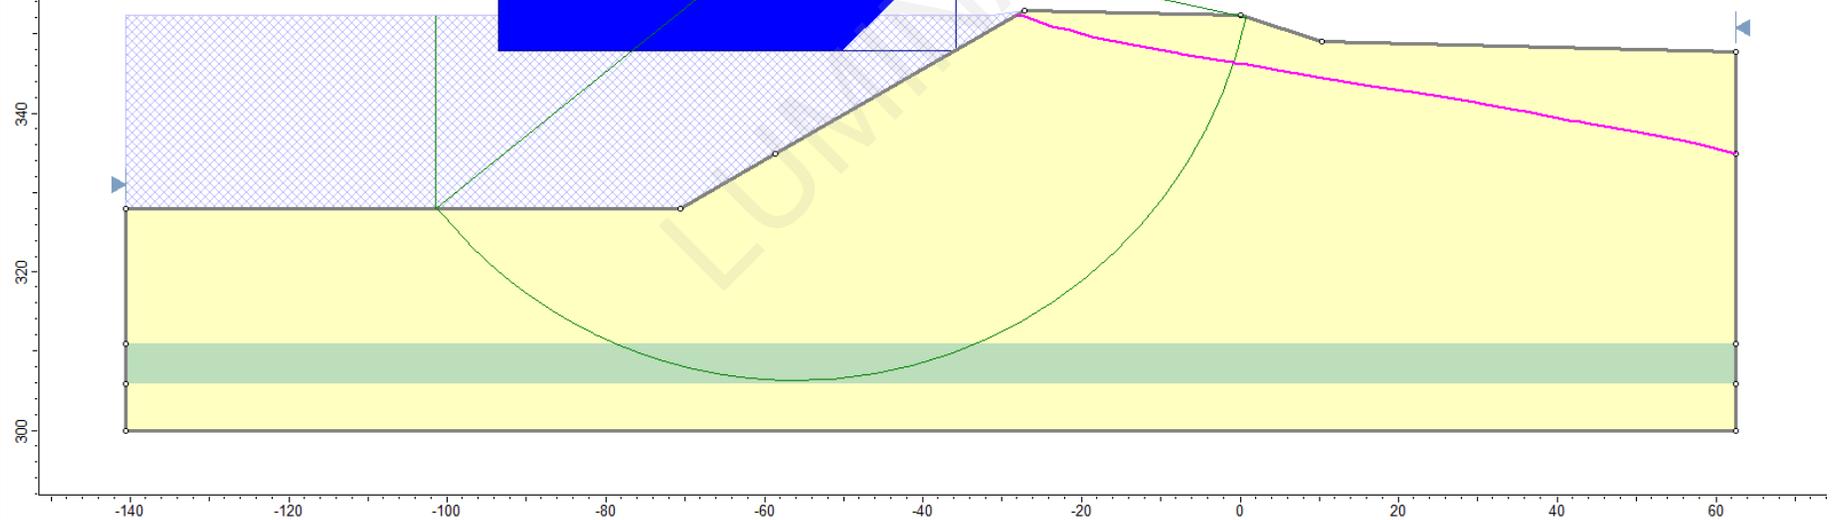
FIGURE D.7
Results of Stability Analysis – BAP: B-B' – Case 4a
 Stability and Safety Factor Assessment, Big Brown SES

Material Name	Color	Unit Weight (lbs/ft ³)	Strength Type	Cohesion (psf)	Phi (deg)
Clayey Sand/ Sandy Clay	Yellow	127	Mohr-Coulomb	1000	14
Clean Sand	Green	127	Mohr-Coulomb	0	29

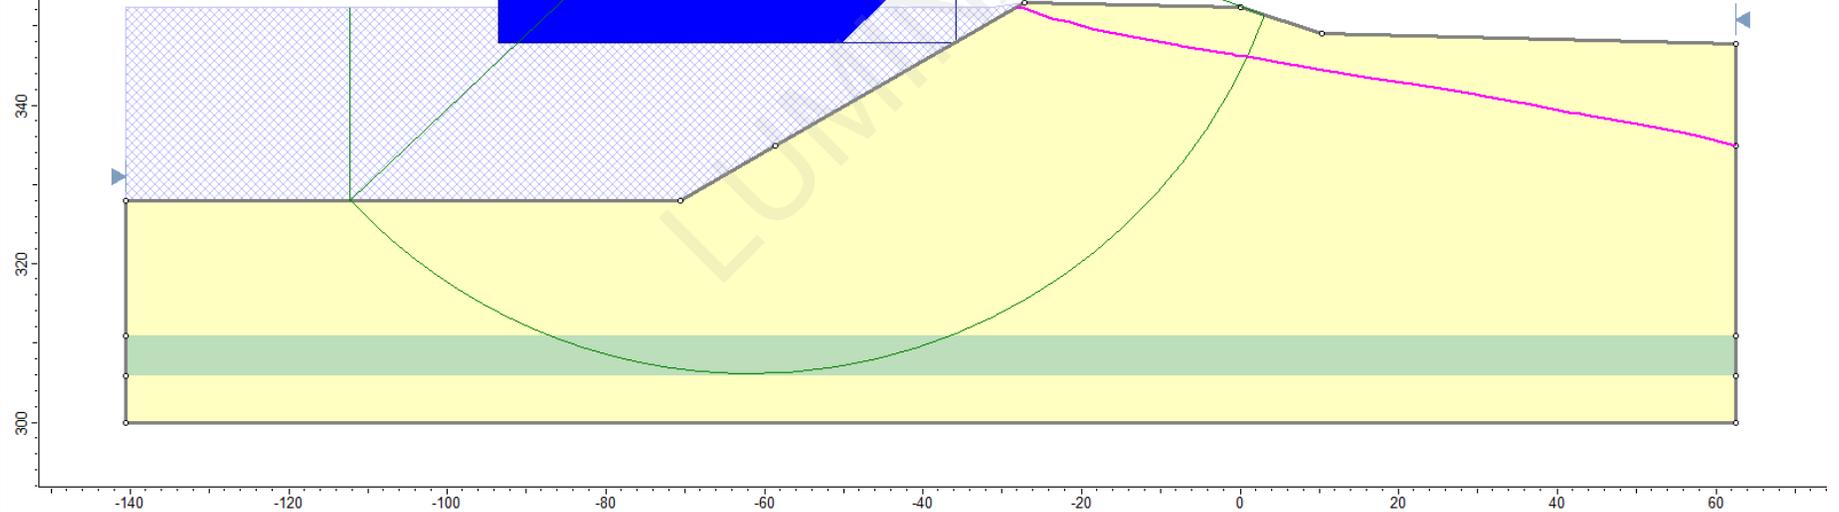
FIGURE D.8
Results of Stability Analysis – BAP: B-B' – Case 4b
 Stability and Safety Factor Assessment, Big Brown SES

Material Name	Color	Unit Weight (lbs/ft ³)	Strength Type	Cohesion (psf)	Phi (deg)
Clayey Sand/ Sandy Clay		127	Mohr-Coulomb	1000	14
Clean Sand		127	Mohr-Coulomb	0	29

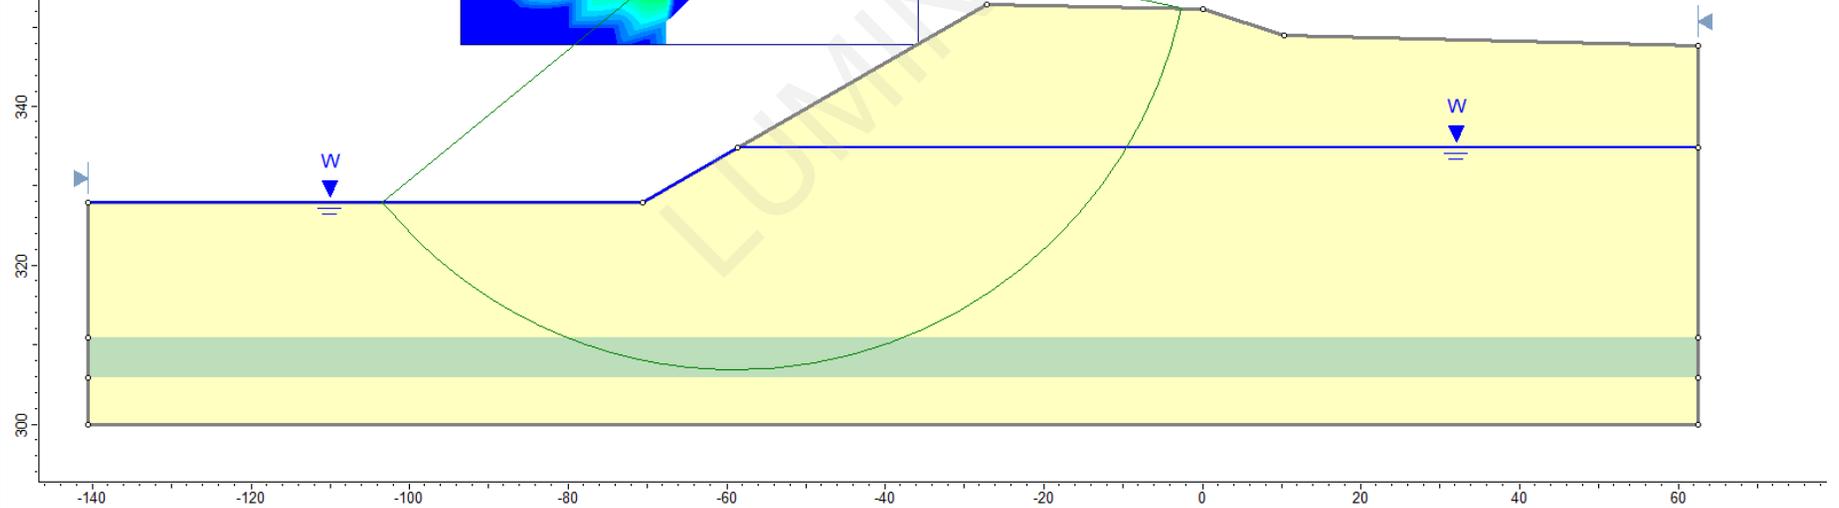
FIGURE D.9
Results of Stability Analysis – BAP: B-B' – Case 5a

Material Name	Color	Unit Weight (lbs/ft ³)	Sat. Unit Weight (lbs/ft ³)	Strength Type	Cohesion (psf)	Phi (deg)
Clayey Sand/ Sandy Clay		127	132	Mohr-Coulomb	1000	14
Clean Sand		127	132	Mohr-Coulomb	0	29
