SAFETY FACTOR ASSESSMENT REPORT

Oak Grove Steam Electric Station

October 2016

Project No. 1648164

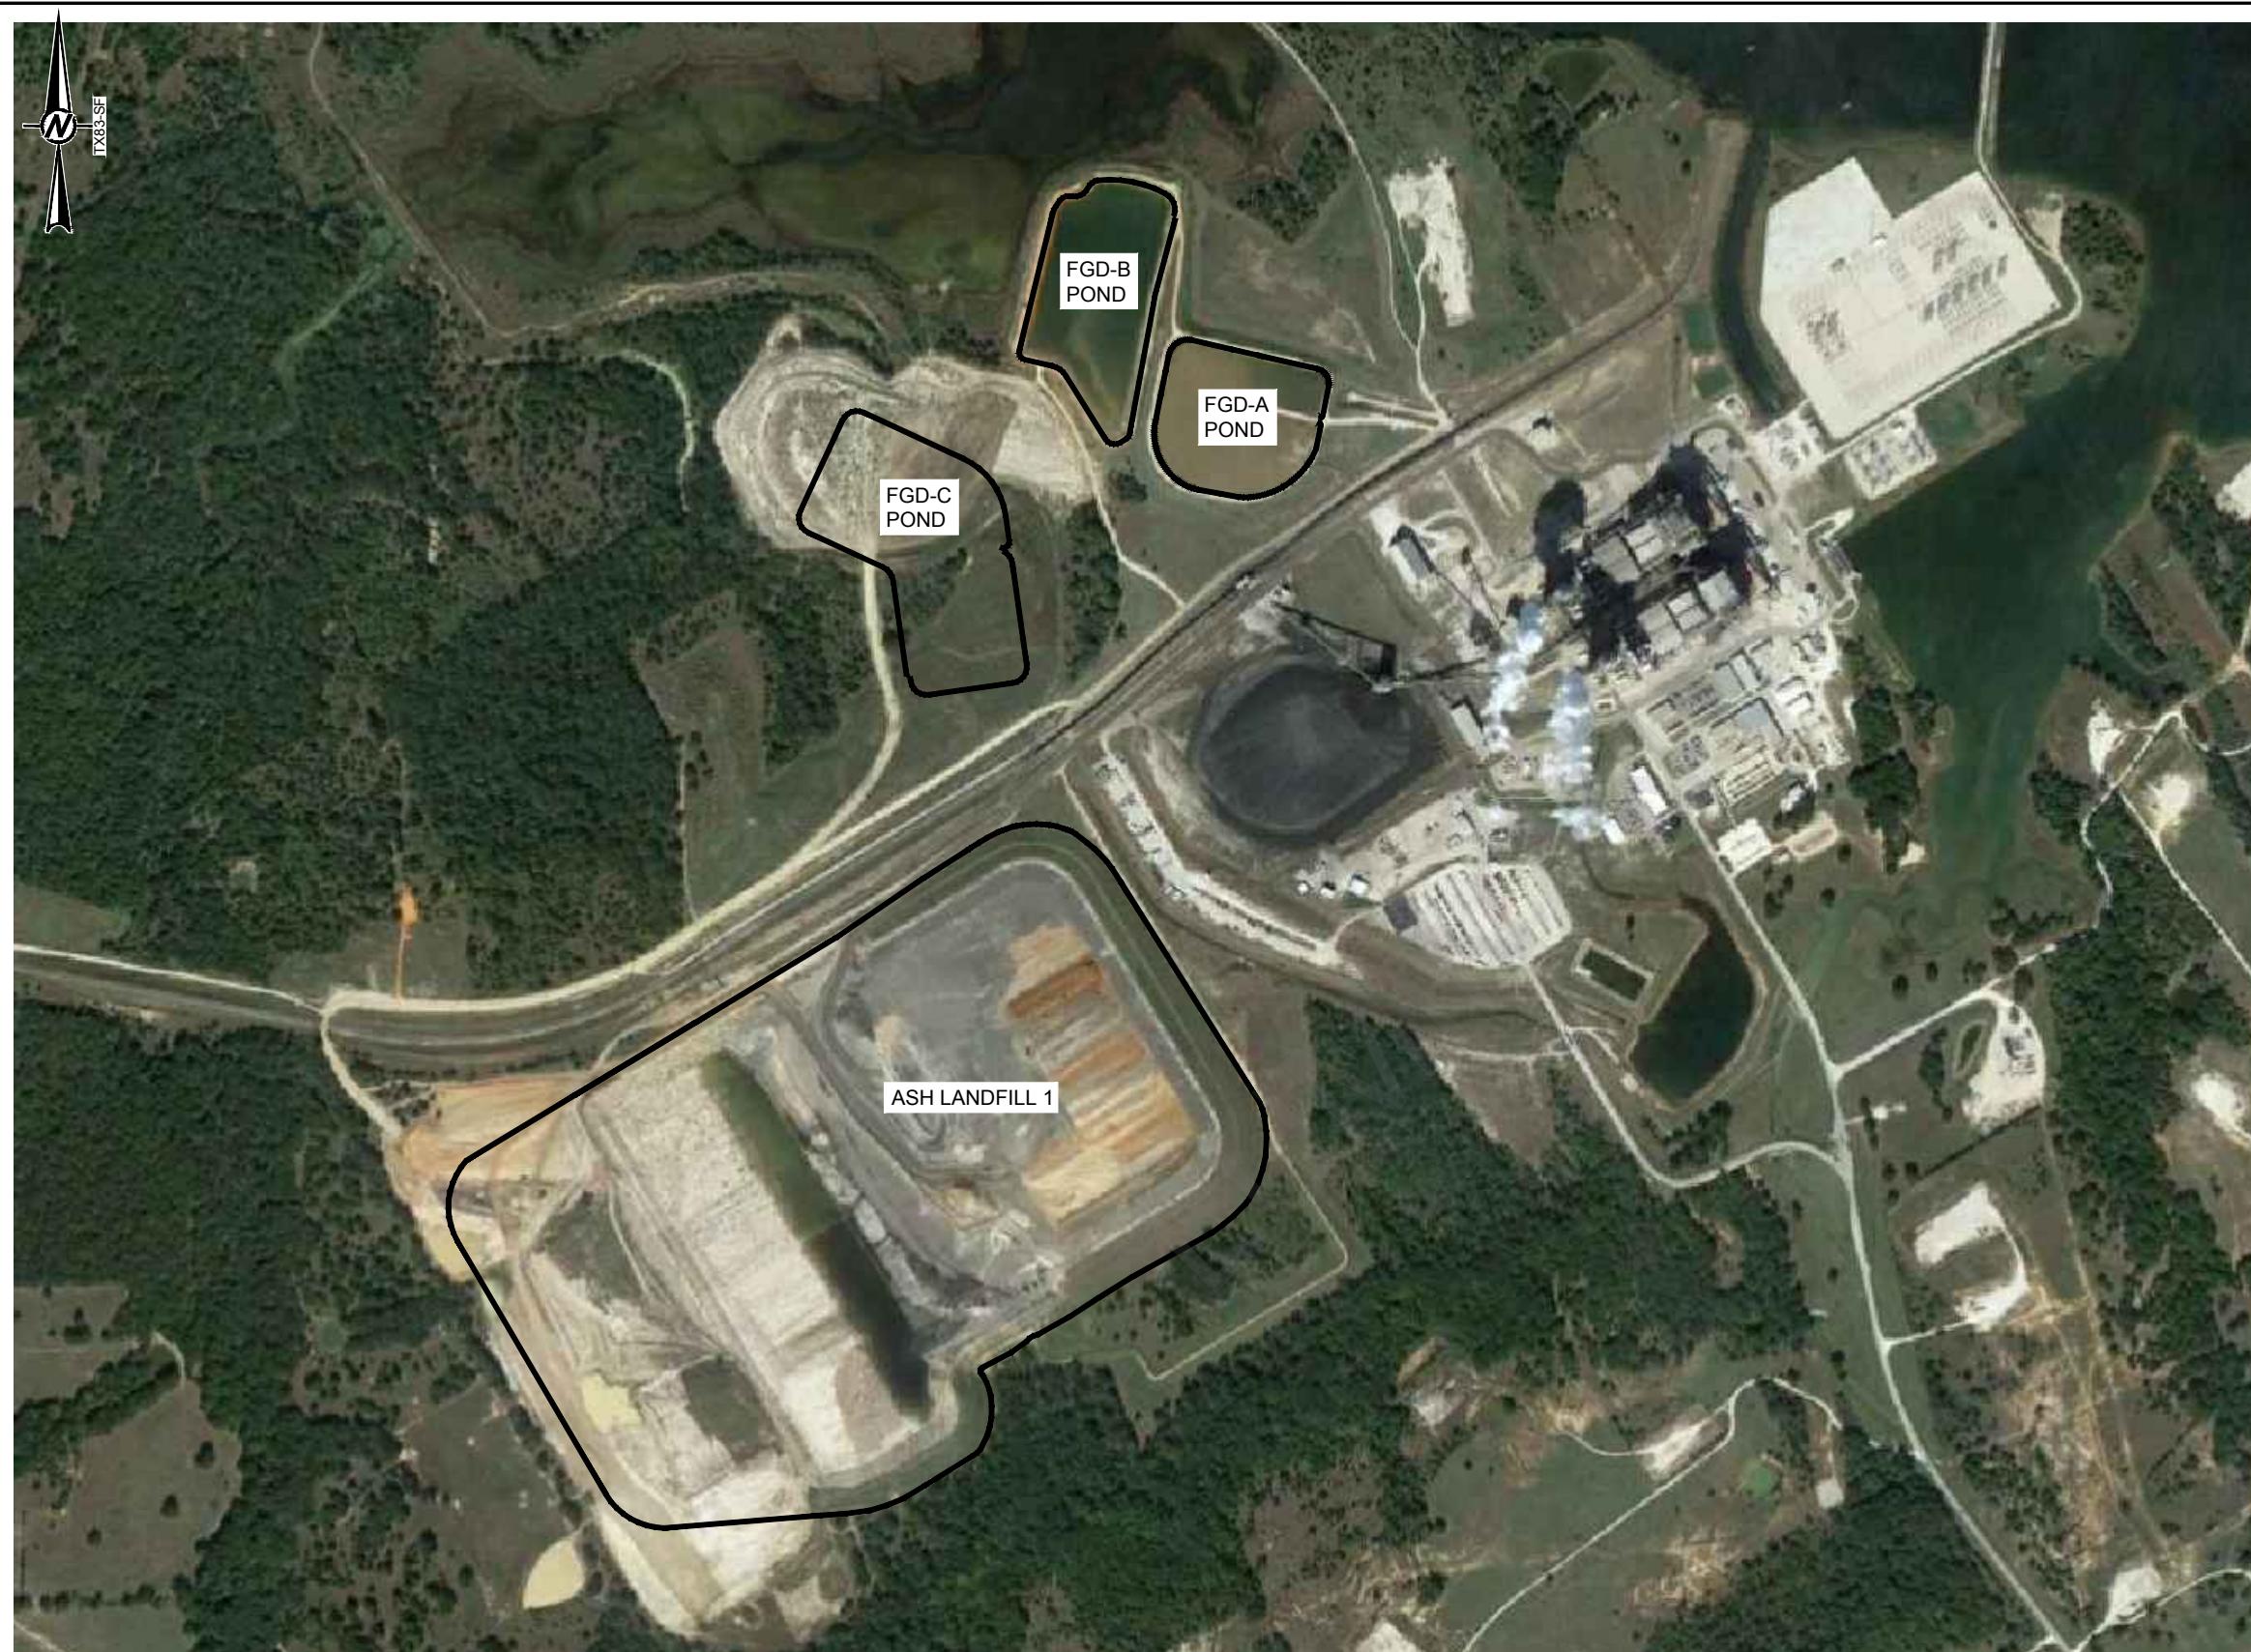
The OGSES generates bottom ash, fly ash, boiler slag and flue gas desulfurization (FGD) sludge (gypsum) during electricity generation. The following surface impoundments, shown on Figure 1, are in operation at the OGSES:

- FGD-A Pond;
- FGD-B Pond; and
- FGD-C Pond.

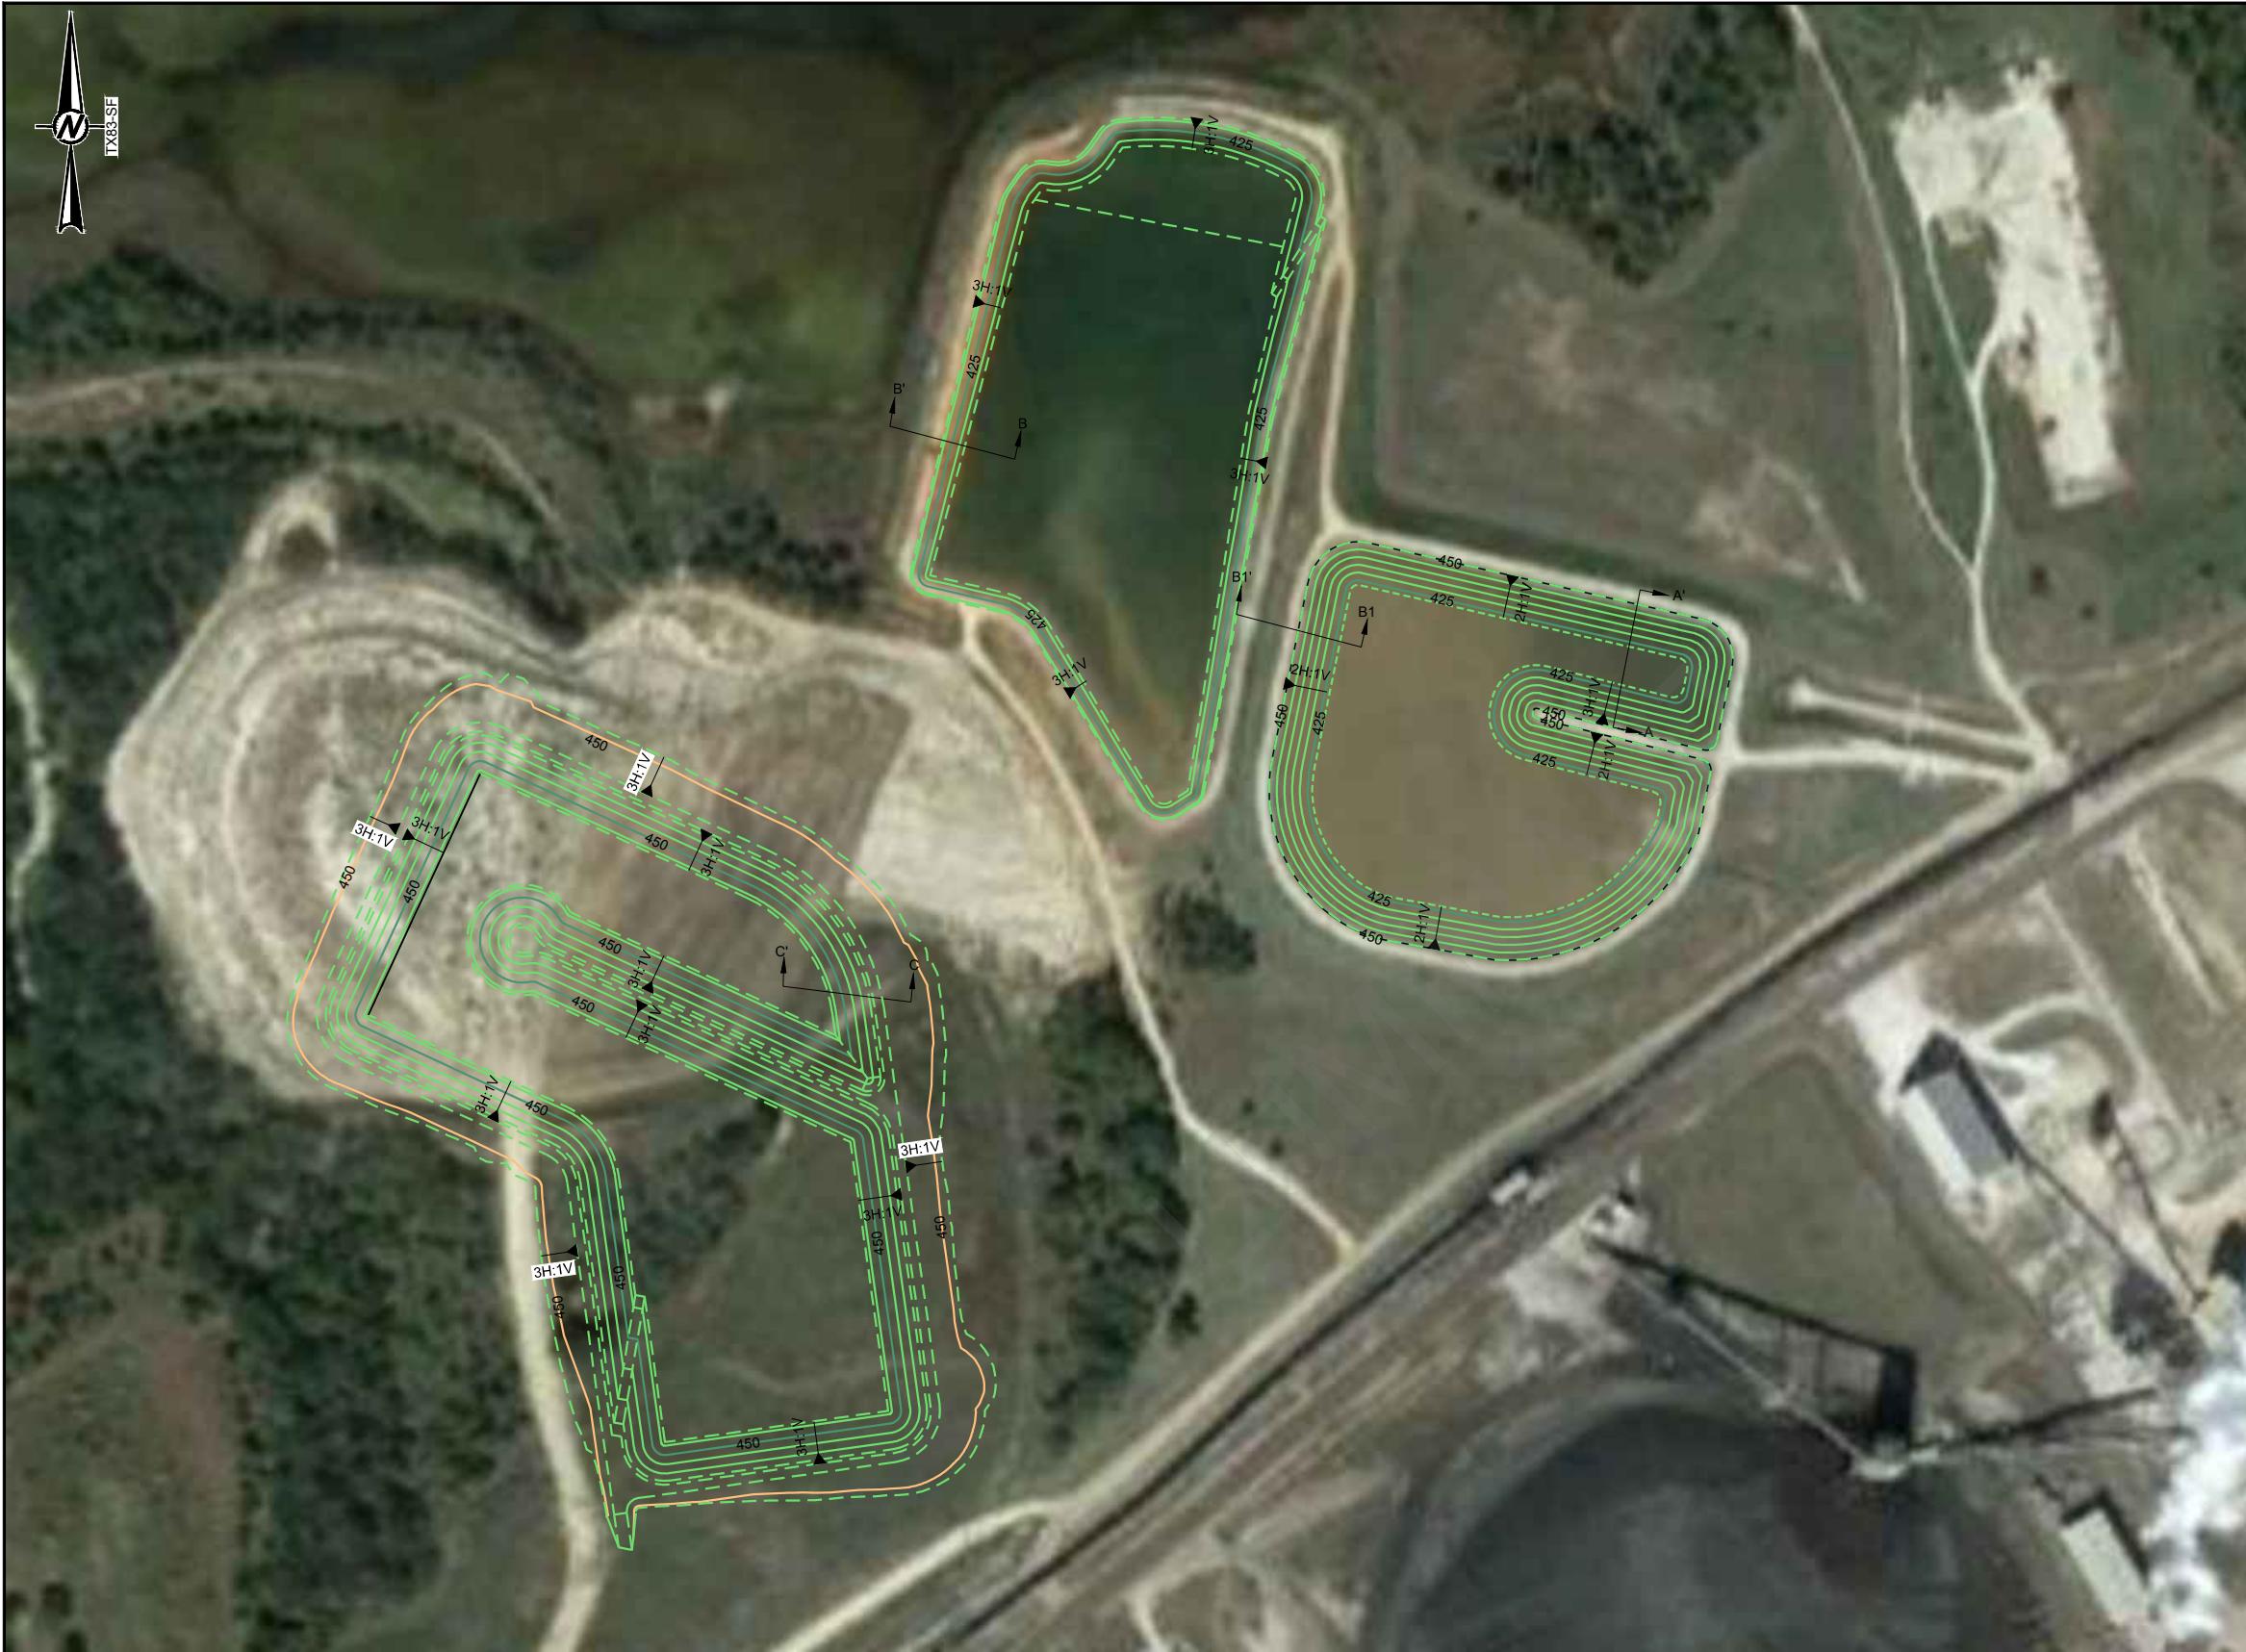
After considering multiple cross-sections a critical cross-section was identified for each pond and used for the stability analysis. The critical cross-section was determined considering the geometry of the slopes, soil profile, phreatic surface and loading conditions. More than one cross-section was used when required. For example, the critical section for the interior slopes of FGD-B is located to the east bordering pond FGD-A. However, since FGD-A adjoins FGD-B here, the critical section for exterior slopes of FGD-B are not located on this section. Hence, another section is analyzed on the west side of FGD-B to evaluate the exterior slopes. The critical cross-sections analyzed – A-A', B-B', B1-B1', C-C' – for each pond are shown in Figure 2.

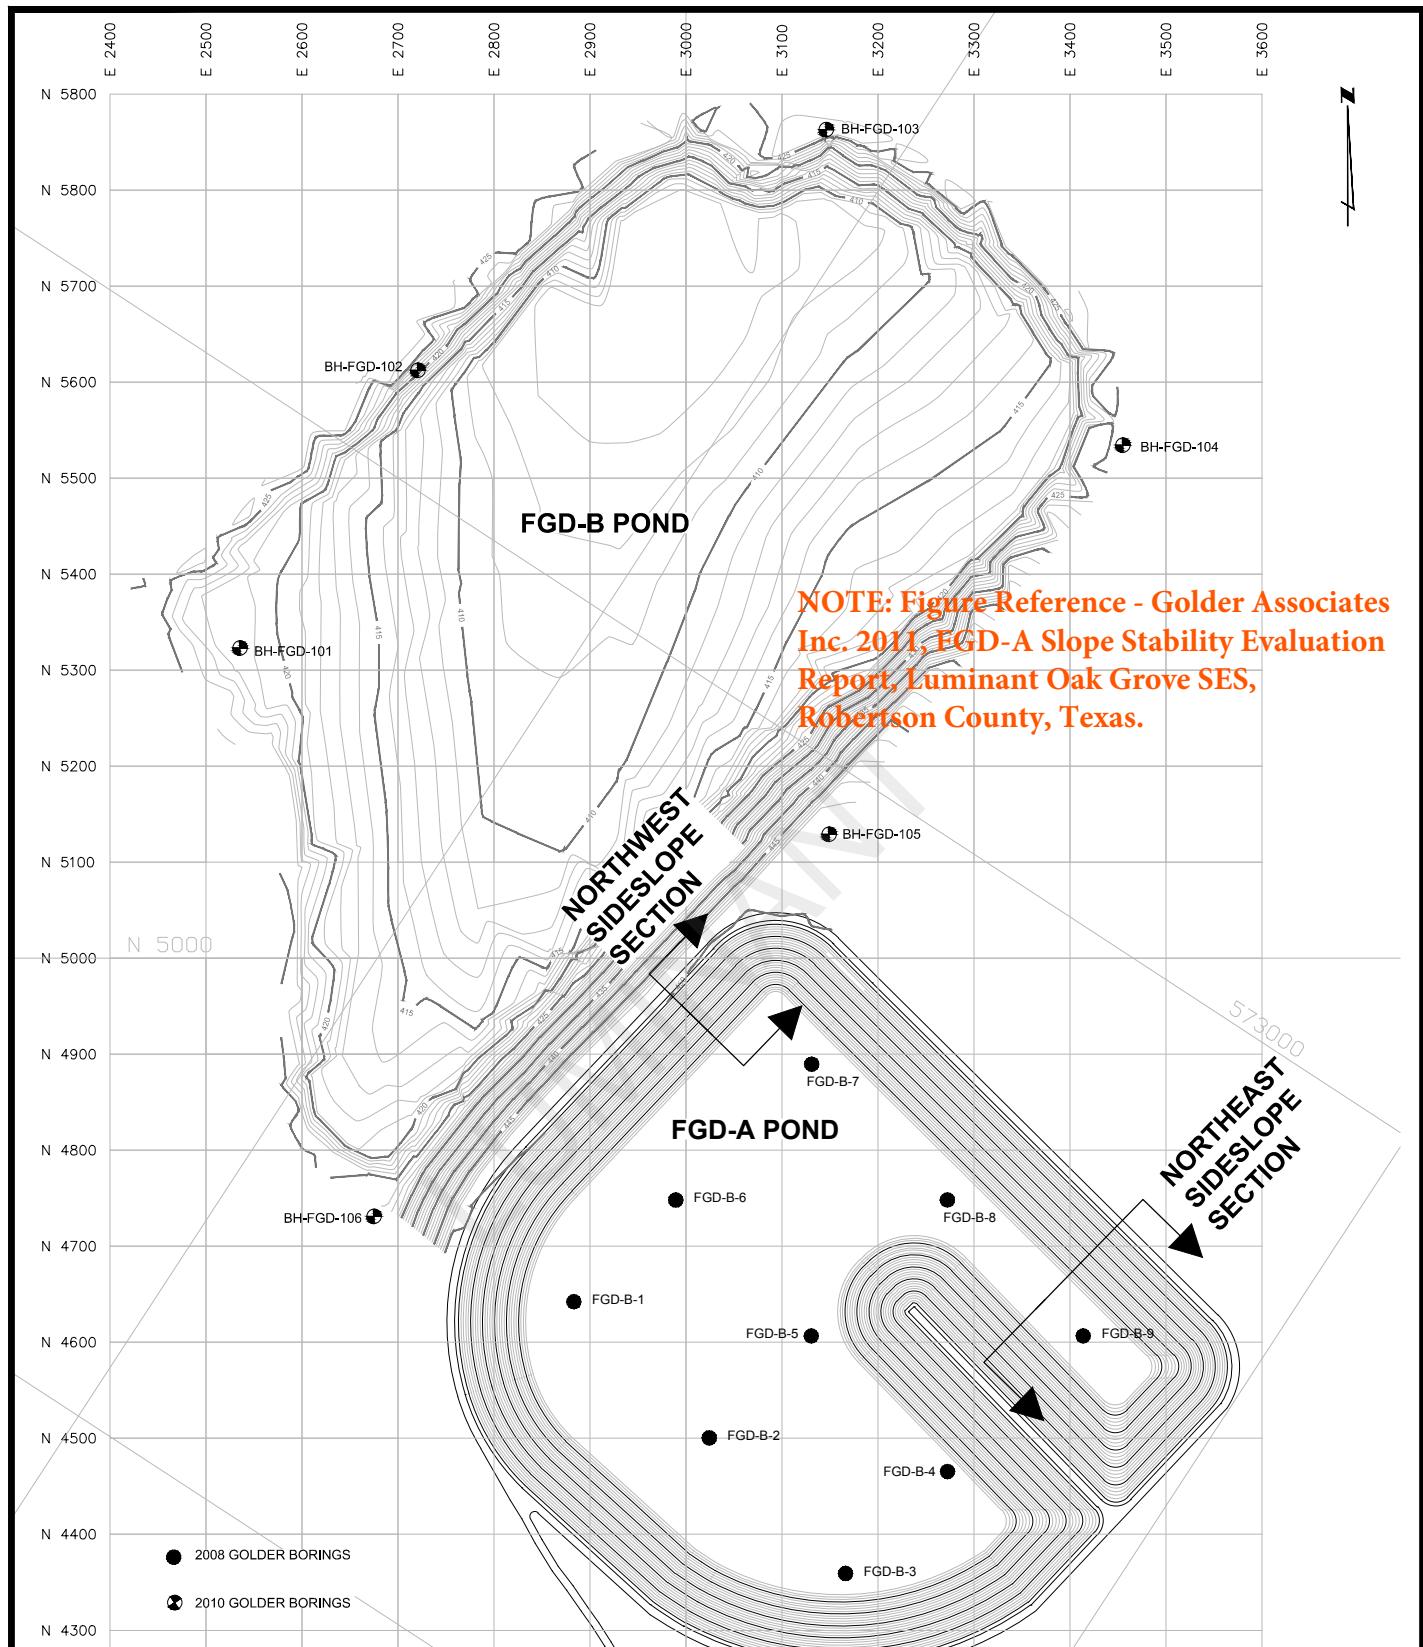
EXISTING BORING LOCATION PLAN

Information from previous subsurface investigations was used to characterize the subsurface site conditions. Golder conducted a subsurface investigation for the FGD-A pond in July 2008, prior to construction of the clay liner within the pond. Golder completed nine borings within the pond footprint with boring depths ranging from 16 to 28 feet below ground surface (bgs) (Golder, 2008). Golder also conducted a subsurface investigation for FGD-B pond in March 2010 (Golder, 2010). In December 2014, Golder completed another subsurface investigation including ten geotechnical boreholes and installation of 3 groundwater monitoring wells, to facilitate design and construction of the FGD-C pond. Appendix A includes the boring location maps and select, representative boring logs.

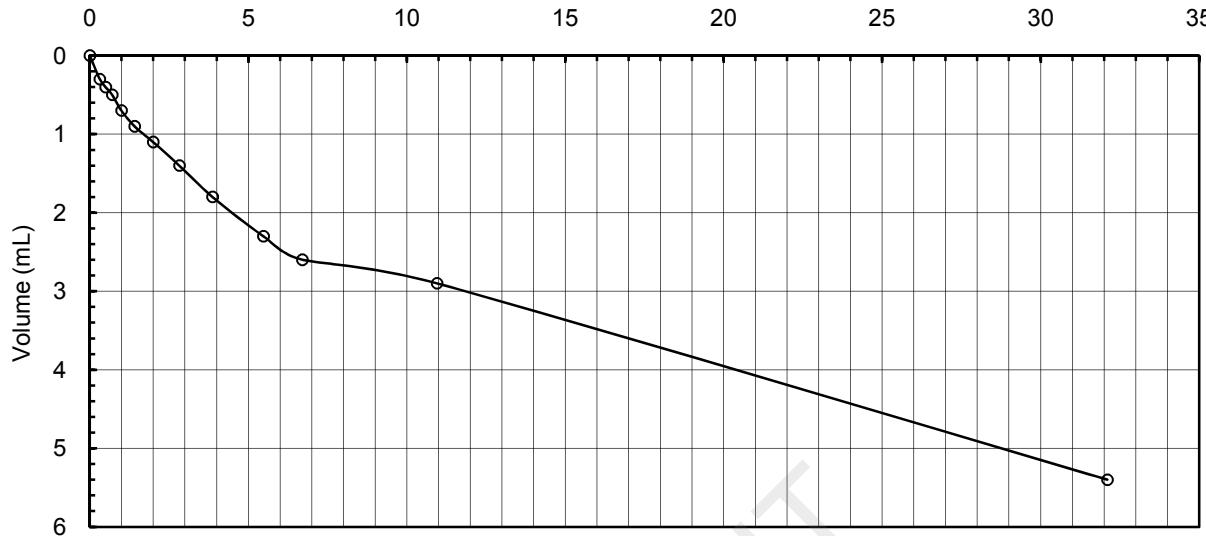
Date: 10-Apr-10
Depth (ft): 8.0

Square Root of Time ($\sqrt{\text{min}}$)

Consolidation Stress (σ'_3 , psf) =	3463		
Consolidation t_{50} (min) =	6		
Consolidation Volume Change (mL) =	5.4		
Unloading Stress (psf) =	NA		
Unloading t_{50} (min) =	NA		
Unloading Volume Change (mL) =	NA		
LL =	51	PI =	32
USCS	CH		
Gs =	2.65	assumed

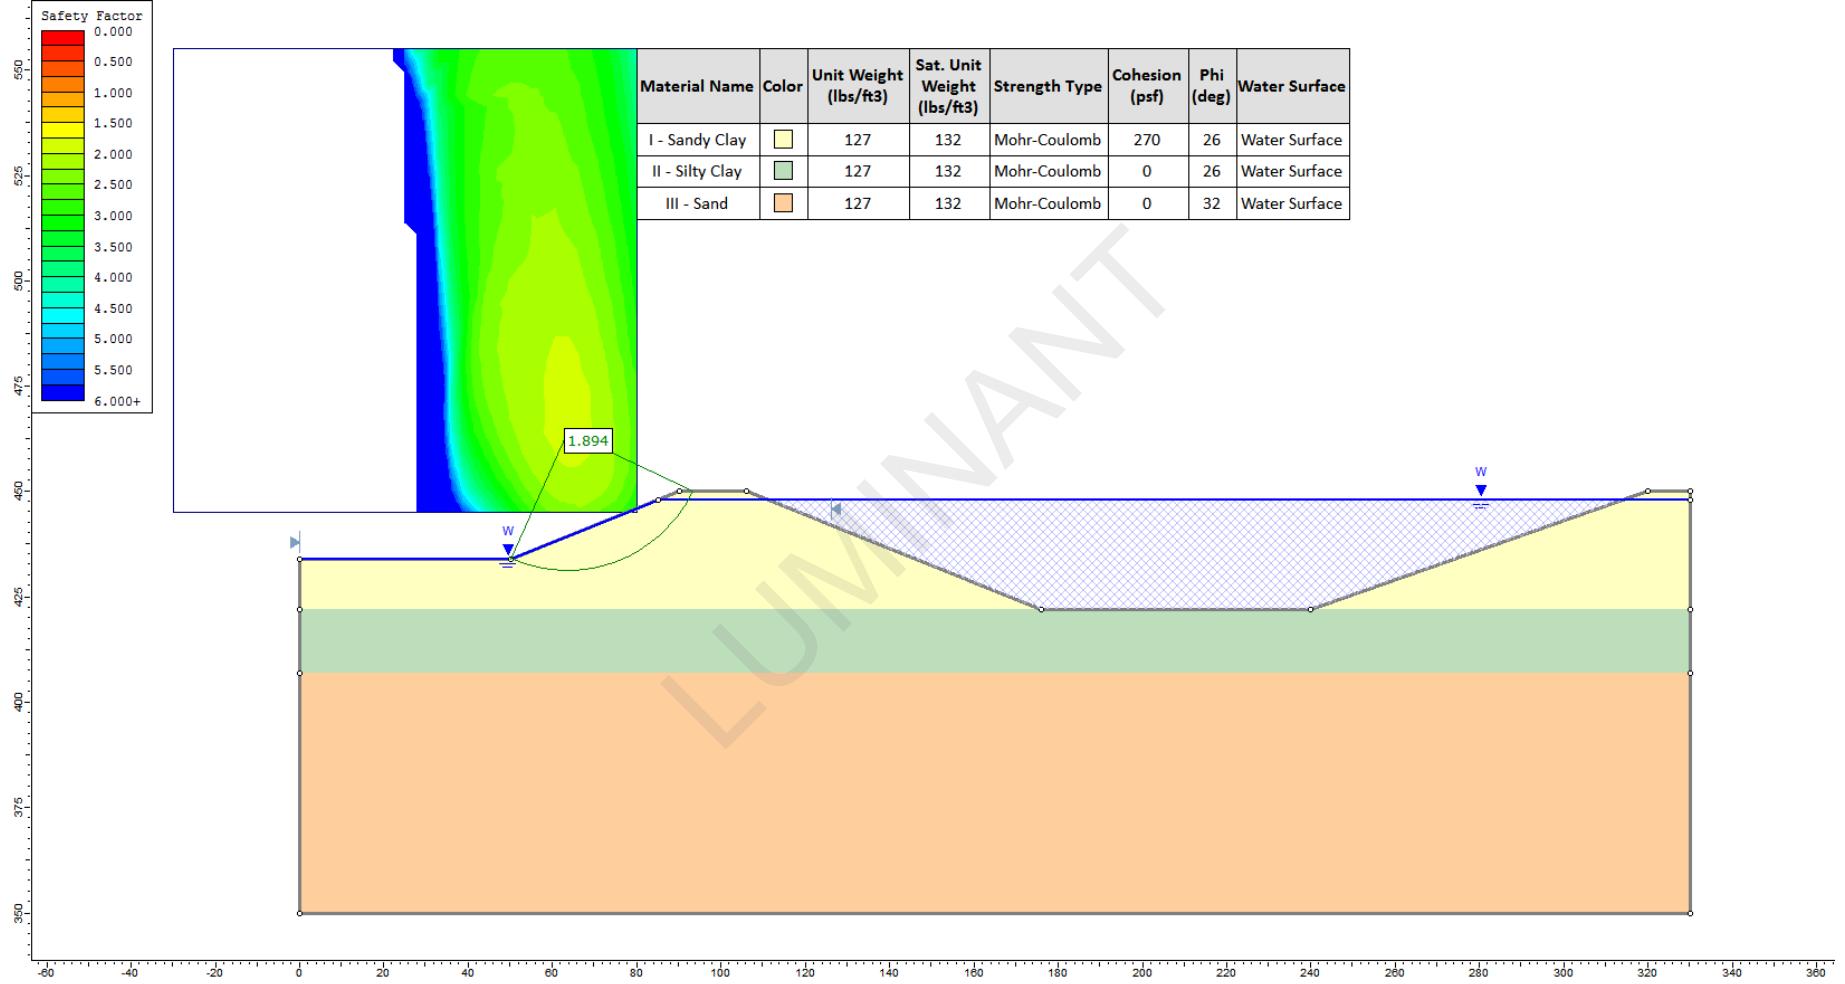
FIGURE C.1
Results of Stability Analysis – FGD-A: A-A' – Case 1a
 Stability and Safety Factor Assessment, Oak Grove SES

Cross-Section	Case #	Slope Location	Pond Pool Level	Loading Condition	Req'd Safety Factor ⁽¹⁾	Calculated Safety Factor
A-A'	1a	Exterior	Storage	Static	1.50	1.89
	1b			Pseudostatic	1.00	1.61
	2a		Surcharge	Static	1.40	1.84
	2b			Pseudostatic	1.00	1.56

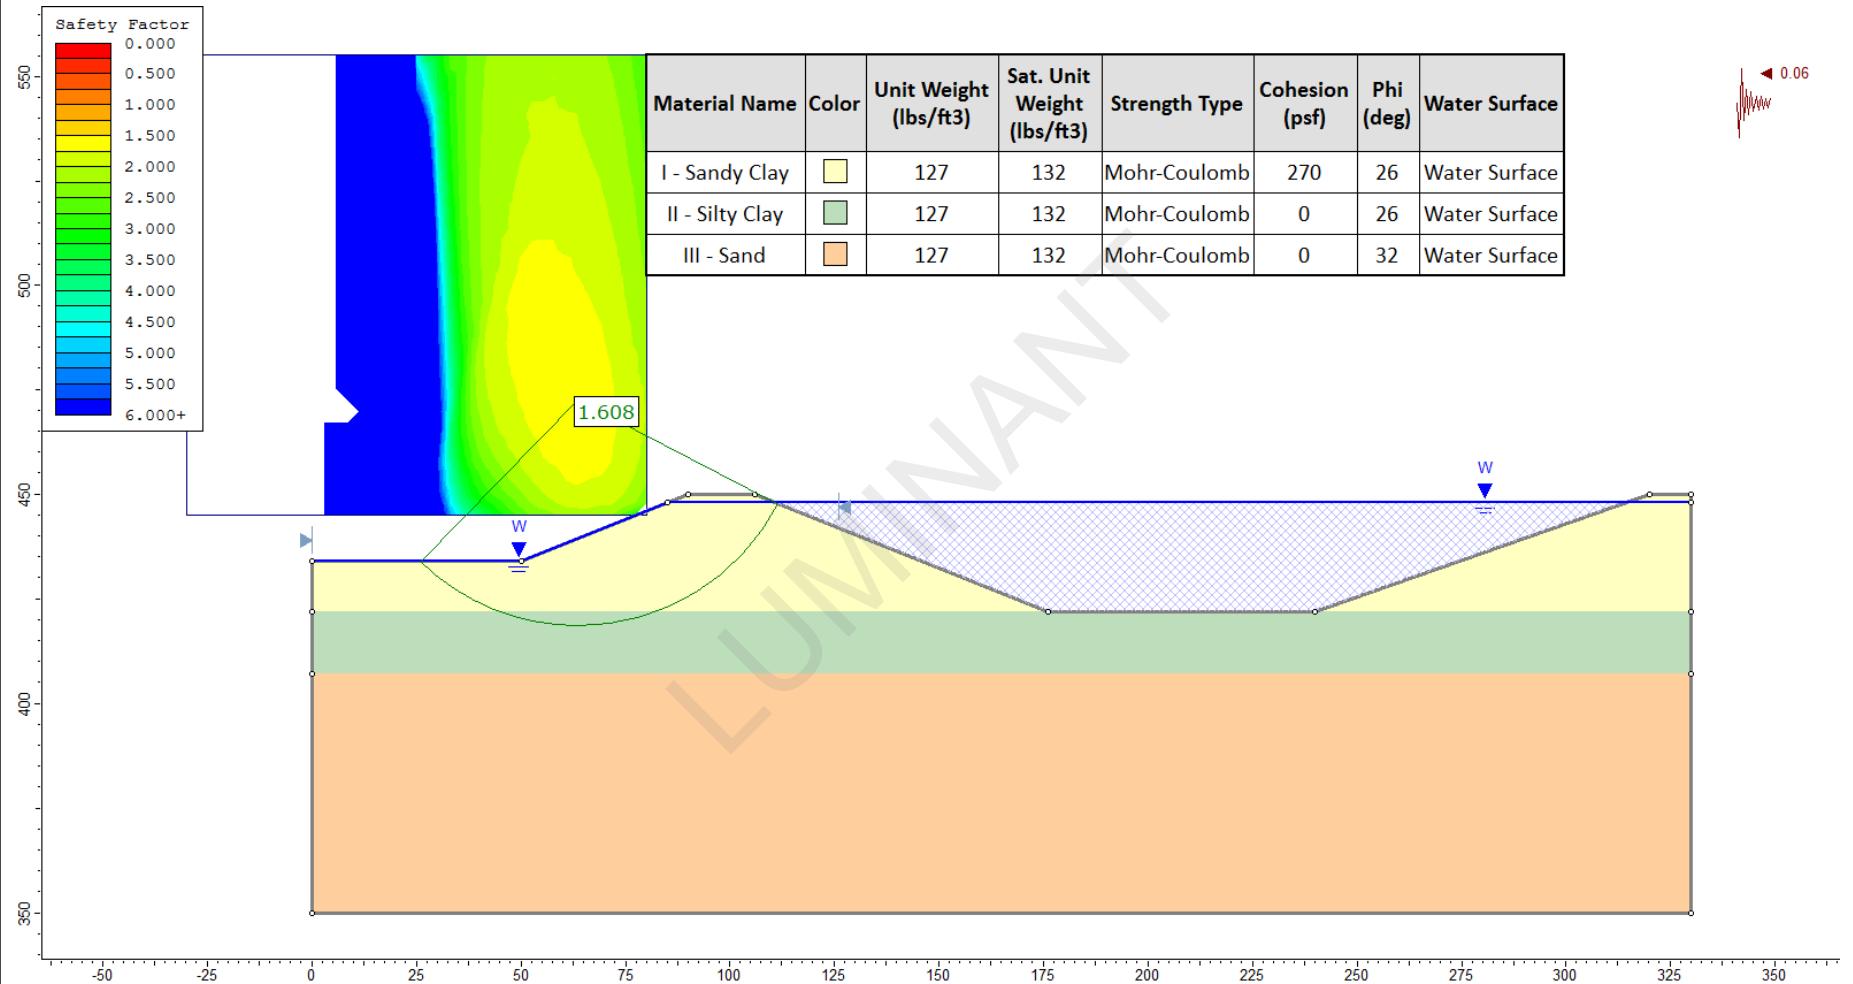
FIGURE C.2
Results of Stability Analysis – FGD-A: A-A' – Case 1b
 Stability and Safety Factor Assessment, Oak Grove SES

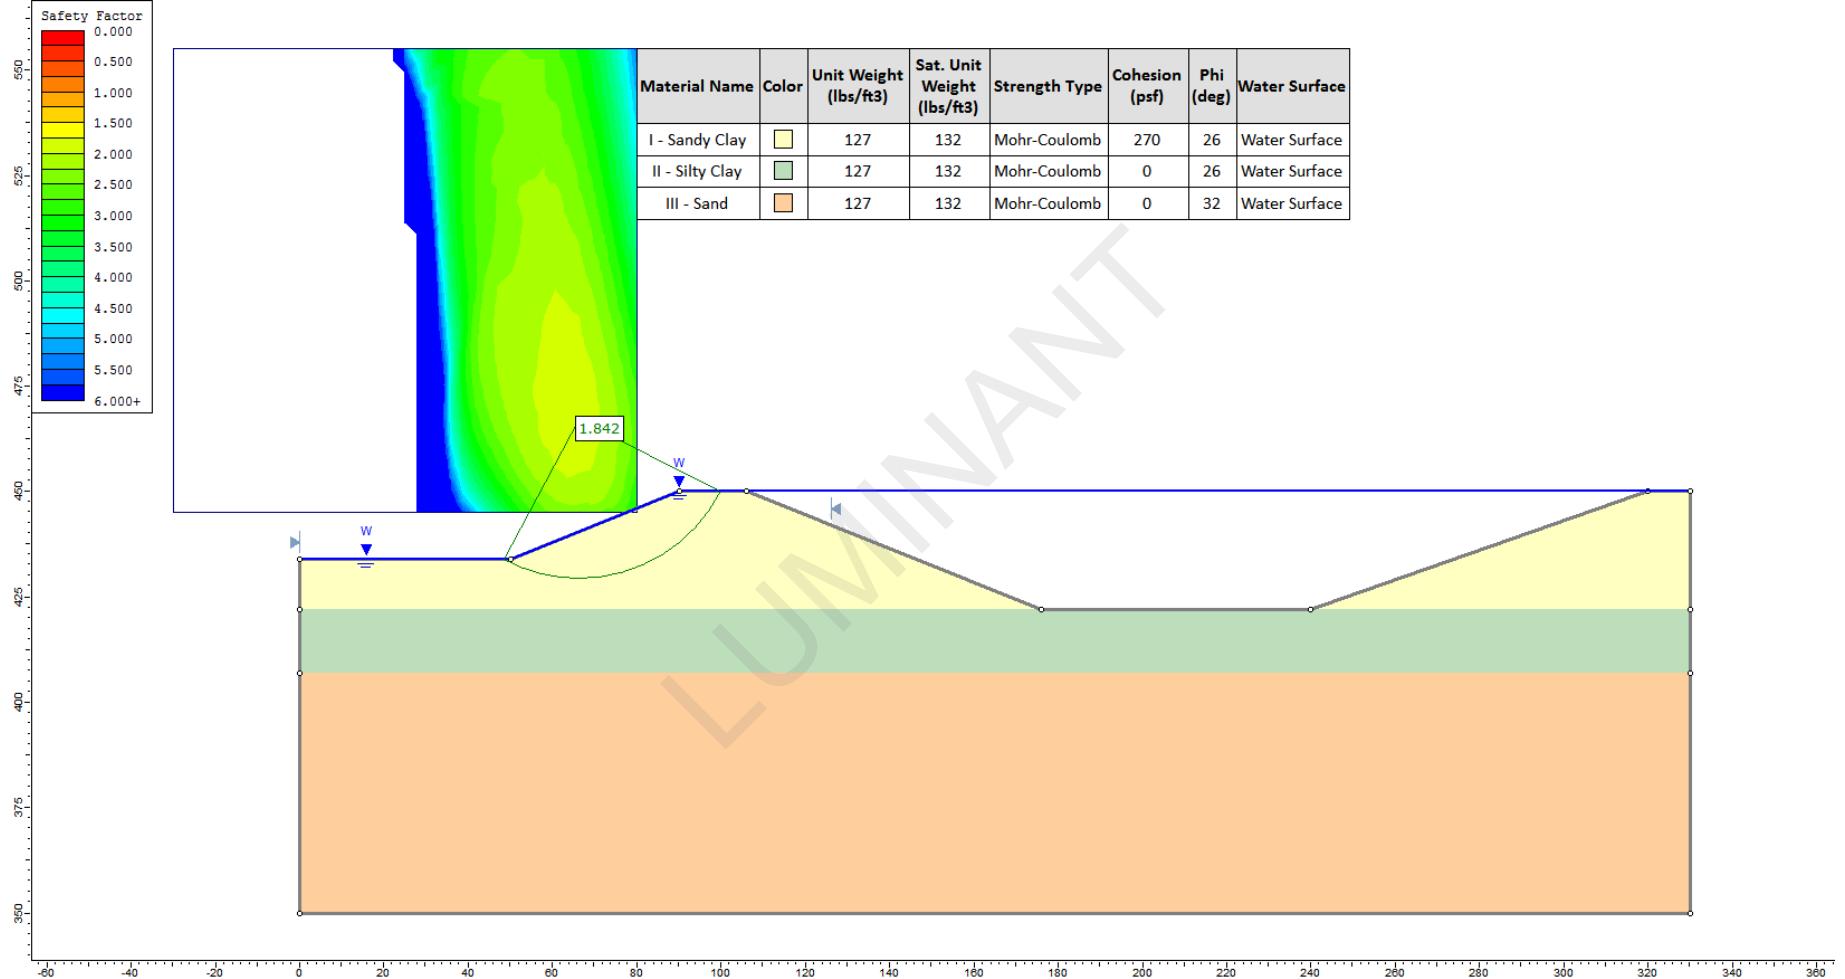
FIGURE C.3
Results of Stability Analysis – FGD-A: A-A' – Case 2a
Stability and Safety Factor Assessment, Oak Grove SES

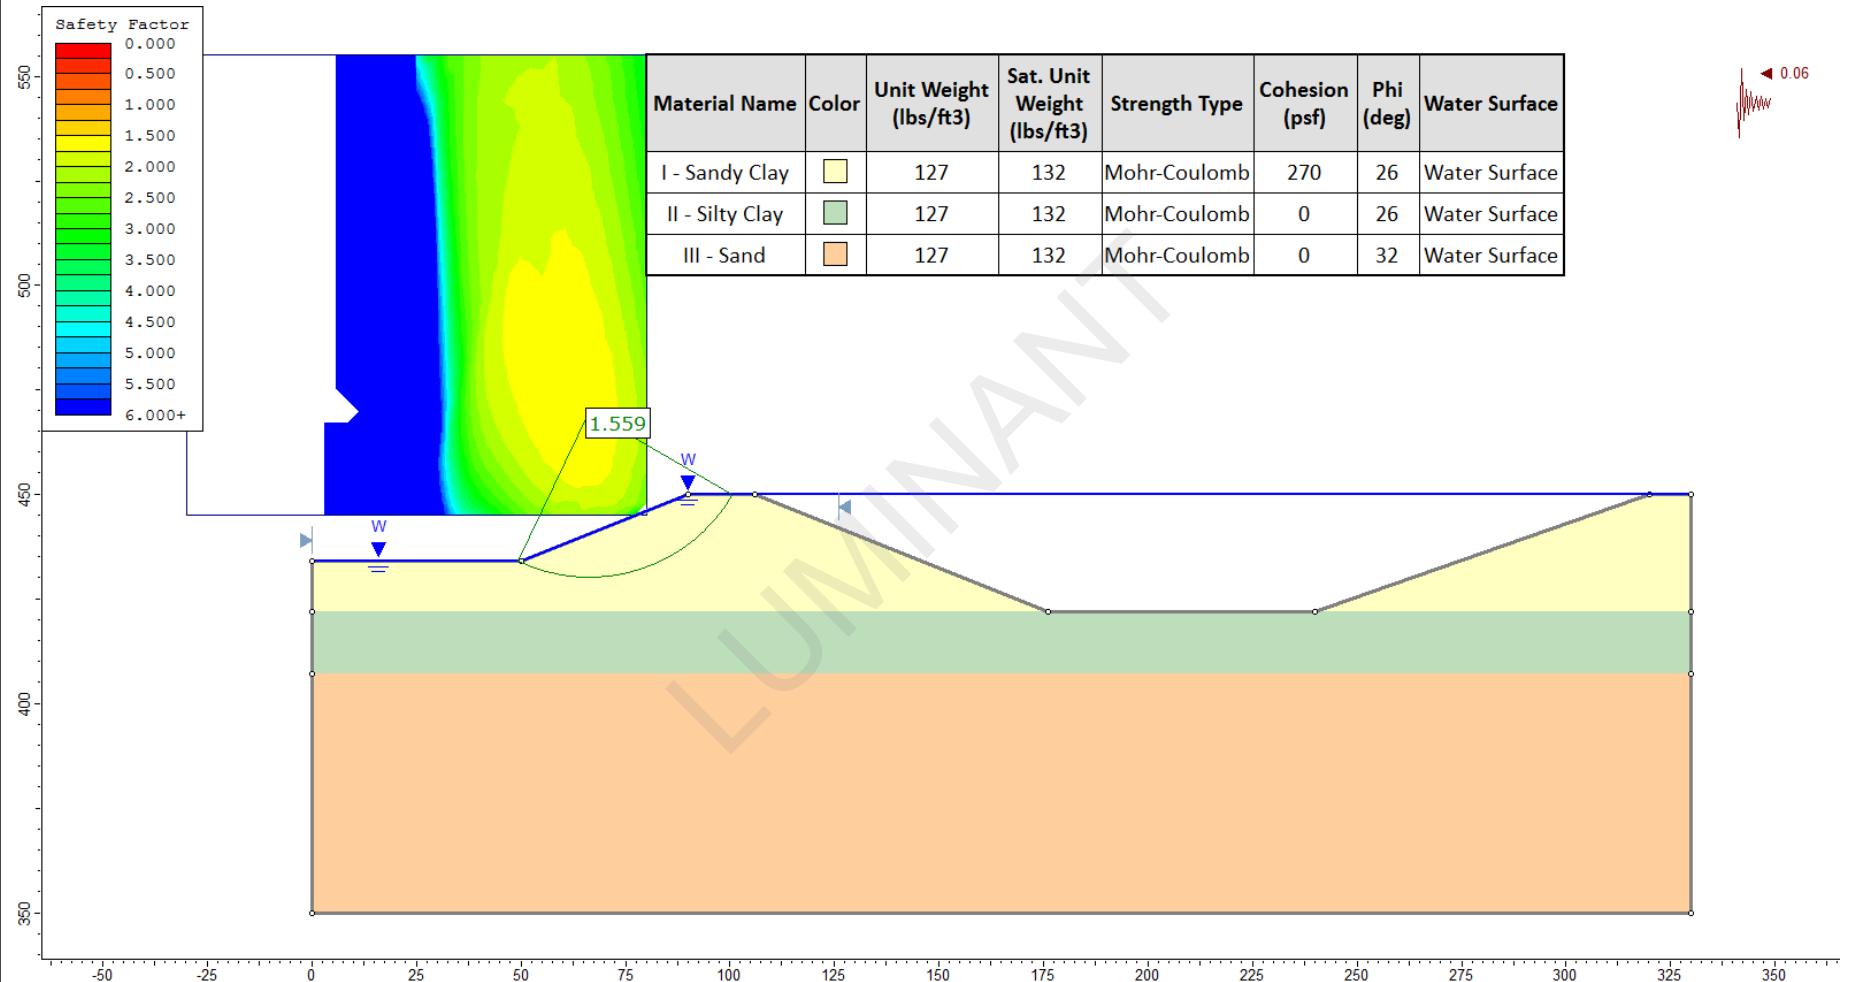
FIGURE C.4
Results of Stability Analysis – FGD-A: A-A' – Case 2b
 Stability and Safety Factor Assessment, Oak Grove SES

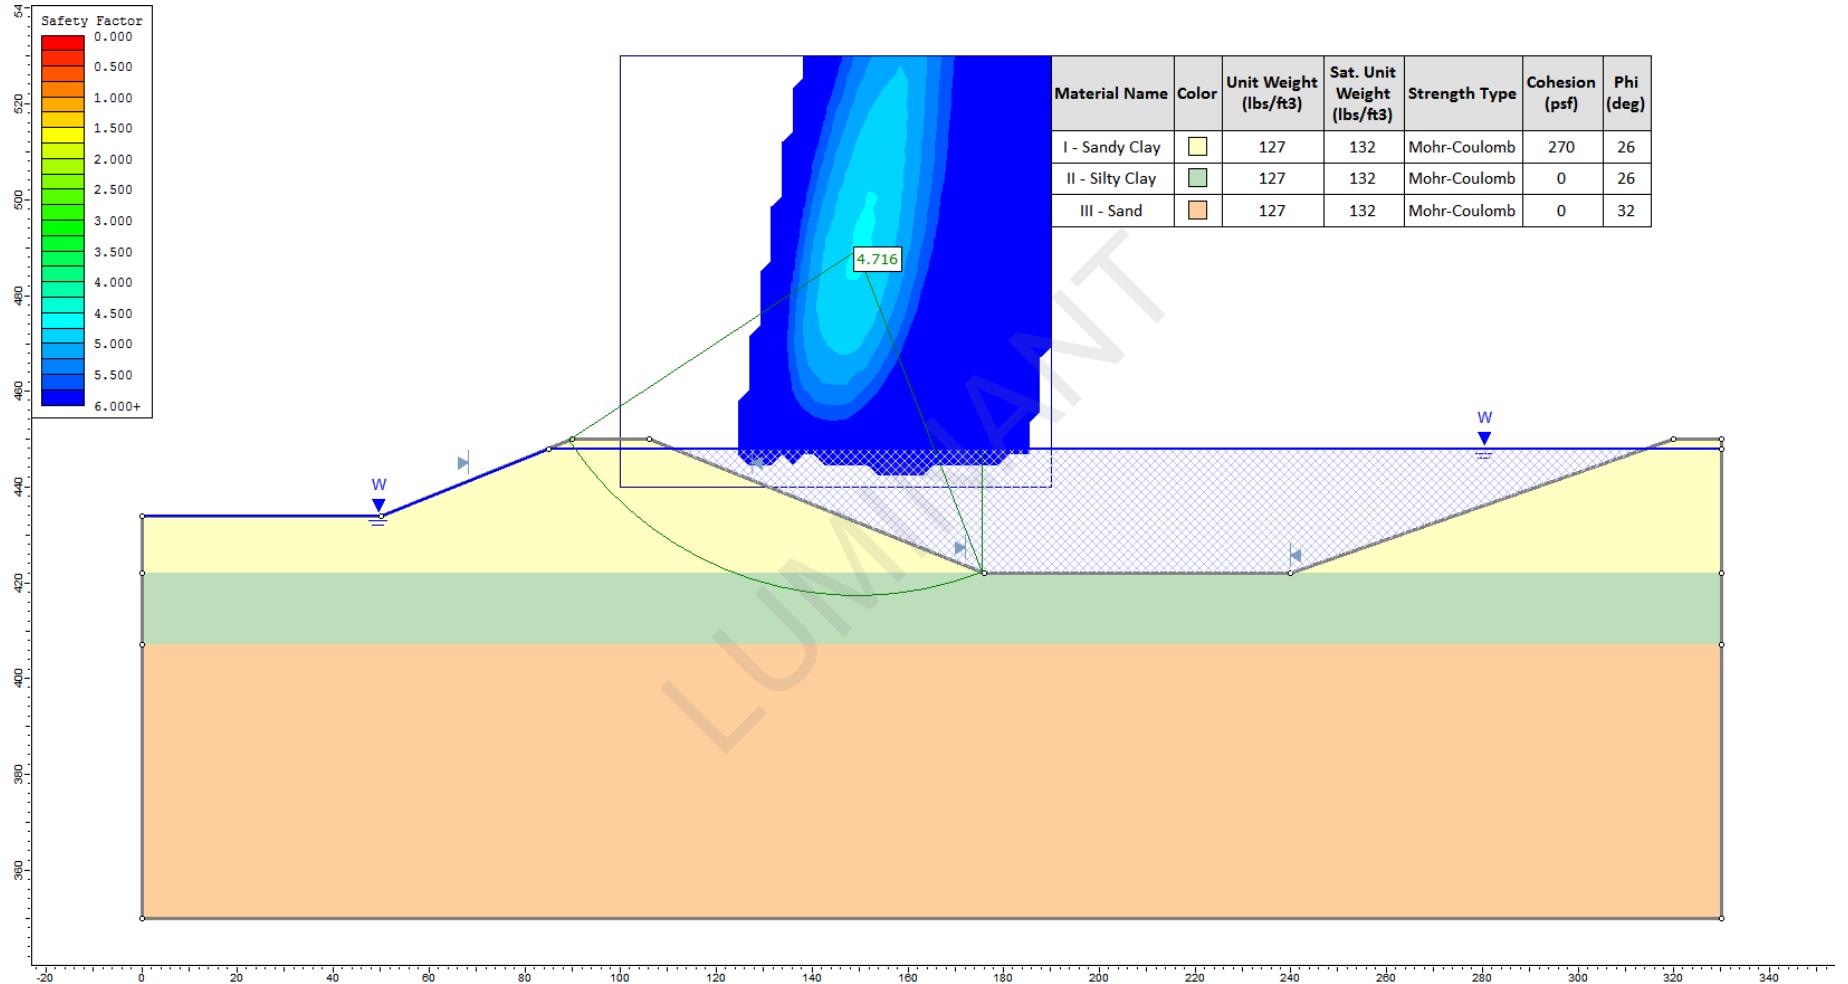
FIGURE C.5
Results of Stability Analysis – FGD-A: A-A' – Case 3a
 Stability and Safety Factor Assessment, Oak Grove SES

Cross-Section	Case #	Slope Location	Pond Pool Level	Loading Condition	Req'd Safety Factor ⁽¹⁾	Calculated Safety Factor
	3a	Interior	Storage	Static	1.50	4.72
	3b			Pseudostatic	1.00	3.58
	4a		Surcharge	Static	1.40	5.20
	4b			Pseudostatic	1.00	3.90
	5a		Empty	Static	1.50	2.15
	5b			Pseudostatic	1.00	1.77

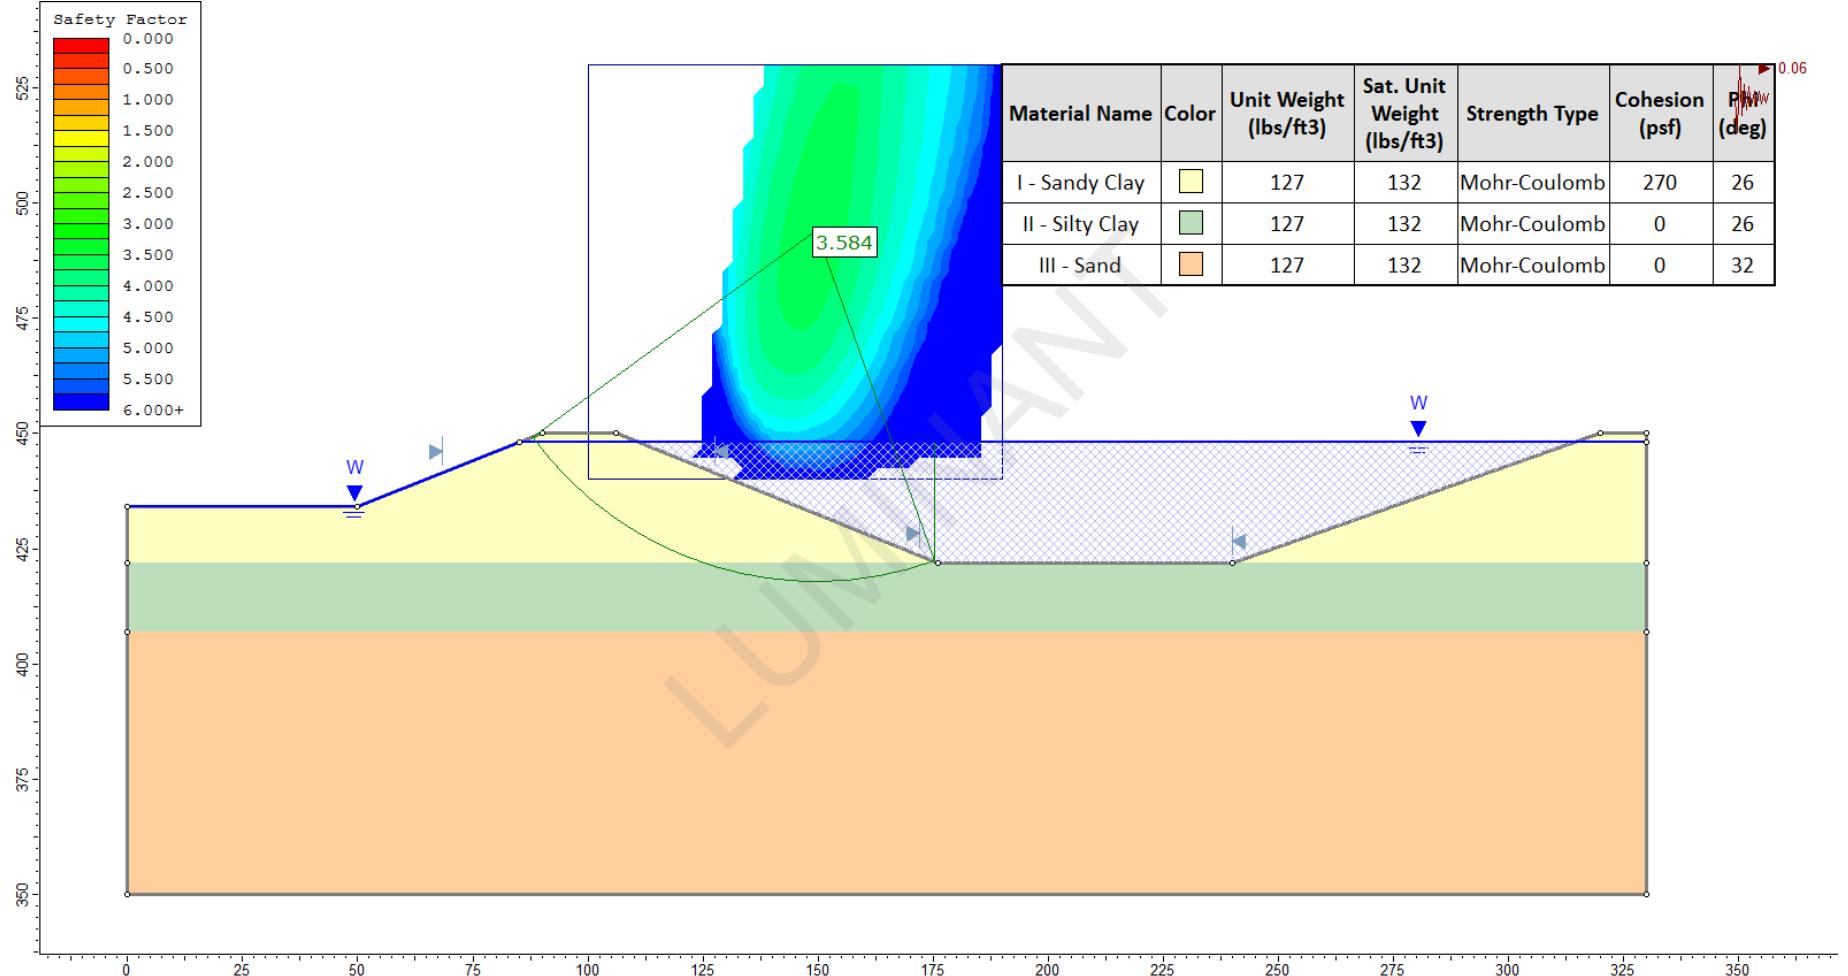
FIGURE C.6
Results of Stability Analysis – FGD-A: A-A' – Case 3b
 Stability and Safety Factor Assessment, Oak Grove SES
