SAFETY FACTOR ASSESSMENT REPORT

Oak Grove Steam Electric Station

October 2016

Project No. 1648164

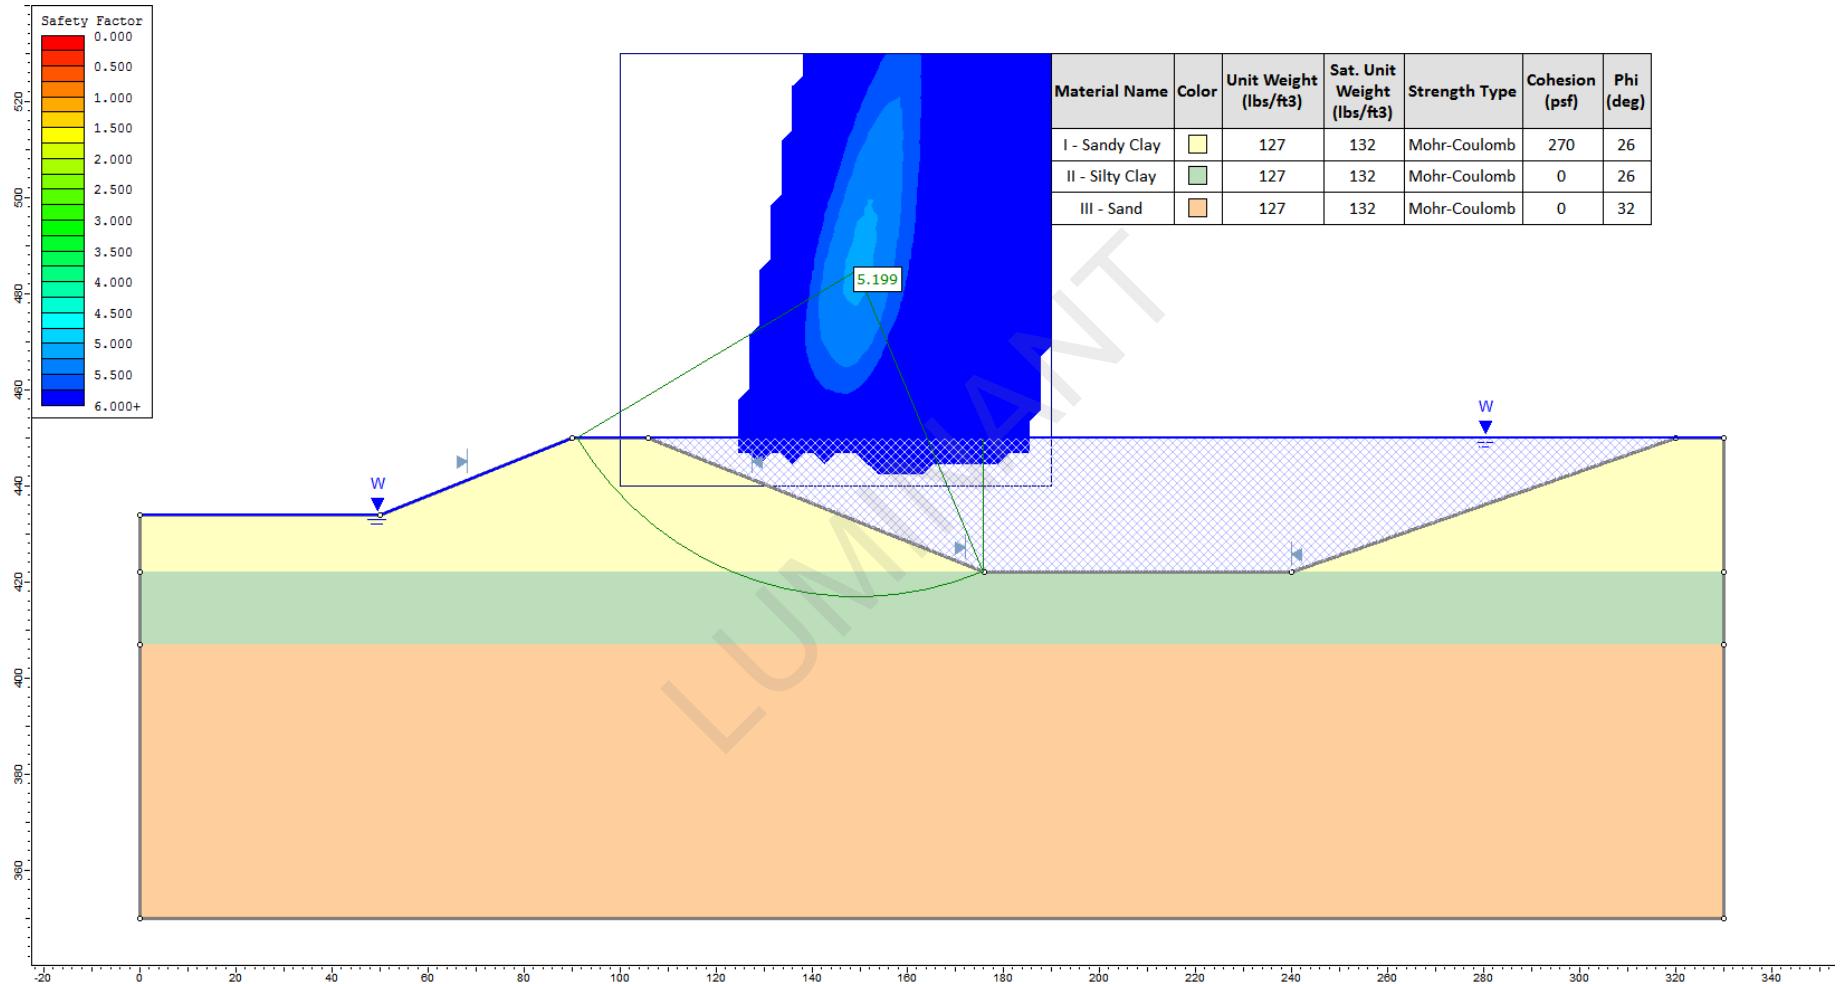
FIGURE C.7
Results of Stability Analysis – FGD-A: A-A' – Case 4a
 Stability and Safety Factor Assessment, Oak Grove SES

Cross-Section	Case #	Slope Location	Pond Pool Level	Loading Condition	Req'd Safety Factor ⁽¹⁾	Calculated Safety Factor
	3a	Interior	Storage	Static	1.50	4.72
	3b			Pseudostatic	1.00	3.58
	4a		Surcharge	Static	1.40	5.20
	4b			Pseudostatic	1.00	3.90
	5a		Empty	Static	1.50	2.15
	5b			Pseudostatic	1.00	1.77

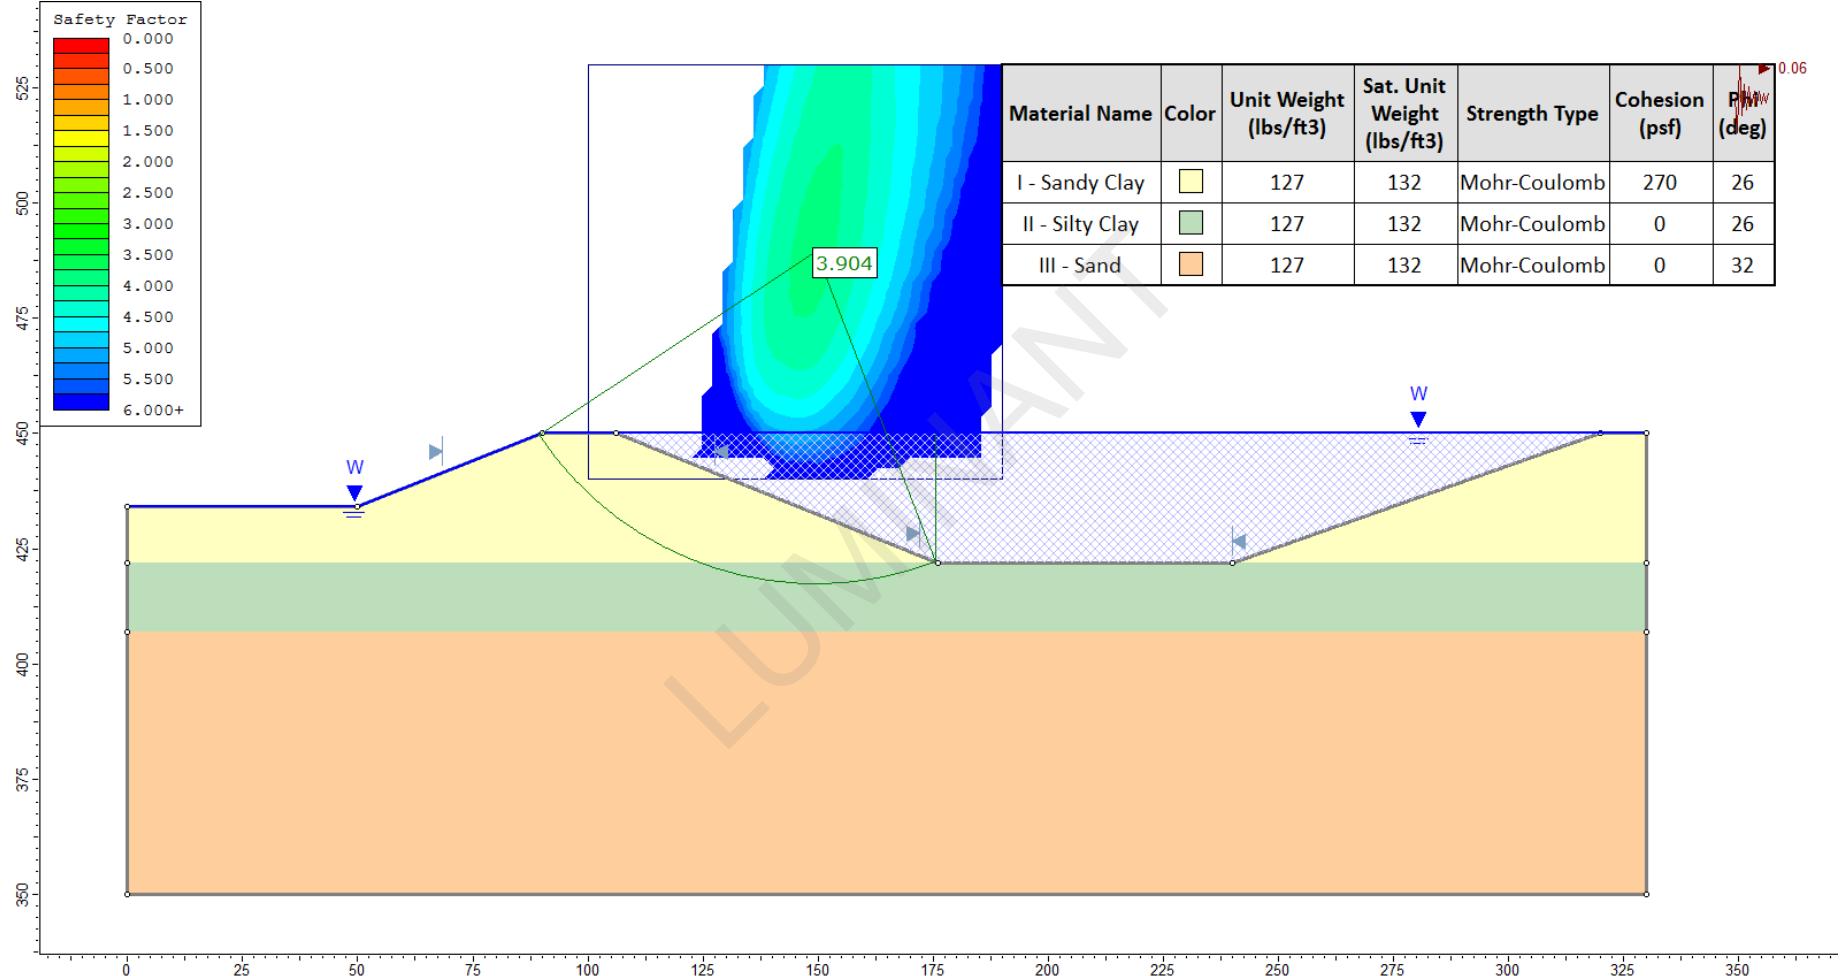
FIGURE C.8
Results of Stability Analysis – FGD-A: A-A' – Case 4b
 Stability and Safety Factor Assessment, Oak Grove SES

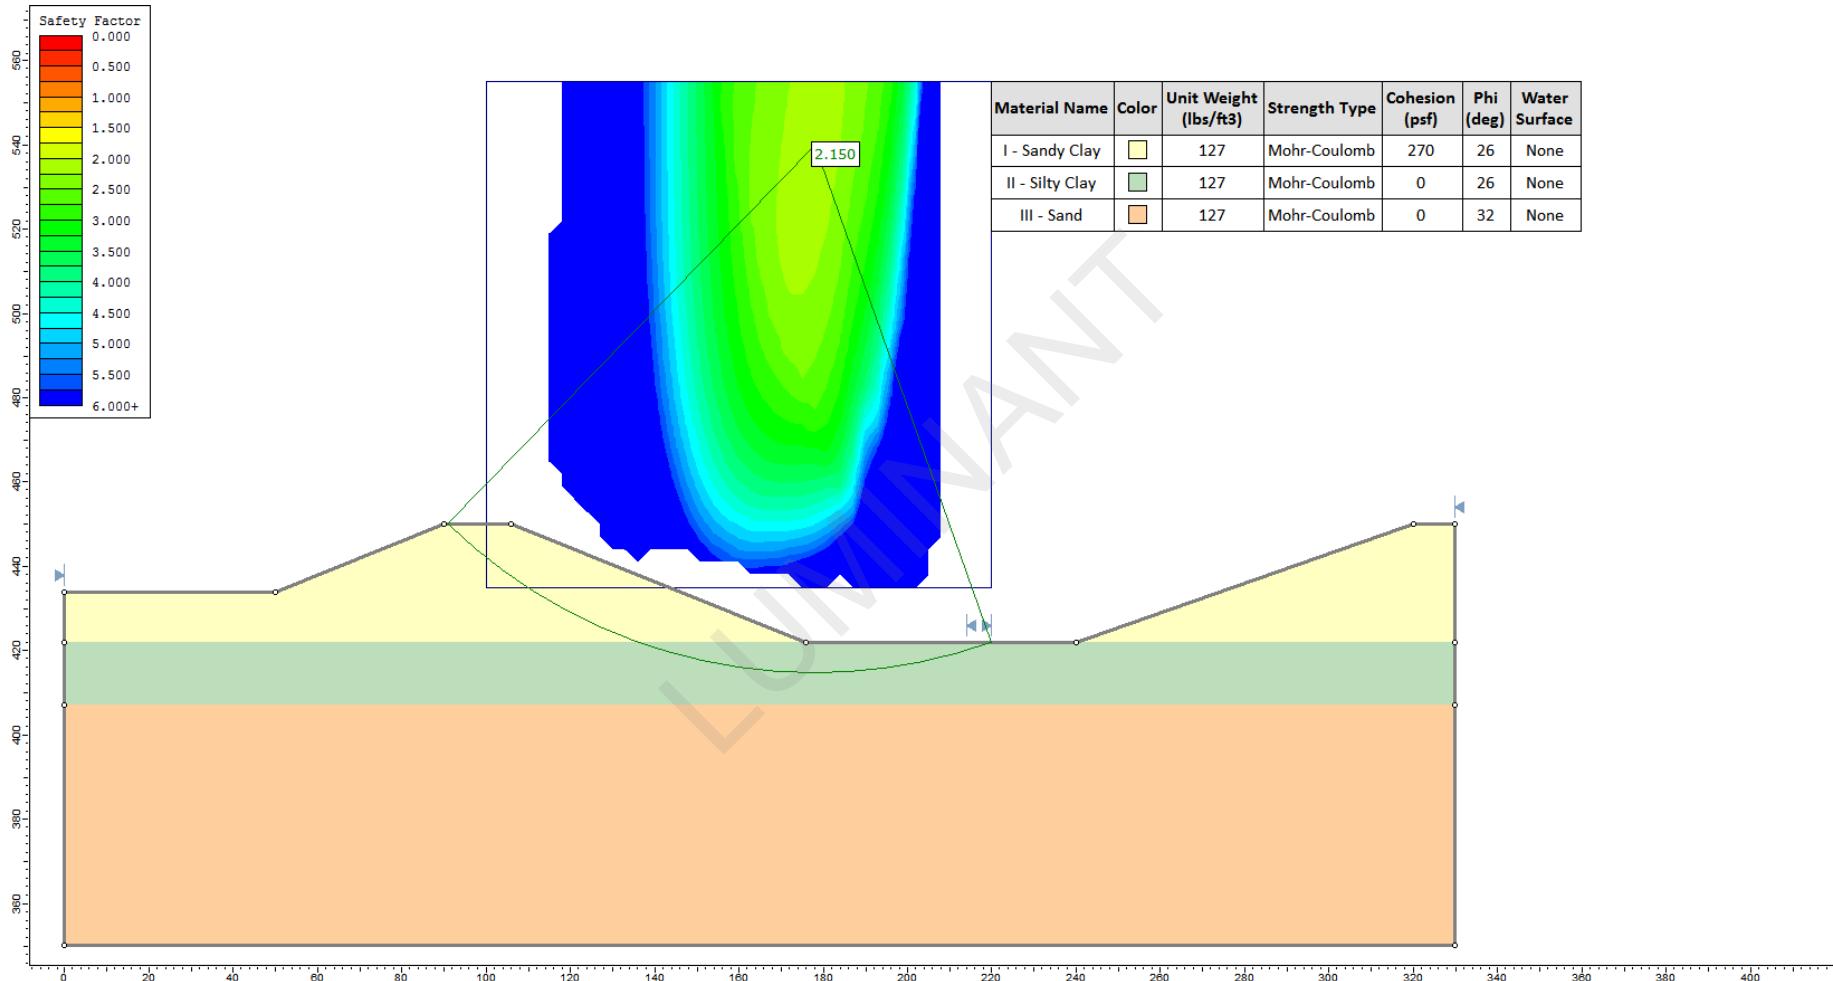
FIGURE C.9
Results of Stability Analysis – FGD-A: A-A' – Case 5a
 Stability and Safety Factor Assessment, Oak Grove SES

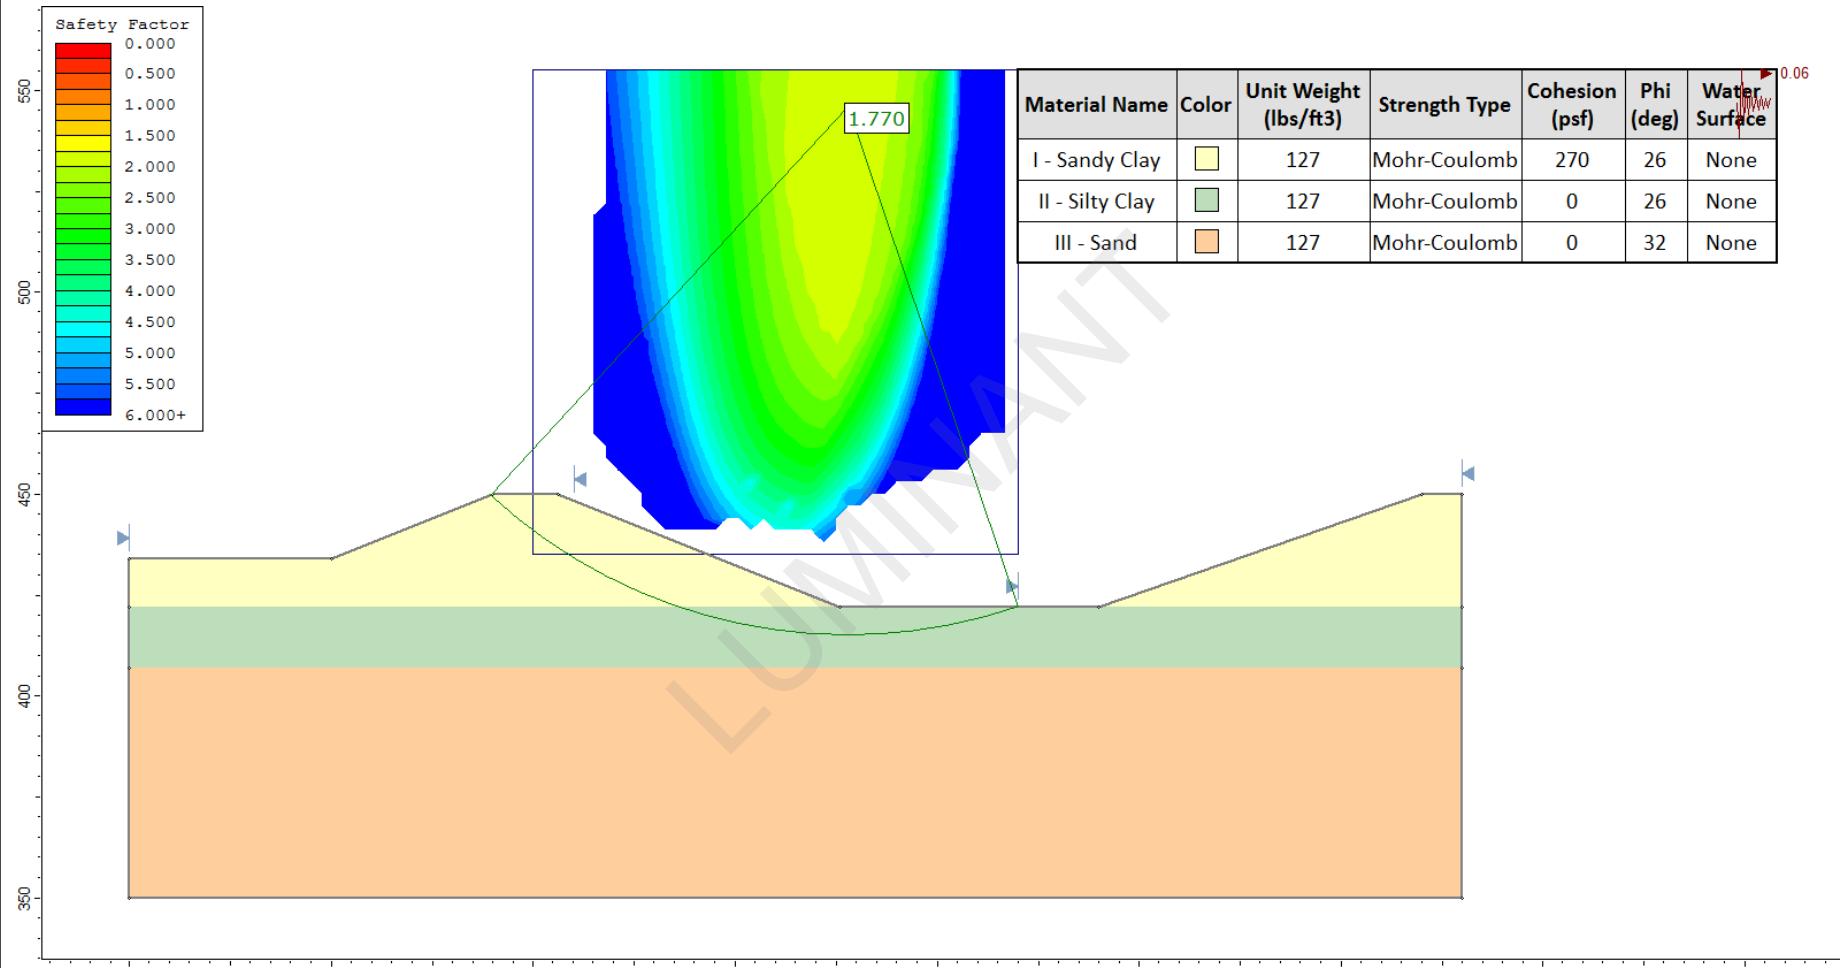
FIGURE C.10
Results of Stability Analysis – FGD-A: A-A' – Case 5b
 Stability and Safety Factor Assessment, Oak Grove SES

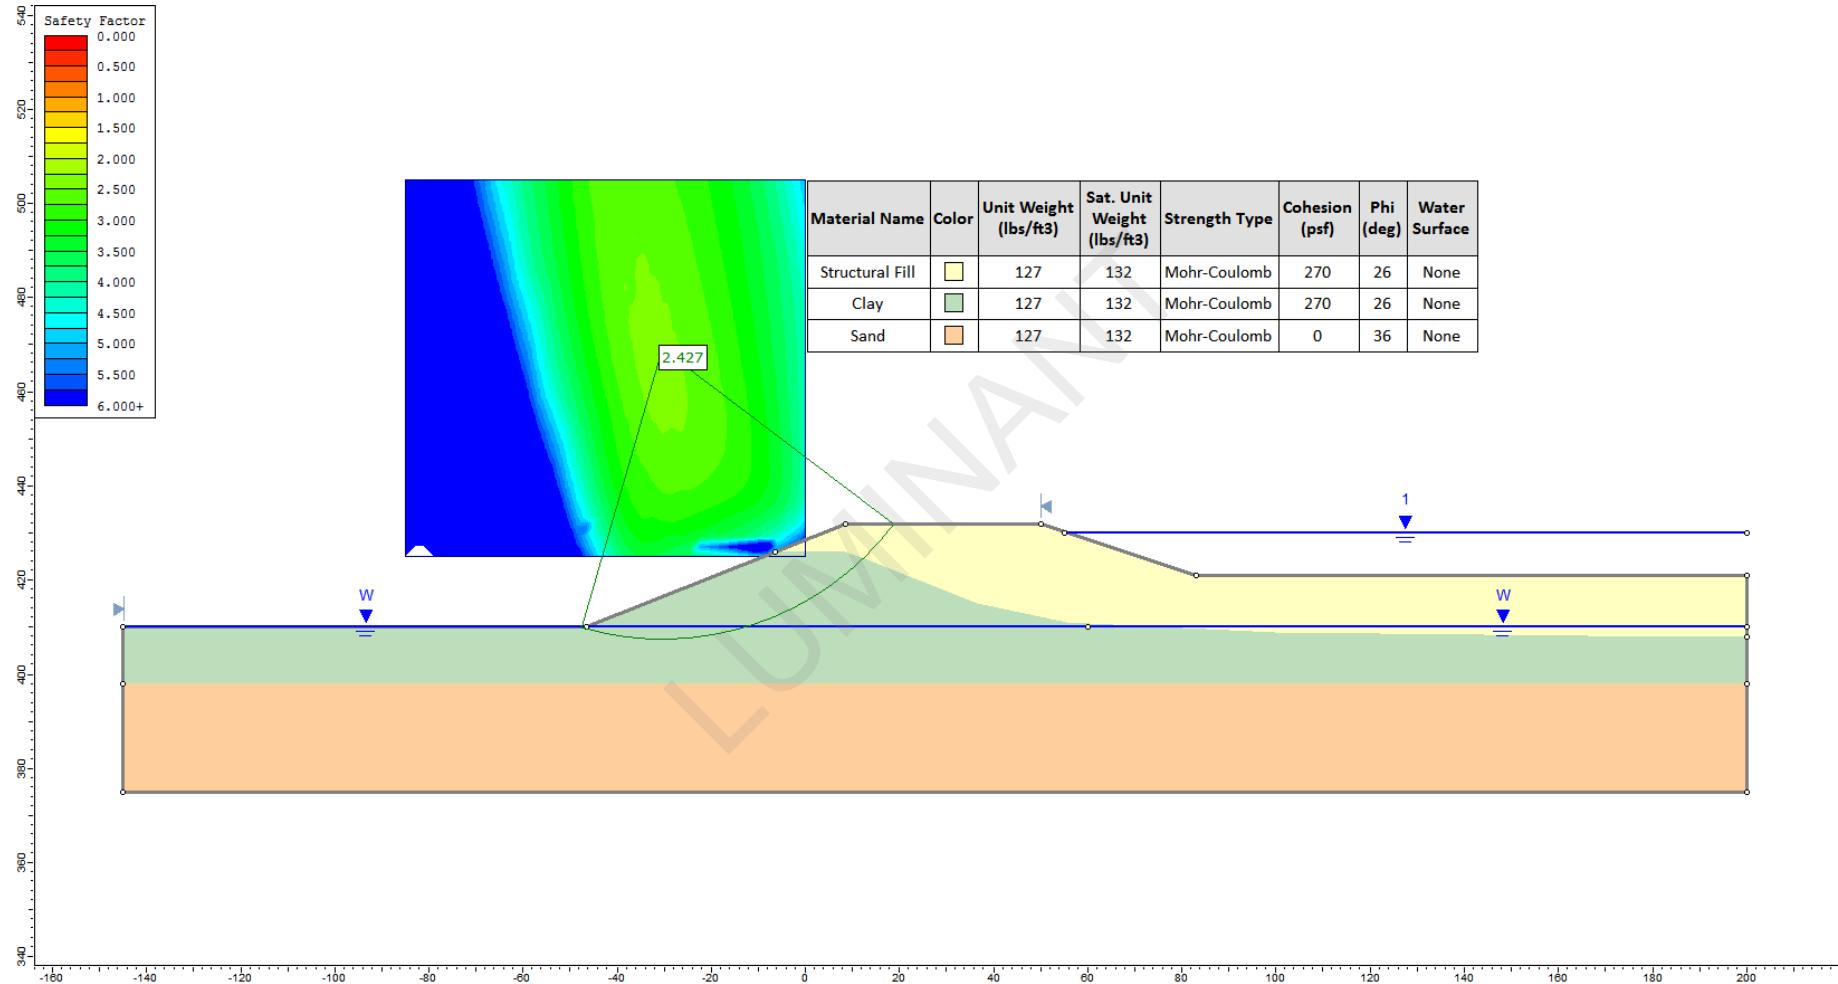
FIGURE C.11
Results of Stability Analysis – FGD-B: B-B' – Case 1a
 Stability and Safety Factor Assessment, Oak Grove SES

Cross-Section	Case #	Slope Location	Pond level	Loading Condition	Req'd Safety Factor ⁽¹⁾	Calculated Safety Factor
B-B'	1a	Exterior	Storage	Static	1.50	2.43
	1b			Pseudostatic	1.00	2.07
	2a		Surcharge	Static	1.40	2.43
	2b			Pseudostatic	1.00	2.07
B1-B1'	3a	Interior	Storage	Static	1.50	1.51
	3b			Pseudostatic	1.00	1.20
	4a		Surcharge	Static	1.40	1.55
	4b			Pseudostatic	1.00	1.25
	5a		Empty	Static	1.50	2.20
	5b			Pseudostatic	1.00	1.79

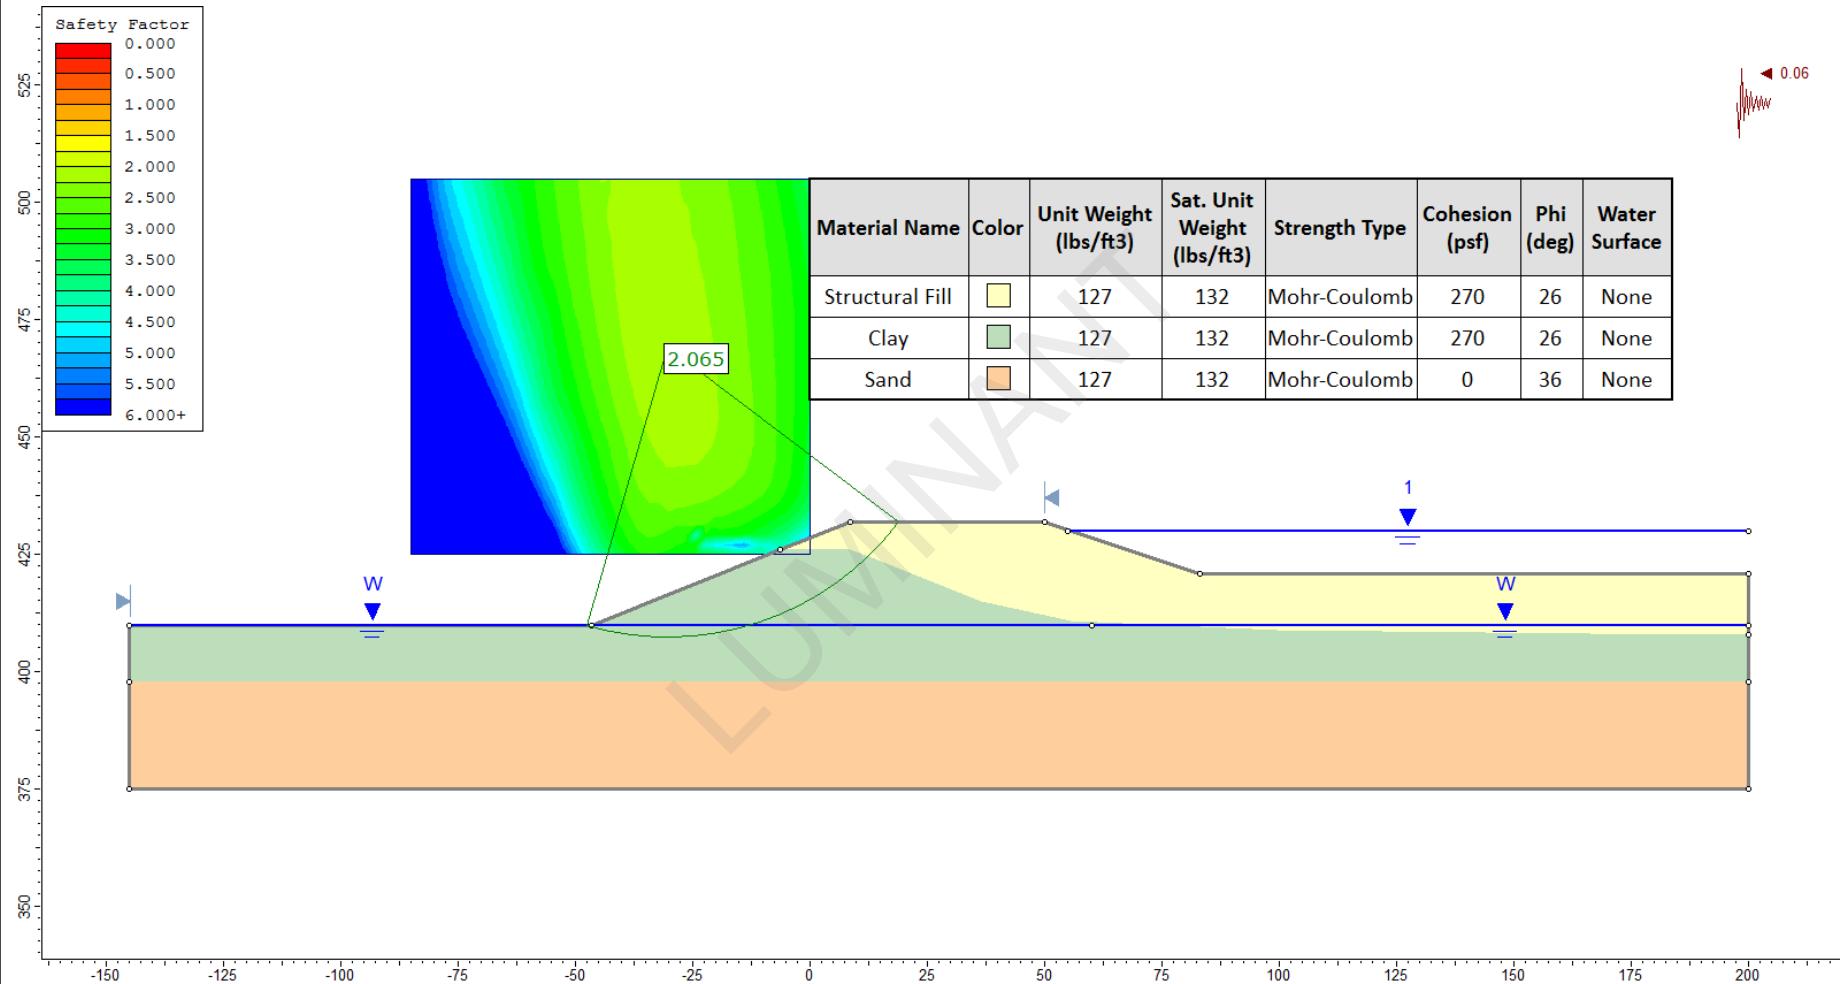
FIGURE C.12
Results of Stability Analysis – FGD-B: B-B' – Case 1b
 Stability and Safety Factor Assessment, Oak Grove SES

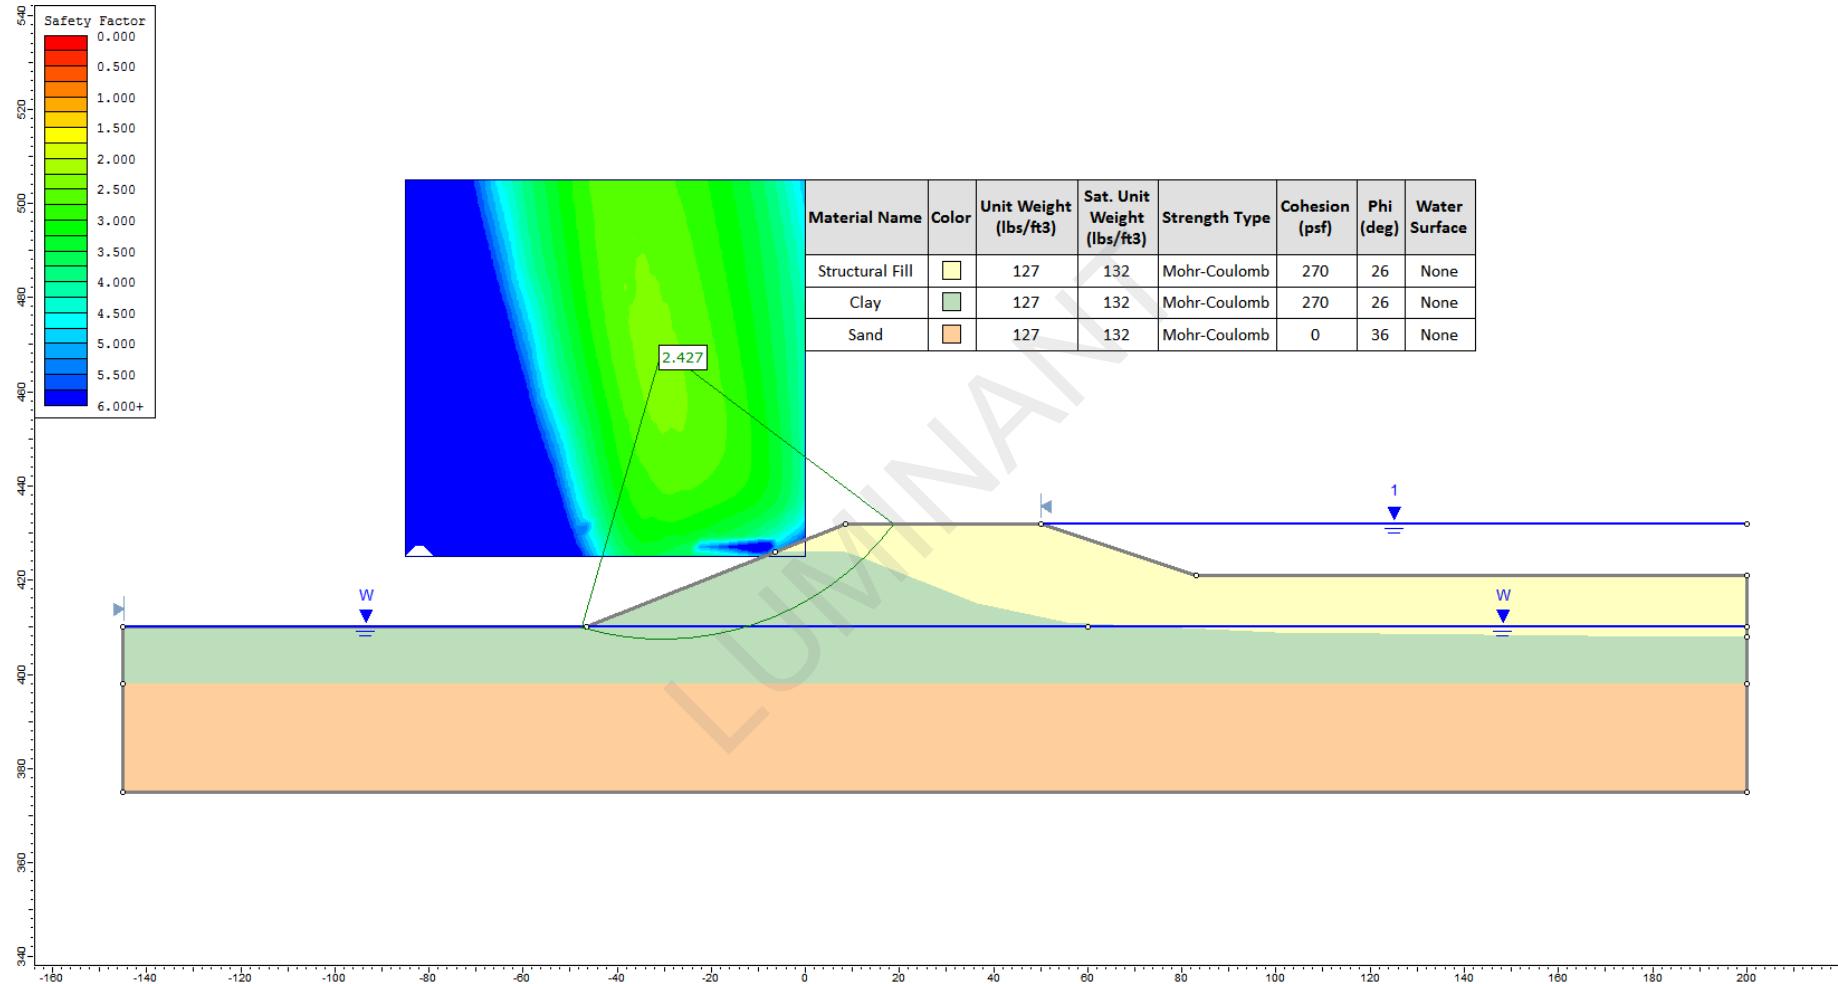
FIGURE C.13
Results of Stability Analysis – FGD-B: B-B' – Case 2a
 Stability and Safety Factor Assessment, Oak Grove SES

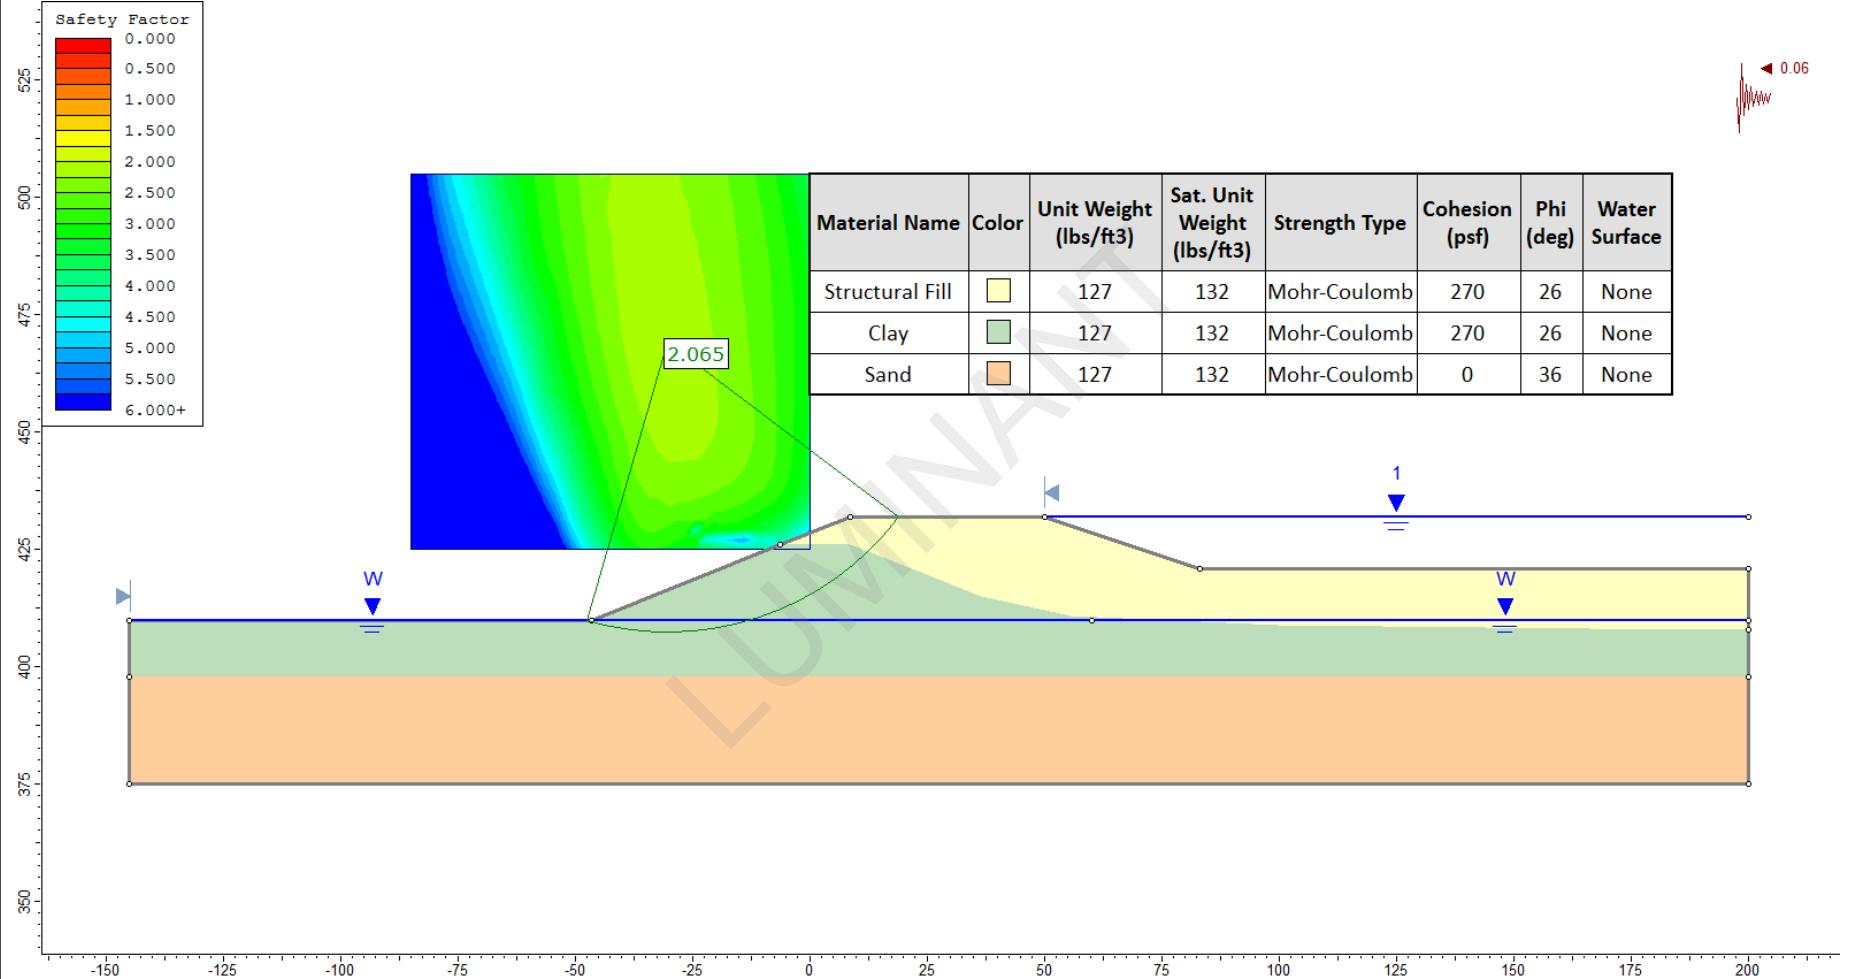
FIGURE C.14
Results of Stability Analysis – FGD-B: B–B' – Case 2b
 Stability and Safety Factor Assessment, Oak Grove SES

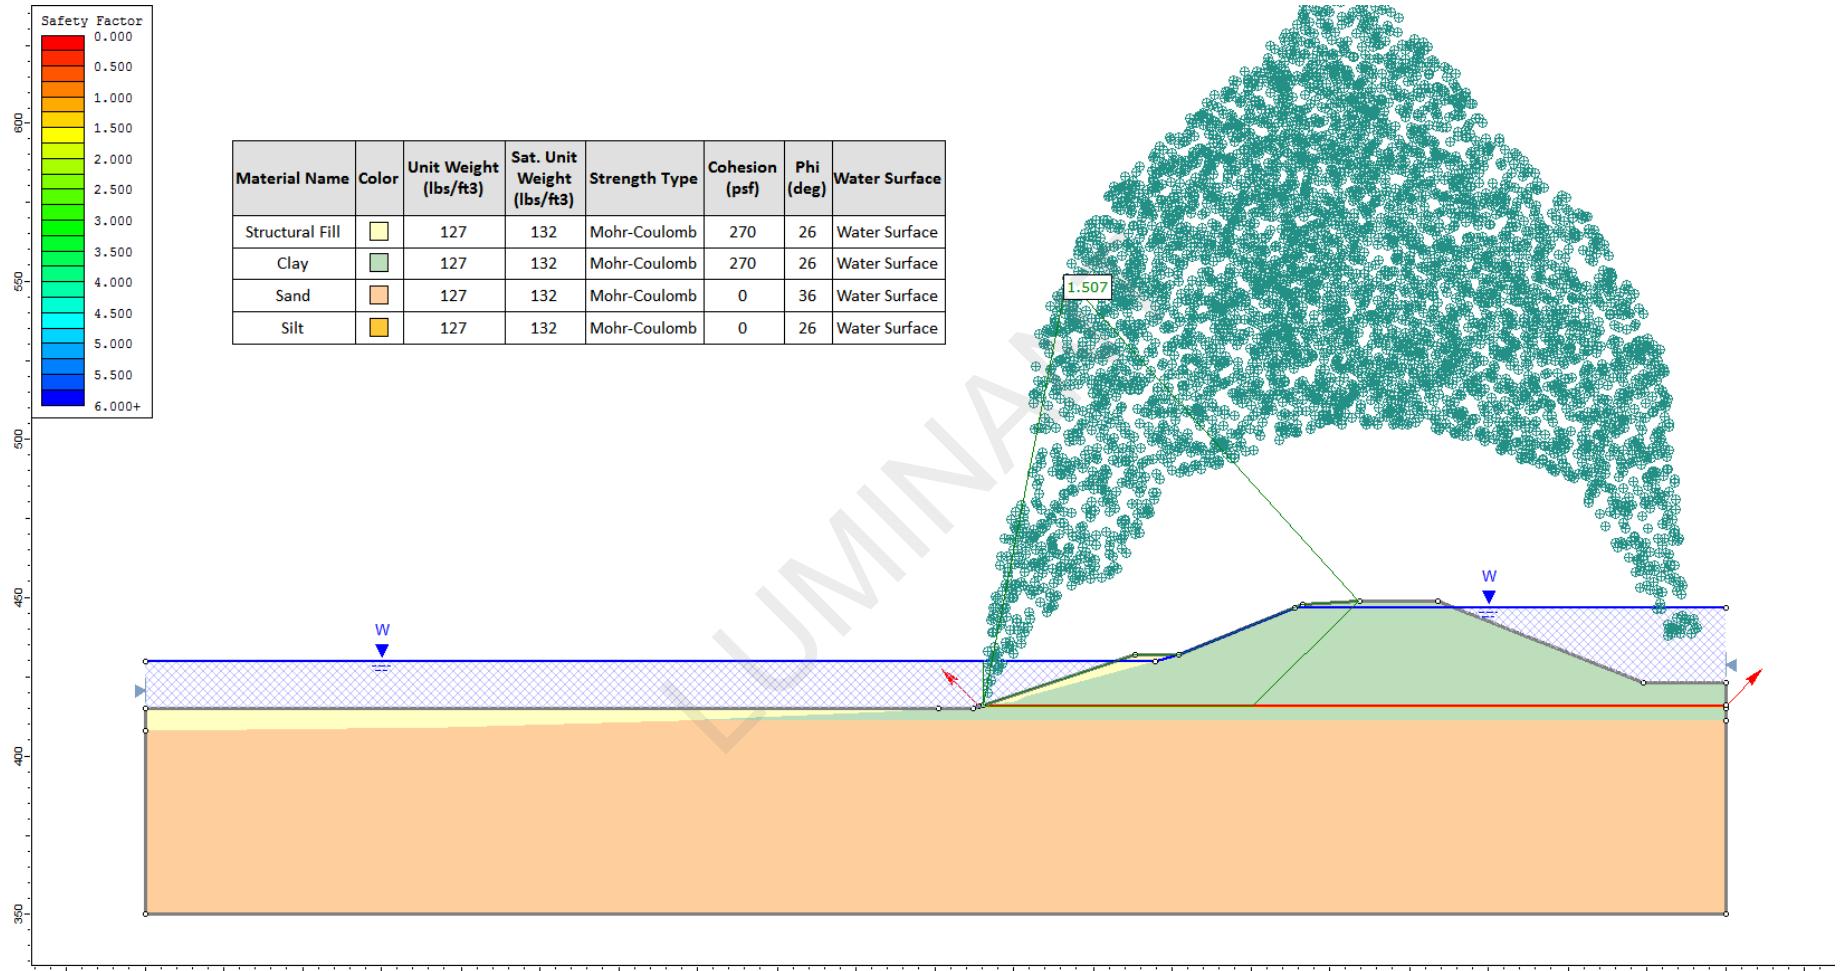
FIGURE C.15
Results of Stability Analysis – FGD-B: B1-B1' – Case 3a
 Stability and Safety Factor Assessment, Oak Grove SES

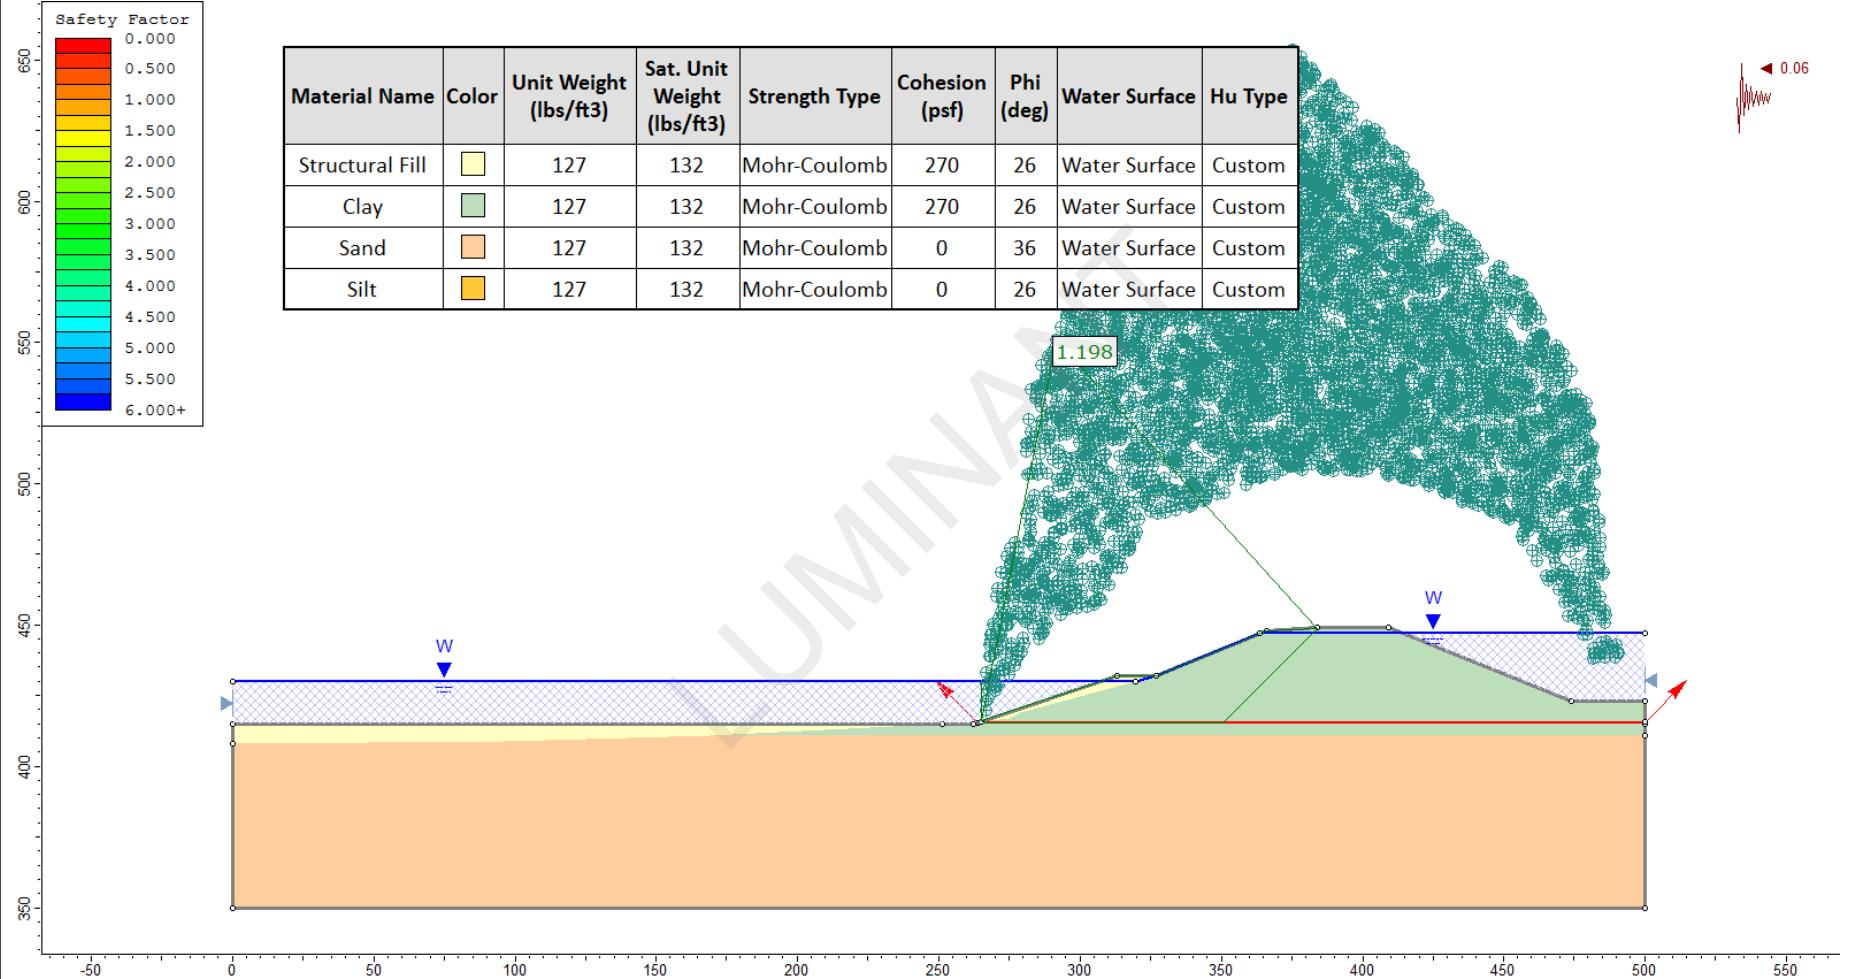
FIGURE C.16
Results of Stability Analysis – FGD-B: B1–B1' – Case 3b
 Stability and Safety Factor Assessment, Oak Grove SES

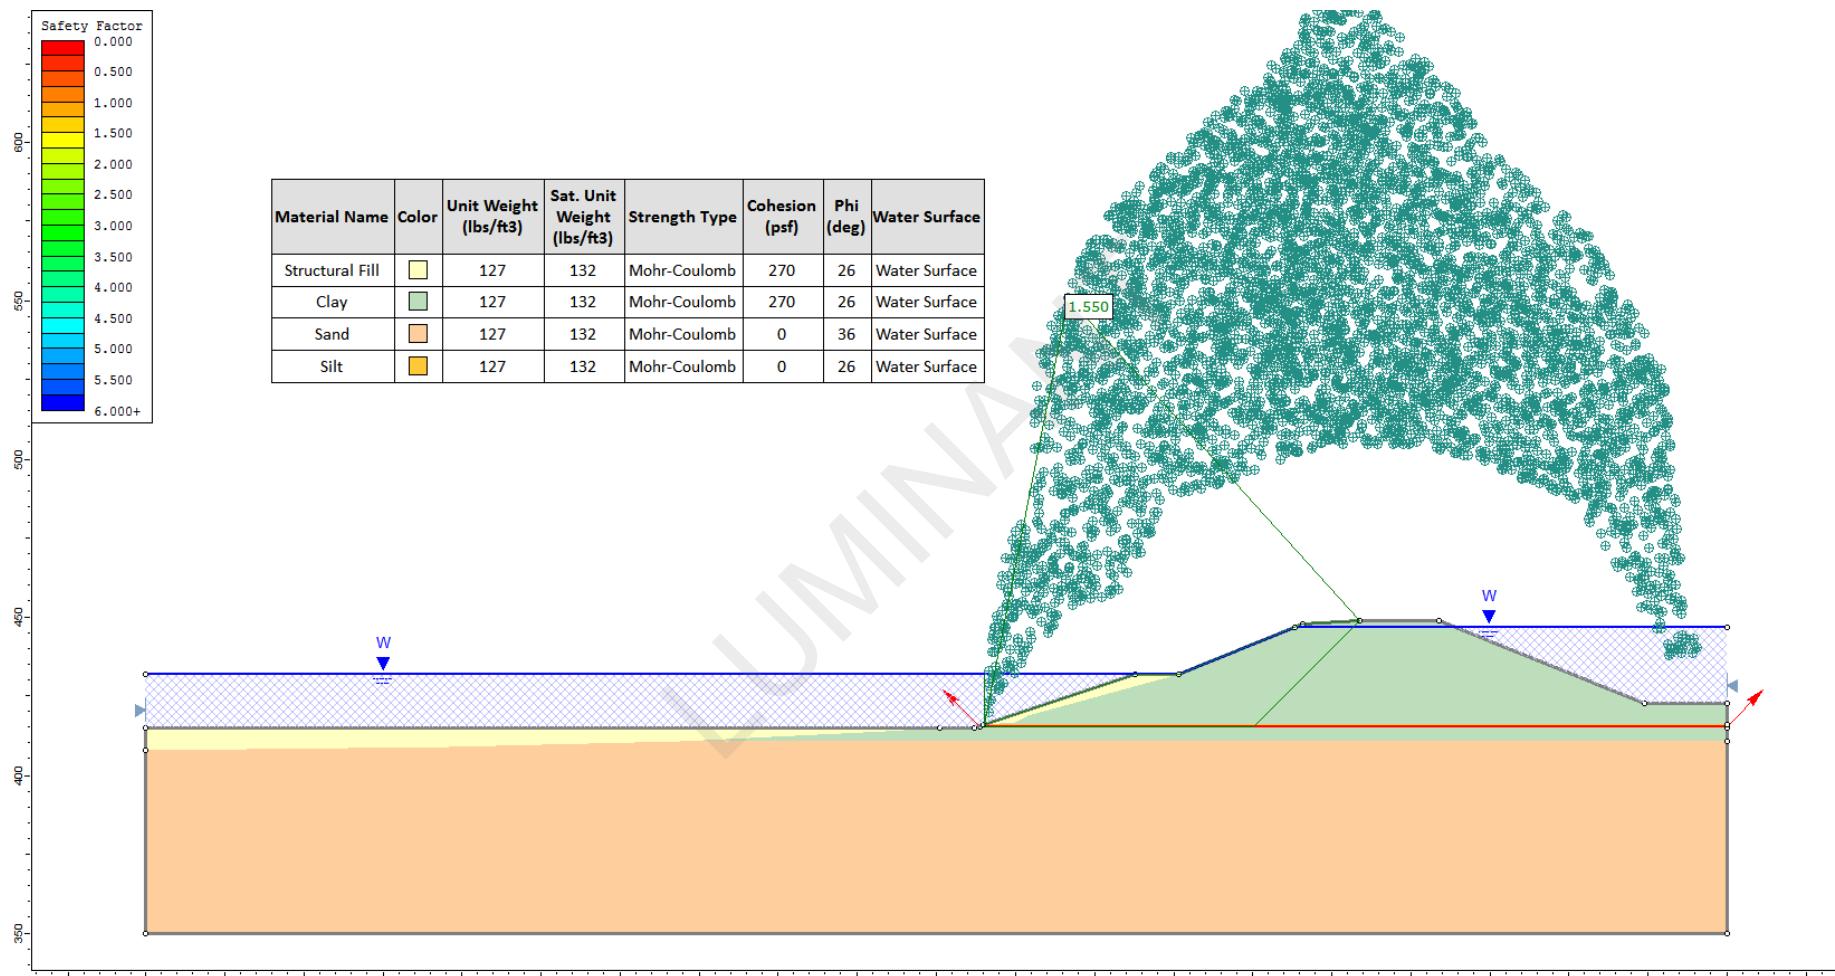
FIGURE C.17
Results of Stability Analysis – FGD-B: B1–B1' – Case 4a
Stability and Safety Factor Assessment, Oak Grove SES

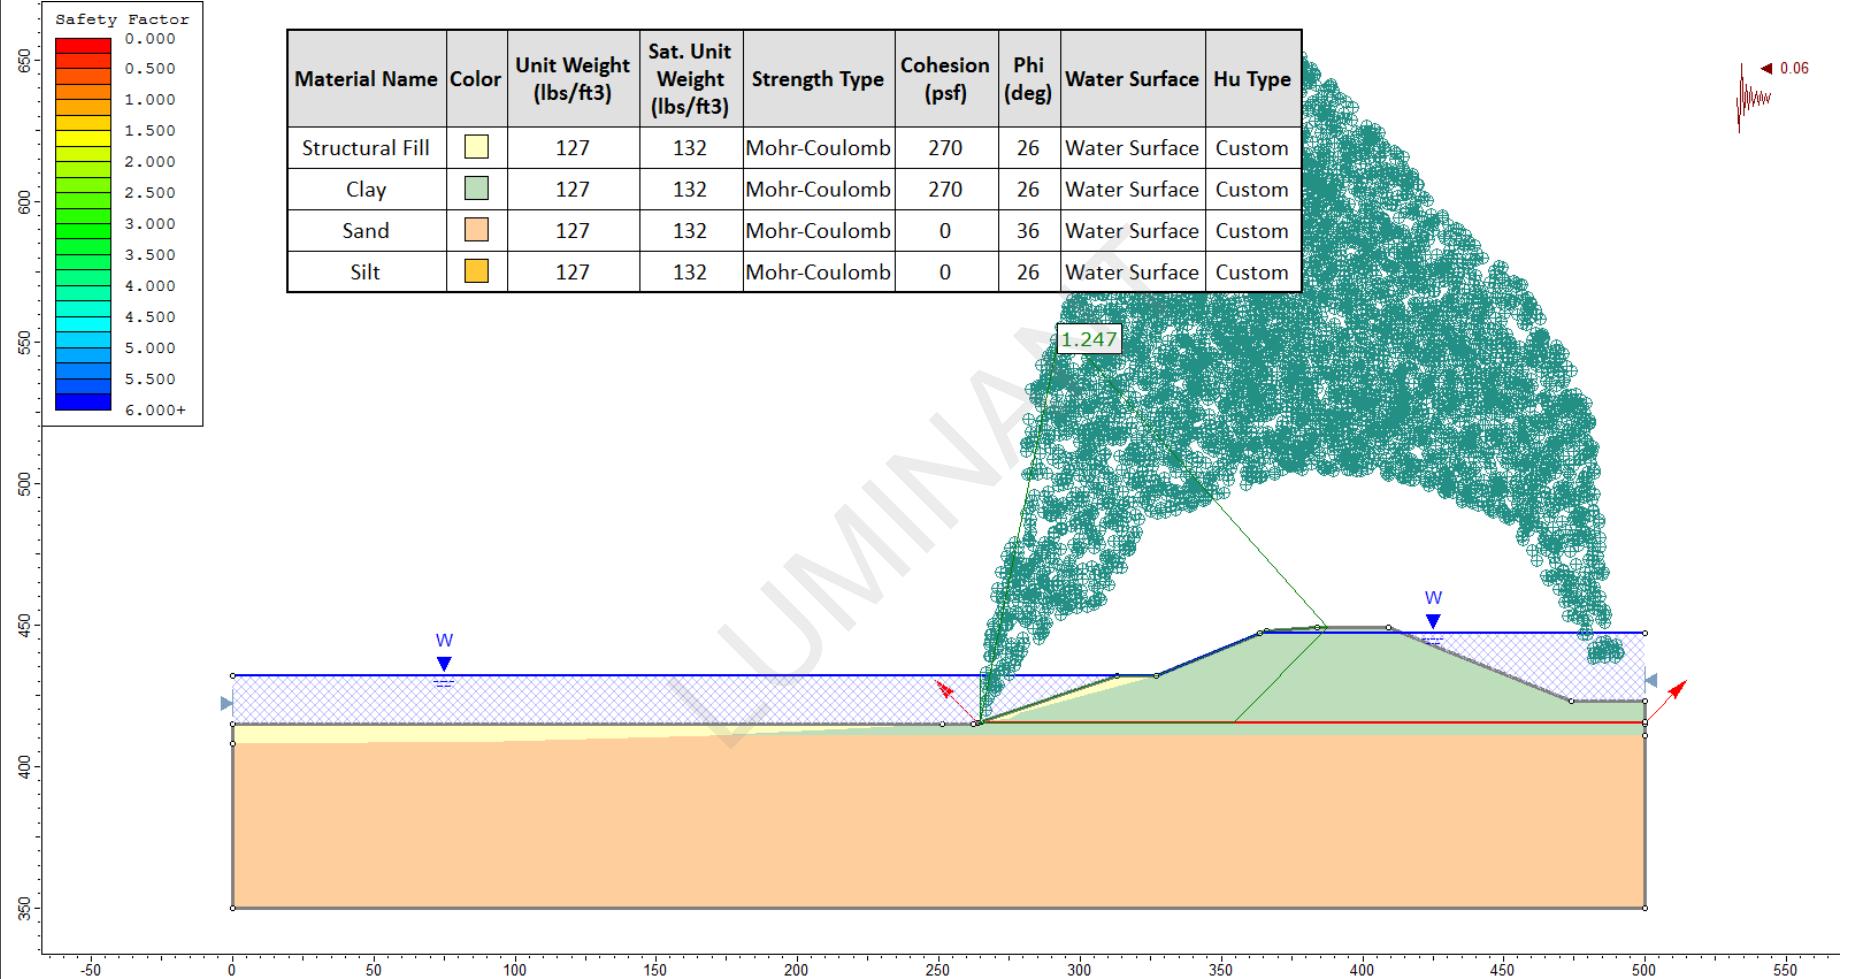
FIGURE C.18
Results of Stability Analysis – FGD-B: B1–B1' – Case 4b
 Stability and Safety Factor Assessment, Oak Grove SES
