SAFETY FACTOR ASSESSMENT REPORT

Oak Grove Steam Electric Station

October 2016

Project No. 1648164

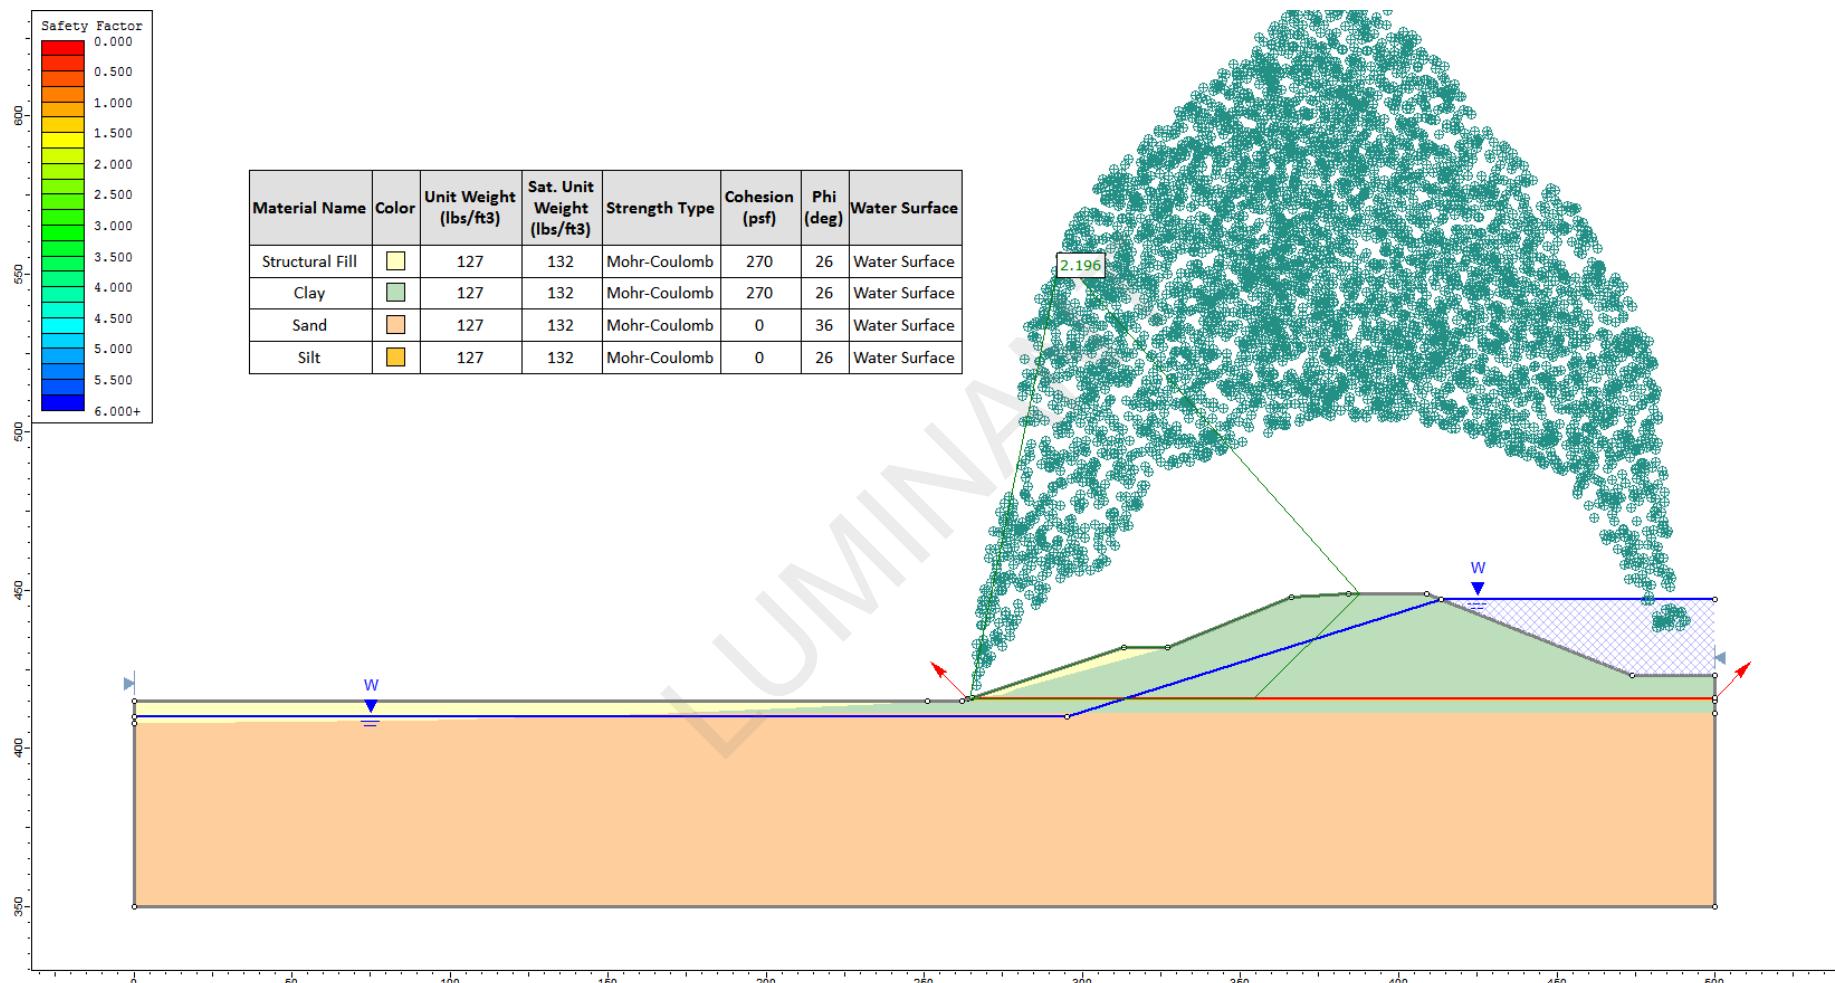
FIGURE C.19
Results of Stability Analysis – FGD-B: B1–B1' – Case 5a
 Stability and Safety Factor Assessment, Oak Grove SES

Cross-Section	Case #	Slope Location	Pond level	Loading Condition	Req'd Safety Factor ⁽¹⁾	Calculated Safety Factor
B-B'	1a	Exterior	Storage	Static	1.50	2.43
	1b			Pseudostatic	1.00	2.07
	2a		Surcharge	Static	1.40	2.43
	2b			Pseudostatic	1.00	2.07
B1-B1'	3a	Interior	Storage	Static	1.50	1.51
	3b			Pseudostatic	1.00	1.20
	4a		Surcharge	Static	1.40	1.55
	4b			Pseudostatic	1.00	1.25
	5a		Empty	Static	1.50	2.20
	5b			Pseudostatic	1.00	1.79

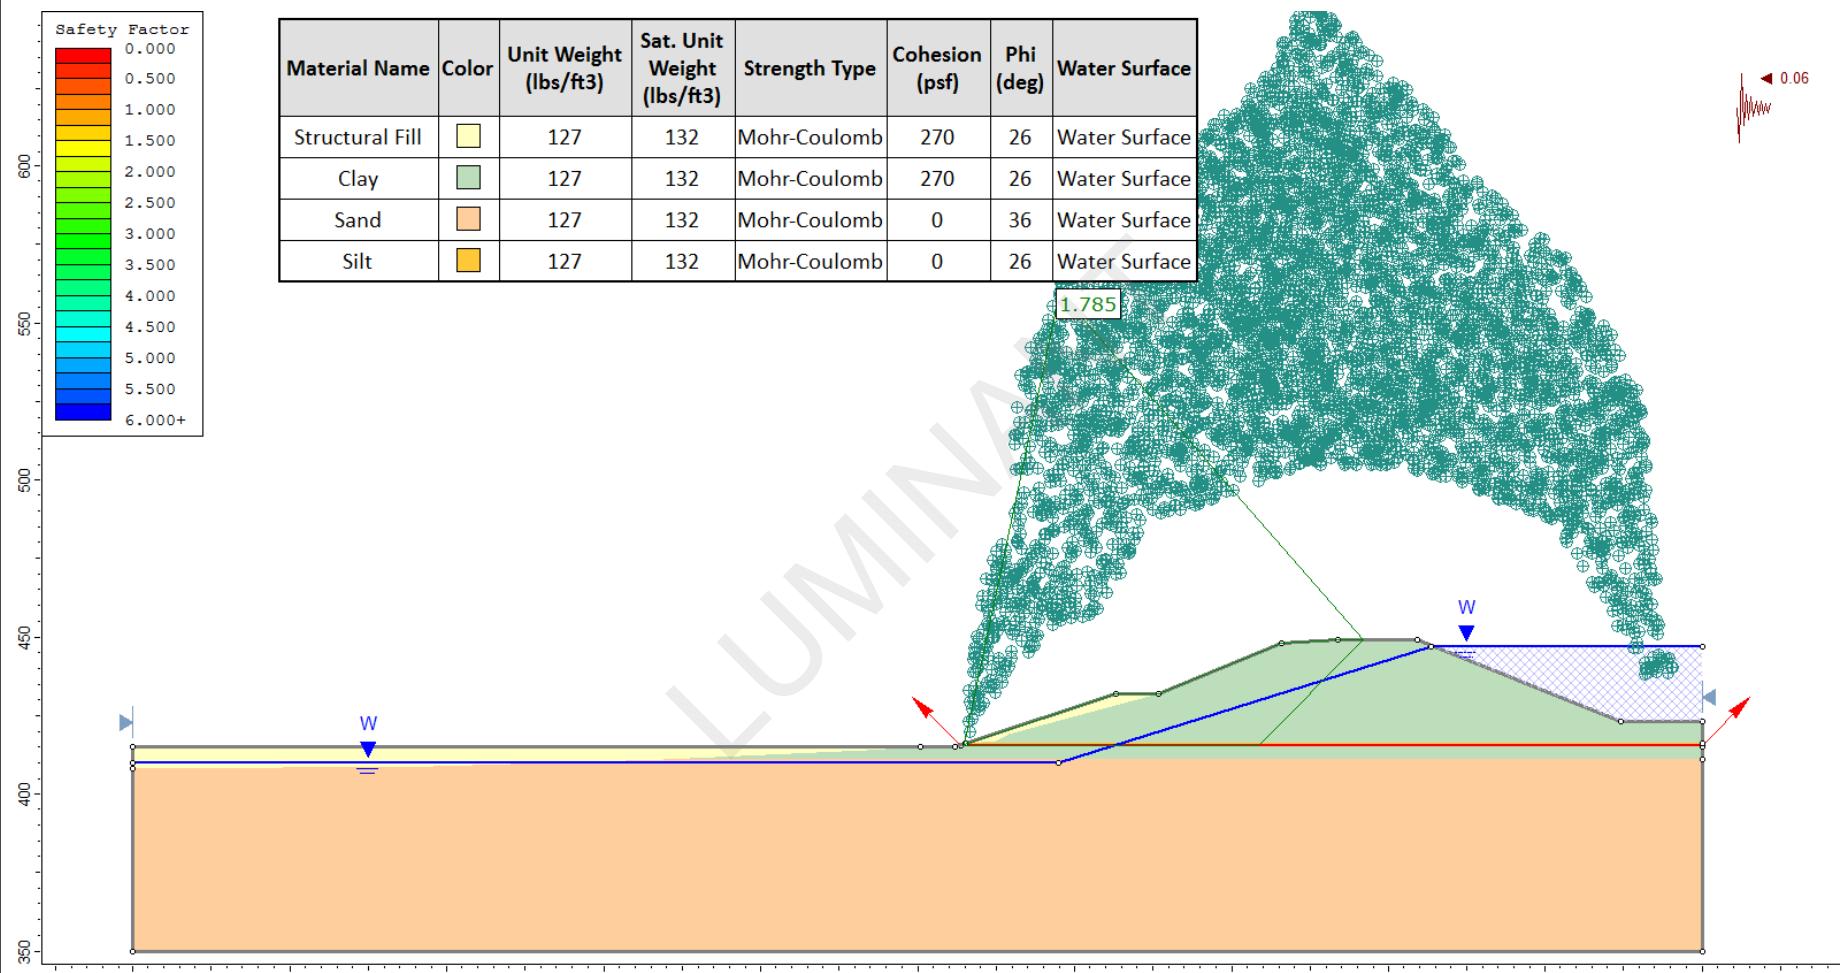
FIGURE C.20
Results of Stability Analysis – FGD-B: B1–B1' – Case 5b
 Stability and Safety Factor Assessment, Oak Grove SES

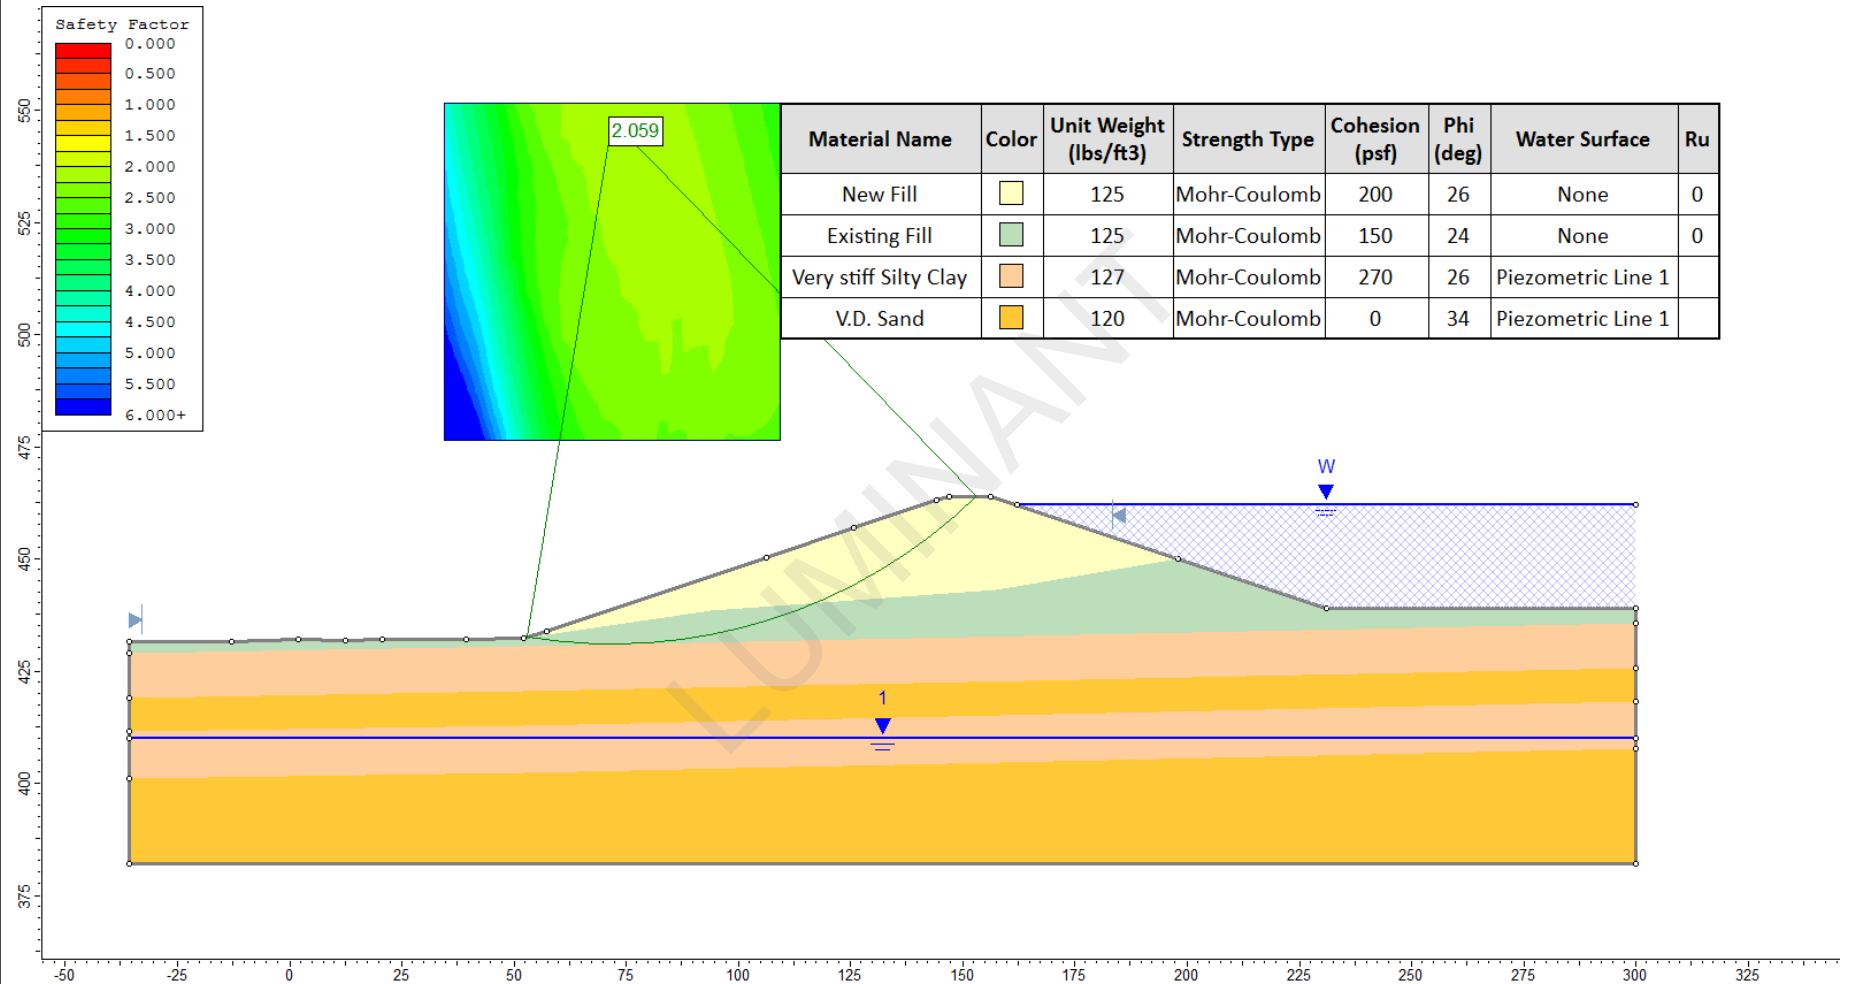
FIGURE C.21
Results of Stability Analysis – FGD-C: C–C' – Case 1a
 Stability and Safety Factor Assessment, Oak Grove SES

Cross-Section	Case #	Slope Location	Pond Pool level	Loading Condition	Req'd Safety Factor ⁽¹⁾	Calculated Safety Factor
C-C'	1a	Exterior	Storage	Static	1.50	2.06
	1b			Pseudostatic	1.00	1.72
	2a		Surcharge	Static	1.40	2.06
	2b			Pseudostatic	1.00	1.72
	3a	Interior	Storage	Static	1.50	5.53
	3b			Pseudostatic	1.00	4.04
	4a		Surcharge	Static	1.40	6.19
	4b			Pseudostatic	1.00	4.44
	5a		Empty	Static	1.50	2.16
	5b			Pseudostatic	1.00	1.80

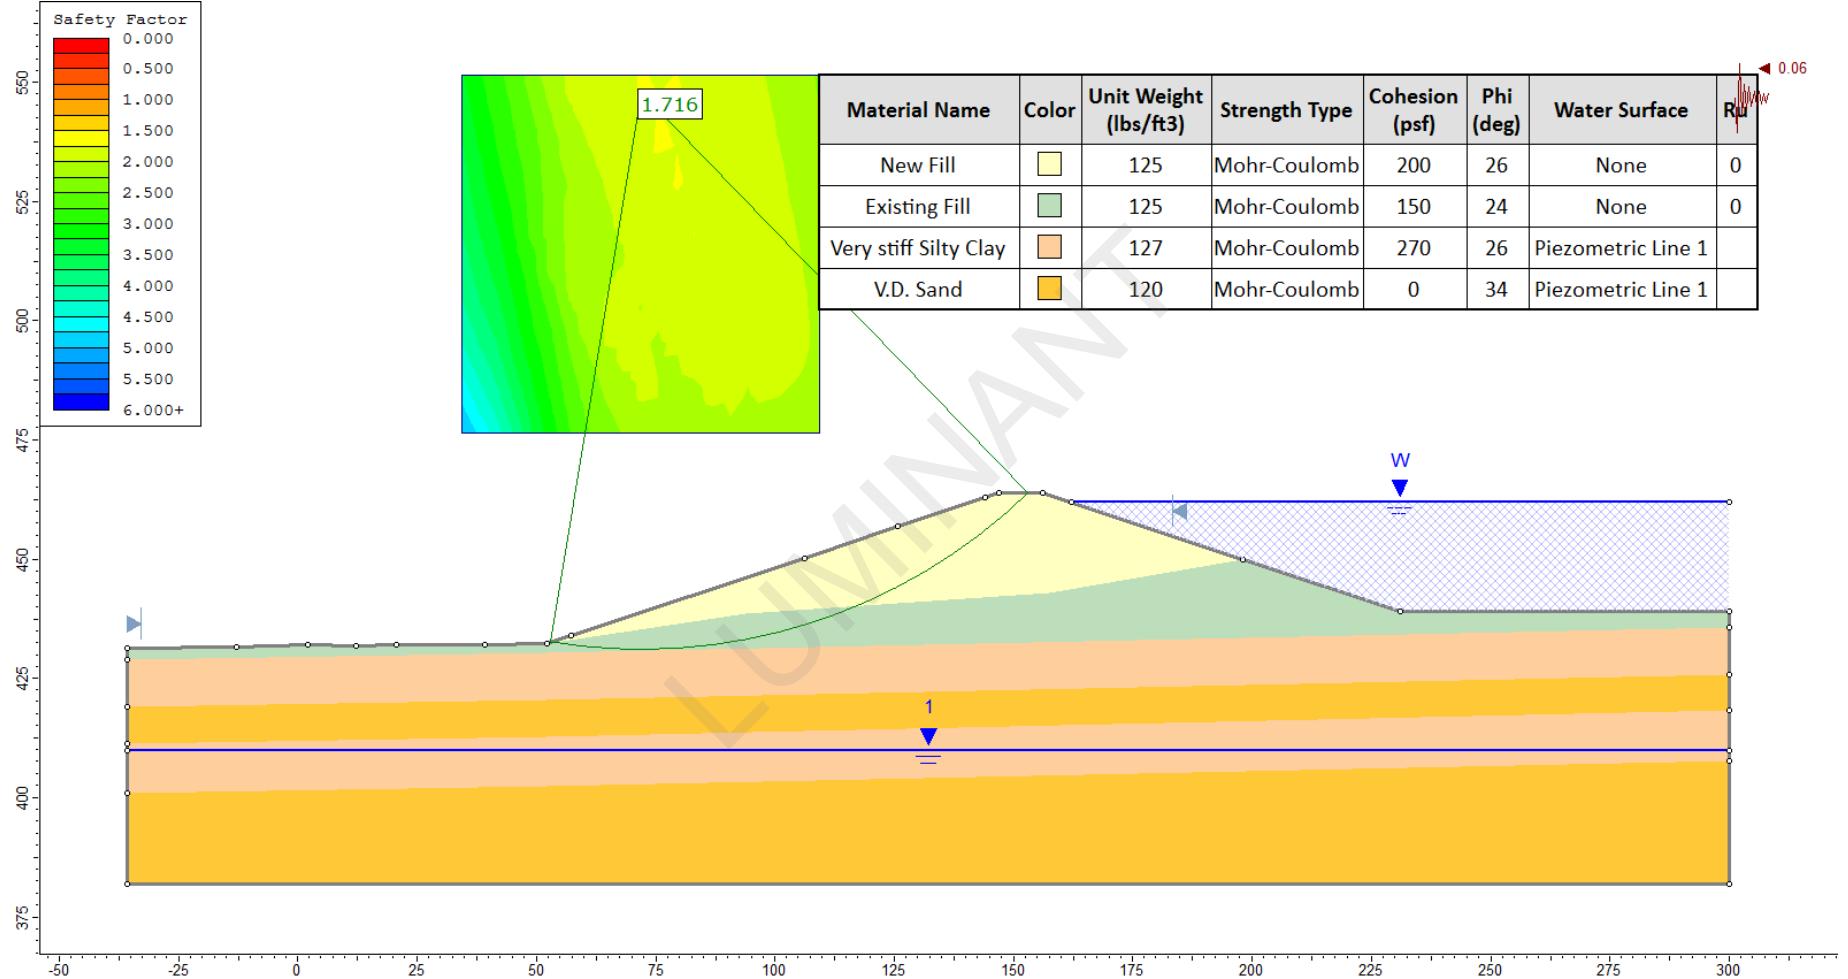
FIGURE C.22
Results of Stability Analysis – FGD-C: C-C' – Case 1b
 Stability and Safety Factor Assessment, Oak Grove SES

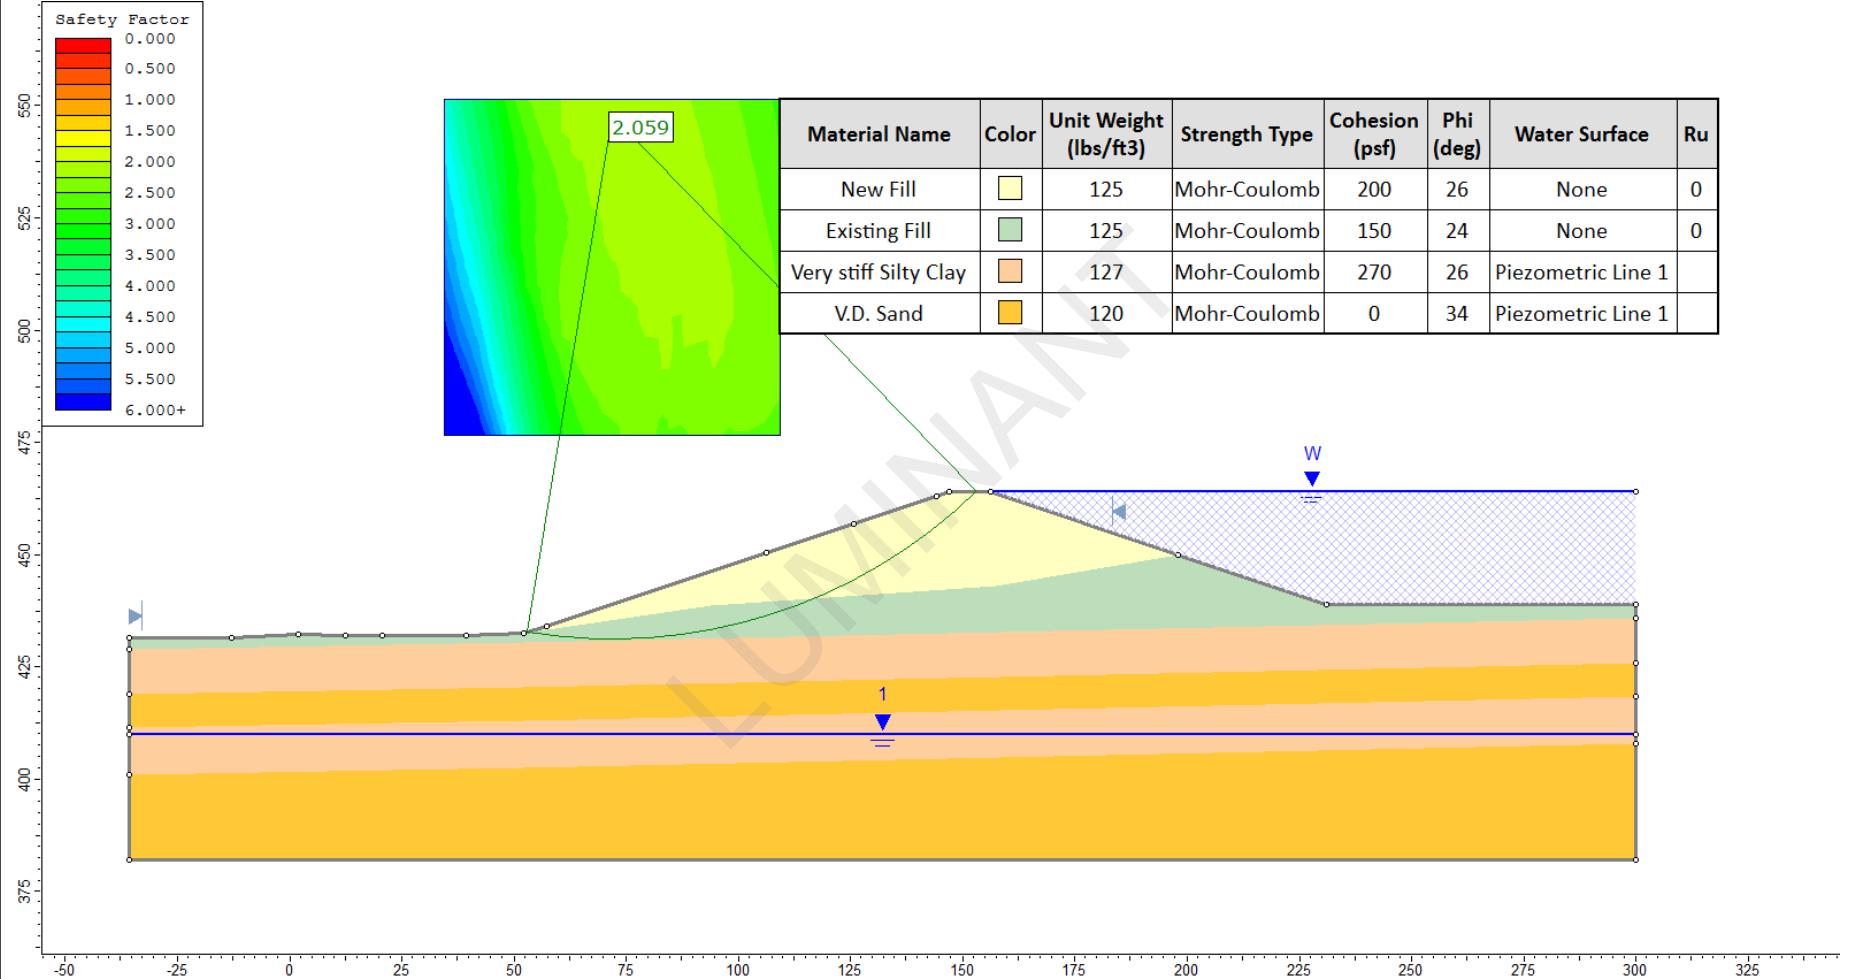
FIGURE C.23
Results of Stability Analysis – FGD-C: C–C' – Case 2a
 Stability and Safety Factor Assessment, Oak Grove SES

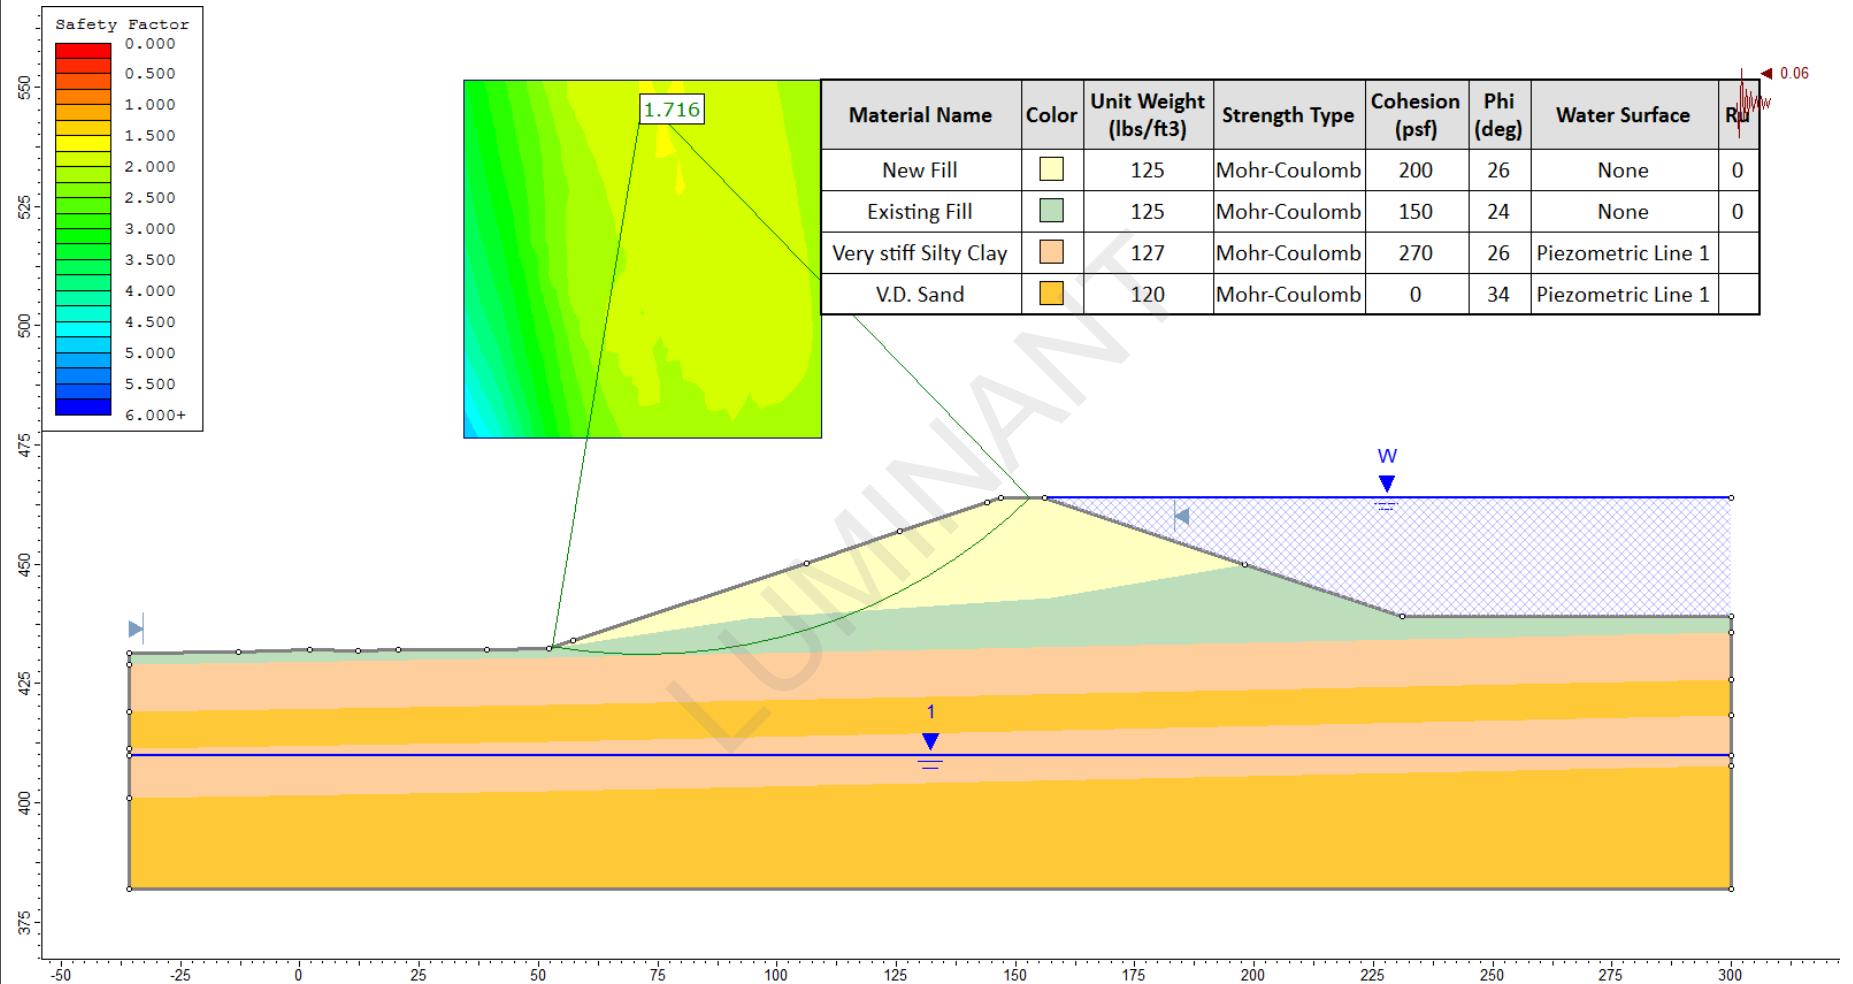
FIGURE C.24
Results of Stability Analysis – FGD-C: C–C' – Case 2b
 Stability and Safety Factor Assessment, Oak Grove SES

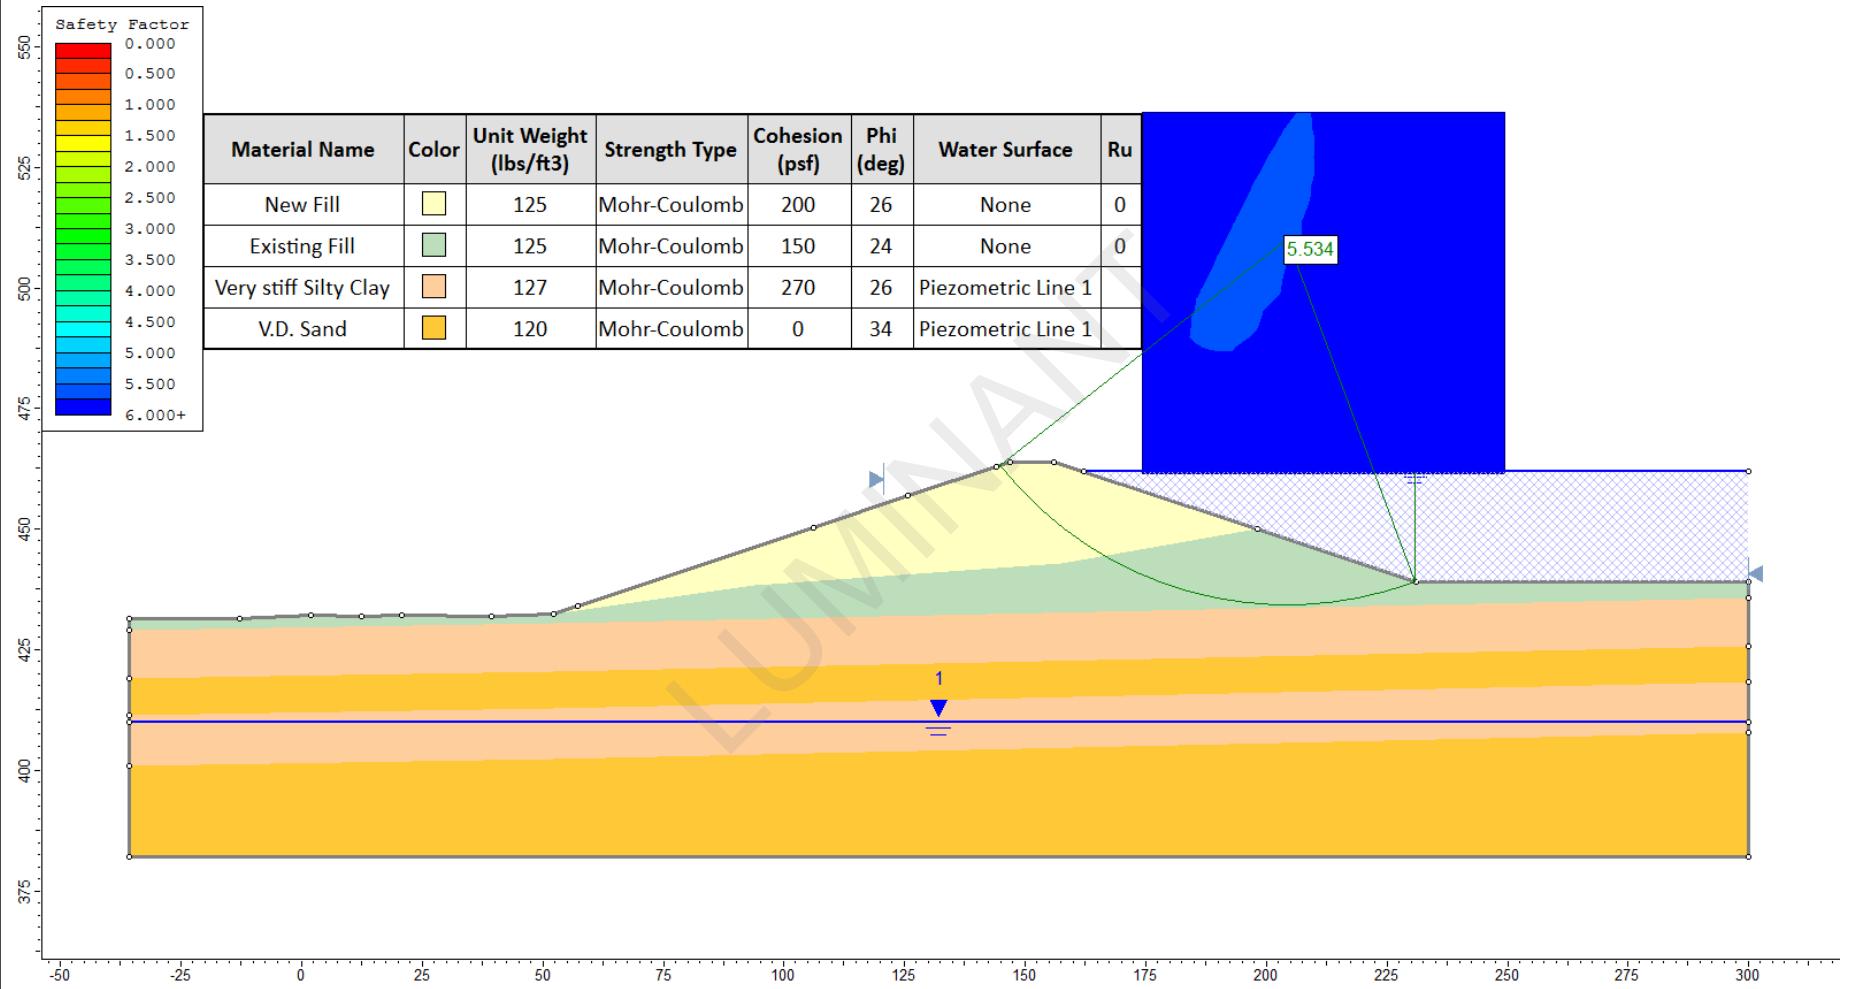
FIGURE C.25
Results of Stability Analysis – FGD-C: C–C' – Case 3a
 Stability and Safety Factor Assessment, Oak Grove SES

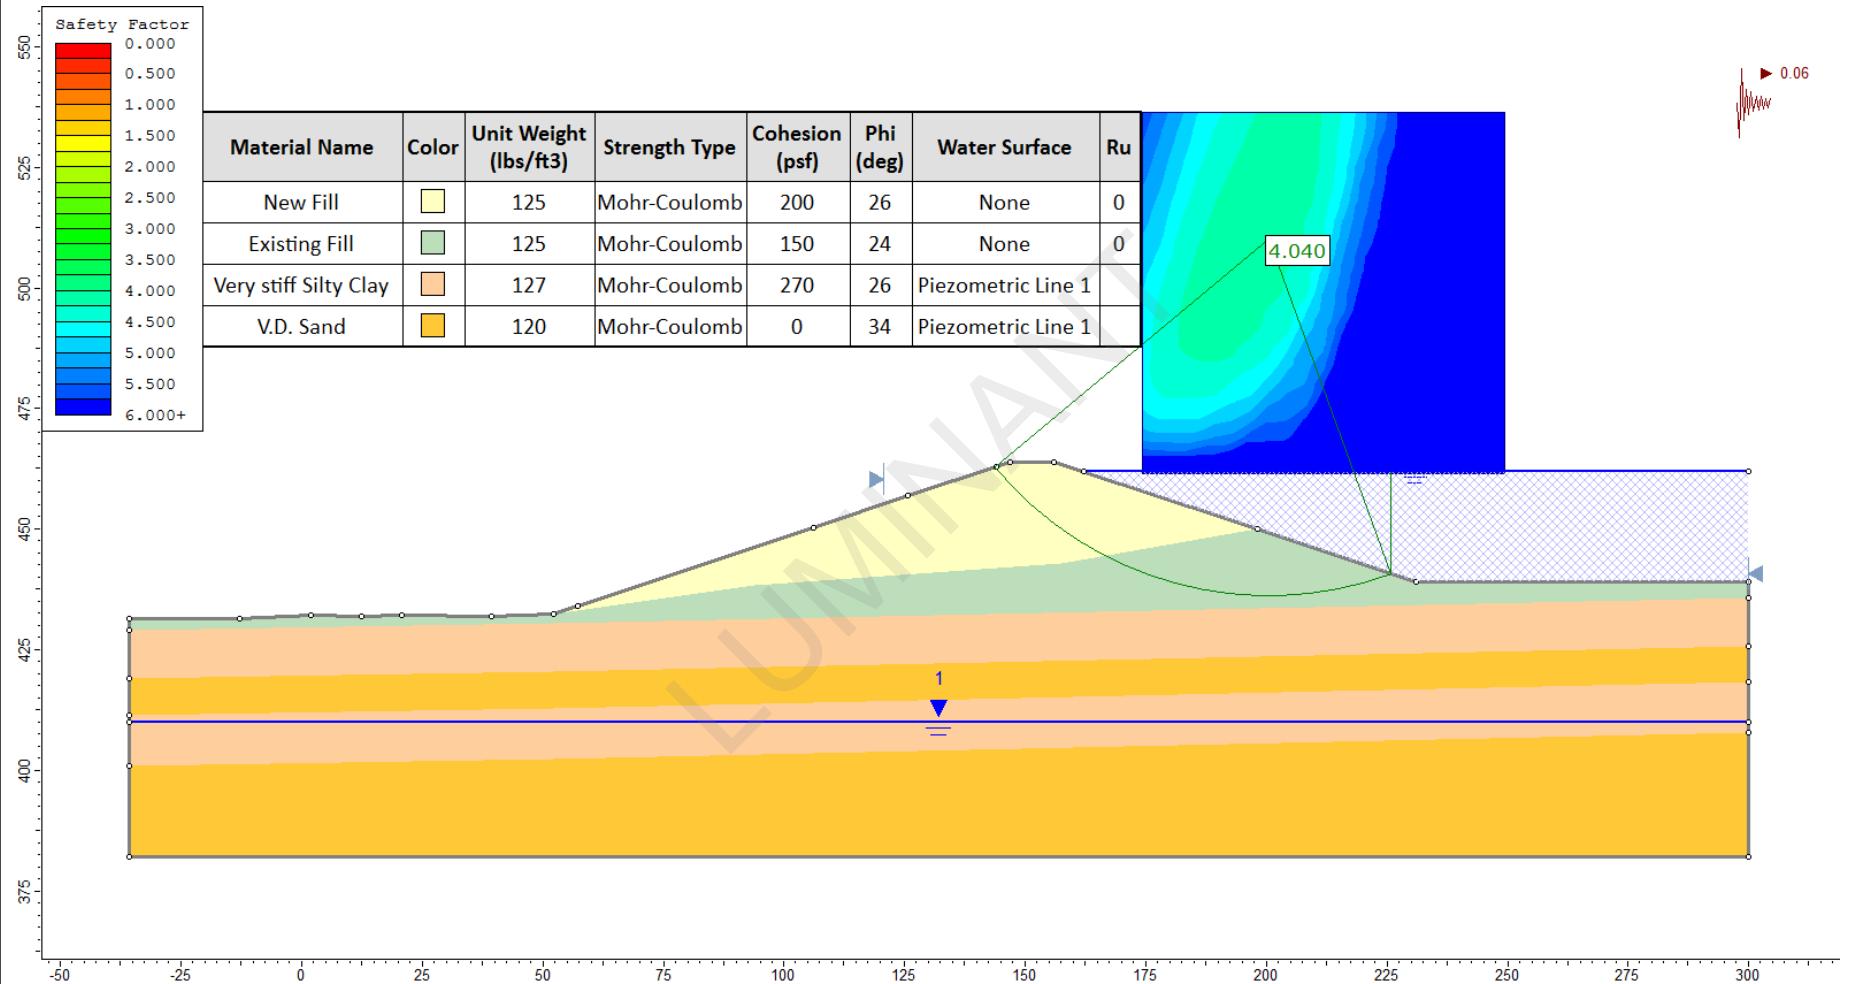
FIGURE C.26
Results of Stability Analysis – FGD-C: C–C' – Case 3b
 Stability and Safety Factor Assessment, Oak Grove SES

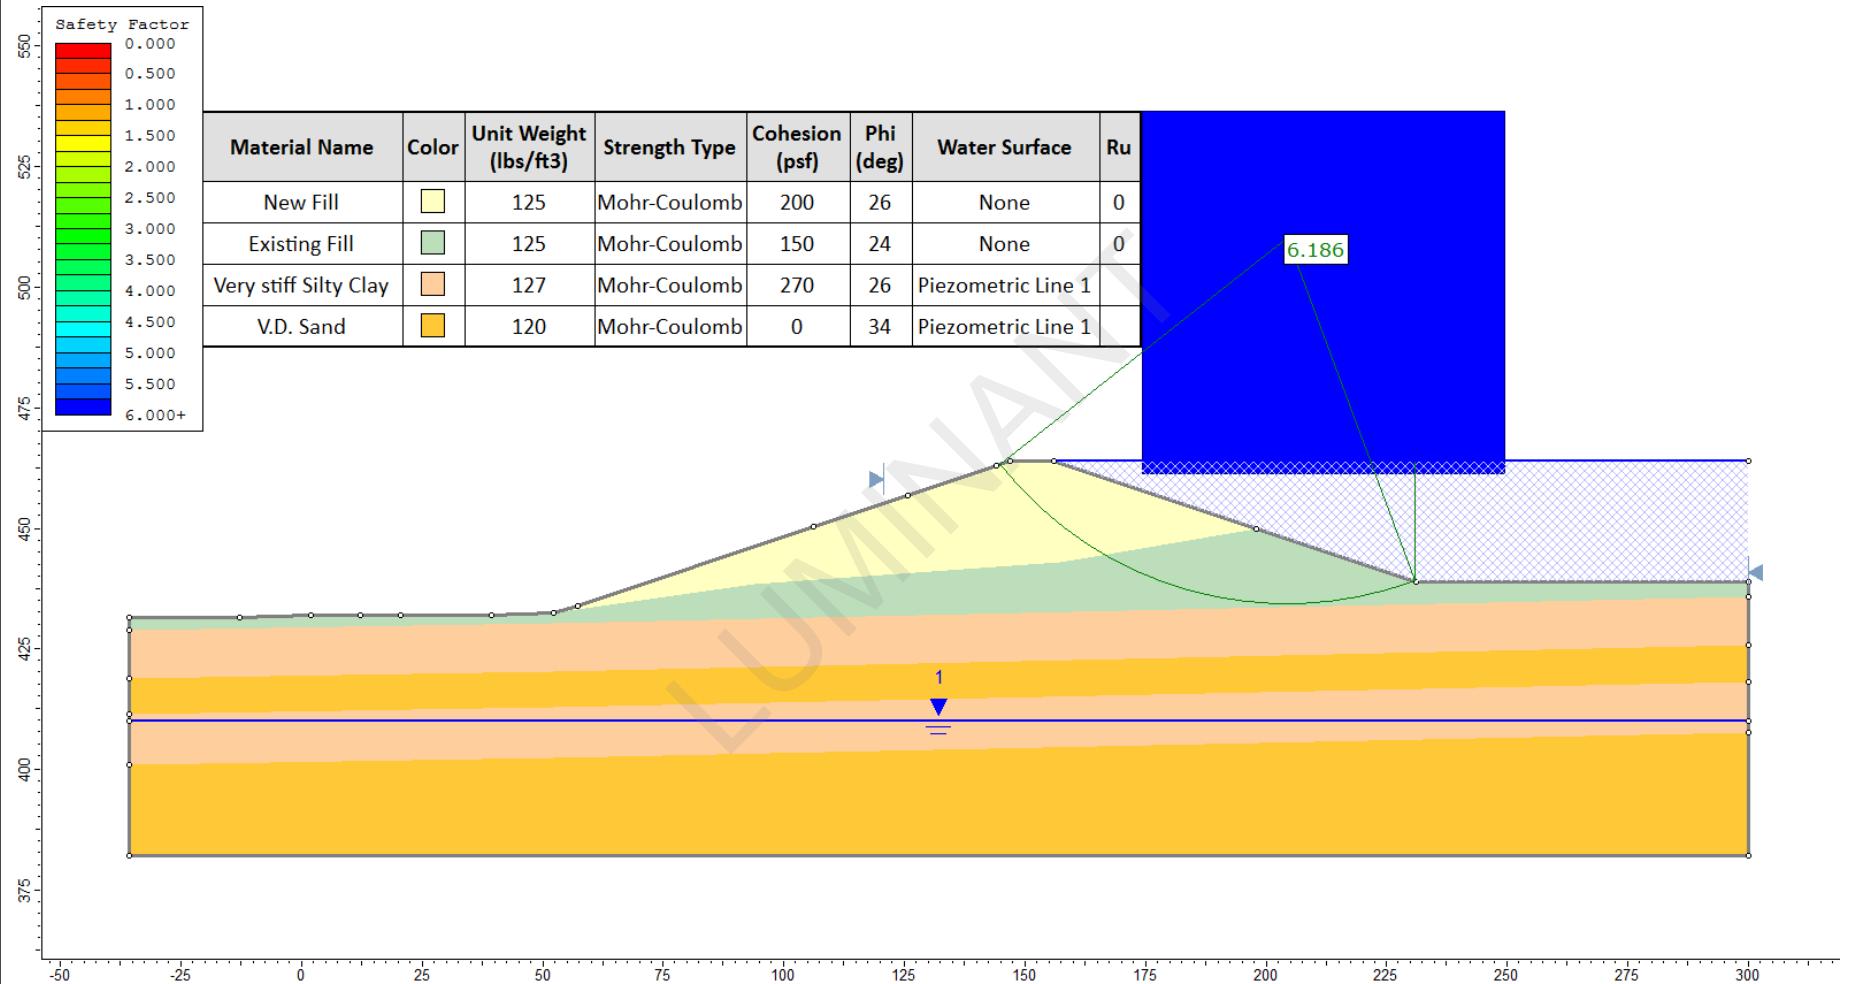
FIGURE C.27
Results of Stability Analysis – FGD-C: C–C' – Case 4a
 Stability and Safety Factor Assessment, Oak Grove SES

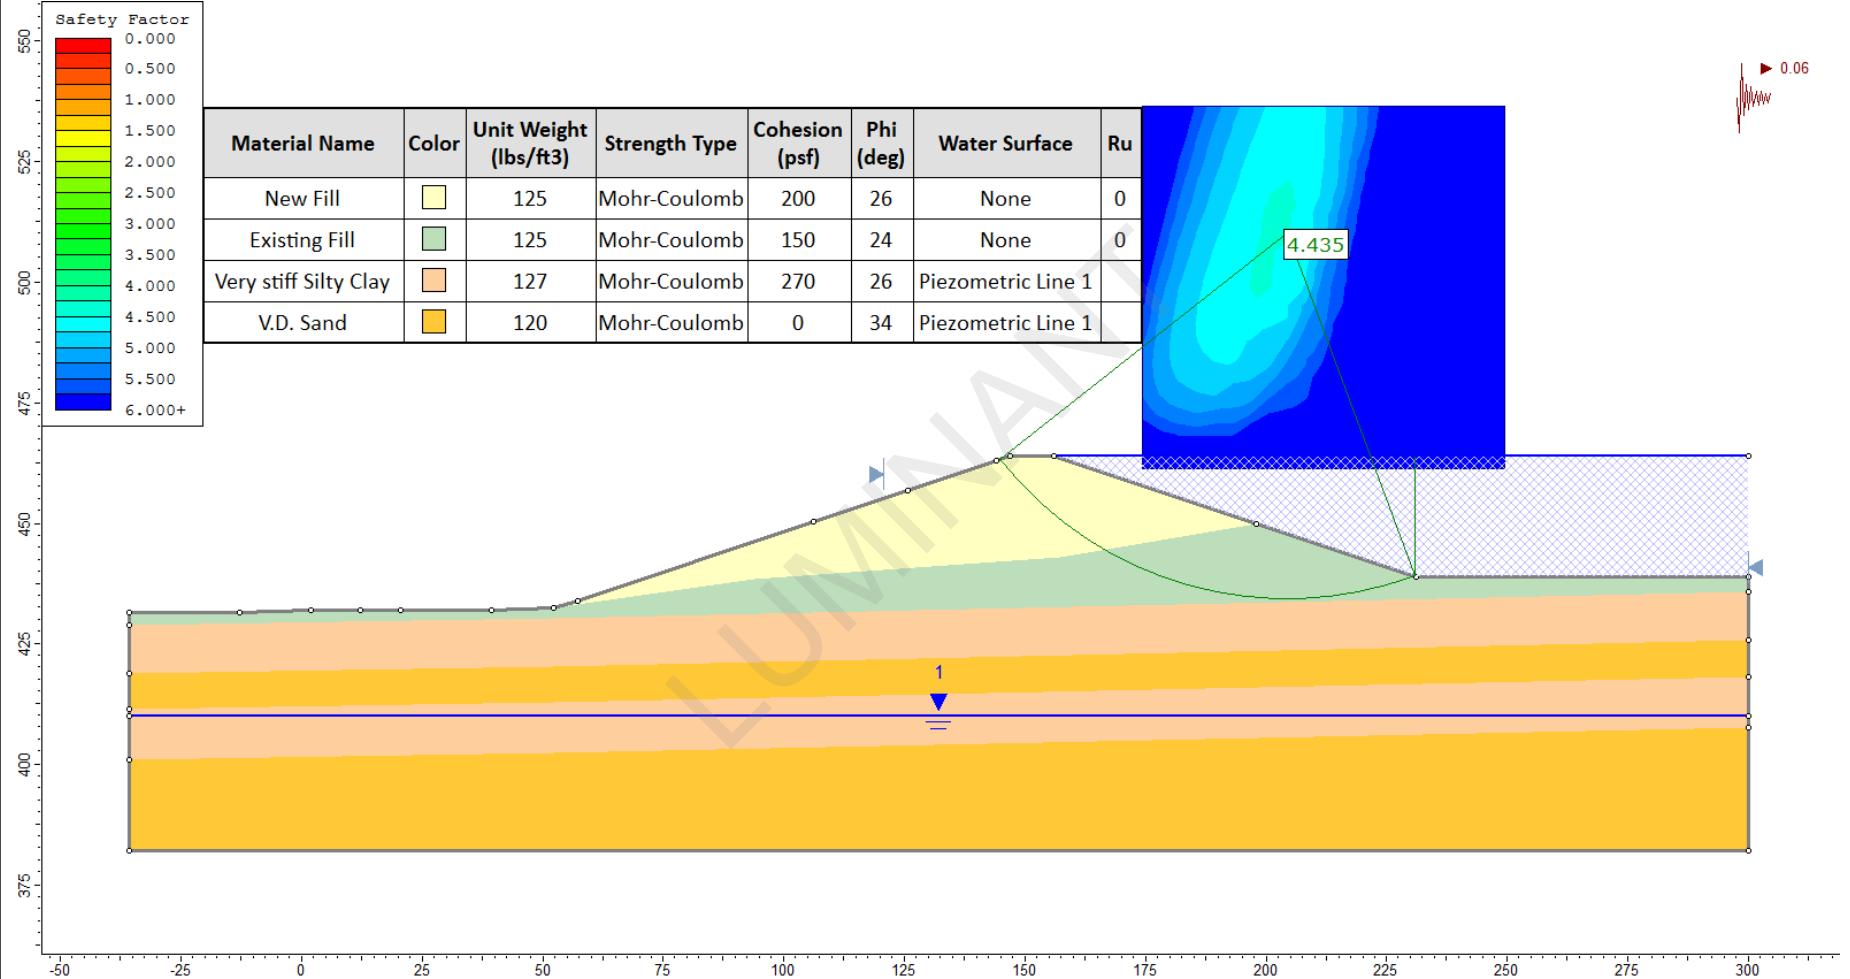
FIGURE C.28
Results of Stability Analysis – FGD-C: C-C' – Case 4b
 Stability and Safety Factor Assessment, Oak Grove SES

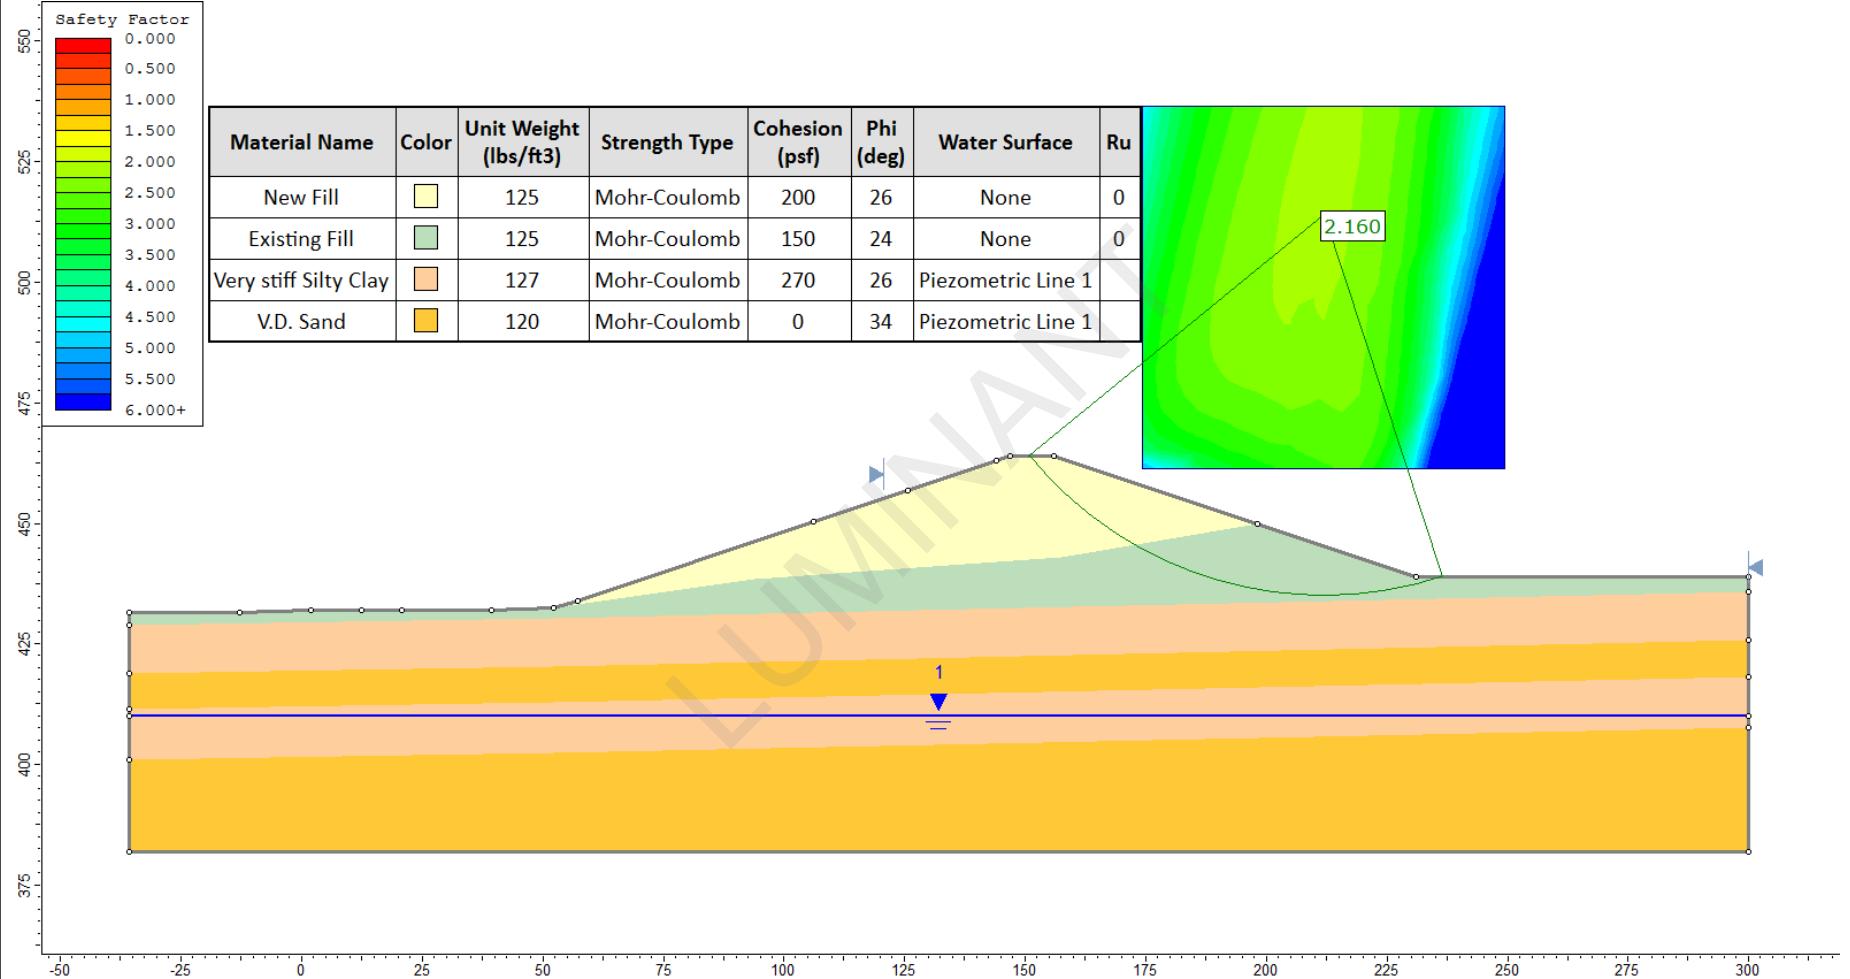
FIGURE C.29
Results of Stability Analysis – FGD-C: C–C' – Case 5a
 Stability and Safety Factor Assessment, Oak Grove SES

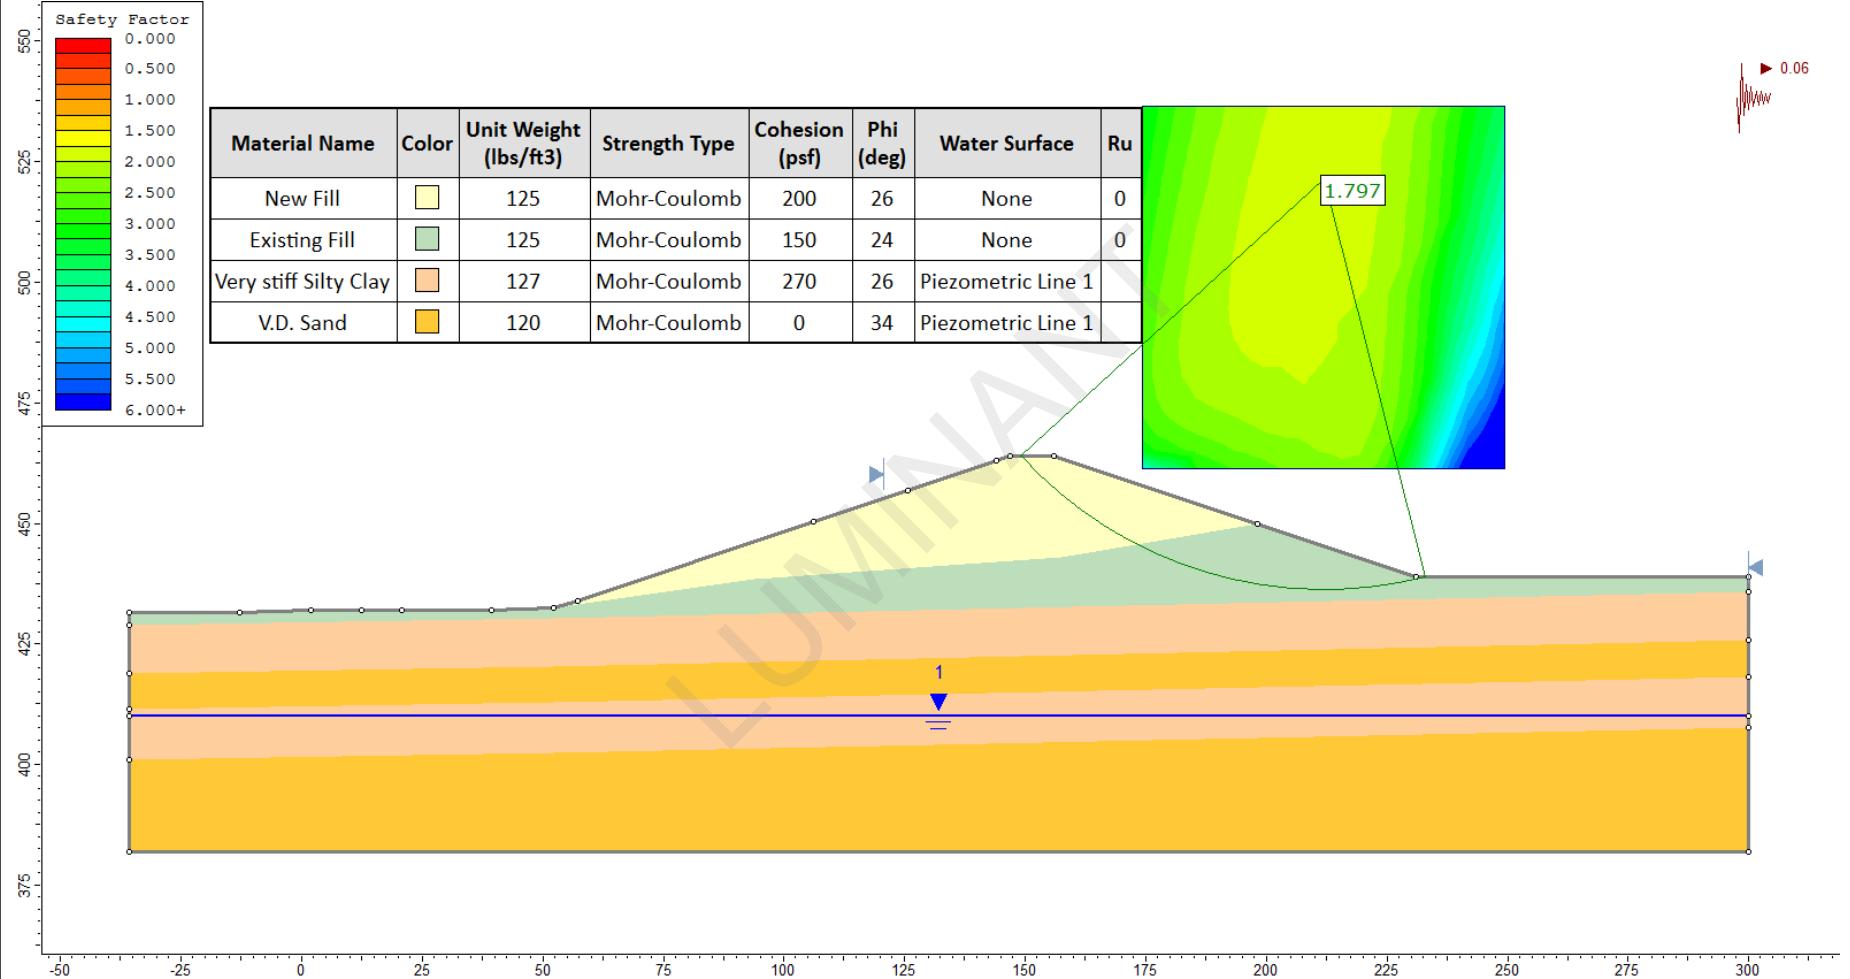
FIGURE C.30
Results of Stability Analysis – FGD-C: C–C' – Case 5b
 Stability and Safety Factor Assessment, Oak Grove SES
