# STRUCTURAL STABILITY ASSESSMENT REPORT

## Monticello Steam Electric Station

October 2016

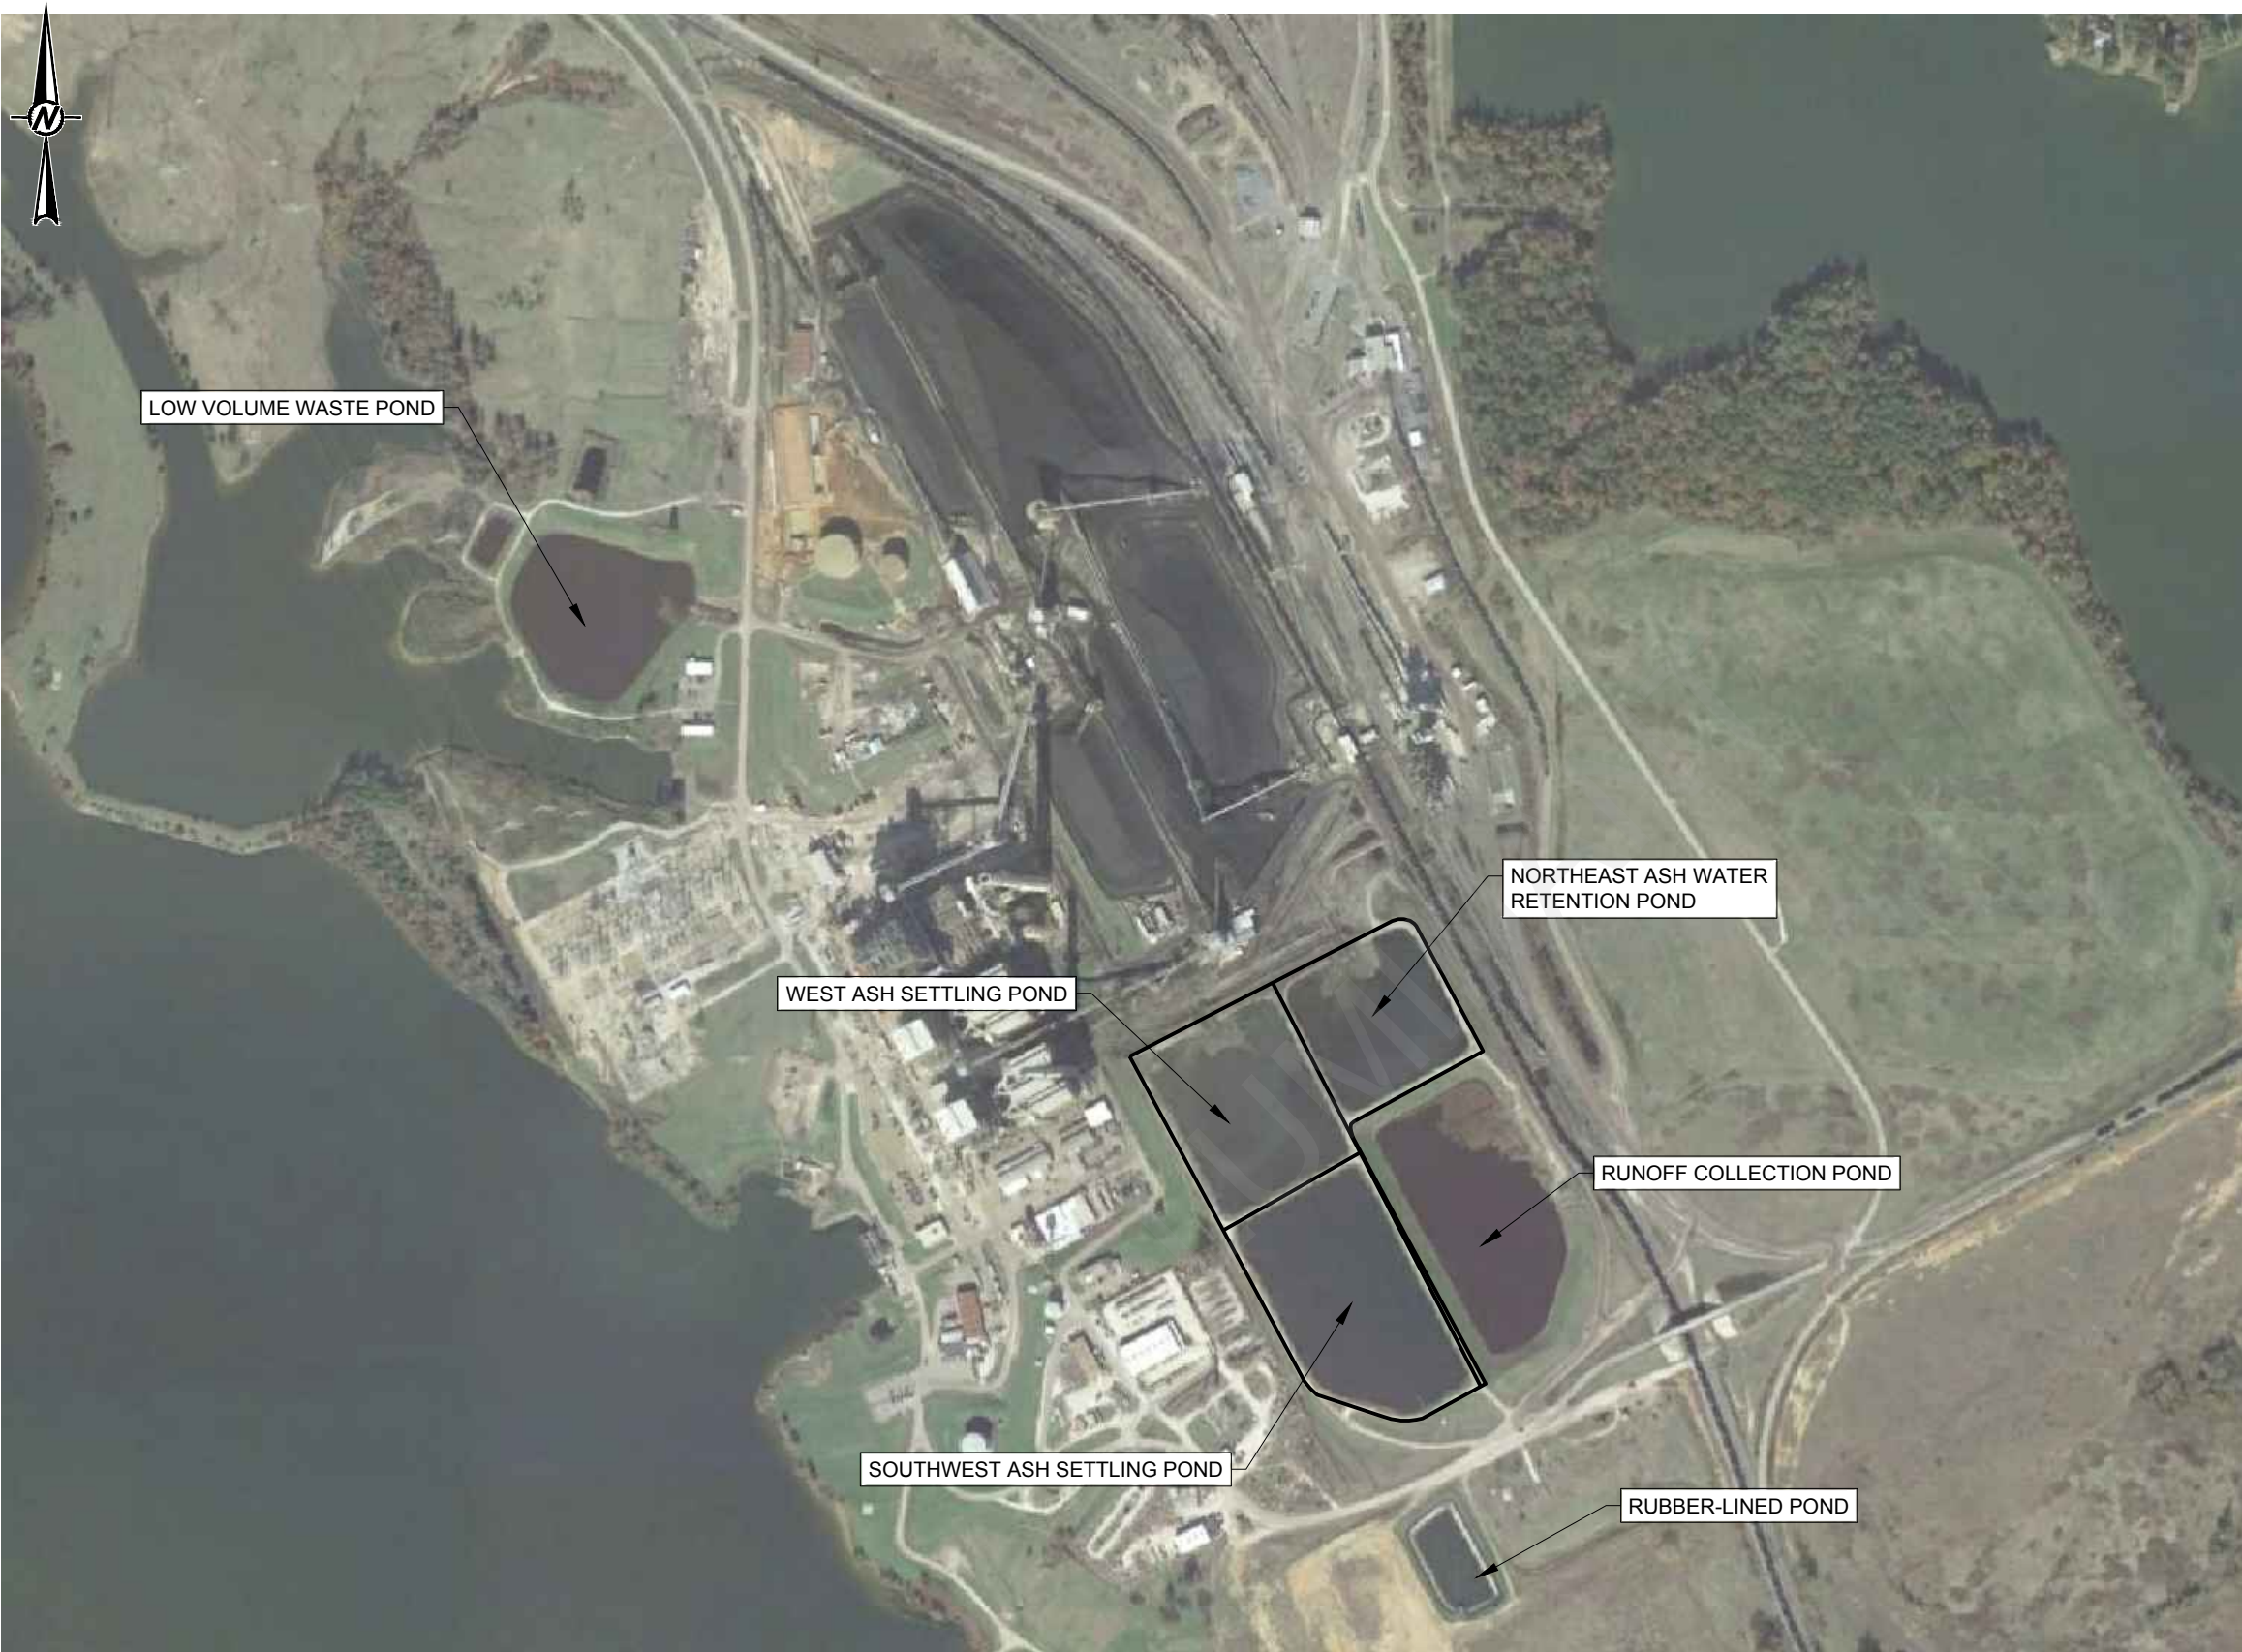
REFERENCE(S)  
AERIAL PHOTO SOURCED FROM GOOGLE EARTH PRO DATED 2015

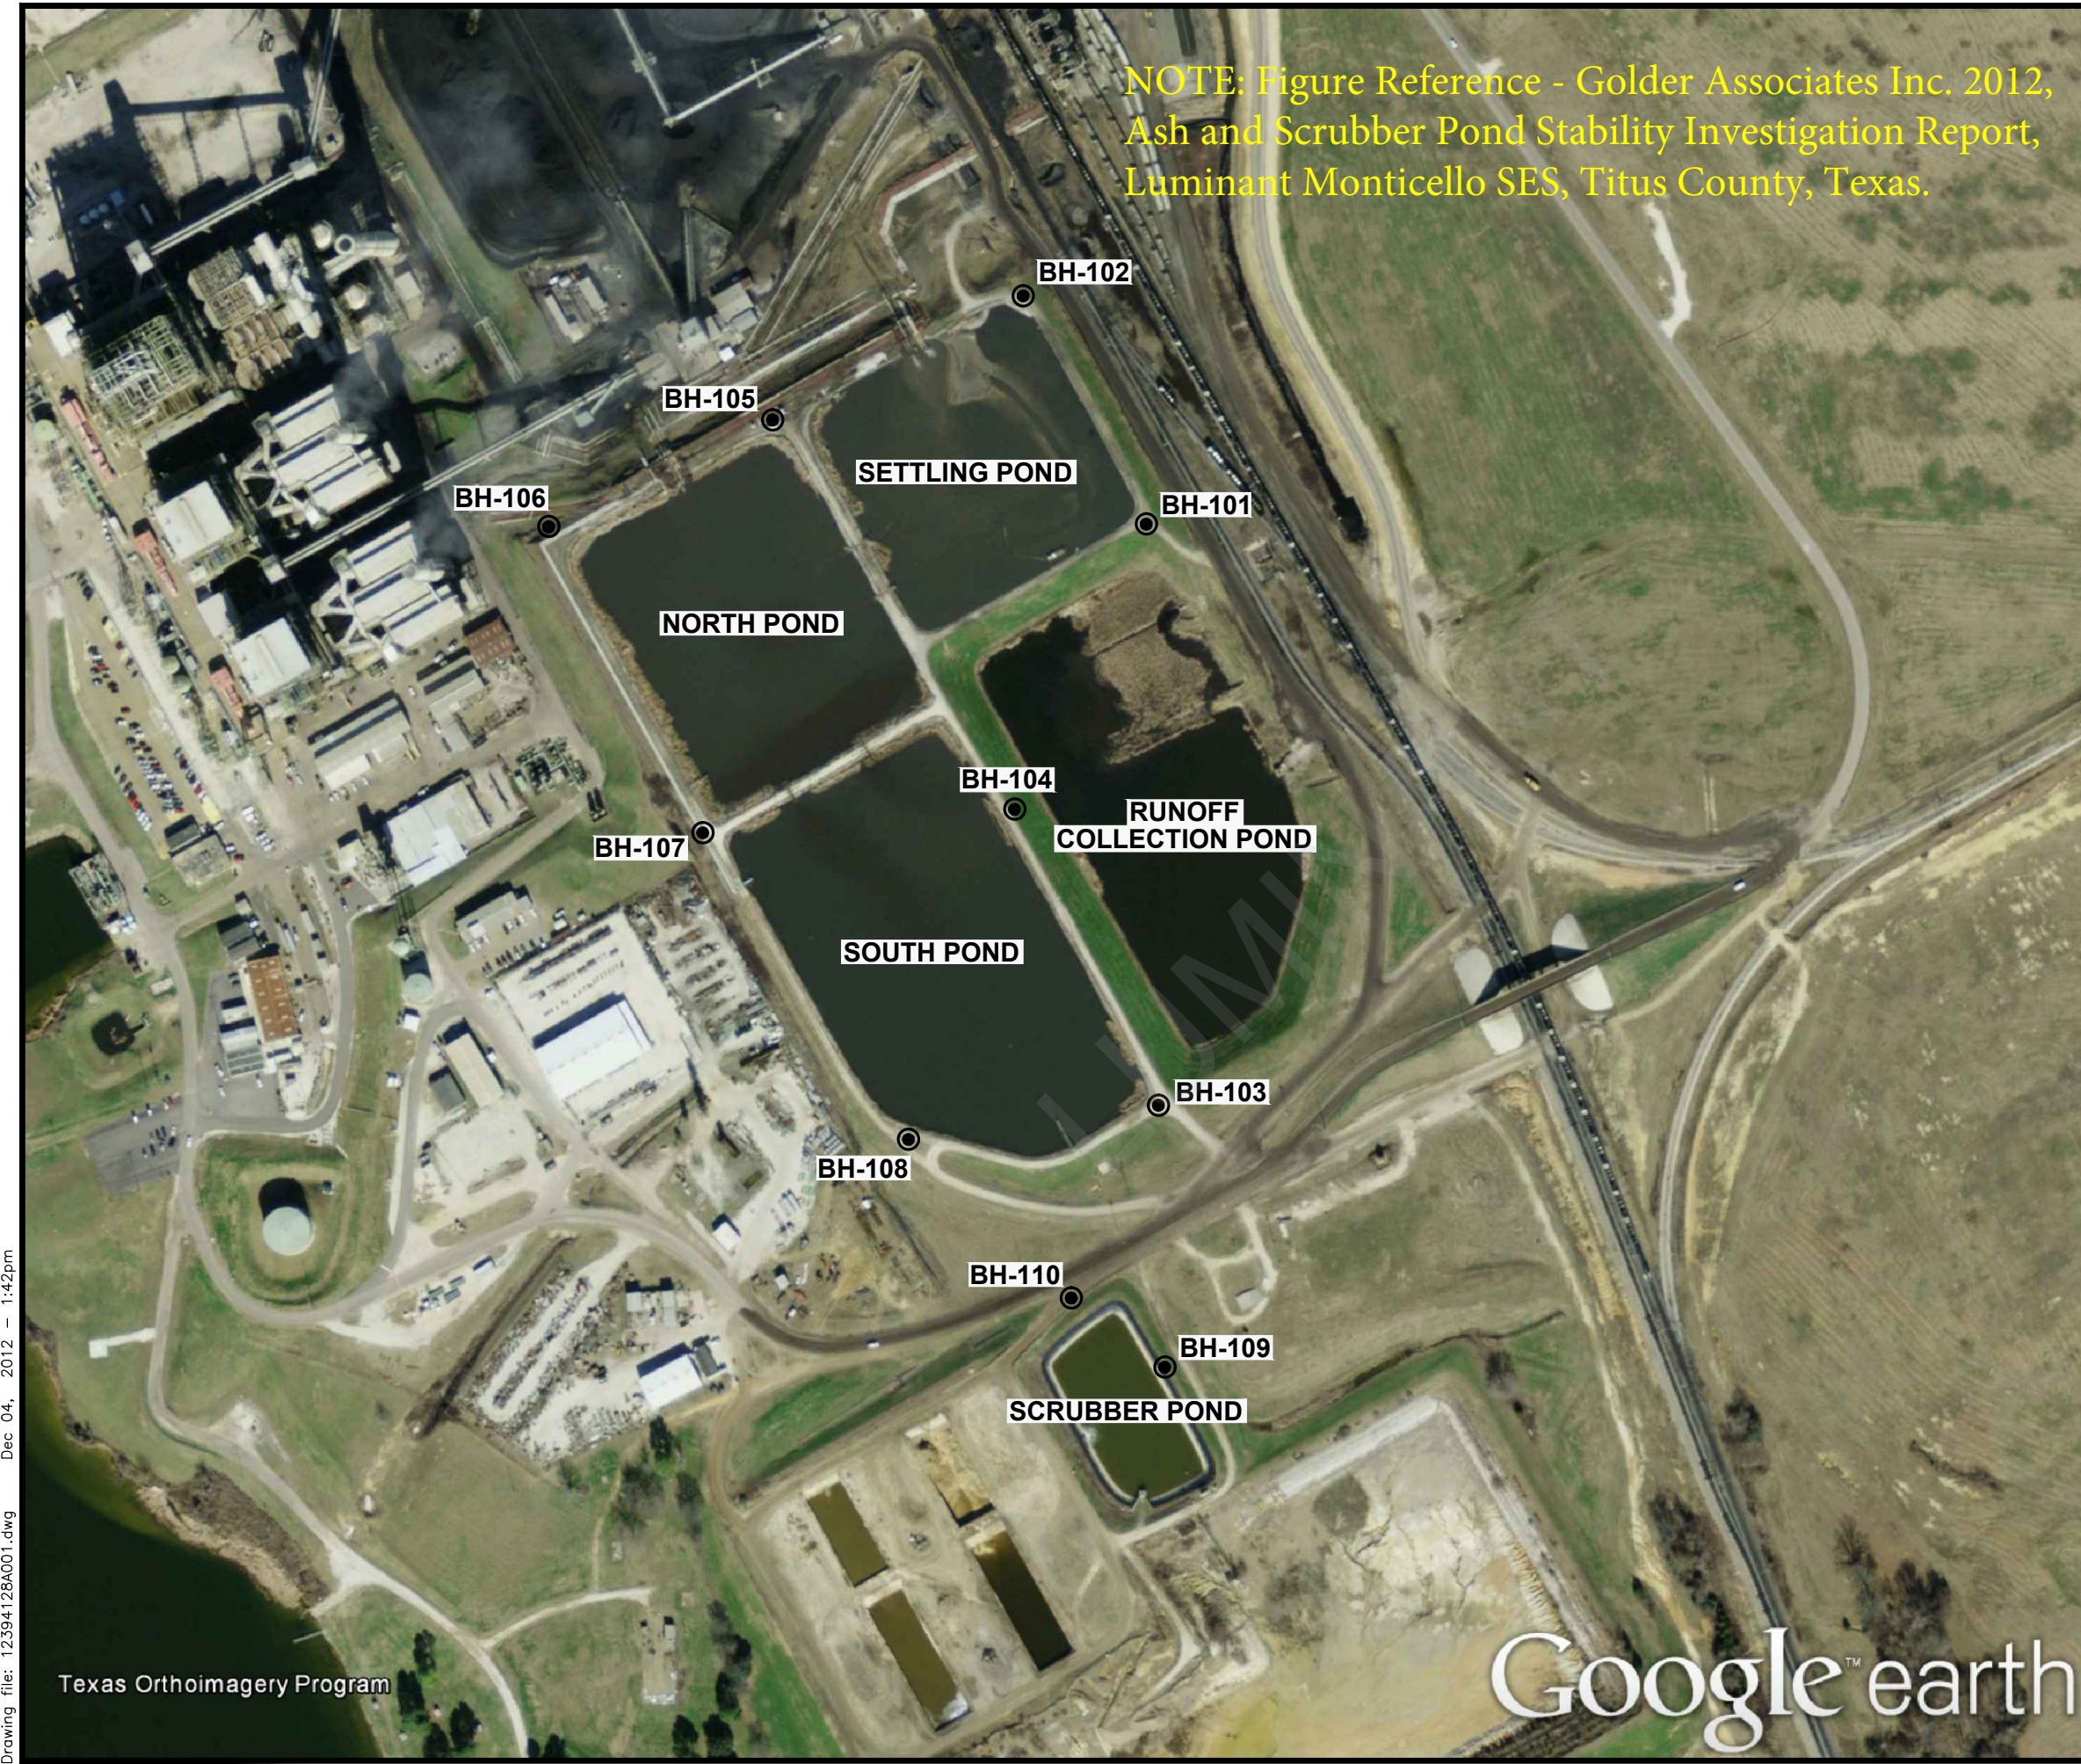
PROJECT No. 123-94128 FILE No. 12394128A001
DESIGN	MGP	11/21/12	SCALE AS SHOWN REV. 0
CADD	RG	11/21/12	<b>FIGURE 1</b>
CHECK	MGP	11/21/12	
REVIEW	PCM	11/21/12

**TITLE**  
**BORING LOCATIONS**

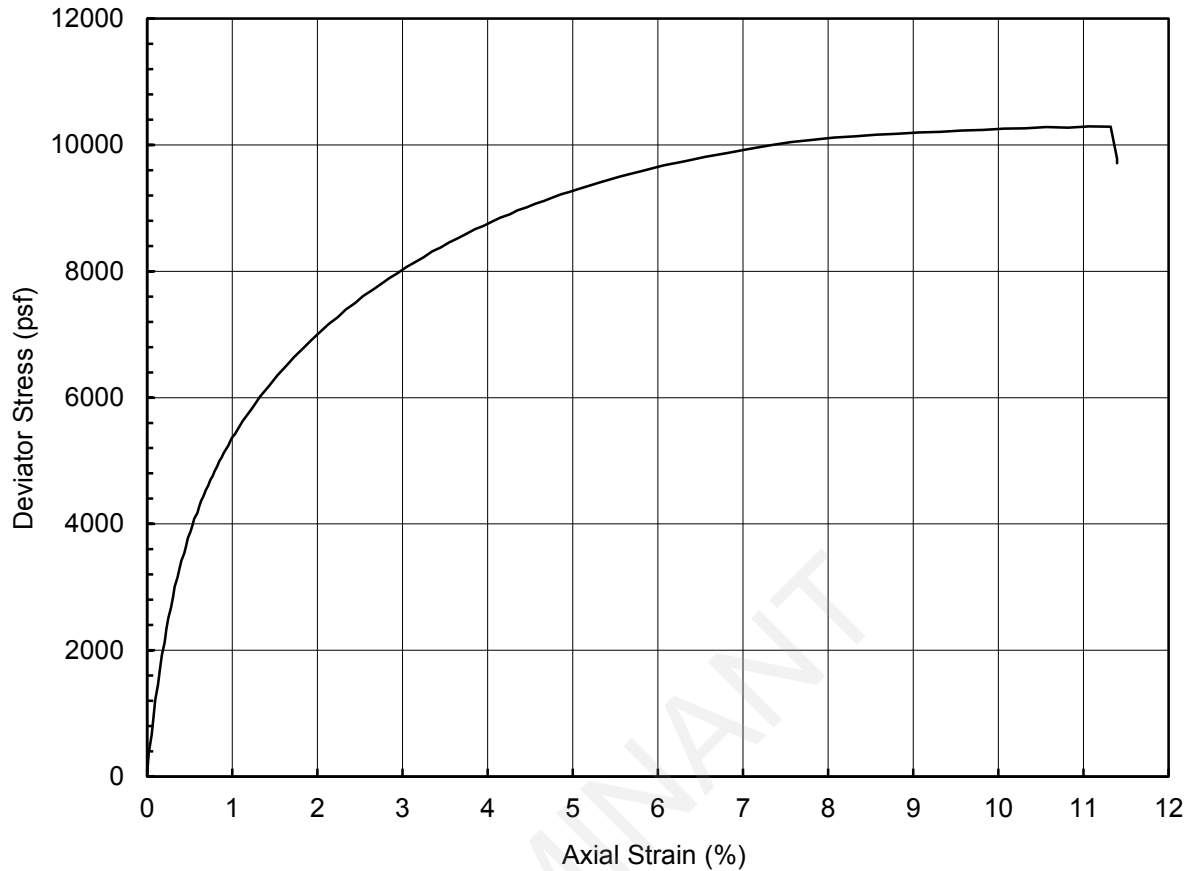
**UNCONSOLIDATED / UNDRAINED COMPRESSIVE STRENGTH  
ASTM D 2850**

Specimen Description	Reddish Gray Clay			
LL		PI		USCS

Depth (ft)	18.0	Confining Pressure (psf)	2873
Specimen Height (inch)	6.0	Strain Rate (%/min)	1.0
Specimen Diameter (inch)	2.8	Peak Deviator Stress (psf)	10292
Initial Specimen Weight (g)	1257.9	Axial Strain at Peak Stress (%)	11.1
Moist Unit Weight (pcf)	131.0		
Initial Water Content (%)	17		
Initial Dry Unit Weight (pcf)	112.3

Project Title	Luminant - Monticello Slope Stability
Project Number	123-94128
Sample Type	Shelby Tube
Sample ID	BH-104 TO-7
Comments	Load cell reached maximum capacity

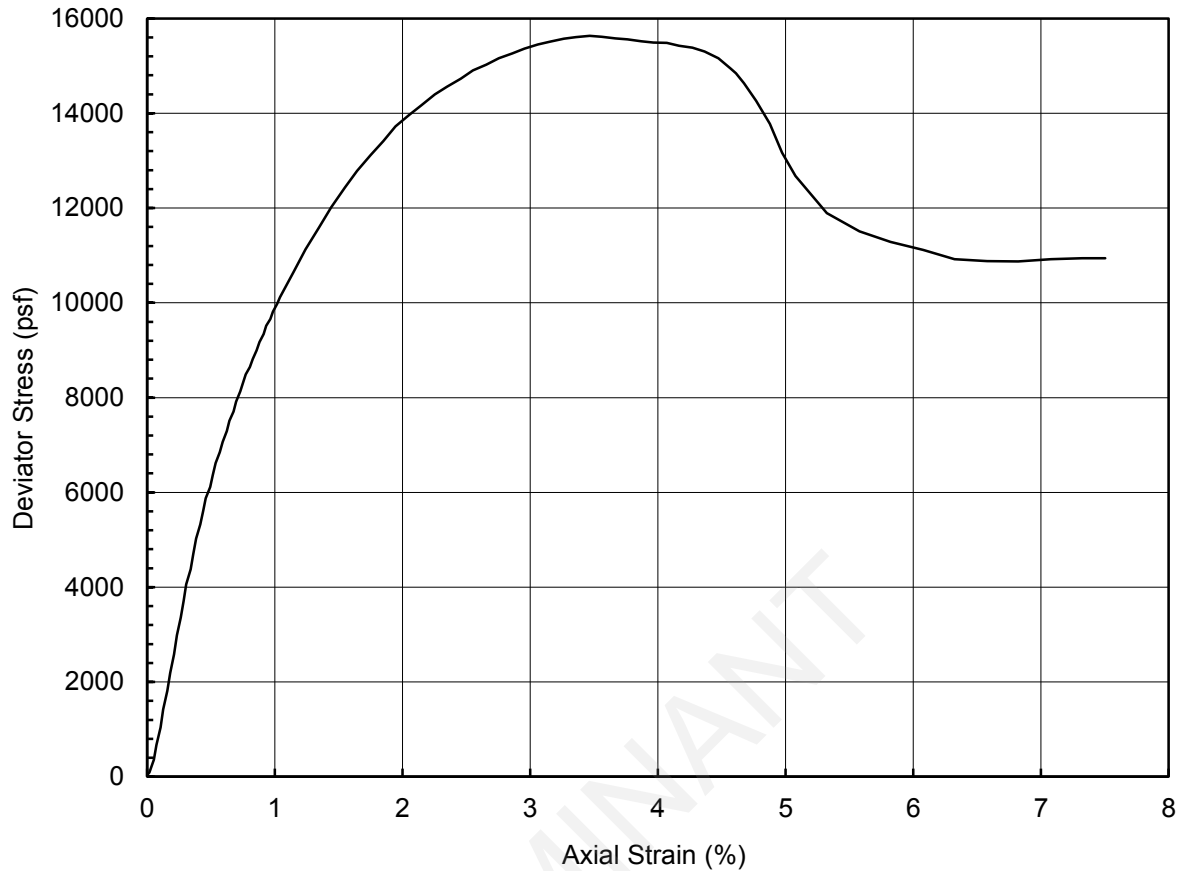
**UNCONSOLIDATED / UNDRAINED COMPRESSIVE STRENGTH  
ASTM D 2850**

Specimen Description		Reddish Gray Clay			
LL		PI		LI	
				USCS

Depth (ft)	2.0	Confining Pressure (psf)	364
Specimen Height (inch)	6.0	Strain Rate (%/min)	1.0
Specimen Diameter (inch)	2.8	Peak Deviator Stress (psf)	15637
Initial Specimen Weight (g)	1242.3	Axial Strain at Peak Stress (%)	3.5
Moist Unit Weight (pcf)	129.1		
Initial Water Content (%)	17		
Initial Dry Unit Weight (pcf)	110.8

Project Title	Luminant - Monticello Slope Stability
Project Number	123-94128
Sample Type	Shelby Tube
Sample ID	BH-106 TO-2
Comments

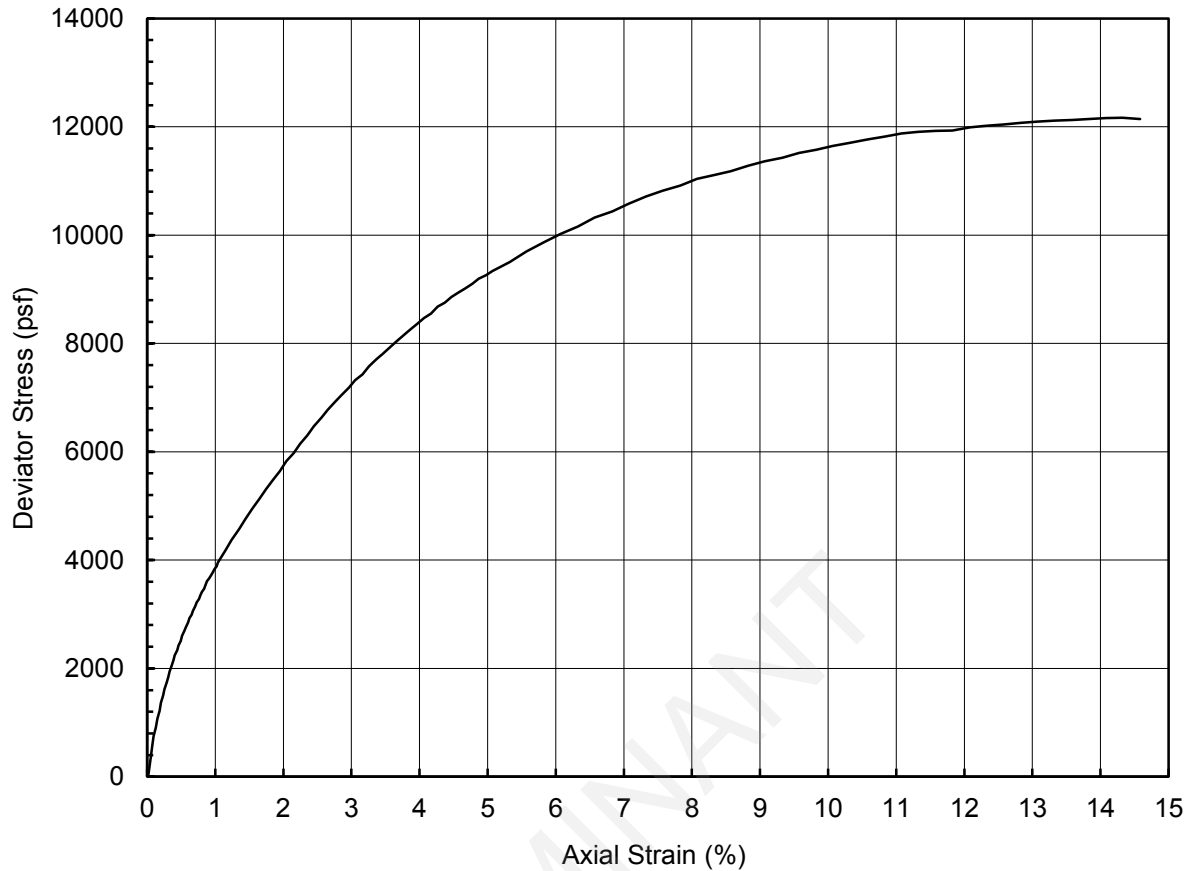
**UNCONSOLIDATED / UNDRAINED COMPRESSIVE STRENGTH  
ASTM D 2850**

Specimen Description	Light Grayish Brown Clay			
LL		PI		USCS

Depth (ft)	23.0	Confining Pressure (psf)	2876
Specimen Height (inch)	6.0	Strain Rate (%/min)	1.0
Specimen Diameter (inch)	2.8	Peak Deviator Stress (psf)	12167
Initial Specimen Weight (g)	1292.1	Axial Strain at Peak Stress (%)	14.3
Moist Unit Weight (pcf)	133.6		
Initial Water Content (%)	14		
Initial Dry Unit Weight (pcf)	116.9

Project Title	Luminant - Monticello Slope Stability	
Project Number	123-94128	
Sample Type	Shelby Tube	
Sample ID	BH-108	TO-8
Comments

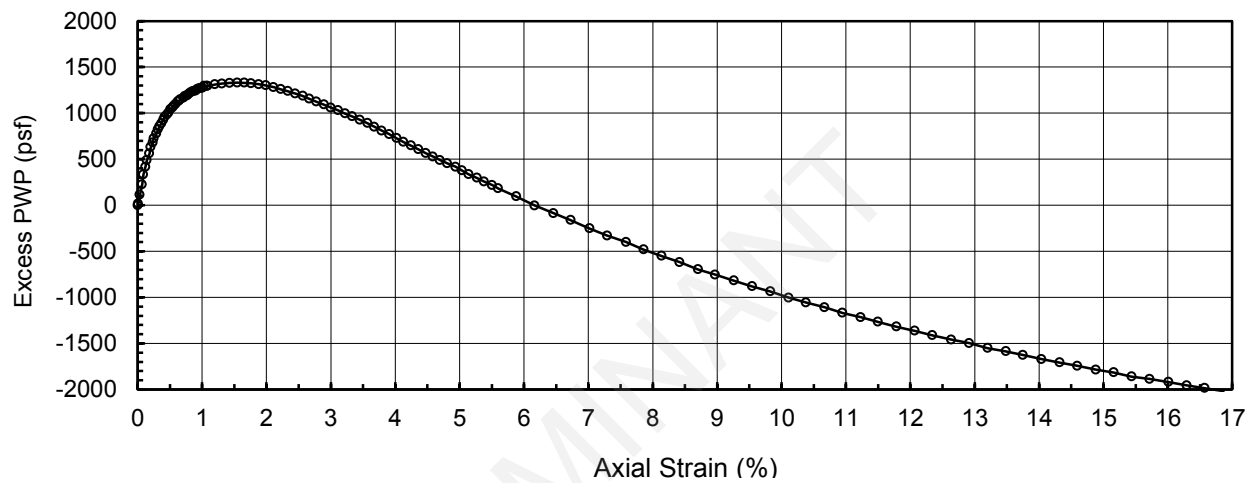
Specimen Description: Light Gray Clay

Initial Specimen Diameter (inch) =		2.84		Initial Specimen Height (inch) =		5.30	
Initial Water Content (%) =		16.8		Water Content at End of Test (%) =		19.5	
Initial Moist Unit Weight (pcf) =		141.6		B-value =		0.98	
Back Pressure (BP, psf) =		5760.0		Consolidation Stress ( $\sigma'_3$ , psf) =		2867.8	
Initial Lateral Stress ( $\sigma'_3$ , psf) =		2867.8		Consolidation $t_{50}$ (min) =		9	
Initial Deviator Stress ( $\sigma_1 - \sigma_3$ , psf) =		98.6		Rebound Stress ( $\sigma'_3$ , psf) =		NA	
Test Strain Rate (%/hour) =		1.0		Rebound $t_{50}$ (min) =		NA	
LL =	42	PI =	25	USCS	CL	Performed by	PN
Comments:						Reviewed by	HR
