**ANNUAL CCR SURFACE IMPOUNDMENT  
INSPECTION REPORT (per 40 CFR 257.83(b)(2))**

Power Station: Miami Fort Power Station

CCR Impoundment: Basin B

Date of Inspection: 11/17/2016

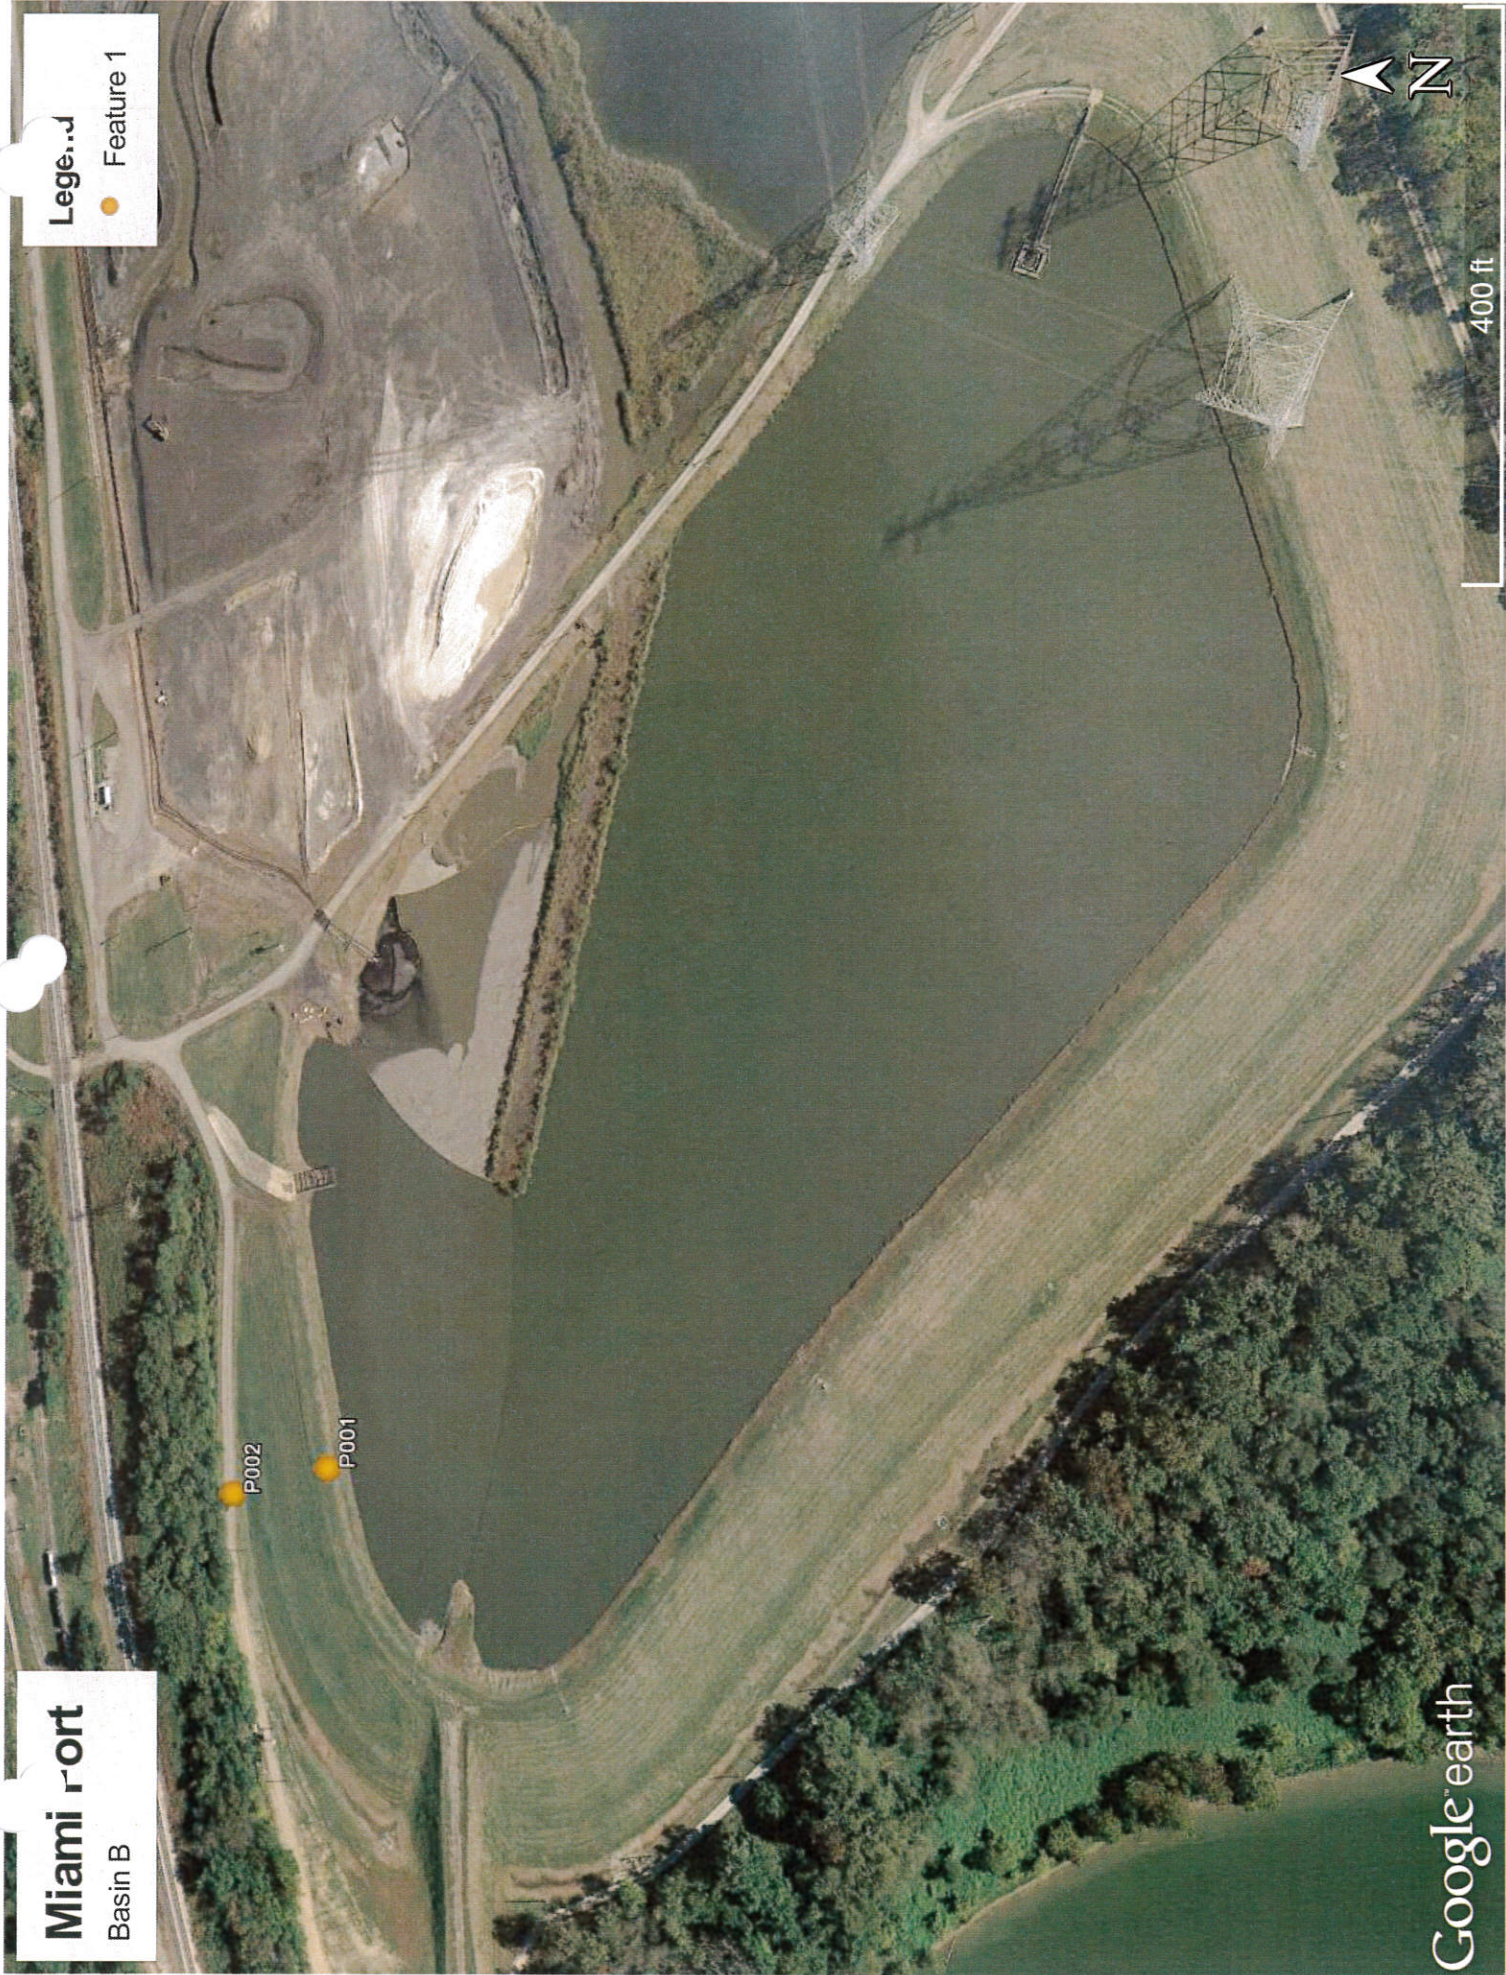
- ii) Instrumentation  
(Please see following page for instrumentation location map)

Instrument ID #	Type	Maximum recorded reading since previous annual inspection (ft)
P001	Piezometer	491.3'
P002	Piezometer	460.1'
