**2021 USEPA CCR RULE PERIODIC
OPERATING RECORD RUN-ON AND RUN-
OFF CONTROL PLAN REVIEW REPORT**

§257.81

**CCR LANDFILL
Miami Fort Power Plant
North Bend, Ohio**

October 11, 2021

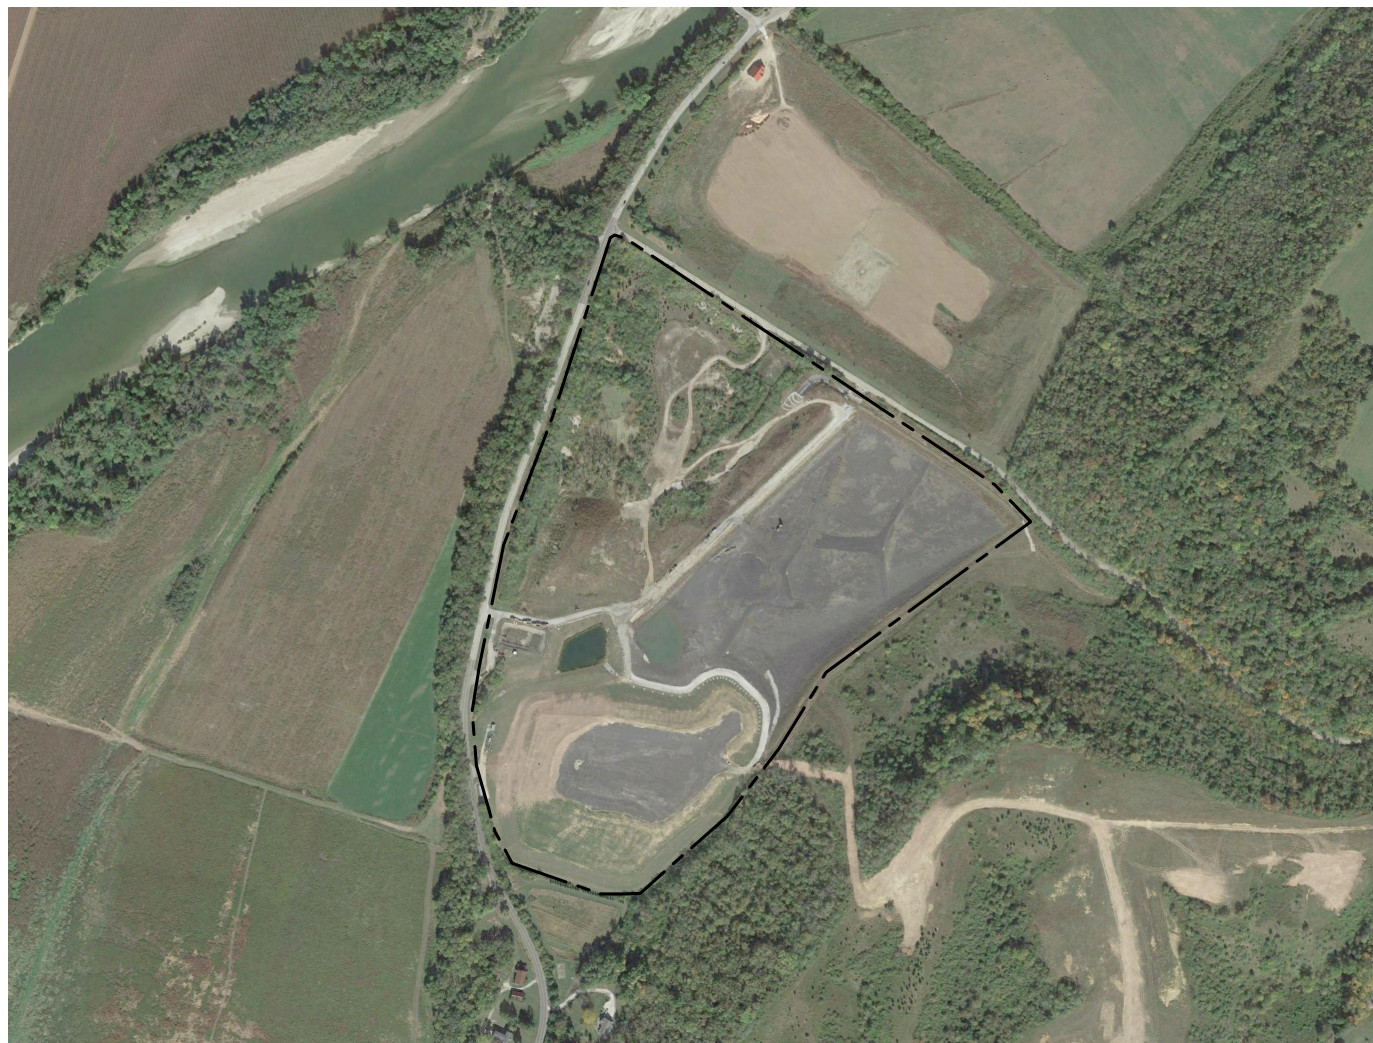
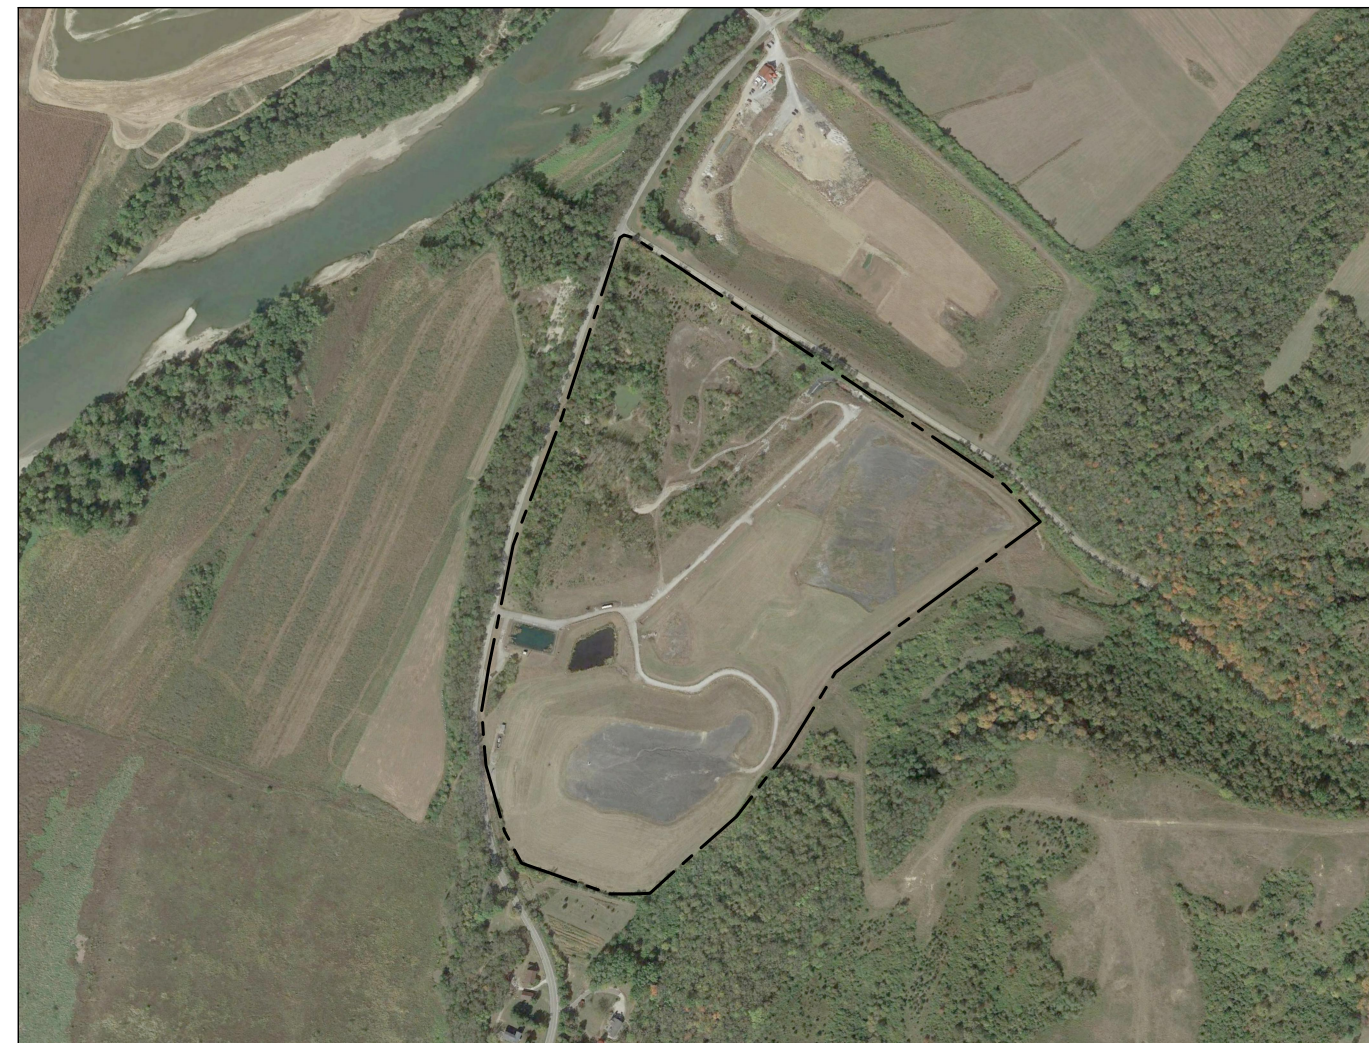
INITIAL TO PERIODIC AERIAL
IMAGERY COMPARISON
CCR LANDFILL
MIAMI FORT POWER PLANT
NORTH BEND, OHIO

Initial aerial photographs of the LF were prepared from Google Earth [3] imagery dated October 2015 and were compared to periodic aerial photographs prepared from Google Earth [3] imagery dated October 2020 to visually evaluate if potential site changes (i.e., changes to the embankment, outlet structures, limits of CCR, other appurtenances) may have occurred. A comparison of these aerial photographs is provided in **Drawing 1**, and the basin appeared to be dry during the 2015 photograph and has since been flooded.

- Between 2015 and 2020, no material changes to the geometry were made to either Area 1, Area 2, or Area 3.
- It appears that approximately half of Area 3 received vegetative cover.

INITIAL AERIAL
10-2015 IMAGERY

PERIODIC AERIAL
10-2020 IMAGERY

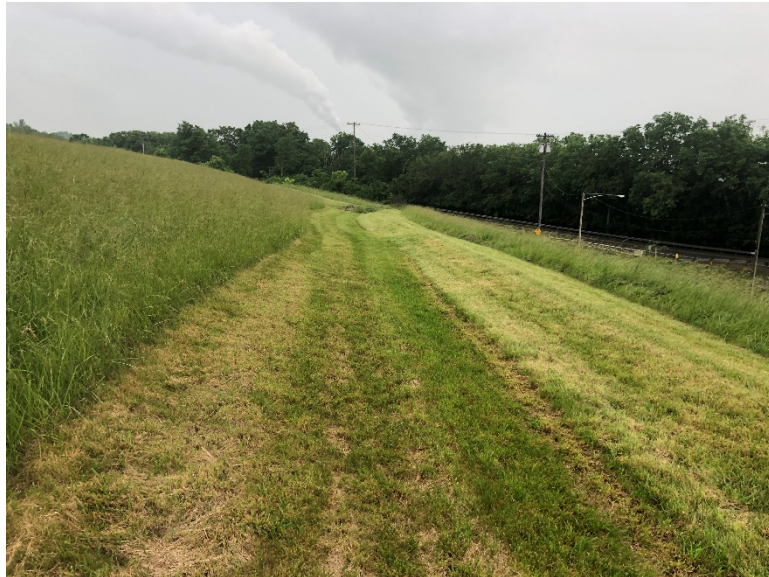
Photo: 01

Comments:
Photo of the diversion ditch along the western side of the landfill. Ditch has good vegetative cover and drains to the south, consistent with runon and runoff plan.

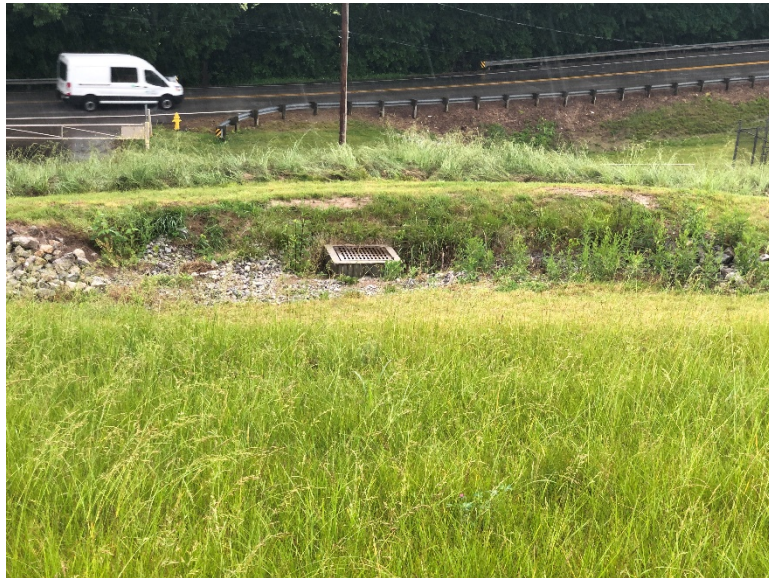
Photo: 02

Comments:
Stormwater collection point on the western slope of the landfill, consistent with the runon and runoff plan (drainage north to south). Geosyntec recommended sedimentation be cleared from rock lined sections as part of regular maintenance.

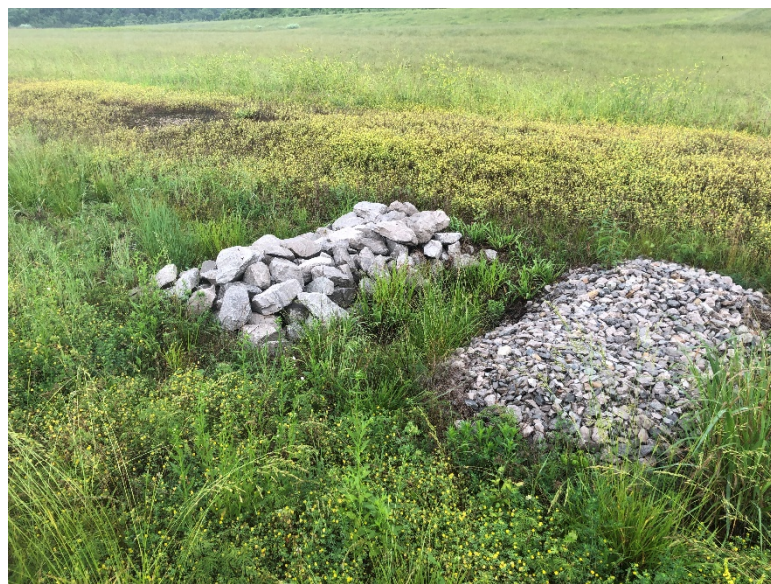
Photo: 04

Comments:
Example of check dams set in the perimeter ditch of the western side of Area 3.

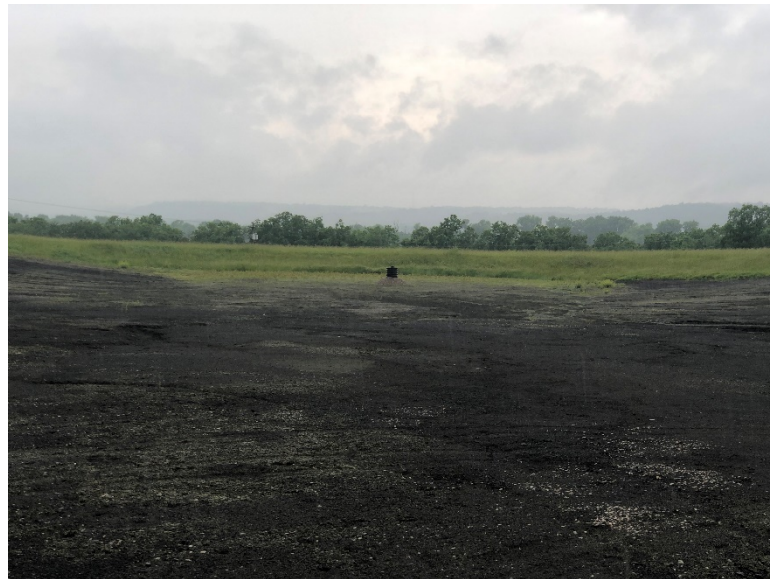
Photo: 06

Comments:
Active landfill area. No signs of erosion or runoff. Water drains to a chimney drain near the center of the open cell.

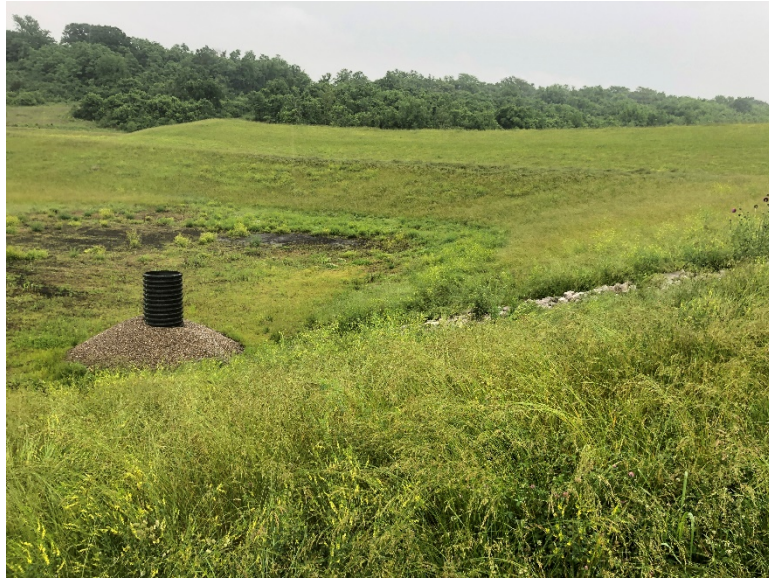
Photo: 05

Comments:
Photo of the low area in Area 3. Stormwater collects in a chimney drain and then drains to the Leachate Treatment Building. Photo also show good vegetative cover along the northern side of the Area 1 permanent cover.

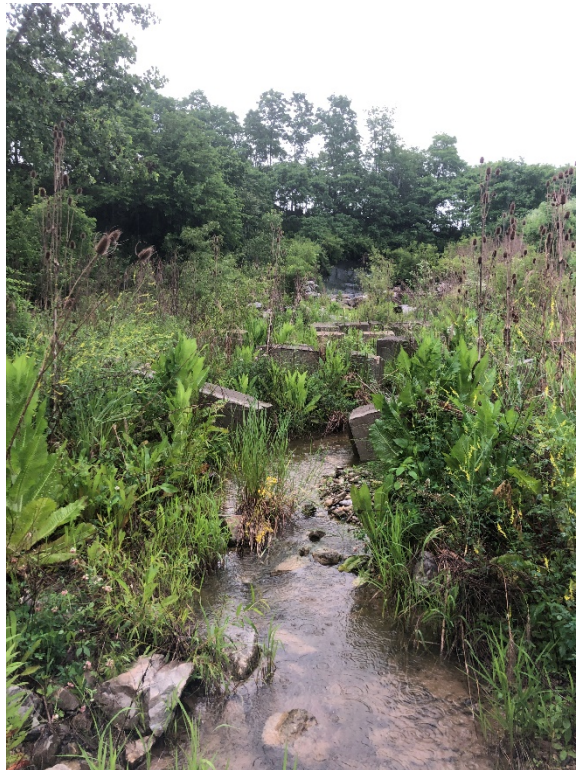
Photo: 06

Comments:
Photo of the mitigated natural stream in Area 2.
