# STRUCTURAL STABILITY ASSESSMENT REPORT

## Big Brown Steam Electric Station

**Submitted To:** Luminant  
1601 Bryan Street  
Dallas, TX 75201

Project No. 164816401

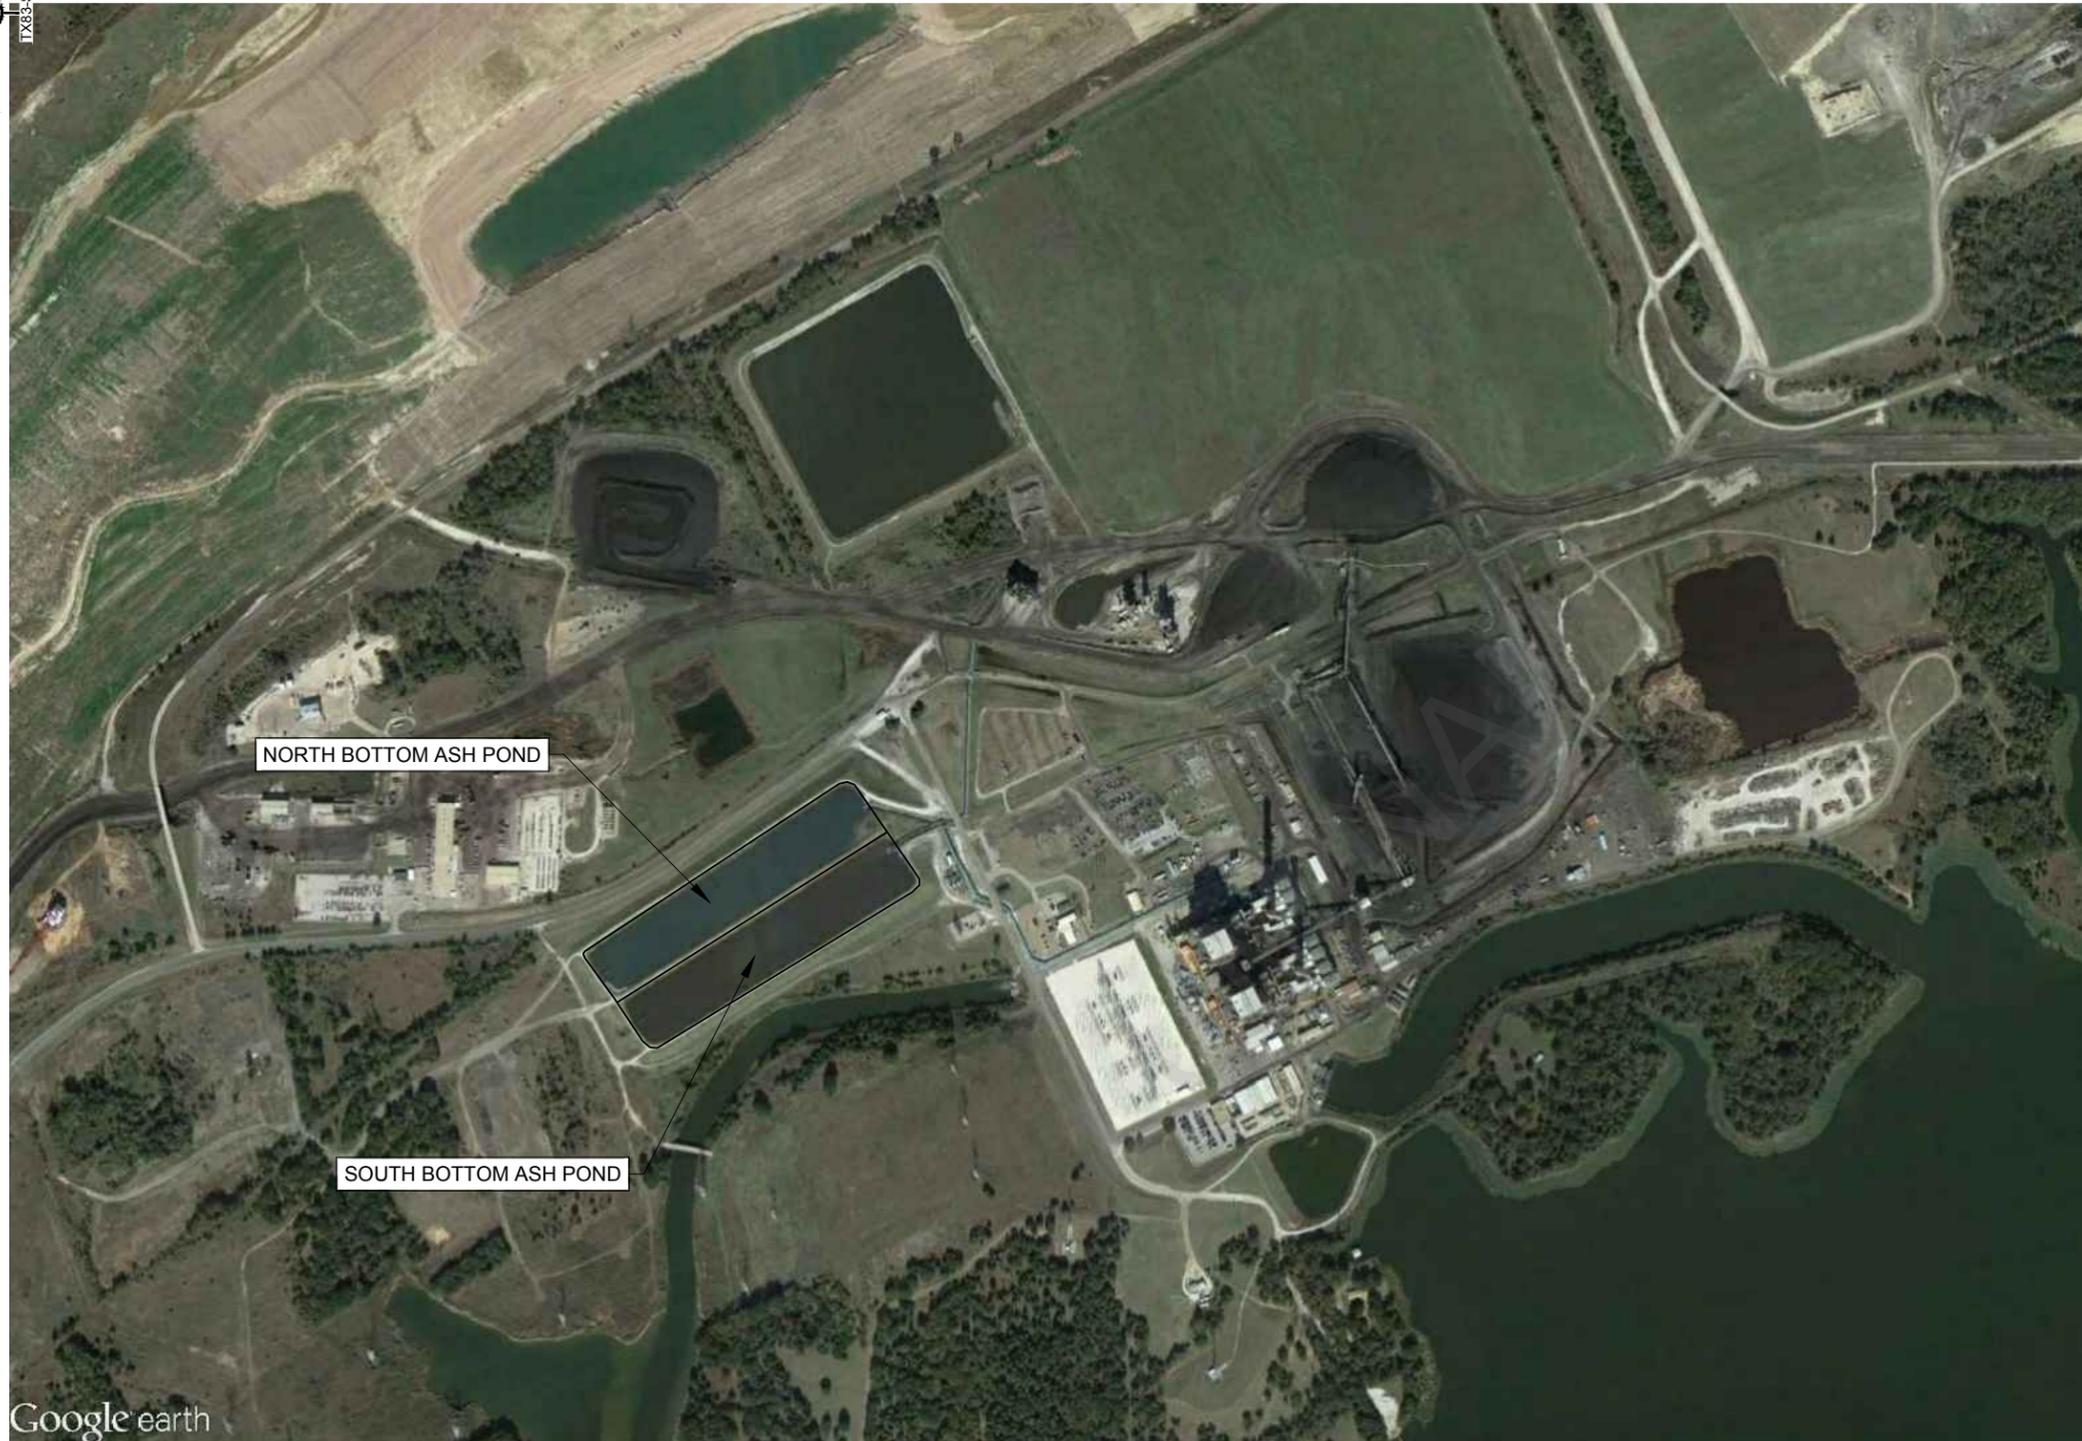
TITLE  
**GENERAL SITE MAP**

The BAP embankment is bordered to the south by a narrow water channel connected to Fairfield Lake (a man-made reservoir) (Figure 1). Based on visual observations, the water channel bank is located approximately 25 feet from the embankment toe and is sloped at approximately 3H:1V (horizontal to vertical). The bank height is estimated to be 20 to 30 feet from the bottom of the channel, based on TWDB, 1999.

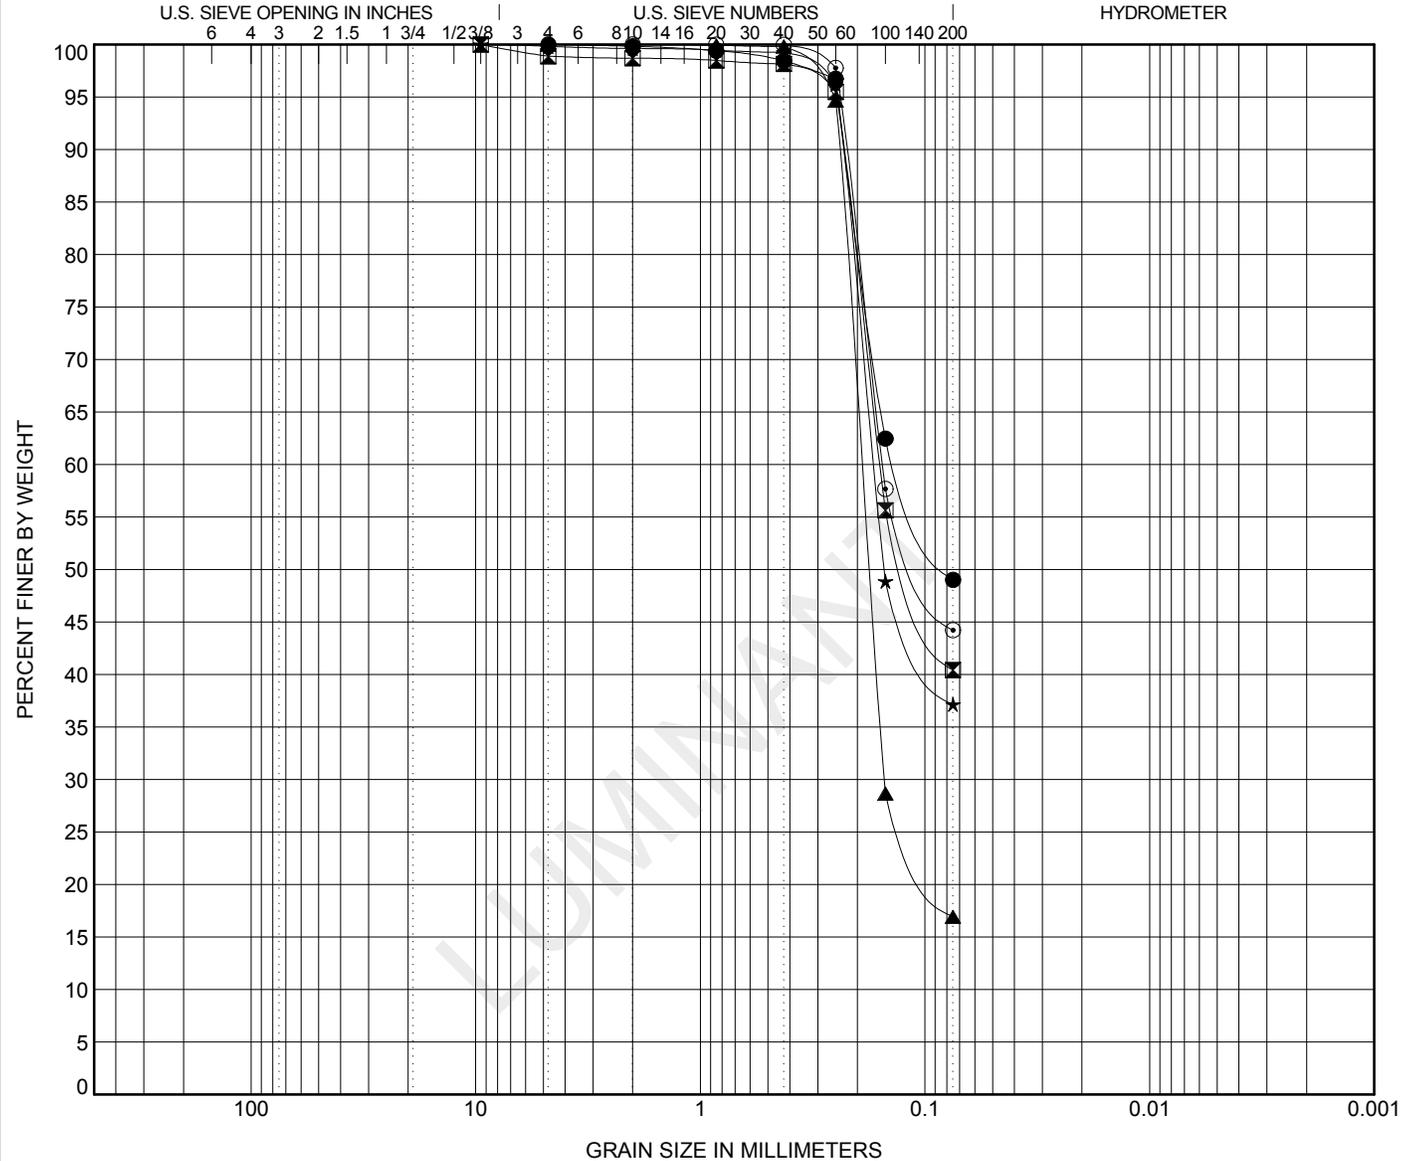
COBBLES	GRAVEL		SAND			SILT OR CLAY
	coarse	fine	coarse	medium	fine

BOREHOLE	DEPTH	Classification					LL	PL	PI	Cc	Cu
● BH-1	6										
☒ BH-2	39										
▲ BH-3	29										
★ BH-4	18										
◎ BH-5	33										
BOREHOLE	DEPTH	D100	D60	D30	D10	%Gravel	%Sand	%Silt	%Clay		
● BH-1	6	4.75	0.132			0.0	51.0		49.0		
☒ BH-2	39	9.5	0.159			1.1	58.5		40.4		
▲ BH-3	29	4.75	0.191	0.152		0.0	83.1		16.9		
★ BH-4	18	9.5	0.169			0.2	62.7		37.2		
◎ BH-5	33	2	0.155			0.0	55.8		44.2

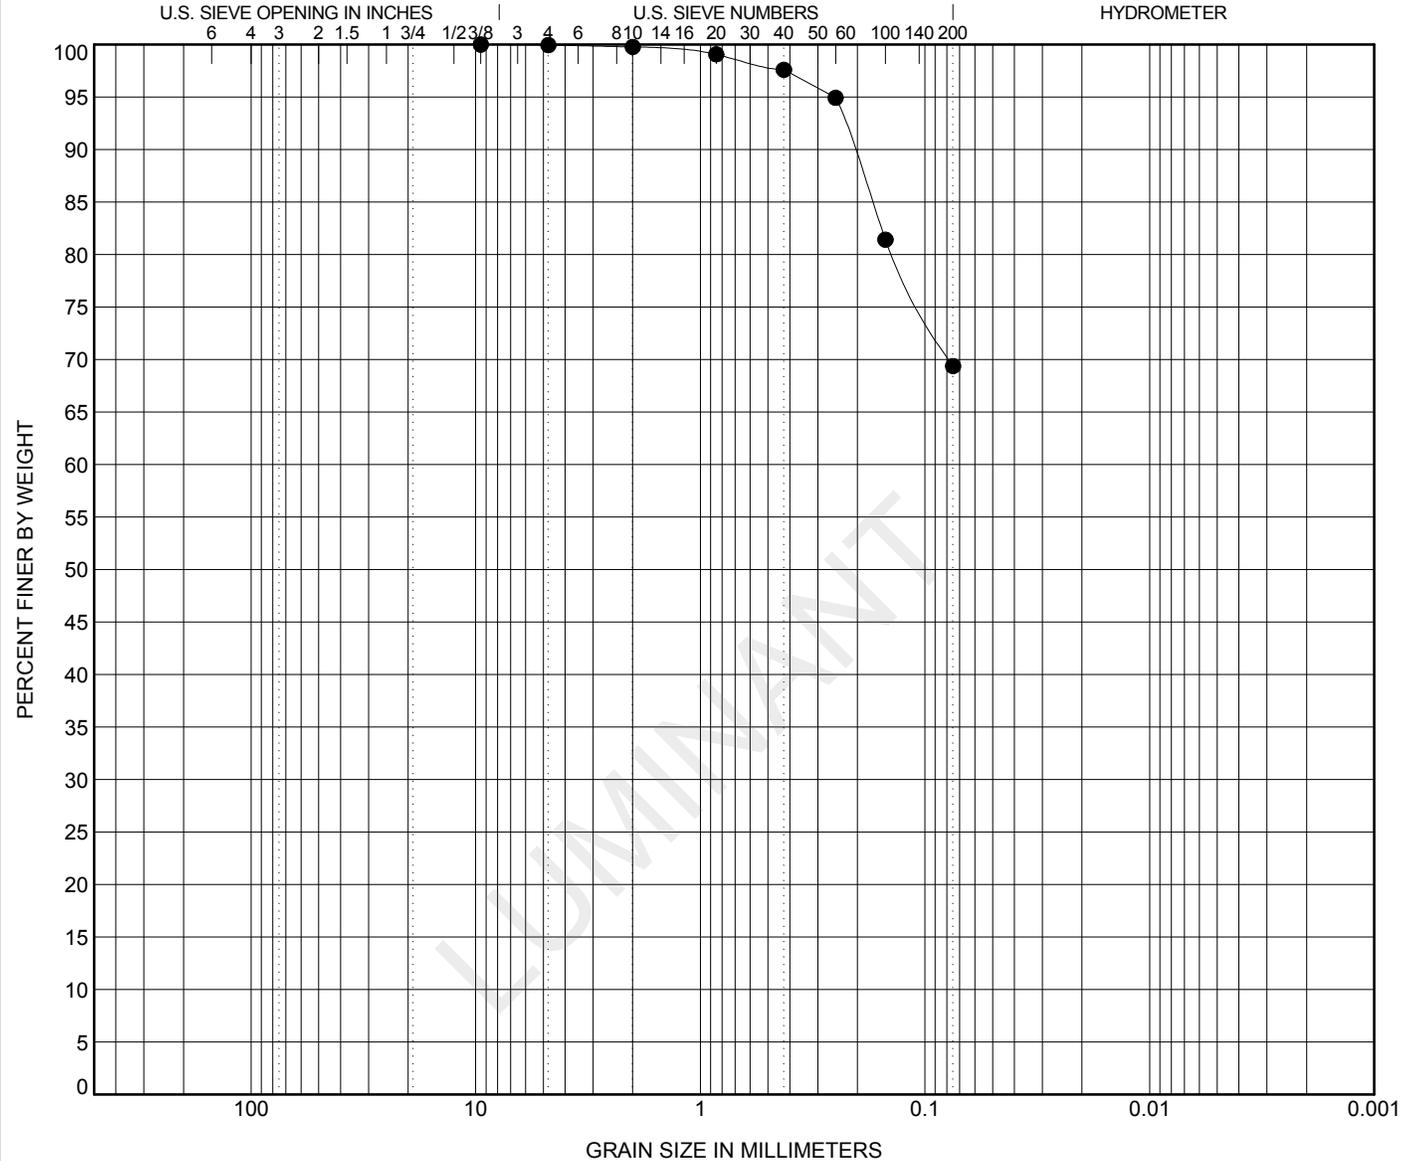
COBBLES	GRAVEL		SAND			SILT OR CLAY
	coarse	fine	coarse	medium	fine

BOREHOLE	DEPTH	Classification					LL	PL	PI	Cc	Cu
● BH-6	38										
BOREHOLE	DEPTH	D100	D60	D30	D10	%Gravel	%Sand	%Silt	%Clay		
● BH-6	38	9.5				0.1	30.6	69.4

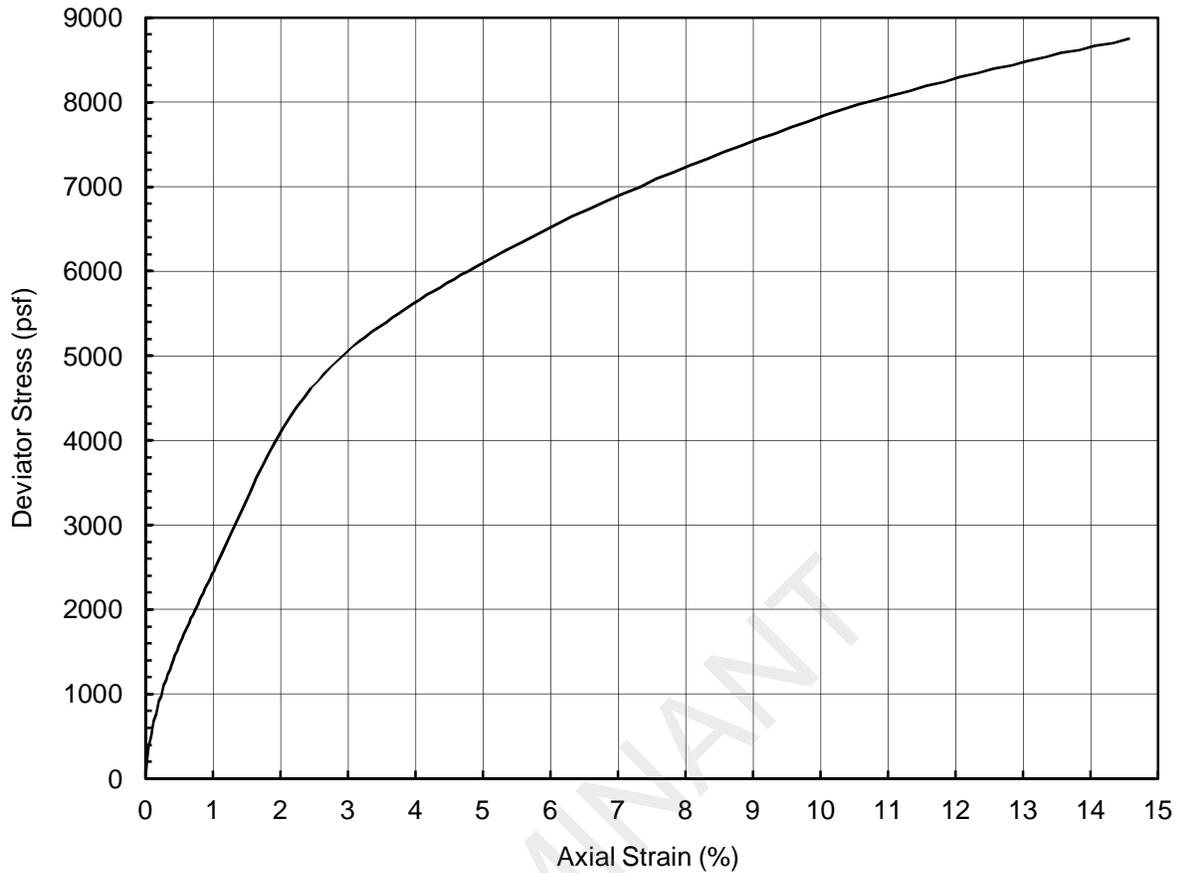
**UNCONSOLIDATED / UNDRAINED COMPRESSIVE STRENGTH  
ASTM D 2850**

Specimen Description		Light Tan and Gray Clayey Sand					
LL	33	PI	20	LI	0.2	USCS	CL

Depth (ft)	28.0	Confining Pressure (psf)	2879
Specimen Height (inch)	5.9	Strain Rate (%/min)	1.0
Specimen Diameter (inch)	2.8	Peak Deviator Stress (psf)	8784
Initial Specimen Weight (g)	1253.7	Axial Strain at Peak Stress (%)	15.0
Moist Unit Weight (pcf)	132.8		
Initial Water Content (%)	17		
Initial Dry Unit Weight (pcf)	113.3

Project Title	Luminant - Big Brown Slope Stability
Project Number	123-94128
Sample Type	Shelby Tube
Sample ID	BH-2 TO-8
Comments

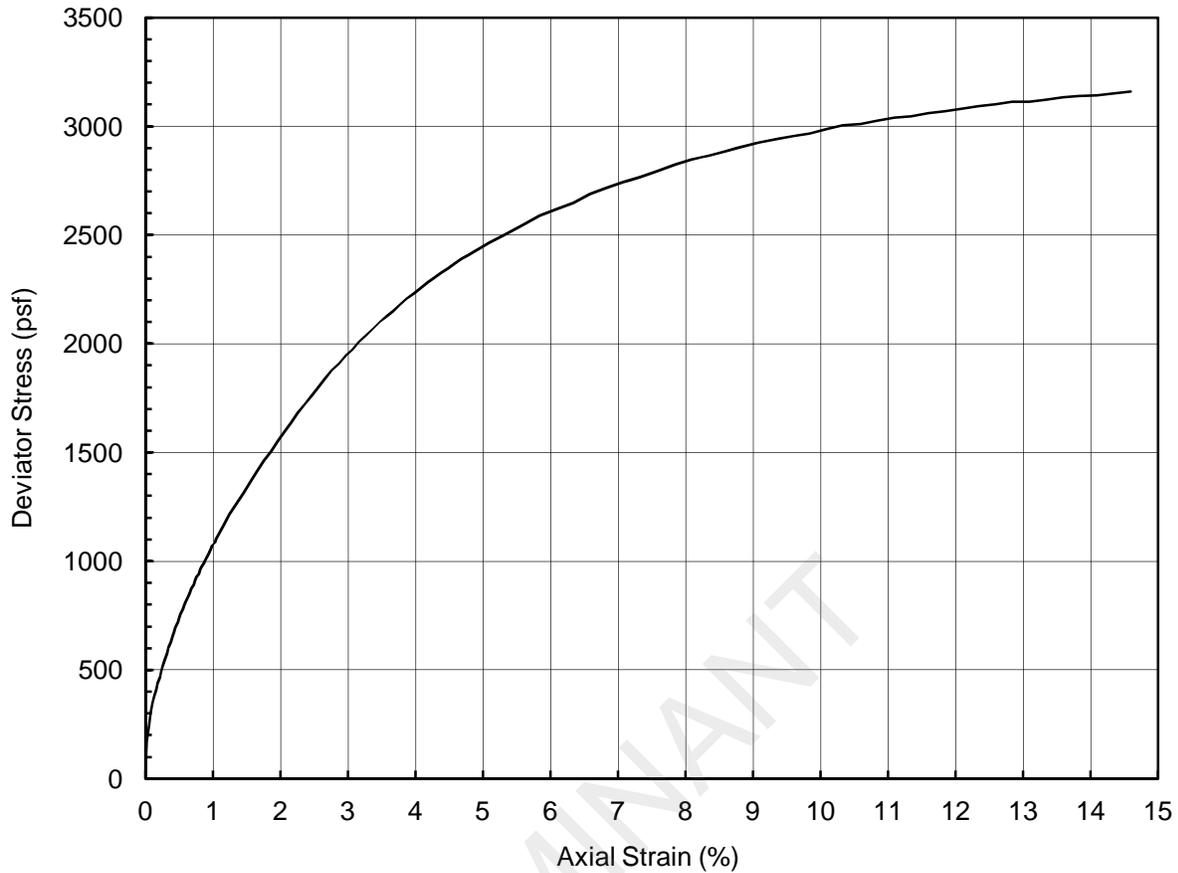
**UNCONSOLIDATED / UNDRAINED COMPRESSIVE STRENGTH  
ASTM D 2850**

Specimen Description		Light Tan and Gray Clayey Sand					
LL	39	PI	23	LI	0.2	USCS	CL

Depth (ft)	13.0	Confining Pressure (psf)	1754
Specimen Height (inch)	4.9	Strain Rate (%/min)	1.0
Specimen Diameter (inch)	2.8	Peak Deviator Stress (psf)	3164
Initial Specimen Weight (g)	950.5	Axial Strain at Peak Stress (%)	14.8
Moist Unit Weight (pcf)	121.4		
Initial Water Content (%)	20		
Initial Dry Unit Weight (pcf)	101.3

Project Title	Luminant - Big Brown Slope Stability
Project Number	123-94128
Sample Type	Shelby Tube
Sample ID	BH-4 TO-5
Comments	Sample L/D ratio < 2

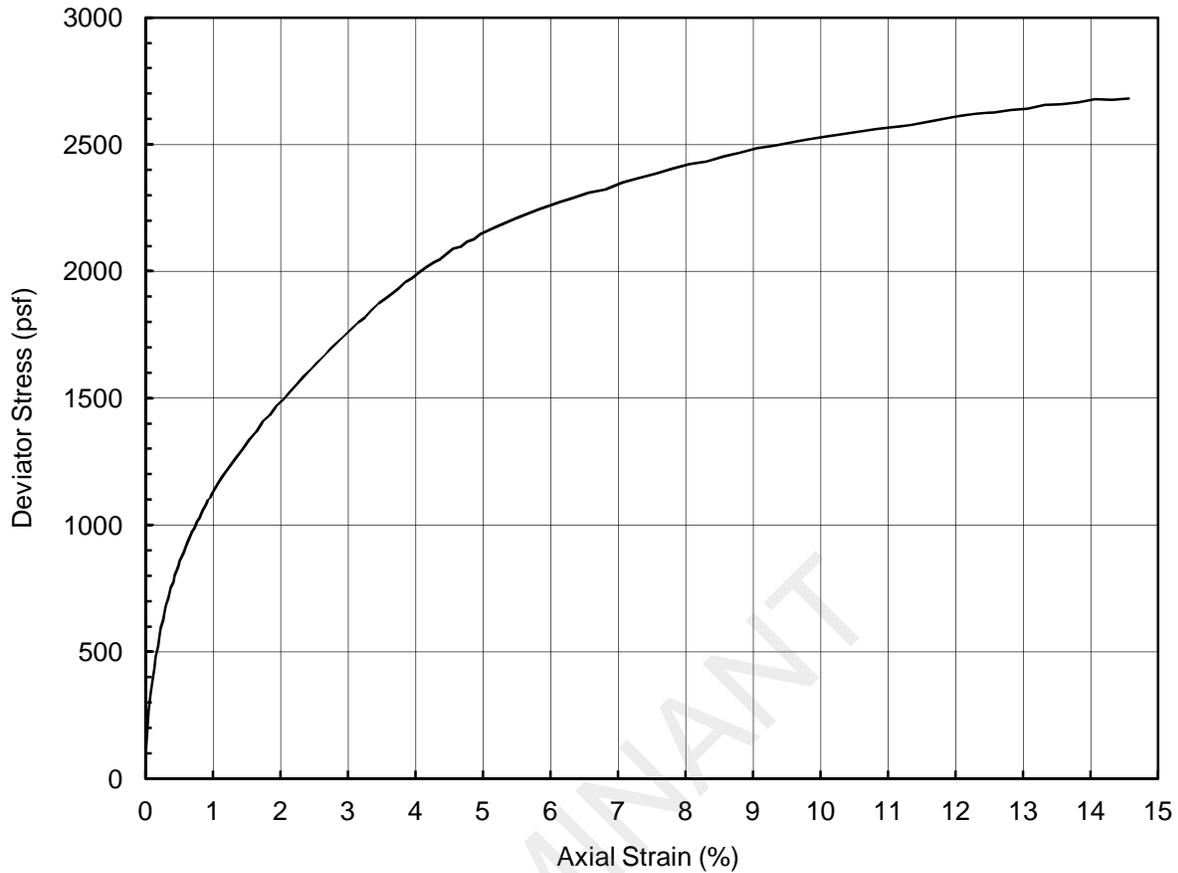
**UNCONSOLIDATED / UNDRAINED COMPRESSIVE STRENGTH  
ASTM D 2850**

Specimen Description		Reddish Gray Clayey Sand					
LL	43	PI	28	LI	0.2	USCS	CL

Depth (ft)	6.0	Confining Pressure (psf)	891
Specimen Height (inch)	4.6	Strain Rate (%/min)	1.0
Specimen Diameter (inch)	2.8	Peak Deviator Stress (psf)	2688
Initial Specimen Weight (g)	926.5	Axial Strain at Peak Stress (%)	14.8
Moist Unit Weight (pcf)	122.1		
Initial Water Content (%)	20		
Initial Dry Unit Weight (pcf)	101.5

Project Title	Luminant - Big Brown Slope Stability
Project Number	123-94128
Sample Type	Shelby Tube
Sample ID	BH-5 TO-3
Comments	Sample L/D ratio < 2

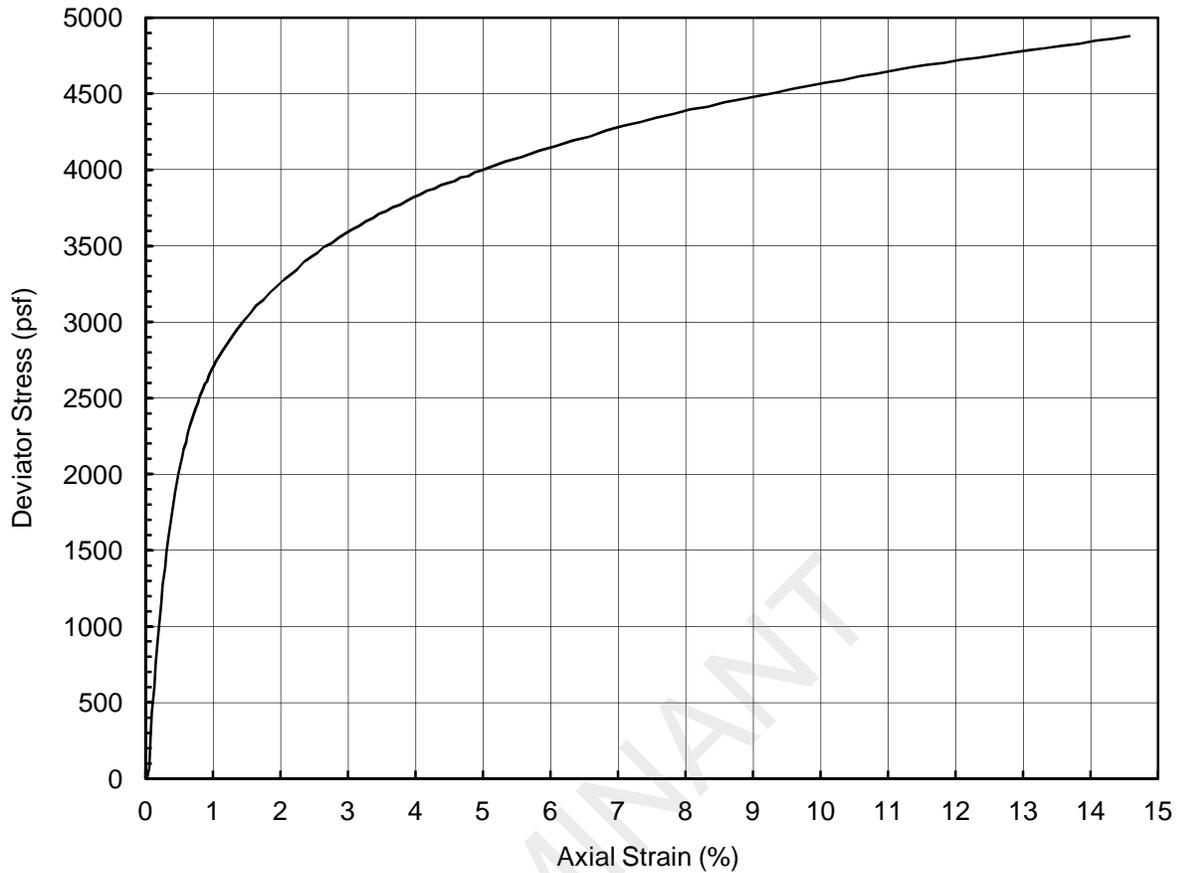
**UNCONSOLIDATED / UNDRAINED COMPRESSIVE STRENGTH  
ASTM D 2850**

Specimen Description		Reddish Gray Clay					
LL	60	PI	46	LI	0.1	USCS	CH

Depth (ft)	23.0	Confining Pressure (psf)	2879
Specimen Height (inch)	6.0	Strain Rate (%/min)	1.0
Specimen Diameter (inch)	2.8	Peak Deviator Stress (psf)	4887
Initial Specimen Weight (g)	1218.0	Axial Strain at Peak Stress (%)	15.0
Moist Unit Weight (pcf)	131.2		
Initial Water Content (%)	20		
Initial Dry Unit Weight (pcf)	109.1

Project Title	Luminant - Big Brown Slope Stability
Project Number	123-94128
Sample Type	Shelby Tube
Sample ID	BH-5 TO-7
Comments

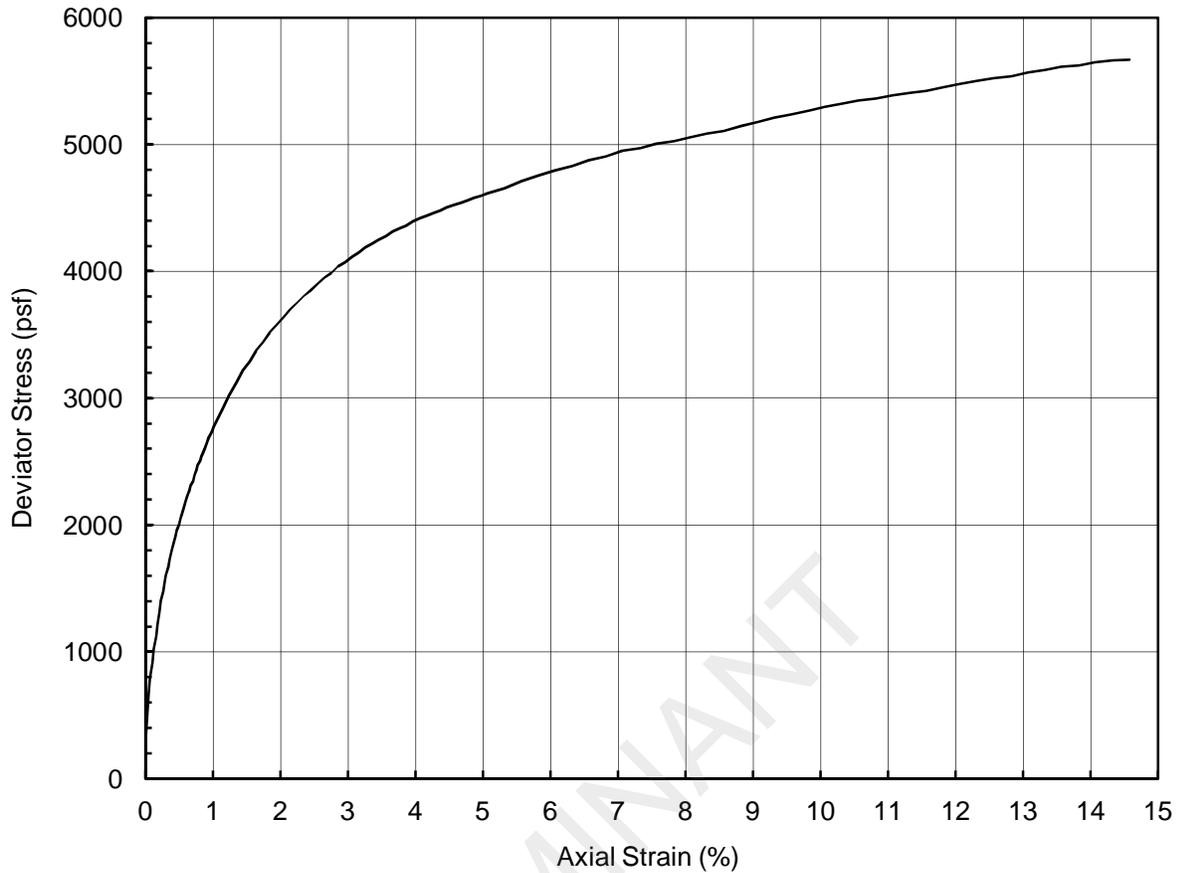
**UNCONSOLIDATED / UNDRAINED COMPRESSIVE STRENGTH  
ASTM D 2850**

Specimen Description		Light Red Sandy Clay					
LL	49	PI	33	LI	0.0	USCS	CL

Depth (ft)	13.0	Confining Pressure (psf)	1752
Specimen Height (inch)	5.7	Strain Rate (%/min)	1.0
Specimen Diameter (inch)	2.8	Peak Deviator Stress (psf)	5685
Initial Specimen Weight (g)	1150.2	Axial Strain at Peak Stress (%)	14.8
Moist Unit Weight (pcf)	125.3		
Initial Water Content (%)	17		
Initial Dry Unit Weight (pcf)	107.5

Project Title	Luminant - Big Brown Slope Stability
Project Number	123-94128
Sample Type	Shelby Tube
Sample ID	BH-6 TO-5
Comments

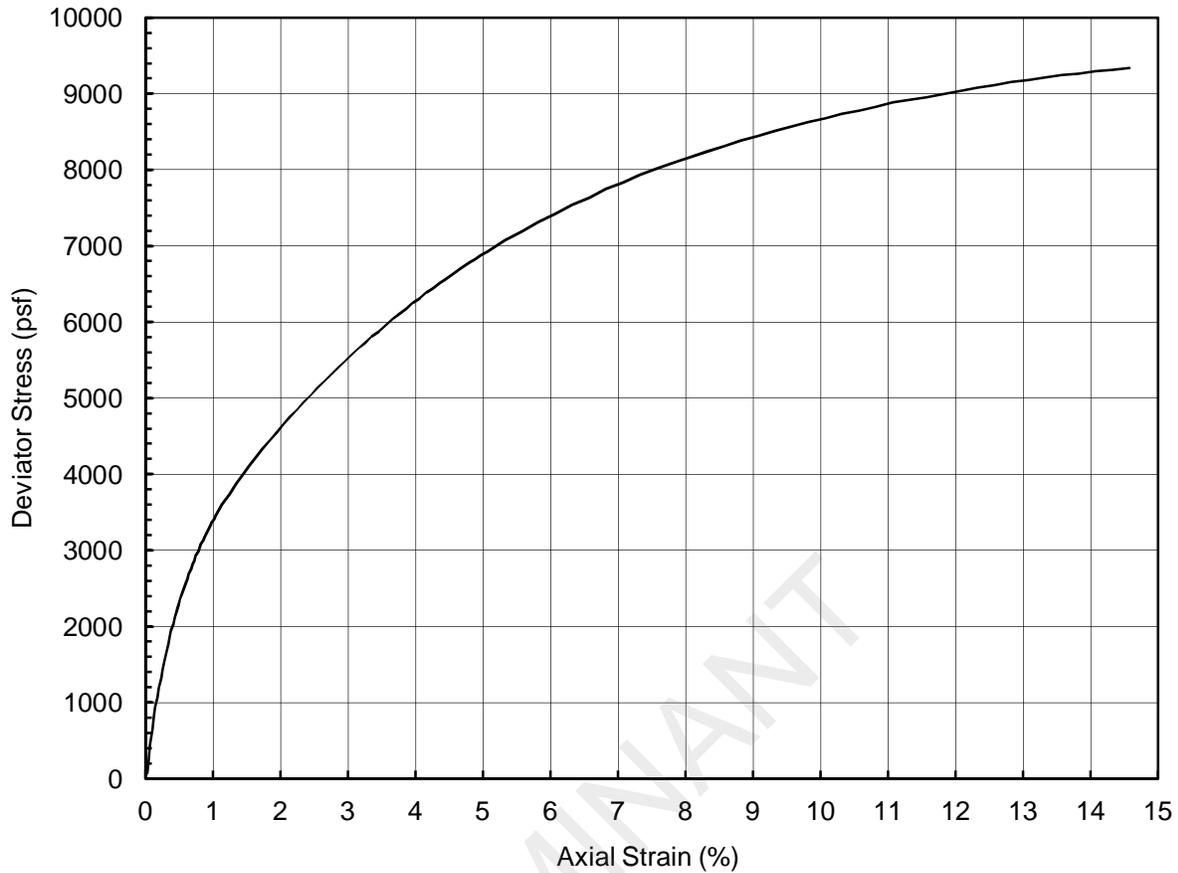
**UNCONSOLIDATED / UNDRAINED COMPRESSIVE STRENGTH  
ASTM D 2850**

Specimen Description		Light Gray Sandy Clay					
LL	44	PI	30	LI	0.1	USCS	CL

Depth (ft)	33.0	Confining Pressure (psf)	3304
Specimen Height (inch)	6.0	Strain Rate (%/min)	1.0
Specimen Diameter (inch)	2.9	Peak Deviator Stress (psf)	9360
Initial Specimen Weight (g)	1270.9	Axial Strain at Peak Stress (%)	15.0
Moist Unit Weight (pcf)	127.4		
Initial Water Content (%)	18		
Initial Dry Unit Weight (pcf)	107.9

Project Title	Luminant - Big Brown Slope Stability	
Project Number	123-94128	
Sample Type	Shelby Tube	
Sample ID	BH-6	TO-9
Comments

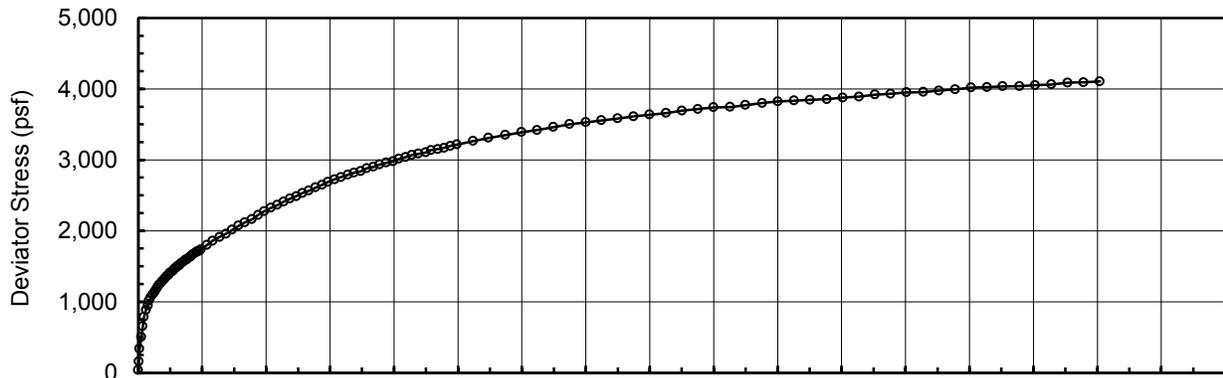
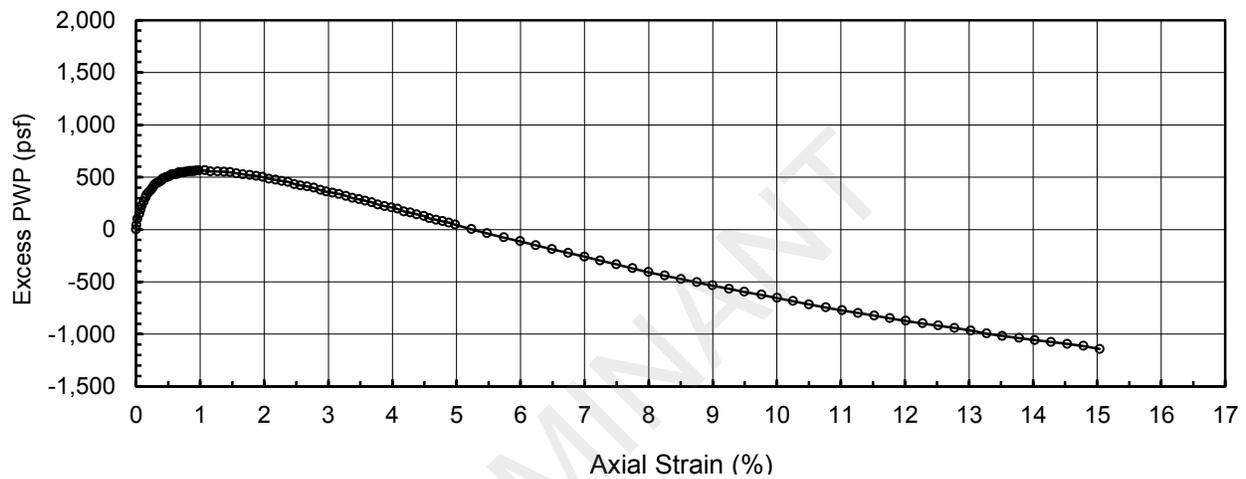
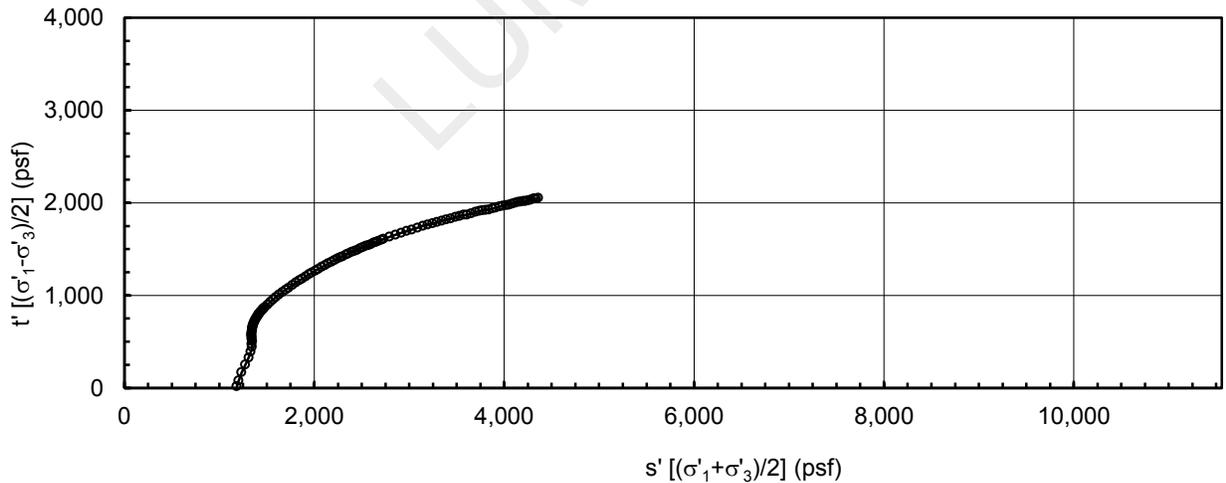
Specimen Description: Dark Gray Sandy CLAY

Initial Specimen Diameter (inch) =	2.84	Initial Specimen Height (inch) =	5.95
Initial Water Content (%) =	15.4	Water Content at End of Test (%) =	18.4
Initial Moist Unit Weight (pcf) =	127.6	B-value =	0.98
Back Pressure (BP, psf) =	4320.0	Consolidation Stress ( $\sigma'_3$ , psf) =	1165.6
Initial Lateral Stress ( $\sigma'_3$ , psf) =	1165.6	Consolidation $t_{50}$ (min) =	10
Initial Deviator Stress ( $\sigma_1 - \sigma_3$ , psf) =	36.4	Rebound Stress ( $\sigma'_3$ , psf) =	NA
Test Strain Rate (%/hour) =	1.0	Rebound $t_{50}$ (min) =	NA
LL =	33	PI =	20
USCS	CL	Performed by	SBK
Comments:		Reviewed by	PCM

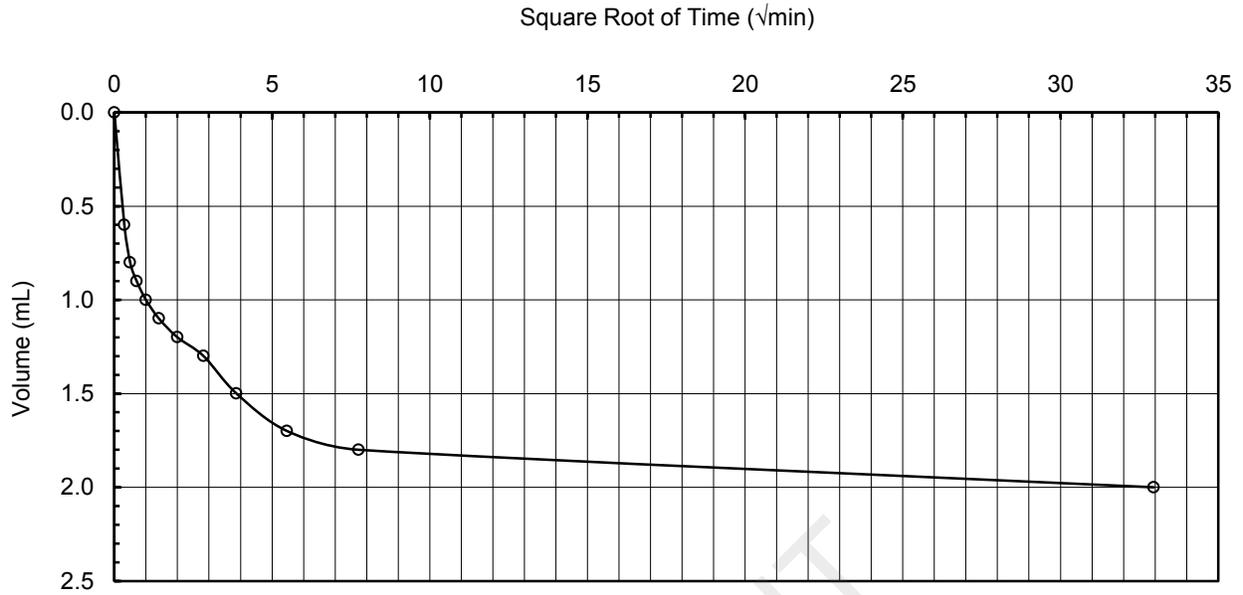
Consolidation Stress ( $\sigma'_3$ , psf) =		1165.6	
Consolidation $t_{50}$ (min) =		10	
Consolidation Volume Change (mL) =		2.0	
Unloading Stress (psf) =		NA	
Unloading $t_{50}$ (min) =		NA	
Unloading Volume Change (mL) =		NA	
LL =	33	PI =	20
USCS	CL		
Gs =	2.65	assumed

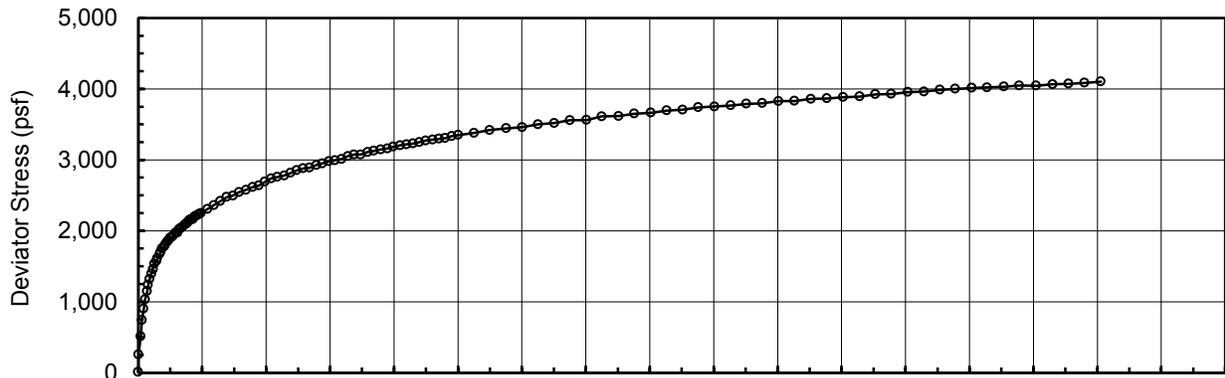
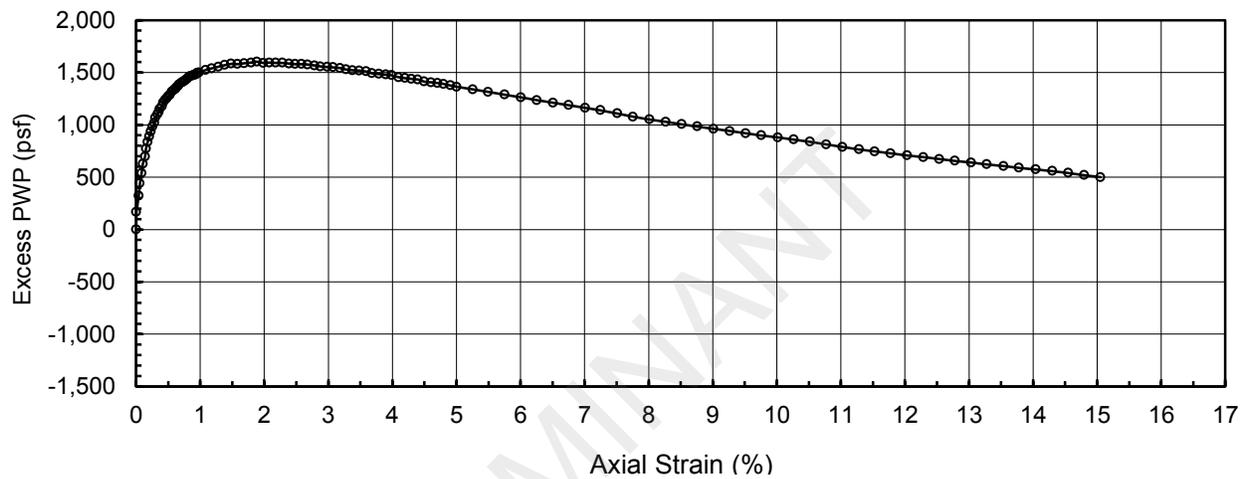
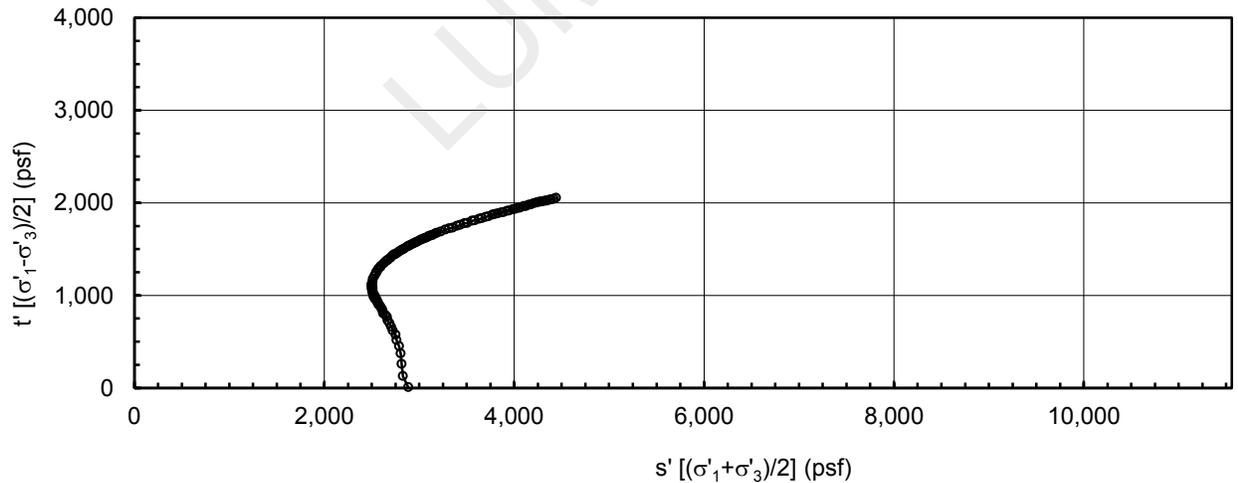
Specimen Description: Dark Gray Sandy CLAY

Initial Specimen Diameter (inch) =	2.83	Initial Specimen Height (inch) =	5.95
Initial Water Content (%) =	16.9	Water Content at End of Test (%) =	18.0
Initial Moist Unit Weight (pcf) =	128.7	B-value =	0.99
Back Pressure (BP, psf) =	3600.0	Consolidation Stress ( $\sigma'_3$ , psf) =	2879.8
Initial Lateral Stress ( $\sigma'_3$ , psf) =	2879.8	Consolidation $t_{50}$ (min) =	3
Initial Deviator Stress ( $\sigma_1 - \sigma_3$ , psf) =	11.4	Rebound Stress ( $\sigma'_3$ , psf) =	NA
Test Strain Rate (%/hour) =	1.0	Rebound $t_{50}$ (min) =	NA
LL =	33	PI =	20
USCS	CL	Performed by	SBK
Comments:		Reviewed by	PCM

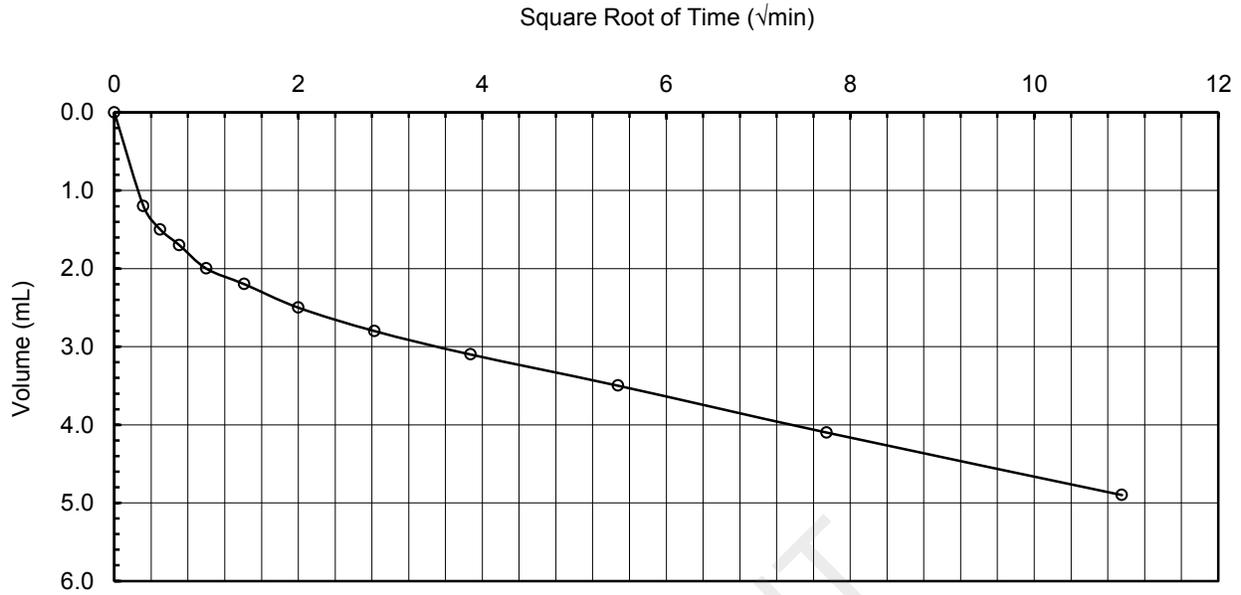
Consolidation Stress ( $\sigma'_3$ , psf) =		2879.8	
Consolidation $t_{50}$ (min) =		3	
Consolidation Volume Change (mL) =		4.9	
Unloading Stress (psf) =		NA	
Unloading $t_{50}$ (min) =		NA	
Unloading Volume Change (mL) =		NA	
LL =	33	PI =	20
USCS	CL		
Gs =	2.65	assumed

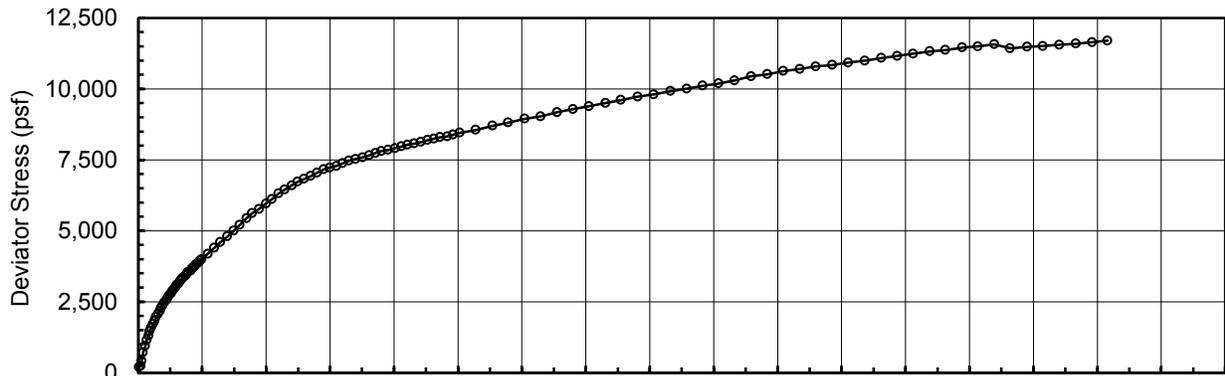
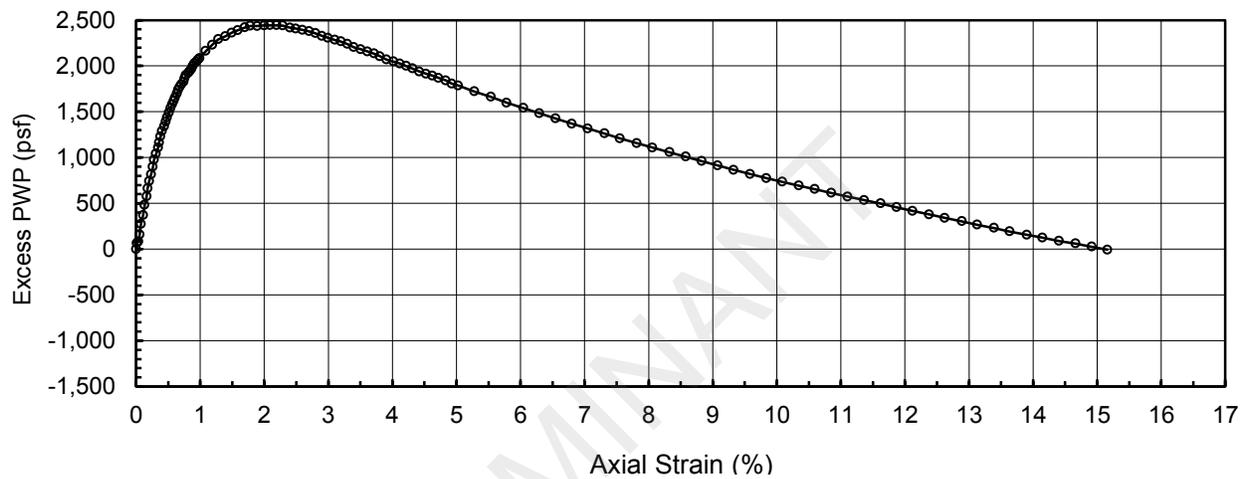
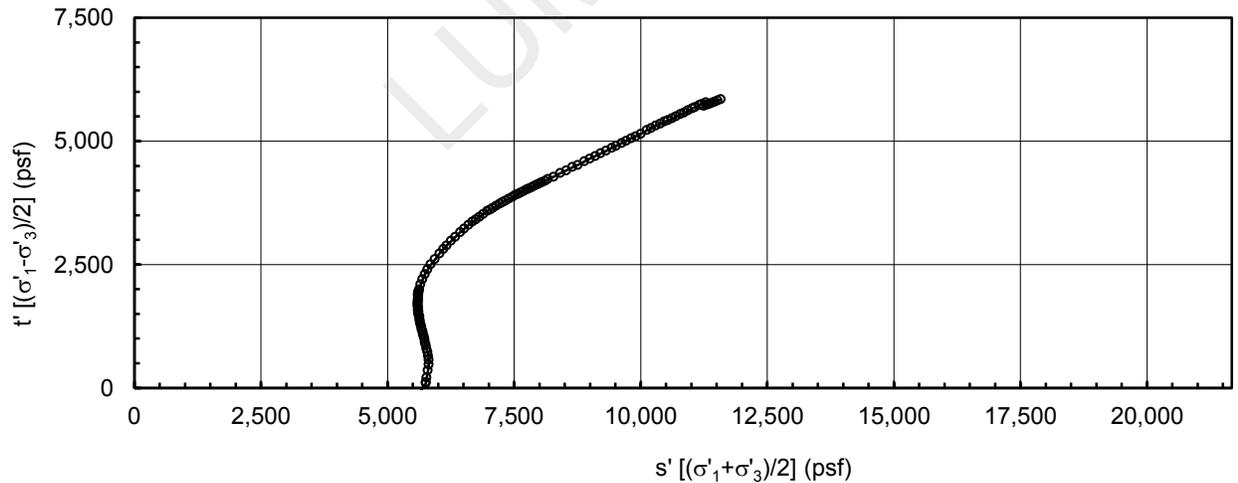
Specimen Description: Light Gray Sandy CLAY (visual classification)

Initial Specimen Diameter (inch) =	2.83	Initial Specimen Height (inch) =	5.89
Initial Water Content (%) =	16.1	Water Content at End of Test (%) =	17.9
Initial Moist Unit Weight (pcf) =	127.4	B-value =	0.97
Back Pressure (BP, psf) =	5040.0	Consolidation Stress ( $\sigma'_3$ , psf) =	5717.7
Initial Lateral Stress ( $\sigma'_3$ , psf) =	5717.7	Consolidation $t_{50}$ (min) =	11
Initial Deviator Stress ( $\sigma_1 - \sigma_3$ , psf) =	-164.7	Rebound Stress ( $\sigma'_3$ , psf) =	NA
Test Strain Rate (%/hour) =	1.0	Rebound $t_{50}$ (min) =	NA
LL =		PI =	
		USCS	(CL)
Comments:			Performed by
			Reviewed by
			SBK
			PCM

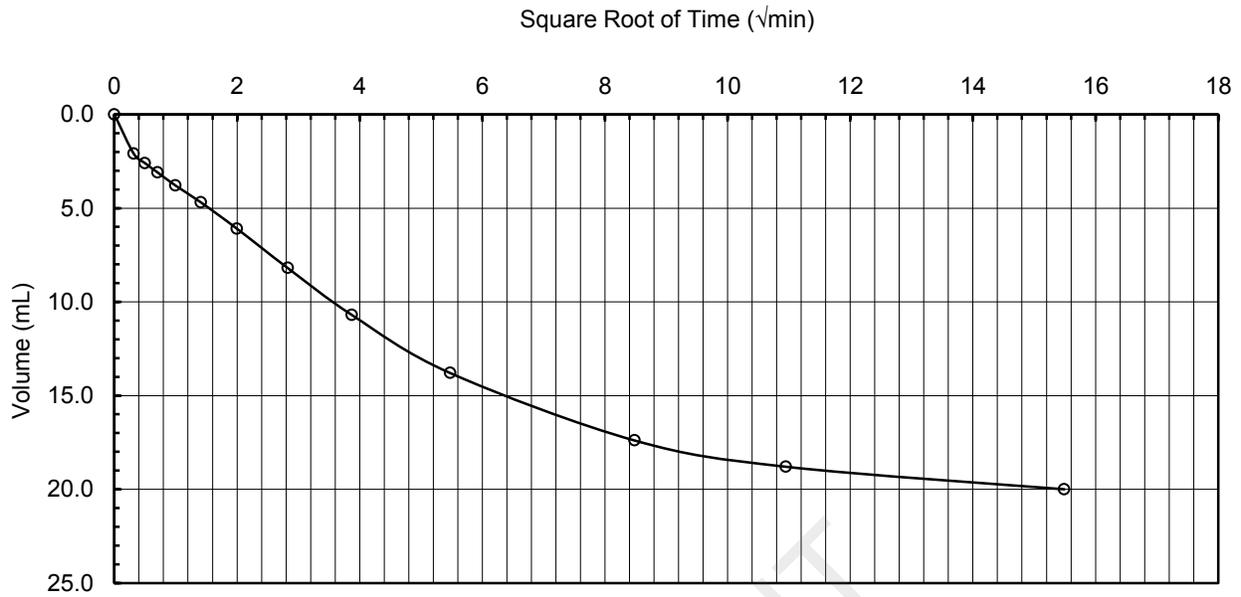
Consolidation Stress ( $\sigma'_3$ , psf) =		5717.7	
Consolidation $t_{50}$ (min) =		11	
Consolidation Volume Change (mL) =		20.0	
Unloading Stress (psf) =		NA	
Unloading $t_{50}$ (min) =		NA	
Unloading Volume Change (mL) =		NA	
LL =		PI =	
USCS	(CL)		
Gs =	2.65	assumed
