Groundwater Monitoring System Certification Addendum No. 1

*Sandow Steam Electric Station - AX Landfill
Rockdale, Texas*

November 2022

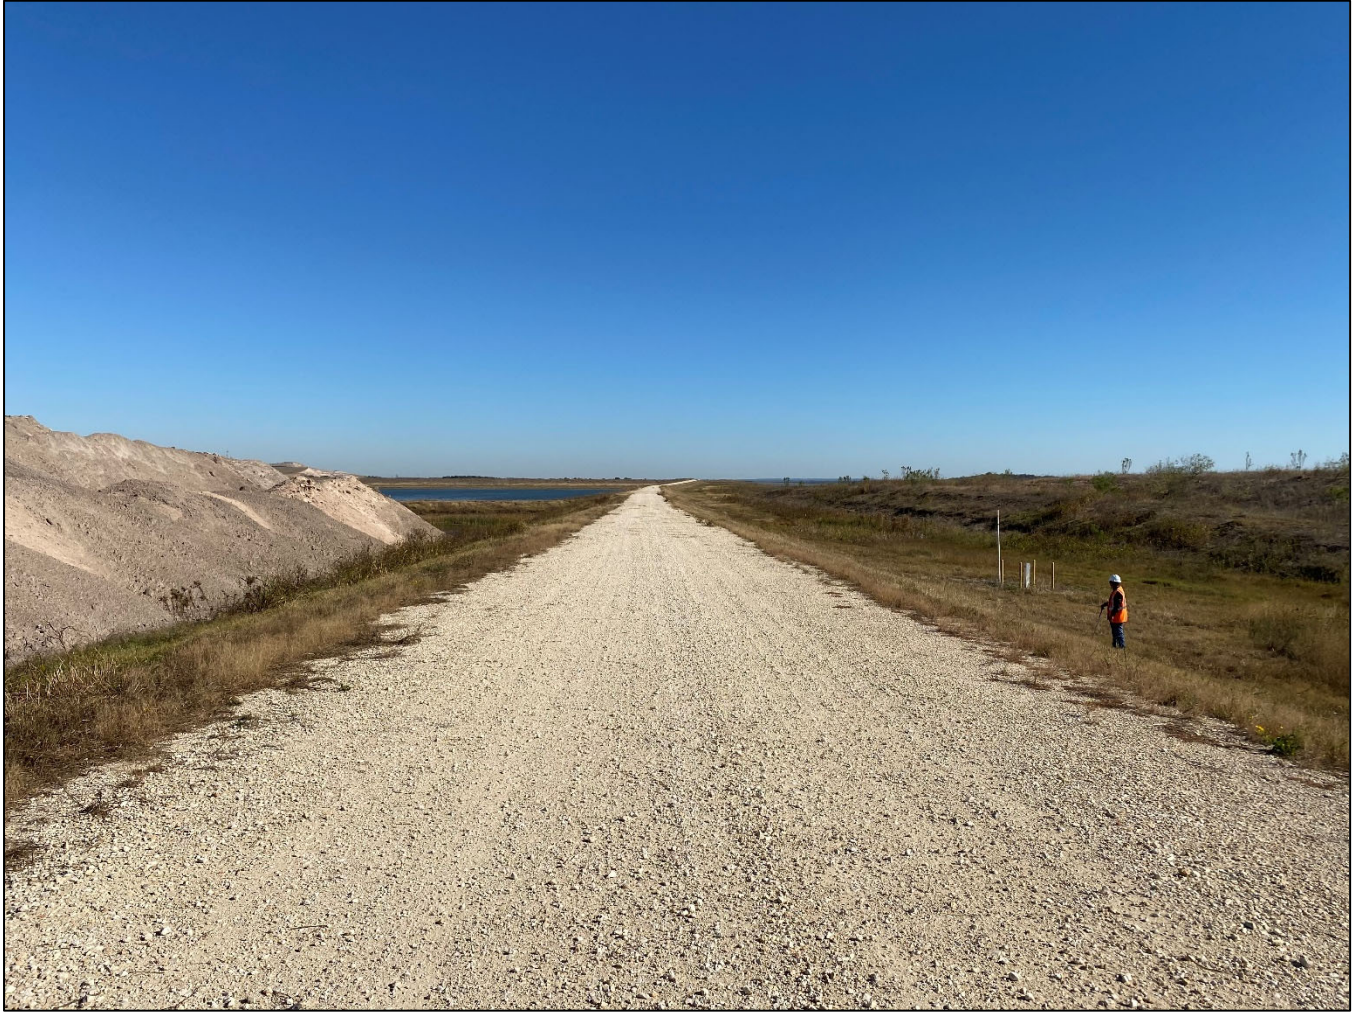
Photograph of CCR Well AX-27

DESCRIPTION	Photograph 1 – CCR Well AX-27 (right side of photo) shown outside the bermed AX LF waste boundary.	
SITE NAME	Sadow AX Landfill	DATE 2020

CCR well location maps included herein and provided in previous CCR reports could be mistakenly interpreted to indicate that CCR well AX-27 is located within the waste cell boundary of the AX LF. A photograph of well AX-27 is provided in Appendix A that shows AX-27(right side of photo) located outside the above-grade berm that marks the boundary of the AX LF waste cells. Although AX-27 may be located within the deed recorded boundary for the AX LF, it is outside the AX LF waste cell boundary; therefore, its position complies with the monitoring well location requirements of 40 C.F.R. § 257.91(a)(2).
