ANNUAL CCR UNIT INSPECTION REPORT

**LUMINANT – MARTIN LAKE STEAM ELECTRIC STATION
ASH POND AREA, PERMANENT DISPOSAL POND NO. 5 & A1 AREA LANDFILL
RUSK & PANOLA COUNTY, TEXAS**

January 18, 2016

PBW Project No. 5178B

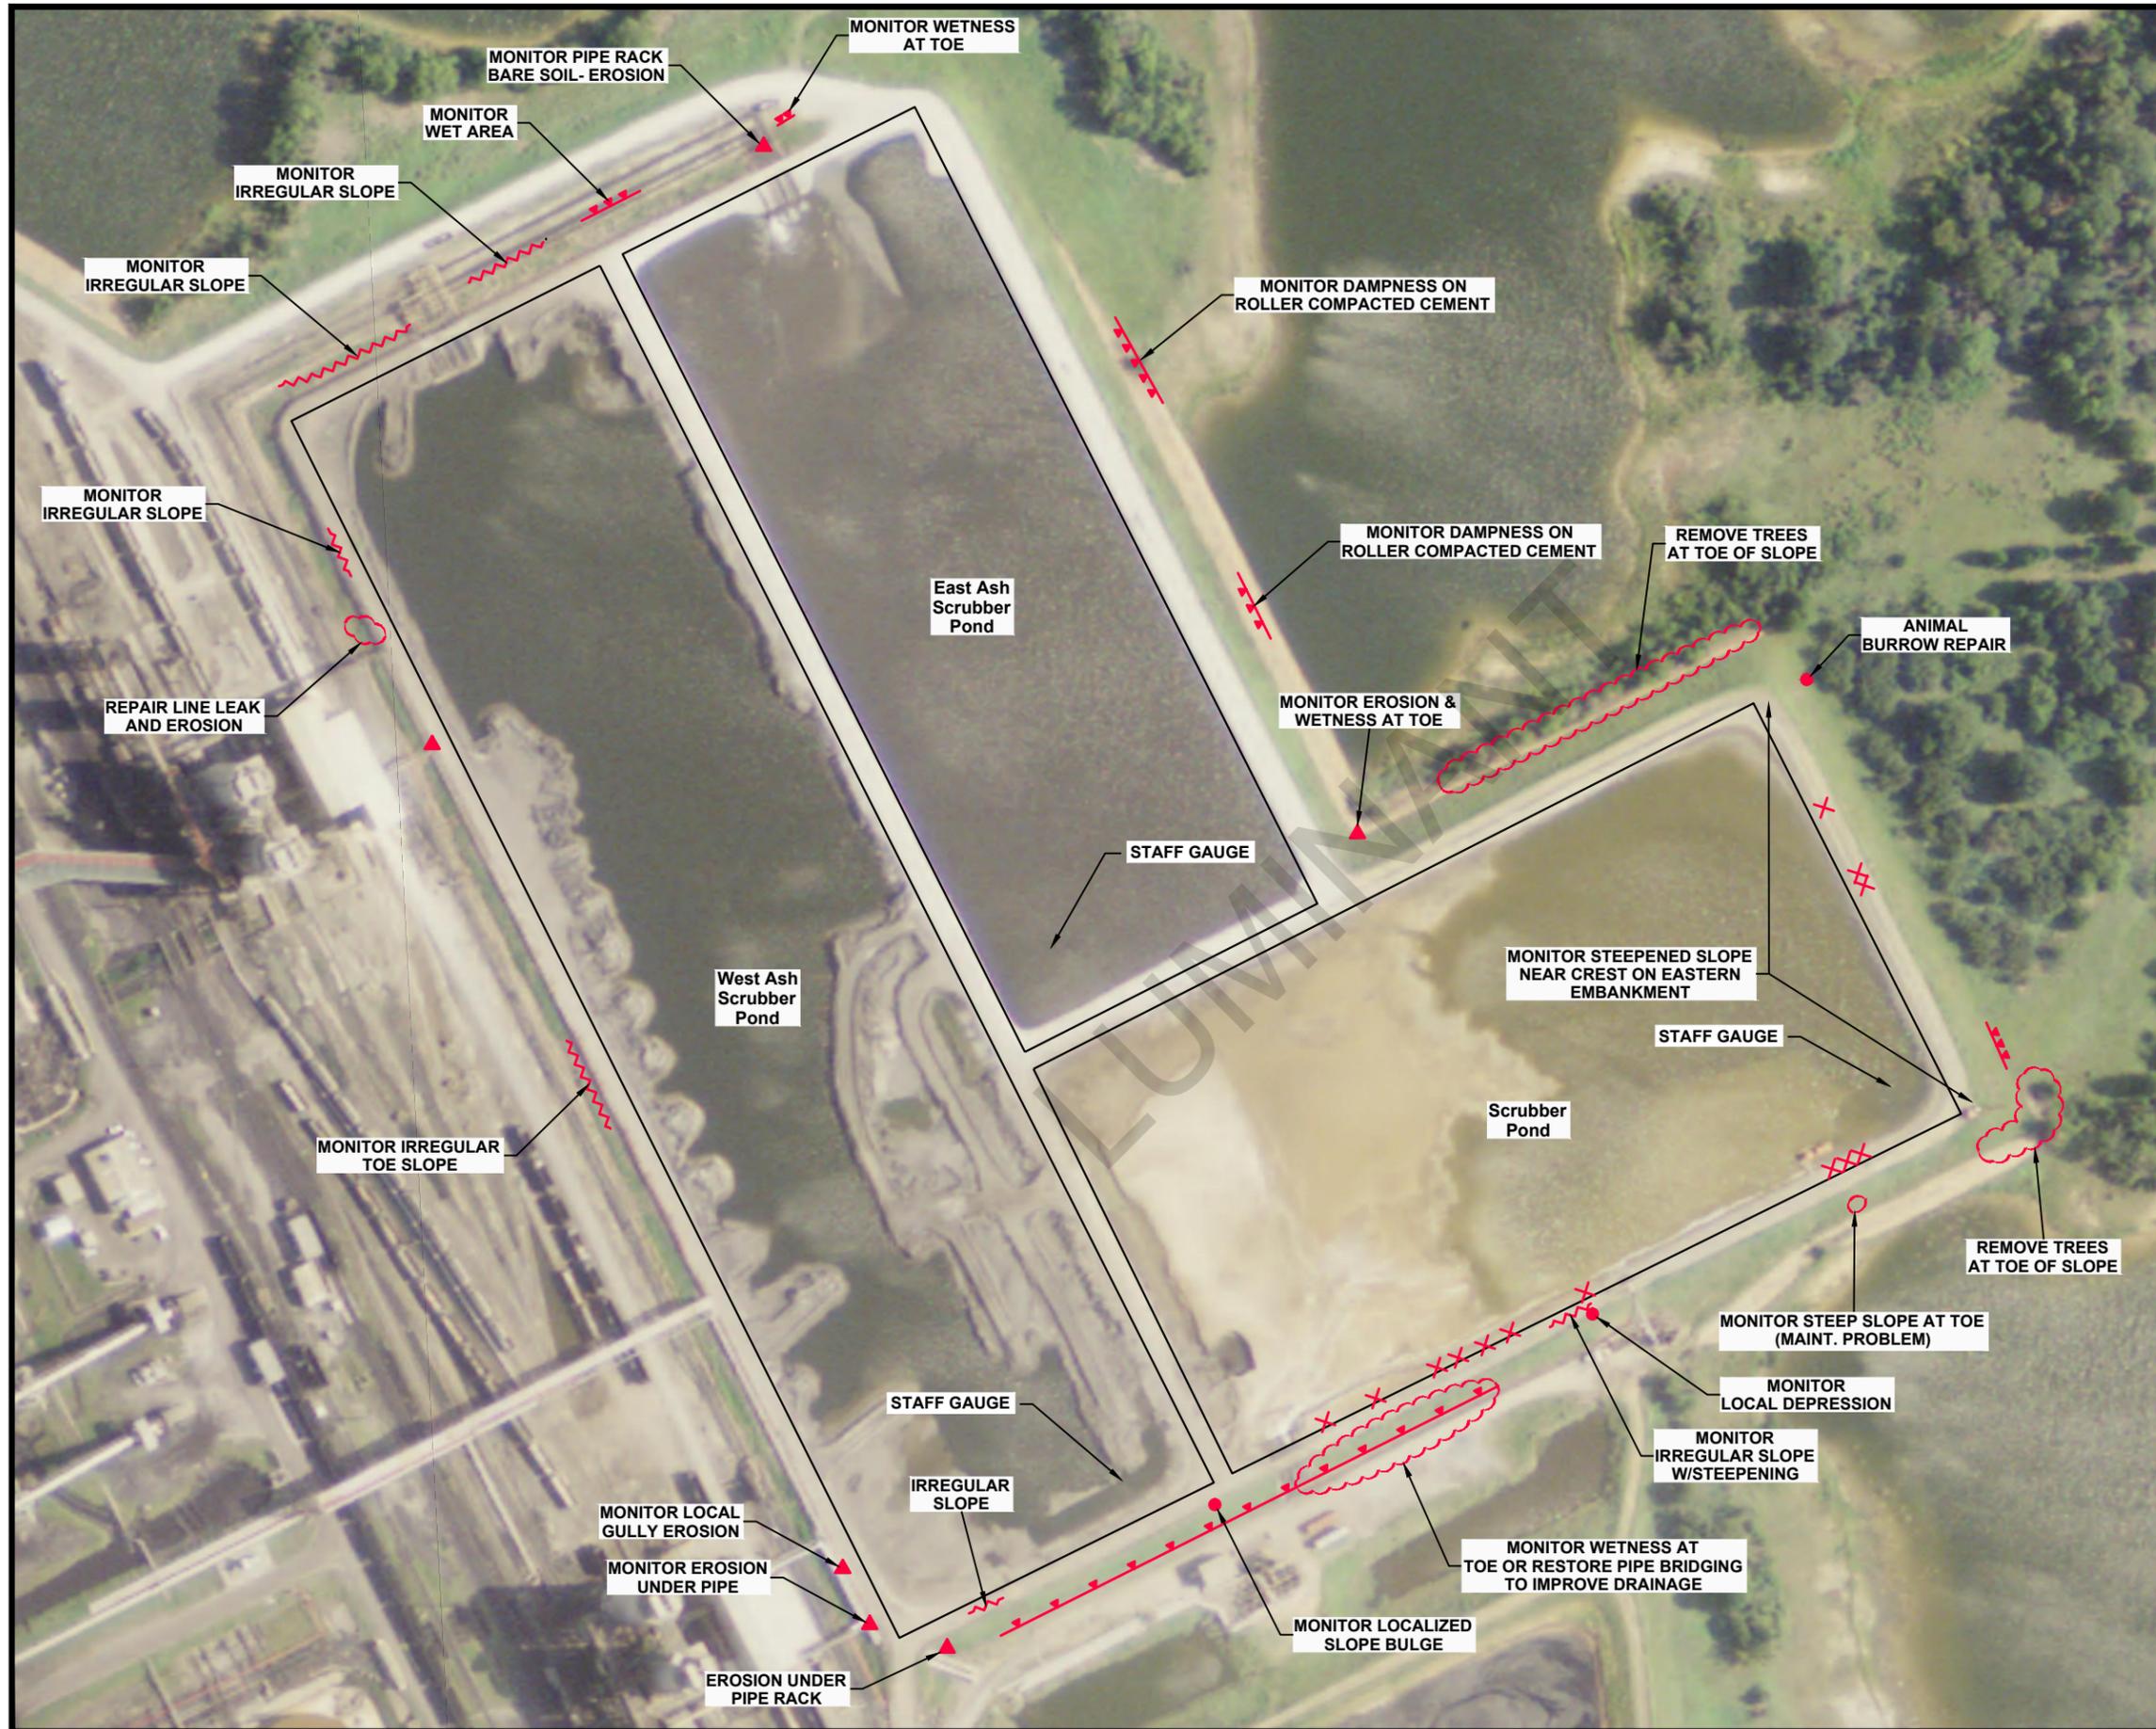
Figure 3

- ▲ Monitor Erosion
- ✕ Monitor Revetment Mat Damage
□Liner Visibility□
- Monitor Wet Area at Toe or Improve Drainage
- ~ Monitor Irregular Slope

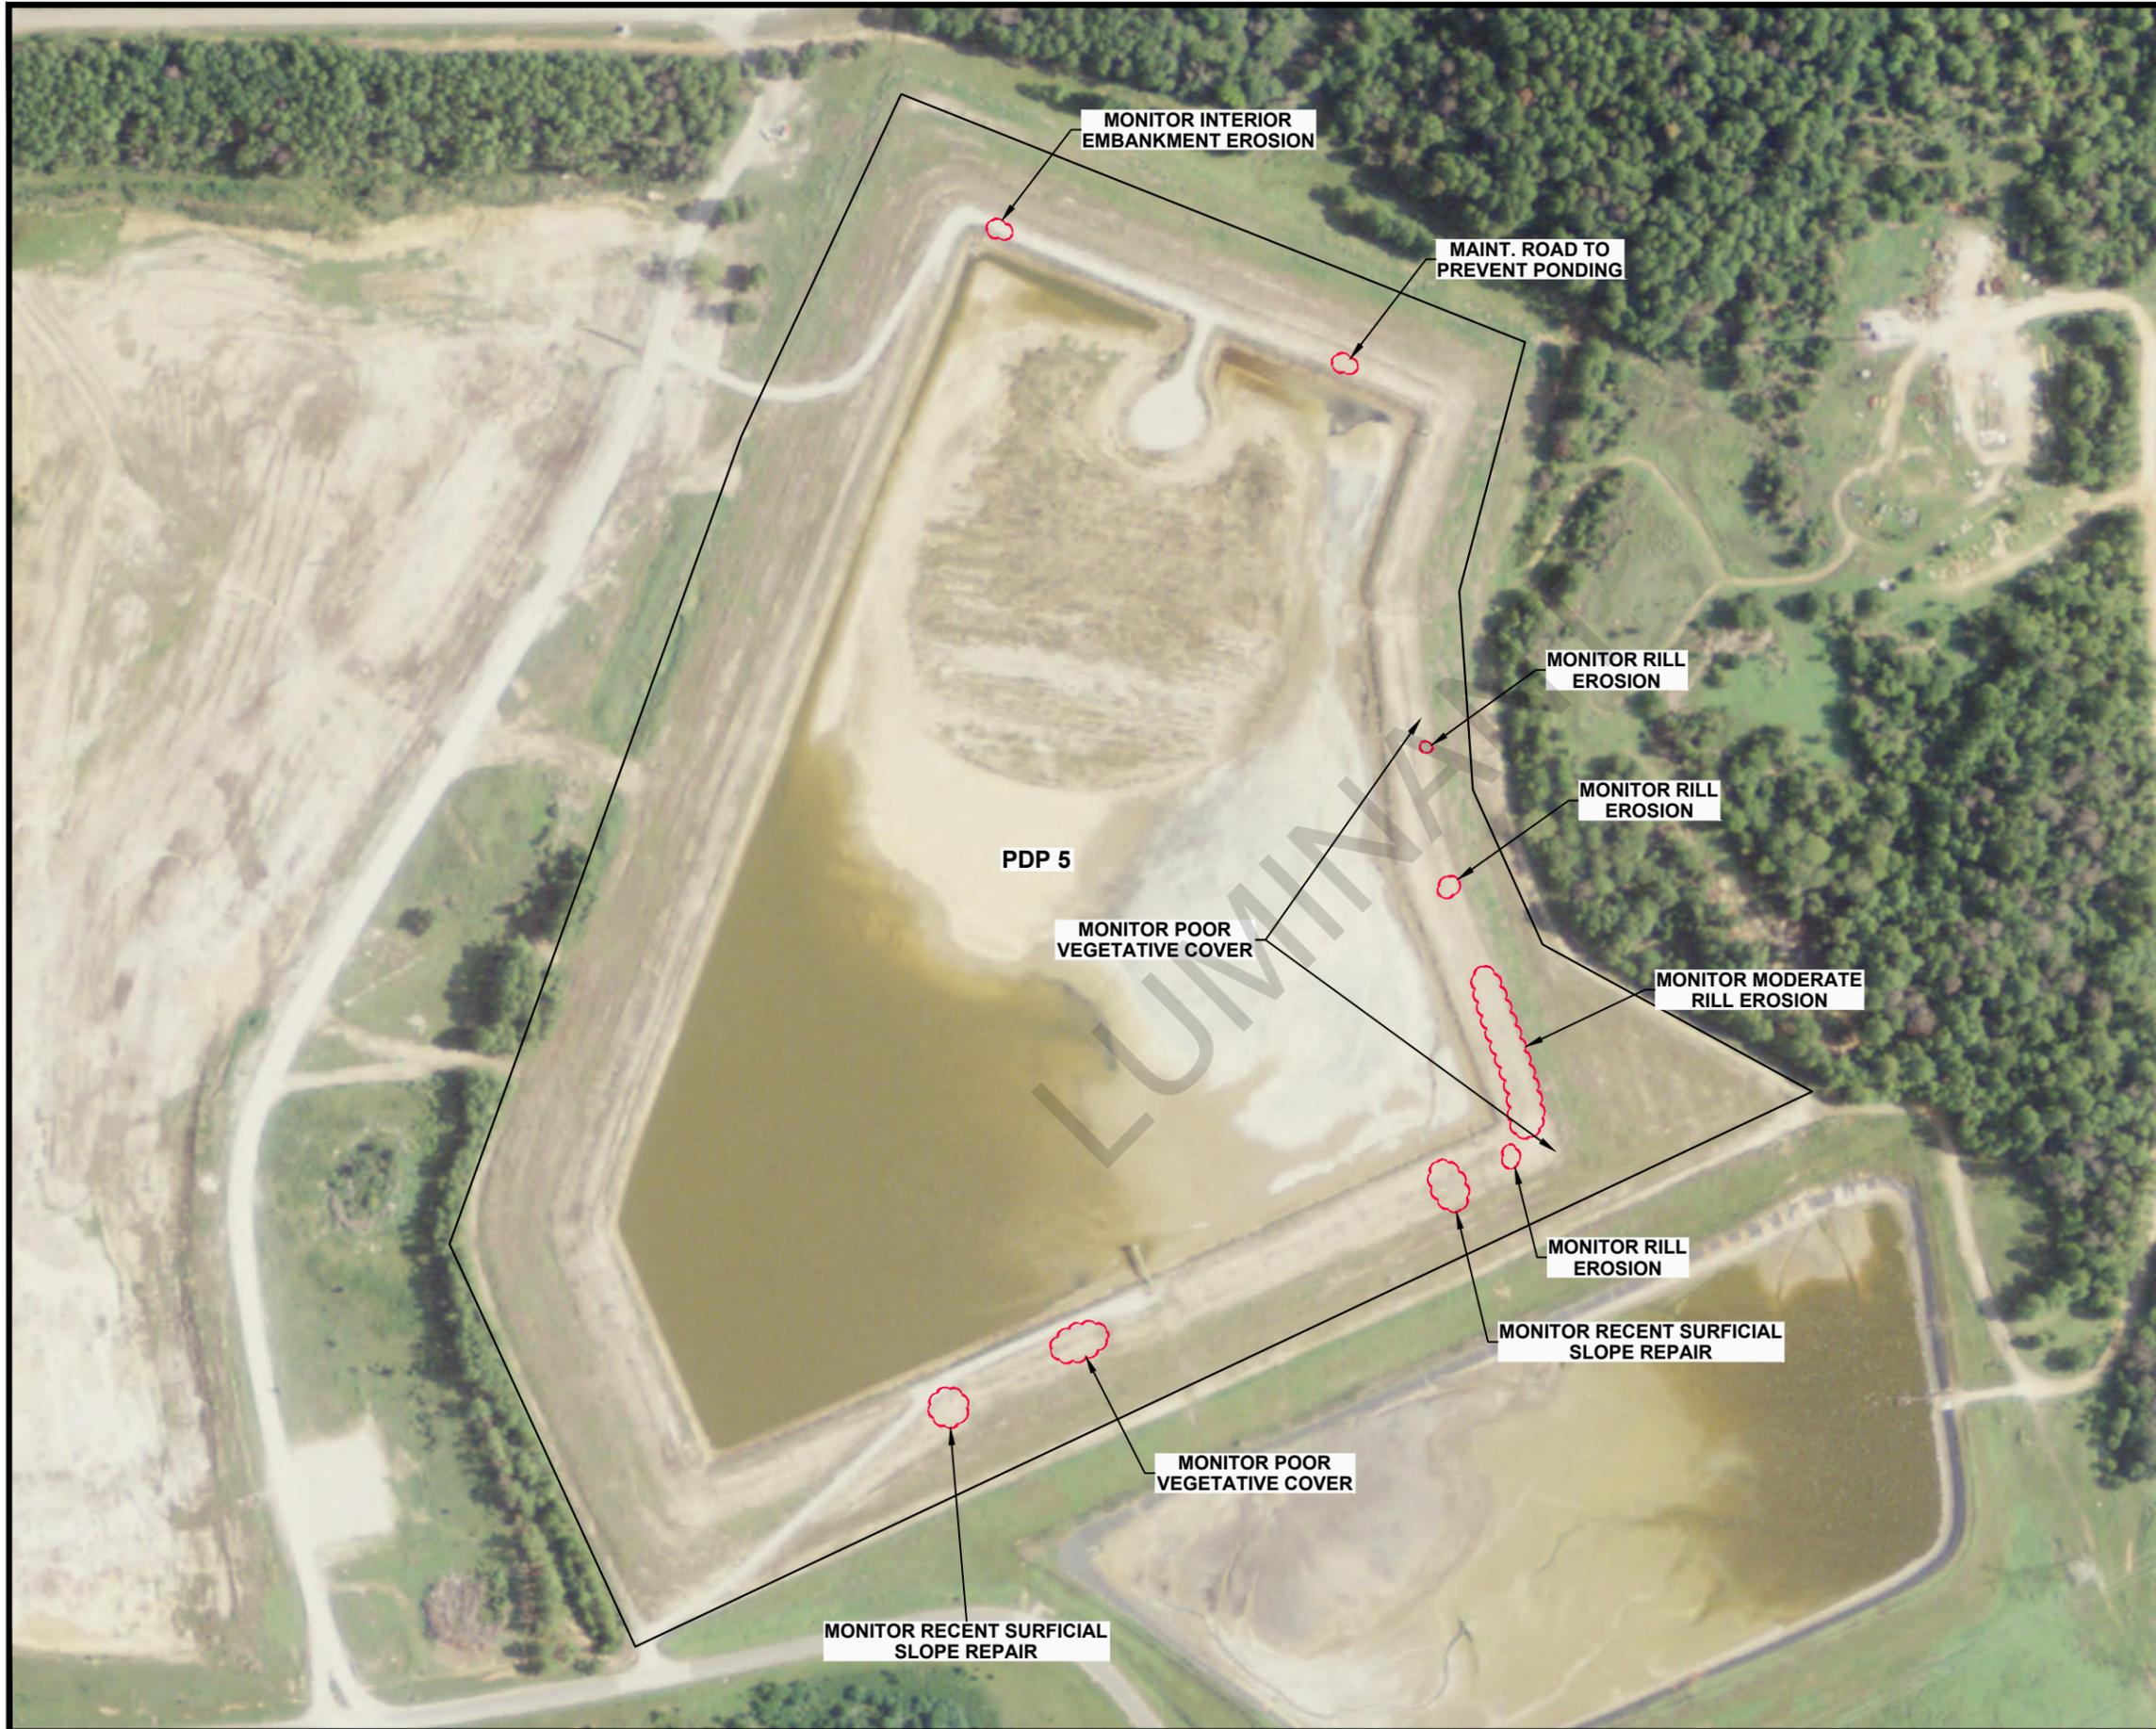
Figure 5
ANNUAL INSPECTION FINDINGS SUMMARY MAP PDP 5

MONITOR INTERIOR EMBANKMENT EROSION

MAINT. ROAD TO PREVENT PONDING

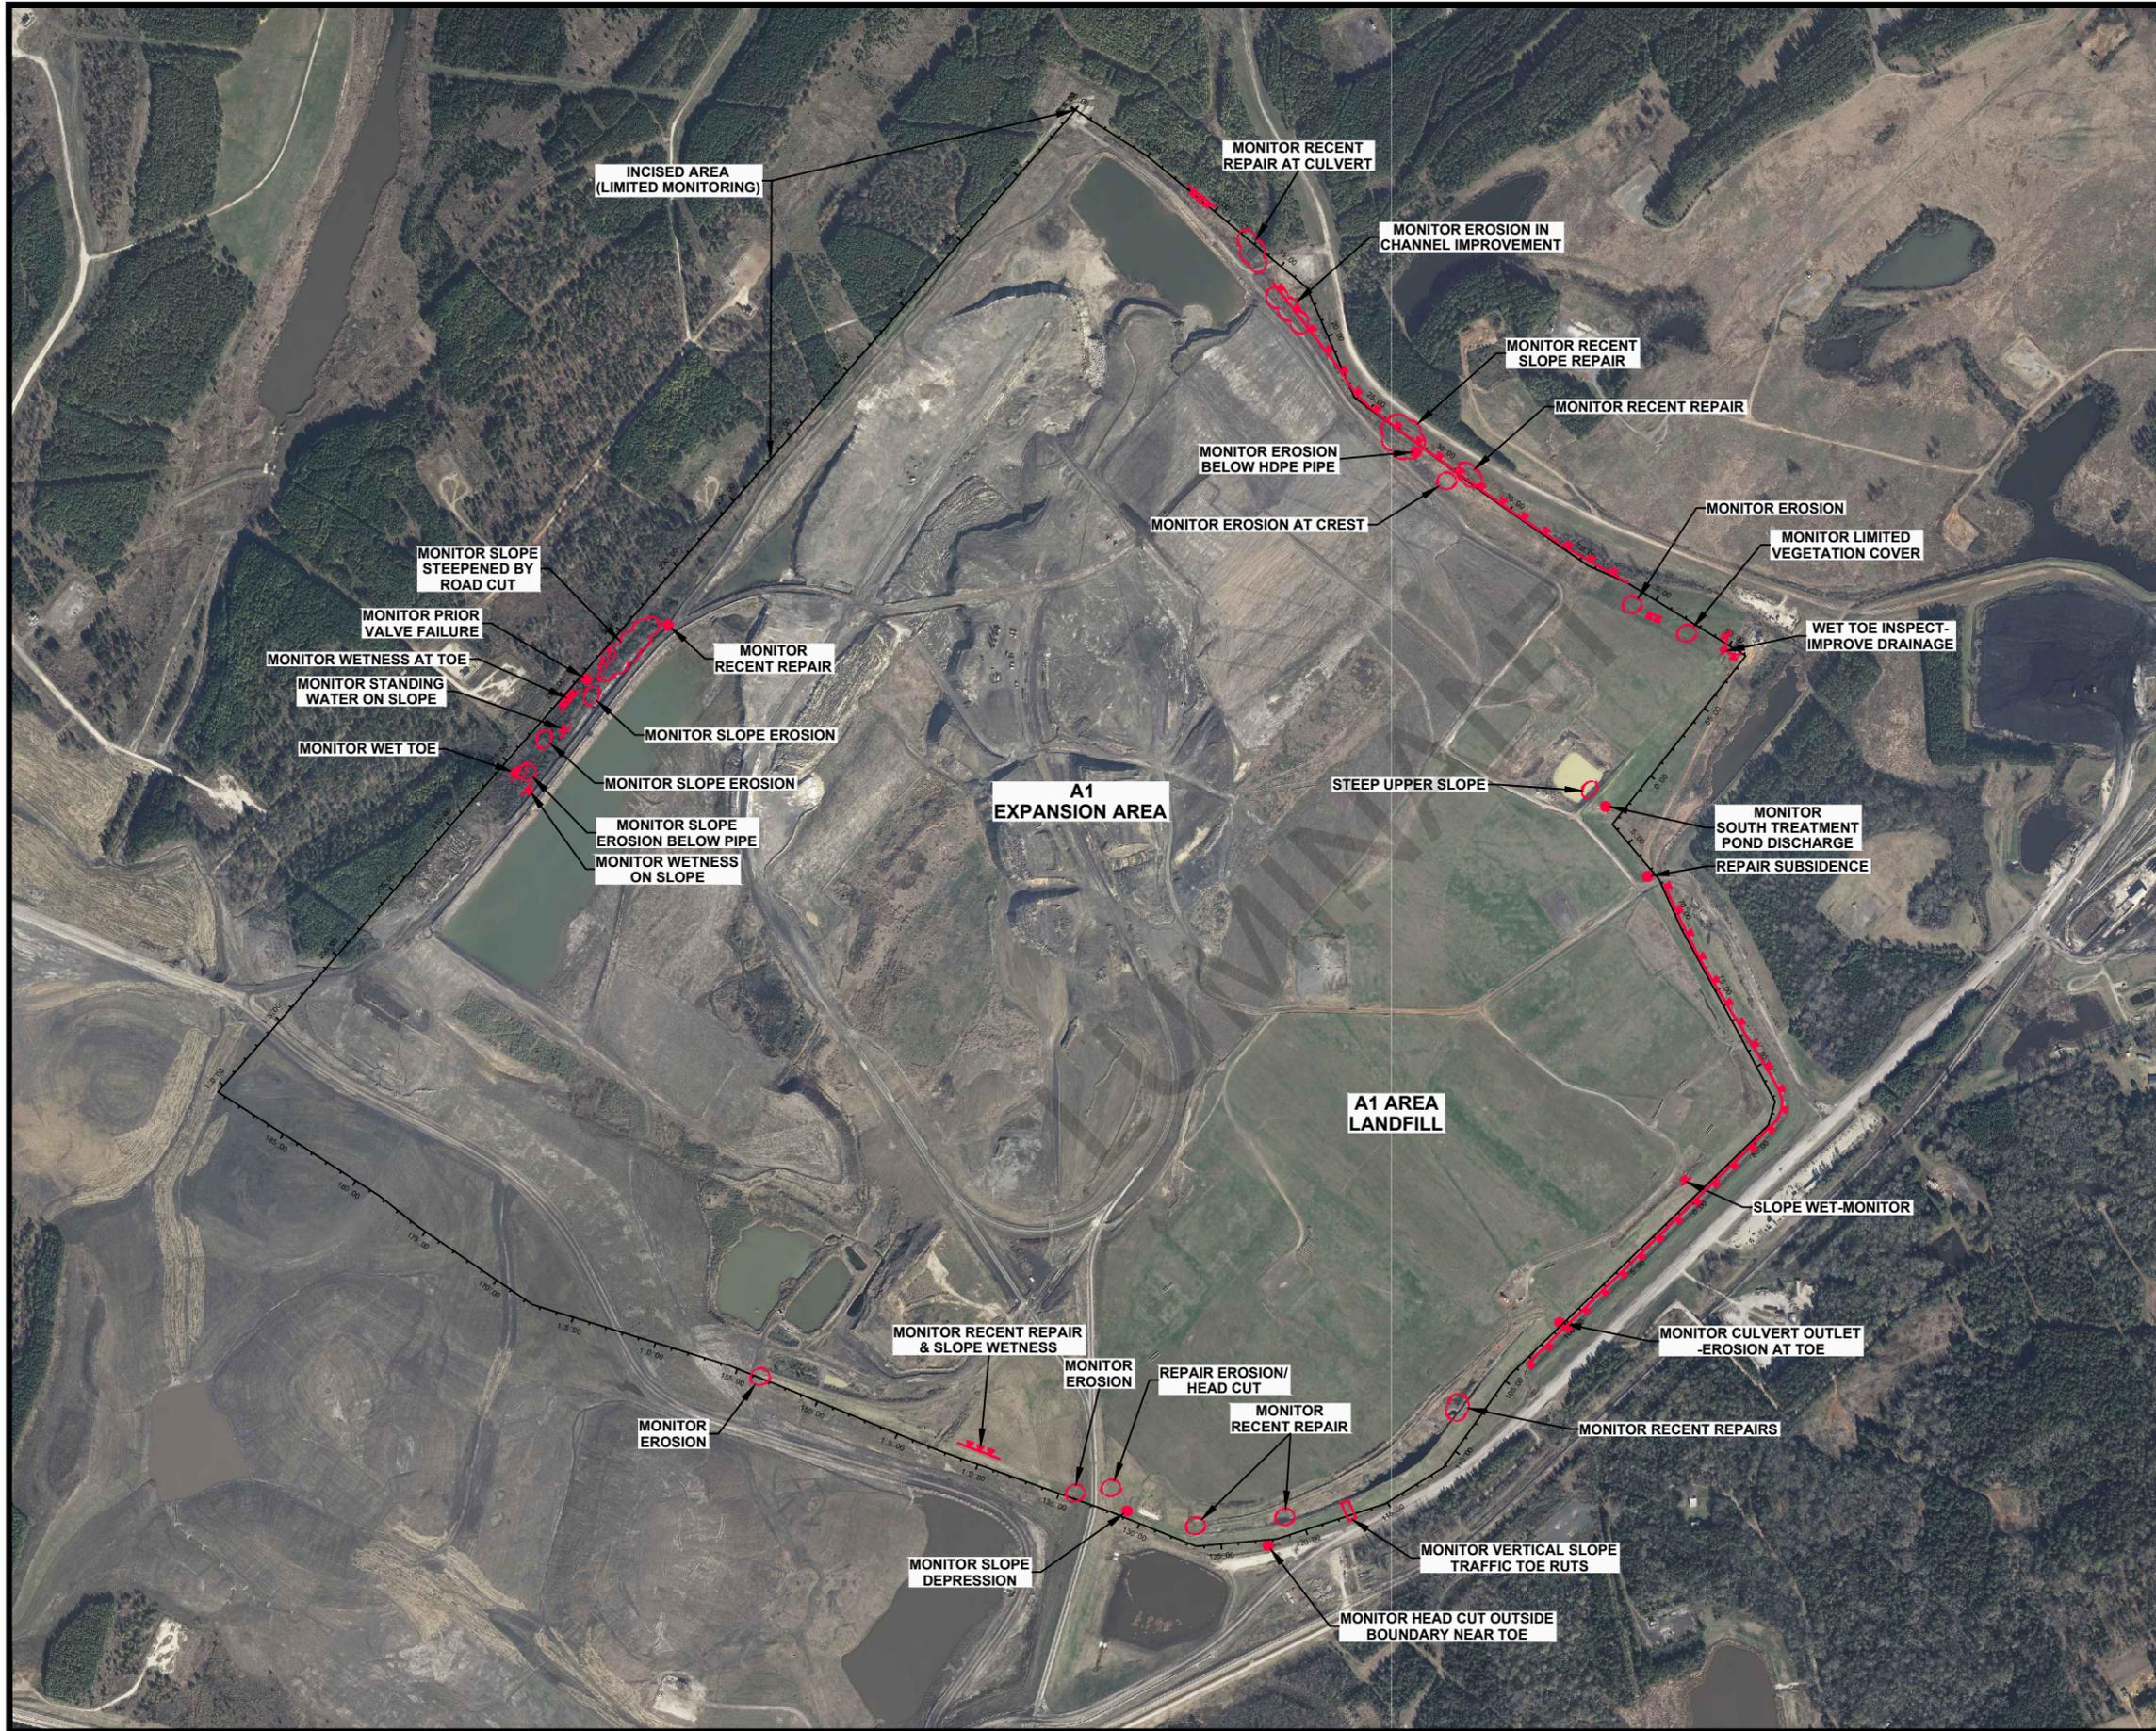
Figure 7

▲▲▲ Monitor Wet Area at Toe

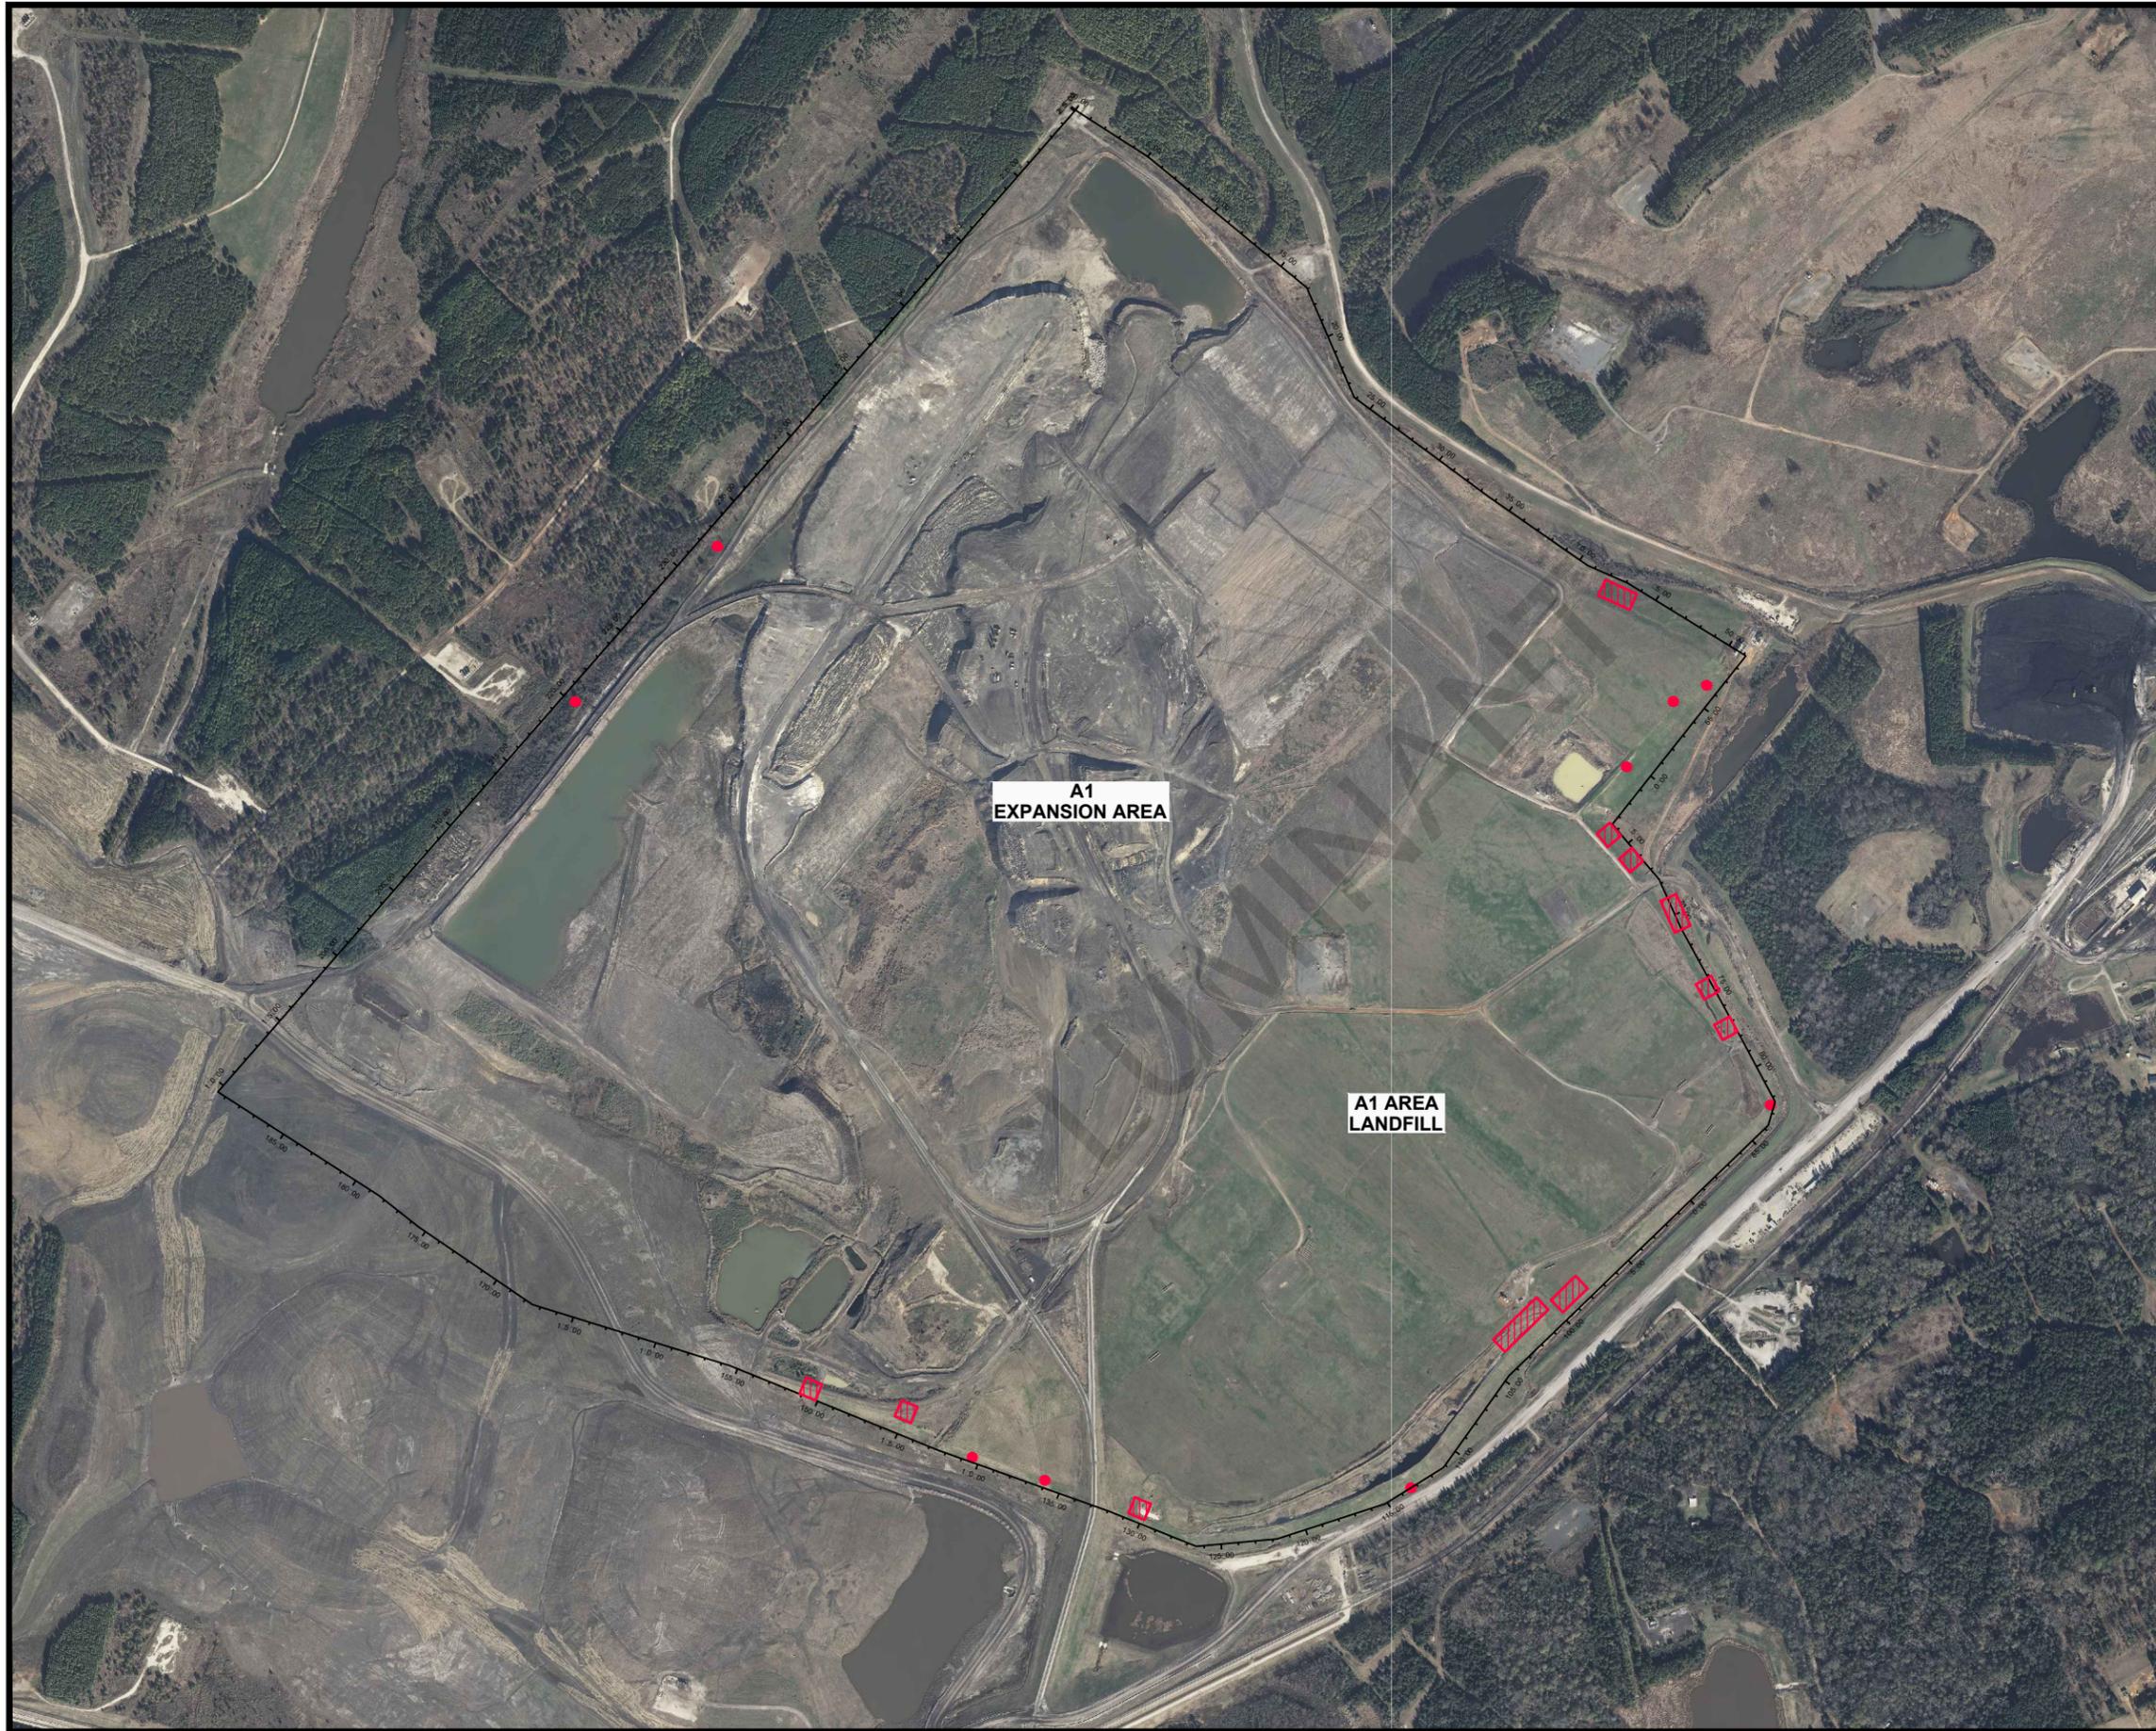
Figure 8
**ANNUAL INSPECTION
 FINDINGS SUMMARY MAP
 A1 AREA LANDFILL-FERAL HOG DAMAGE**

- Feral Hog Damage
- ▨ Heavy Hog Damage

- Monitor erosion/head cut occurring beyond the toe of the embankment just past the permitted limits of the landfill to ensure the erosion does not encroach towards the embankment.
- Monitor depression at the crest of the embankment slope immediately west of the south contact water containment sump (Station 131+00).
- Widespread feral hog damage is present on the embankment as illustrated on Figure 8. Areas of heavy damage noted should be monitored to ensure erosion is not occurring due to the irregular slope and loss of vegetation. These areas should be repaired when conditions allow and a more aggressive deterrent program should be implemented.

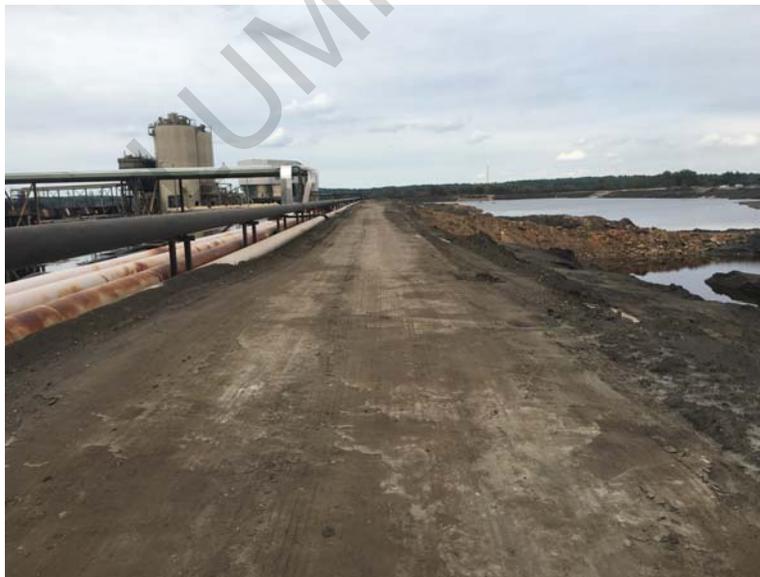
Pastor, Behling & Wheeler	DESCRIPTION	Photograph 8 – (View NNW) View of embankment crest of WAP.	
PROJECT NO. 5178-B	SITE NAME	Martin Lake Steam Electric Station– Annual Surface Impoundment Inspection	DATE 11/10/2015

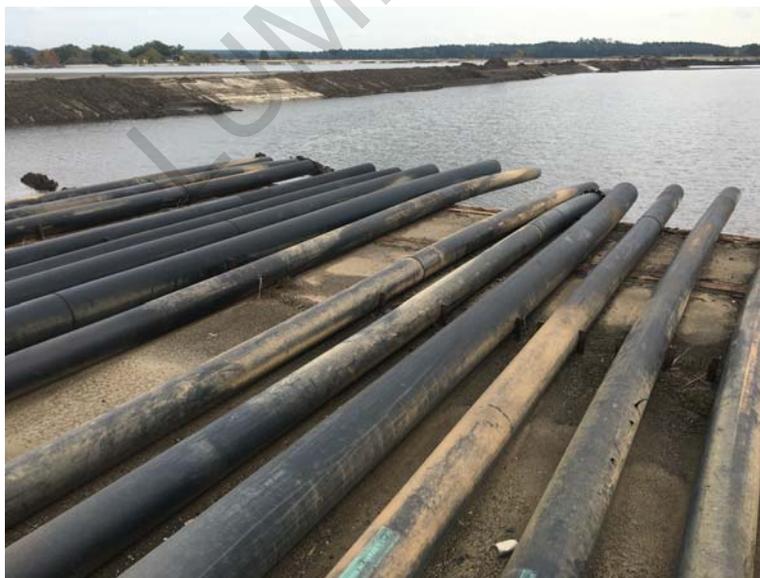
Pastor, Behling & Wheeler	DESCRIPTION	Photograph 10 – (View SE) View of influent to WAP and interior embankment between EAP and WAP.	
PROJECT NO. 5178-B	SITE NAME	Martin Lake Steam Electric Station– Annual Surface Impoundment Inspection	DATE 11/10/2015

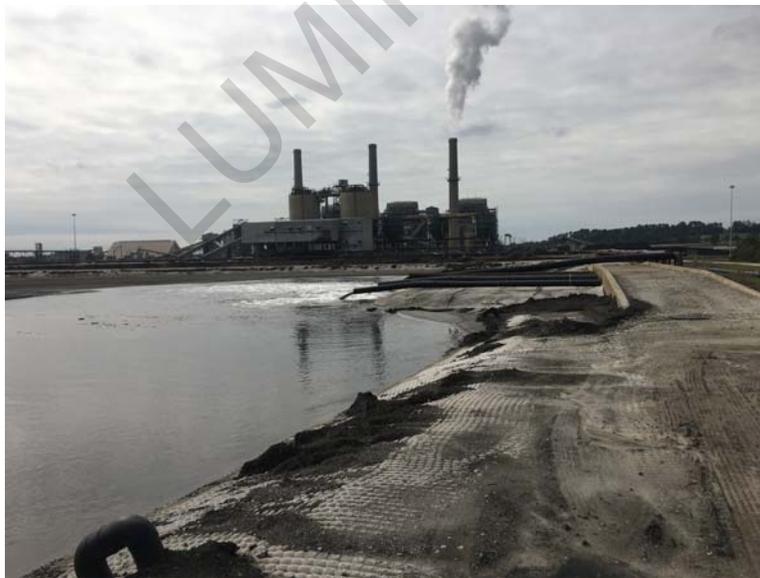
Pastor, Behling & Wheeler	DESCRIPTION	Photograph 12 – (View SW) Influent piping to EAP with above-ground concrete pipe crossing. Concrete revetment mat and liner system vent visible on upstream (interior) embankment.	
PROJECT NO. 5178-B	SITE NAME	Monticello Steam Electric Station– Annual Surface Impoundment Inspection	DATE 11/3/2015

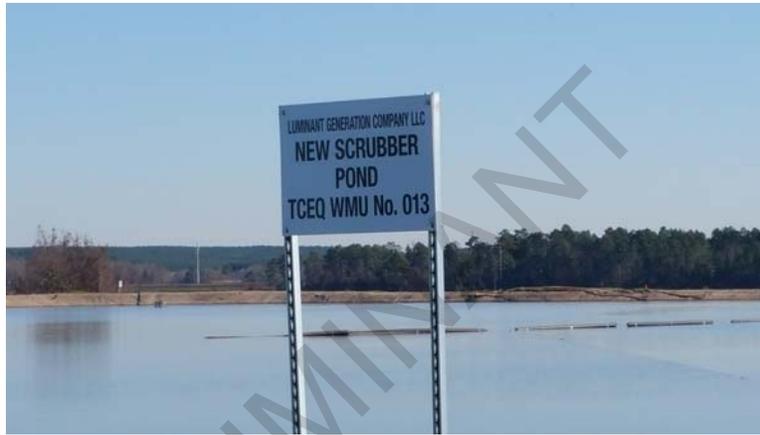
Pastor, Behling & Wheeler	DESCRIPTION	Photograph 13 – (View SE) Posted CCR signage for SP. Signage typical of each MLSES CCR unit.	
PROJECT NO. 5178-B	SITE NAME	Monticello Steam Electric Station– Annual Surface Impoundment Inspection	DATE 11/3/2015

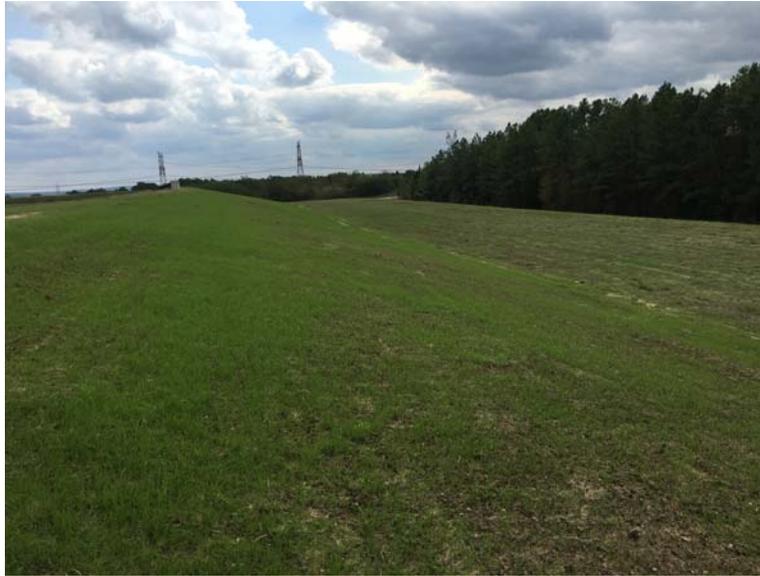
Pastor, Behling & Wheeler	DESCRIPTION	Photograph 1 – (View SE) Downstream embankment of PDP-5 with annual rye grass in good condition.	
PROJECT NO. 5178-B	SITE NAME	Martin Lake Steam Electric Station– Annual Surface Impoundment Inspection	DATE 11/10/2015

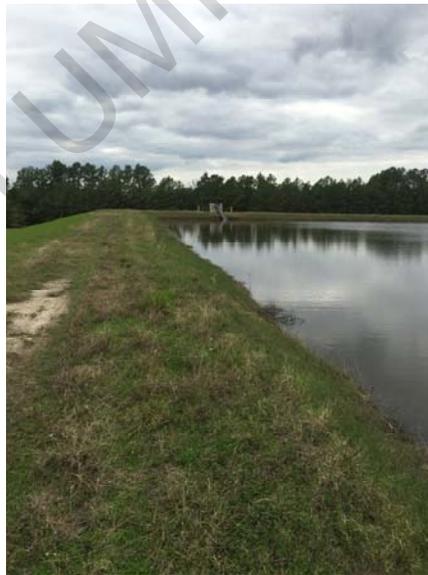
Pastor, Behling & Wheeler	DESCRIPTION	Photograph 6 – (View SW) Upstream embankment with collection sump in background.	
PROJECT NO. 5178-B	SITE NAME	Martin Lake Steam Electric Station– Annual Surface Impoundment Inspection	DATE 11/10/2015

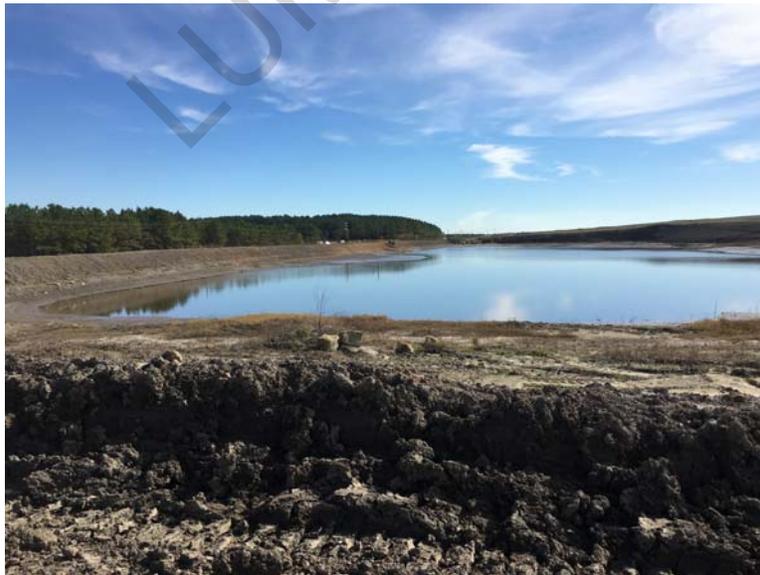
Pastor, Behling & Wheeler	DESCRIPTION	Photograph 4 – (View E; Sta. 263+00) North Holding Pond.	
PROJECT NO. 5178-B	SITE NAME	Martin Lake A1 Landfill – Annual Inspection	DATE 12/9/2015

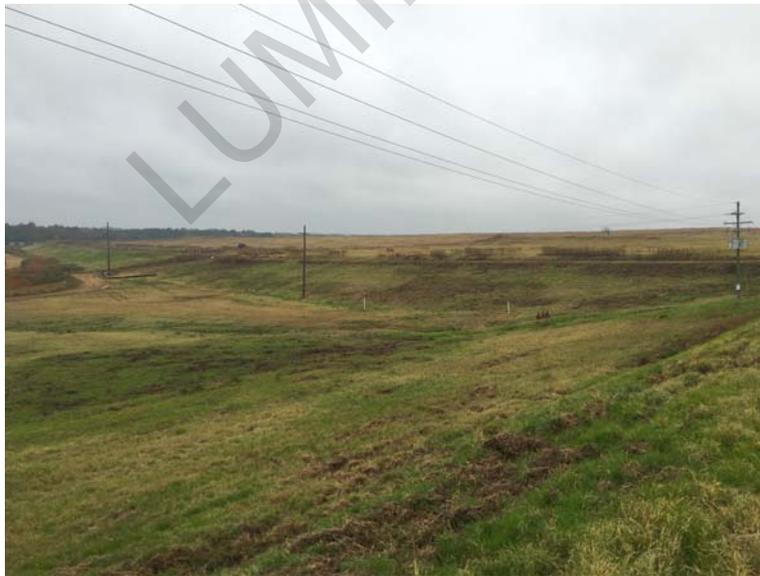
Pastor, Behling & Wheeler PROJECT NO. 5178-B	DESCRIPTION	Photograph 12 – (View S; Sta. 57+00) View of southeast portion of capped landfill. Discharge controls for North Treatment Pond visible at center-right.	
	SITE NAME	Martin Lake A1 Landfill – Annual Inspection	DATE 12/10/2015
