**2017 ANNUAL CCR UNIT INSPECTION REPORT
LUMINANT SANDOW 5 GENERATING PLANT
AX LANDFILL
MILAM COUNTY, TEXAS**

January 10, 2018

PASTOR, BEHLING & WHEELER, LLC
2201 Double Creek Drive, Suite 4004
Round Rock, Texas 78664
Texas Engineering Firm No. 4760

PBW Project No. 5313B

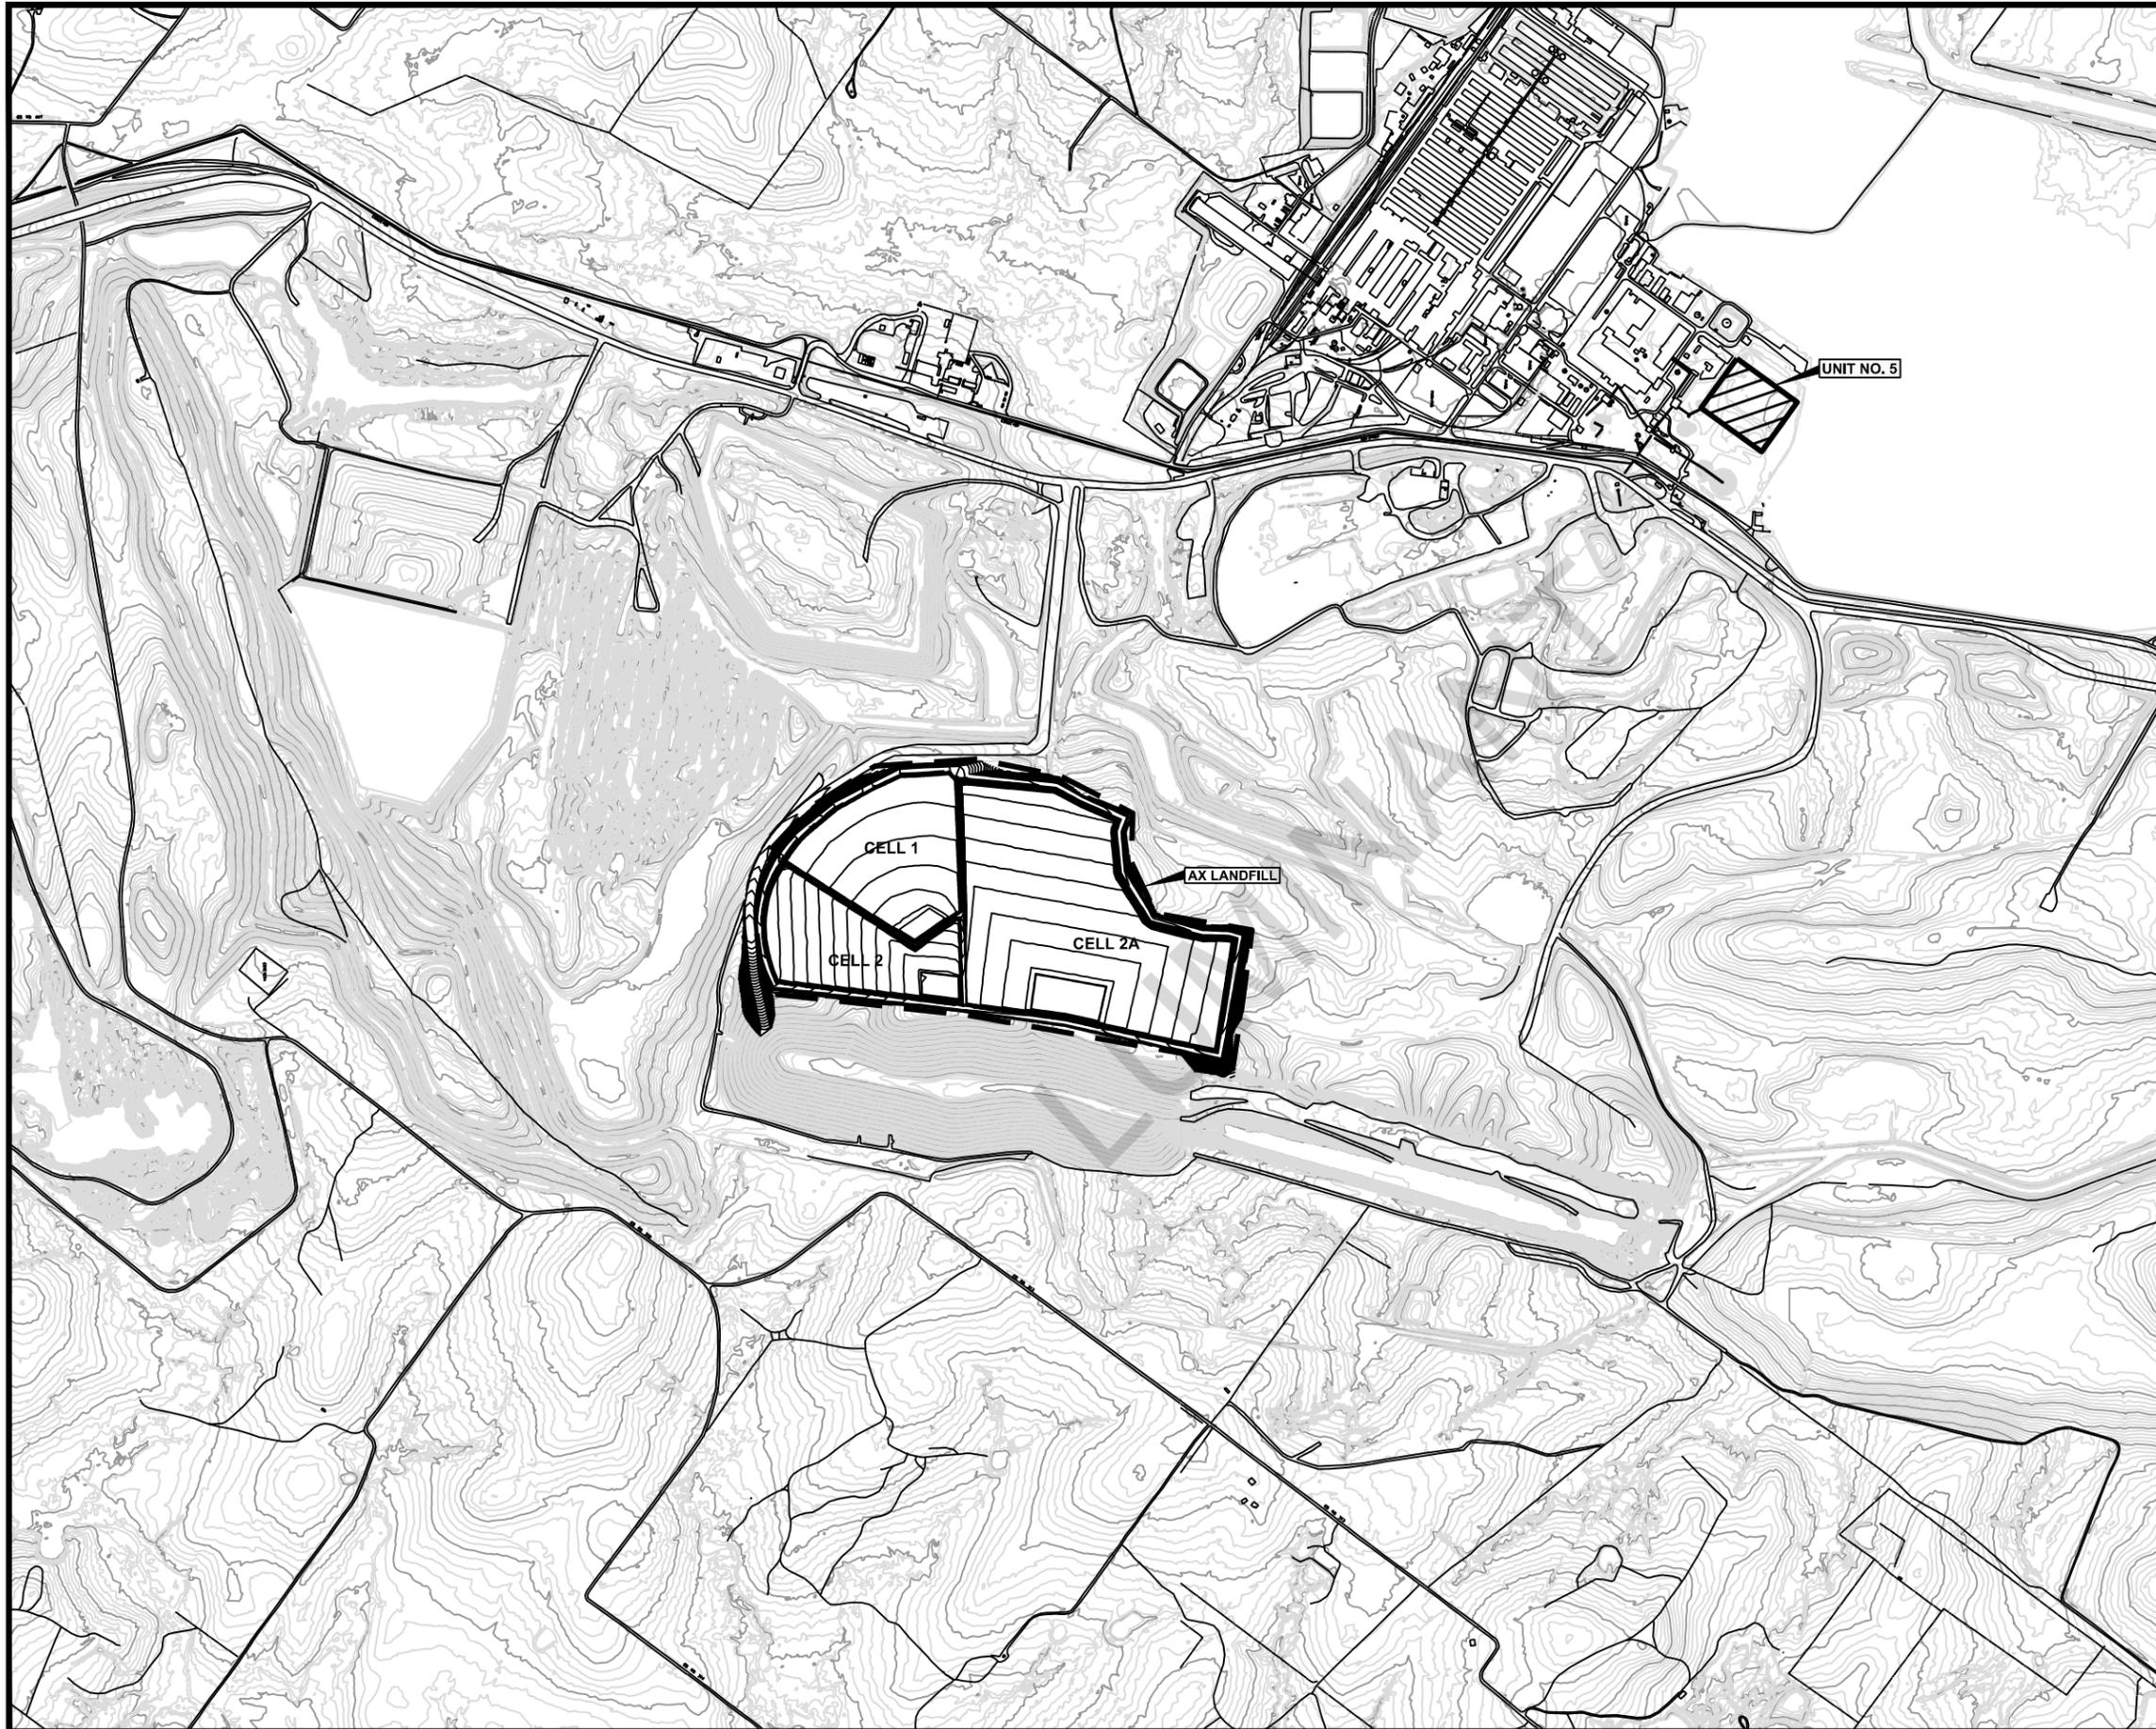
Figure 3
ANNUAL INSPECTION FINDINGS SUMMARY MAP AX LANDFILL

The following areas were noted for repairs/maintenance at the landfill (see Figure 3 for locations):

- Heavy vegetation was observed in areas along the interior face of the permanent embankment on the south side of Cell 2 and the interior face of the temporary embankment on the east side of Cells 1 and 2. It is recommended that the vegetation in these areas be cut/maintained to reduce the potential for liner/embankment damage due to shrub/tree roots.
- A small area of significant erosion (liner visible) was observed along the temporary embankment between Cells 2 and 2A. This area should be repaired.

- An accumulation of silt was observed blocking the inlets to two culverts that cross the haul road on the north side of the AX Landfill, northeast of the access ramp. The silt should be removed from the culvert inlets.

The following areas were noted for future monitoring at the landfill (See Figure 3 for locations):

- Two areas of limited vegetation were observed on the exterior slopes of the permanent embankment on the west side of Cell 1 and south side of Cells 2 and 2A. These areas should be monitored and repaired as necessary.
- Minor erosion was observed in a small area along the interior slope of the permanent embankment on the south side of Cell 2, near the contact water collection area. This area should be monitored and repaired as necessary.
- Feral hog damage was observed in a small area along the permanent embankment along the north side of Cell 1. This area should be monitored and repaired as necessary.

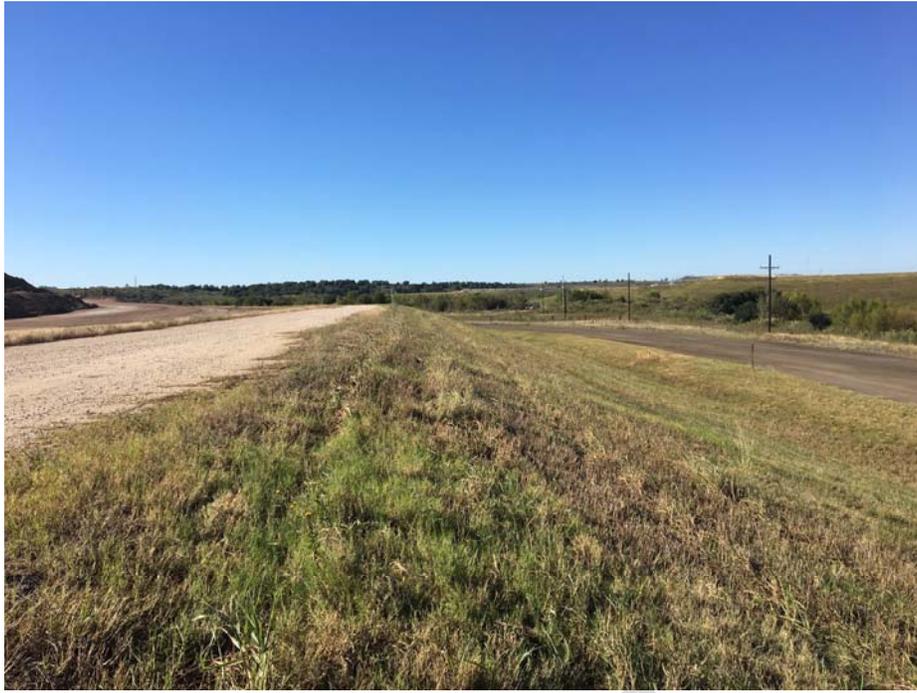
Pastor, Behling & Wheeler	DESCRIPTION	Photograph 1 – (View SW) Top of embankment along north side of Cell 1. Cell 1 to left.	
PROJECT NO. 5313B	SITE NAME	Sandow Unit No. 5 – AX Landfill Annual Inspection	DATE 10/24/17

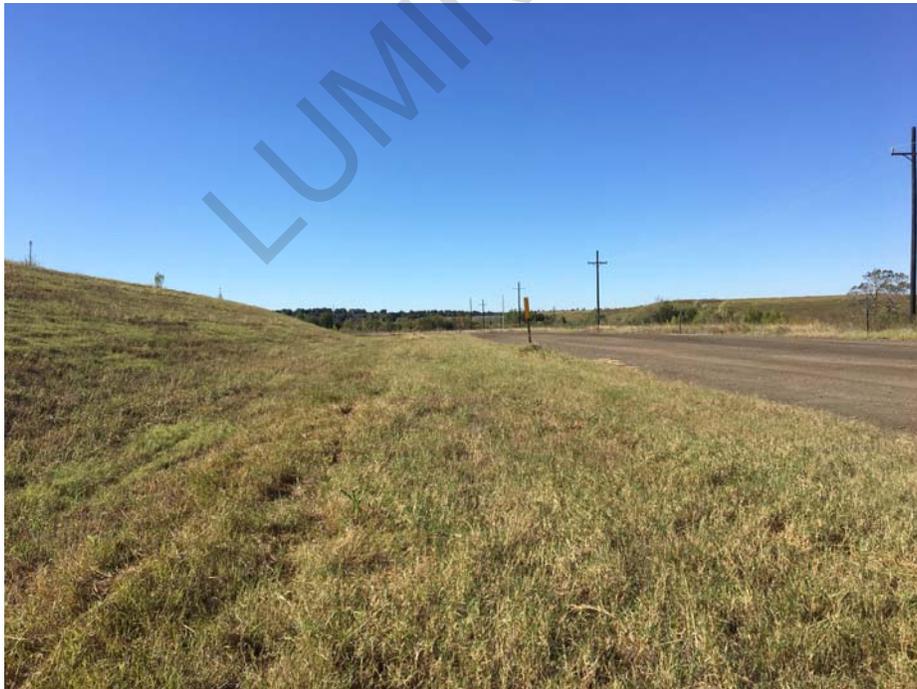
Pastor, Behling & Wheeler	DESCRIPTION	Photograph 2 – (View SW) Toe of embankment along north side of Cell 1. Haul road to right.	
PROJECT NO. 5313B	SITE NAME	Sandow Unit No. 5 – AX Landfill Annual Inspection	DATE 10/24/17

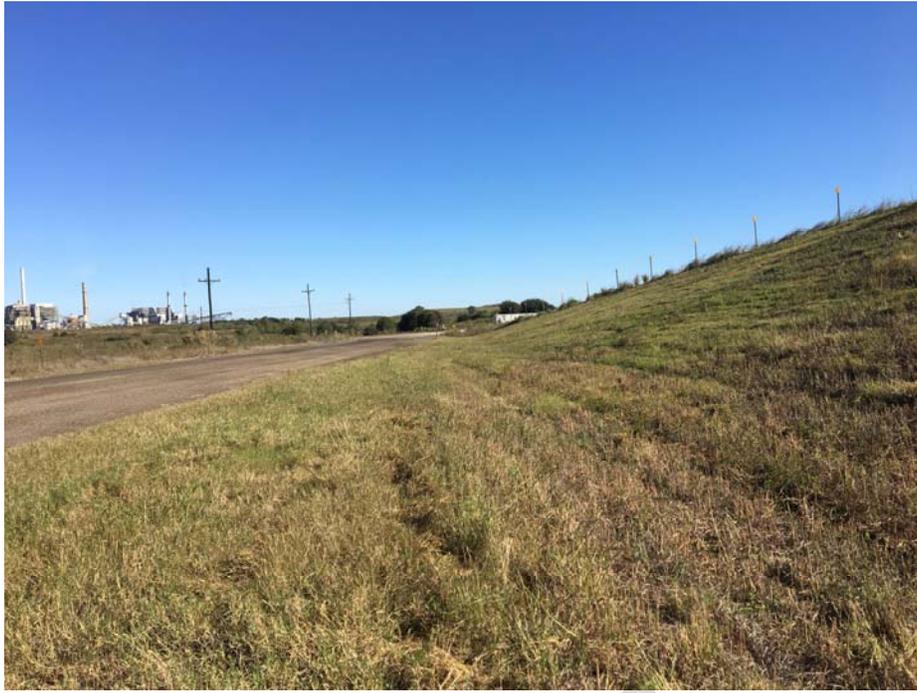
Pastor, Behling & Wheeler PROJECT NO. 5313B	DESCRIPTION	Photograph 3 – (View NE) Toe of embankment along north side of Cell 1. Haul road to left.	
	SITE NAME	Sandow Unit No. 5 – AX Landfill Annual Inspection	DATE 10/24/17

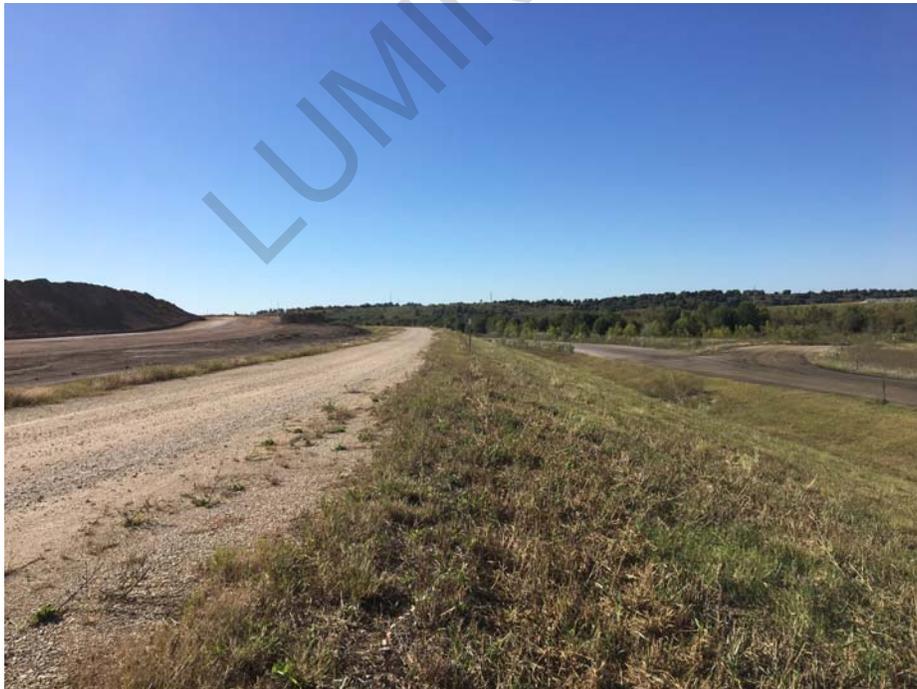
Pastor, Behling & Wheeler PROJECT NO. 5313B	DESCRIPTION	Photograph 4 – (View S) Top of embankment along west side of Cell 1. Cell 1 to left.	
	SITE NAME	Sandow Unit No. 5 – AX Landfill Annual Inspection	DATE 10/24/17

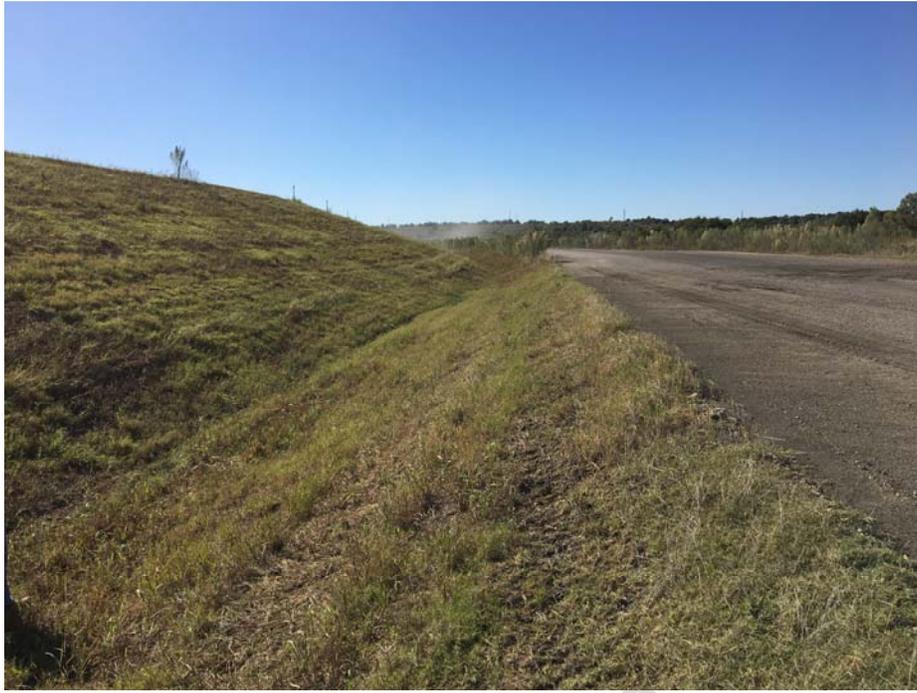
Pastor, Behling & Wheeler PROJECT NO. 5313B	DESCRIPTION	Photograph 5 – (View S) Toe of embankment along west side of Cell 1. Haul road to right.	
	SITE NAME	Sandow Unit No. 5 – AX Landfill Annual Inspection	DATE 10/24/17

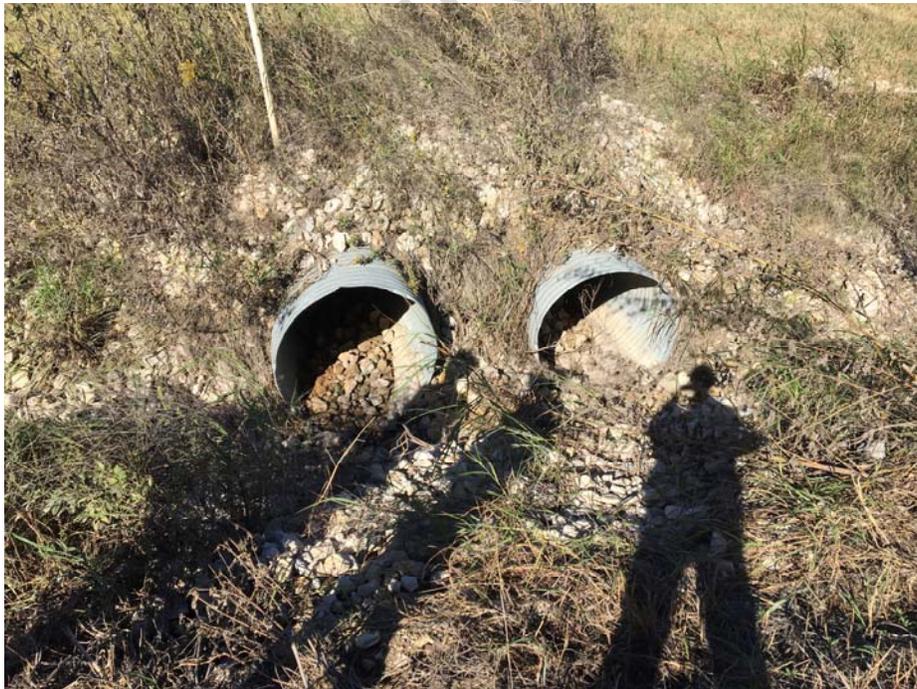
Pastor, Behling & Wheeler PROJECT NO. 5313B	DESCRIPTION	Photograph 6 – Culverts along west side of Cell 1.	
	SITE NAME	Sandow Unit No. 5 – AX Landfill Annual Inspection	DATE 10/24/17

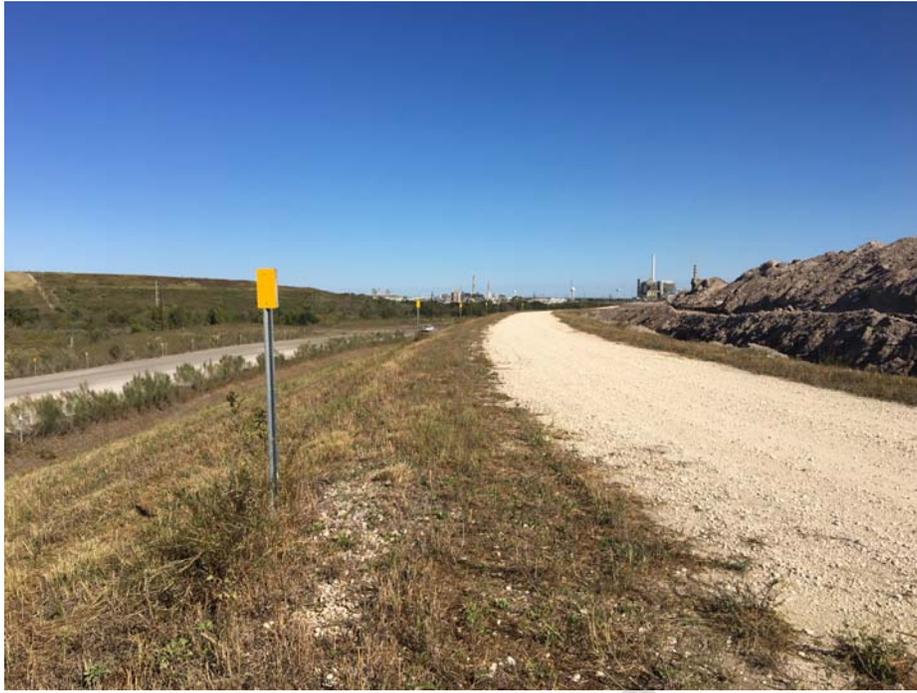
Pastor, Behling & Wheeler	DESCRIPTION	Photograph 7 – (View N) Top of embankment along west side of Cell 1. Cell 1 to right.	
PROJECT NO. 5313B	SITE NAME	Sandow Unit No. 5 – AX Landfill Annual Inspection	DATE 10/24/17

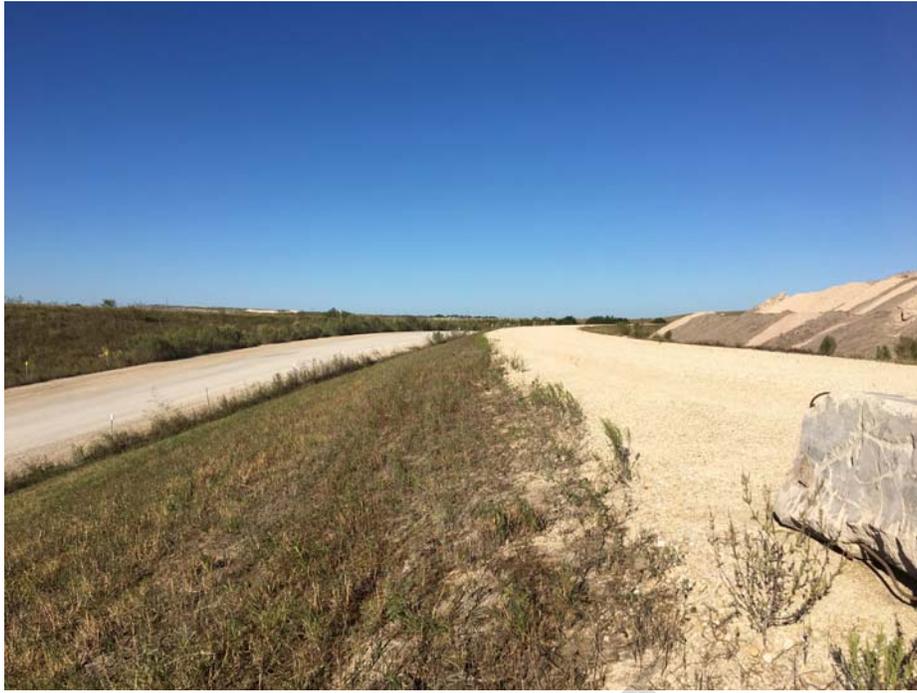
Pastor, Behling & Wheeler	DESCRIPTION	Photograph 9 – (View NW) Top of west embankment at south corner of Cell 2. Cell 2 to right.	
PROJECT NO. 5313B	SITE NAME	Sandow Unit No. 5 – AX Landfill Annual Inspection	DATE 10/24/17

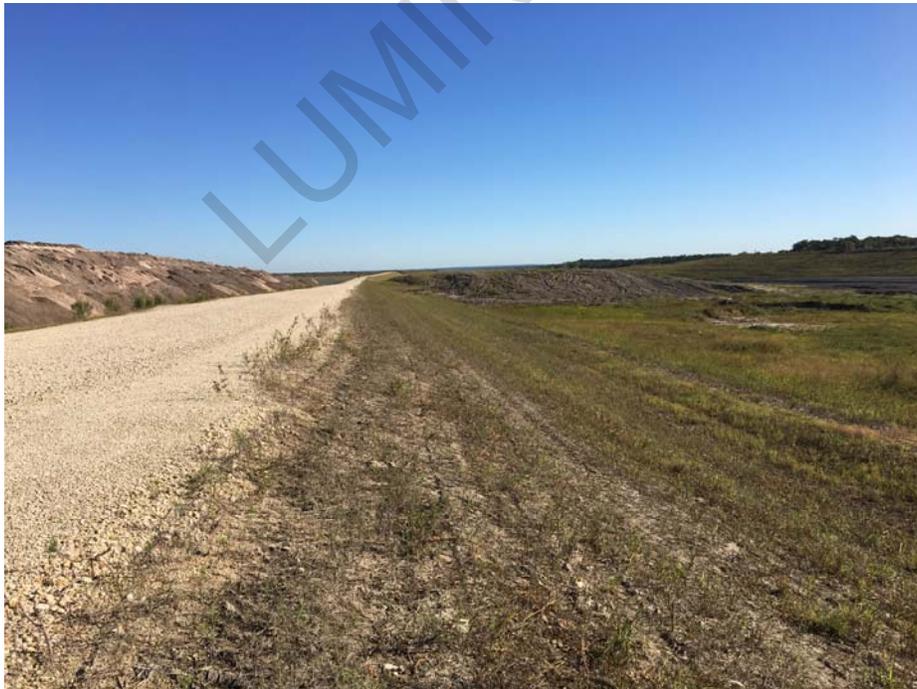
Pastor, Behling & Wheeler	DESCRIPTION	Photograph 10 – (View NE) Top of embankment along south side of Cell 2. Cell 2 to left.	
PROJECT NO. 5313B	SITE NAME	Sandow Unit No. 5 – AX Landfill Annual Inspection	DATE 10/24/17

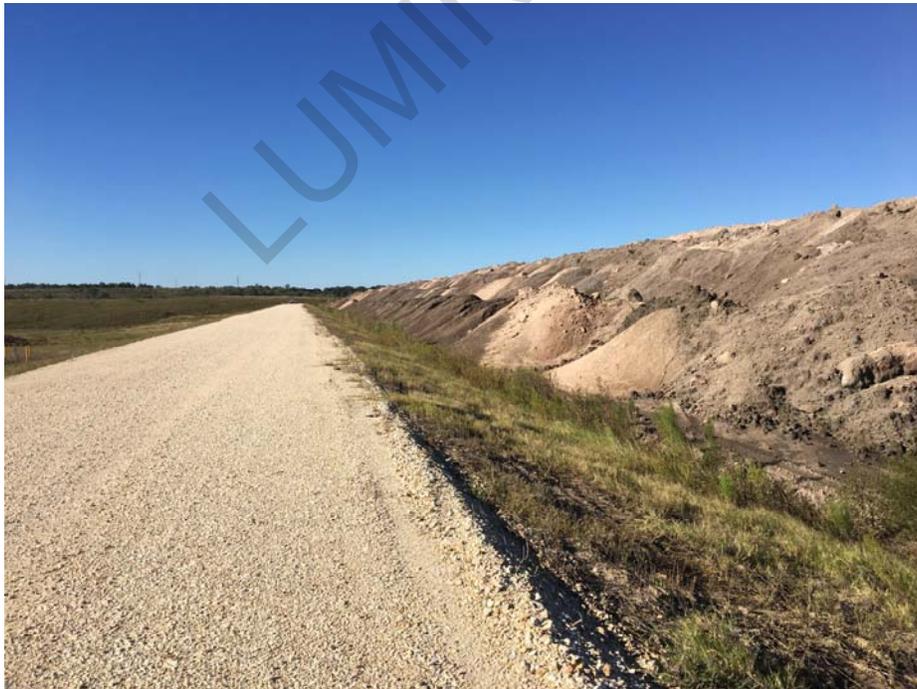
Pastor, Behling & Wheeler PROJECT NO. 5313B	DESCRIPTION	Photograph 12 – (View SW) Top of east embankment of Cell 2. Cell 2 to right.	
	SITE NAME	Sandow Unit No. 5 – AX Landfill Annual Inspection	DATE 10/24/17

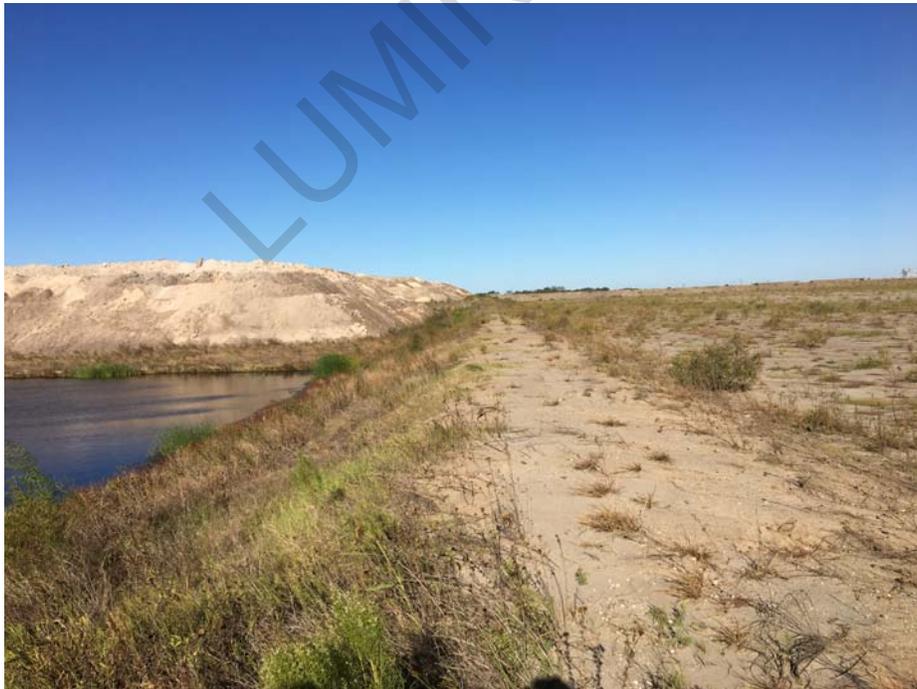
Pastor, Behling & Wheeler PROJECT NO. 5313B	DESCRIPTION	Photograph 14 – (View NW) Temporary embankment between Cell 2 and Cell 2A. Cell 2 to left, Cell 2A to right.	
	SITE NAME	Sandow Unit No. 5 – AX Landfill Annual Inspection	DATE 10/24/17

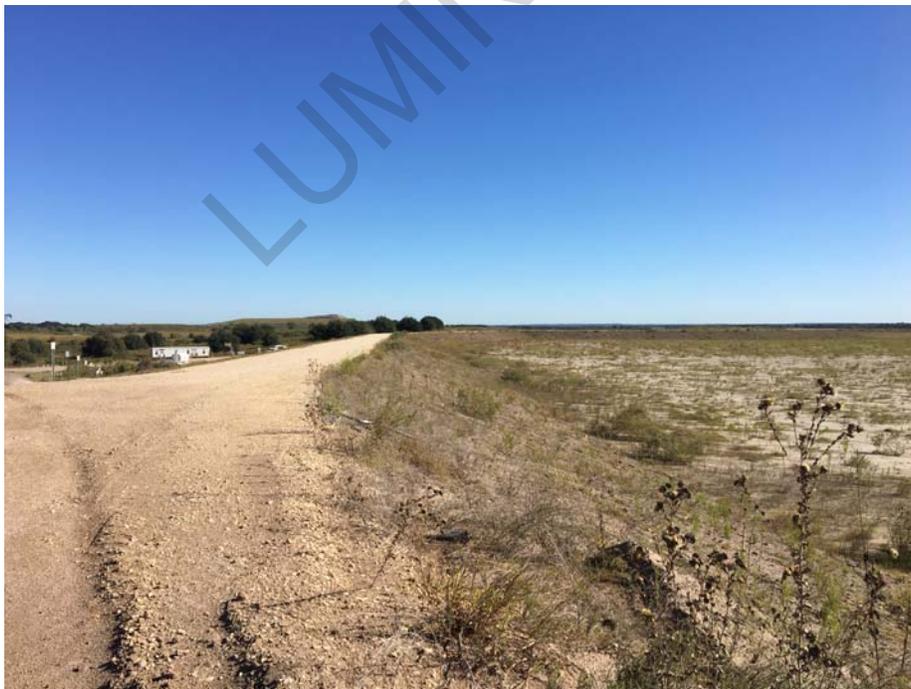
Pastor, Behling & Wheeler PROJECT NO. 5313B	DESCRIPTION	Photograph 18 – (View NE) Top of embankment along north side of cell 2A, from NW corner of cell 2A. Cell 2A to right.	
	SITE NAME	Sandow Unit No. 5 – AX Landfill Annual Inspection	DATE 10/24/17

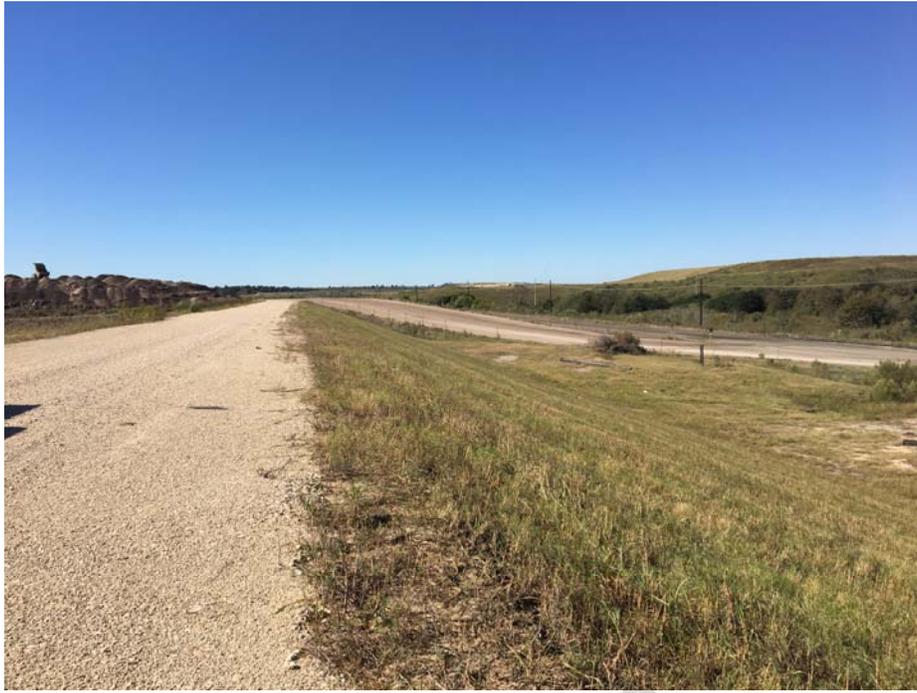
Pastor, Behling & Wheeler PROJECT NO. 5313B	DESCRIPTION	Photograph 19 – (View SW) Top of embankment on north side of Cell 2A. Cell 2A to left.	
	SITE NAME	Sandow Unit No. 5 – AX Landfill Annual Inspection	DATE 10/24/17

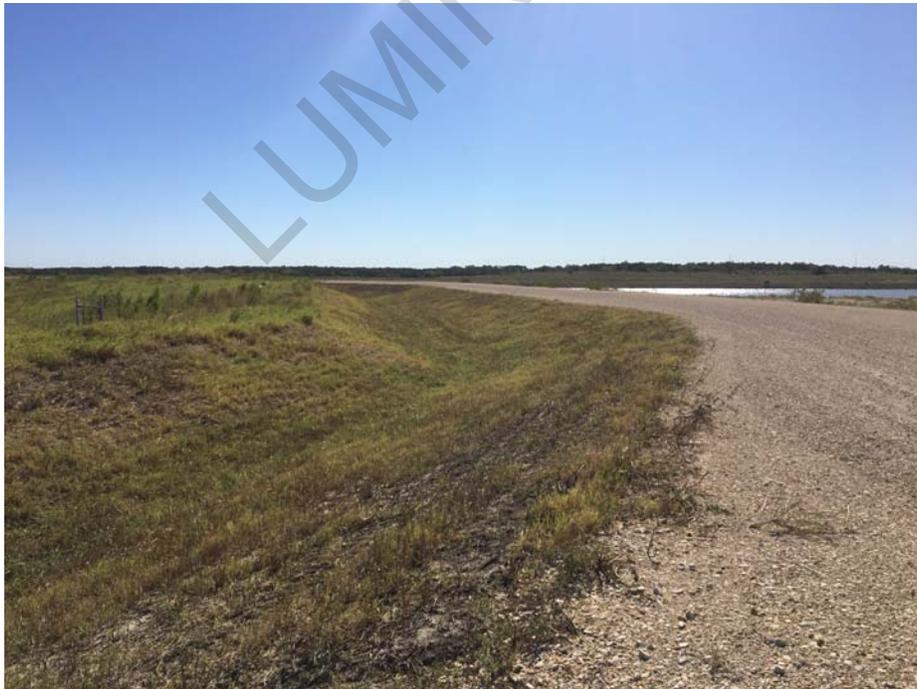
Pastor, Behling & Wheeler PROJECT NO. 5313B	DESCRIPTION	Photograph 20 – (View NE) Top of embankment on north side of Cell 2A. Cell 2A to right.	
	SITE NAME	Sandow Unit No. 5 – AX Landfill Annual Inspection	DATE 10/24/17

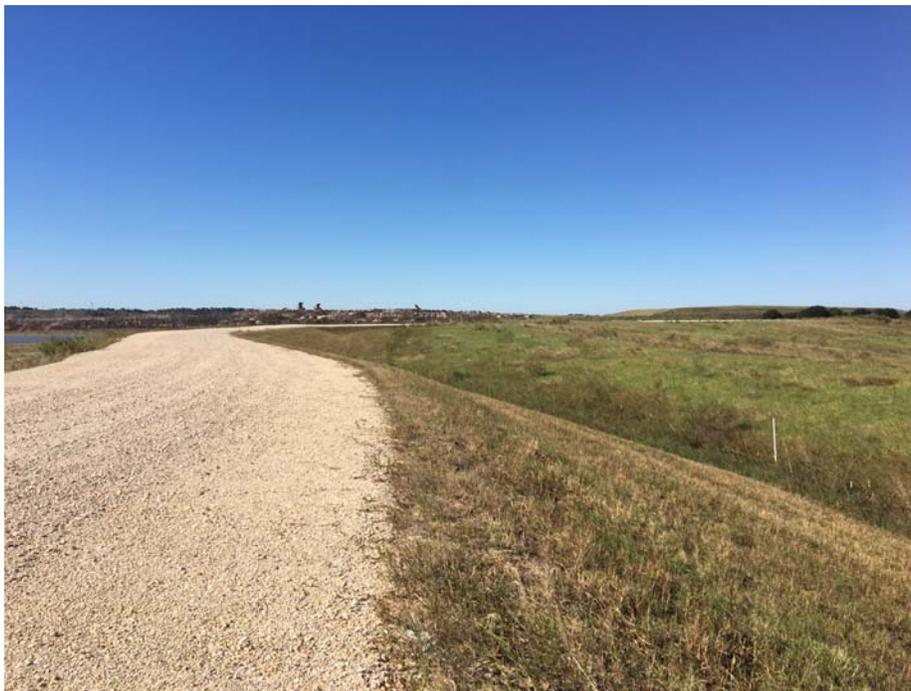
Pastor, Behling & Wheeler	DESCRIPTION	Photograph 21 – (View W) Top of embankment along north side of Cell 2A, from NE corner of Cell 2A.	
PROJECT NO. 5313B	SITE NAME	Sandow Unit No. 5 – AX Landfill Annual Inspection	DATE 10/24/17

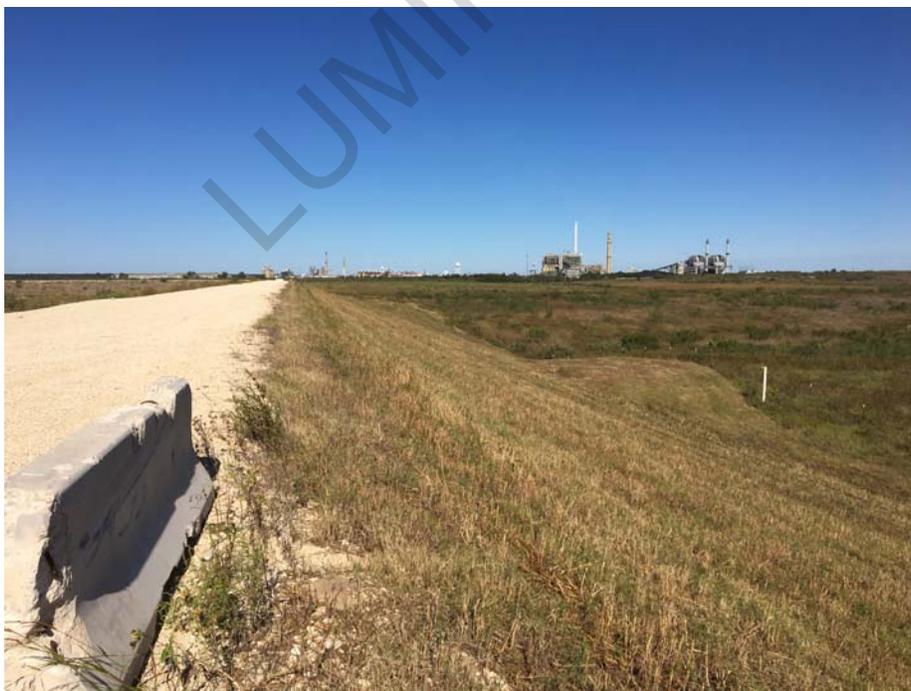
Pastor, Behling & Wheeler	DESCRIPTION	Photograph 22 – (View NW) Top of embankment along east side of Cell 2A, from SE corner of cell 2A.	
PROJECT NO. 5313B	SITE NAME	Sandow Unit No. 5 – AX Landfill Annual Inspection	DATE 10/24/17

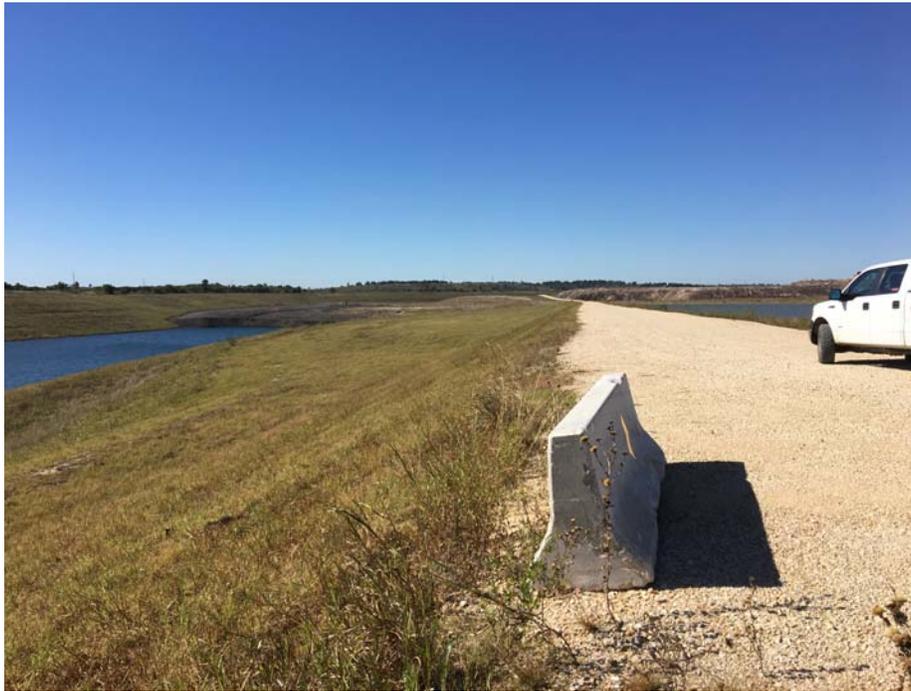
Pastor, Behling & Wheeler	DESCRIPTION	Photograph 23 – (View SW) Top of embankment along south side of Cell 2A, from SE corner of Cell 2A.	
PROJECT NO. 5313B	SITE NAME	Sandow Unit No. 5 – AX Landfill Annual Inspection	DATE 10/24/17
