October 2016

**RE: History of Construction
USEPA Final CCR Rule, 40 CFR § 257.73(c)
Joppa Power Station
Joppa, Illinois**

On behalf of Electric Energy, Inc., AECOM has prepared the following history of construction for the East Ash Pond at the Joppa Power Station in accordance with 40 CFR § 257.73(c).

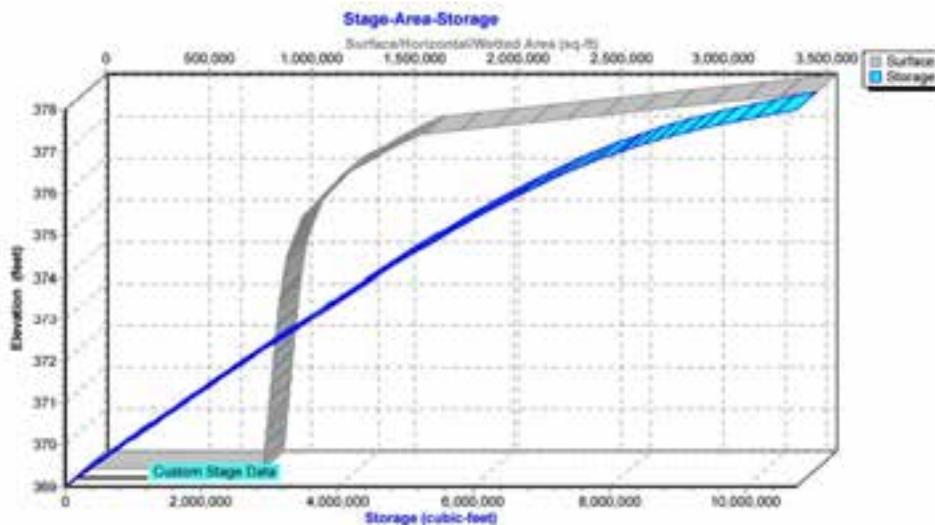
Figure 1. Area-capacity curve for East Ash Pond - south sub-basin

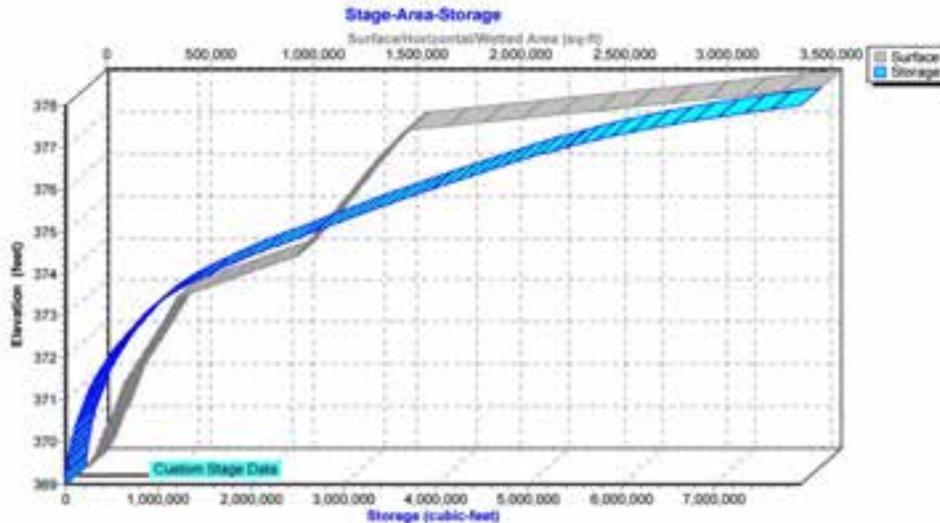
Figure 2. Area-capacity curve for East Ash Pond - north sub-basin

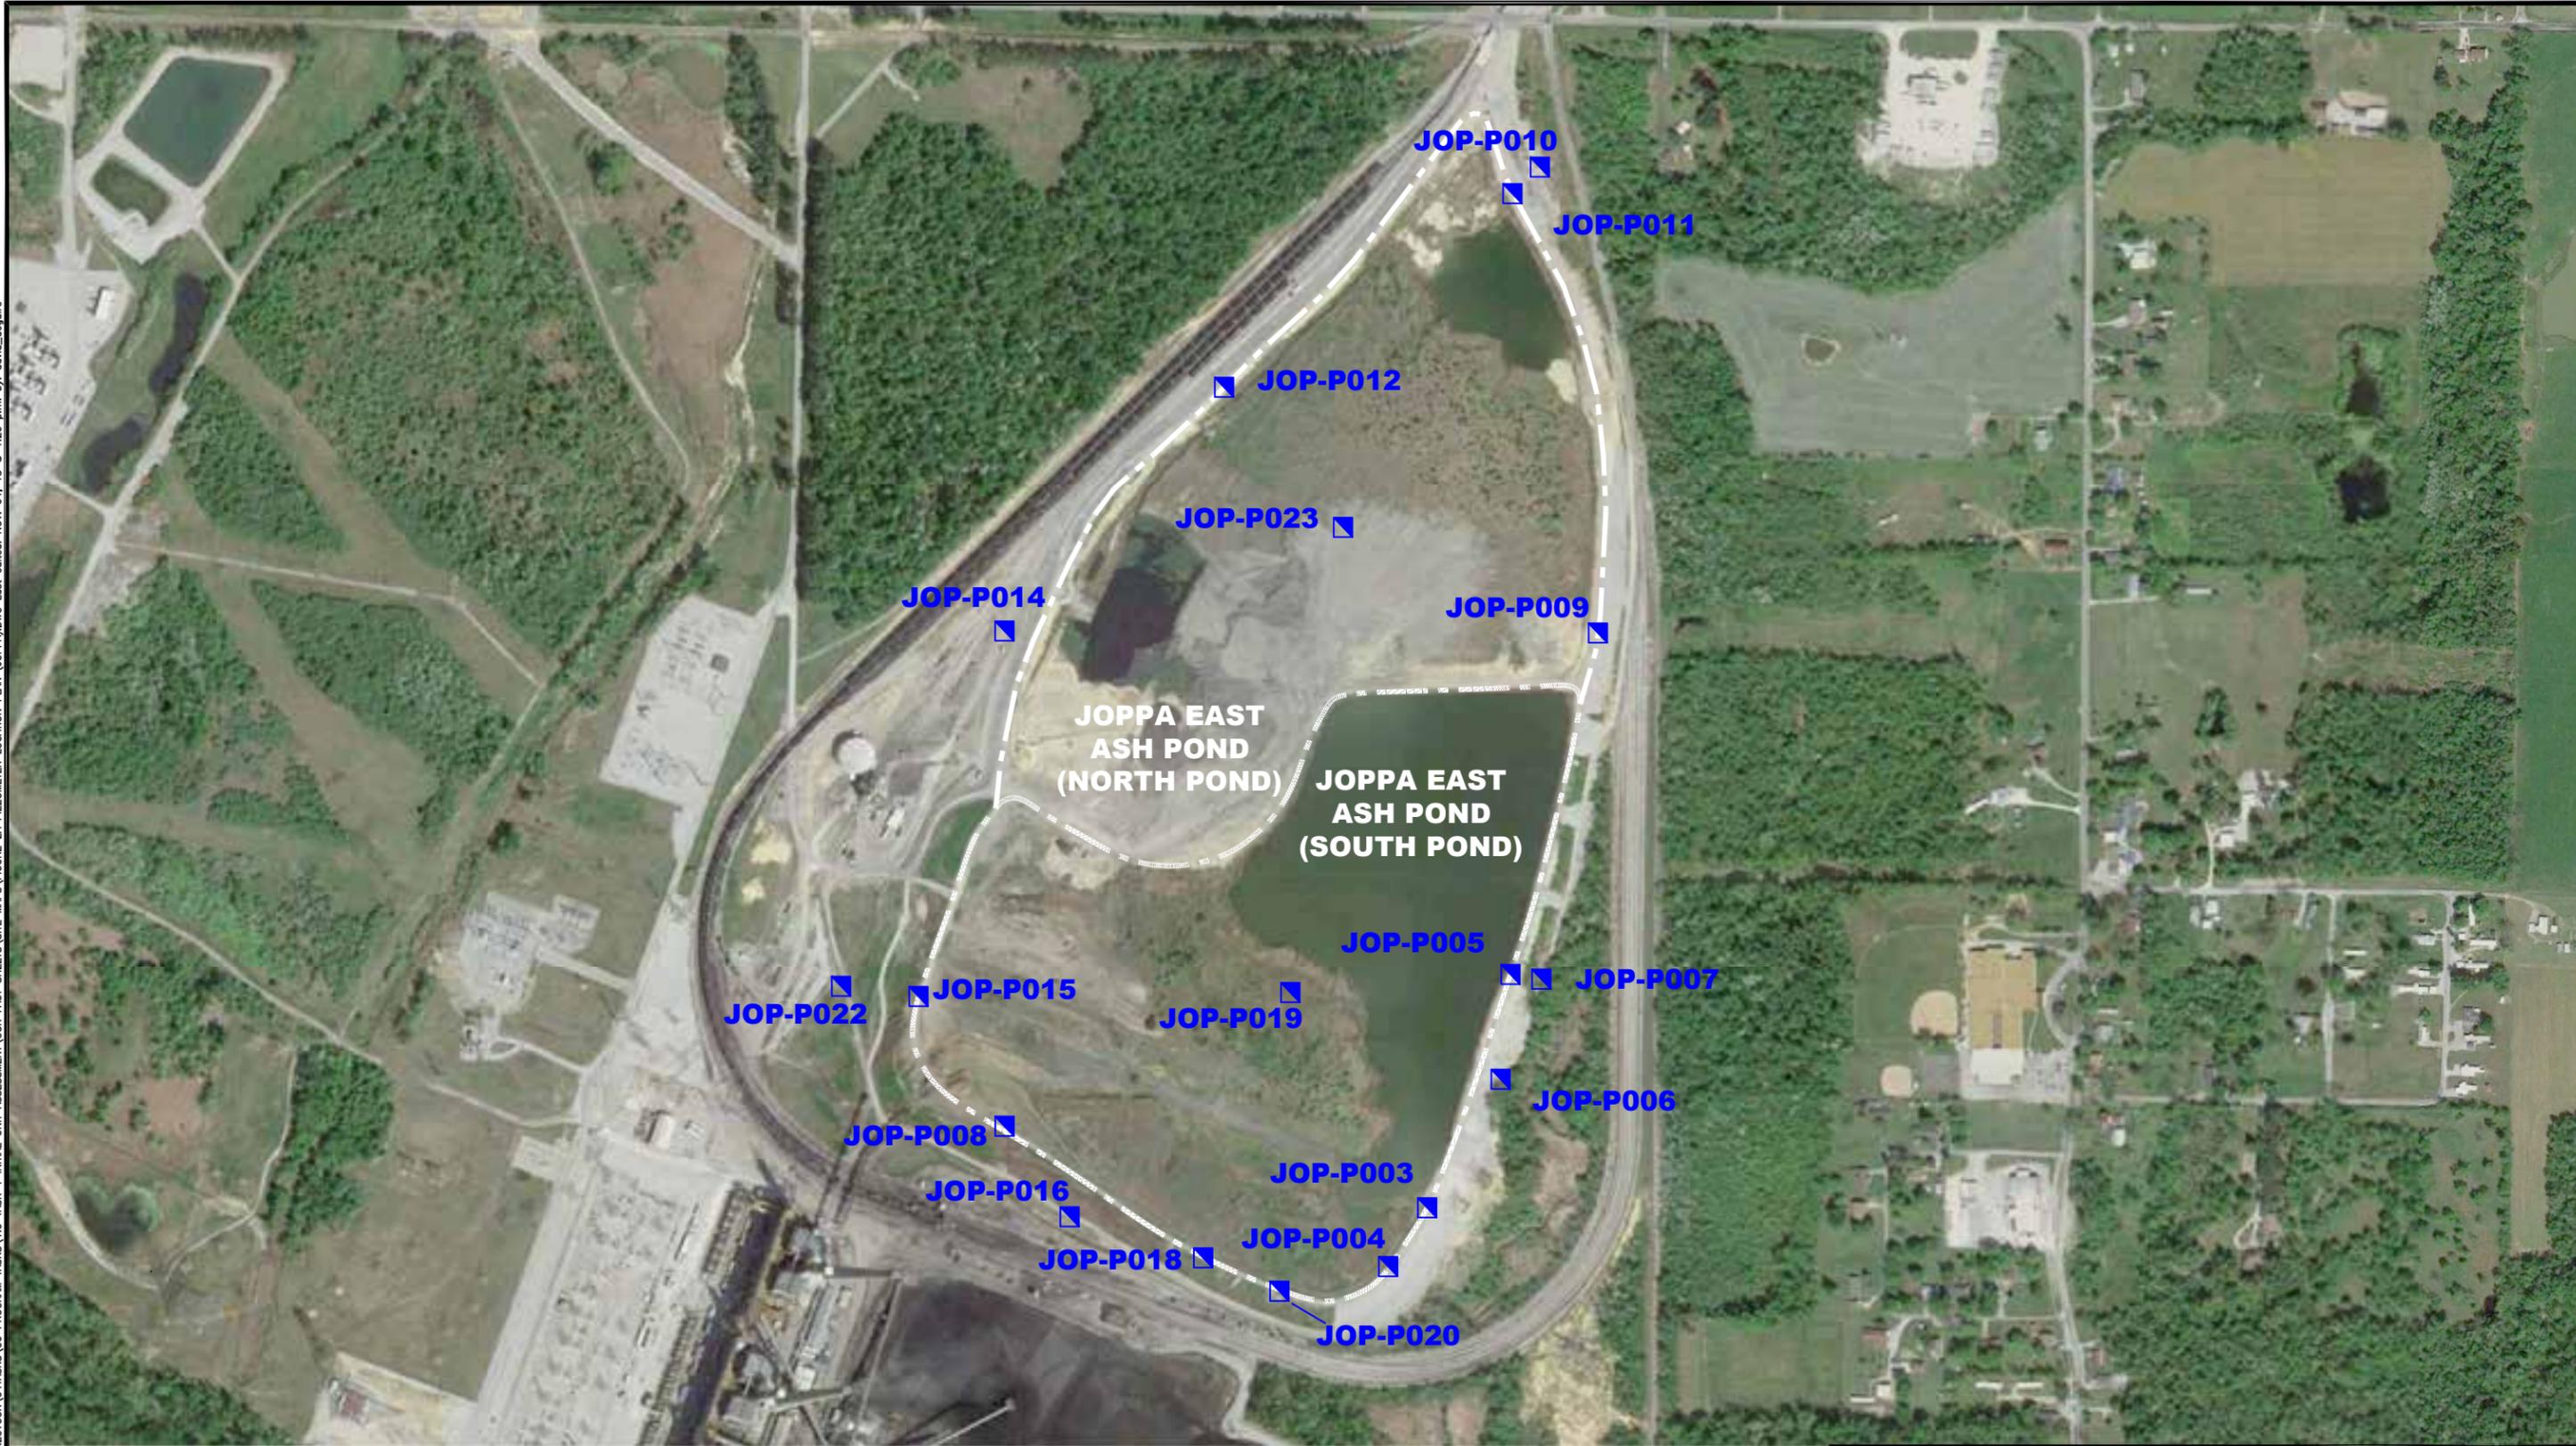
Electric Energy, Inc.		PROJECT NO. 60440155
AECOM		
DRN. BY:djd October 2015 DSGN. BY:eg CHKD. BY:eg	Joppa East Ash Pond Piezometer Locations	FIG. NO. 2A

Existing instrumentation at the East Ash Pond include vibrating-wire and open-standpipe piezometers. The purpose of the piezometers is to measure the pore water pressures within and around the impoundment. Two (2) existing open-standpipe piezometers (B-1 and B-4) were installed in 2010 and the locations are presented on Plate 2 in **Appendix C**. Eighteen (18) vibrating-wire piezometers were installed in 2015 and the locations are presented on Figure 2A in **Appendix C**.

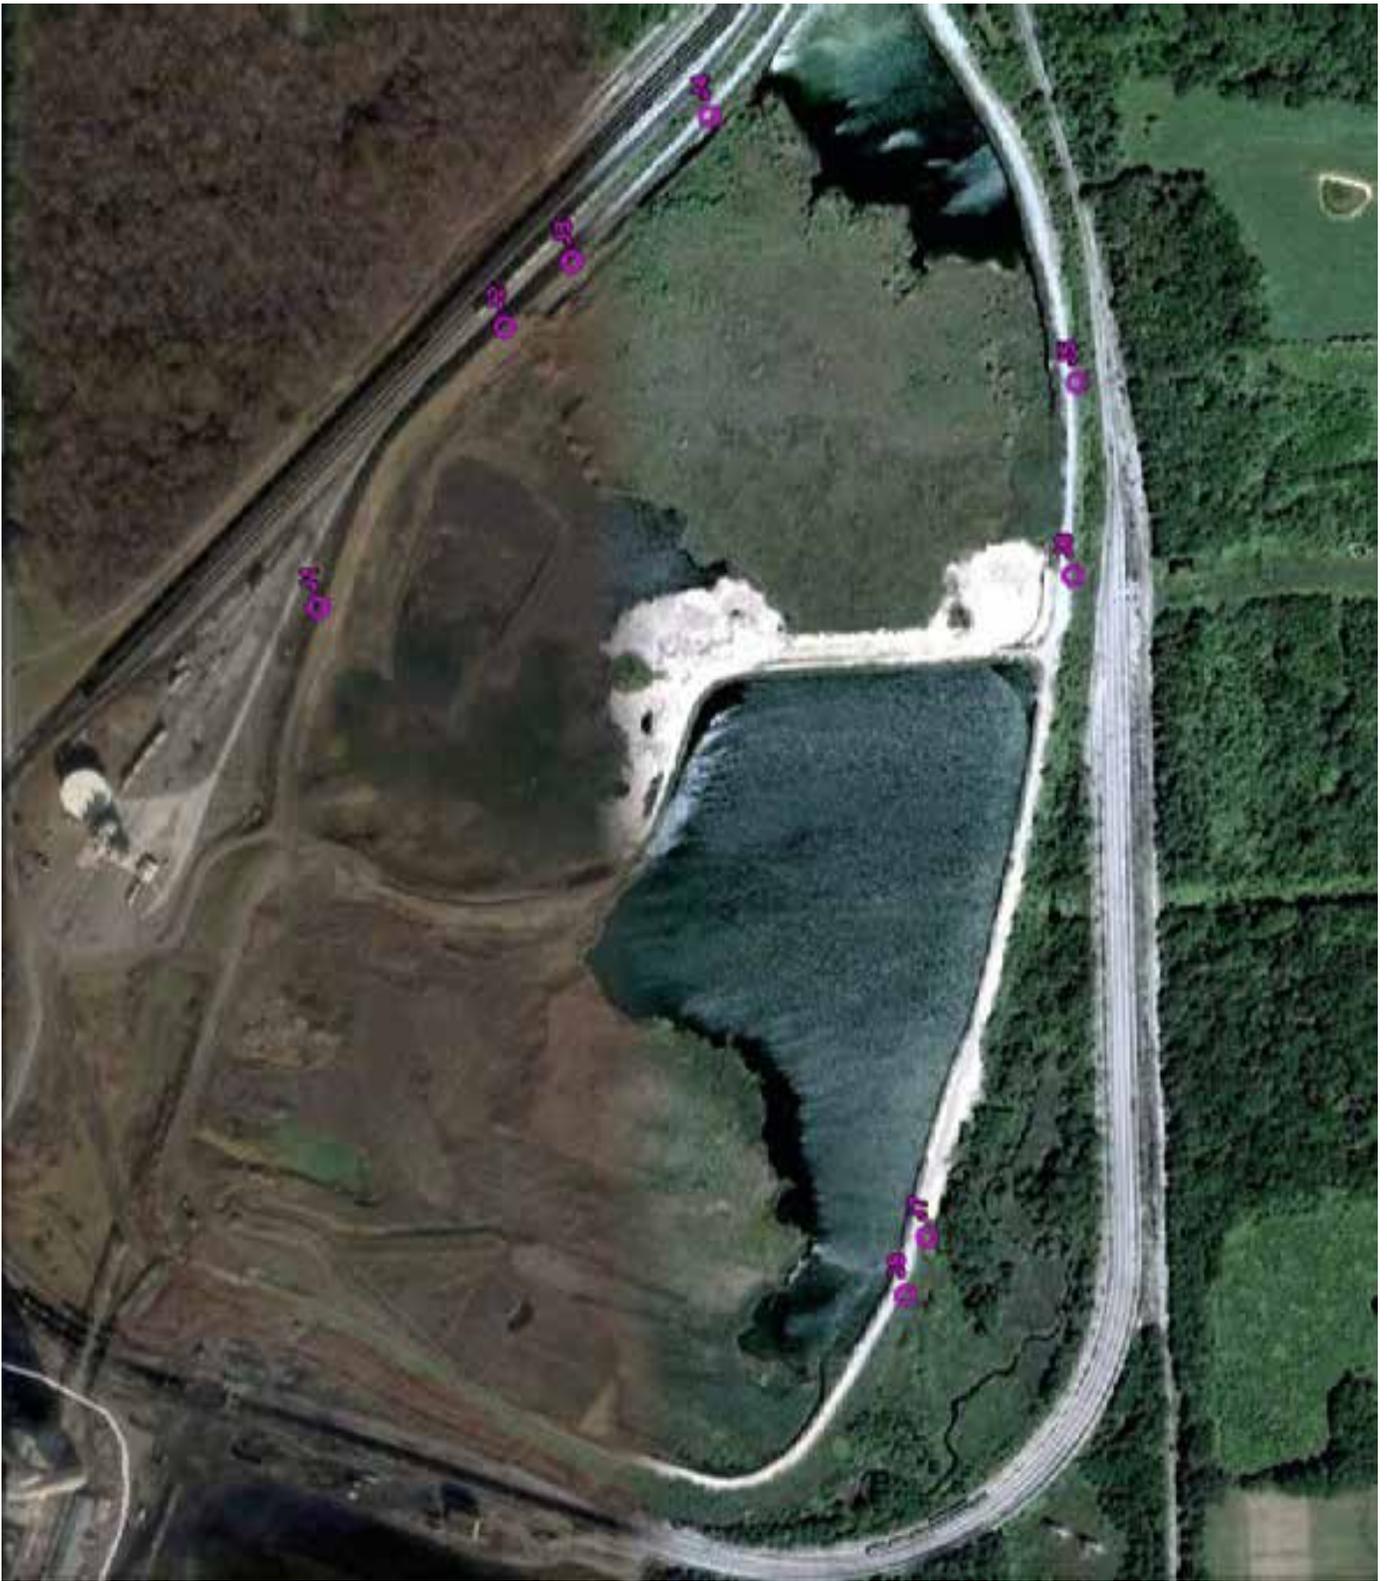
During the inspection, sloughs at eight areas of instability were observed. The areas of instability are shown on the attached photographs. The sloughs appeared to be relatively shallow. The length of scarp varied from as little as 25 ft in length to as much as 150 ft in length. The scarps generally began at the top of the slope and extended to between one-half of the embankment height and the full embankment height. The embankment soils exposed by the slide were observed to be firm to hard at a shallow depth (less than 1 ft in most instances) when probed with a thin steel rod (drain tile probe).

The sloughs observed on the northern ash pond (#1 through #6) and one of two slough areas on the southern ash pond (area #7) appeared to be mainly due to sliding at the interface between ash materials apparently added to the downstream embankment slope and the original cohesive soil embankment constructed in 1985. Water infiltration through the ash materials that did not infiltrate the cohesive soils appears to have reduced the friction between these materials and caused sloughing. The sloughed material appeared to be composed of partially hydrated flyash and was generally hard and brittle.
