**2017 ANNUAL CCR UNIT INSPECTION REPORT**

**LUMINANT – MARTIN LAKE STEAM ELECTRIC STATION  
ASH POND AREA, PERMANENT DISPOSAL POND NO. 5 & A-1 AREA LANDFILL  
RUSK & PANOLA COUNTY, TEXAS**

January 2018

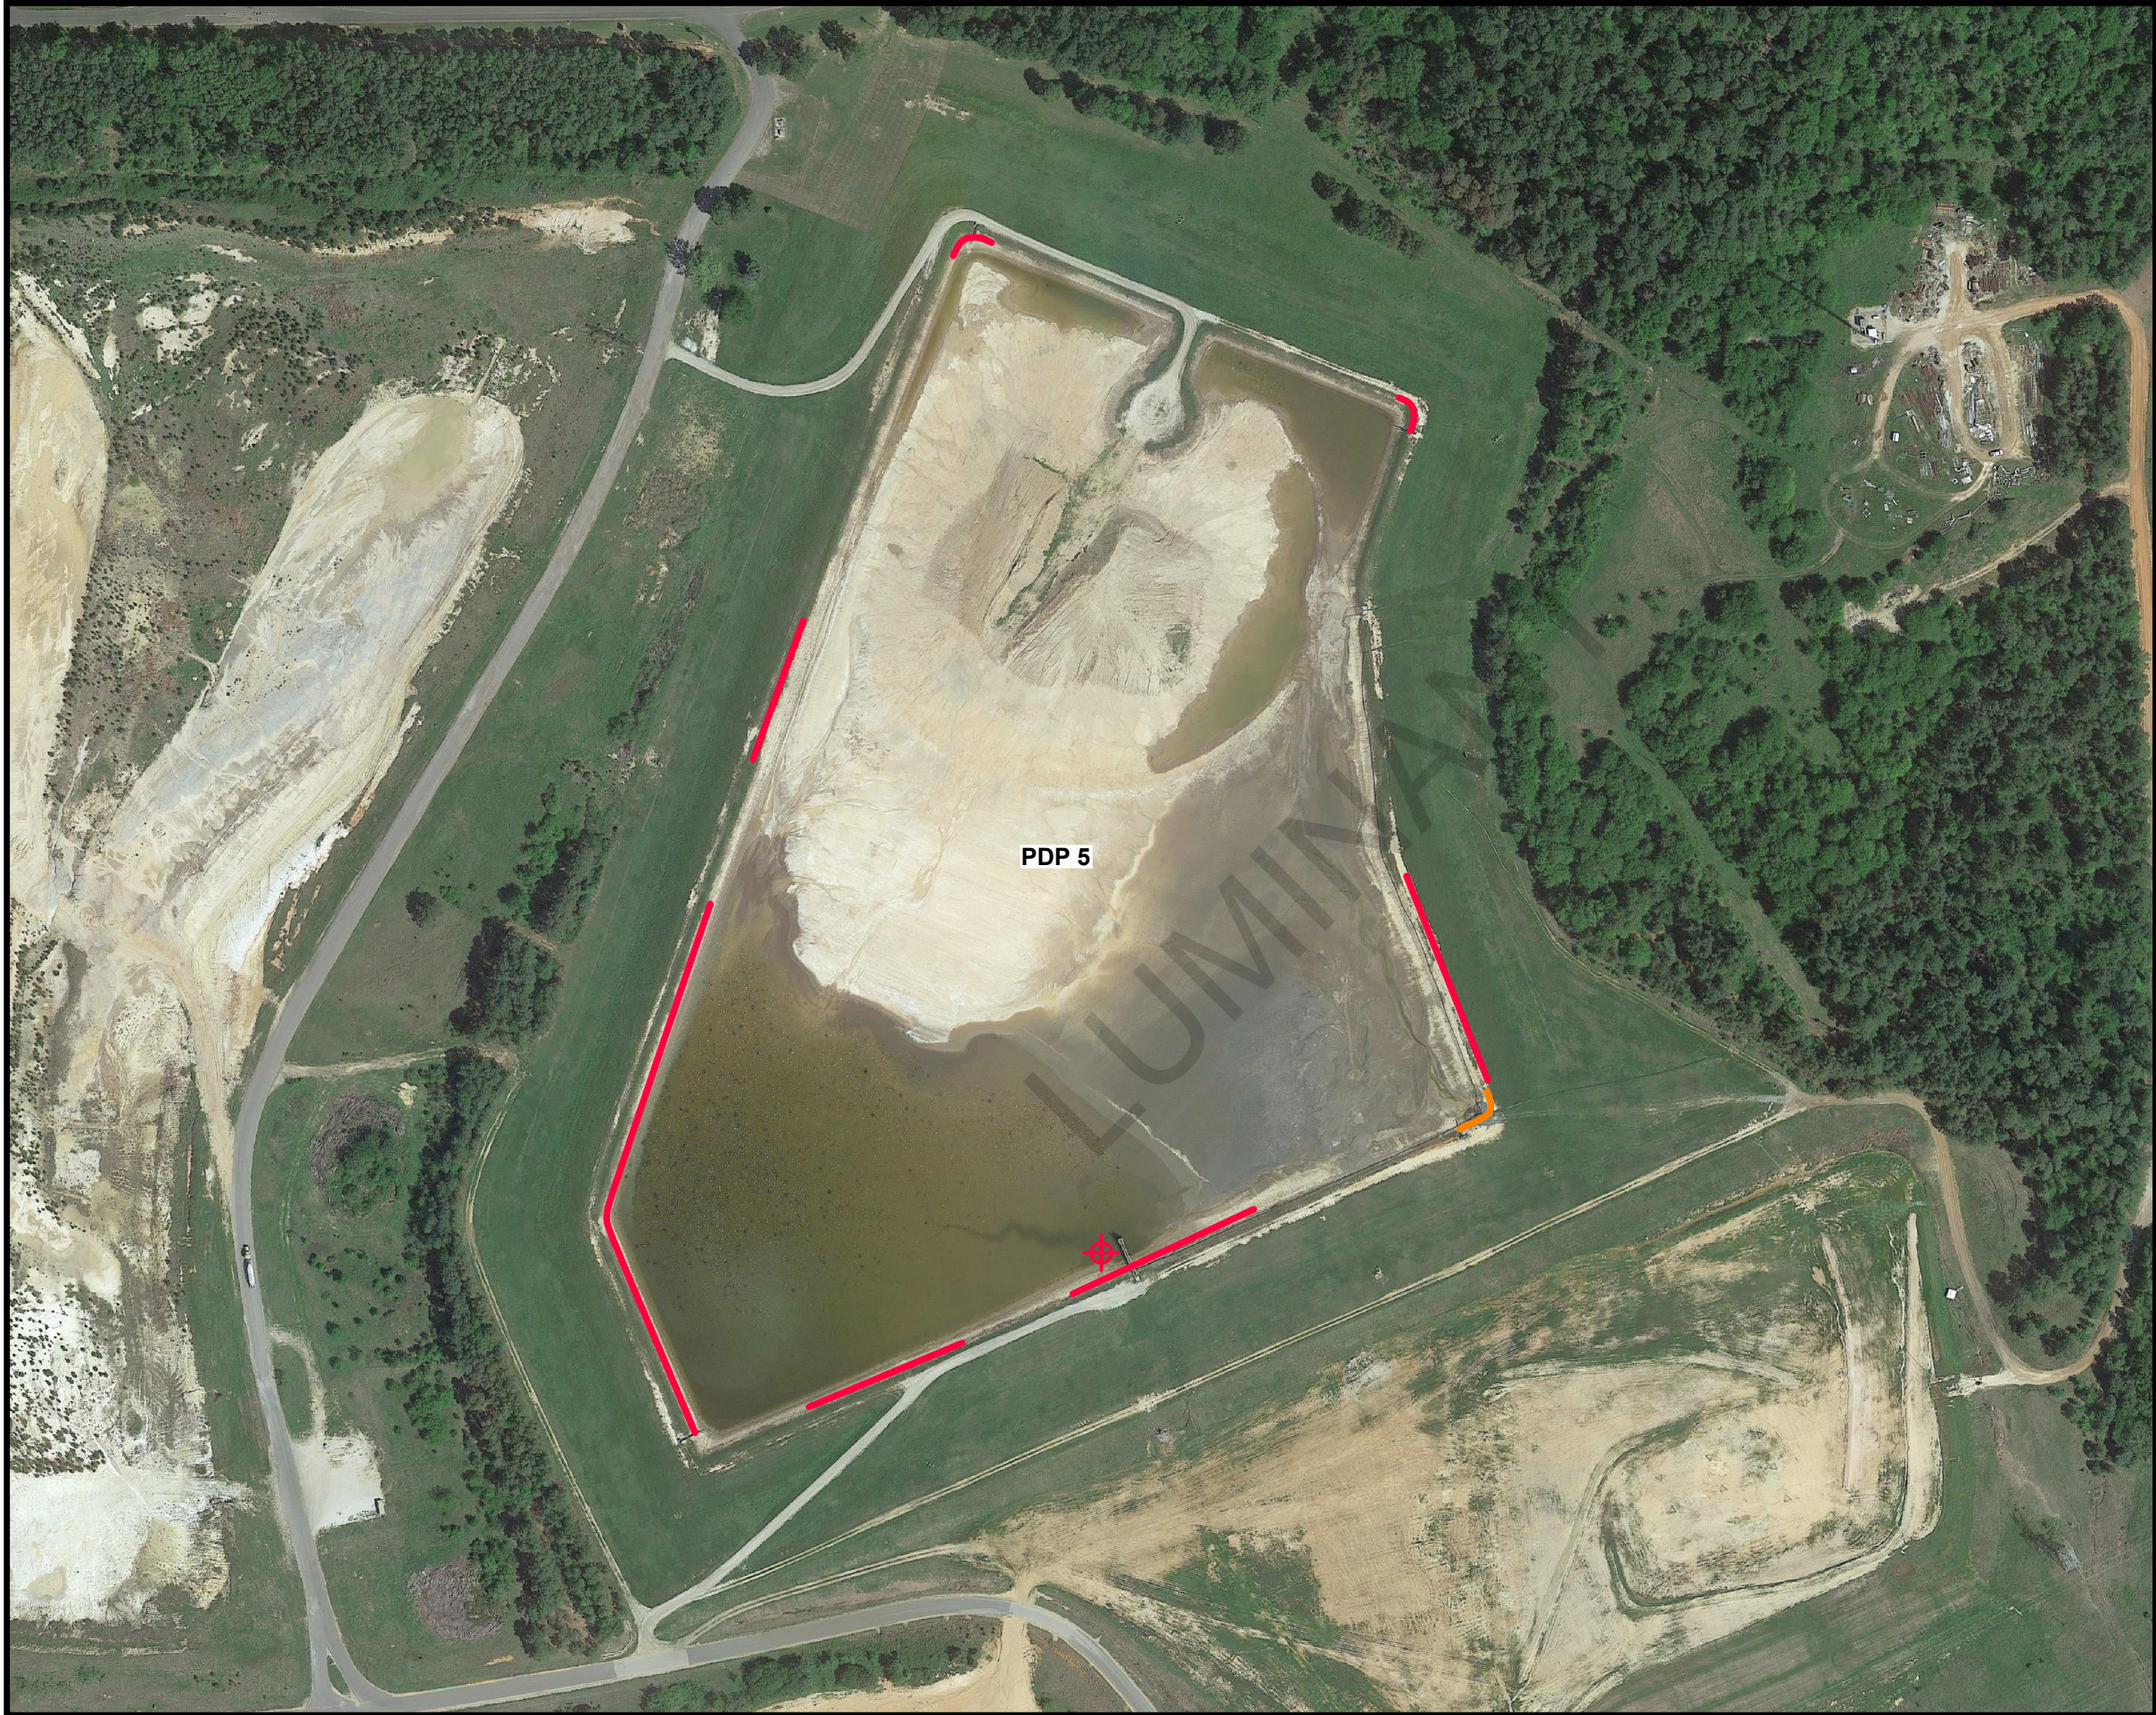
- Monitor Interior (Upstream) Embankment Erosion
- Repair Erosion/Armor Interior Embankment at Point of Discharge to PDP 5 (Influent Piping)
- Impoundment Staff Gauge

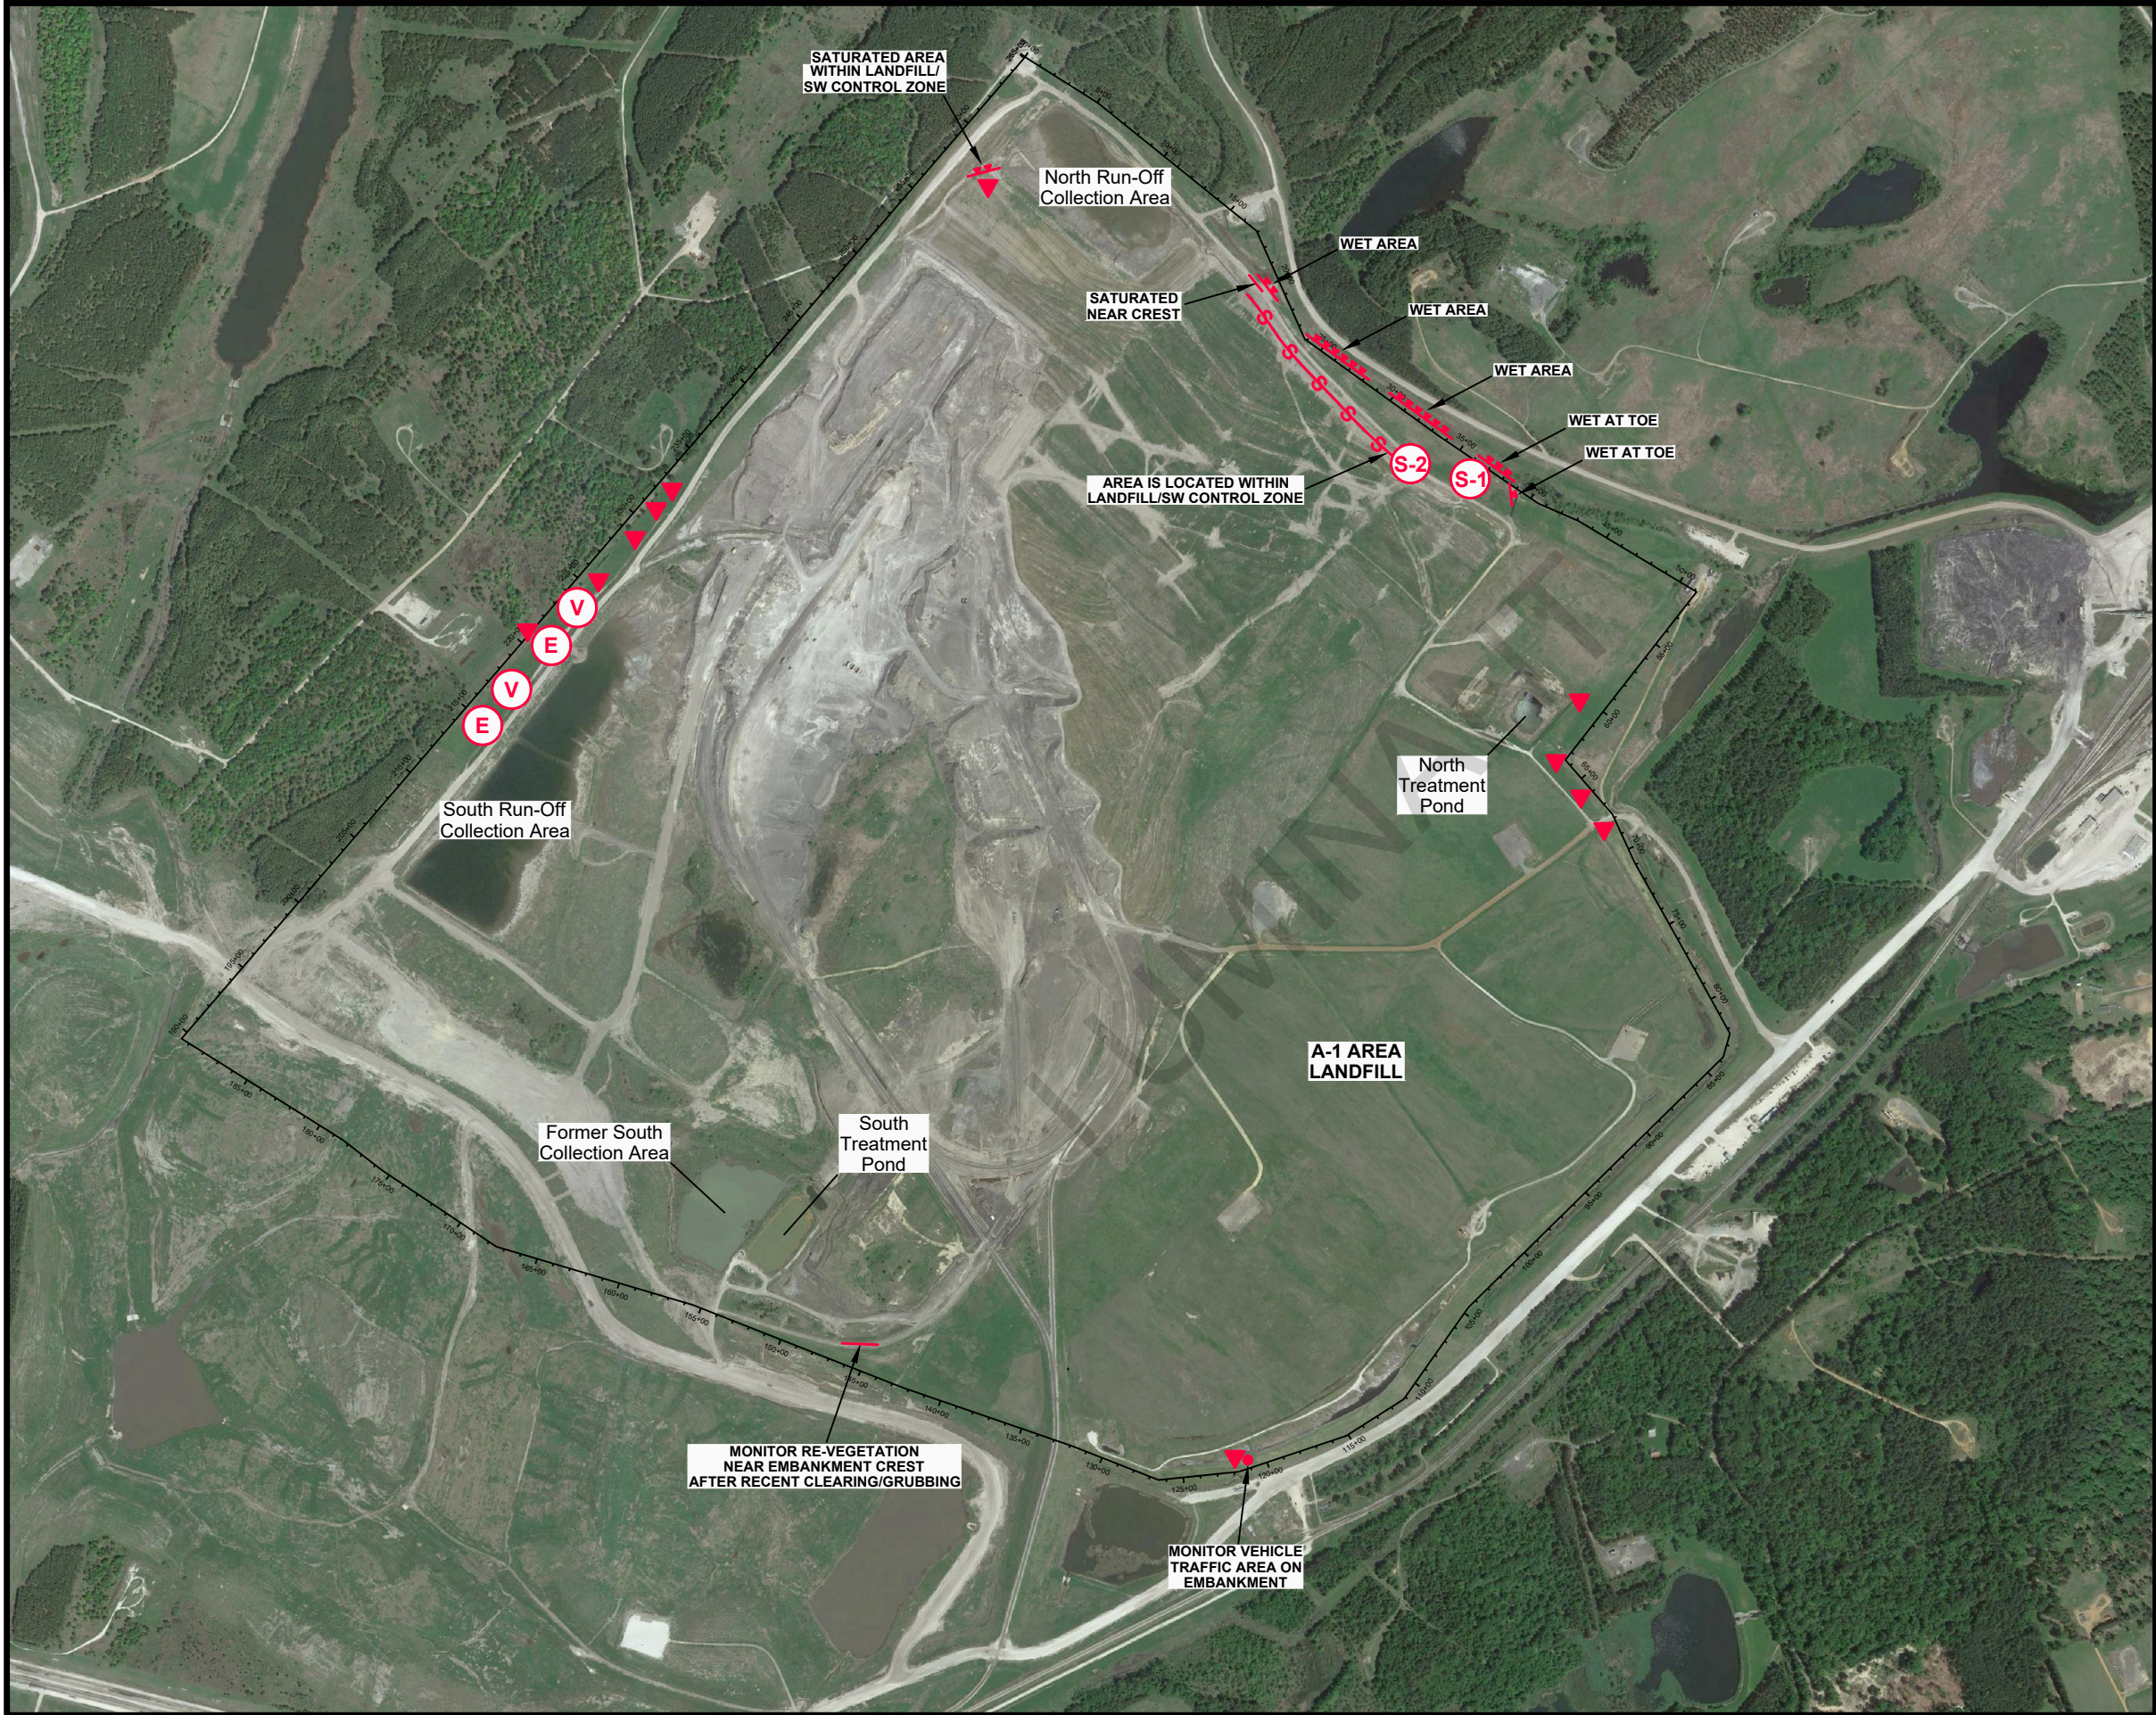
- ▼ Monitor Hog Damage
- (S-1) Category-1 Seep (No Discharge; Control Locally)
- (S-2) Category-2 Seep (Controlled by Landfill SW Control System)
- S— Saturated Soil Near Crest with Drainage Control Diversion (Recently capped area)
- (V) Monitor Limited Vegetative Cover on Embankment
- (E) Monitor Minor Erosion on Embankment
- ▲▲▲ Monitor Wet Area at toe
