**RE: History of Construction  
USEPA Final CCR Rule, 40 CFR § 257.73(c)  
Kincaid Power Station  
Kincaid, Illinois**

On behalf of Kincaid Generation, L.L.C., AECOM has prepared the following history of construction for the Ash Pond at the Kincaid Power Station in accordance with 40 CFR § 257.73(c).

RE: Ash Pond Embankment Settlement

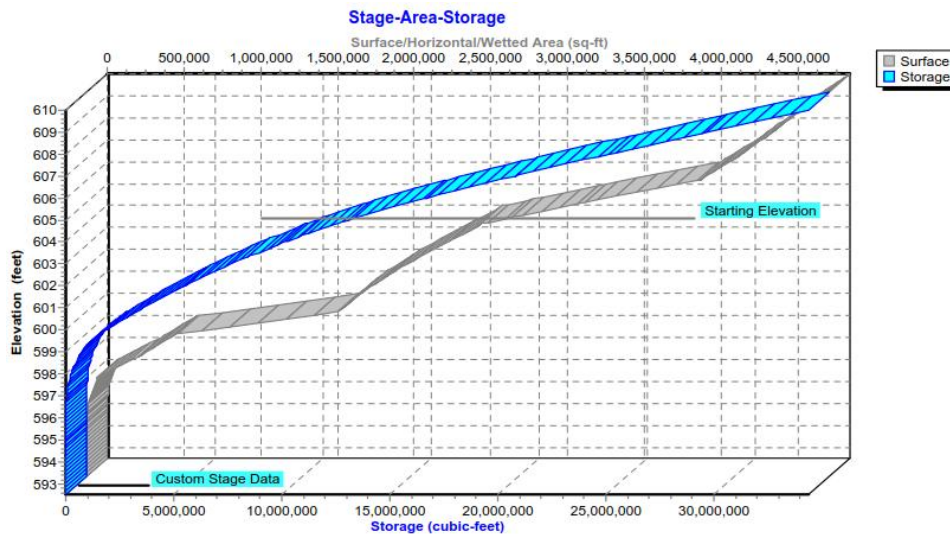
**Figure 1. Area-capacity curve for Ash Pond**

The area-capacity curve shown was taken from the pond modeling analysis. Actual pond capacity is limited to the approximate berm elevation listed in **Table 5** below. Any information above berm elevation should be disregarded.
