# Office Memorandum

**Subject:** Ash Pond Structural Stability Assessment  
Kincaid Generation, LLC  
Kincaid Power Station

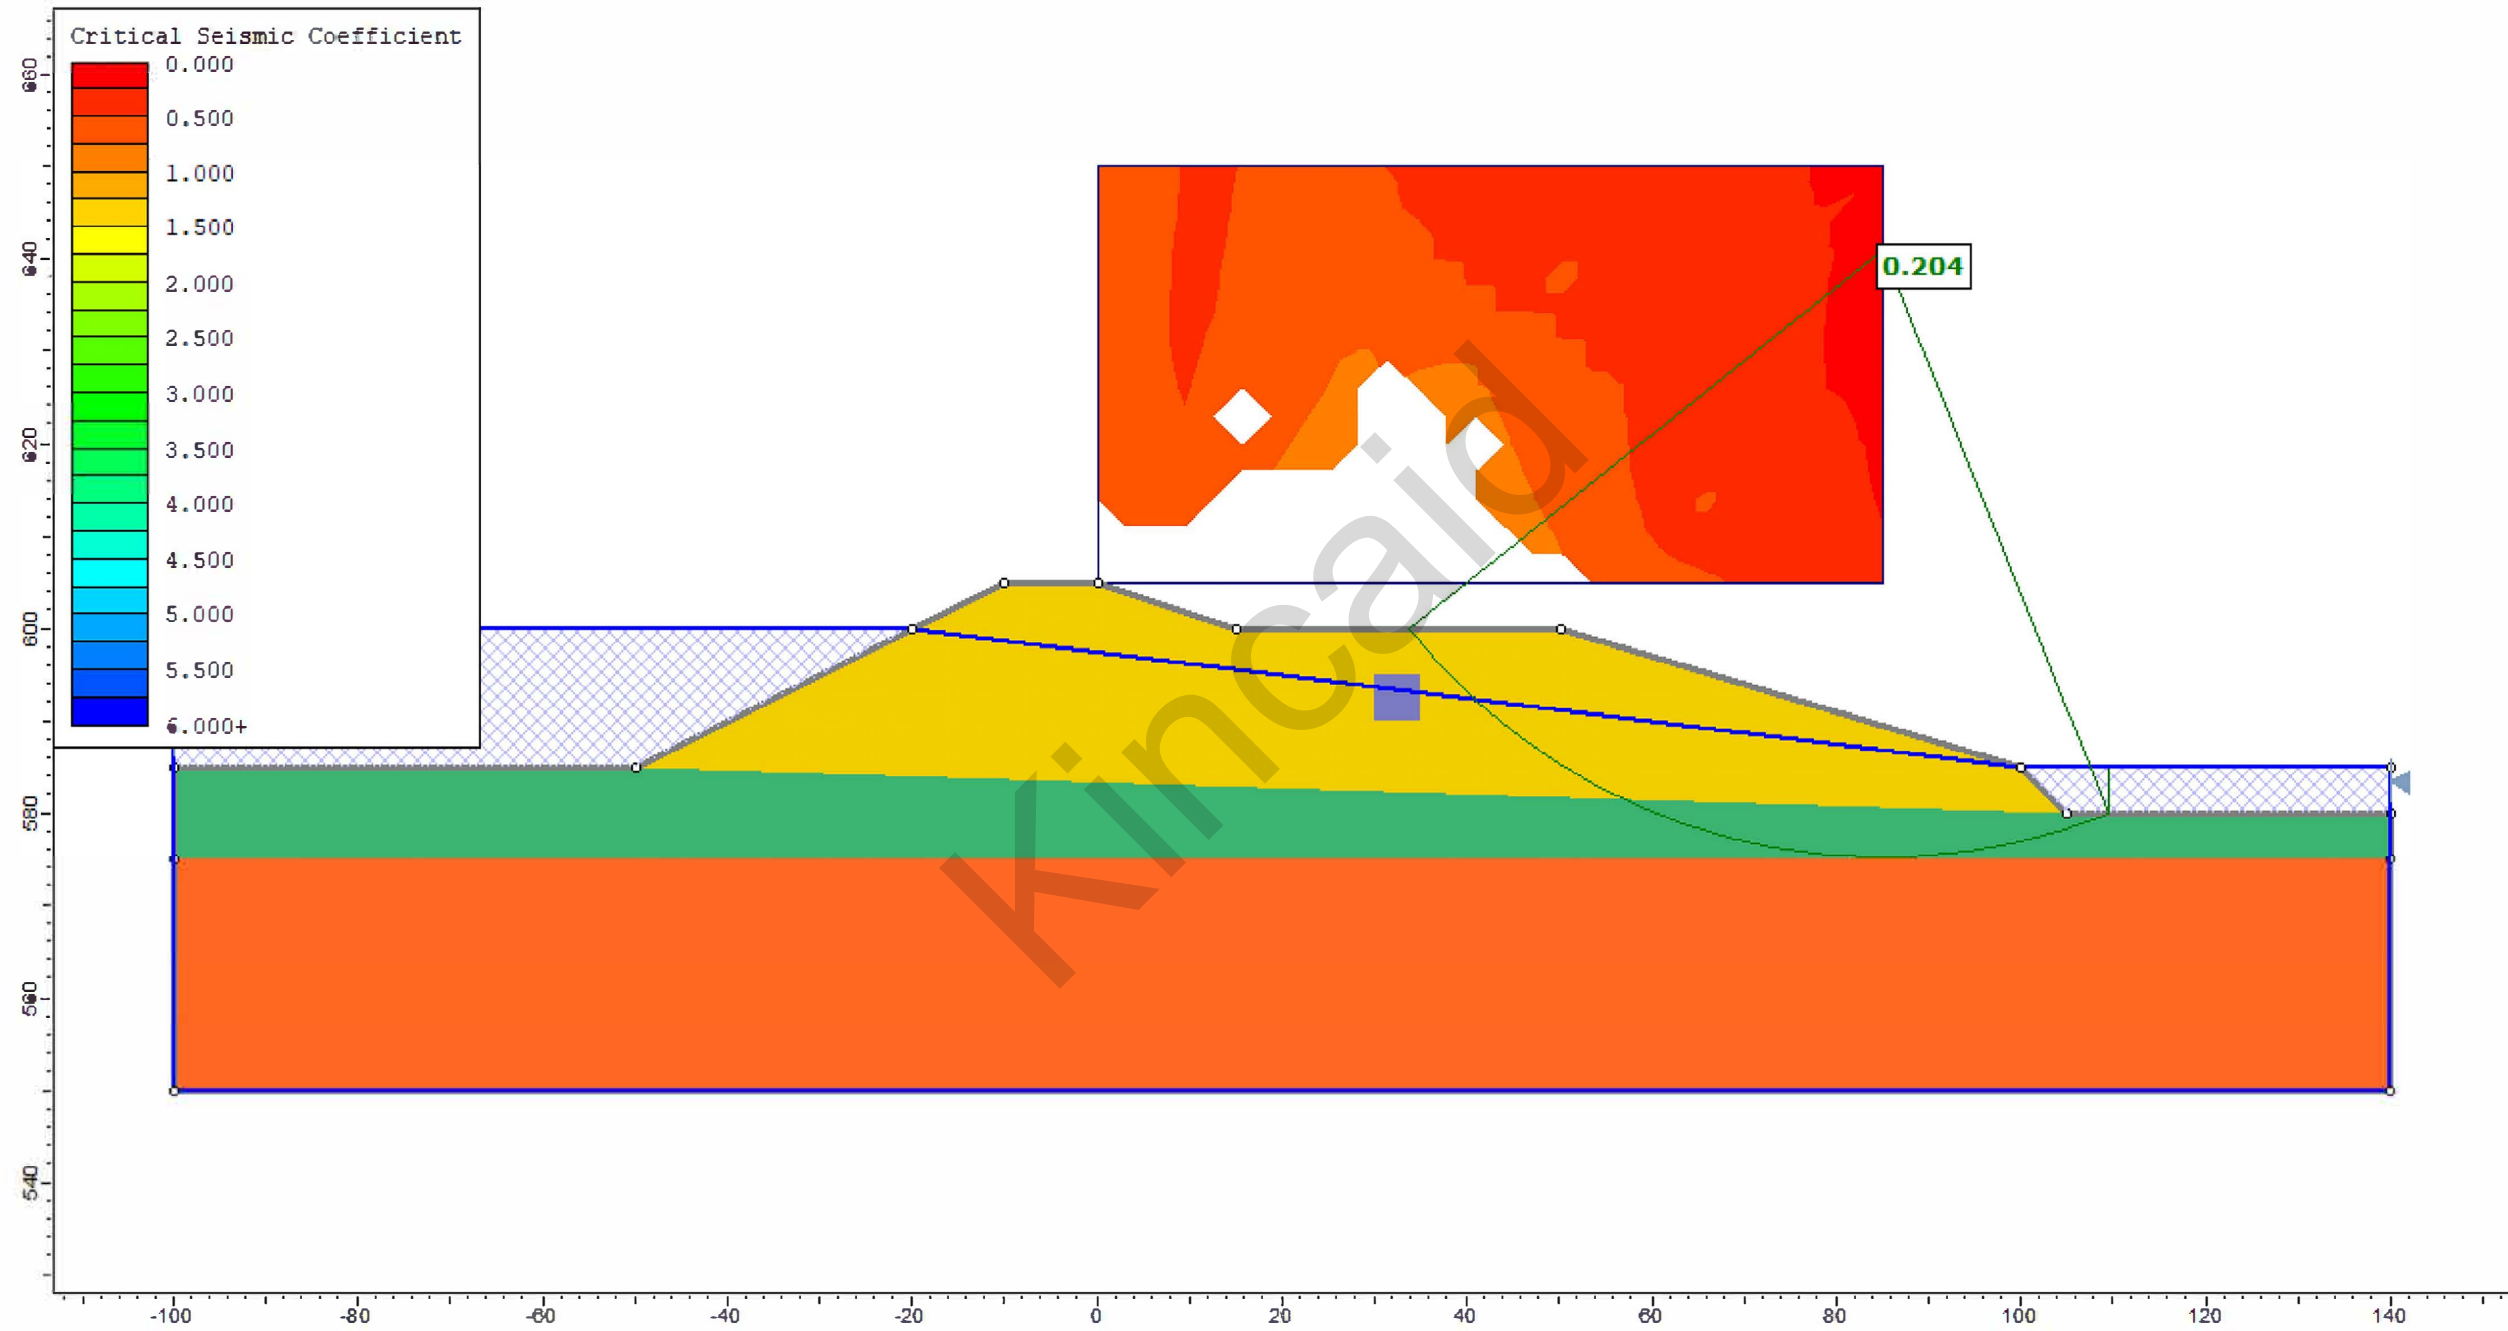
- The analysis of the movement shown in Figure 3A is to determine the integrity of the pipe should earthquake movement occur at the outlet.
  - The design earthquake parameters were taken from the results of the Probabilistic Seismic Hazard Analysis (PSHA) from the 2016 AECOM report.

**§257.73(e)(1)(III) Seismic Safety Factor must be at least 1.0**

- Square in embankment represents the 60-inch diameter pipe - in failure - no strength
- This analysis shows the displacement from the modeled earthquake in the PSHA from the certification report
- Reference: Jibson, R.W., Rathje, E.M., Jibson, M.W. and Lee, Y.W., 2013. SLAMMER: Seismic landslide movement modeled using earthquake records (No. 12-B1). US Geological Survey.
