**2021 USEPA CCR RULE OPERATING
RECORD PERIODIC CERTIFICATION
REPORT
§257.73(a)(2)-(3), (c), (d¹), (e) and §257.82
MIAMI FORT POND SYSTEM
Miami Fort Power Plant
North Bend, Ohio**

Miami Fort Power Company, LLC

October 11, 2021

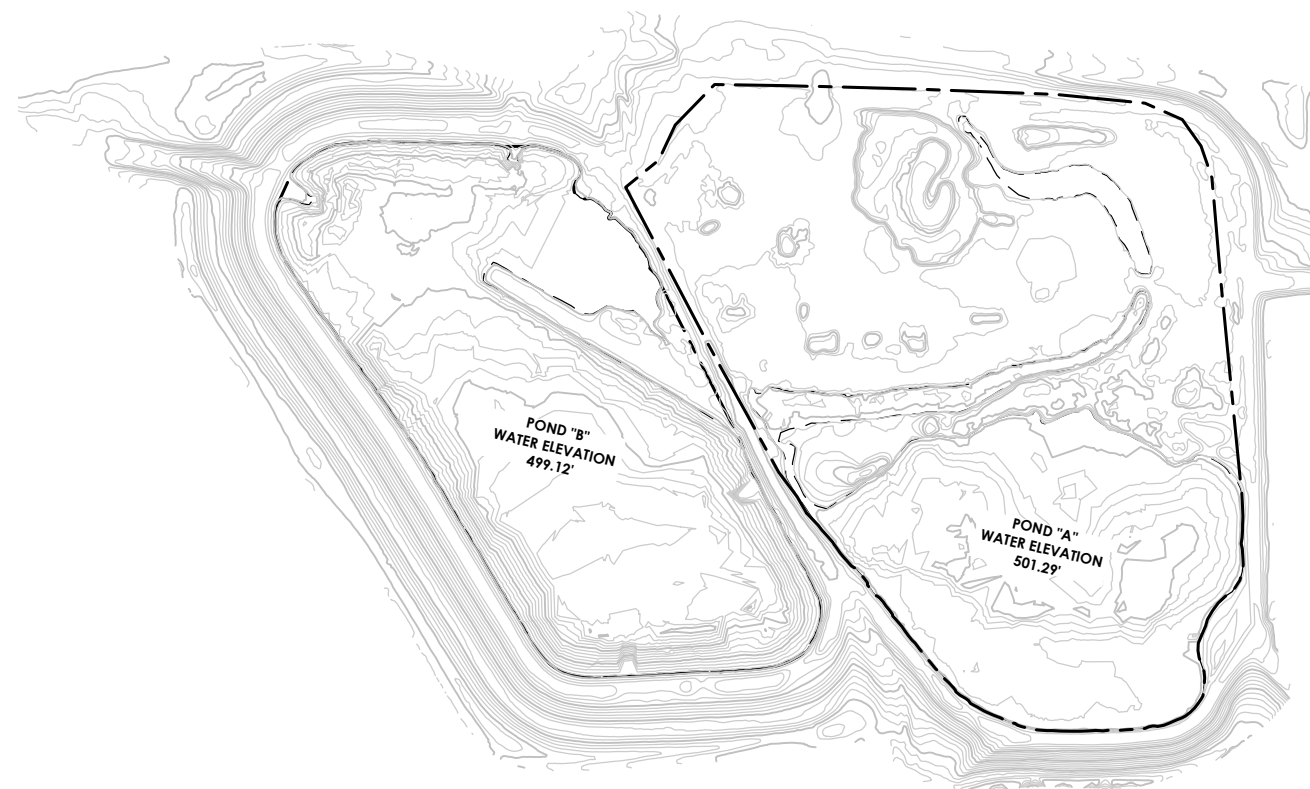
PERIODIC AERIAL
10-2020 IMAGERY

- General grading of the bottom ash and dry material handling area within Basin A is changed because of observed relocations and handling of stockpiles;
- No changes observed to the geometry of the perimeter or interior embankments; and
- Some maintenance dredging of accumulated sediment at the mouth of Basin B inlet pipe from Basin A is observed.

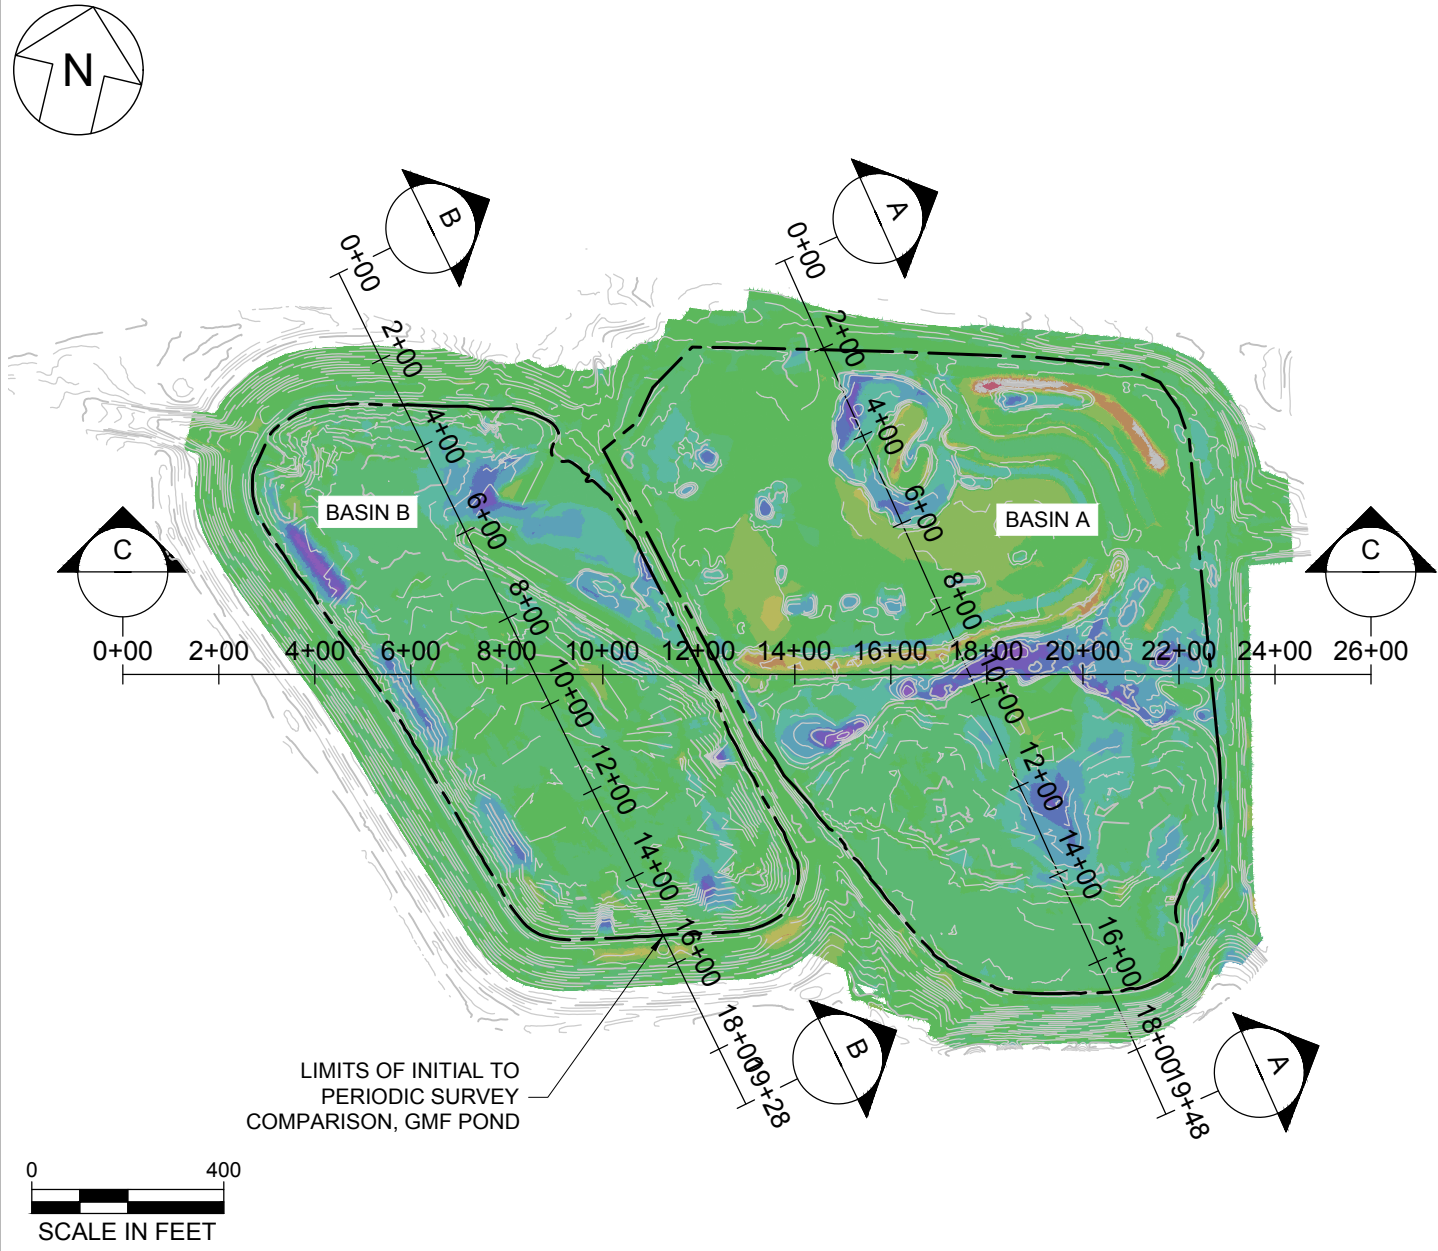
LIMITS OF INITIAL TO PERIODIC SURVEY COMPARISON, GMF POND

INITIAL TO PERIODIC SURVEY COMPARISON SUMMARY - BASIN A			
SURFACE IMPOUNDMENT	CUT	FILL	NET (CU. YD.)
ASH POND	32,234	63,967	31,733 (FILL)
ABOVE SWSE	28,060	42,193	14,133 (FILL)
BELOW SWSE	4,174	21,774	17,600 (FILL)

INITIAL TO PERIODIC SURVEY COMPARISON SUMMARY - BASIN B			
SURFACE IMPOUNDMENT	CUT	FILL	NET (CU. YD.)
ASH POND	7,459	35,153	27,694 (FILL)
ABOVE SWSE	2,379	4,108	1,729 (FILL)
BELOW SWSE	5,080	31,045	25,965 (FILL)
