**2017 ANNUAL CCR UNIT INSPECTION REPORT  
LUMINANT BIG BROWN STEAM ELECTRIC STATION  
NORTH AND SOUTH ASH PONDS & ASH DISPOSAL AREA II  
FREESTONE COUNTY, TEXAS**

January 10, 2018

**PASTOR, BEHLING & WHEELER, LLC**  
2201 Double Creek Drive, Suite 4004  
Round Rock, Texas 78664  
Texas Engineering Firm No. 4760

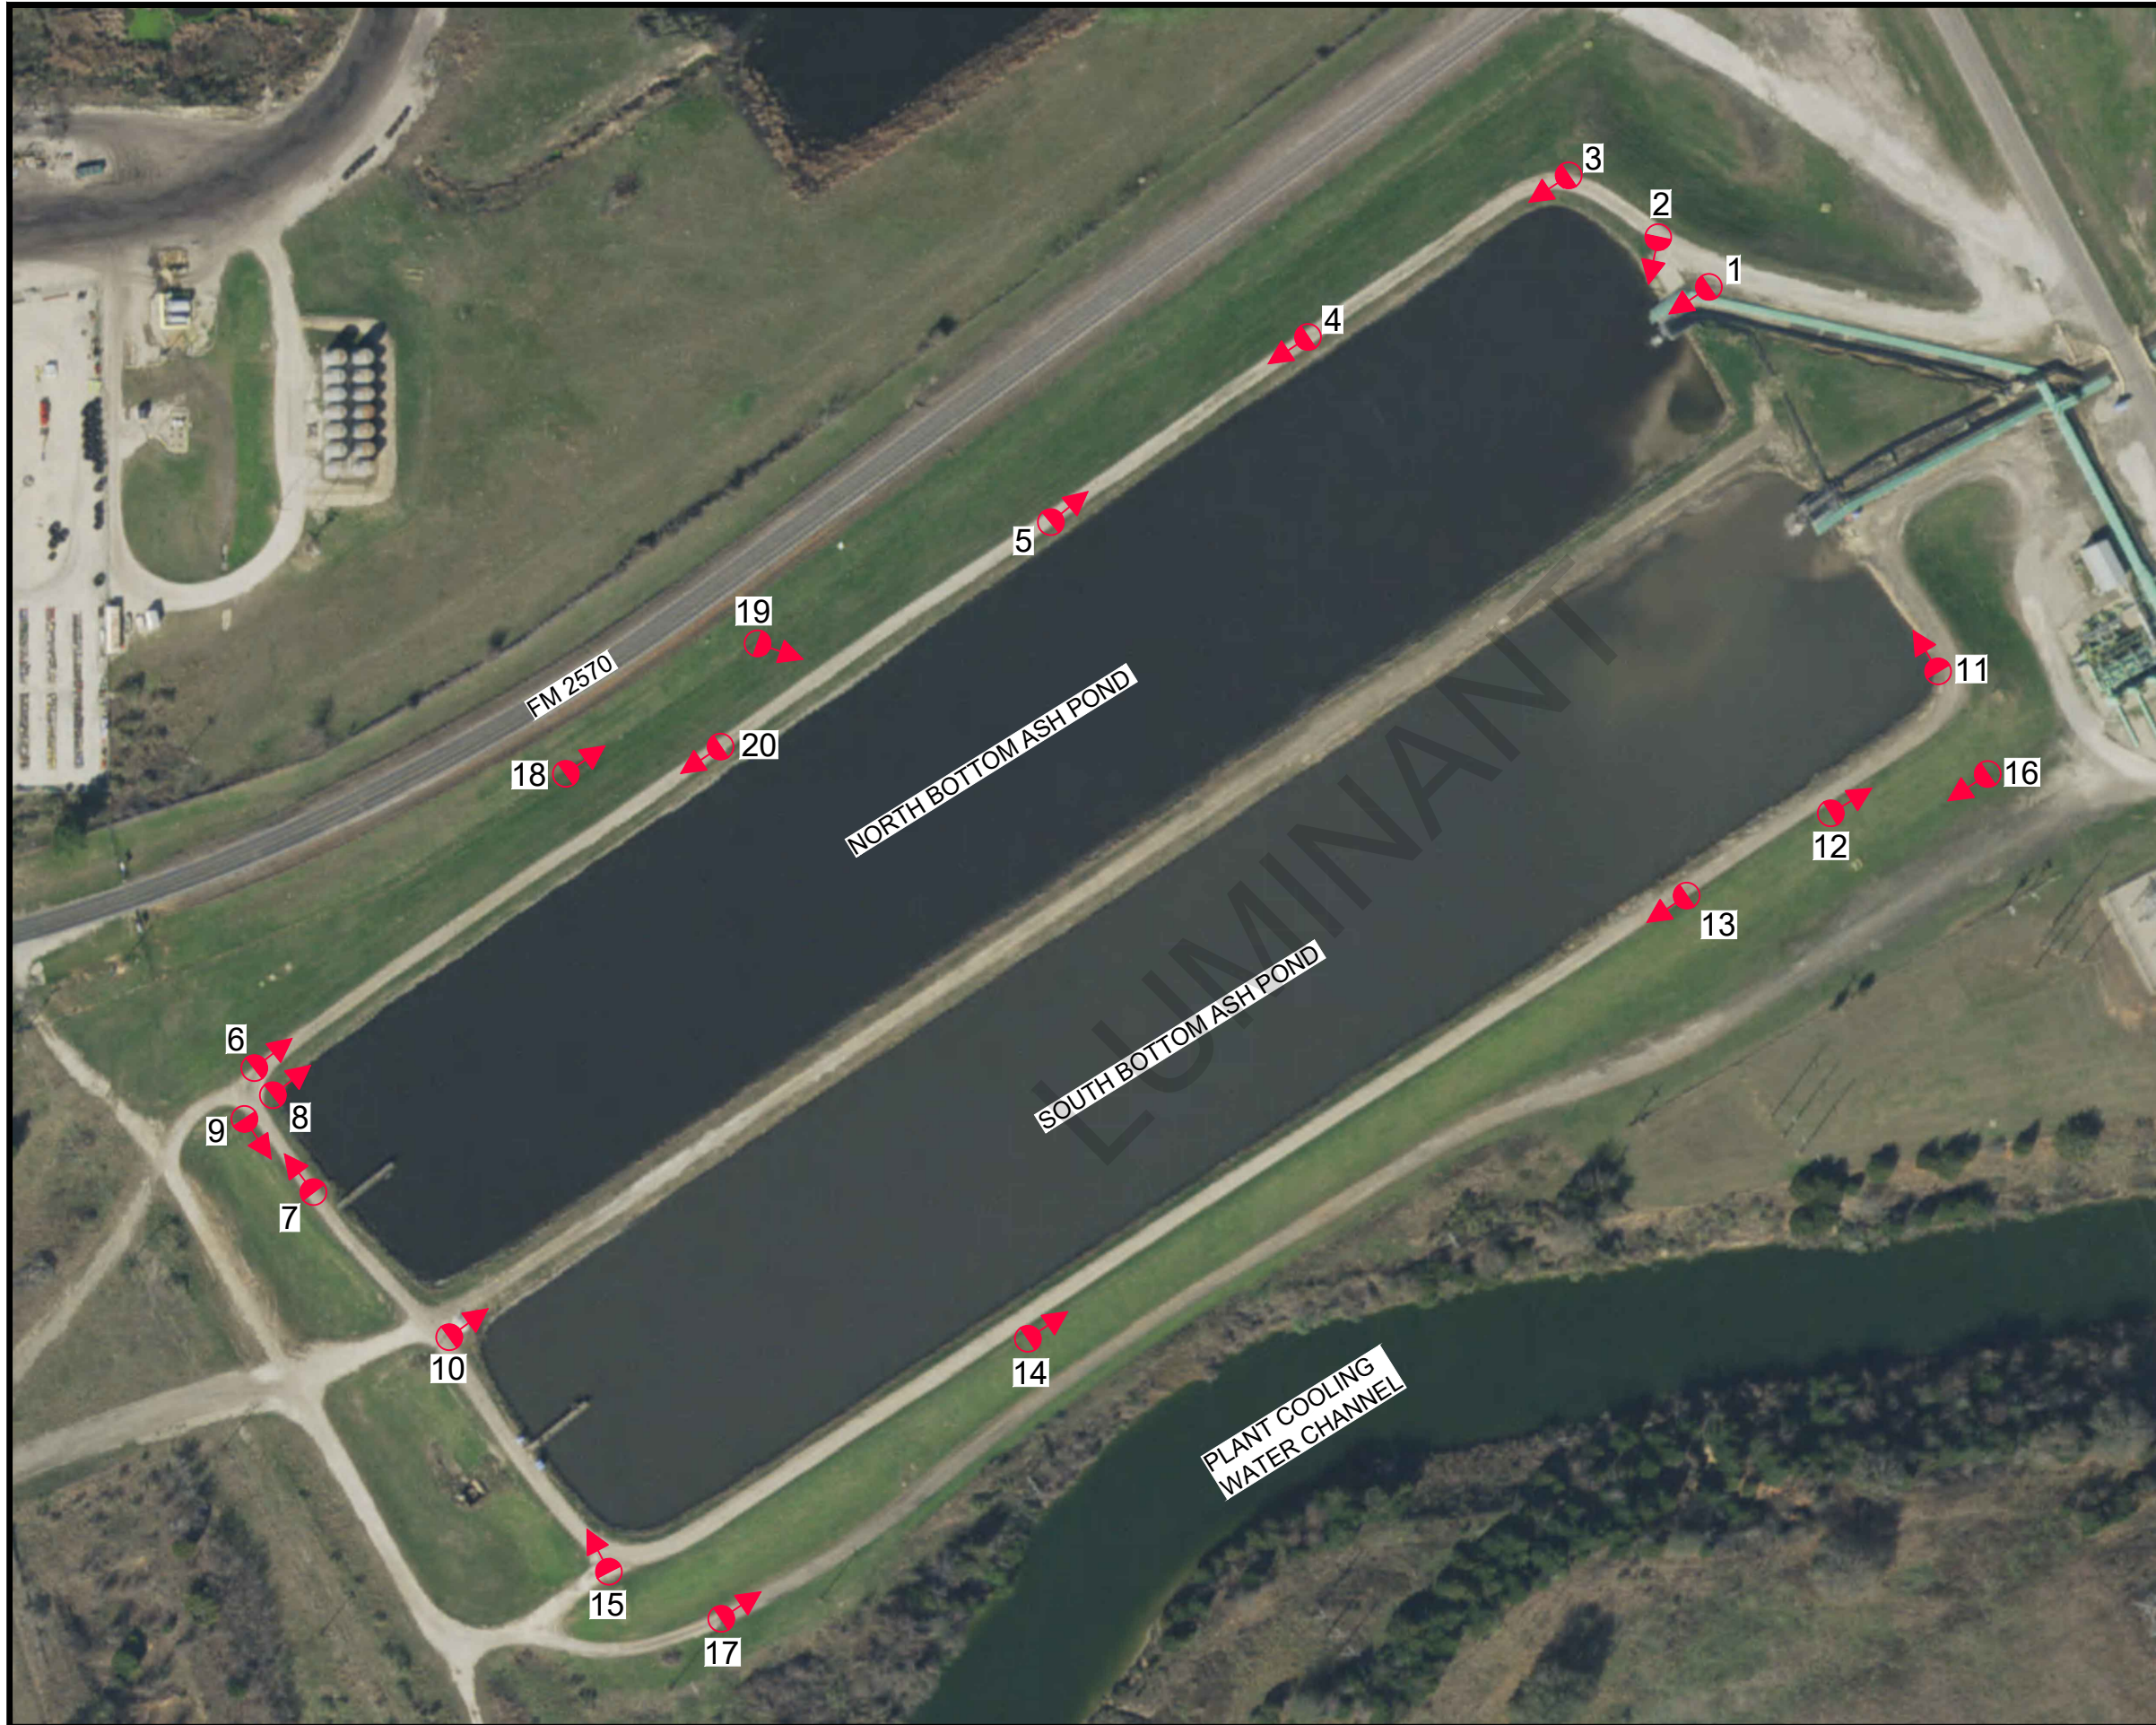
Figure 3  
**ANNUAL INSPECTION FINDINGS  
SUMMARY MAP NORTH AND  
SOUTH BOTTOM ASH PONDS**

Surface conditions near the BAPs were generally dry and in good condition. As indicated on Figure 3, the following areas were noted for future monitoring or repair:

The majority of the embankment crest is improved with a crushed aggregate access road. The access roads are generally in good condition. As indicated on Figure 3, the following areas were noted for future monitoring or repair:

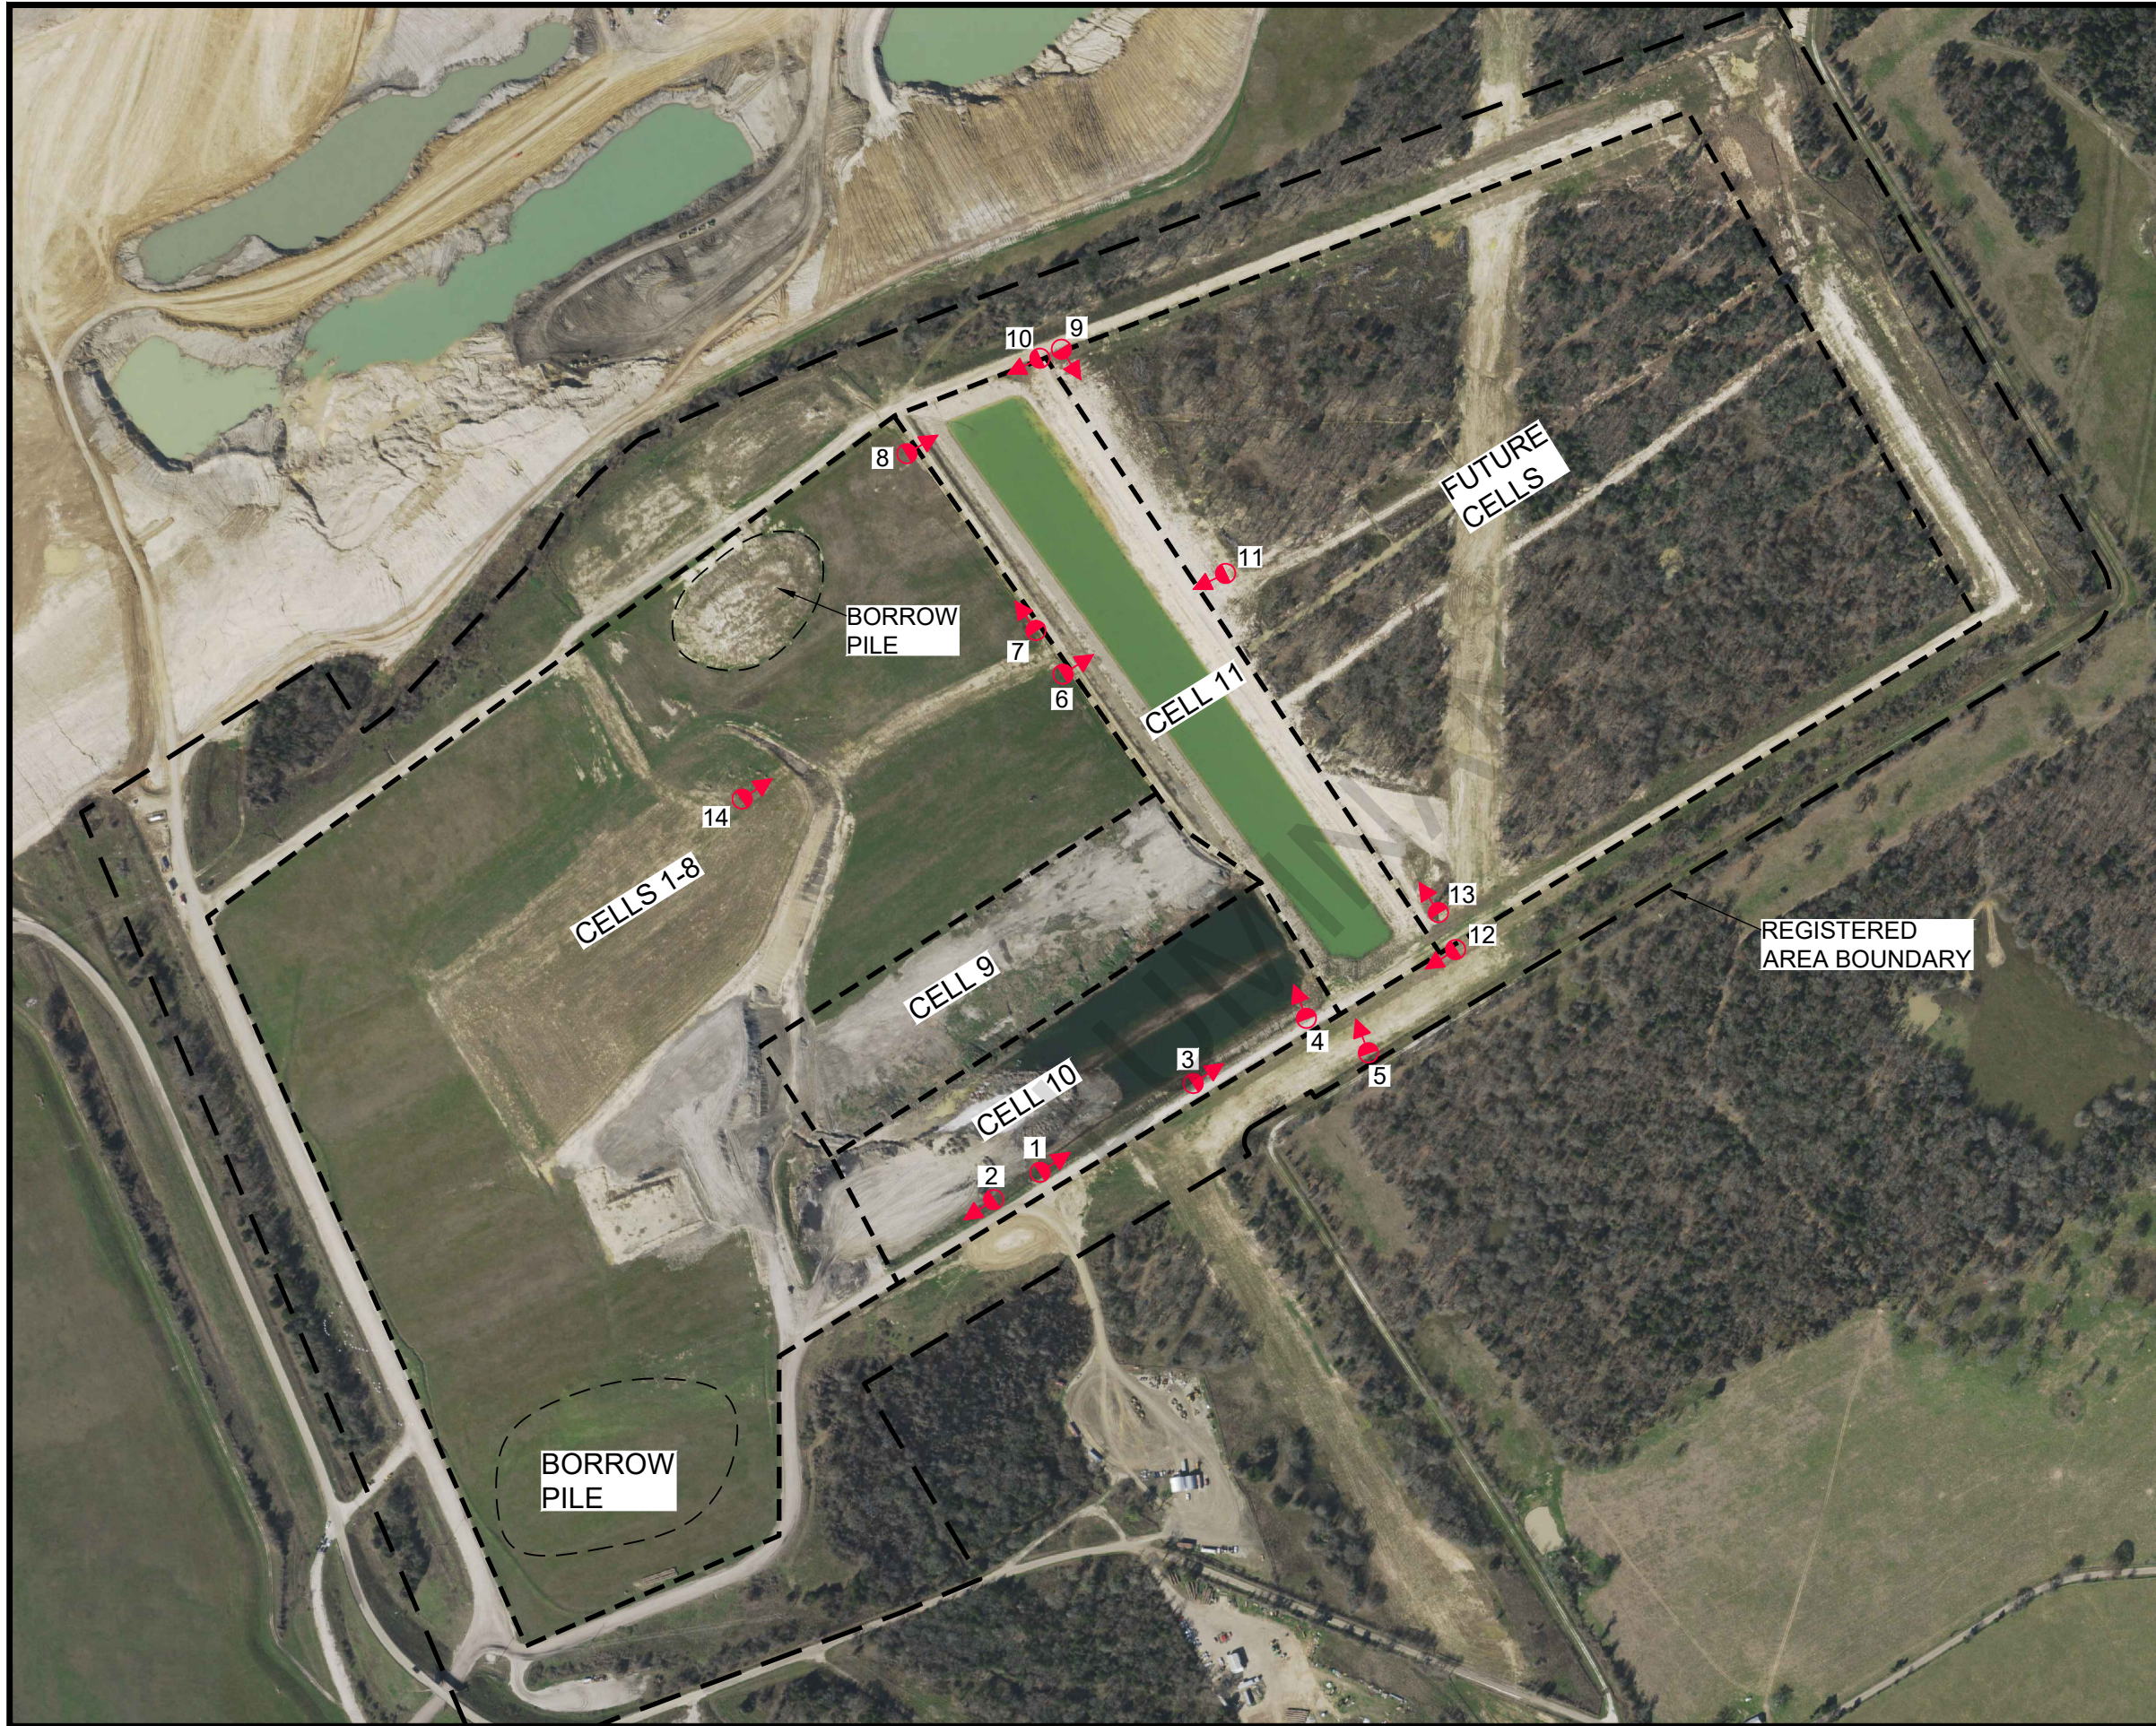
Figure 5  
**ANNUAL INSPECTION FINDINGS**  
**SUMMARY MAP**  
**ASH DISPOSAL AREA II**

As indicated on Figure 5, the following areas were noted for future monitoring or repair on the embankments around Cells 10 and 11:

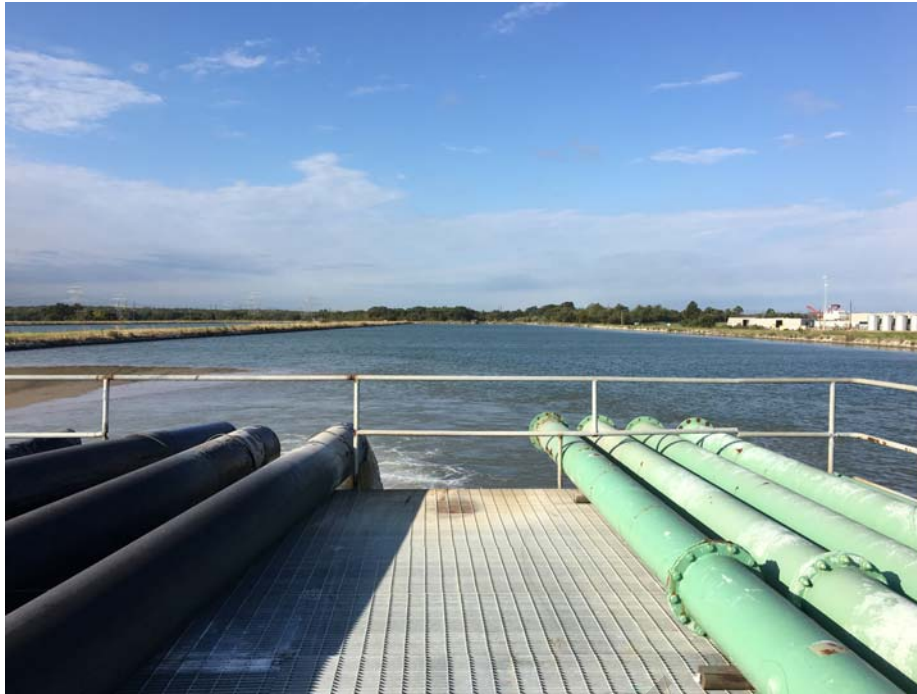
Pastor, Behling & Wheeler	DESCRIPTION	<b>Photograph 1</b> – (View SW) NBAP Ash Slurry Inlet Piping Structure at east end of pond.	
PROJECT NO. 5313A	SITE NAME	Big Brown Steam Electric Station – Bottom Ash Ponds Annual Inspection	DATE 10/10/2017

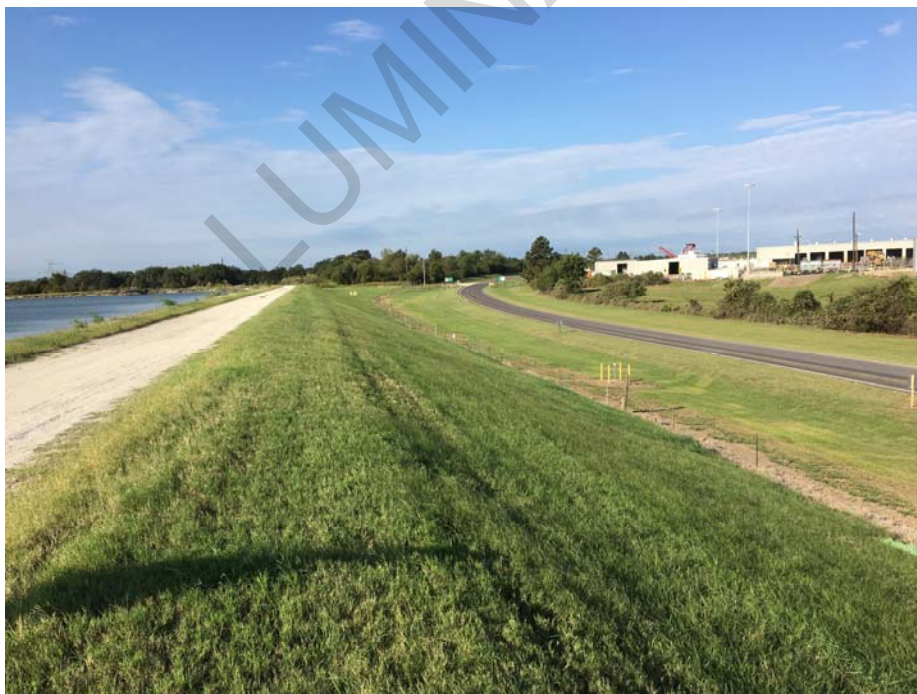
Pastor, Behling & Wheeler	DESCRIPTION	<b>Photograph 4</b> – (View SW) Exterior of north embankment of NBAP. FM 2570 on right.	
PROJECT NO. 5313A	SITE NAME	Big Brown Steam Electric Station – Bottom Ash Ponds Annual Inspection	DATE 10/10/2017

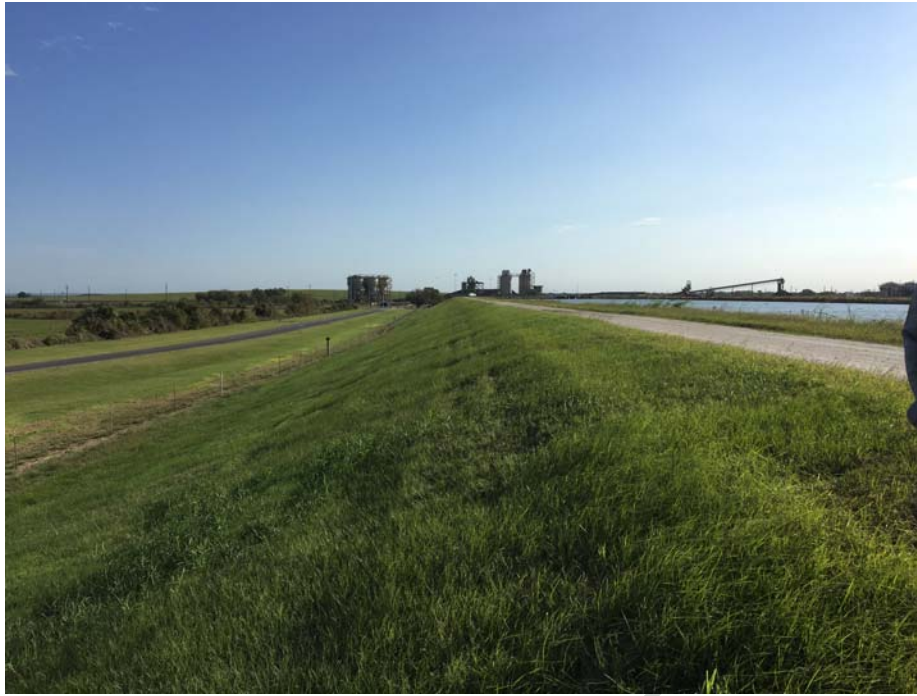
Pastor, Behling & Wheeler	DESCRIPTION	<b>Photograph 5</b> – (View NE) Exterior of north embankment of NBAP.	
PROJECT NO. 5313A	SITE NAME	Big Brown Steam Electric Station – Bottom Ash Ponds Annual Inspection	DATE 10/10/2017

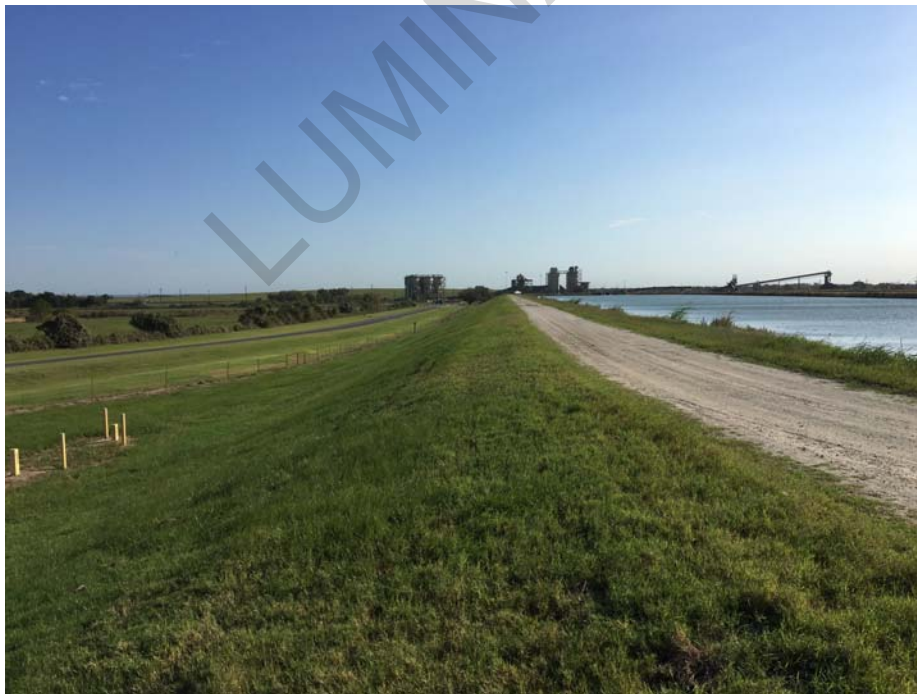
Pastor, Behling & Wheeler	DESCRIPTION	<b>Photograph 6</b> – (View NE) Exterior of north embankment of NBAP from NW corner of pond.	
PROJECT NO. 5313A	SITE NAME	Big Brown Steam Electric Station – Bottom Ash Ponds Annual Inspection	DATE 10/10/2017

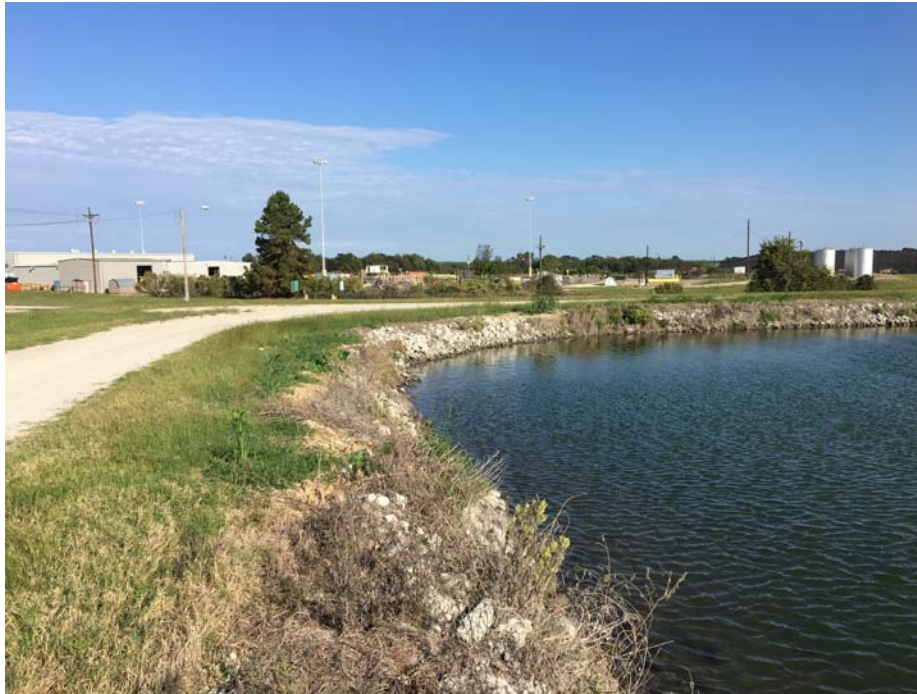
Pastor, Behling & Wheeler	DESCRIPTION	<b>Photograph 7</b> – (View NW) West embankment of NBAP, toward NW Corner of pond.	
PROJECT NO. 5313A	SITE NAME	Big Brown Steam Electric Station – Bottom Ash Ponds Annual Inspection	DATE 10/10/2017

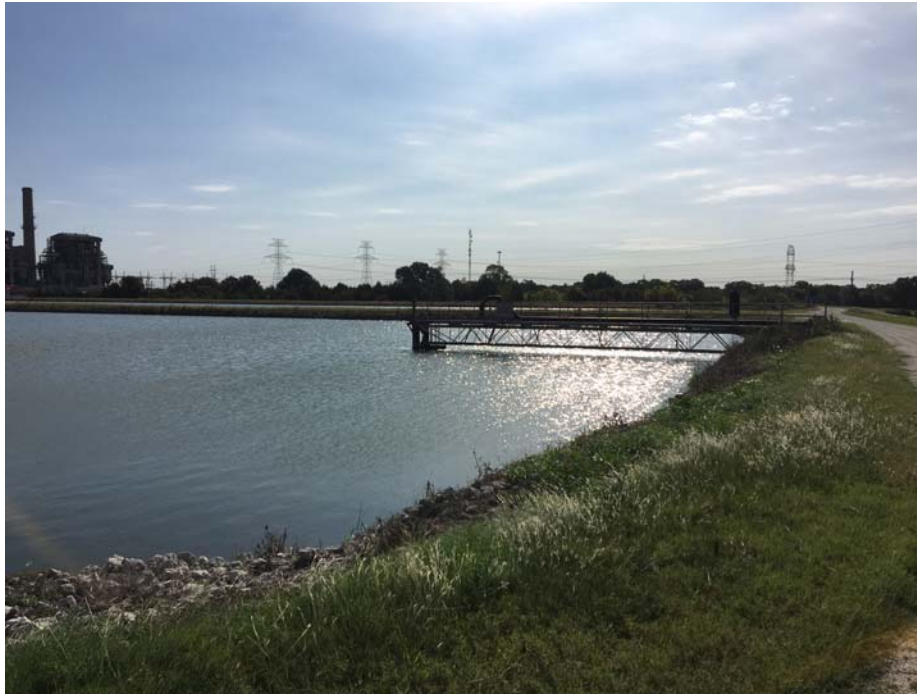
Pastor, Behling & Wheeler	DESCRIPTION	<b>Photograph 9</b> – (View SE) West embankment of NBAP, from NW corner of pond.	
PROJECT NO. 5313A	SITE NAME	Big Brown Steam Electric Station – Bottom Ash Ponds Annual Inspection	DATE 10/10/2017

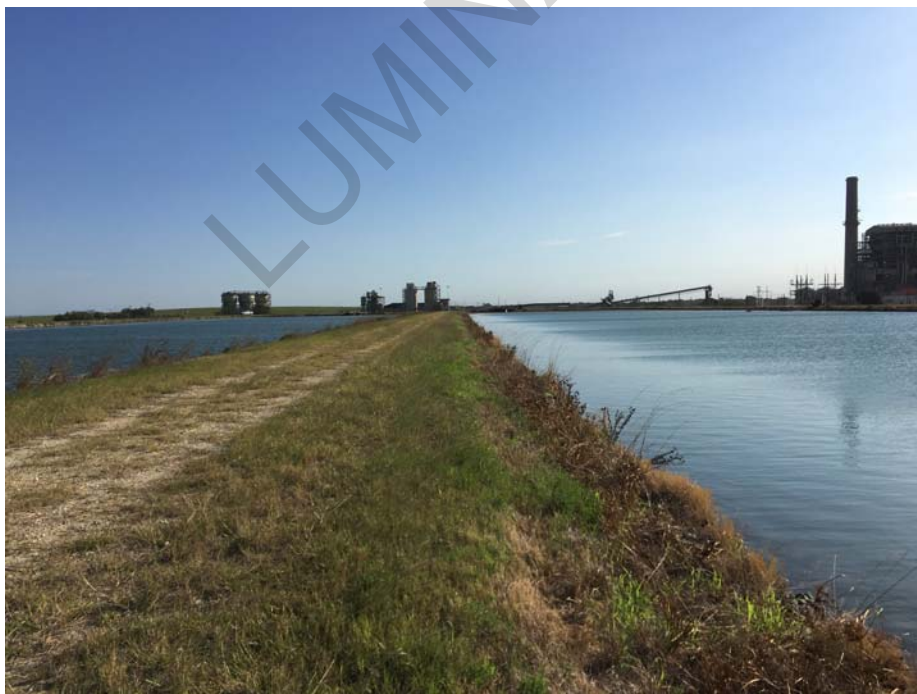
Pastor, Behling & Wheeler	DESCRIPTION	<b>Photograph 10</b> – (View NE) Center embankment of BAPs from west end. NBAP to left, SBAP to right.	
PROJECT NO. 5313A	SITE NAME	Big Brown Steam Electric Station – Bottom Ash Ponds Annual Inspection	DATE 10/10/2017

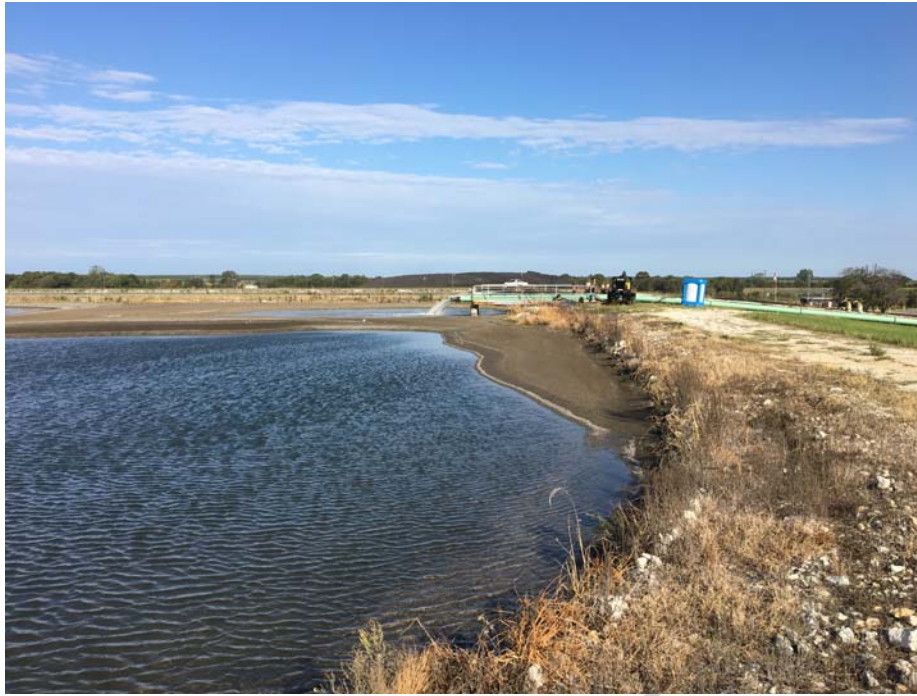
Pastor, Behling & Wheeler	DESCRIPTION	<b>Photograph 11</b> – (View NW) East embankment of SBAP from SE corner of pond.	
PROJECT NO. 5313A	SITE NAME	Big Brown Steam Electric Station – Bottom Ash Ponds Annual Inspection	DATE 10/10/2017

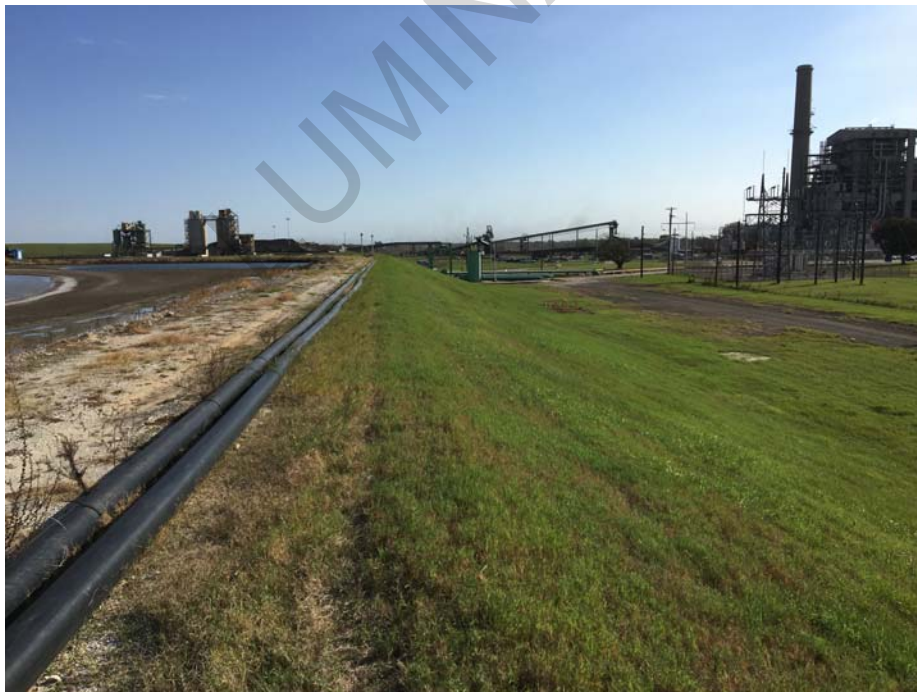
Pastor, Behling & Wheeler	DESCRIPTION	<b>Photograph 12</b> – (View NE) Exterior of south embankment of SBAP. Temporary pond water return piping on ground surface at left.	
PROJECT NO. 5313A	SITE NAME	Big Brown Steam Electric Station – Bottom Ash Ponds Annual Inspection	DATE 10/10/2017

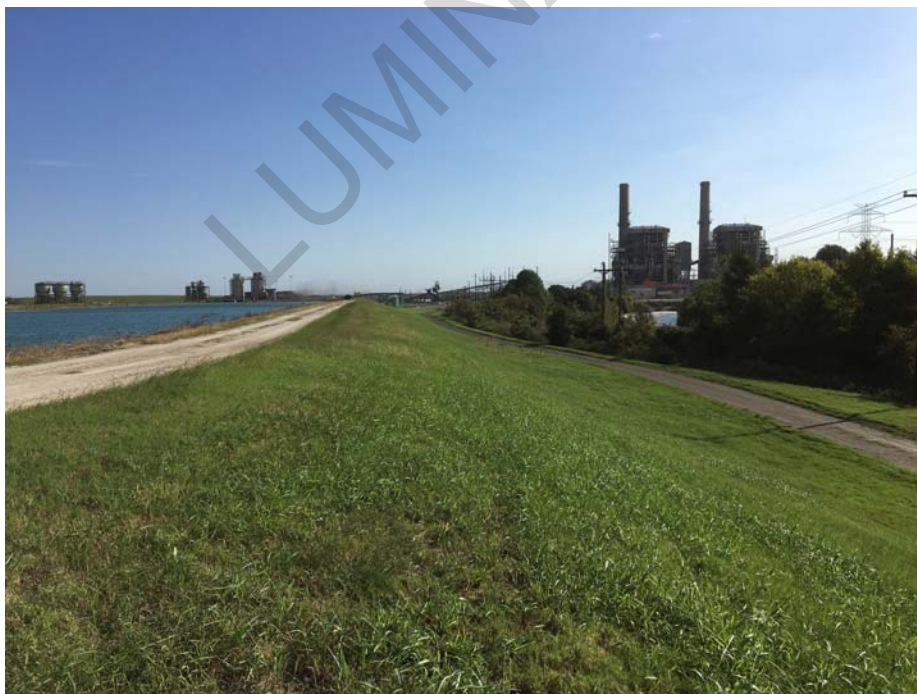
Pastor, Behling & Wheeler	DESCRIPTION	<b>Photograph 14</b> – (View NE) Exterior of south embankment of SBAP from SW corner of pond.	
PROJECT NO. 5313A	SITE NAME	Big Brown Steam Electric Station – Bottom Ash Ponds Annual Inspection	DATE 10/10/2017

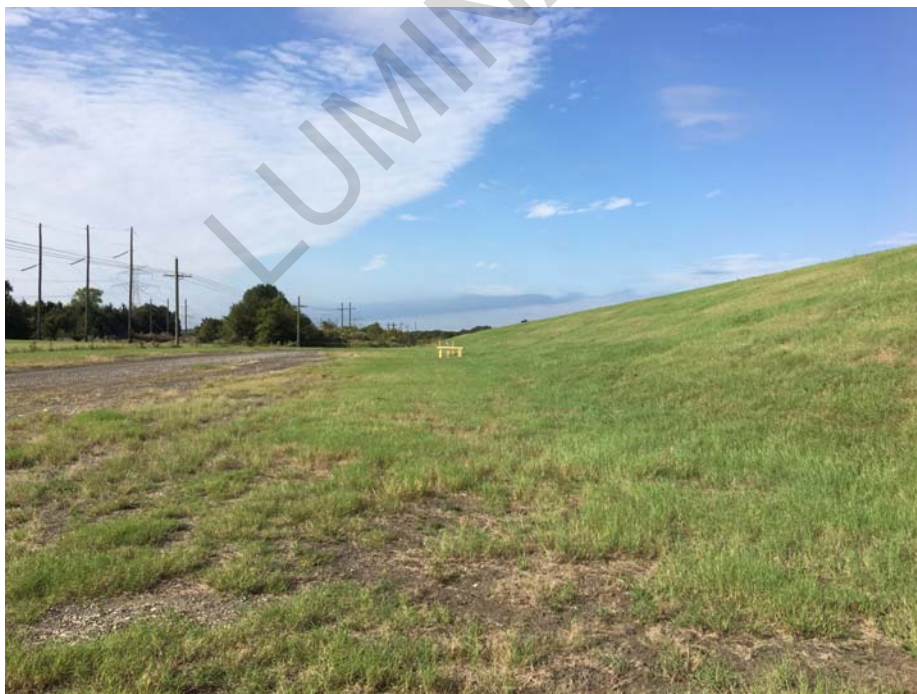
Pastor, Behling & Wheeler	DESCRIPTION	<b>Photograph 16</b> – (View SW) Exterior of south embankment of SBAP.	
PROJECT NO. 5313A	SITE NAME	Big Brown Steam Electric Station – Bottom Ash Ponds Annual Inspection	DATE 10/10/2017

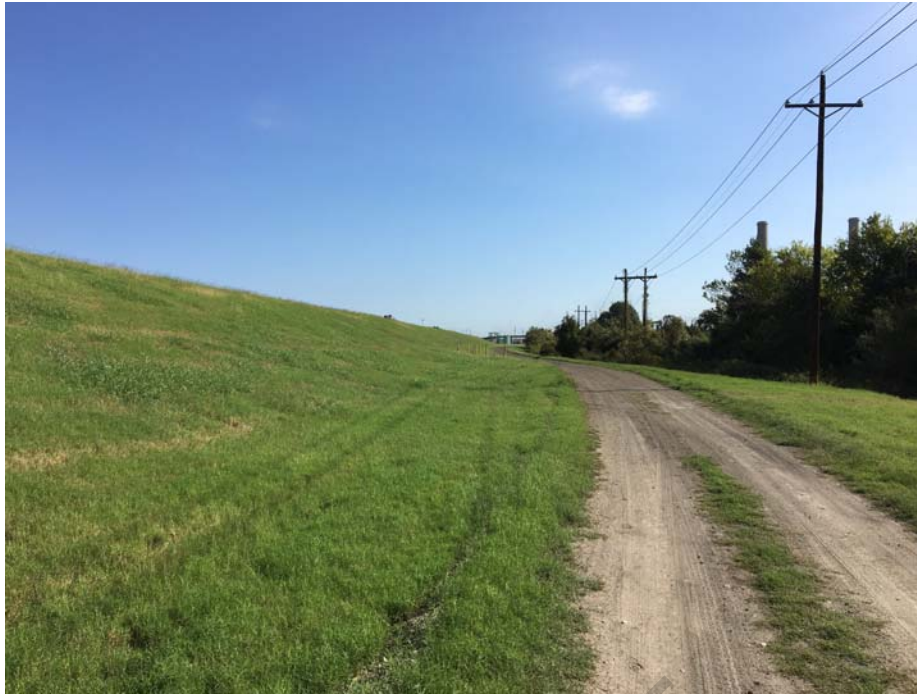
Pastor, Behling & Wheeler	DESCRIPTION	<b>Photograph 17</b> – (View NE) Exterior of south embankment of SBAP from SW corner of pond.	
PROJECT NO. 5313A	SITE NAME	Big Brown Steam Electric Station – Bottom Ash Ponds Annual Inspection	DATE 10/10/2017

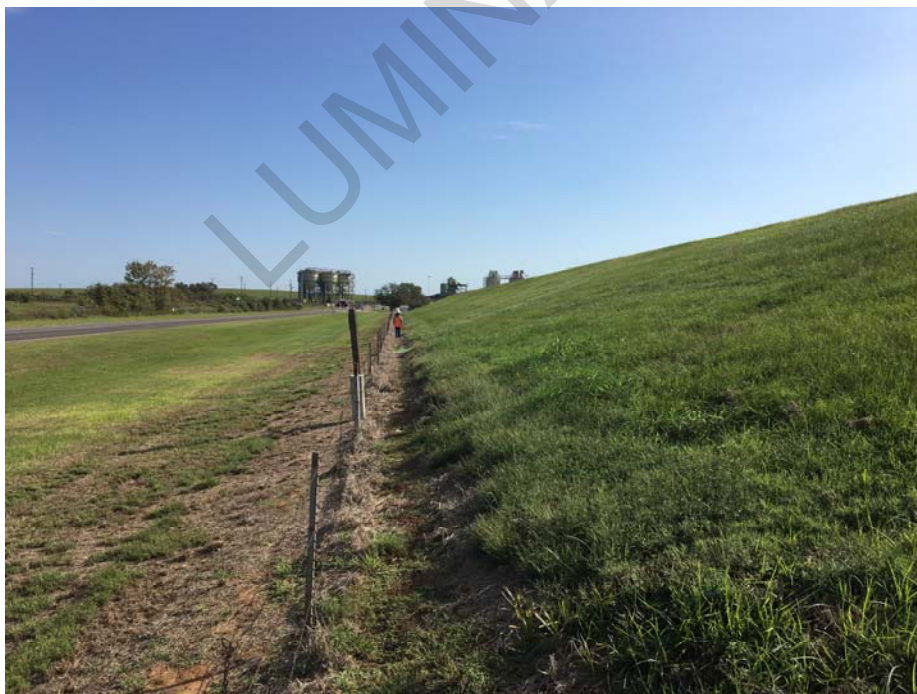
Pastor, Behling & Wheeler	DESCRIPTION	<b>Photograph 18</b> – (View NE) Exterior of north embankment of NBAP.	
PROJECT NO. 5313A	SITE NAME	Big Brown Steam Electric Station – Bottom Ash Ponds Annual Inspection	DATE 10/10/2017

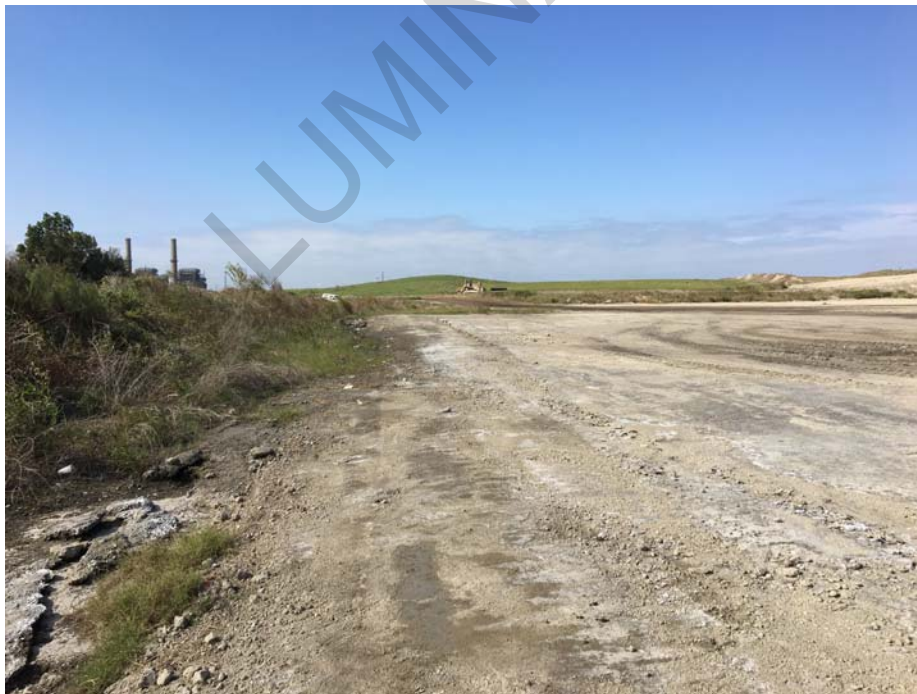
Pastor, Behling & Wheeler	DESCRIPTION	<b>Photograph 2</b> – (View SW) Interior toe of south embankment of Cell 10. Cell 10 on right. Active ash placement area.	
PROJECT NO. 5313A	SITE NAME	Big Brown Steam Electric Station – Ash Disposal Area II Annual Inspection	DATE 10/10/2017

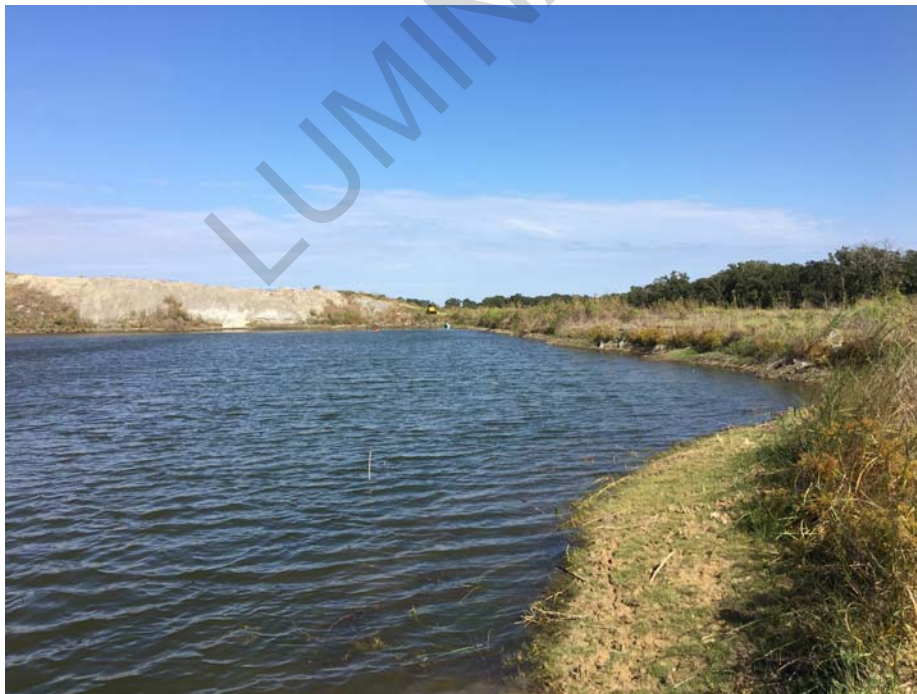
Pastor, Behling & Wheeler	DESCRIPTION	<b>Photograph 4</b> – (View NW) North embankment of Cell 10. Cell 10 contact water collection area in foreground. Cell 9 in background.	
PROJECT NO. 5313A	SITE NAME	Big Brown Steam Electric Station – Ash Disposal Area II Annual Inspection	DATE 10/10/2017

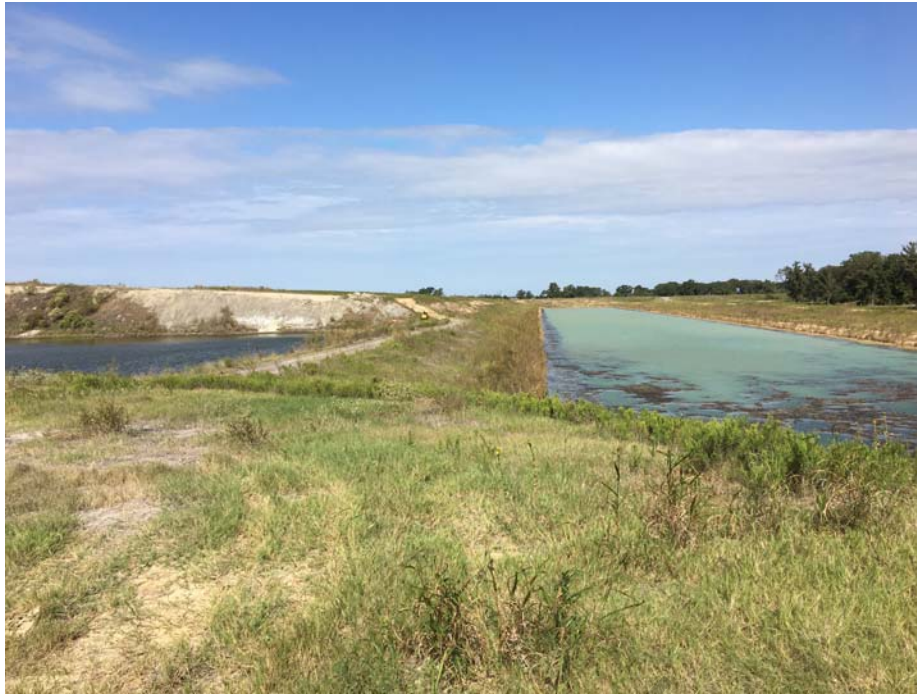
Pastor, Behling & Wheeler	DESCRIPTION	<b>Photograph 5</b> – (View NW) East embankment of Cell 10 at SE corner of cell. Cell 10 to left, Cell 11 to right.	
PROJECT NO. 5313A	SITE NAME	Big Brown Steam Electric Station – Ash Disposal Area II Annual Inspection	DATE 10/10/2017

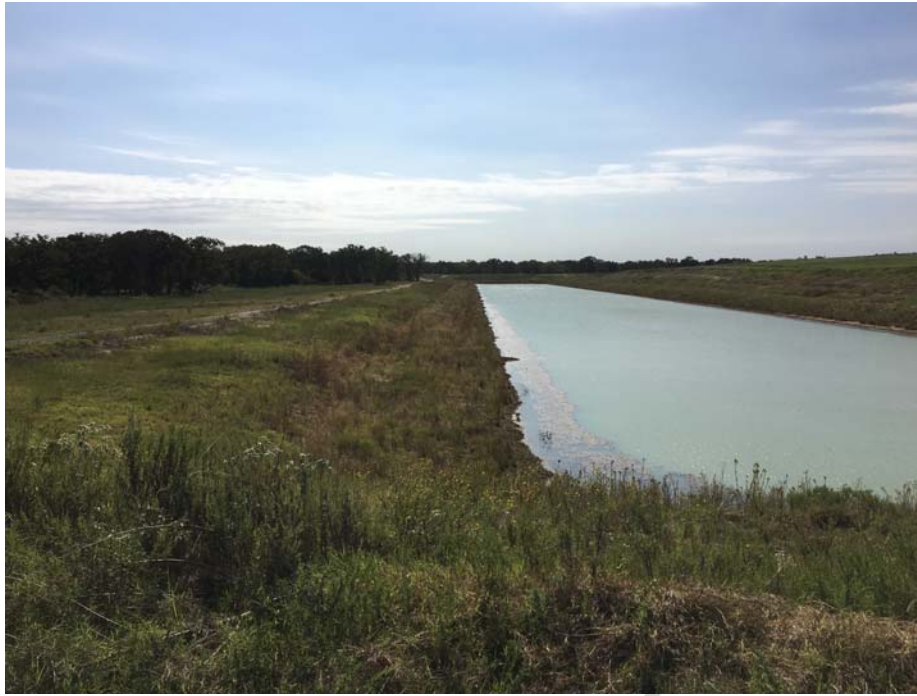
Pastor, Behling & Wheeler	DESCRIPTION	<b>Photograph 9</b> – (View SE) East embankment of Cell 11 from NE corner.	
PROJECT NO. 5313A	SITE NAME	Big Brown Steam Electric Station – Ash Disposal Area II Annual Inspection	DATE 10/10/2017

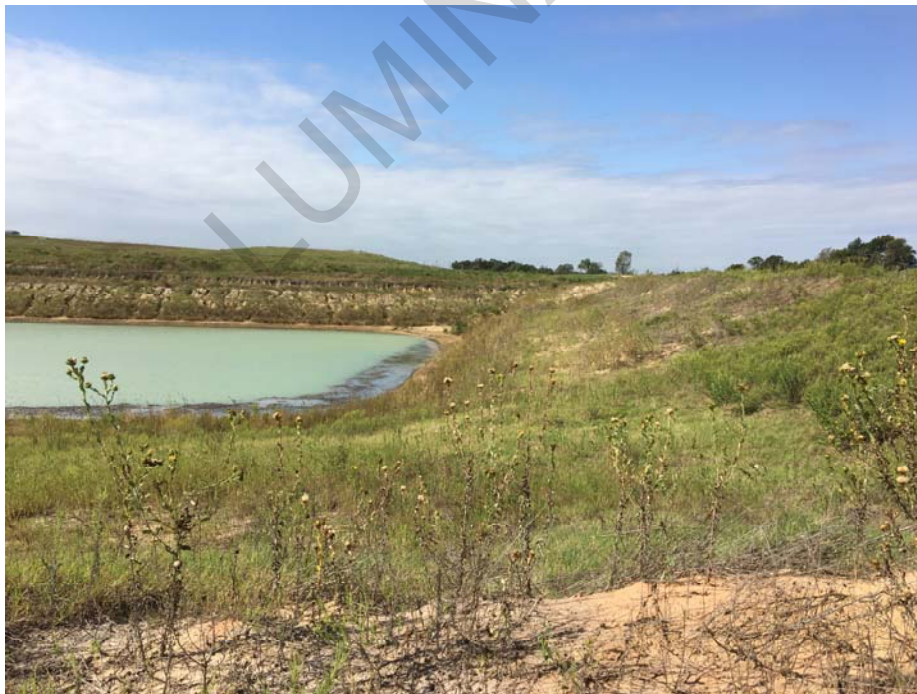
Pastor, Behling & Wheeler	DESCRIPTION	<b>Photograph 10</b> – (View SW) North embankment of Cell 11 from NE corner.	
PROJECT NO. 5313A	SITE NAME	Big Brown Steam Electric Station – Ash Disposal Area II Annual Inspection	DATE 10/10/2017

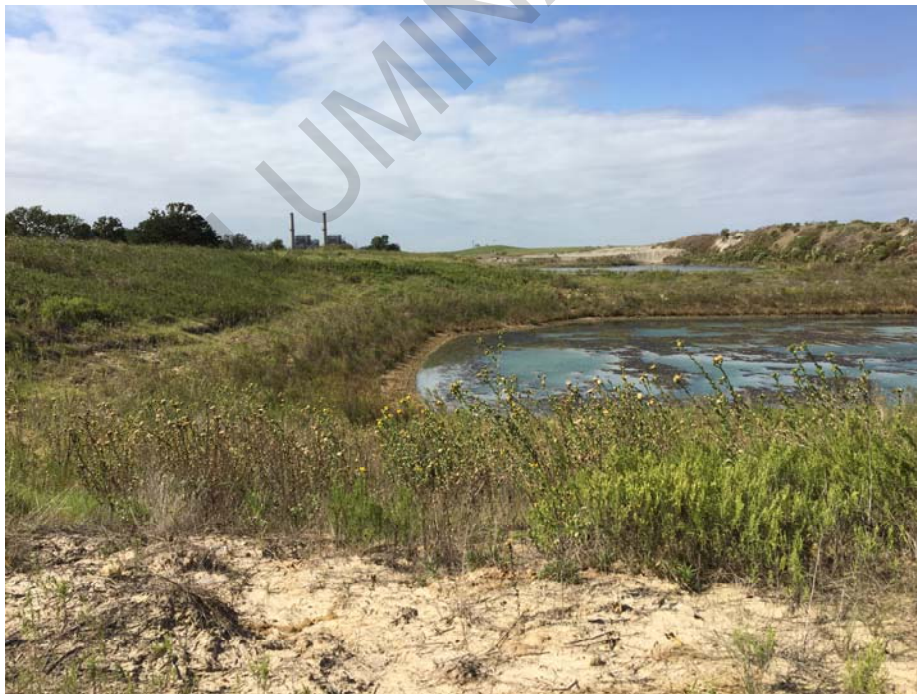
Pastor, Behling & Wheeler	DESCRIPTION	<b>Photograph 12</b> – (View SW) South embankment of Cell 11 from SE corner.	
PROJECT NO. 5313A	SITE NAME	Big Brown Steam Electric Station – Ash Disposal Area II Annual Inspection	DATE 10/10/2017

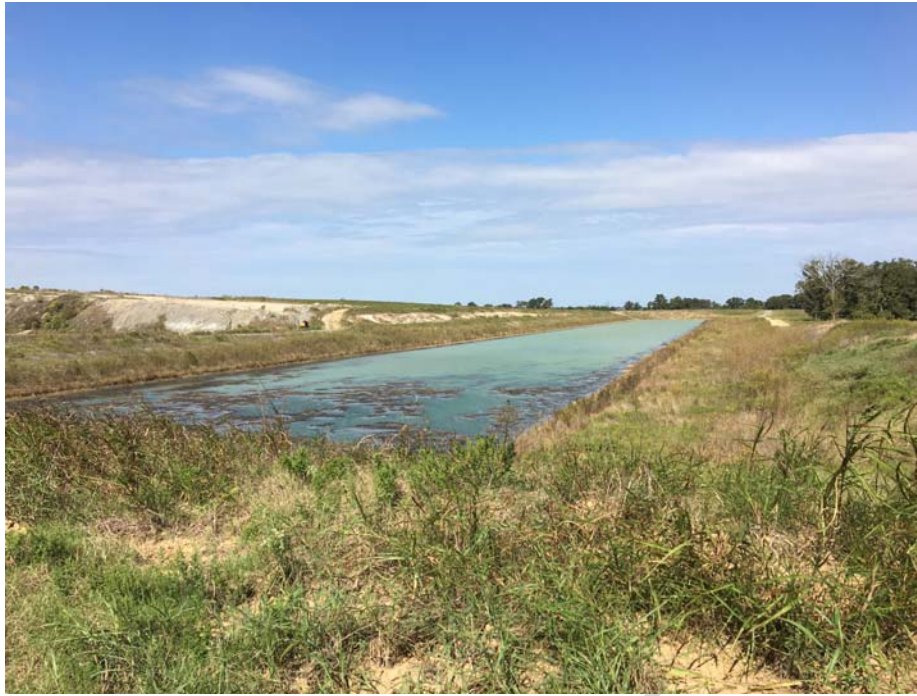
Pastor, Behling & Wheeler	DESCRIPTION	<b>Photograph 13</b> – (View NW) East embankment of Cell 11 from SE corner.	
PROJECT NO. 5313A	SITE NAME	Big Brown Steam Electric Station – Ash Disposal Area II Annual Inspection	DATE 10/10/2017
