**ANNUAL CCR UNIT INSPECTION REPORT
LUMINANT – SANDOW 5 GENERATING PLANT
AX LANDFILL
MILAM COUNTY, TEXAS**

January 14, 2016

PBW Project No. 5170B

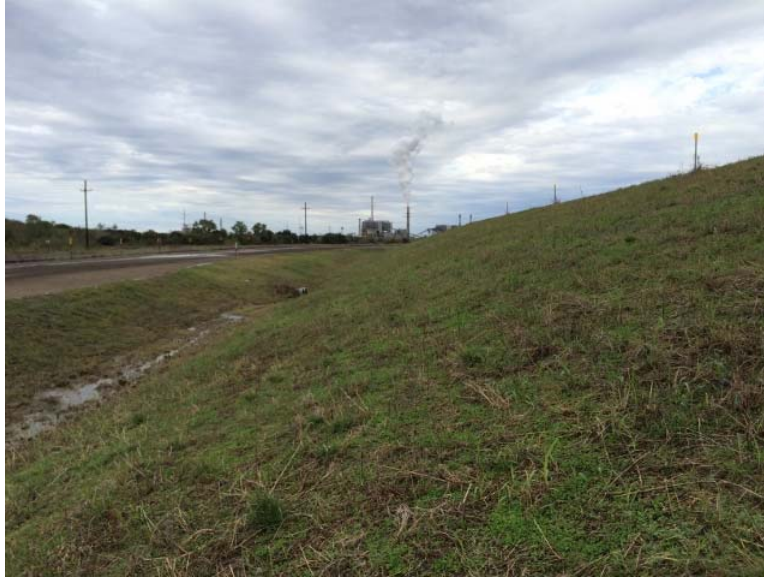
Pastor, Behling & Wheeler	DESCRIPTION	Photograph 1 – (View N) View along toe of permanent earthen embankment of Cell 1. Cell 1 to right	
PROJECT NO. 5170B	SITE NAME	Sandow 5 Generating Plant – AX Landfill Annual Inspection	DATE 11/17/2015

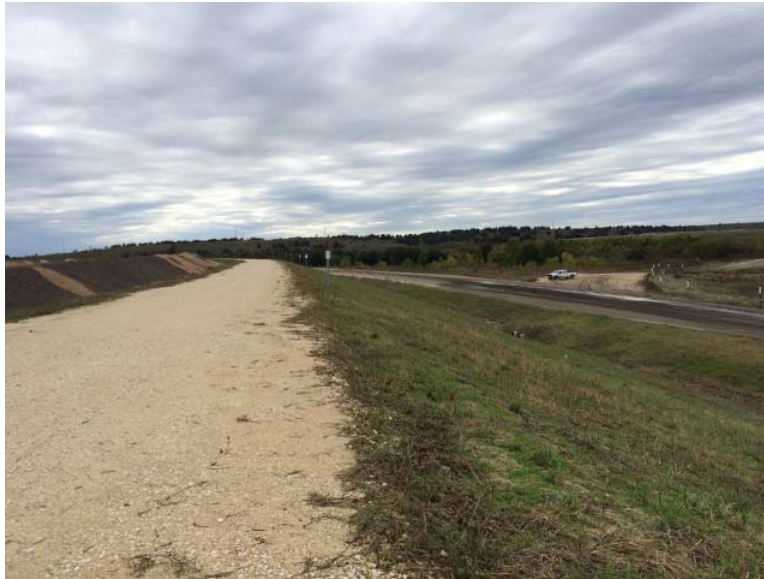
Pastor, Behling & Wheeler PROJECT NO. 5170B	DESCRIPTION	Photograph 3 – (View S) View along crest of permanent embankment along west side of Cell 1. Cell 1 to left	
	SITE NAME	Sandow 5 Generating Plant – AX Landfill Annual Inspection	DATE 11/17/2015

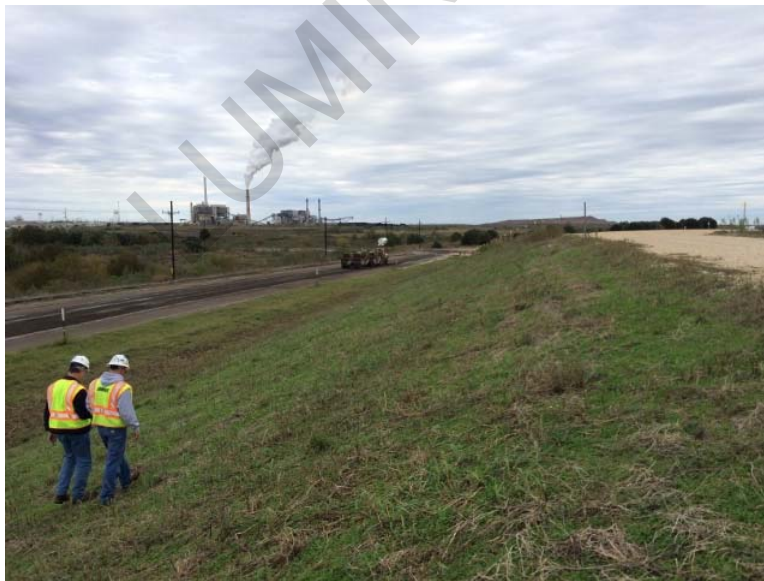
Pastor, Behling & Wheeler PROJECT NO. 5170B	DESCRIPTION	Photograph 4 – (View N) View along middle of permanent embankment along west side of Cell 1	
	SITE NAME	Sandow 5 Generating Plant – AX Landfill Annual Inspection	DATE 11/17/2015

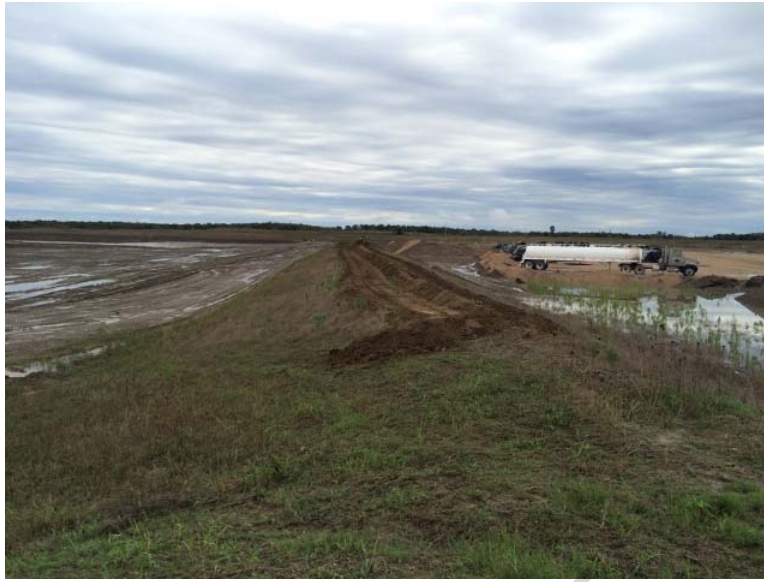
Pastor, Behling & Wheeler	DESCRIPTION	Photograph 5 – (View SE) View along temporary embankment separating Cell 1 (right) from Cell 2A (left)	
PROJECT NO. 5170B	SITE NAME	Sandow 5 Generating Plant – AX Landfill Annual Inspection	DATE 11/17/2015

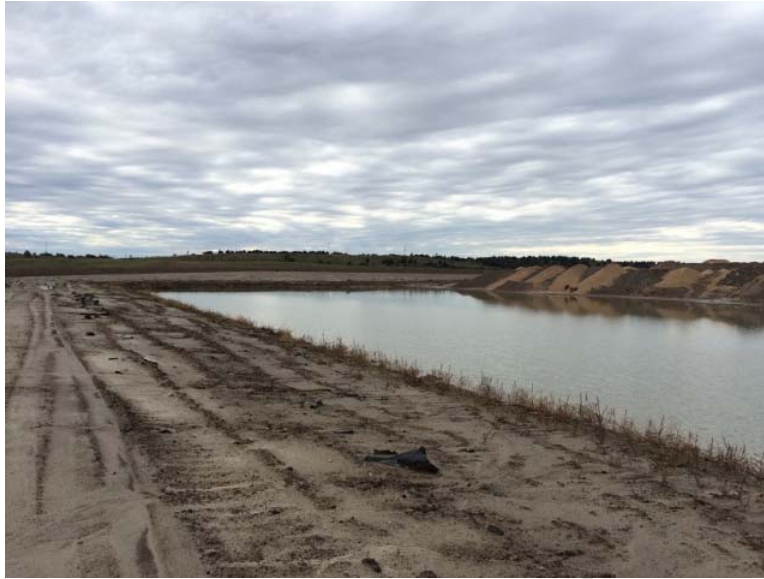
Pastor, Behling & Wheeler	DESCRIPTION	Photograph 7 – (View SE) Crest of temporary embankment between Cell 1 (right) and Cell 2A (left). Contact water contained in Cell 1 on right	
PROJECT NO. 5170B	SITE NAME	Sandow 5 Generating Plant – AX Landfill Annual Inspection	DATE 11/17/2015

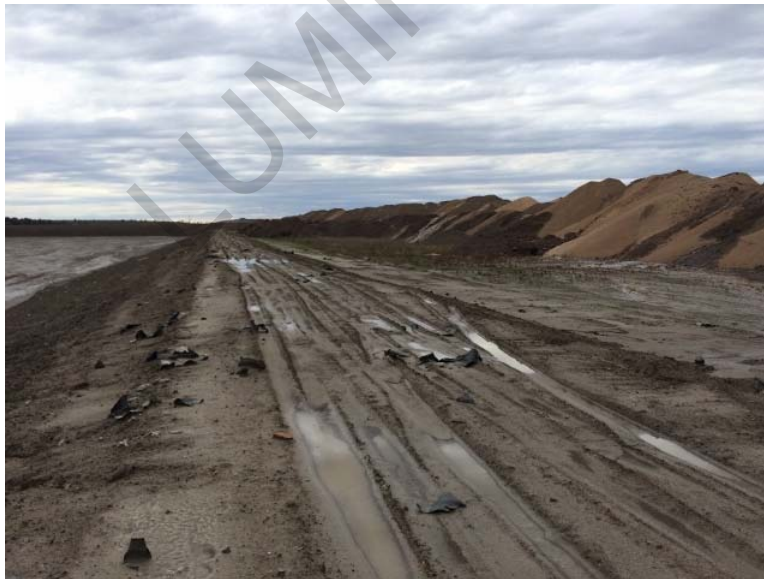
Pastor, Behling & Wheeler	DESCRIPTION	Photograph 8 – (View SW) View along crest of embankment between Cell 1 (right) and Cell 2 (left)	
PROJECT NO. 5170B	SITE NAME	Sandow 5 Generating Plant – AX Landfill Annual Inspection	DATE 11/17/2015

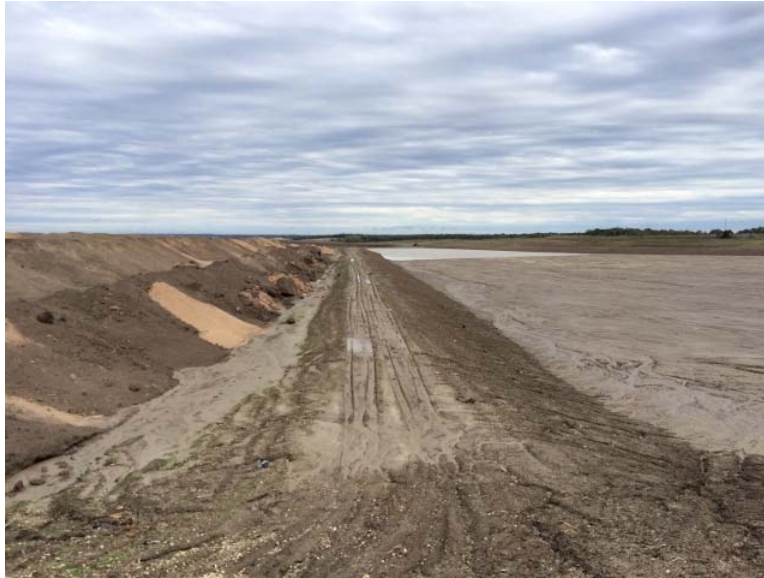
Pastor, Behling & Wheeler	DESCRIPTION	Photograph 9 – (View NE) View along crest of temporary embankment between Cell 1 (left) and Cell 2 (right)	
PROJECT NO. 5170B	SITE NAME	Sandow 5 Generating Plant – AX Landfill Annual Inspection	DATE 11/17/2015

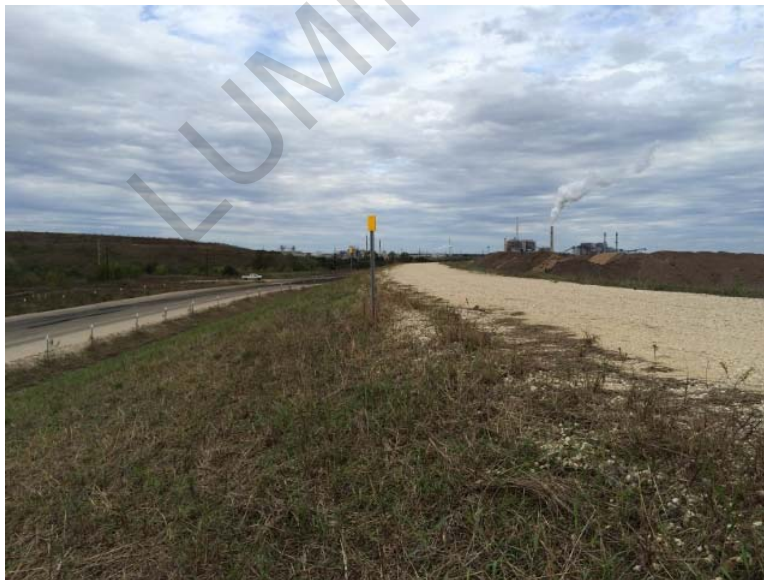
Pastor, Behling & Wheeler	DESCRIPTION	Photograph 10 – (View NW) View along crest of permanent embankment along west side of Cell 1	
PROJECT NO. 5170B	SITE NAME	Sandow 5 Generating Plant – AX Landfill Annual Inspection	DATE 11/17/2015

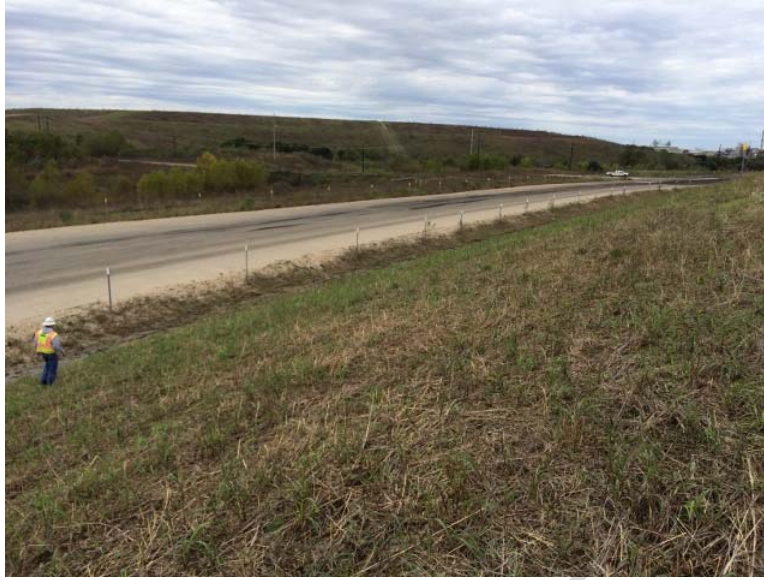
Pastor, Behling & Wheeler	DESCRIPTION	Photograph 11 – (View N) View along crest of permanent embankment along west side of Cell 1	
PROJECT NO. 5170B	SITE NAME	Sandow 5 Generating Plant – AX Landfill Annual Inspection	DATE 11/17/2015

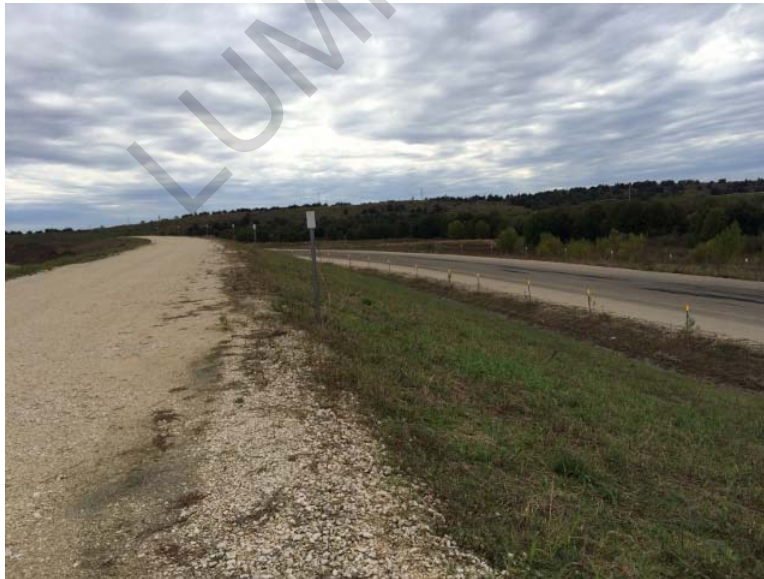
Pastor, Behling & Wheeler	DESCRIPTION	Photograph 12 – (View S) View along crest of permanent embankment along west side of Cell 1	
PROJECT NO. 5170B	SITE NAME	Sandow 5 Generating Plant – AX Landfill Annual Inspection	DATE 11/17/2015
