**Subject: USEPA CCR Rule and IEPA Part 845 Rule Applicability Cross-Reference
2021 USEPA CCR Rule Periodic Certification Report
GMF Pond, Duck Creek Power Plant, Canton, Illinois**

**2021 USEPA CCR RULE PERIODIC
CERTIFICATION REPORT
§257.73(a)(2), (c), (d), (e) and §257.82
GMF POND
Duck Creek Power Plant
Fulton County, Illinois**

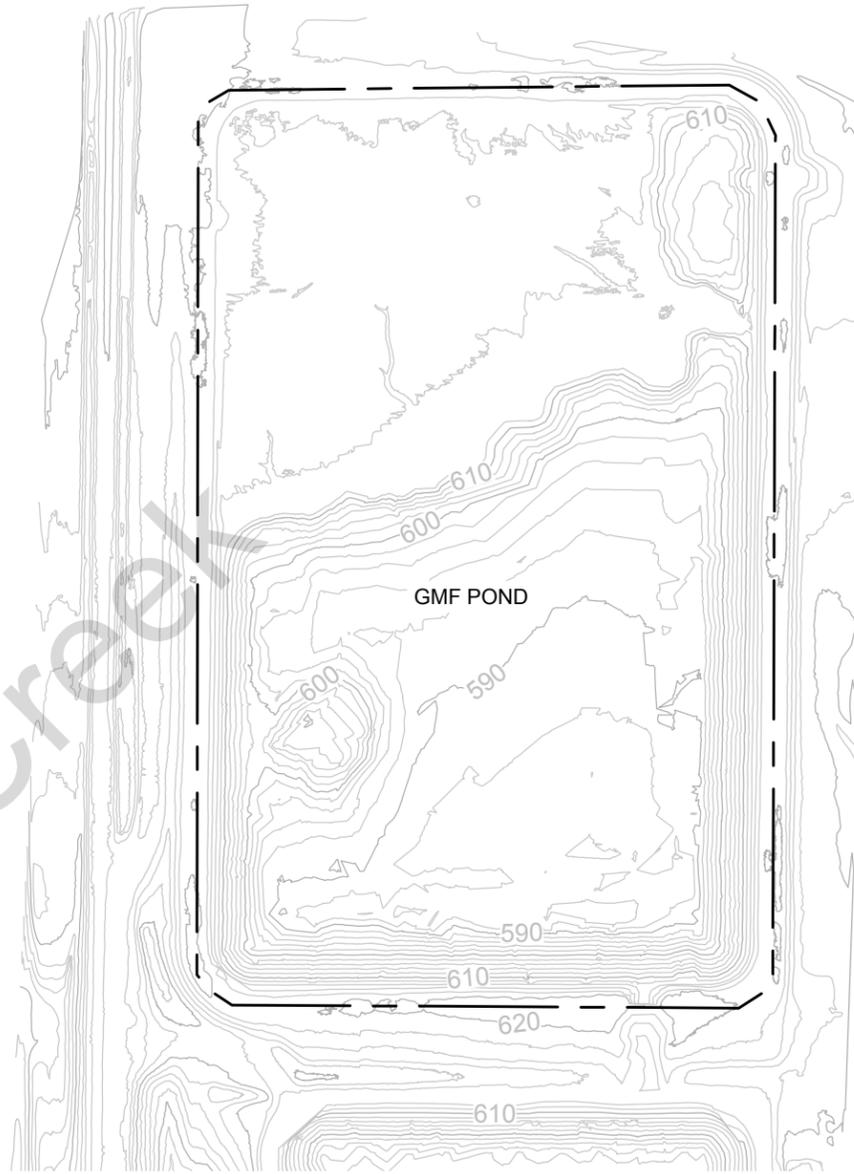
PERIODIC SURVEY
02-09-2021 TOPOGRAPHY

The comparison indicated that approximately 8,000 CY of CCR was placed in the GMF Pond between the initial and periodic surveys. The CCR was placed entirely below the SWSE and a net cut occurred above the SWSE. CCR grades above the SWSE were generally similar to the initial survey (e.g., within +/- 2 ft). These changes are considered unlikely to result in increase in the peak water surface elevation (PWSE) during a flood event, as additional flood storage is present relative to conditions observed in 2015. No significant changes to embankment geometry appeared to have occurred between the initial and periodic surveys.

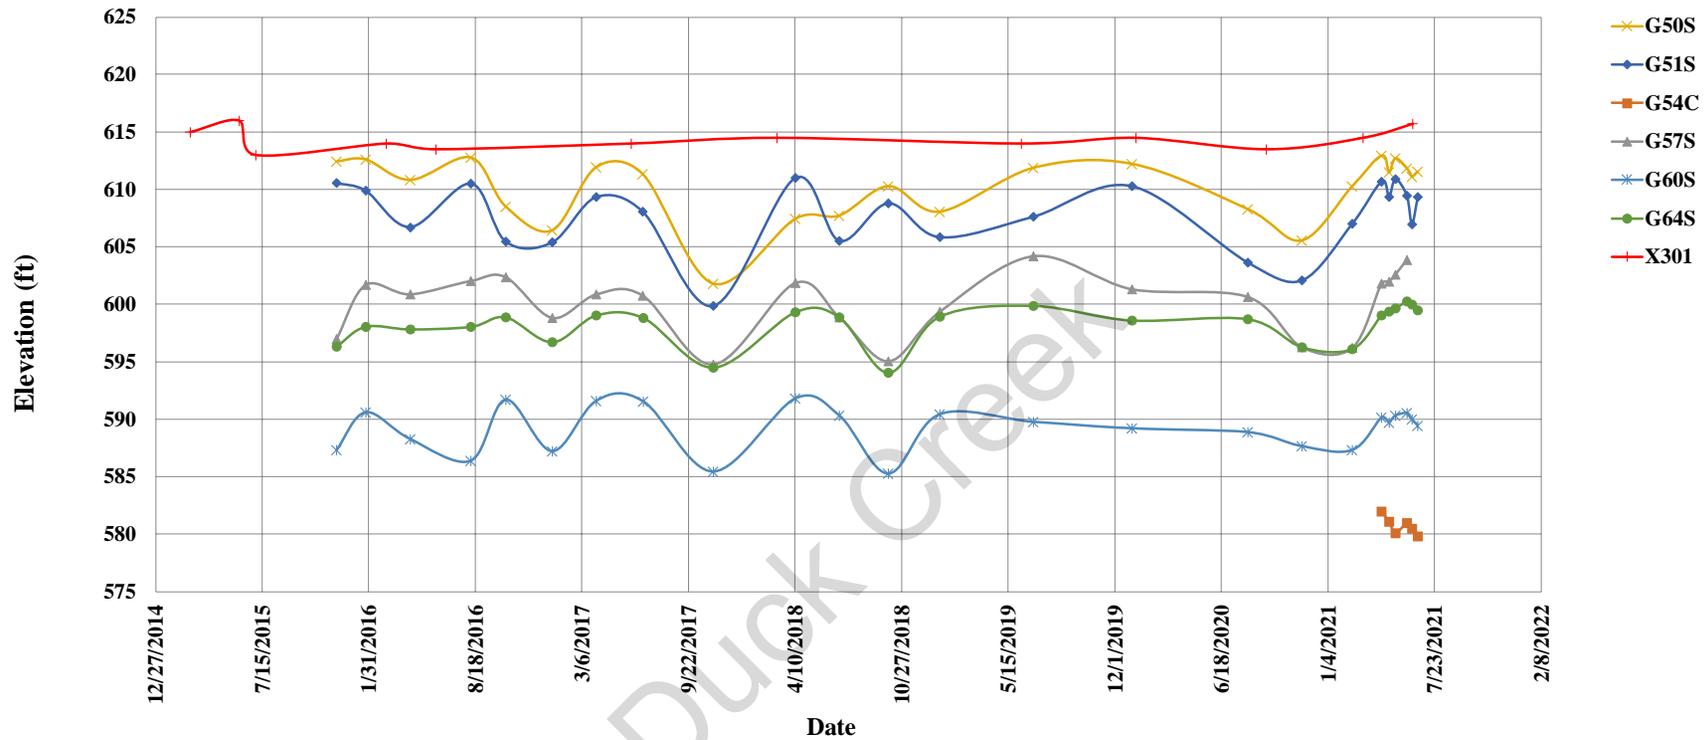
PIEZOMETER DATA PERIODIC CERTIFICATION DUCK CREEK POWER PLANT- GMF POND FULTON, ILLINOIS	
GLP8027	7/23/2021
Figure 1

In summary, only minor changes in phreatic conditions were observed in the available monitoring well level data. Phreatic levels typically exhibited consistent seasonal variations of 5 to 10 ft, with the exception of X301 and G54C, which varied by approximately 2 ft. These levels do not significantly differ from those utilized for the initial structural stability and factor of safety certifications ([4], [5], [8]).
