Illinois Power Resources Generating, LLC

EDWARDS POWER STATION
BARTONVILLE, PEORIA COUNTY, ILLINOIS

Emergency Action Plan (EAP)

**Coal Combustion Residual (CCR) Impoundment
& Related Facilities**

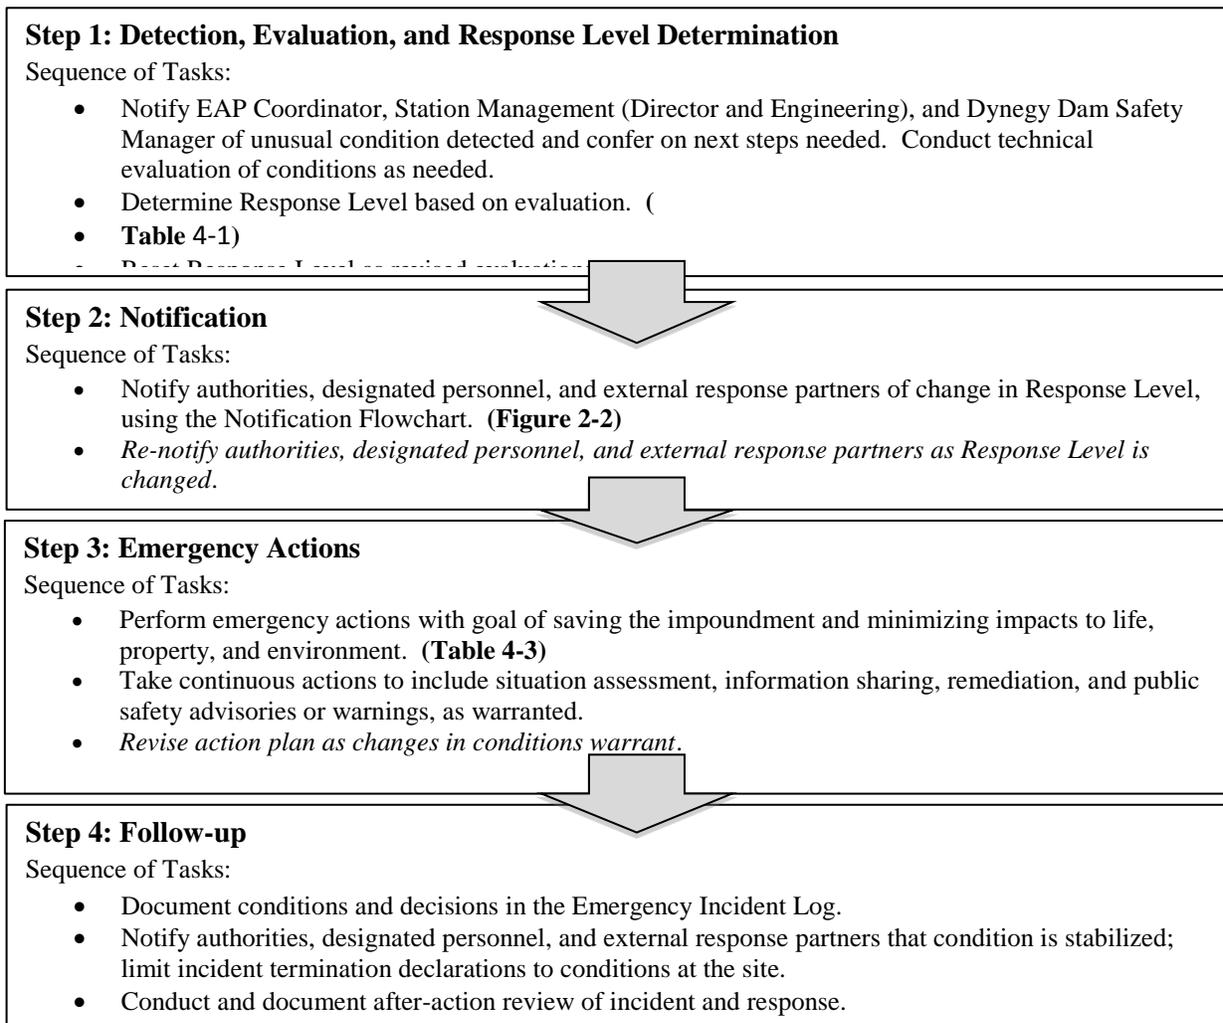
Figure 2-1. Summary/Sequence of Tasks 4-Step Incident Response Process

The 4-Step Incident Response Process is outlined in Figure 2-1. This should be used in conjunction with the Notification Flowchart (Figure 2-2) and EAP Decision Tree (Figure 2-3). Section 4 provides guidance tables for determining Response Levels and a table providing emergency actions to be taken given various situations. Table 2-1 lists contact information for the emergency responders.

The 4-Step Incident Response Process is shown in Figure 2-1. The Decision Tree shown in Figure 2-3 provides a flowchart for the various elements of the response process. Upon reaching Step 4 of the response process (termination and follow-up), the EAP Coordinator is responsible for notifying the ESDA/EMA’s that the condition of the dam/impoundment has been stabilized. The purpose of this section is to provide specific information that can be used during a response. This information is provided in the following tables:

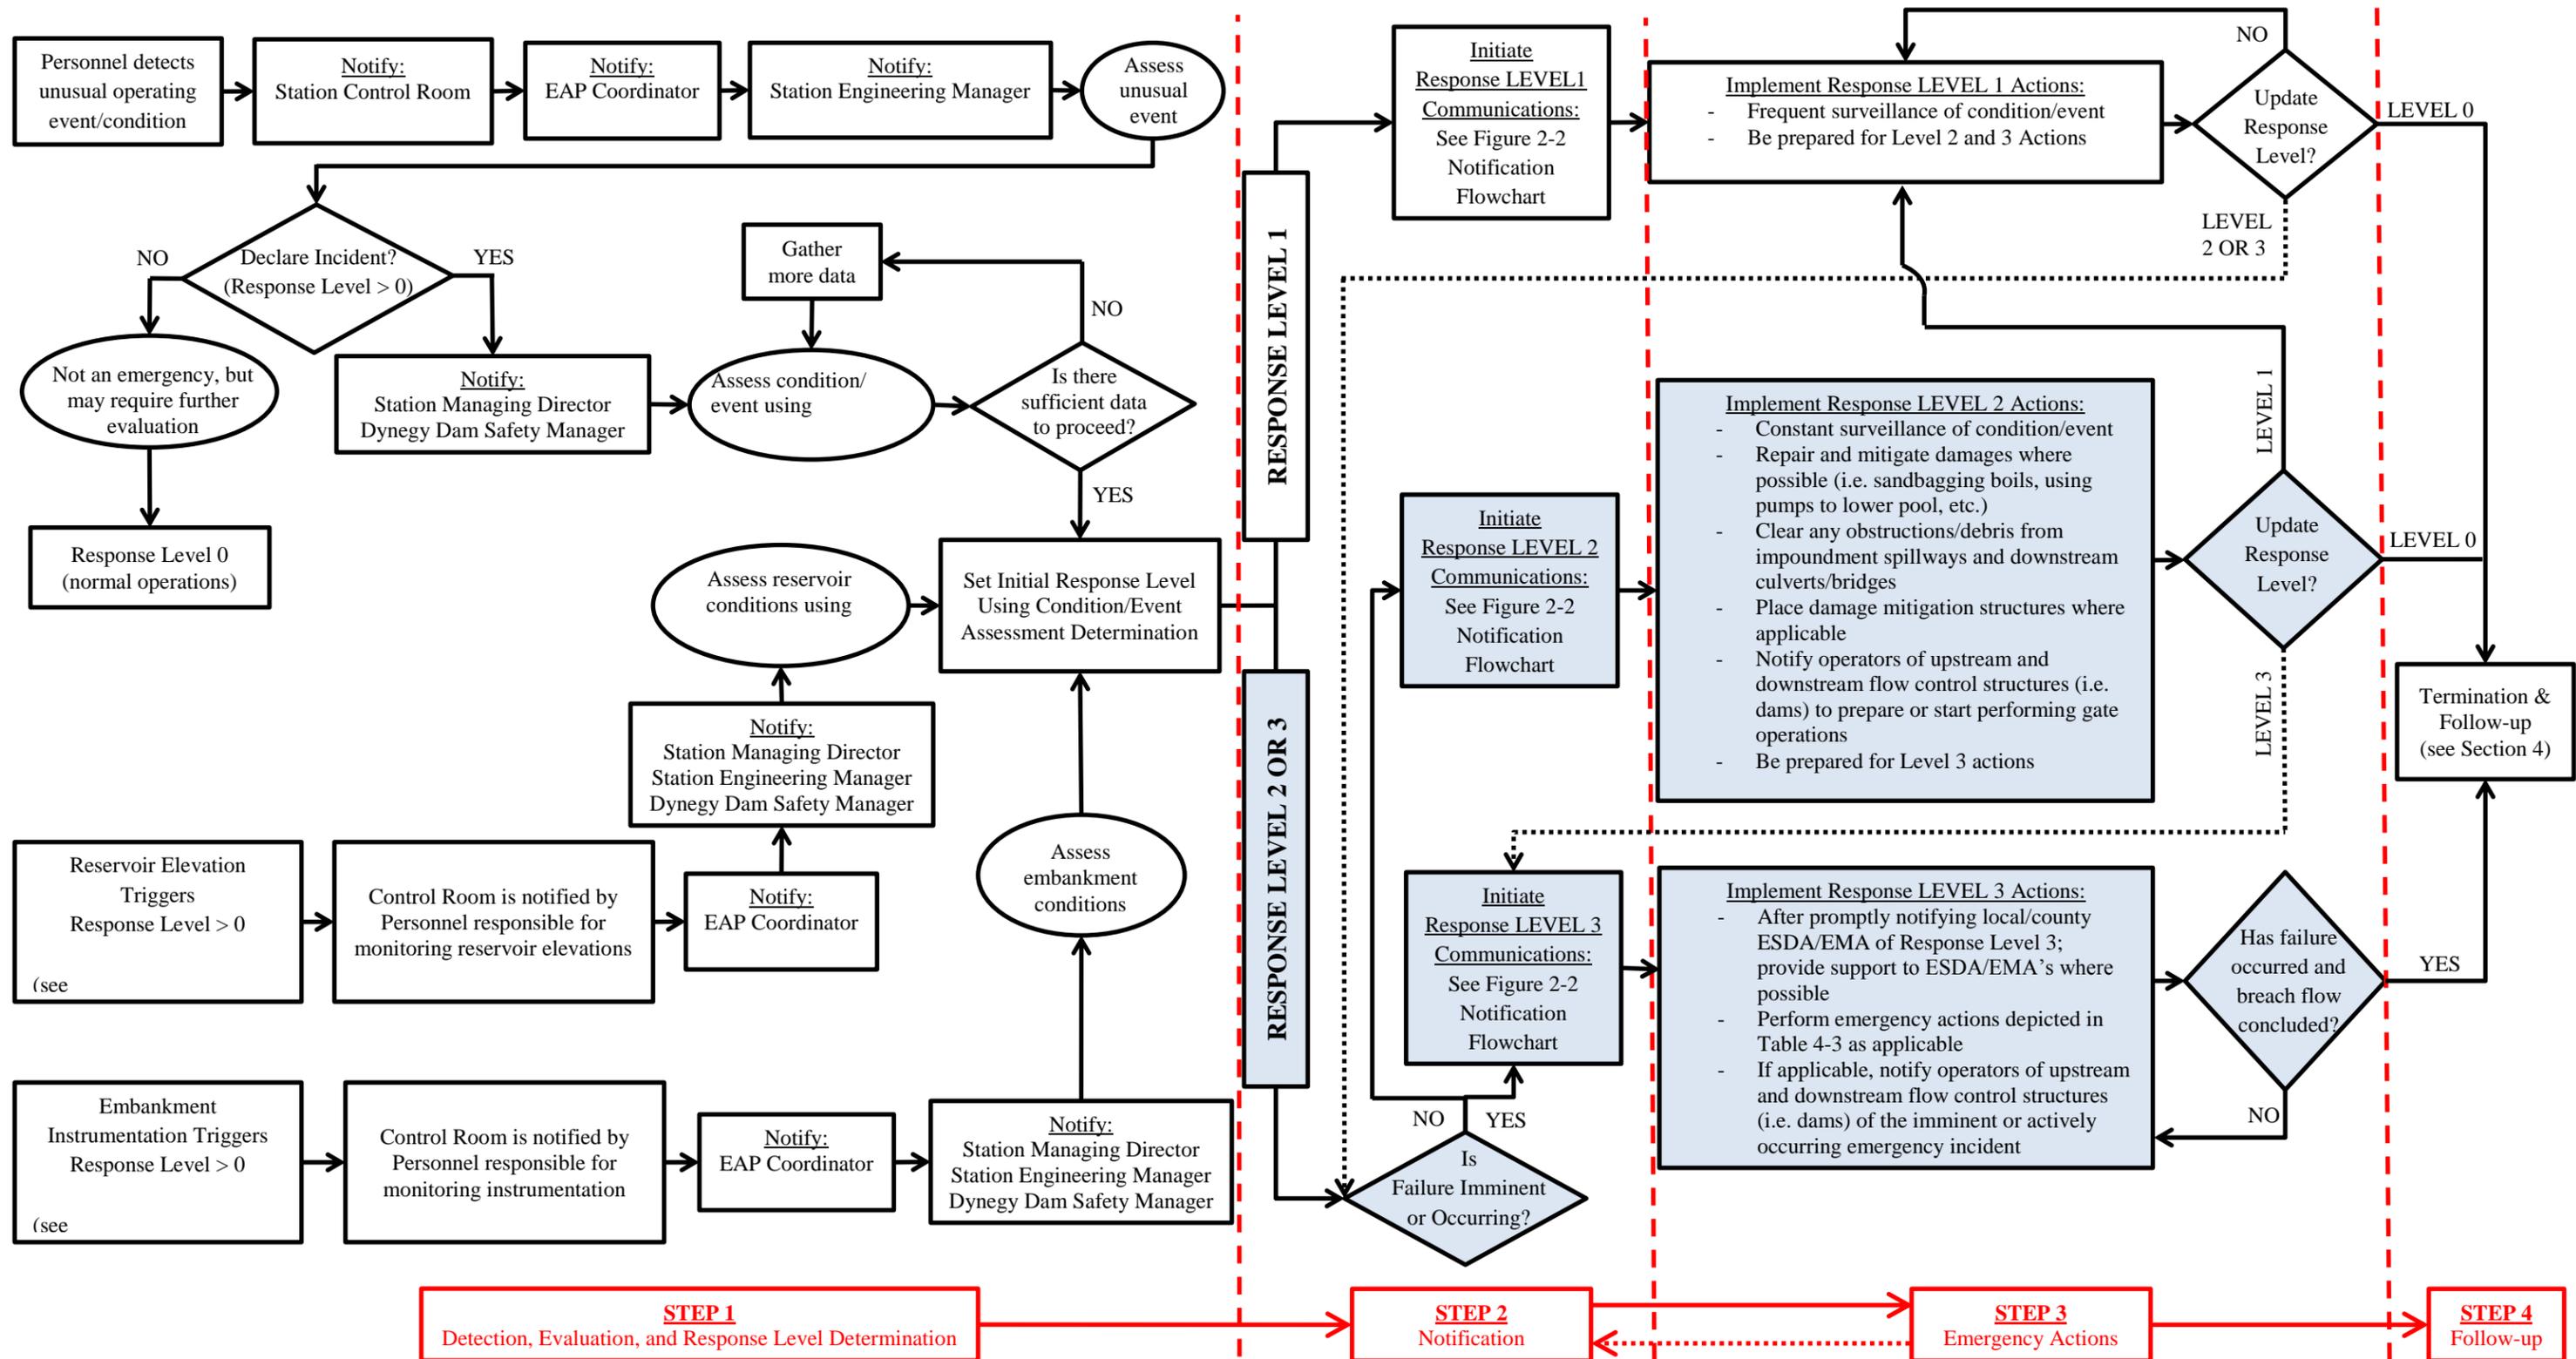
Figure 2-3. EAP Response Process Decision Tree

Note: At any given below, if failure is imminent or actively occurring CALL 911 IMMEDIATELY to notify emergency responders and then continue with process afterwards.

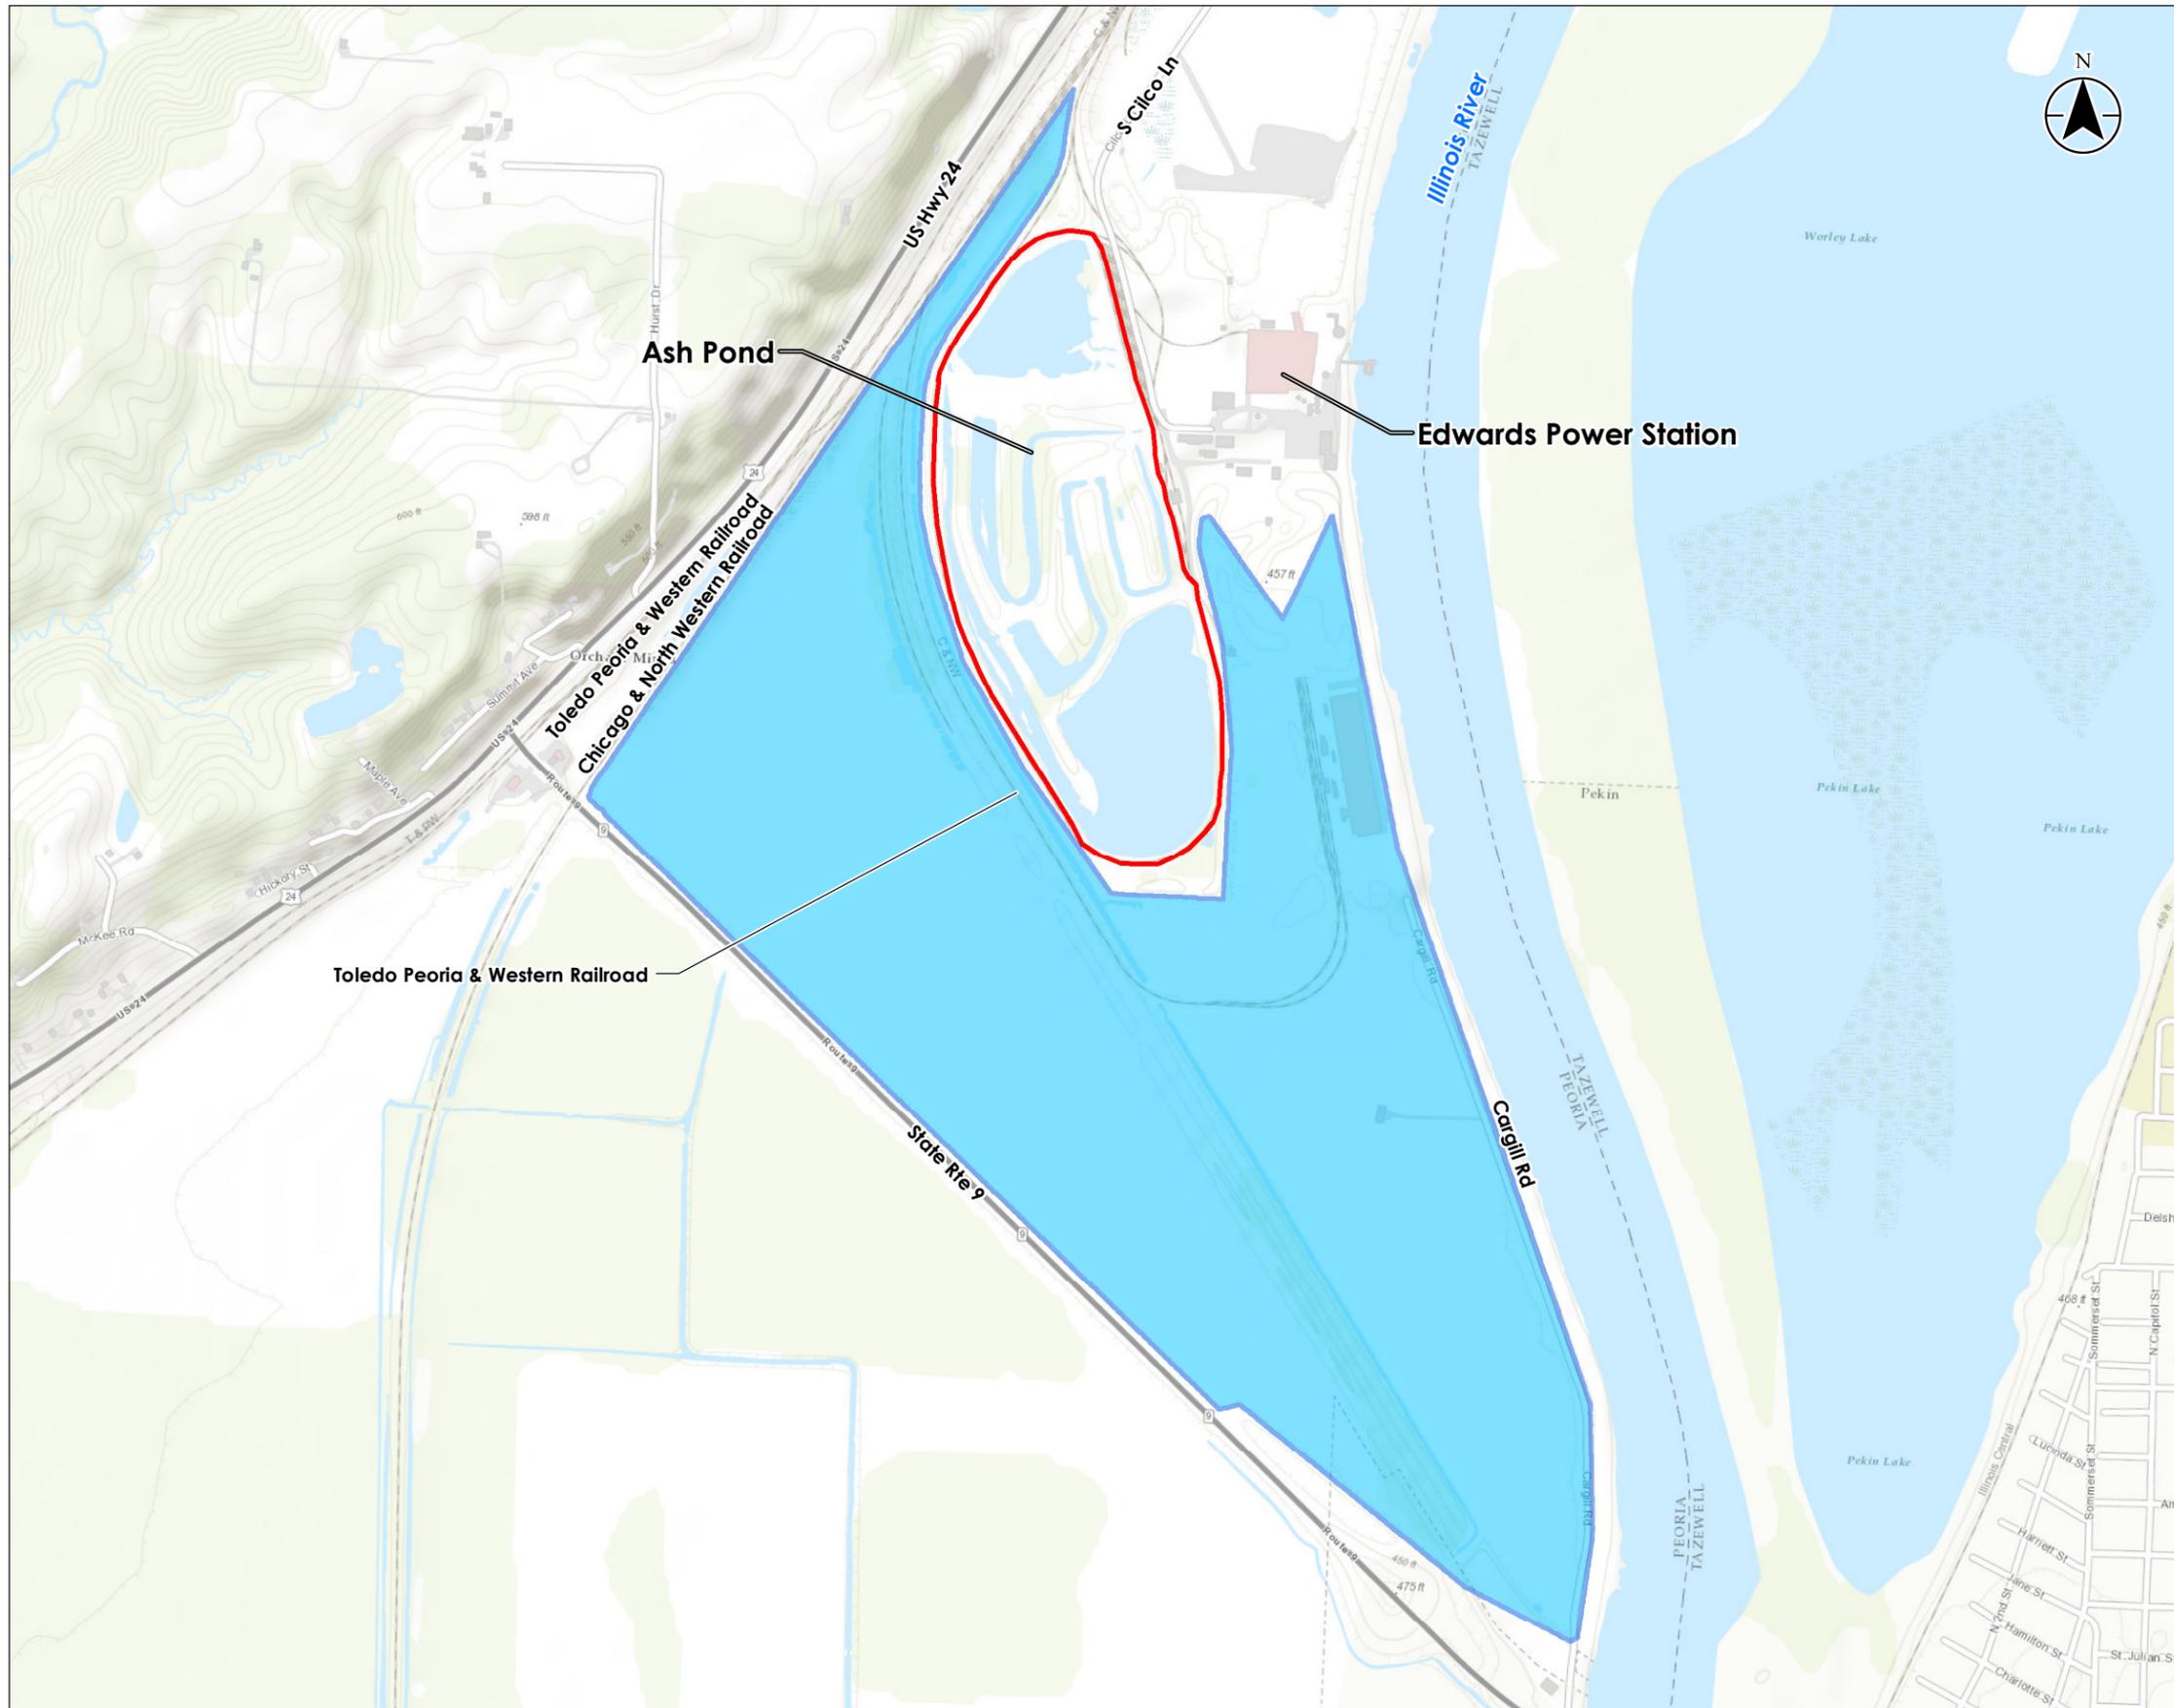
Legend
 [Red Outline] CCR Surface Impoundment Boundary
 [Blue Area] Expected Breach Inundation Area

The methodology used to identify probable inundation extents for potential breach scenarios varied as a function of the impoundment size, location, surrounding topography, and surrounding structures/facilities/waterbodies. Probable Maximum Flood (PMF) and crest volume transfer analyses were completed for potential breach scenarios to the west and east embankments of the Ash Pond. The approximate inundation area is illustrated in Figure 7-1.
