**ANNUAL CCR SURFACE IMPOUNDMENT  
INSPECTION REPORT (per 40 CFR 257.83(b)(2))**

Power Station: Hennepin Power Station

CCR Impoundment: East Ash Pond

Date of Inspection: 11/2/2016

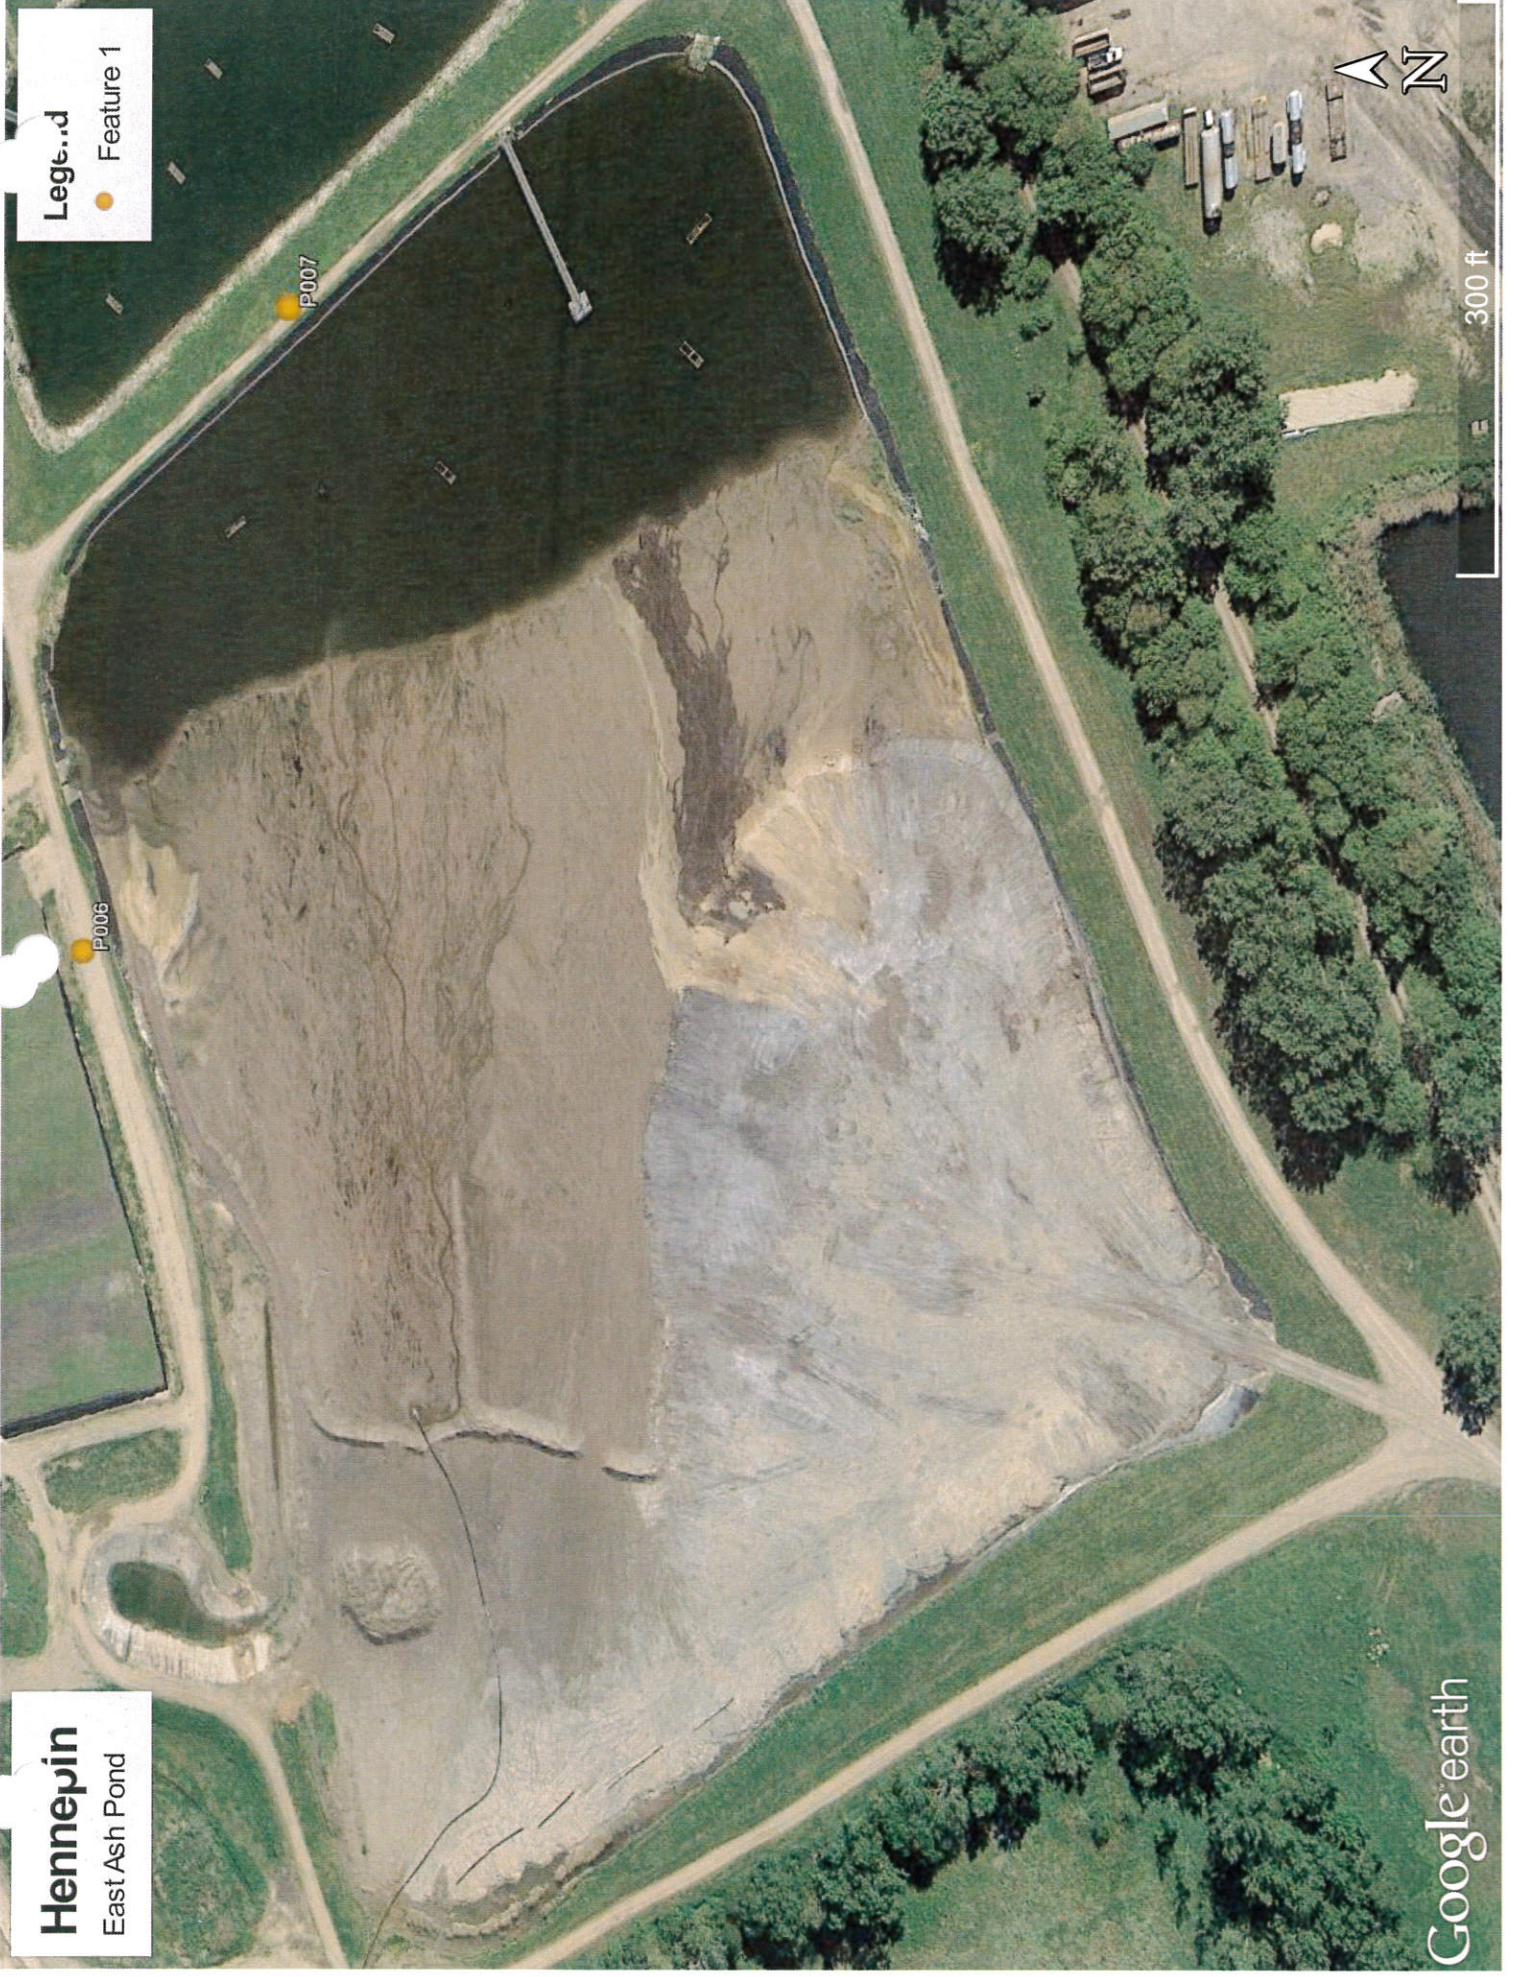
East Ash Pond

- ii) Instrumentation  
(Please see following page for instrumentation location map)
