Electric Energy, Inc.

JOPPA POWER STATION
JOPPA, MASSAC COUNTY, ILLINOIS

Emergency Action Plan (EAP)

- East Ash Pond (NID # IL50714)

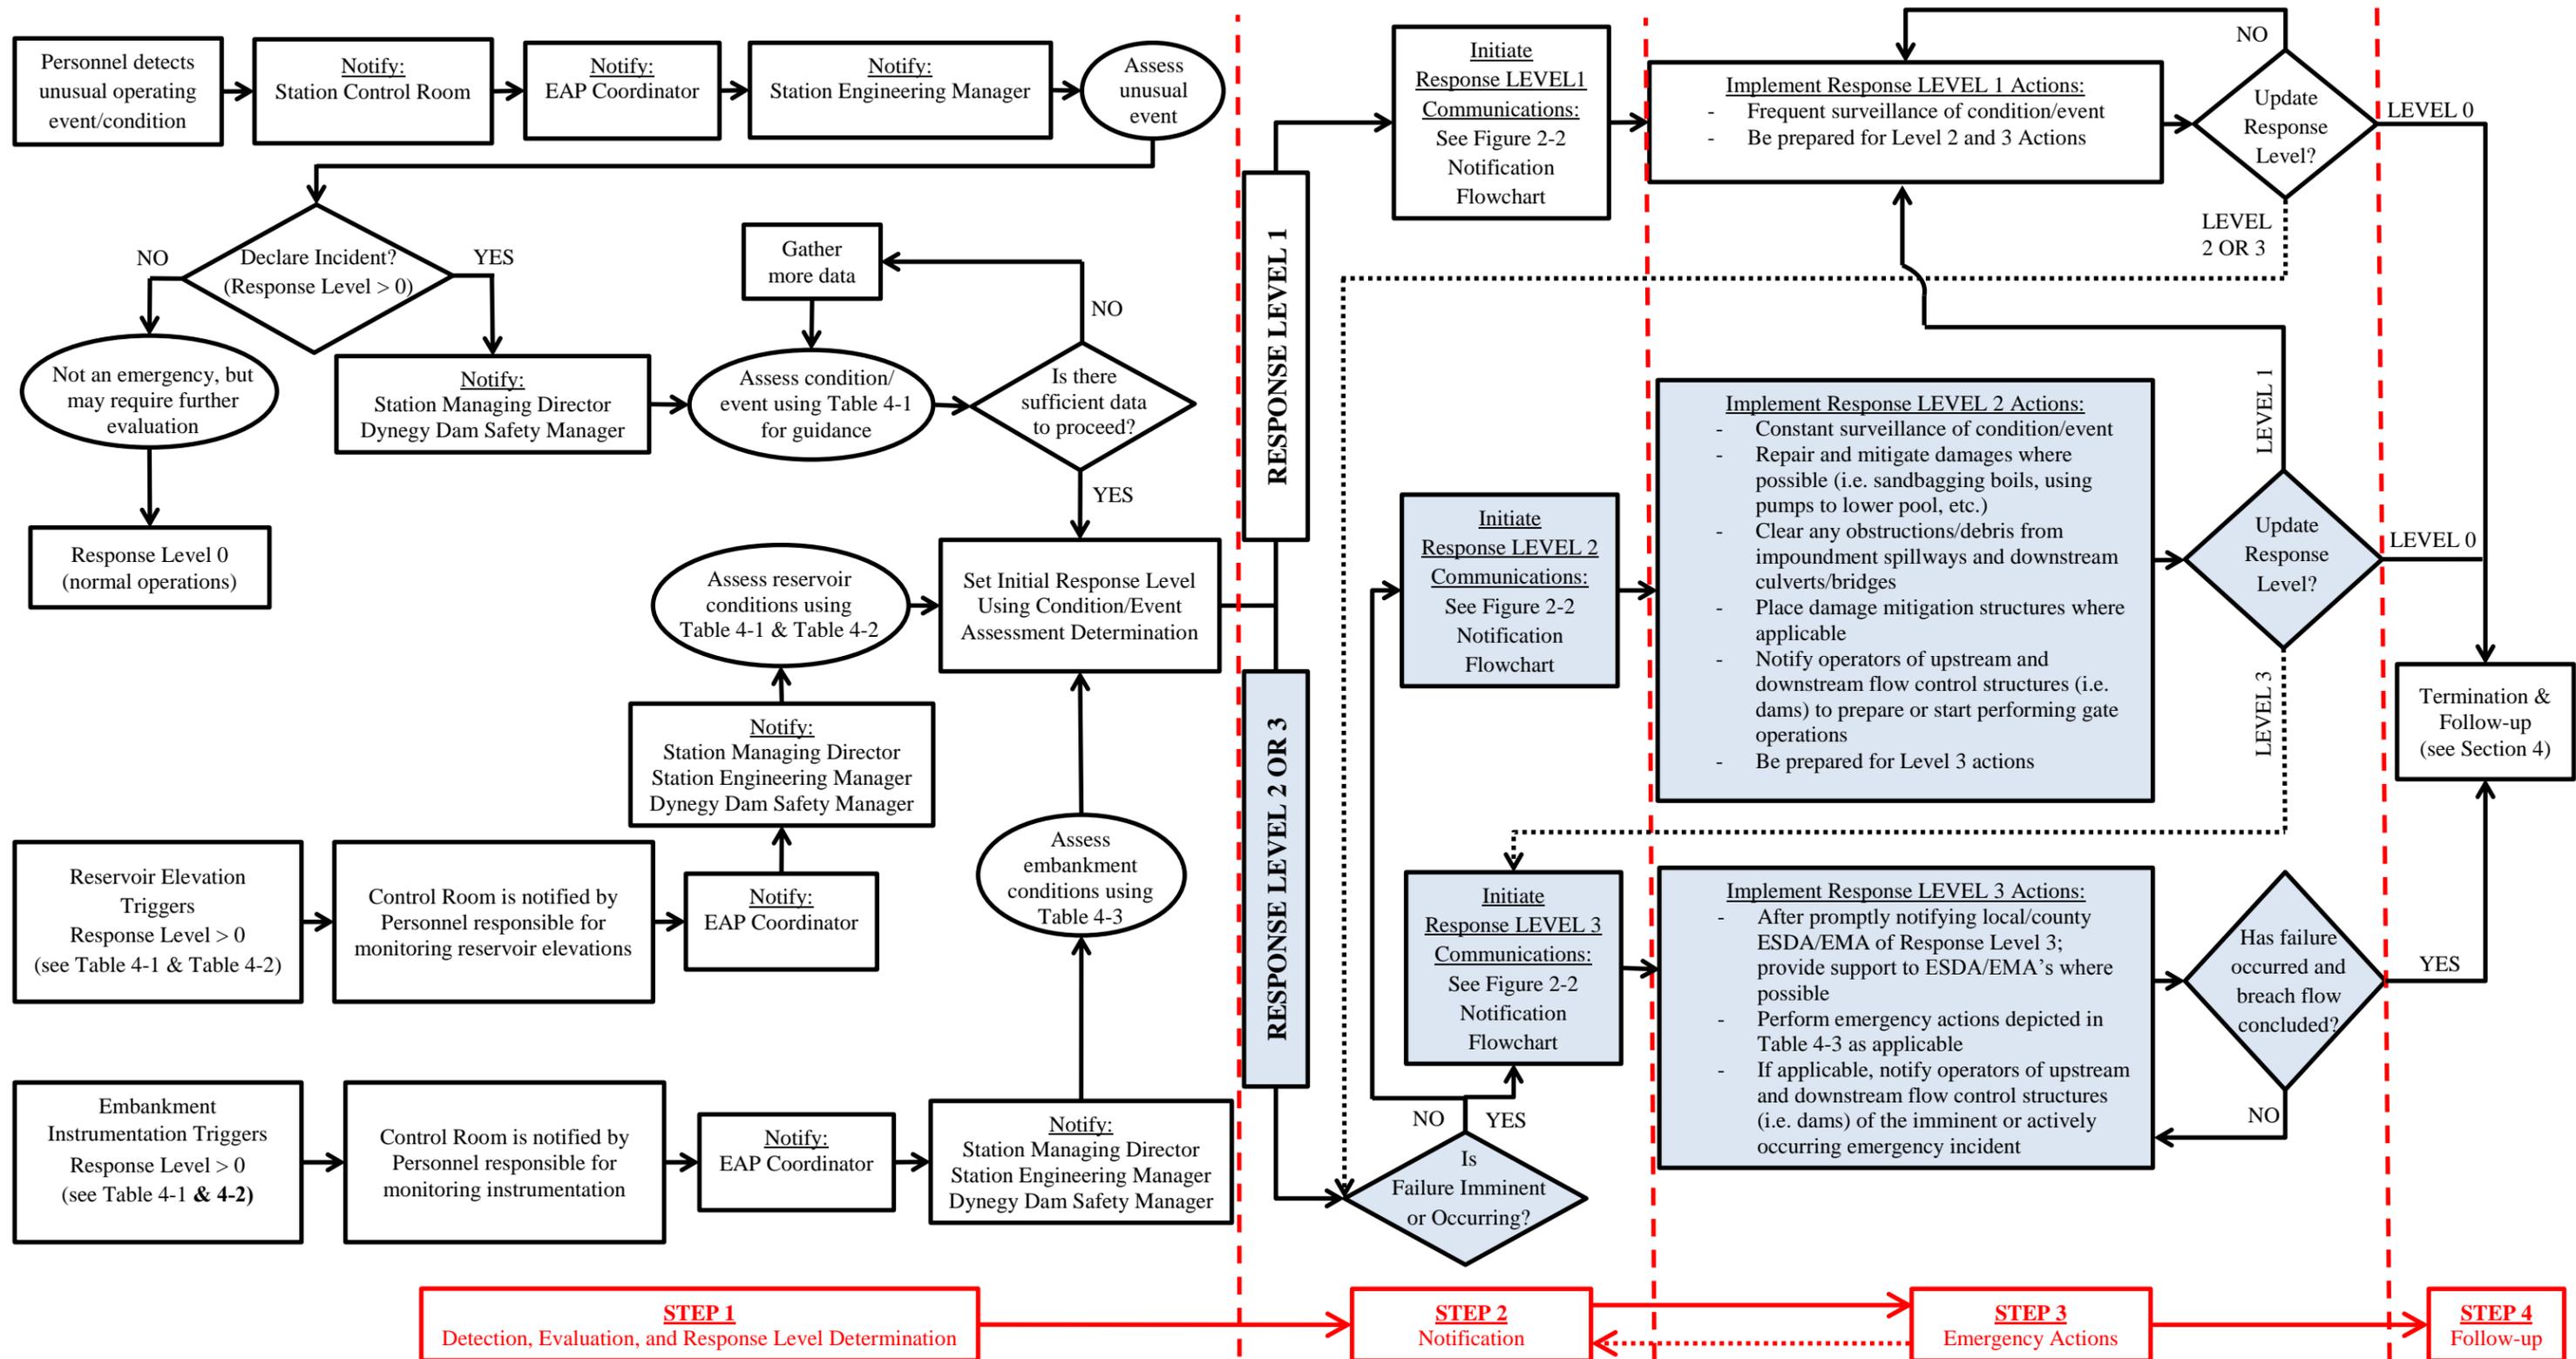
Figure 2-3. EAP Response Process Decision Tree

Note: At any given below, if failure is imminent or actively occurring CALL 911 IMMEDIATELY to notify emergency responders and then continue with process afterwards.

The 4-Step Incident Response Process is outlined in Figure 2-1. This should be used in conjunction with the Notification Flowchart (Figure 2-2) and EAP Decision Tree (Figure 2-3). Section 4 provides guidance tables for determining Response Levels and a table providing emergency actions to be taken given various situations. Table 2-1 lists contact information for the emergency responders.

The 4-Step Incident Response Process is shown in Figure 2-1. The Decision Tree shown in Figure 2-3 provides a flowchart for the various elements of the response process. Upon reaching Step 4 of the response process (termination and follow-up), the EAP Coordinator is responsible for notifying the ESDA/EMA’s that the condition of the dam/impoundment has been stabilized. The purpose of this section is to provide specific information that can be used during a response. This information is provided in the following tables:

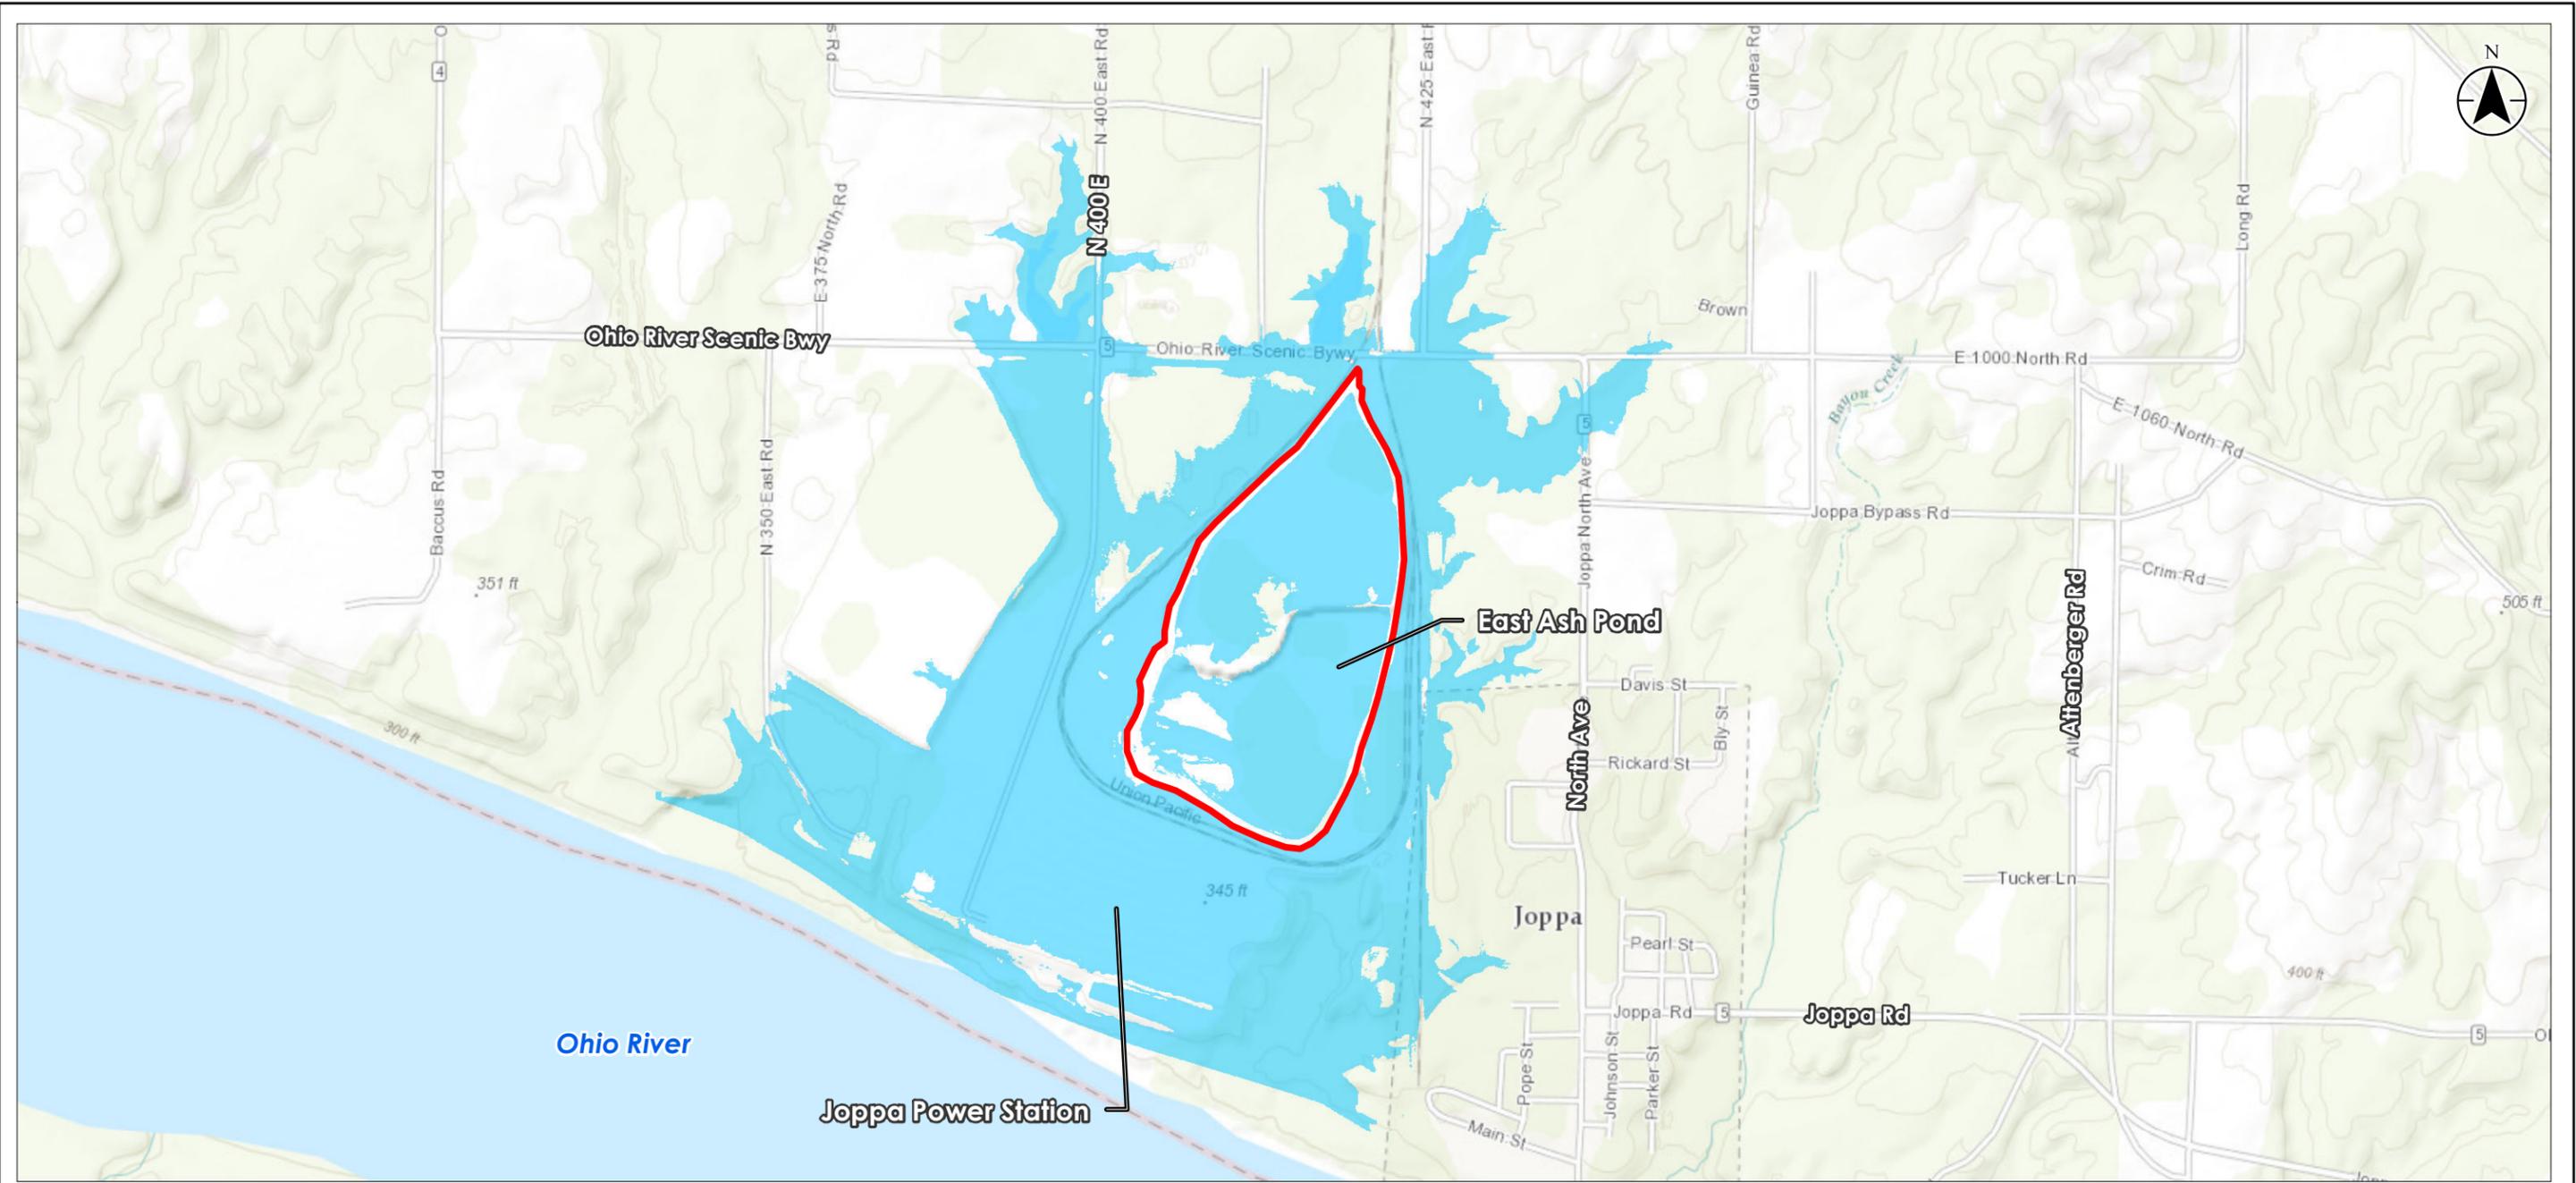
Figure No.
7-1

- Legend**
- CCR Surface Impoundment Boundary
 - Expected Breach Inundation Area

The breach scenario evaluated for the East Ash Pond was a piping breach during the Probable Maximum Precipitation (PMP) event. The East Ash Pond is perched and inflow from the storm events would consist of rainfall falling directly on the Pond. The freeboard for the Pond is greater than the PMP volume, therefore the pool elevation for the breach scenario was the normal pool plus the volume of the PMP event (38-inch depth across 103 AC footprint). Since the PMP event does not overtop the crest of the East Ash Pond, a piping breach was evaluated instead of an overtopping breach. Six breach locations were selected around the East Ash Pond. These locations include: one to the north, two breaches to the west, one breach to the south, and two breaches to the east. The total inundation extents were a combination of the six breach scenarios.

Approximate inundation area is illustrated in Figure 7-1.
