# Dynegy Midwest Generation, LLC

## WOOD RIVER POWER STATION *CITY OF ALTON, MADISON COUNTY, ILLINOIS*

### **Emergency Action Plan (EAP)**

#### **Coal Combustion Residual (CCR) Impoundments & Related Facilities**

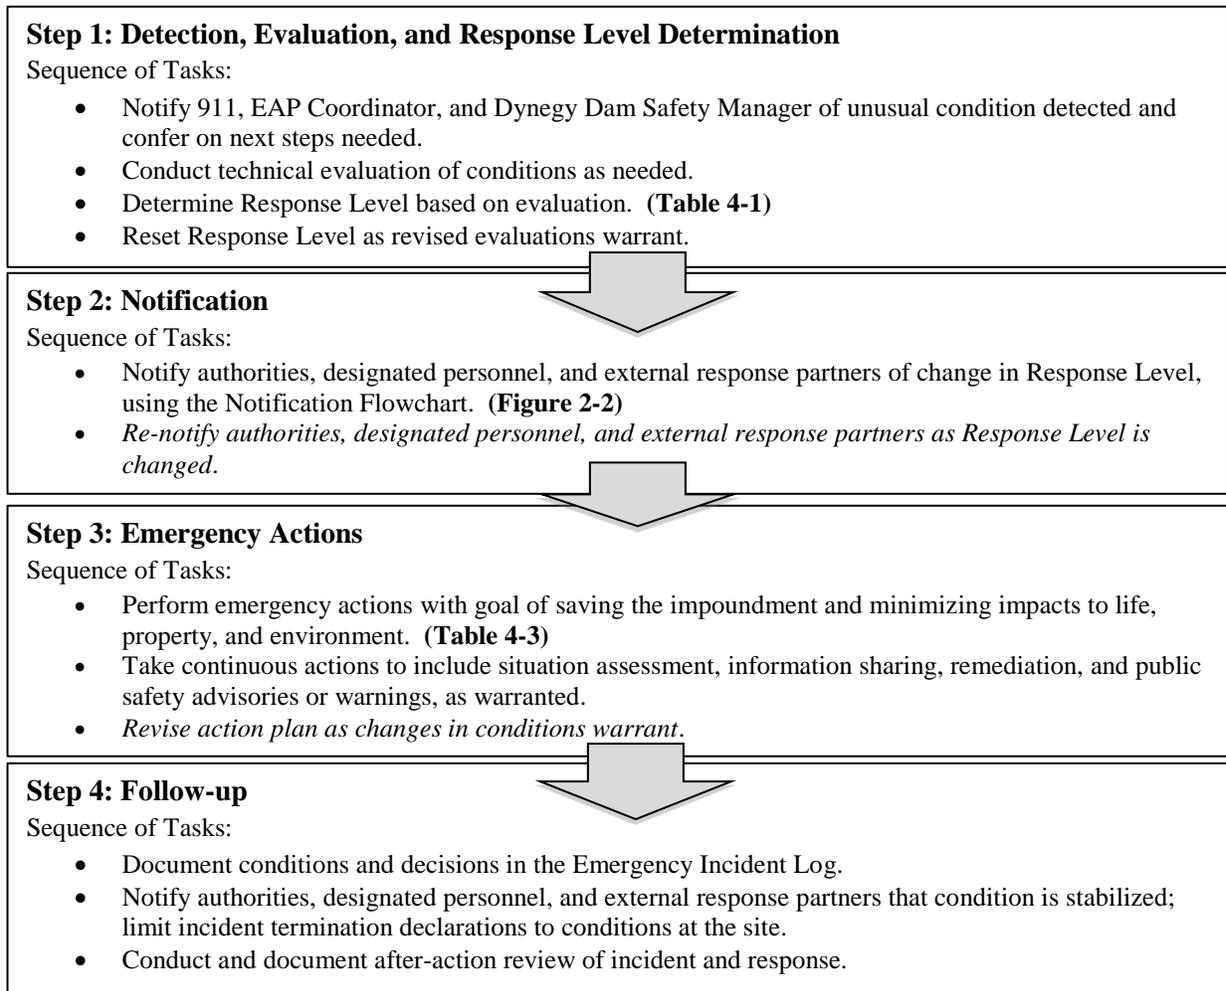
**Figure 2-1. Summary/Sequence of Tasks 4-Step Incident Response Process**

The 4-Step Incident Response Process is outlined in Figure 2-1. This should be used in conjunction with the Notification Flowchart (Figure 2-2) and EAP Decision Tree (Figure 2-3). Section 4 provides guidance tables for determining Response Levels and a table providing emergency actions to be taken given various situations. Table 2-1 lists contact information for the emergency responders.

The 4-Step Incident Response Process is shown in Figure 2-1. The Decision Tree shown in Figure 2-3 provides a flowchart for the various elements of the response process. Upon reaching Step 4 of the response process (termination and follow-up), the EAP Coordinator is responsible for notifying the ESDA/EMA’s that the condition of the dam/impoundment has been stabilized. The purpose of this section is to provide specific information that can be used during a response. This information is provided in the following tables:

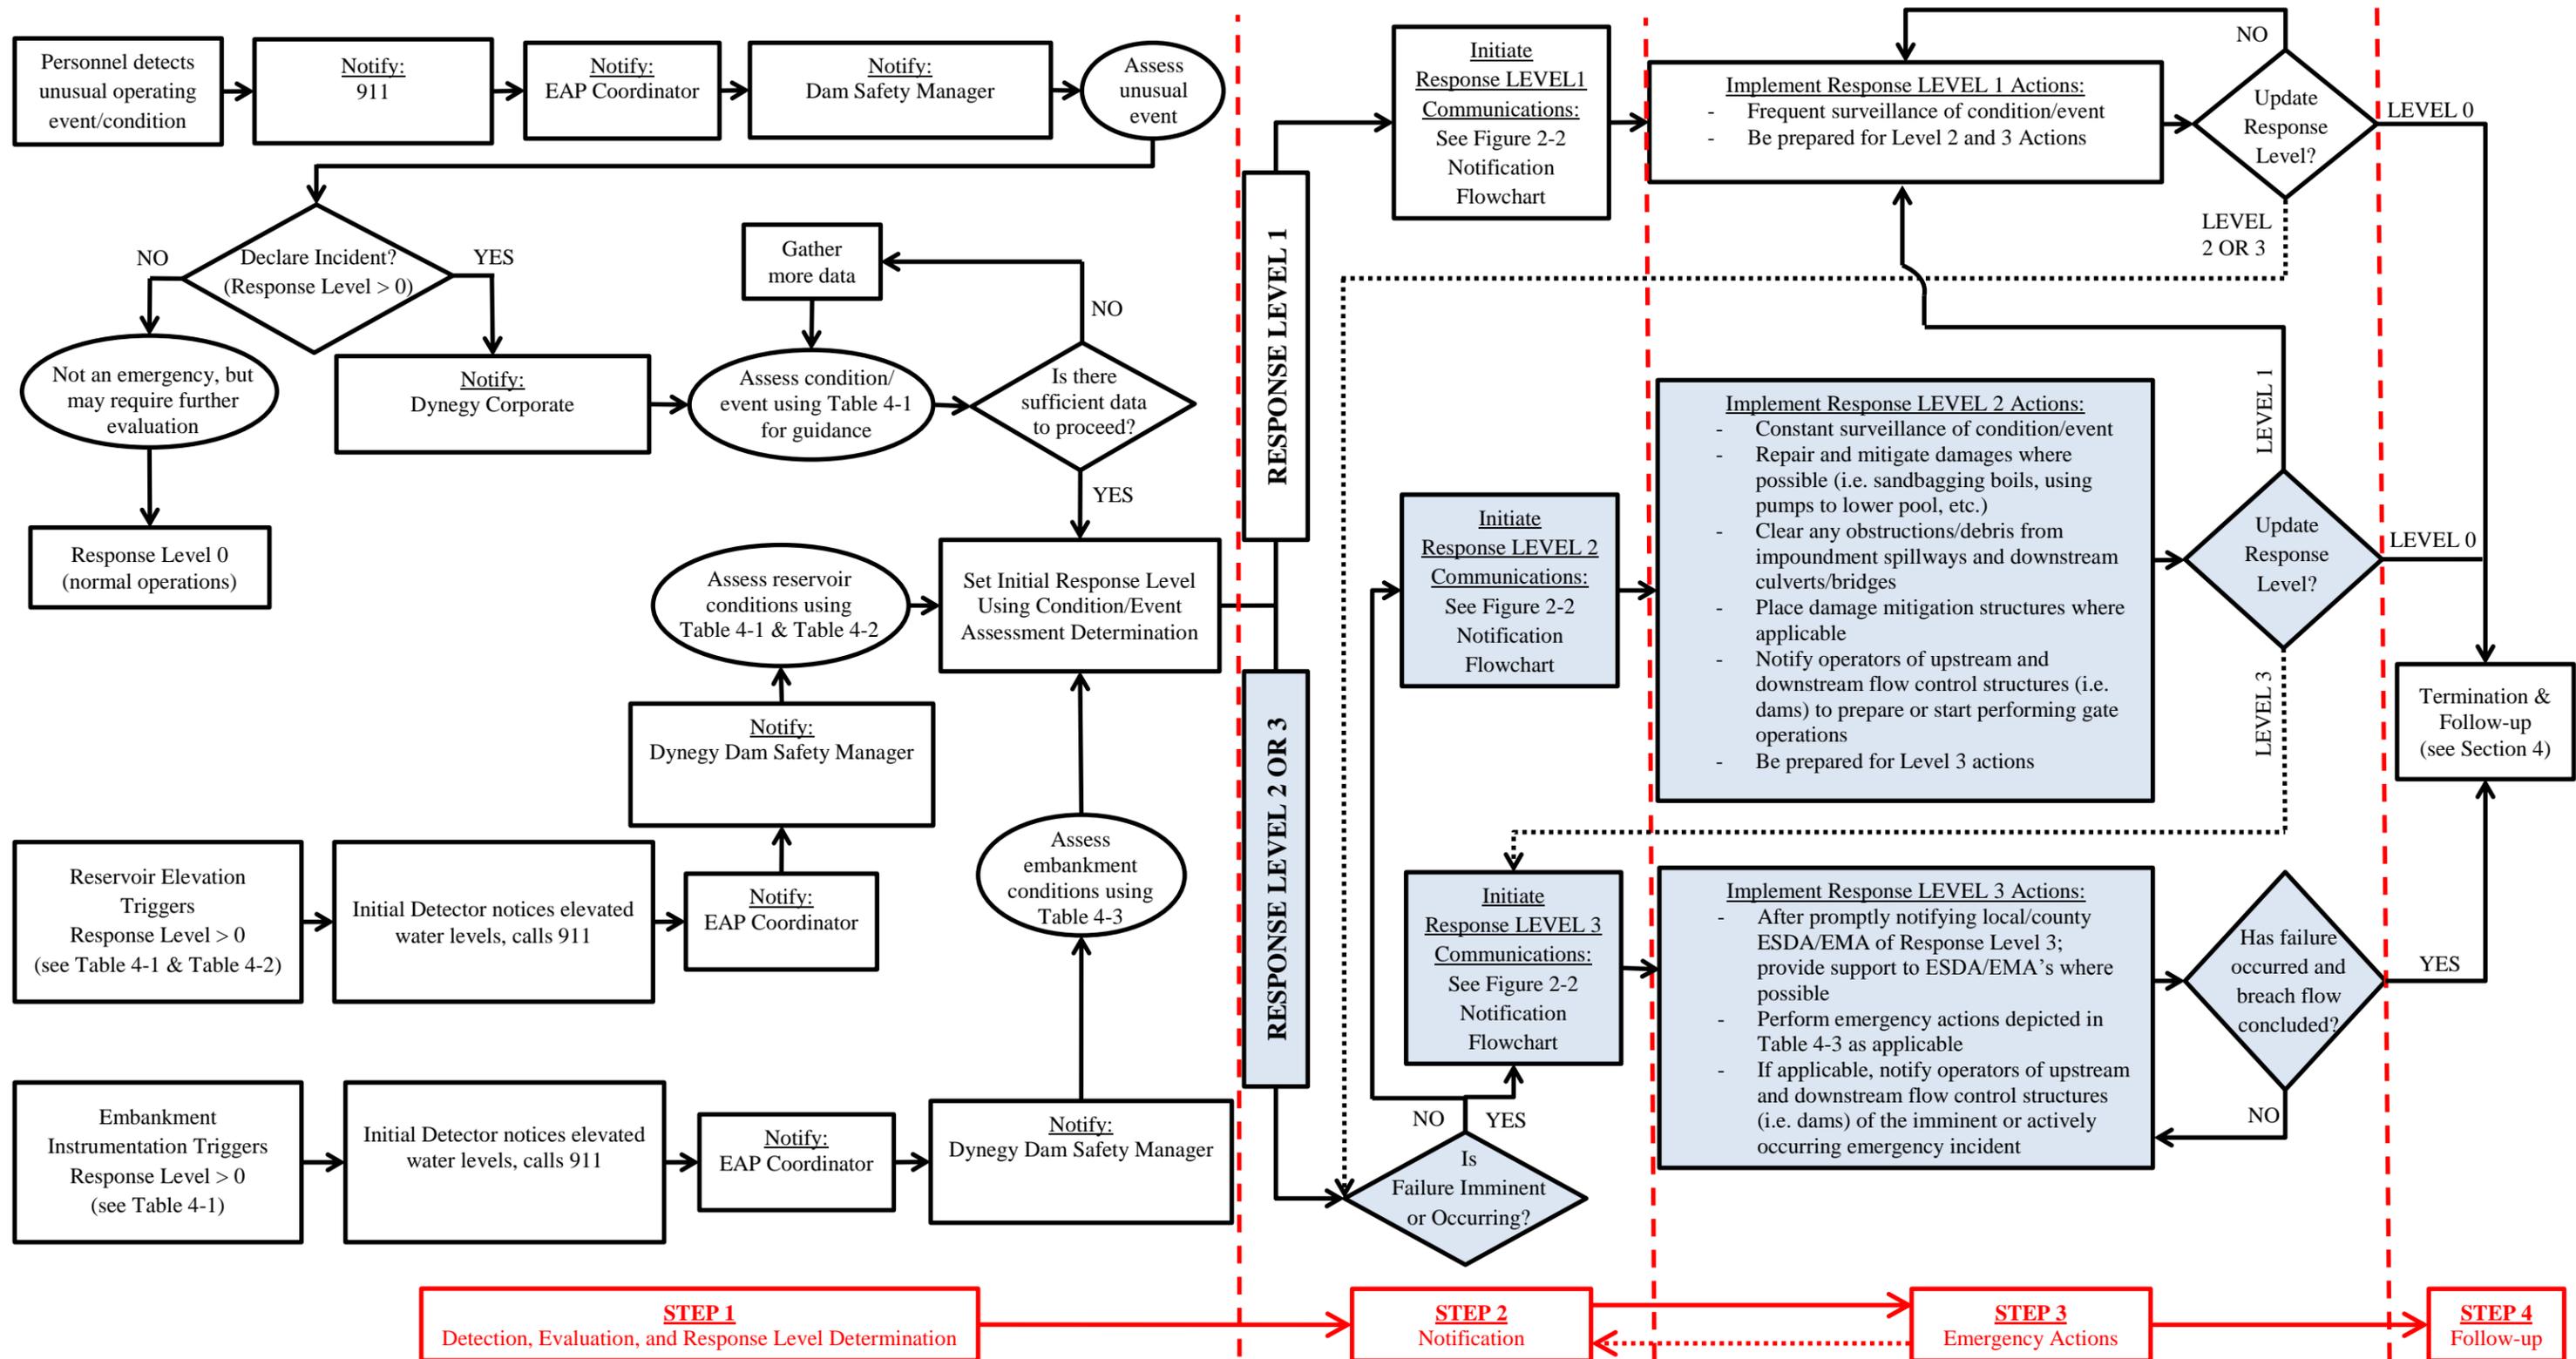
Figure 2-3. EAP Response Process Decision Tree

**Note:** At any given below, if failure is imminent or actively occurring CALL 911 IMMEDIATELY to notify emergency responders and then continue with process afterwards.

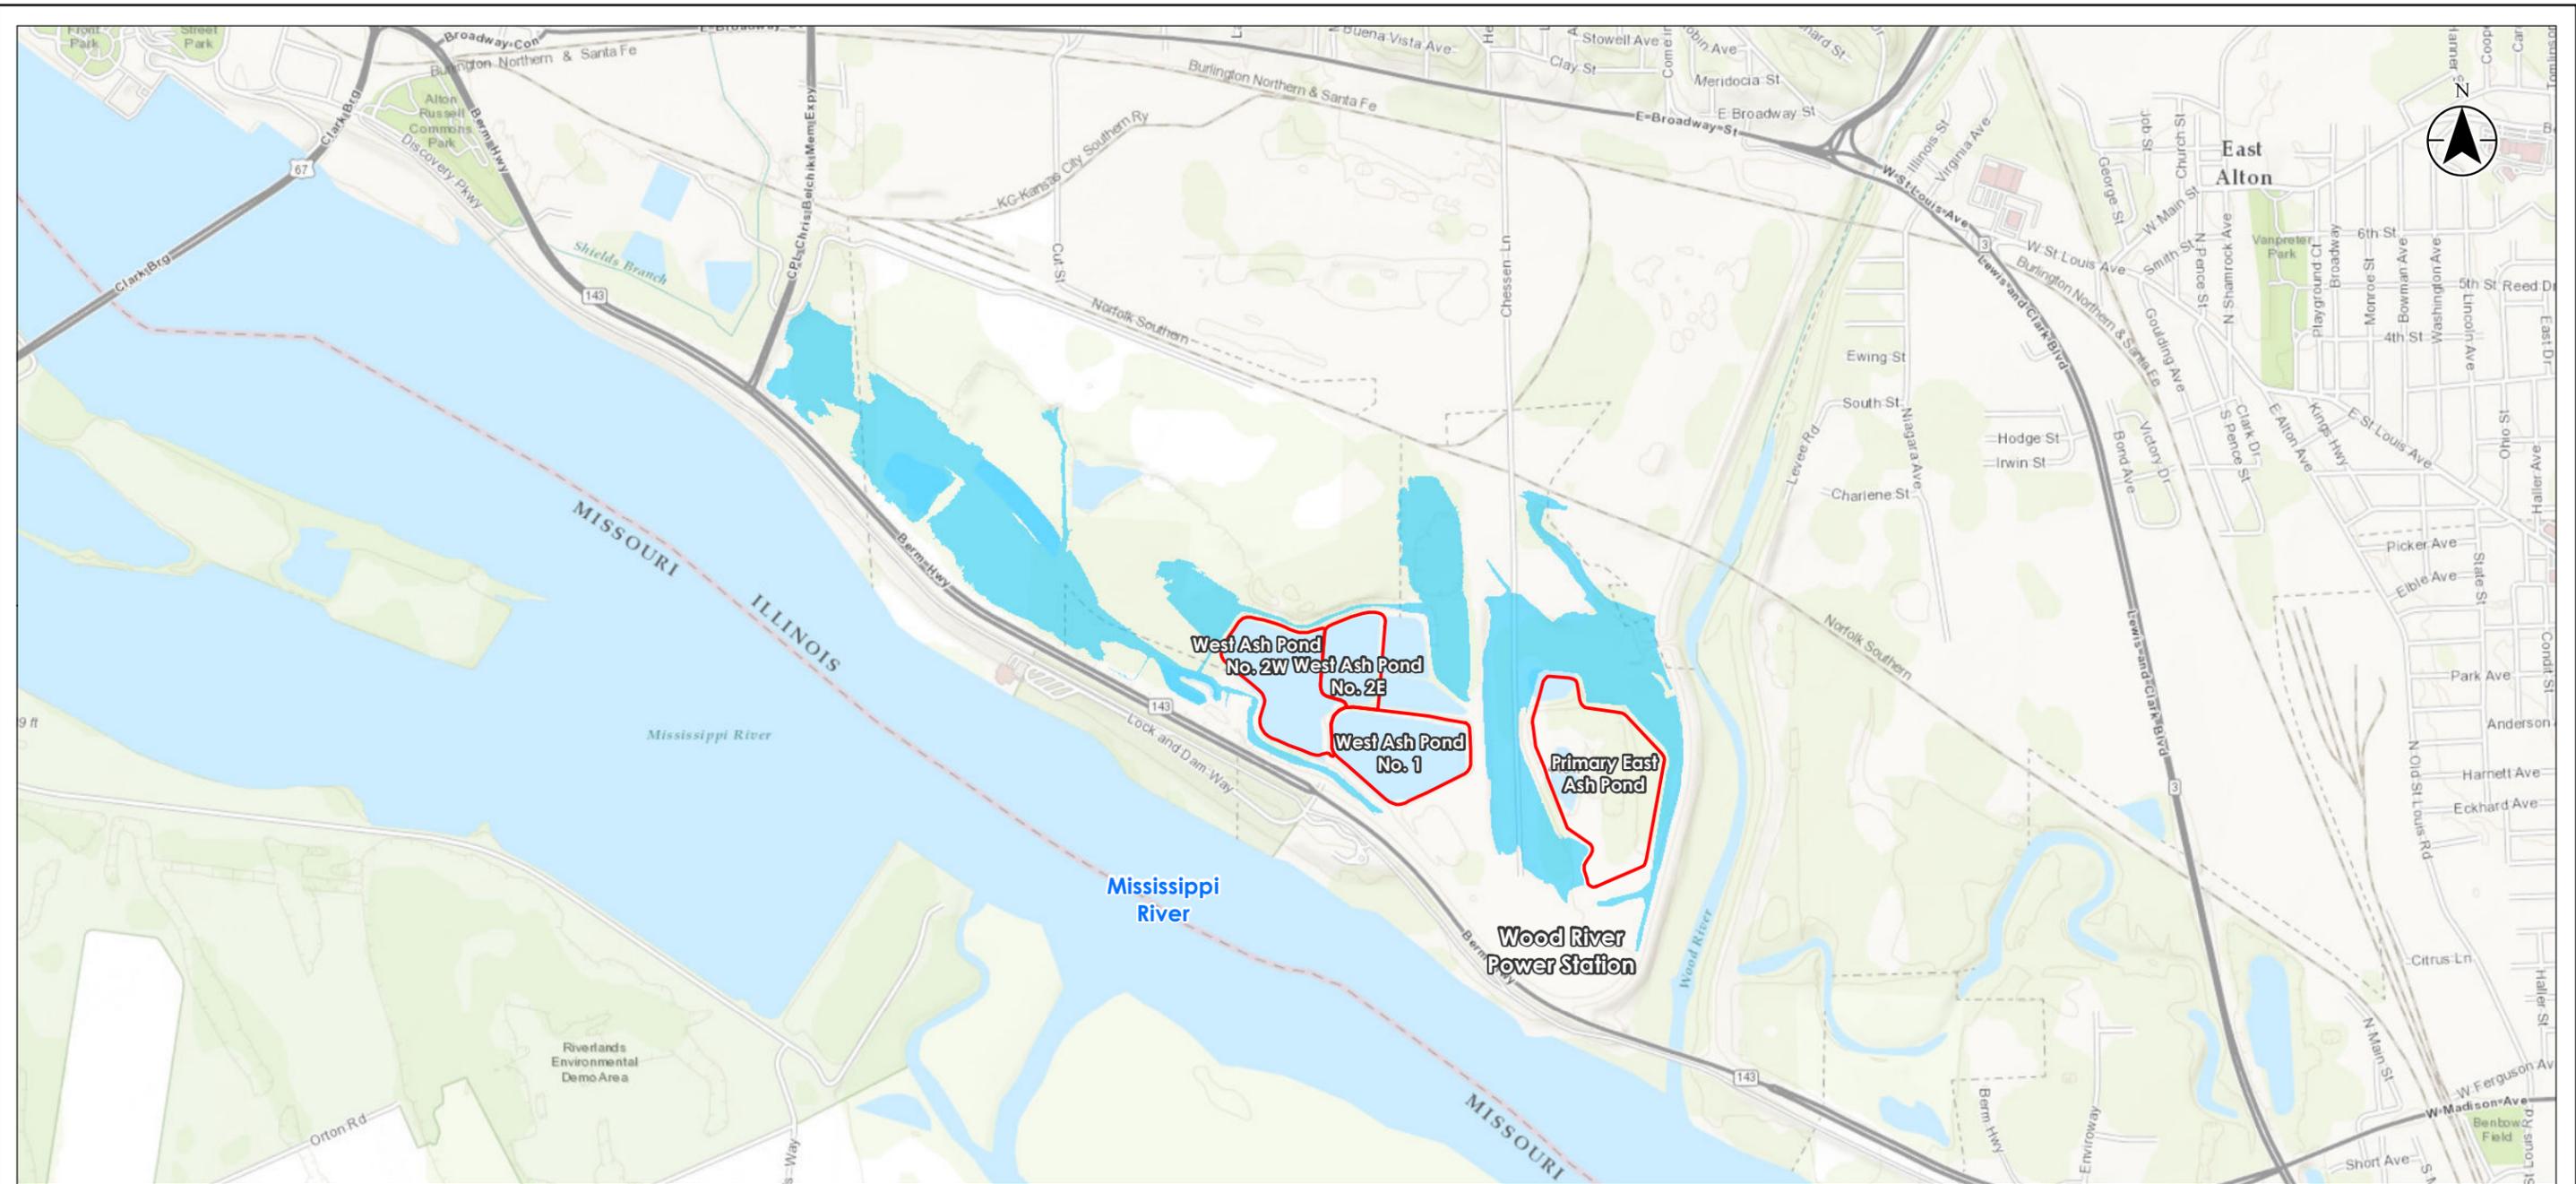
The approximate inundation area is illustrated in Figure 7-1.

- CCR Surface Impoundment Boundary
- Expected Breach Inundation Area

An inundation map for the Primary East Ash Pond and the West Ash Pond System potential breach scenarios is provided in Figure 7-1. It is the Madison County ESDA/EMA's responsibility to keep a current list of affected parties/properties to contact in the case of emergencies that result in Response Level 2 or 3. This list should encompass all properties within and adjacent to the probable inundation extents shown in the provided maps.

The methodology used to identify probable inundation extents for potential breach scenarios varied as a function of the impoundment size, location, surrounding topography, and surrounding structures/facilities/waterbodies. Inundation limits for the Primary East Ash Pond were based on the elevations published in the prior EAP for that impoundment. To develop those elevations URS (now AECOM) performed a volumetric analysis of the pond volume and potential breach inundation limit. Stantec developed breach inundation limits for the West Ash Pond System using a similar approach. All inundation limits were plotted using LiDAR topographic mapping data obtained from the Illinois Height Modernization Program.
