**ANNUAL CCR SURFACE IMPOUNDMENT  
INSPECTION REPORT (per 40 CFR 257.83(b)(2))**

Power Station: Baldwin Energy Complex

CCR Impoundment: Bottom Ash Pond

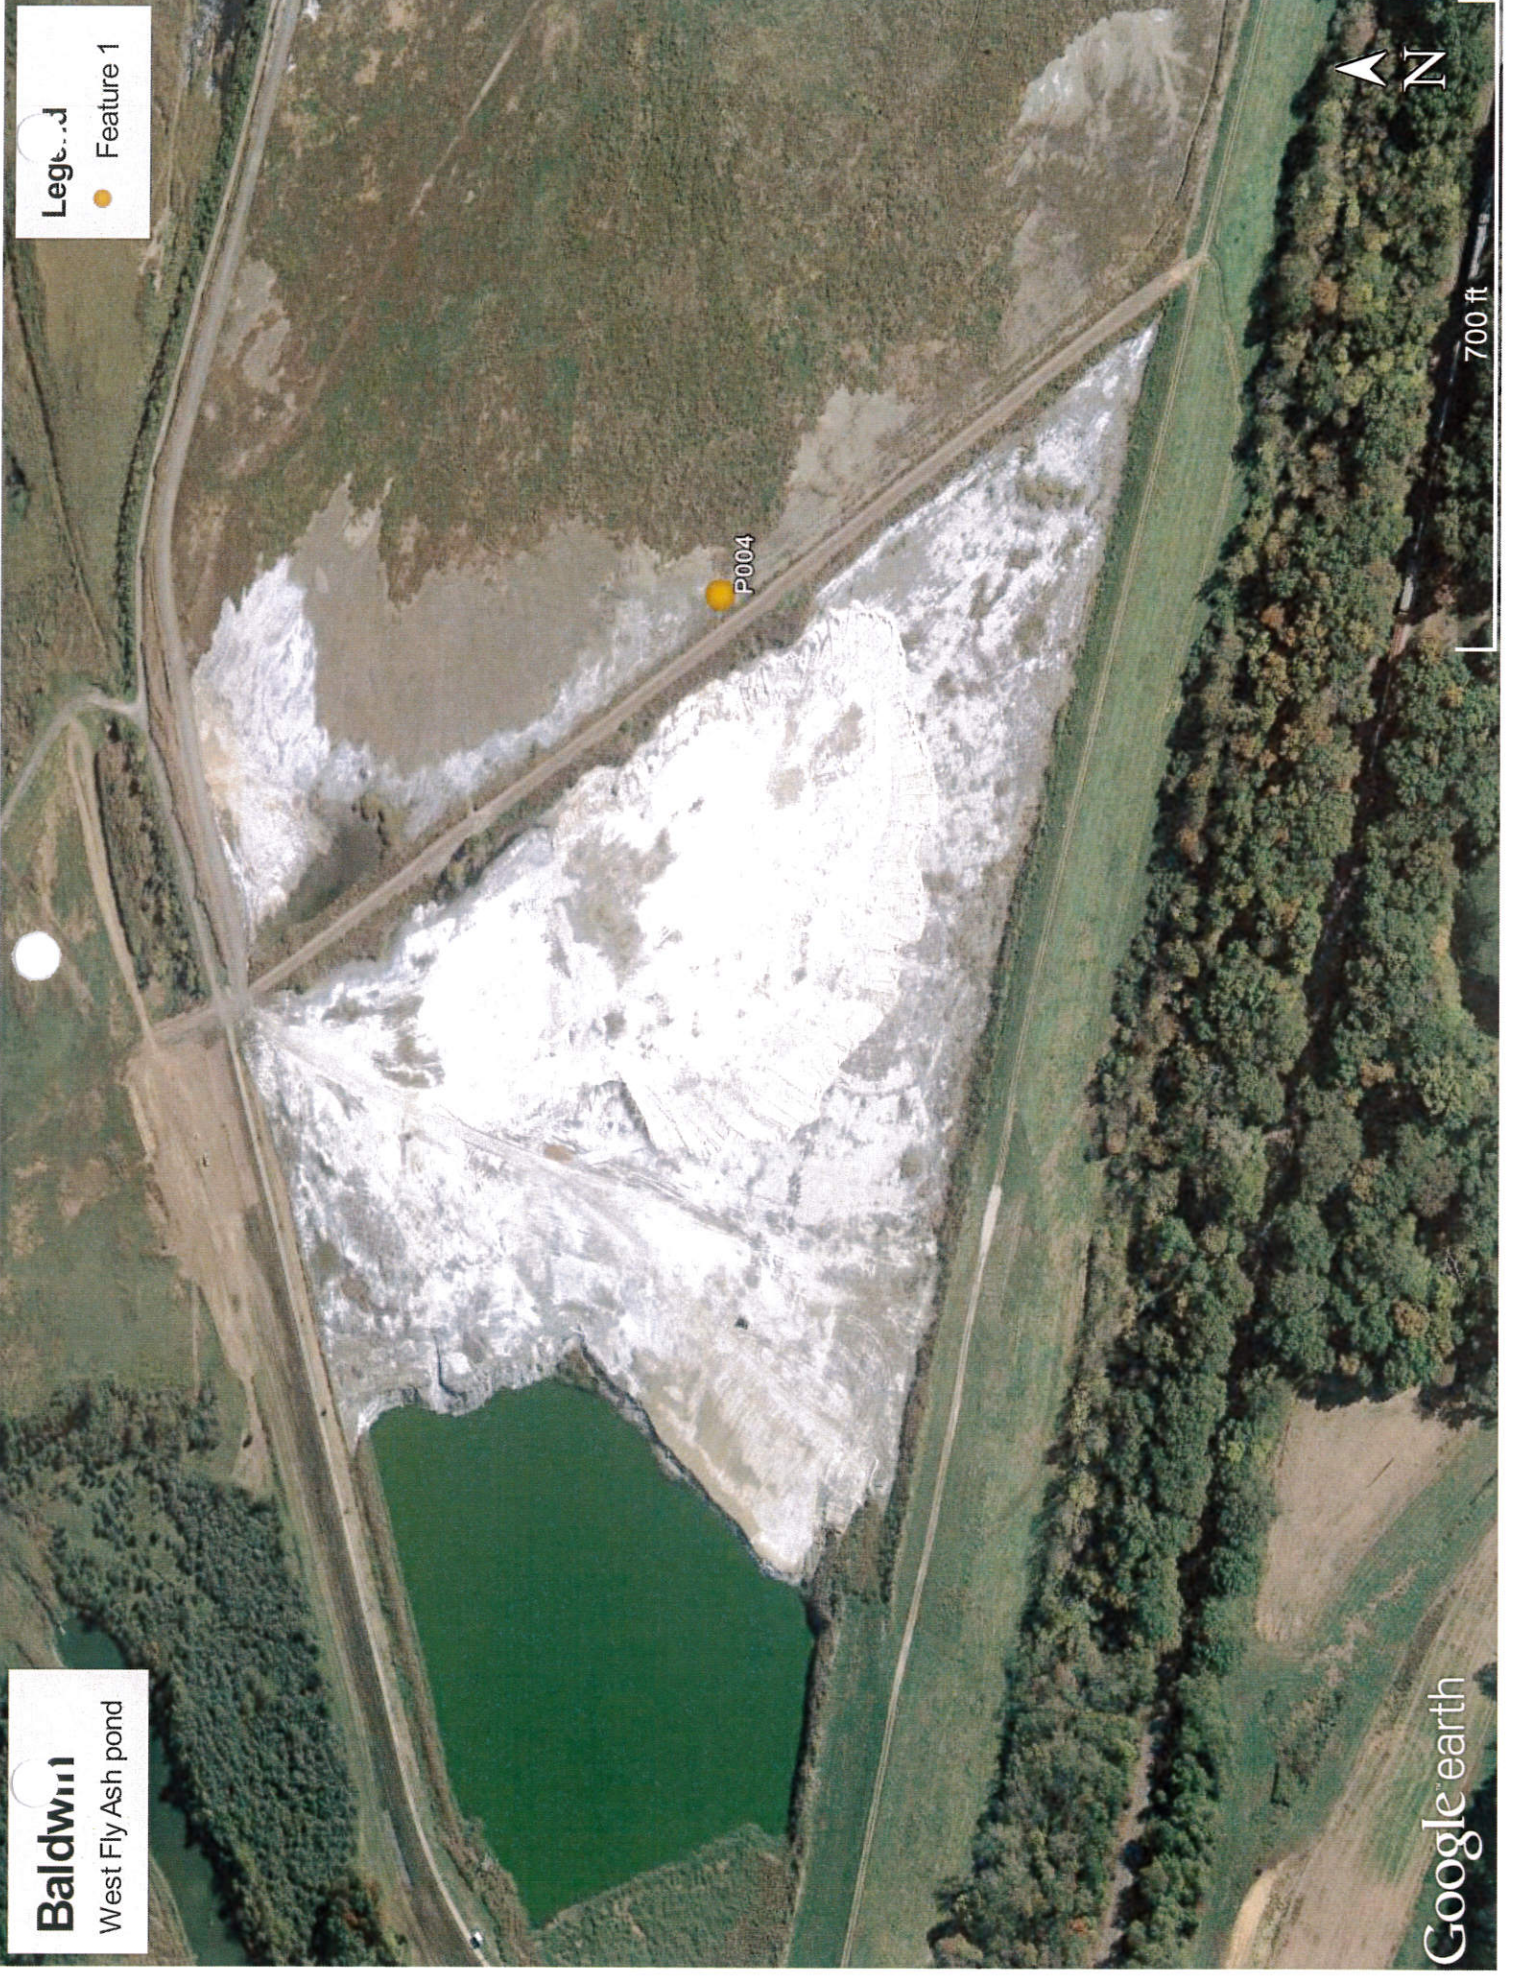
**Baldwin**  
West Fly Ash pond

(Please see following page for instrumentation location map)

Instrument ID #	Type	Maximum recorded reading since previous annual inspection (ft)
P004	Piezometer	440.4'
